**Flood Control Project Maintenance  
Levee Inspections**  
**LMA District Cover Sheet**  
**Spring 2017 Levee Inspection Results**

**Sutter Maintenance Yard Wadsworth Canal**

**Levee Inspection Report By Mile - Spring 2017**

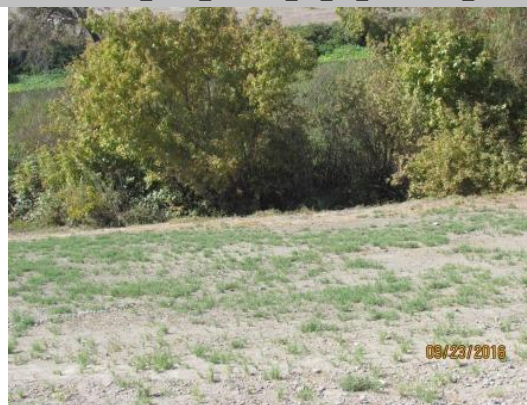
Photo 1 of 1 : SP\_2017\_ST0010\_42\_20\_20170315\_00012.jpg

View of the erosion along the waterside toe.

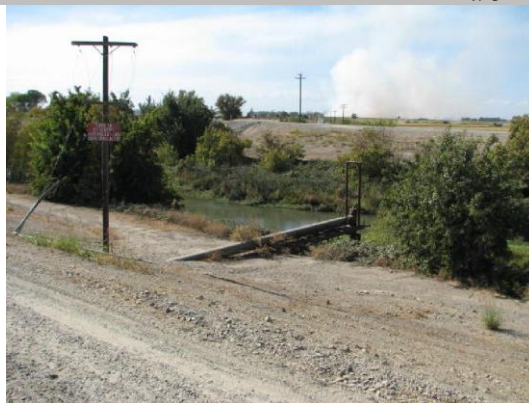
Photo 1 of 3 : UCIP\_SP\_2017\_51493\_64702.jpg

Comment Code					
Inspector Comment					
FS_ID:51493 DS_ID:17059 EP_NO: 1605 Repair Type: Non-Urgent Crossing Status: Found UCIP Comments: 4/10/2017 Abandoned. (DWR Sutter Yard-AFreitag)10/12/2016 Abandoned crossing.(DWR Sutter Yard -afreitag)4/16/2016 Abandoned crossing. Ws pipe end is open and should be capped.5/12/2015 Abandoned crossing. Needs to be properly abandoned.11/18/2014 Same as last inspection.5/13/2014 Same as last inspection.10/29/2013 Same as last inspection.5/16/2013 Same as last inspection.10/9/2012 No pump on Pier and power lines cut. Apparently abandoned-should be abandoned properly. FIELD_STRUCT_DESC: *ABANDONED* 18-inch steel irrigation pipe (permit records indicate 16-inch pipe) through the levee, 3.7 feet below the crown. Siphon breaker on the wterside (WS) slope. Pump on channel bank on steel structure. (16-inch pipe authorized under Permit No. 1605, 1959 - Schnabel, aerial 12 KV power line extension for pump authorized under Permit No. 1631, 1959 - Pacific Gas and Electric Company [PG&E]) [Additional Reference(s): DWR Levee Log, 2005]. FS Date: 4/12/2017 9:32:31 AM

Power pole with cut powerlines, pump missing from steel pier.

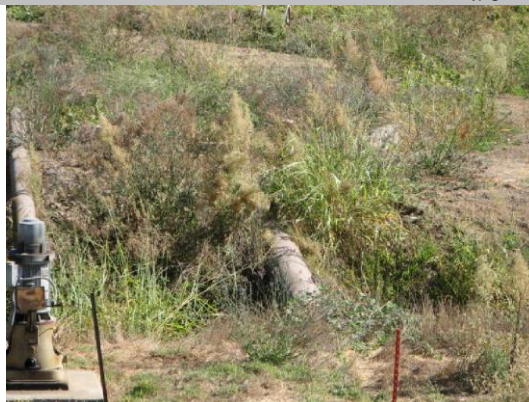
Photo 2 of 3 : UCIP\_SP\_2017\_51493\_64701.jpg

Pipe on LS toe.

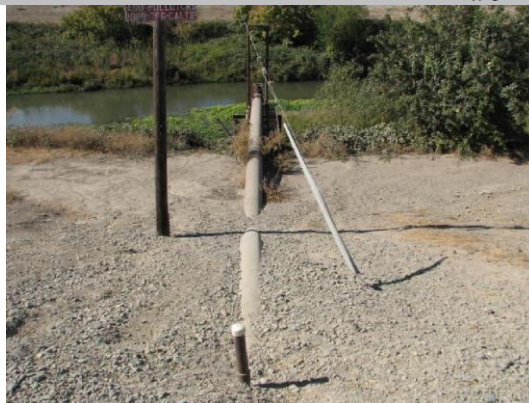
Photo 3 of 3 : UCIP\_SP\_2017\_51493\_64700.jpg

Pipe on WS slope with siphon breaker at WS shoulder.

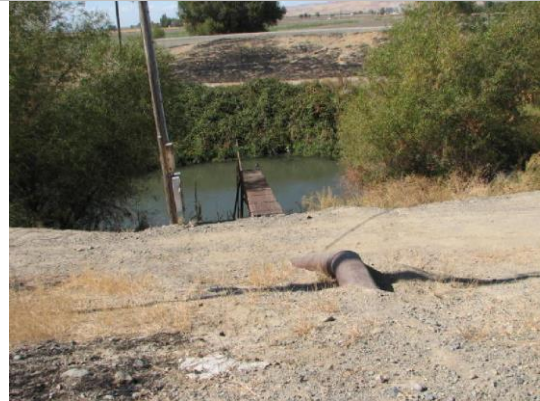
Photo 1 of 3 : UCIP\_SP\_2017\_51498\_64711.jpg

FS\_ID:51498  
DS\_ID:17063  
EP\_NO: N/A  
Repair Type: Non-Urgent  
Crossing Status: Found  
UCIP Comments: 4/10/2017 Abandoned. 10/12/2016 Abandoned crossing.(DWR Sutter Yard - afreitag)4/19/2016 Abandoned crossing. No noticeable issues to report.5/12/2015 Abandoned crossing. Cap was made and installed on WS open end of pipe.11/18/2014 Same as last inspection.5/13/2014 Cap was made and bolted on to WS open end of pipe.10/29/2013 Same as last inspection.5/16/2013 Same as last inspection. Steve Beckley is looking into finding pipe owner to properly abandon pipe.10/9/2012 Pipe abandoned. Pipe open and not plugged. Pipe should be removed or abandoned properly. Extensive animal burrowing occurring along pipe alignment.  
FIELD\_STRUCT\_DESC: \*ABANDONED\* 14-inch steel irrigation pipe (permit records reference 24-inch corrugated metal in 1939 and existing 18-inch pipe in 1932 through levee, USACE O&M references 15-inch pipe 1953) through the levee, 5.7 feet below the crown. Siphon breaker is located on the landside (LS). Vertical pump located on the waterside (WS). Meter pole located on the WS berm. (permit authorized existing 18-inch pipe and new install of pump under Permit No. 572, 1932 - Joaquin). [Additional Reference(s): DWR Levee Log, 2005. USACE Sacramento O&M Manual 135, May 1953, (Station 98+02)].

Pump missing from steel pier on WS toe.

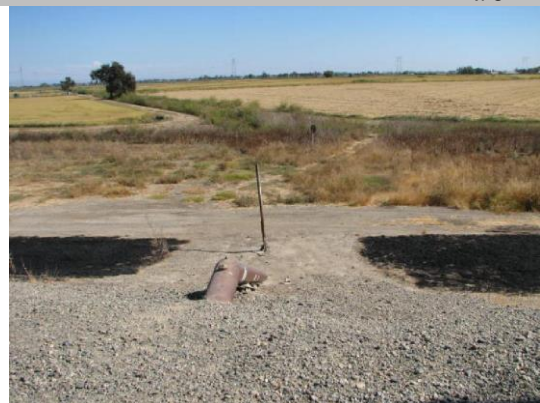
Photo 2 of 3 : UCIP\_SP\_2017\_51498\_64710.jpg

Pipe with siphon breaker plugged on LS shoulder.

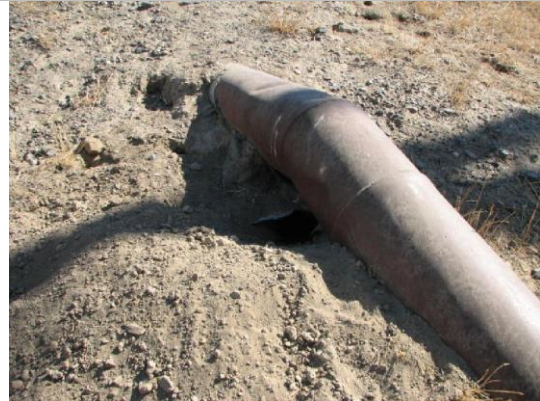
Photo 3 of 3 : UCIP\_SP\_2017\_51498\_64709.jpg

Extensive burrowing along pipe alignment on WS slope.

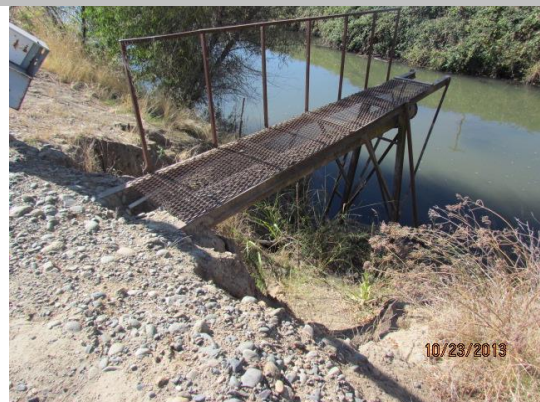
Photo 1 of 3 : SP\_2017\_ST0010\_42\_107\_20170315\_00014.jpg

LM Start	1.85	Rating **	U	Issue No.	107
LM End	1.85	Issue Type +	Ma	Location *	WS
Category	Earthen Levee			GPS Latitude/Longitude	
				Start	End
Item	Erosion / Bank Caving			39.135110 °	39.135110 °
				-121.748230 °	-121.748230 °
DWR ID	DWR_ST0010_01_f_2013_107				
Comment Code					
E2 : Schedule repair of erosion site prior to the next inspection.					
Inspector Comment					
Repair the erosion under the abandoned pump.

View of the erosion along both sides of the abandoned pump.

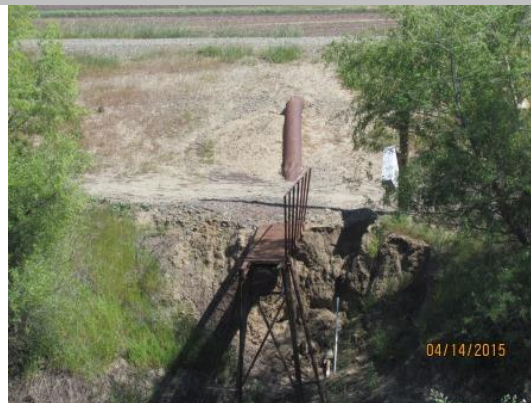
Photo 2 of 3 : SP\_2017\_ST0010\_42\_107\_20170315\_00015.jpg

LM Start	1.85	Rating **	U	Issue No.	107 (cont)	
LM End	1.85	Issue Type +	Ma	Location *	WS	
Category	Earthen Levee			GPS Latitude/Longitude		
				Start		End
Item	Erosion / Bank Caving			39.135110 °		39.135110 °
				-121.748230 °		-121.748230 °
DWR ID	DWR_ST0010_01_f_2013_107					
Comment Code						
E2 : Schedule repair of erosion site prior to the next inspection.						
Inspector Comment						
Repair the erosion under the abandoned pump.

View of the erosion along both sides of the abandoned pump.

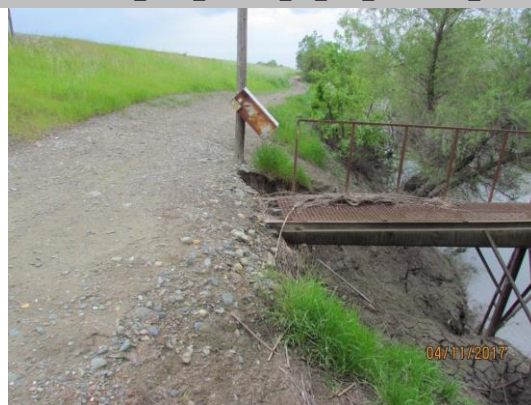
Photo 3 of 3 : SP\_2017\_ST0010\_42\_107\_20170413\_00029.jpg

LM Start	<b>1.85</b>	Rating **	U	Issue No.	<b>107 (cont)</b>
LM End	<b>1.85</b>	Issue Type +	Ma	Location *	WS

View of erosion along both sides of the abandoned pipe.

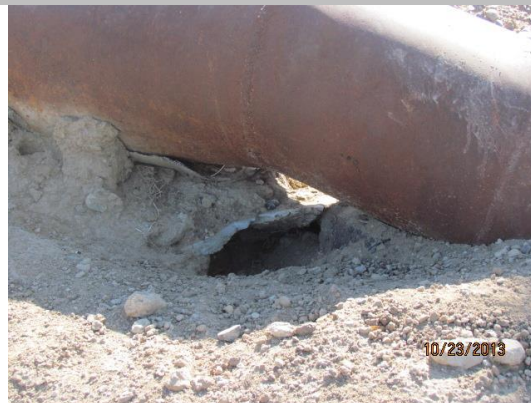
Photo 1 of 1 : SP\_2017\_ST0010\_42\_106\_20170315\_00013.jpg

LM Start	1.85	Rating **	M	Issue No.	106
LM End	1.85	Issue Type +	Ma	Location *	WS
Category	Earthen Levee			GPS Latitude/Longitude	
				Start	End
Item	Animal Control			39.135110 °	39.135110 °
				-121.748229 °	-121.748229 °
DWR ID	DWR_ST0010_01_f_2013_106				
Comment Code					
A3 : No rodents visible, but rodent burrows visible; need to backfill and compact or grout burrows.					
Inspector Comment

View of the rodent holes under the irrigation pipe.

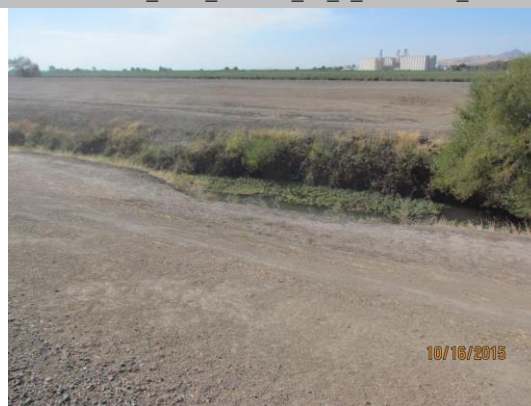
Photo 1 of 4 : SP\_2017\_ST0010\_42\_6\_20170315\_00006.jpg

View of the erosion along the waterside toe.

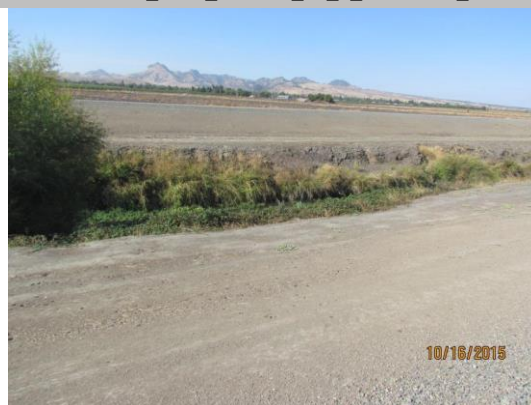
Photo 2 of 4 : SP\_2017\_ST0010\_42\_6\_20170315\_00007.jpg

LM Start	<b>2.43</b>	Rating **	M	Issue No.	<b>6 (cont)</b>
LM End	<b>3.30</b>	Issue Type +	Ma	Location *	WS

View of the erosion along the waterside toe.

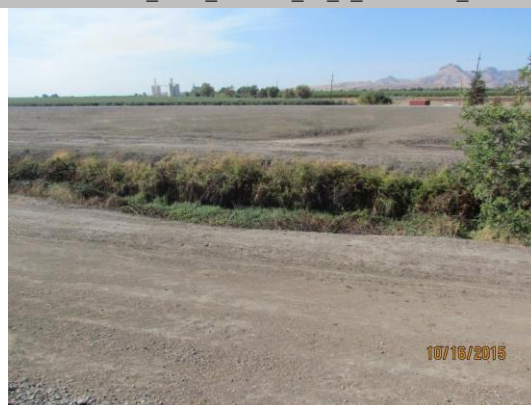
Photo 3 of 4 : SP\_2017\_ST0010\_42\_6\_20170315\_00008.jpg

LM Start	<b>2.43</b>	Rating **	M	Issue No.	<b>6 (cont)</b>
LM End	<b>3.30</b>	Issue Type +	Ma	Location *	WS

View of the erosion along the waterside toe.

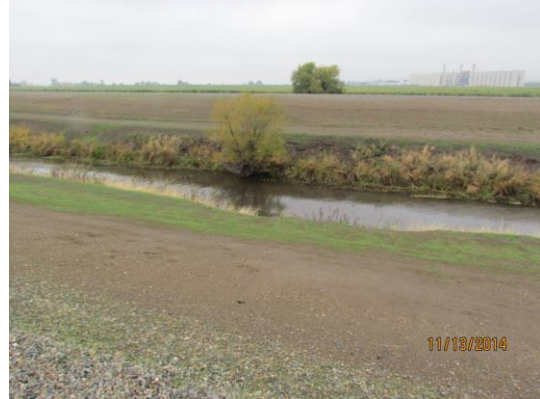
Photo 4 of 4 : SP\_2017\_ST0010\_42\_6\_20170315\_00009.jpg

View of the erosion along the waterside toe.

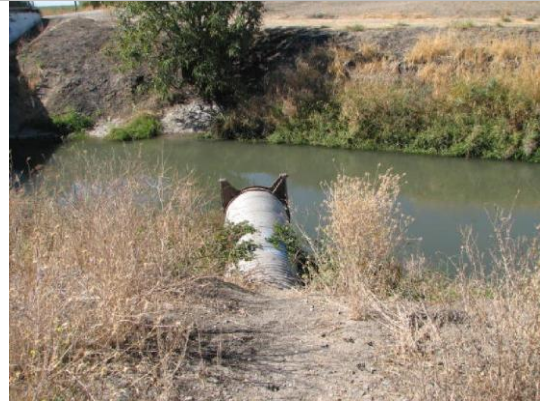
Photo 1 of 3 : UCIP\_SP\_2017\_51500\_64718.jpg

Comment Code					
Inspector Comment					
FS_ID:51500 DS_ID:17065 EP_NO: 7209 Repair Type: Non-Urgent Crossing Status: Found UCIP Comments: 4/10/2017 Ws pipe end is in good condition. LS pipe end is still deformed and vegetated. (DWR Sutter Yard-AFreitag)10/12/2016 LS inlet is still deformed and being overgrown by vegetation.(DWR Sutter Yard - afreitag)4/19/2016 Crossing appears to be in good condition.5/12/2015 LS inlet still deformed a little but does not affect the crossing function.11/18/2014 Same as last inspection.5/13/2014 Same as last inspection.10/29/2013 Same as last inspection.5/16/2013 Pipe intake on LS appears to be bent and damaged but that does not appear to be affecting water flow or channel bank. FIELD_STRUCT_DESC: 36-inch corrugated metal drainage pipe (permit records indicate 30-inch USACE O&M pipe replaced with new 30-inch pipe) through the levee, 9 feet below the crown. Flap gate located on the waterside (WS) end. (original O&M manual crossing was replaced under Permit No. 7209, 1970 - Department of Water Resources) [Additional Reference(s): DWR Levee Log, 2005. USACE Sacramento O&M Manual 135, May 1953, (Station 160+25)]. FS Date: 4/12/2017 9:39:10 AM

36-inch pipe with flapgate on WS slope.

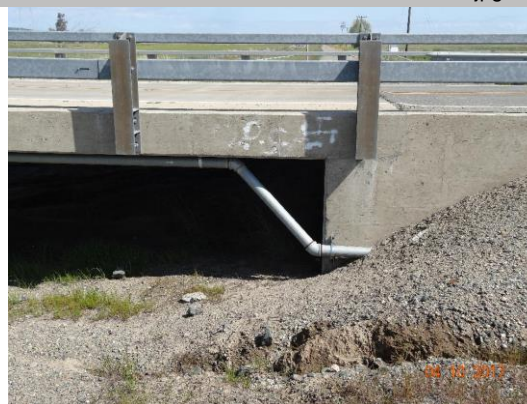
Photo 2 of 3 : UCIP\_SP\_2017\_51501\_76954.jpg

Conduit exiting WS slope and attaching to the downstream side of South Butte Rd bridge.

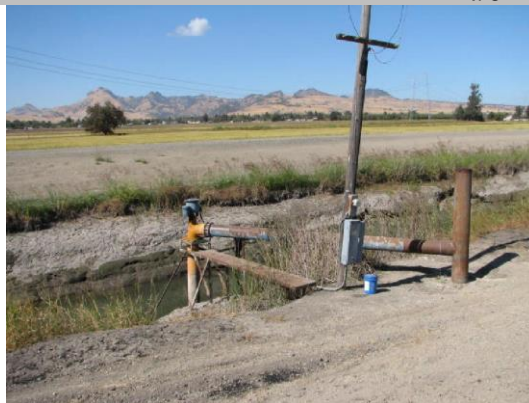
Photo 1 of 3 : UCIP\_SP\_2017\_51502\_64720.jpg

FS\_ID:51502  
DS\_ID:17066  
EP\_NO: N/A  
Repair Type: Non-Urgent  
Crossing Status: Found  
UCIP Comments: 4/10/2017 LS heavily vegetated but nothing appears to have changed with the crossing. LS headwall still silted in and pipe discharges directly into the rice field. (DWR Sutter Yard-AFreitag)10/12/2016 Crossing appears to be in good condition.4/19/2016 Crossing has not changed since the last inspection. LS headwall is silted in and not being used. LS pipe end discharges into the rice field.5/12/2015 Concrete headwall on LS is completely silted in. LS pipe end is located near the edge of rice field. No issues seen on WS.11/18/2014 Same as last inspection.5/13/2014 Same as last inspection.10/29/2013 Concrete headwall is silted in and appears to be abandoned. Discharge end of pipe is approx. 100ft. from LS toe on the edge of the rice field.5/16/2013 Same as last inspection.  
FIELD\_STRUCT\_DESC: 24-inch steel irrigation pipe (USACE O&M refers to 24-inch corrugated metal pipe) through the levee, 11 feet below the crown. Slide gate in 4-foot by 6-foot concrete distribution box located at the waterside (WS) toe. (not found in 2012) Vertical pump mounted on a steel structure in channel. Service pole on the berm with 18-inch standpipe located on the WS toe. Concrete "U" shaped headwall located on the landside (LS) toe. [Additional Reference(s): DWR Levee Log, 2005. USACE Sacramento O&M Manual 135, May 1953, (Station 184+87)].

Pump, Pipe, walkway, power pole, and standpipe on WS toe.

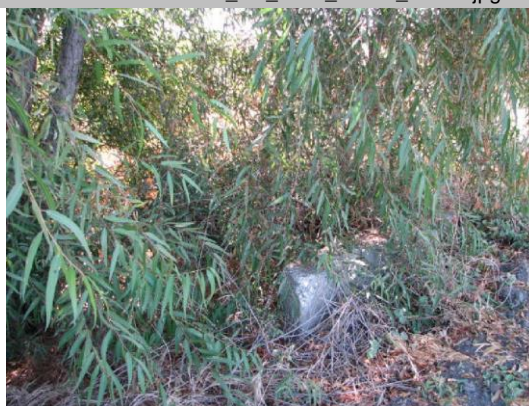
Photo 2 of 3 : UCIP\_SP\_2017\_51502\_64719.jpg

Concrete U shaped headwall on LS toe under tree.

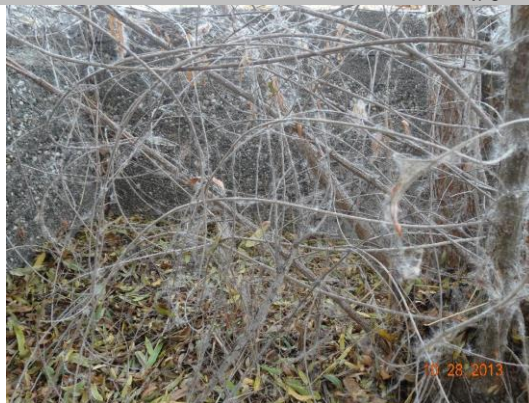
Photo 3 of 3 : UCIP\_SP\_2017\_51502\_64721.jpg

FS\_ID:51502  
DS\_ID:17066  
EP\_NO: N/A  
Repair Type: Non-Urgent  
Crossing Status: Found  
UCIP Comments: 4/10/2017 LS heavily vegetated but nothing appears to have changed with the crossing. LS headwall still silted in and pipe discharges directly into the rice field. (DWR Sutter Yard-AFreitag)10/12/2016 Crossing appears to be in good condition.4/19/2016 Crossing has not changed since the last inspection. LS headwall is silted in and not being used. LS pipe end discharges into the rice field.5/12/2015 Concrete headwall on LS is completely silted in. LS pipe end is located near the edge of rice field. No issues seen on WS.11/18/2014 Same as last inspection.5/13/2014 Same as last inspection.10/29/2013 Concrete headwall is silted in and appears to be abandoned. Discharge end of pipe is approx. 100ft. from LS toe on the edge of the rice field.5/16/2013 Same as last inspection.  
FIELD\_STRUCT\_DESC: 24-inch steel irrigation pipe (USACE O&M refers to 24-inch corrugated metal pipe) through the levee, 11 feet below the crown. Slide gate in 4-foot by 6-foot concrete distribution box located at the waterside (WS) toe. (not found in 2012) Vertical pump mounted on a steel structure in channel. Service pole on the berm with 18-inch standpipe located on the WS toe. Concrete "U" shaped headwall located on the landside (LS) toe. [Additional Reference(s): DWR Levee Log, 2005. USACE Sacramento O&M Manual 135, May 1953, (Station 184+87)].

View of LS headwall silted in.

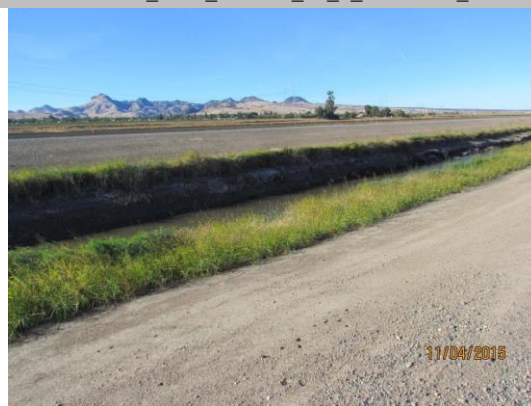
Photo 1 of 1 : SP\_2017\_ST0010\_42\_3\_20170315\_00001.jpg

View of the erosion along the waterside toe.

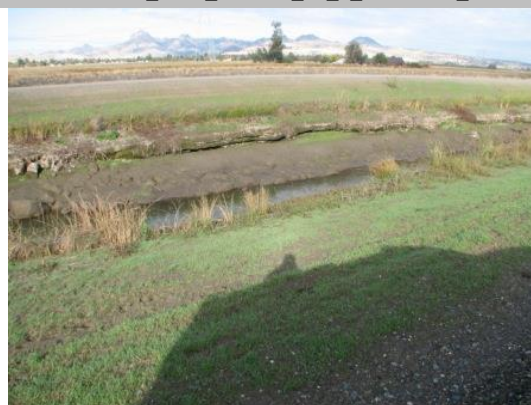
Photo 1 of 2 : SP\_2017\_ST0010\_42\_4\_20170315\_00002.jpg

View of the erosion along the waterside toe of the levee.

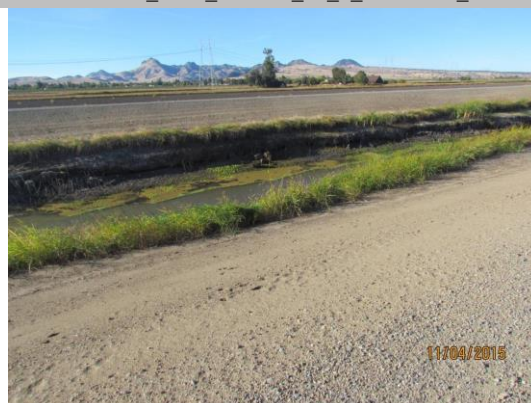
Photo 2 of 2 : SP\_2017\_ST0010\_42\_4\_20170315\_00003.jpg

View of the erosion along the waterside toe.

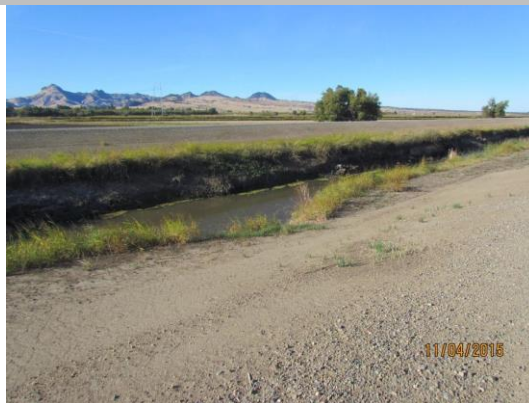
Photo 1 of 1 : SP\_2017\_ST0010\_42\_17\_20170315\_00010.jpg

View of the erosion along the waterside toe.

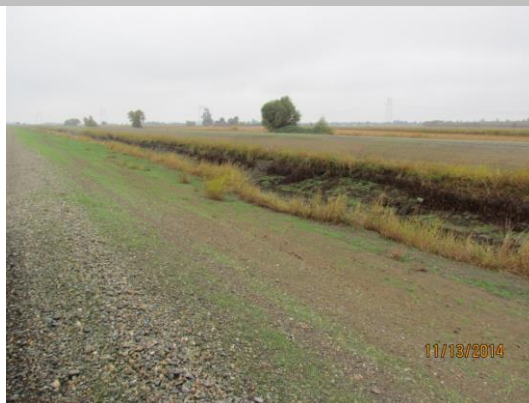
Photo 1 of 2 : SP\_2017\_ST0010\_42\_5\_20170315\_00004.jpg

View of the erosion along the waterside toe.

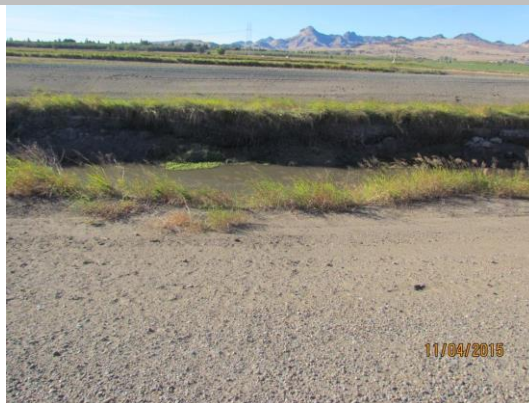
Photo 2 of 2 : SP\_2017\_ST0010\_42\_5\_20170315\_00005.jpg

View of the erosion along the waterside toe.

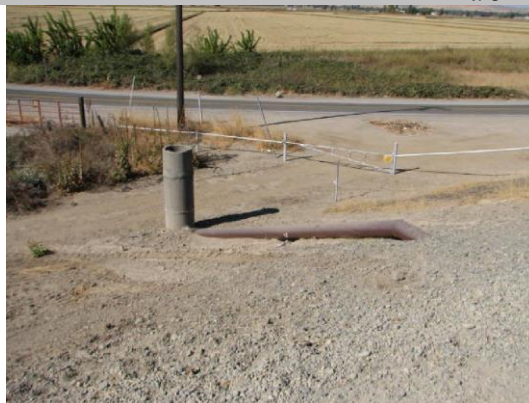
Photo 1 of 3 : UCIP\_SP\_2017\_51506\_64728.jpg

Pipe and Standpipe on LS toe.

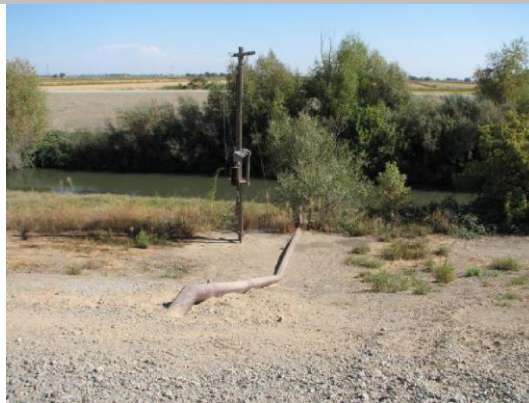
Photo 2 of 3 : UCIP\_SP\_2017\_51506\_64727.jpg

Pipe and pump facilities on WS slope.

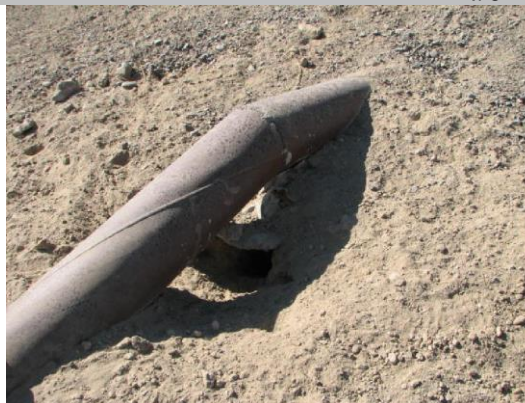
Photo 3 of 3 : UCIP\_SP\_2017\_51506\_64726.jpg

Comment Code						
Inspector Comment						
FS_ID:51506 DS_ID:17069 EP_NO: N/A Repair Type: Non-Urgent Crossing Status: Found UCIP Comments: 4/10/2017 Abanoned crossing with heavy rodent activity around it. Needs to be removed. (DWR Sutter Yard-AFreitag)10/12/2016 Abandoned crossing.(DWR Sutter Yard -afreitag)4/19/2016 Abandoned crossing. Rodent activity still present on WS slope.5/12/2015 Abandoned crossing. Signs of rodent activity on both sides of levee.11/18/2014 Same as last inspection.5/13/2014 Same as last inspection.10/29/2013 Same as last inspection.5/16/2013 Same as last inspection.10/9/2012 Pipe appears improperly abandoned. No motor present, electrical equipment is stripped. Heavy rodent activity along pipe WS and LS. Pipe needs to be removed or properly abandoned. FIELD_STRUCT_DESC: *ABANDONED* 10-inch steel irrigation pipe through the levee, 4.8 feet below the crown. Pump mounted on concrete pad near canal bank located on the waterside (WS). Service pole located on the berm. 36-inch concrete standpipe located on the landside (LS) toe. (Permit No. 945, 1944 - Becker). [Additional Reference(s): DWR Levee Log, 2005. USACE Sacramento O&M Manual 135, May 1953, (Station 61+10)]. FS Date: 4/12/2017 9:47:25 AM

Heavy rodent activity along pipe, both sides.

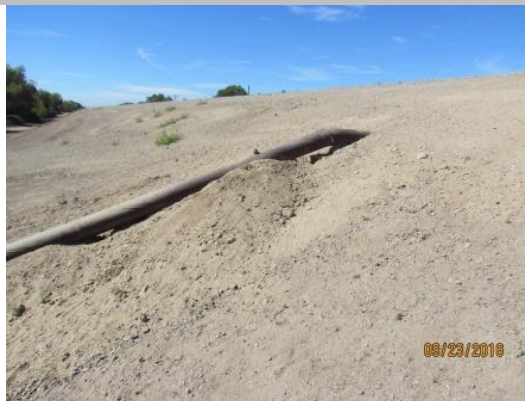
Photo 1 of 2 : SP\_2017\_ST0010\_43\_19\_20170315\_00014.jpg

LM Start	1.16	Rating **	U	Issue No.	19
LM End	1.16	Issue Type +	Ma	Location *	WS
Category	Earthen Levee			GPS Latitude/Longitude	
				Start	End
Item	Animal Control			39.127527 °	39.127527 °
				-121.756493 °	-121.756493 °
DWR ID	DWR_ST0010_02_f_2016_19				
Comment Code					
A3 : No rodents visible, but rodent burrows visible; need to backfill and compact or grout burrows.					
Inspector Comment					
Repair the rodent holes along the waterside slope.

View of the rodent holes along the waterside slope.

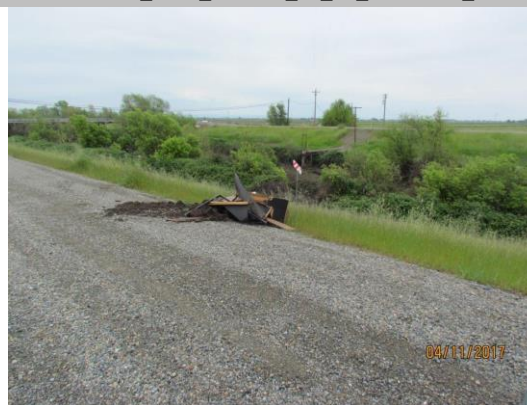
Photo 1 of 1 : SP\_2017\_ST0010\_43\_23\_20170413\_00037.jpg

View of the garbage along the waterside slope.

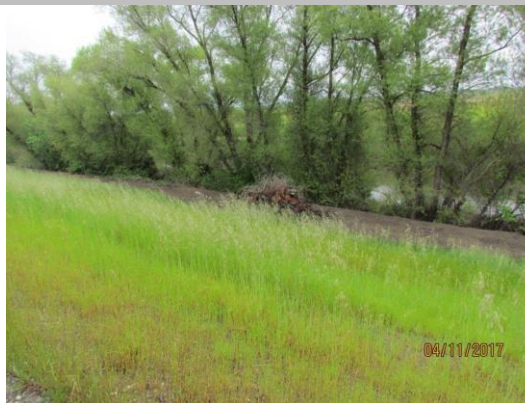
Photo 1 of 1 : SP\_2017\_ST0010\_43\_24\_20170413\_00038.jpg

View of the prunings along the waterside toe.

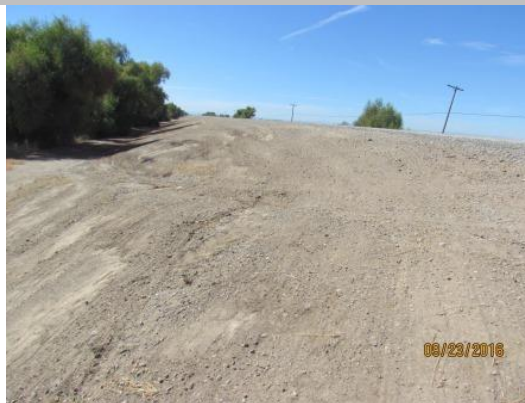
Photo 1 of 1 : SP\_2017\_ST0010\_43\_20\_20170315\_00015.jpg

View the ramp encroaching into the levee.

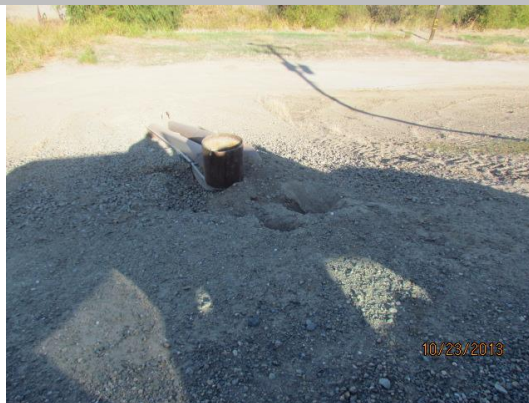
Photo 1 of 2 : SP\_2017\_ST0010\_43\_11\_20170315\_00012.jpg

View of the rodent holes above the irrigation pipe.

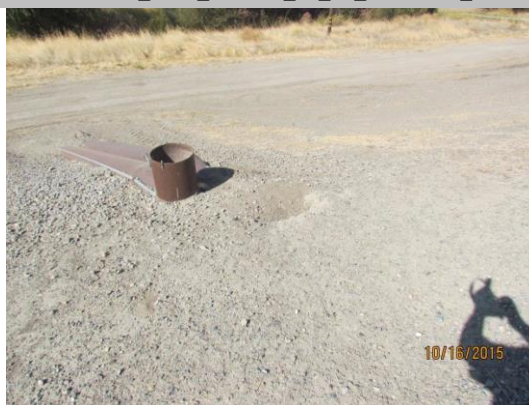
Photo 2 of 2 : SP\_2017\_ST0010\_43\_11\_20170315\_00013.jpg

View of the rodent hole above the irrigation pipe.

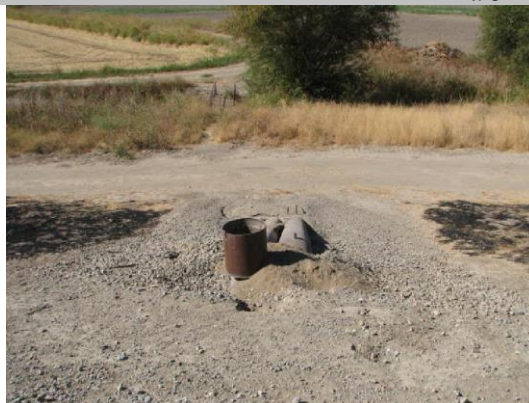
Photo 1 of 3 : UCIP\_SP\_2017\_51512\_64736.jpg

Pipe on LS showing rodent activity.

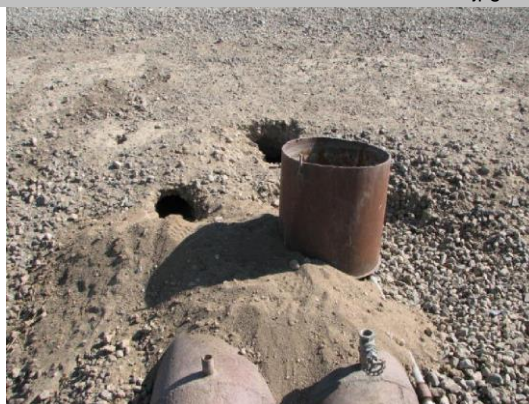
Photo 2 of 3 : UCIP\_SP\_2017\_51512\_64735.jpg

Pipe on LS showing rodent activity.

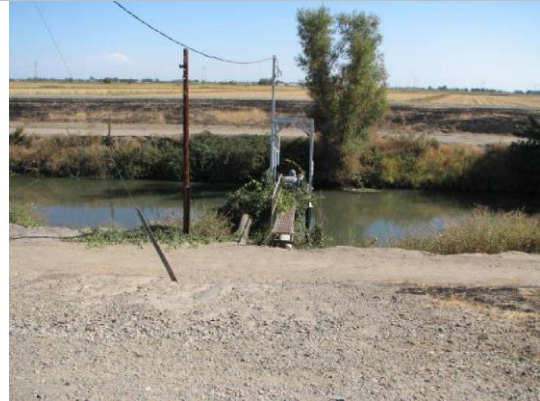
Photo 3 of 3 : UCIP\_SP\_2017\_51512\_64734.jpg

Pipe on left without pump.

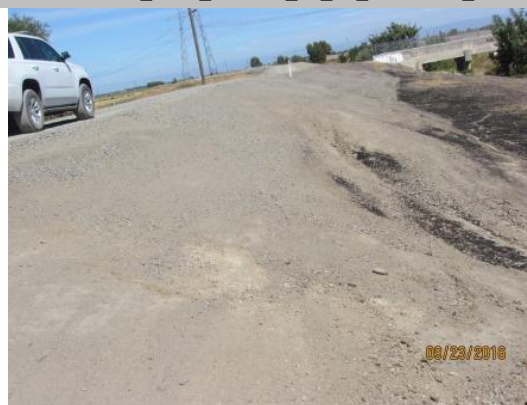
Photo 1 of 1 : SP\_2017\_ST0010\_43\_21\_20170315\_00016.jpg

View the ramp encroaching into the levee.

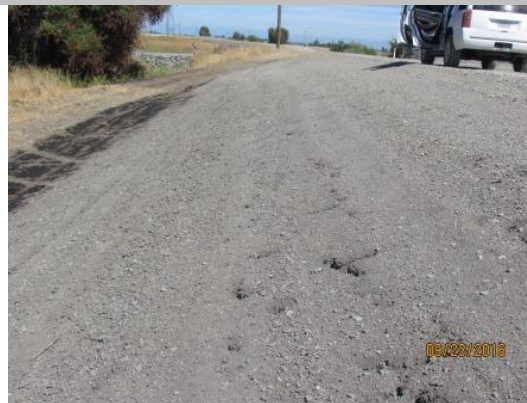
Photo 1 of 2 : SP\_2017\_ST0010\_43\_22\_20170315\_00017.jpg

View of the longitudinal cracks along the landside slope.

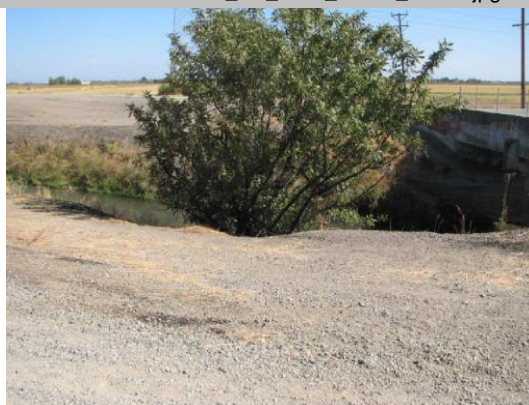
Photo 1 of 3 : UCIP\_SP\_2017\_51515\_64744.jpg

Bush camouflaging outlet of pipe on WS slope.

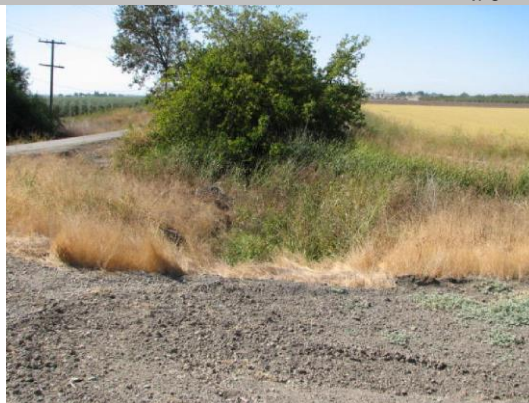
Photo 2 of 3 : UCIP\_SP\_2017\_51515\_64743.jpg

Heavy vegetation at LS inlet at channel.

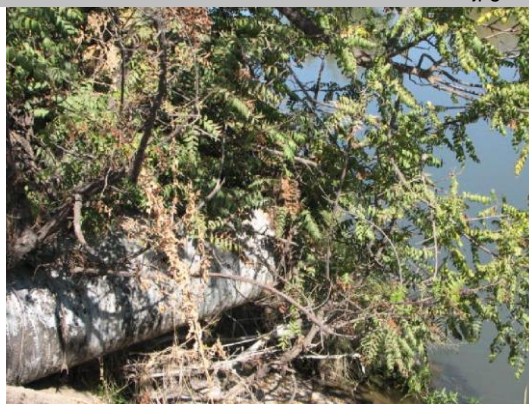
Photo 3 of 3 : UCIP\_SP\_2017\_51515\_64742.jpg

Pipe and flap gate at WS outlet.

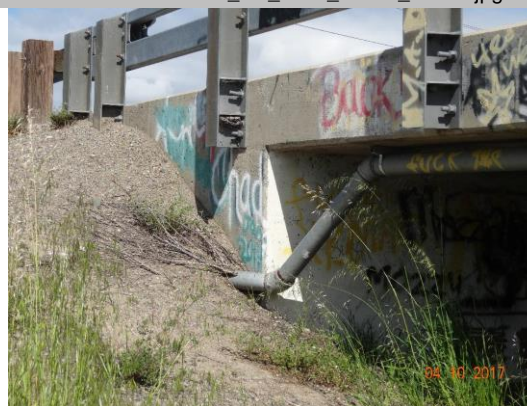
Photo 3 of 3 : UCIP\_SP\_2017\_51516\_76967.jpg

WS slope where conduit exits and attaches to downstream side of South Butte Rd bridge.

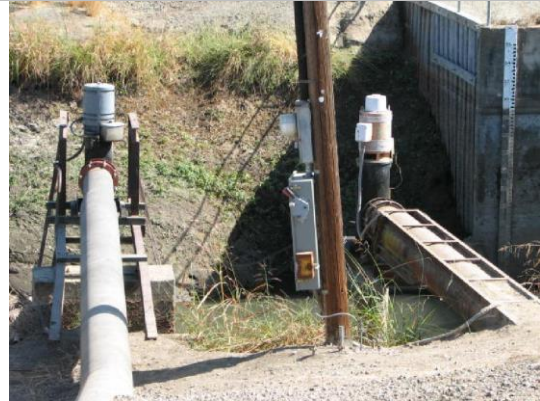
Photo 1 of 2 : UCIP\_SP\_2017\_51517\_64761.jpg

Pump on steel pier at WS toe.

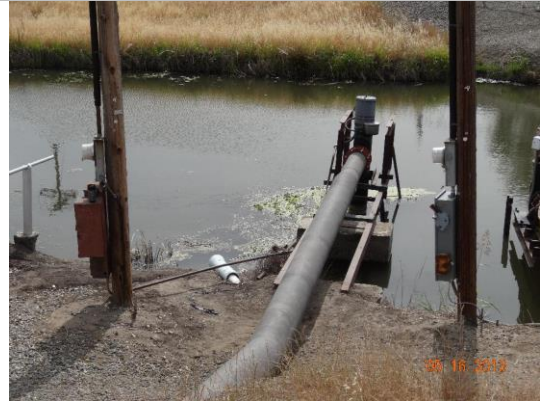
Photo 1 of 3 : UCIP\_SP\_2017\_51518\_64764.jpg

Pump station in channel on WS

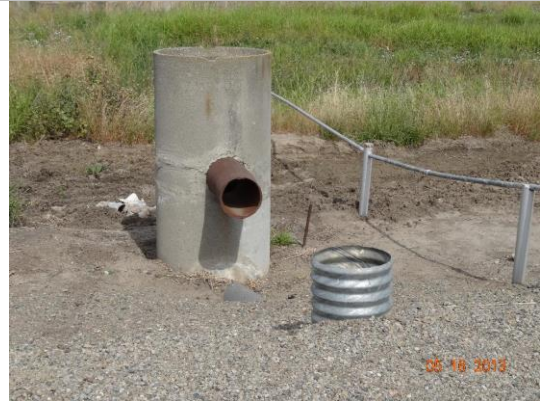
Photo 2 of 3 : UCIP\_SP\_2017\_51518\_64763.jpg

36in. concrete standpipe and 12in. cm riser on LS.

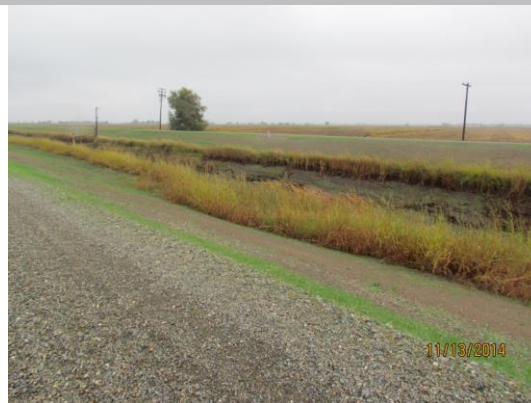
Photo 1 of 2 : SP\_2017\_ST0010\_43\_4\_20170315\_00002.jpg

View of the erosion at the waterside toe.

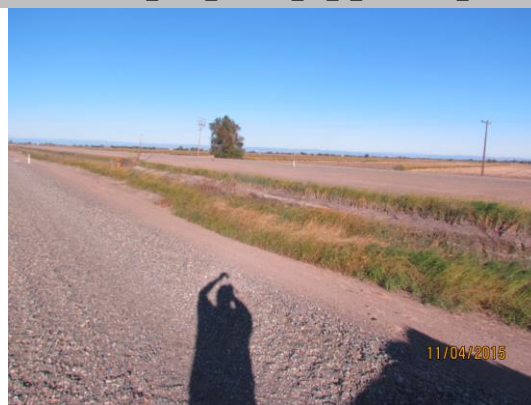
Photo 2 of 2 : SP\_2017\_ST0010\_43\_4\_20170315\_00003.jpg

View of the erosion at the waterside toe.

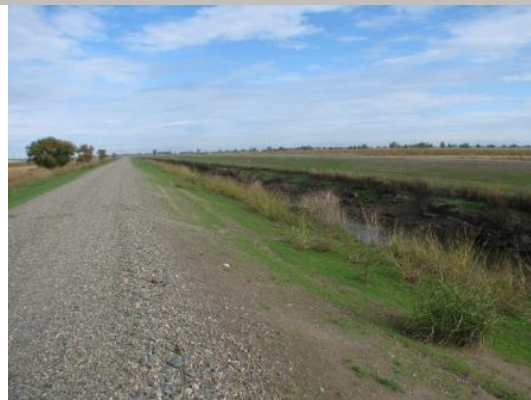
Photo 1 of 2 : SP\_2017\_ST0010\_43\_5\_20170315\_00004.jpg

View of the erosion along the waterside toe.

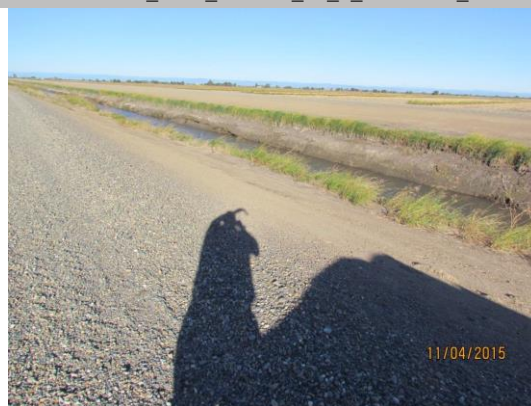
Photo 2 of 2 : SP\_2017\_ST0010\_43\_5\_20170315\_00005.jpg

View of erosion at the waterside toe

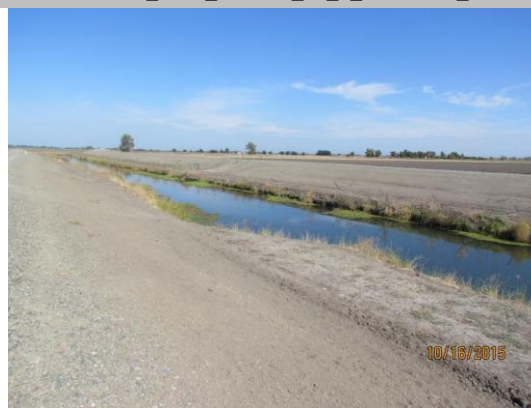
Photo 1 of 2 : SP\_2017\_ST0010\_43\_9\_20170315\_00010.jpg

View of the erosion along the waterside toe.

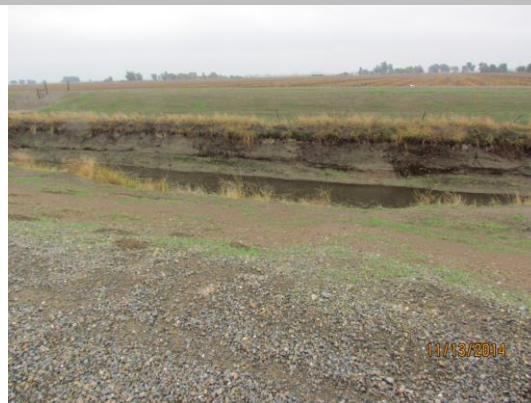
Photo 2 of 2 : SP\_2017\_ST0010\_43\_9\_20170315\_00011.jpg

View of the erosion along the waterside toe.

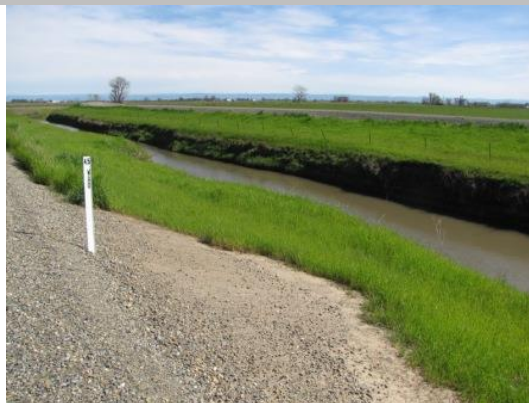
Photo 1 of 2 : SP\_2017\_ST0010\_43\_7\_20170315\_00006.jpg

View of the erosion along the W/S toe.

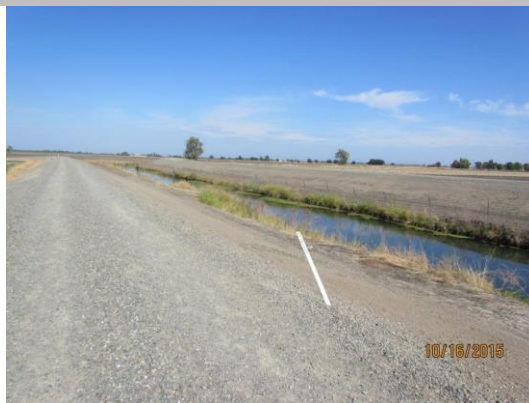
Photo 2 of 2 : SP\_2017\_ST0010\_43\_7\_20170315\_00007.jpg

View of the erosion along the waterside toe.
