**Flood Control Project Maintenance
Levee Inspections**
LMA District Cover Sheet
Spring 2018 Levee Inspection Results

Spring 2018 Levee Inspection Results

Sutter Maintenance Yard Wadsworth Canal

Waterway			Bank	Unit Miles
Unit No. 01 Wadsworth Canal			Left	4.63
	Spring (March - May)	Summer (June - August)	(September - November) Fall	Winter (December - February)
Unit Maintenance Rating (Fall Only)				
Date of Inspection	3/29/2018 - 3/29/2018			
DWR Inspector	Bob Duffey			
Accompanied By	Steve Beckley Sutter Maintenance Yard

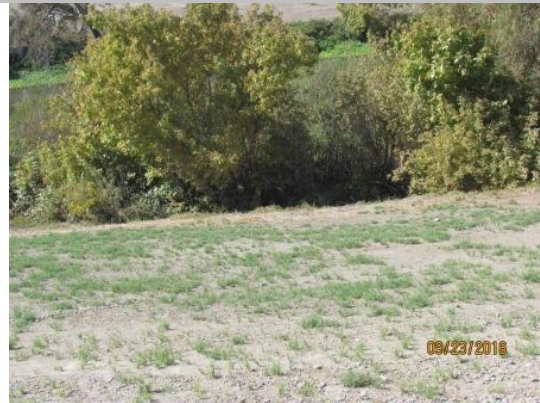
Photo 1 of 1 : SP_2018_ST0010_42_20_20180305_00013.jpg

View of the erosion along the waterside toe.

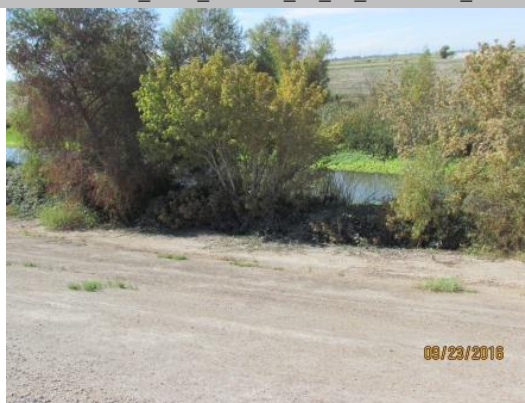
Photo 1 of 1 : SP_2018_ST0010_42_19_20180305_00012.jpg

View of the erosion along the waterside toe.

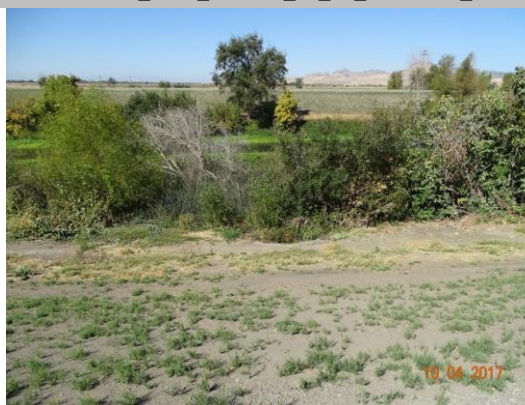
Photo 1 of 1 : SP_2018_ST0010_42_22_20180305_00014.jpg

LM Start	0.50	Rating **	U	Issue No.	22
LM End	0.50	Issue Type +	Ma	Location *	WS
Category	Earthen Levee			GPS Latitude/Longitude	
				Start	End
Item	Erosion / Bank Caving			39.119348 °	39.119348 °
				-121.763120 °	-121.763120 °
DWR ID	DWR_ST0010_01_f_2017_22				
Comment Code					
E2 : Schedule repair of erosion site prior to the next inspection.					
Inspector Comment					
Repair the beaver hole along the waterside berm.

View of the beaver hole along the waterside berm.

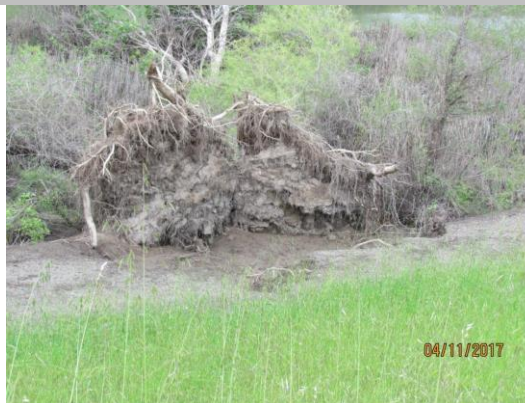
Photo 1 of 1 : SP_2018_ST0010_42_18_20180305_00011.jpg

LM Start	0.56	Rating **	M	Issue No.	18
LM End	0.56	Issue Type +	Ma	Location *	WS
Category	Earthen Levee			GPS Latitude/Longitude	
				Start	End
Item	Erosion / Bank Caving			39.119985 °	39.119985 °
				-121.762600 °	-121.762600 °
DWR ID	DWR_ST0010_01_s_2017_18				
Comment Code					
E2 : Schedule repair of erosion site prior to the next inspection.					
Inspector Comment					
Repair the erosion along the water side toe.

View of the erosion along the waterside toe caused by a tree that fell into the water.

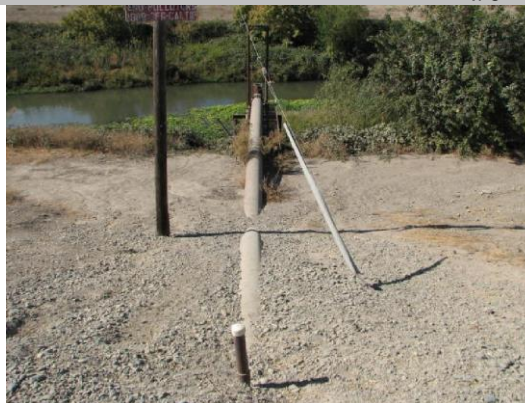
Photo 3 of 3 : UCIP_SP_2018_51493_64700.jpg

Pipe on WS slope with siphon breaker at WS shoulder.

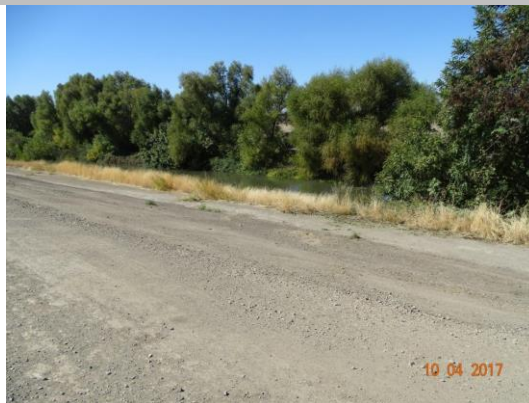
Photo 1 of 1 : SP_2018_ST0010_42_23_20180305_00015.jpg

LM Start	1.76	Rating **	M	Issue No.	23
LM End	1.76	Issue Type +	Ma	Location *	WS
Category	Earthen Levee			GPS Latitude/Longitude	
				Start	End
Item	Animal Control			39.133978 °	39.133978 °
				-121.749327 °	-121.749327 °
DWR ID	DWR_ST0010_01_f_2017_23				
Comment Code					
A3 : No rodents visible, but rodent burrows visible; need to backfill and compact or grout burrows.					
Inspector Comment					
Repair the rodent holes along the waterside slope.

View of the rodent holes along the waterside slope.

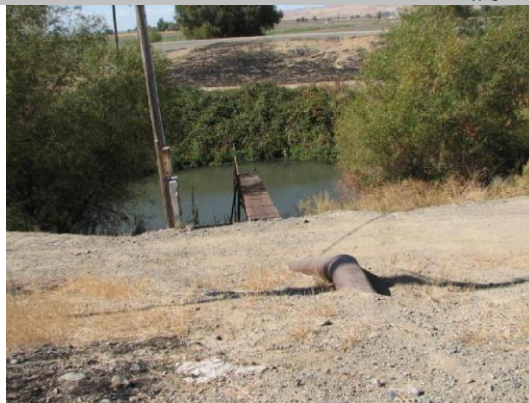
Photo 1 of 3 : UCIP_SP_2018_51498_64711.jpg

FS_ID:51498
DS_ID:17063
EP_NO: N/A
Repair Type: Non-Urgent
Crossing Status: Found
UCIP Comments: 4/10/2017 Abandoned. 10/12/2016 Abandoned crossing.(DWR Sutter Yard - afreitag)4/19/2016 Abandoned crossing. No noticeable issues to report.5/12/2015 Abandoned crossing. Cap was made and installed on WS open end of pipe.11/18/2014 Same as last inspection.5/13/2014 Cap was made and bolted on to WS open end of pipe.10/29/2013 Same as last inspection.5/16/2013 Same as last inspection. Steve Beckley is looking into finding pipe owner to properly abandon pipe.10/9/2012 Pipe abandoned. Pipe open and not plugged. Pipe should be removed or abandoned properly. Extensive animal burrowing occurring along pipe alignment.
FIELD_STRUCT_DESC: *ABANDONED* 14-inch steel irrigation pipe (permit records reference 24-inch corrugated metal in 1939 and existing 18-inch pipe in 1932 through levee, USACE O&M references 15-inch pipe in 1953) through the levee, 5.7 feet below the crown. Siphon breaker located on the landside (LS). Vertical pump located on the waterside (WS). Meter pole located on the WS berm. (Permit authorized existing 18-inch pipe and new installation of pump under Permit No. 572, 1932 - Joaquin). [Additional Reference(s): DWR Levee Log, 2005. USACE Sacramento O&M Manual 135, May 1953, (Station 98+02)].

Pump missing from steel pier on WS toe.

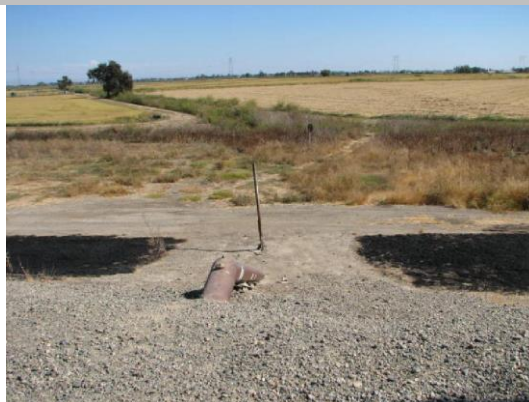
Photo 2 of 3 : UCIP_SP_2018_51498_64710.jpg

Pipe with siphon breaker plugged on LS shoulder.

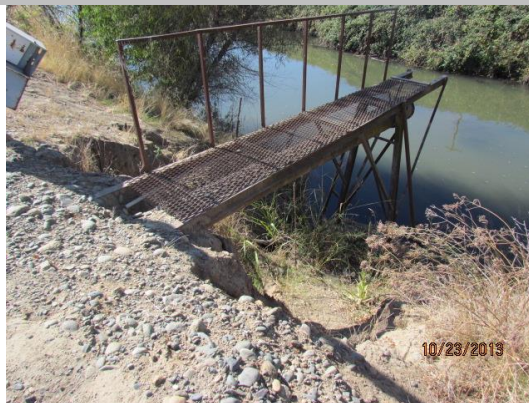
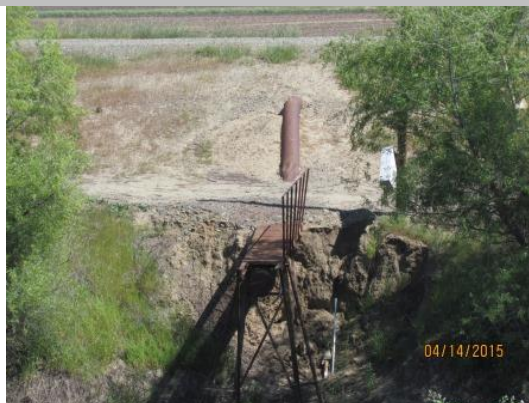
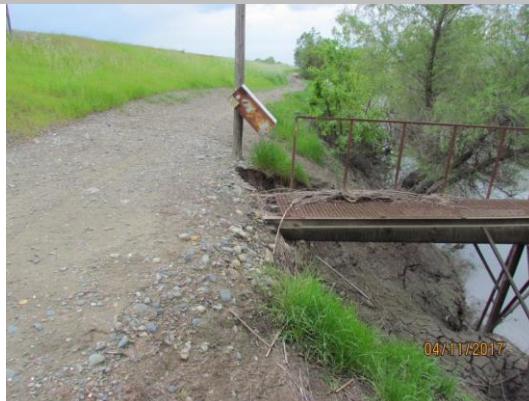
LM Start	1.85	Rating **	U	Issue No.	107
LM End	1.85	Issue Type +	Ma	Location *	WS
Category	Earthen Levee			GPS Latitude/Longitude	
				Start	End
Item	Erosion / Bank Caving			39.135110 °	39.135110 °
				-121.748230 °	-121.748230 °
DWR ID	DWR_ST0010_01_f_2013_107				
Comment Code					
E2 : Schedule repair of erosion site prior to the next inspection.					
Inspector Comment					
Repair the erosion under the abandoned pump.

View of the erosion along both sides of the abandoned pump.

View of erosion along both sides of the abandoned pipe.

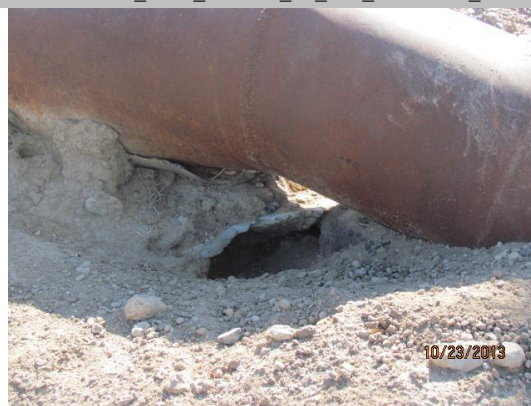
Photo 1 of 1 : SP_2018_ST0010_42_106_20180305_00016.jpg

View of the rodent holes under the irrigation pipe.

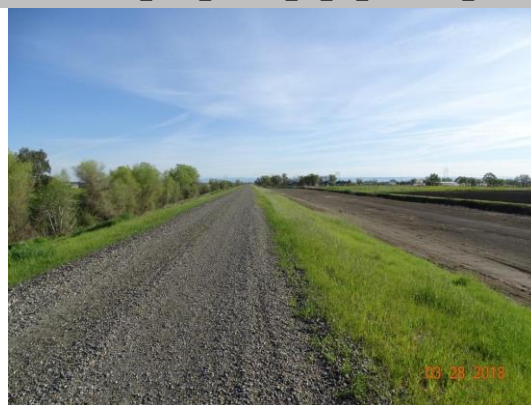
Photo 1 of 1 : SP_2018_ST0010_42_21_20180403_00035.jpg

LM Start	2.07	Rating **	A	Issue No.	21
LM End	2.07	Issue Type +	Ma	Location *	LS
Category	Earthen Levee			GPS Latitude/Longitude	
				Start	End
Item	Vegetation			39.137720 °	39.137720 °
				-121.746115 °	-121.746115 °
DWR ID	DWR_ST0010_01_s_2018_21				
Comment Code					
V1 : Control annual grass and weeds on the levee slopes and easements.					
Inspector Comment					
LMA should continue to manage the native grasses on both slopes.

View of the native grasses on both slopes.

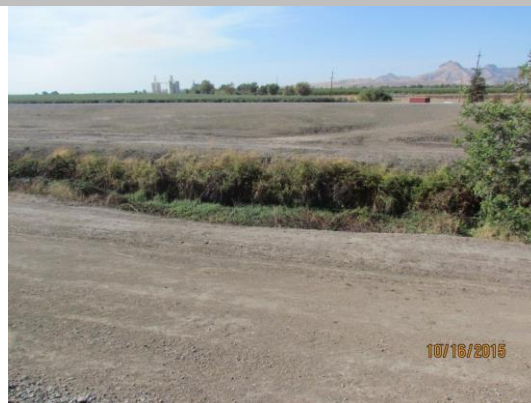
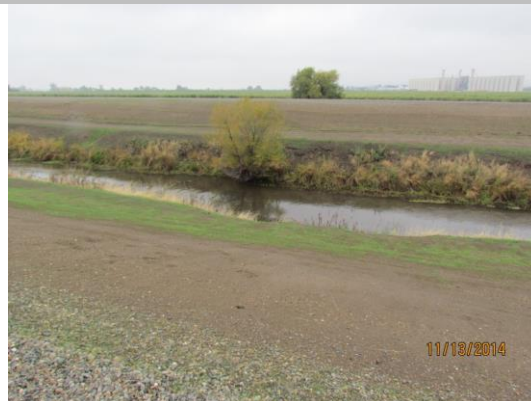
LM Start	2.43	Rating **	M	Issue No.	6
LM End	3.30	Issue Type +	Ma	Location *	WS
Category	Supplemental			GPS Latitude/Longitude	
				Start	End
Item	2015 USACE Erosion Survey, DRAFT			39.142235 °	39.153095 °
				-121.742609 °	-121.734390 °
DWR ID	DWR_ST0010_01_f_2015_6				
Comment Code					
Inspector Comment					
2010 - Over steepened levees, some slumping, reach-wide problem. 2011 - Still a reach-wide problem. 2015: Site is part of the extended inventory, last inspected 2011. [2015 Site ID: WAD_2-4_L]

View of the erosion along the waterside toe.

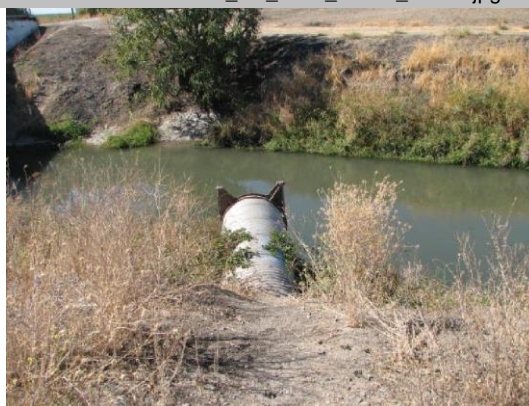
Photo 1 of 3 : UCIP_SP_2018_51500_64718.jpg

FS_ID:51500
DS_ID:17065
EP_NO: 7209
Repair Type: Non-Urgent
Crossing Status: Found
UCIP Comments: 4/10/2017 Ws pipe end is in good condition. LS pipe end is still deformed and vegetated. (DWR Sutter Yard - AFreitag)10/12/2016 LS inlet is still deformed and being overgrown by vegetation.(DWR Sutter Yard - afreitag)4/19/2016 Crossing appears to be in good condition.5/12/2015 LS inlet still deformed a little but does not affect the crossing function.11/18/2014 Same as last inspection.5/13/2014 Same as last inspection.10/29/2013 Same as last inspection.5/16/2013 Pipe intake on LS appears to be bent and damaged but that does not appear to be affecting water flow or channel bank.
FIELD_STRUCT_DESC: 36-inch corrugated metal drainage pipe (permit records indicate 30-inch, USACE O&M pipe replaced with new 30-inch pipe) through the levee, 9 feet below the crown. Flap gate located on the waterside (WS) end. (Original O&M manual crossing was replaced under Permit No. 7209, 1970 - Department of Water Resources [DWR]) [Additional Reference(s): DWR Levee Log, 2005. USACE Sacramento O&M Manual 135, May 1953, (Station 160+25)].

36-inch pipe with flapgate on WS slope.

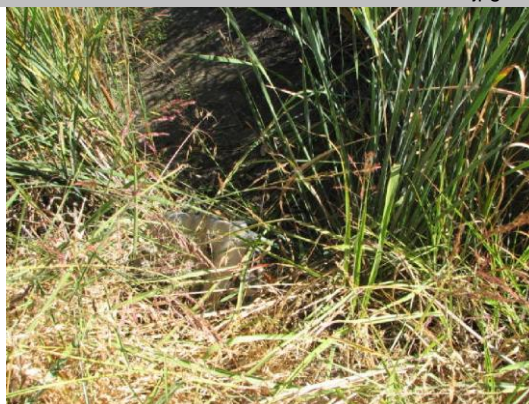
Photo 2 of 3 : UCIP_SP_2018_51500_64717.jpg

Inlet in weeds on LS toe.

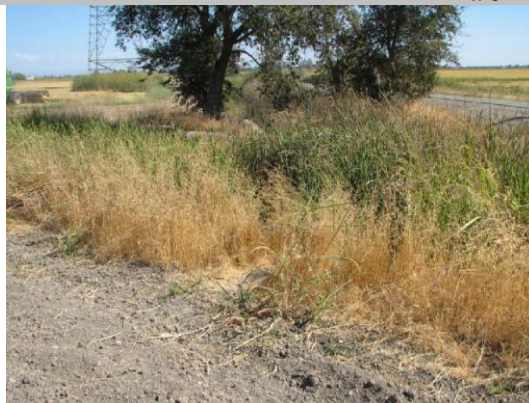
Photo 3 of 3 : UCIP_SP_2018_51500_64716.jpg

Pipe inlet heavily shielded by vegetation.

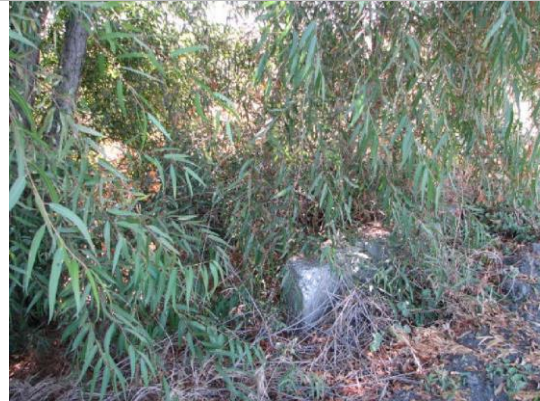
Photo 2 of 3 : UCIP_SP_2018_51502_64719.jpg

Concrete U shaped headwall on LS toe under tree.

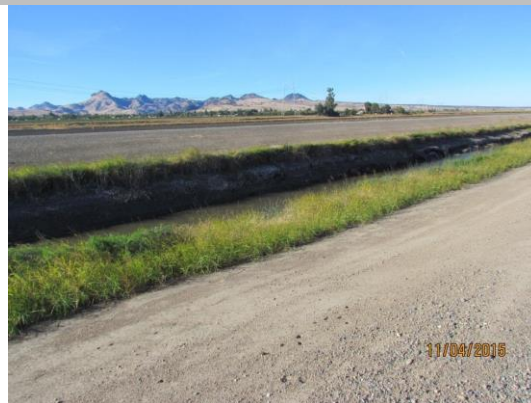
Photo 1 of 1 : SP_2018_ST0010_42_3_20180305_00001.jpg

View of the erosion along the waterside toe.

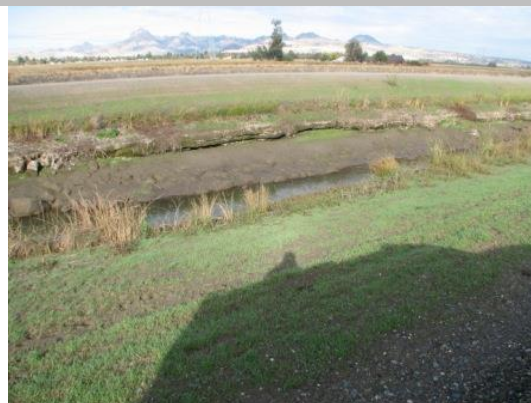
View of the erosion along the waterside toe of the levee.

View of the erosion along the waterside toe.

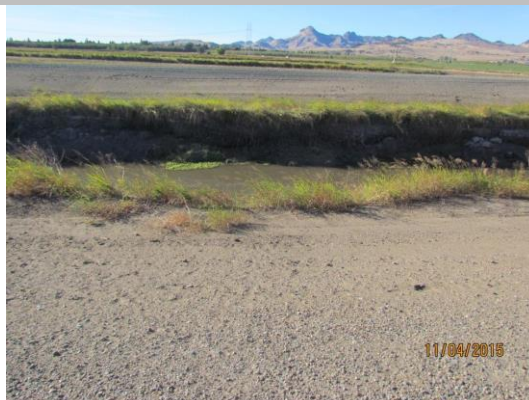
View of the erosion along the waterside toe.

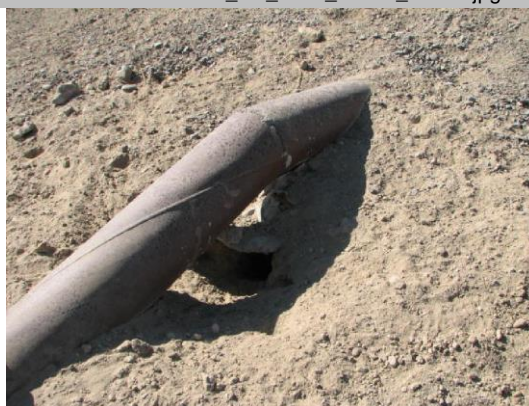
Photo 3 of 3 : UCIP_SP_2018_51506_64726.jpg

Comment Code						
Inspector Comment						
FS_ID:51506 DS_ID:17069 EP_NO: N/A Repair Type: Non-Urgent Crossing Status: Found UCIP Comments: 4/10/2017 Abanoned crossing with heavy rodent activity around it. Needs to be removed. (DWR Sutter Yard-AFreitag)10/12/2016 Abandoned crossing.(DWR Sutter Yard -afreitag)4/19/2016 Abandoned crossing. Rodent activity still present on WS slope.5/12/2015 Abandoned crossing. Signs of rodent activity on both sides of levee.11/18/2014 Same as last inspection.5/13/2014 Same as last inspection.10/29/2013 Same as last inspection.5/16/2013 Same as last inspection.10/9/2012 Pipe appears improperly abandoned. No motor present, electrical equipment is stripped. Heavy rodent activity along pipe WS and LS. Pipe needs to be removed or properly abandoned. FIELD_STRUCT_DESC: *ABANDONED* 10-inch steel irrigation pipe through the levee, 4.8 feet below the crown. Pump mounted on concrete pad near canal bank located on the waterside (WS). Service pole located on the berm. 36-inch concrete standpipe located on the landside (LS) toe. (Permit No. 945, 1944 - Becker). [Additional Reference(s): DWR Levee Log, 2005. USACE Sacramento O&M Manual 135, May 1953, (Station 61+10)]. FS Date: 4/12/2017 9:47:25 AM

Heavy rodent activity along pipe, both sides.

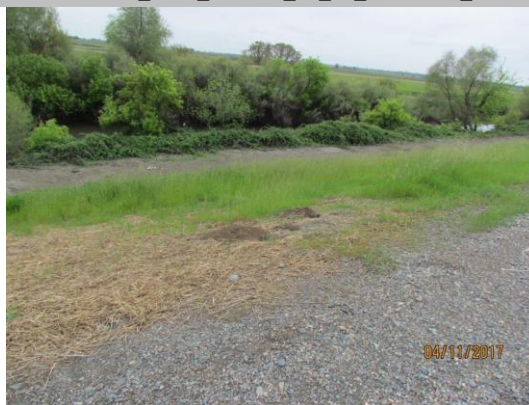
Photo 1 of 1 : SP_2018_ST0010_43_19_20180305_00014.jpg

LM Start	1.16	Rating **	U	Issue No.	19
LM End	1.16	Issue Type +	Ma	Location *	WS
Category	Earthen Levee			GPS Latitude/Longitude	
				Start	End
Item	Animal Control			39.127527 °	39.127527 °
				-121.756493 °	-121.756493 °
DWR ID	DWR_ST0010_02_f_2016_19				
Comment Code					
A3 : No rodents visible, but rodent burrows visible; need to backfill and compact or grout burrows.					
Inspector Comment					
Repair the rodent holes along the waterside slope.

View of the rodent holes along the waterside slope.

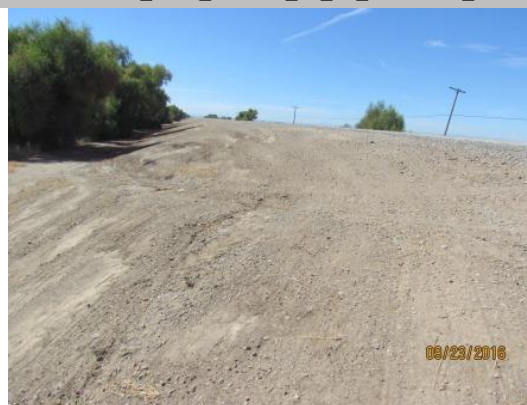
Photo 1 of 1 : SP_2018_ST0010_43_20_20180305_00015.jpg

View the ramp encroaching into the levee.

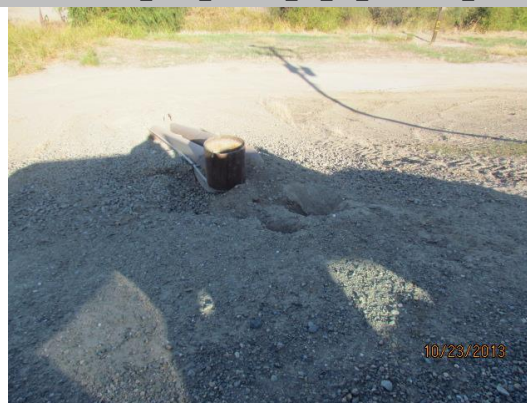
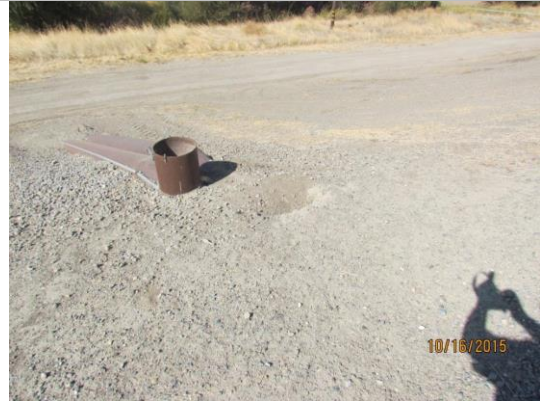
View of the rodent holes above the irrigation pipe.

View of the rodent hole above the irrigation pipe.

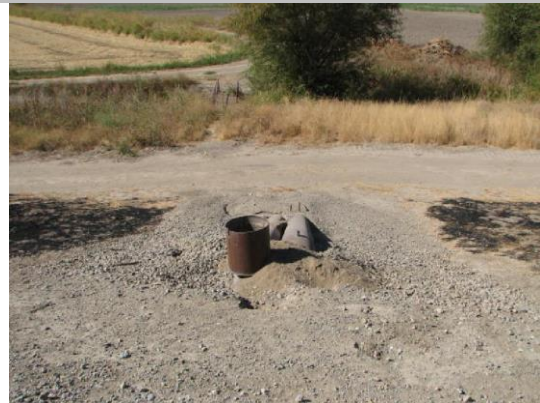
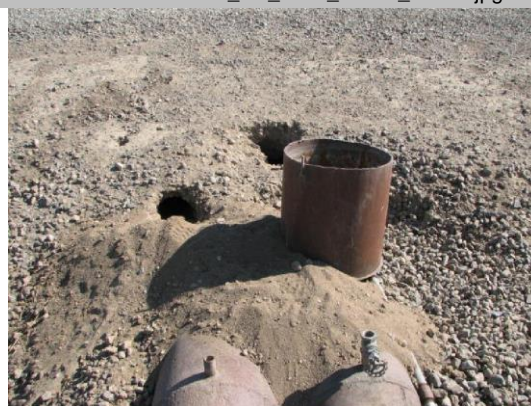
Pipe on LS showing rodent activity.

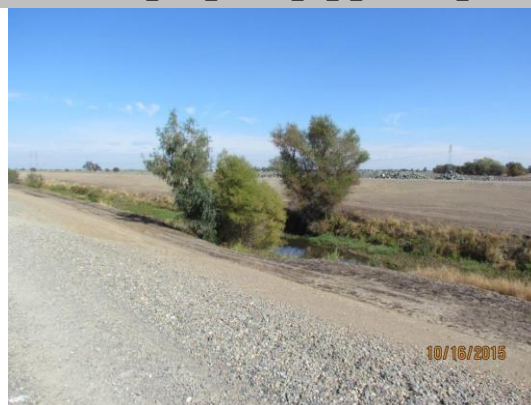
Photo 2 of 2 : SP_2018_ST0010_43_8_20180305_00008.jpg

View of the erosion along the landside toe.

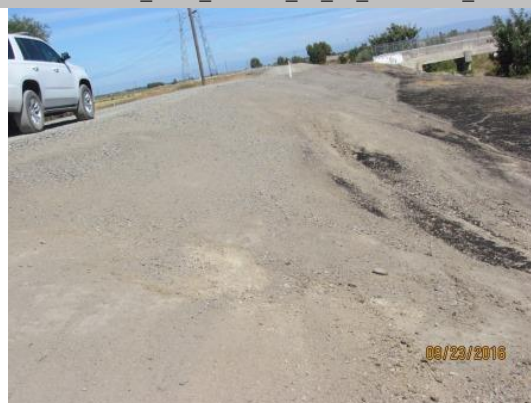
Photo 1 of 1 : SP_2018_ST0010_43_21_20180305_00016.jpg

View the ramp encroaching into the levee.

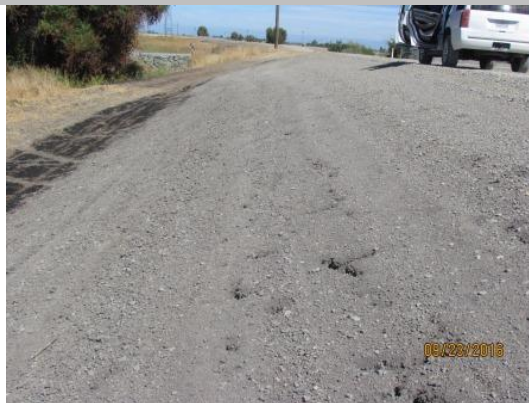
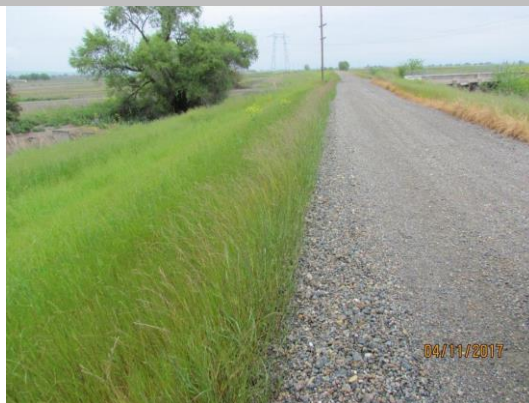
View of the longitudinal cracks along the landside slope.

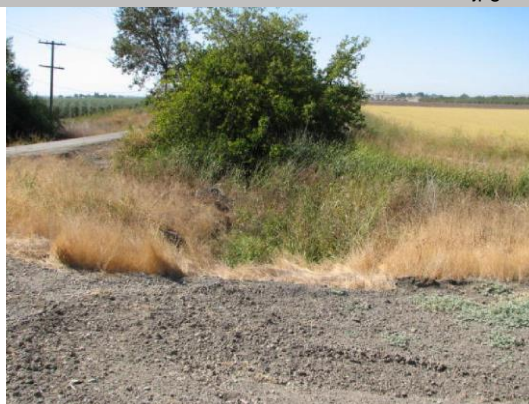
Photo 2 of 3 : UCIP_SP_2018_51515_64743.jpg

Heavy vegetation at LS inlet at channel.

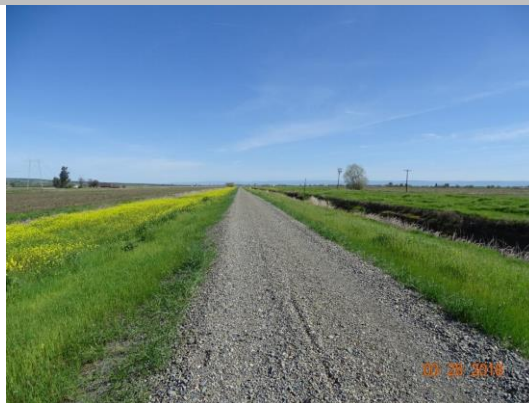
Photo 1 of 1 : SP_2018_ST0010_43_17_20180403_00037.jpg

View of the native grasses on both slopes.

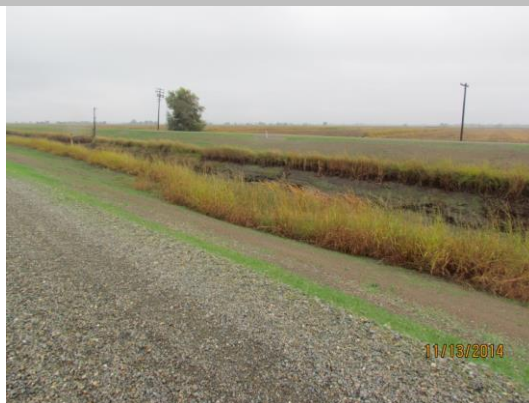
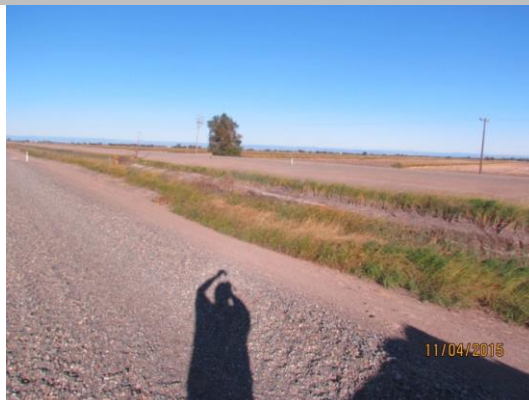
View of the erosion at the waterside toe.

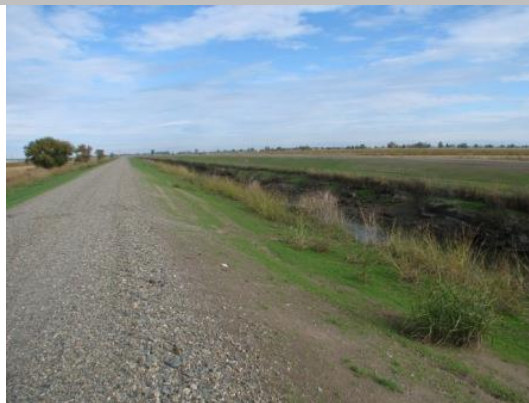
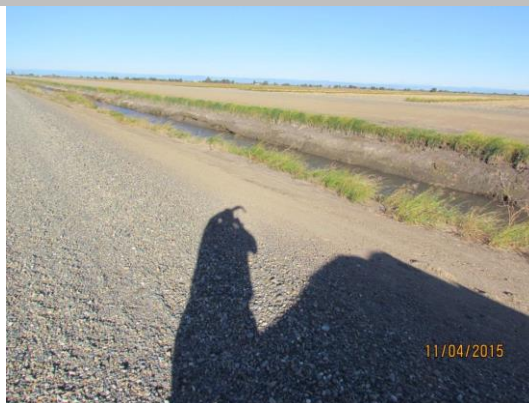
View of the erosion along the waterside toe.

View of erosion at the waterside toe

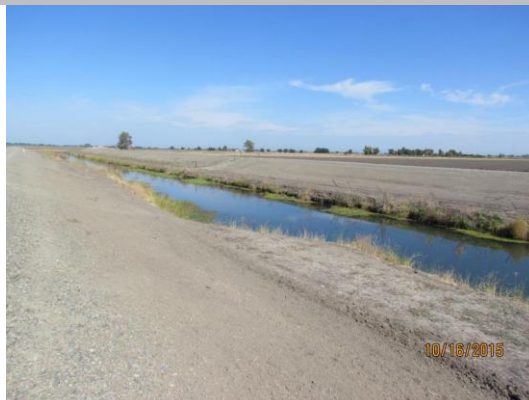
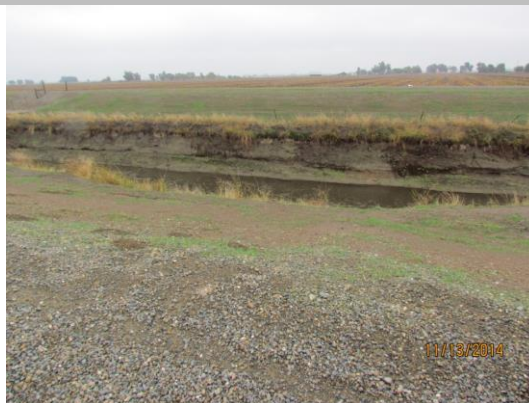
View of the erosion along the waterside toe.

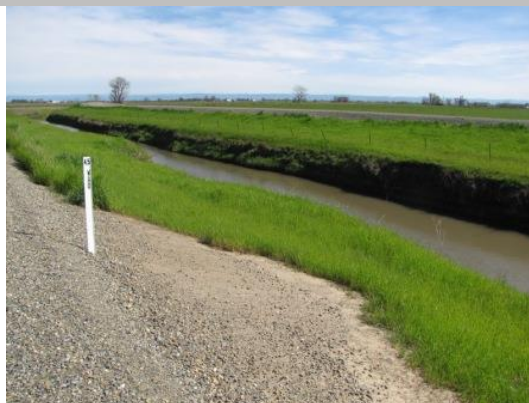
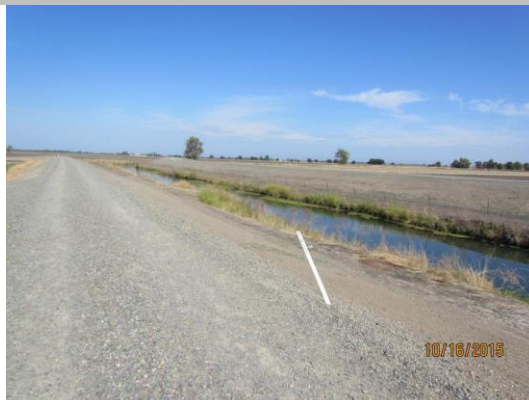
View of the erosion along the W/S toe.

View of the erosion along the waterside toe.
