**Flood Control Project Maintenance  
Levee Inspections**  
**LMA District Cover Sheet**  
**Spring 2019 Levee Inspection Results**

**Sutter Maintenance Yard Wadsworth Canal**

**Spring 2019 Levee Inspection Results**

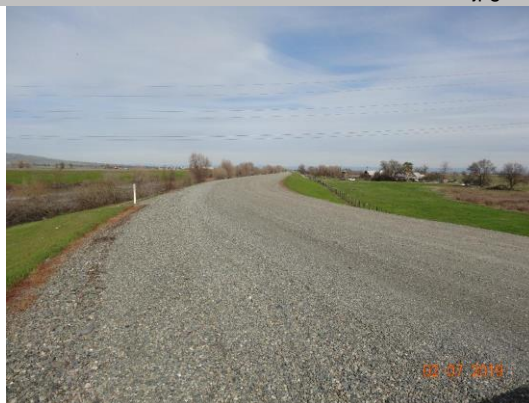
Photo 2 of 3 : UCIP\_SP\_2019\_53741\_78654.jpg

Overview of levee crown at location where crossing should be.

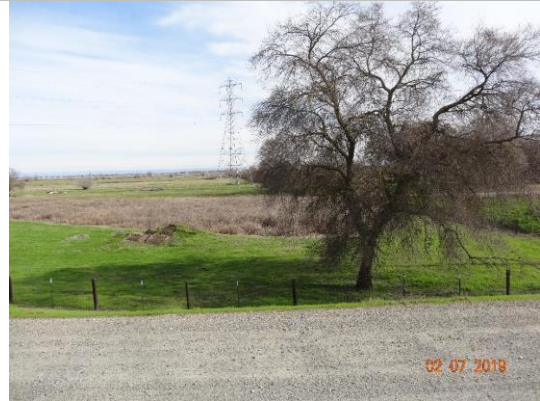
Photo 3 of 3 : UCIP\_SP\_2019\_53741\_78655.jpg

LS view: No markers visible on LS.

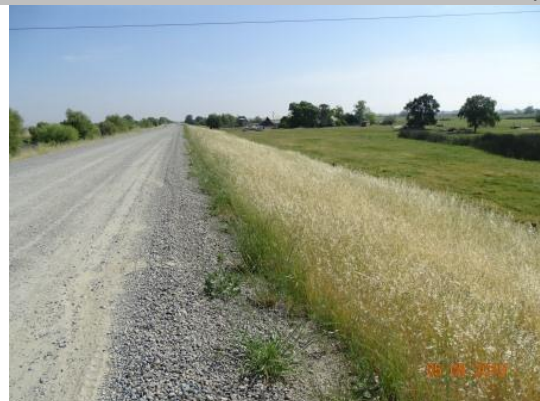
Photo 1 of 1 : SP\_2019\_ST0010\_42\_2\_20190510\_00052.jpg

LM Start	0.03	Rating **	U	Issue No.	2
LM End	4.61	Issue Type +	Ma	Location *	LS
Category	Earthen Levee			GPS Latitude/Longitude	
				Start	End
Item	Vegetation			39.113804 °	39.170986 °
				-121.768283 °	-121.726687 °
DWR ID	DWR_ST0010_01_s_2012_2				
Comment Code					
V1 : Control annual grass and weeds on the levee slopes and easements.					
Inspector Comment

View of the vegetation on the landside slope. Spring 2019.

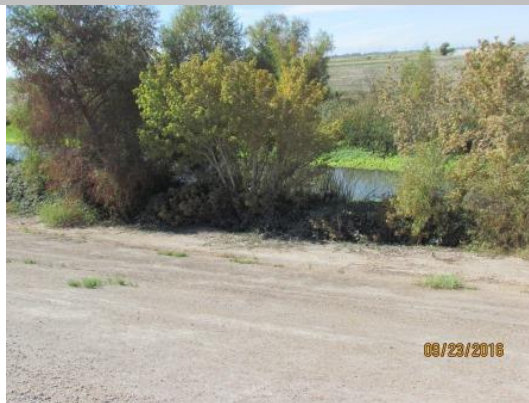
Photo 1 of 1 : SP\_2019\_ST0010\_42\_19\_20190327\_00012.jpg

View of the erosion along the waterside toe.

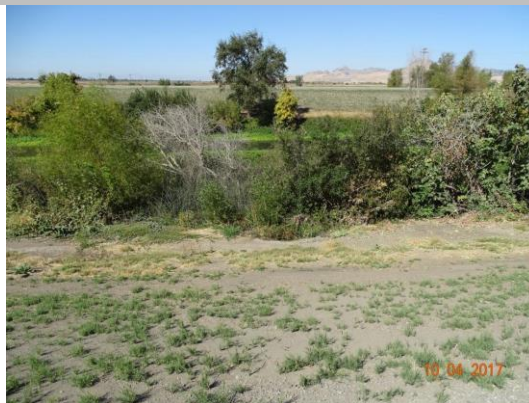
Photo 1 of 1 : SP\_2019\_ST0010\_42\_22\_20190327\_00014.jpg

LM Start	0.50	Rating **	U	Issue No.	22
LM End	0.50	Issue Type +	Ma	Location *	WS
Category	Earthen Levee			GPS Latitude/Longitude	
				Start	End
Item	Erosion / Bank Caving			39.119348 °	39.119348 °
				-121.763120 °	-121.763120 °
DWR ID	DWR_ST0010_01_f_2017_22				
Comment Code					
E2 : Schedule repair of erosion site prior to the next inspection.					
Inspector Comment					
Repair the beaver hole along the waterside berm.

View of the beaver hole along the waterside berm.

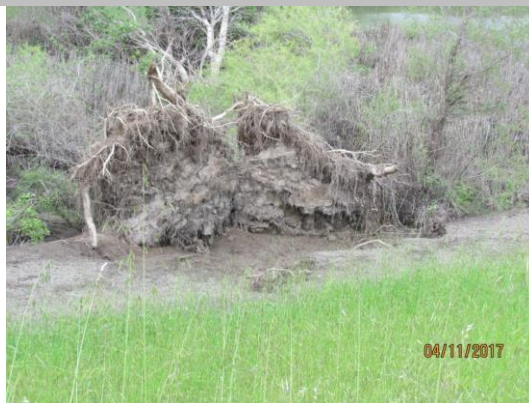
Photo 1 of 1 : SP\_2019\_ST0010\_42\_18\_20190327\_00011.jpg

LM Start	0.56	Rating **	M	Issue No.	18
LM End	0.56	Issue Type +	Ma	Location *	WS
Category	Earthen Levee			GPS Latitude/Longitude	
				Start	End
Item	Erosion / Bank Caving			39.119985 °	39.119985 °
				-121.762600 °	-121.762600 °
DWR ID	DWR_ST0010_01_s_2017_18				
Comment Code					
E2 : Schedule repair of erosion site prior to the next inspection.					
Inspector Comment

View of the erosion along the waterside toe caused by a tree that fell into the water.

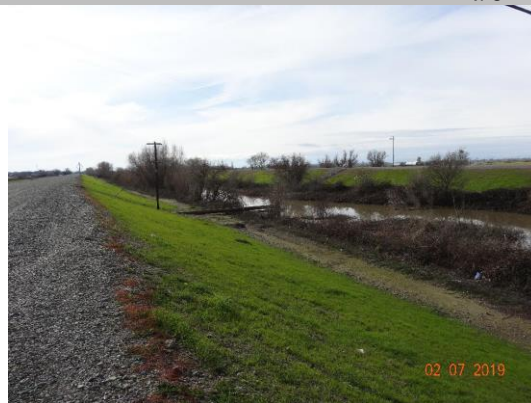
Photo 3 of 3 : UCIP\_SP\_2019\_53595\_78663.jpg

WS view: marker just immediately upstream from 18-inch pipe crossing.

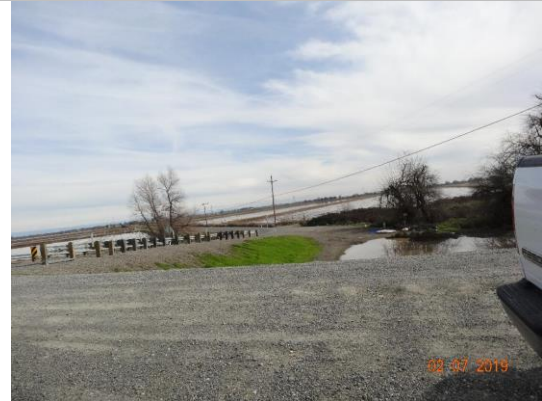
Photo 3 of 3 : UCIP\_SP\_2019\_53593\_78668.jpg

LS view: no markers visible along LS or county road.

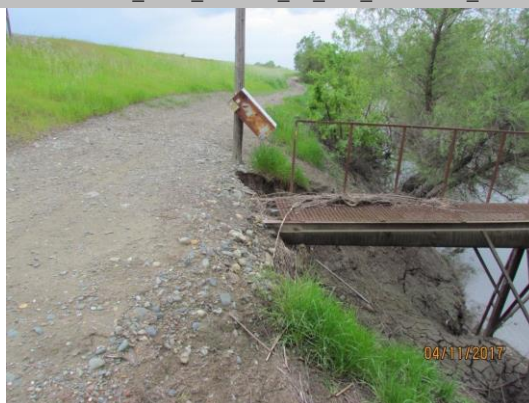
Photo 3 of 3 : SP\_2019\_ST0010\_42\_107\_20190327\_00018.jpg

LM Start	1.85	Rating **	U	Issue No.	107
LM End	1.85	Issue Type +	Ma	Location *	WS
Category	Earthen Levee			GPS Latitude/Longitude	
				Start	End
Item	Erosion / Bank Caving			39.135110 °	39.135110 °
				-121.748230 °	-121.748230 °
DWR ID	DWR_ST0010_01_f_2013_107				
Comment Code					
E2 : Schedule repair of erosion site prior to the next inspection.					
Inspector Comment

View of erosion along both sides of the abandoned pipe.

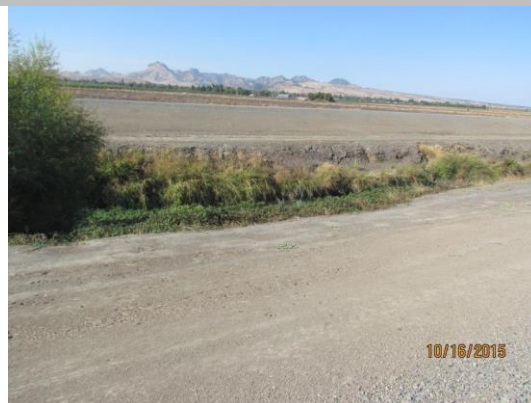
Photo 2 of 4 : SP\_2019\_ST0010\_42\_6\_20190327\_00007.jpg

View of the erosion along the waterside toe.

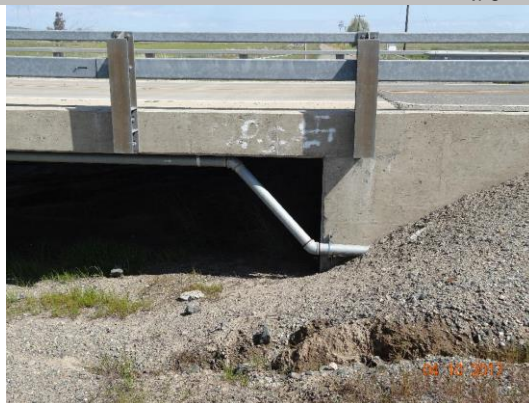
Photo 3 of 3 : UCIP\_SP\_2019\_53598\_76954.jpg

Conduit exiting WS slope and attaching to the downstream side of South Butte Rd bridge.

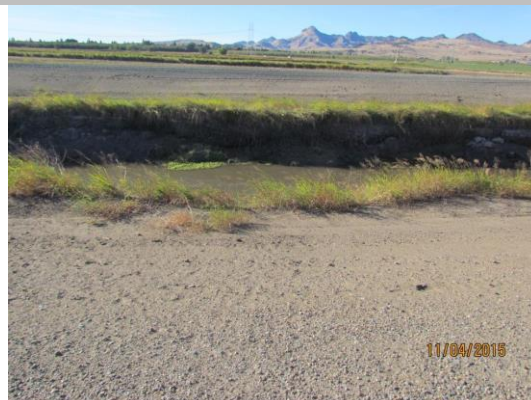
Photo 2 of 2 : SP\_2019\_ST0010\_42\_5\_20190327\_00005.jpg

View of the erosion along the waterside toe.

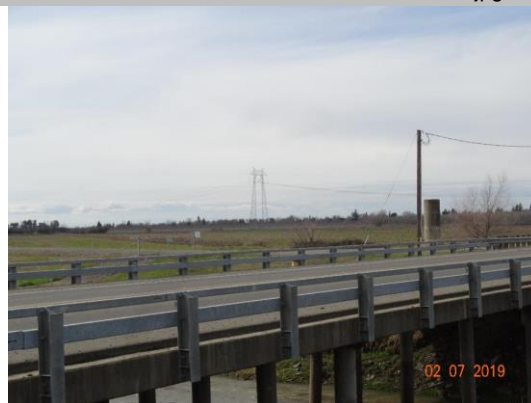
Photo 2 of 3 : UCIP\_SP\_2019\_53600\_78706.jpg

No markers visible on levee crown for conduit, photo 2 of 2.

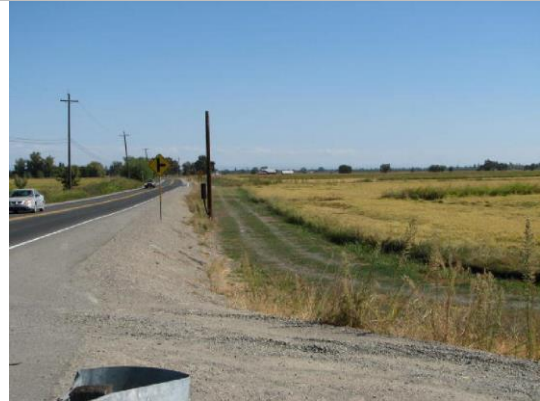
Photo 3 of 3 : UCIP\_SP\_2019\_53600\_64725.jpg

Telephone pole on east side of canal with underground line attached.  
This is a good indicator of where crossing is or was located.

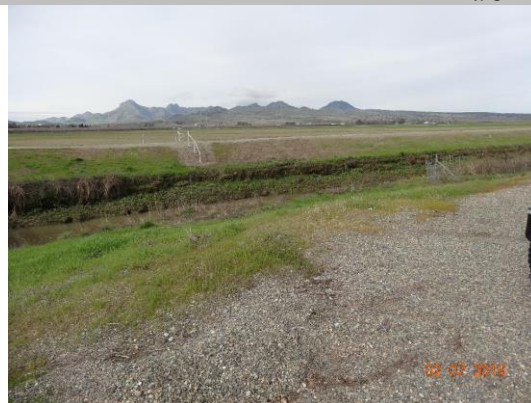
Photo 1 of 3 : UCIP\_SP\_2019\_53601\_78707.jpg

WS view: overview of WS, no signs of pipe.

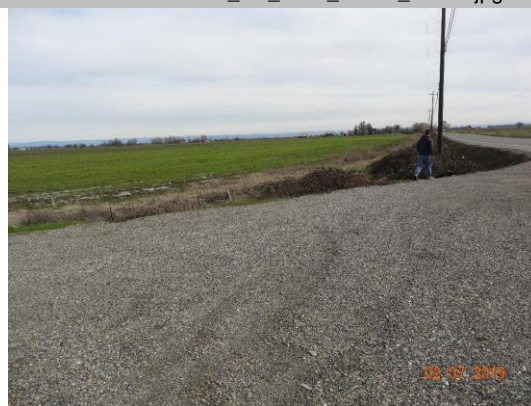
Photo 3 of 3 : UCIP\_SP\_2019\_53601\_78709.jpg

LS view: overview of LS, no signs of pipe.

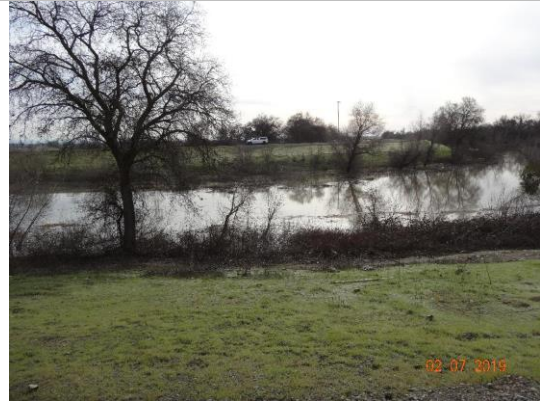
Photo 3 of 3 : UCIP\_SP\_2019\_53603\_78710.jpg

WS view: overview of WS; no markers visible of gas line.

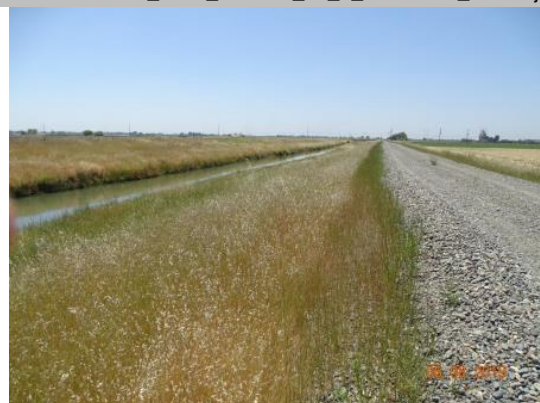
Photo 1 of 1 : SP\_2019\_ST0010\_43\_2\_20190510\_00053.jpg

View of the vegetation on the waterside slope. Spring 2019.

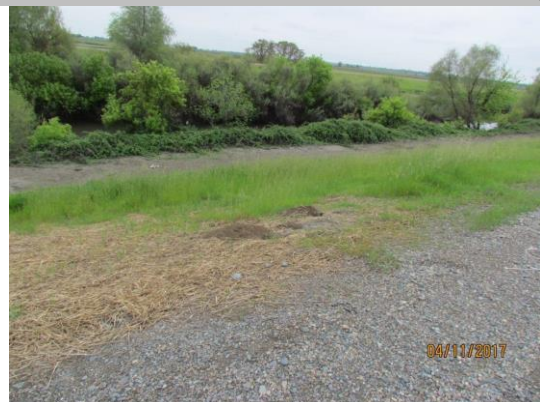
Photo 1 of 1 : SP\_2019\_ST0010\_43\_19\_20190327\_00008.jpg

View of the rodent holes along the waterside slope.

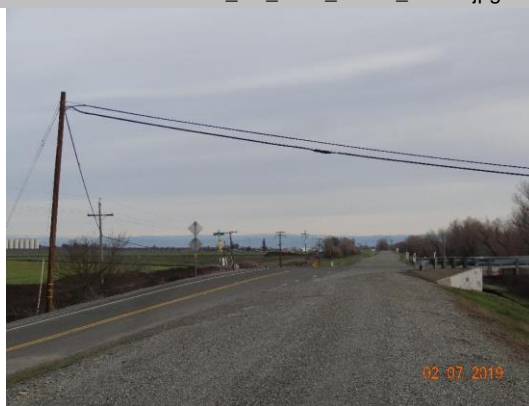
Photo 3 of 3 : UCIP\_SP\_2019\_53606\_78728.jpg

Aerial lines visible only no signs of communication line.

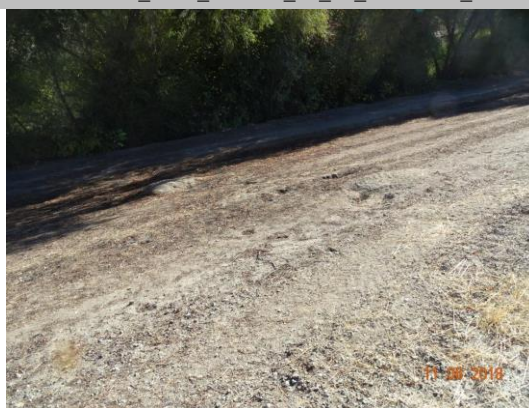
Photo 1 of 1 : SP\_2019\_ST0010\_43\_23\_20190327\_00013.jpg

View of the rodent holes along the waterside slope.

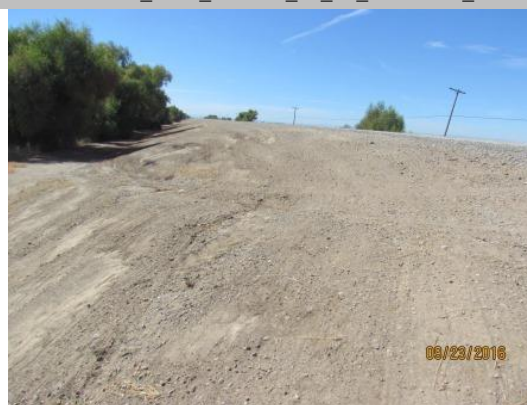
Photo 1 of 1 : SP\_2019\_ST0010\_43\_20\_20190327\_00009.jpg

View of the ramp encroaching into the levee.

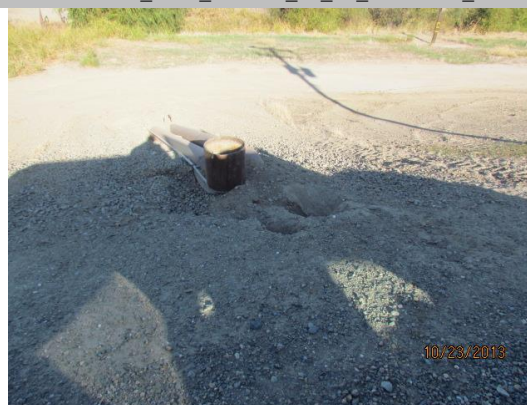
Photo 1 of 2 : SP\_2019\_ST0010\_43\_11\_20190327\_00005.jpg

View of the rodent holes above the irrigation pipe.

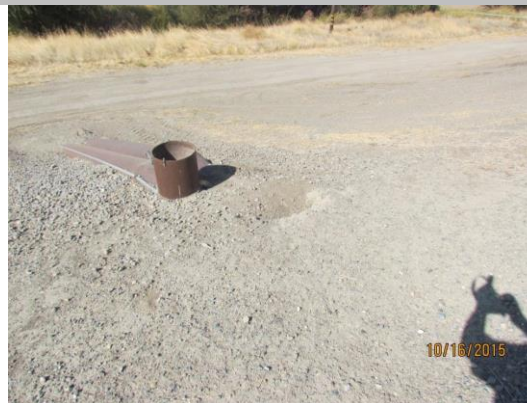
Photo 2 of 2 : SP\_2019\_ST0010\_43\_11\_20190327\_00006.jpg

View of the rodent hole above the irrigation pipe.

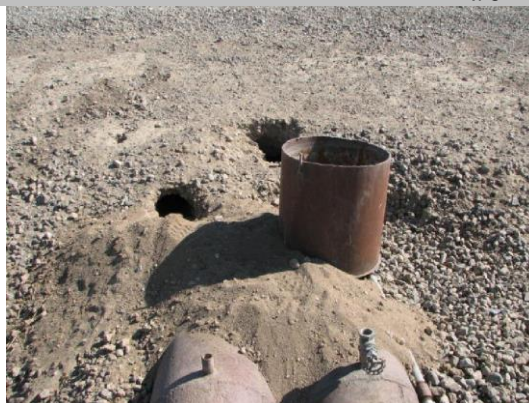
Photo 2 of 3 : UCIP\_SP\_2019\_53609\_64735.jpg

Pipe on LS showing rodent activity.

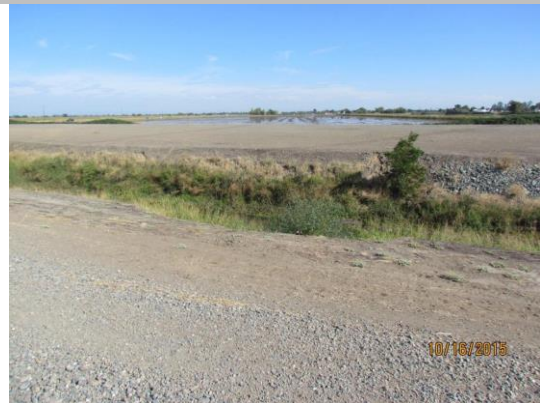
Photo 1 of 2 : SP\_2019\_ST0010\_43\_8\_20190327\_00001.jpg

View of erosion along the waterside toe.

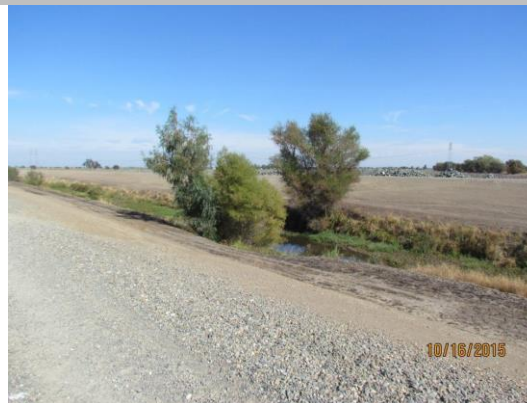
Photo 2 of 2 : SP\_2019\_ST0010\_43\_8\_20190327\_00002.jpg

View of the erosion along the landside toe.

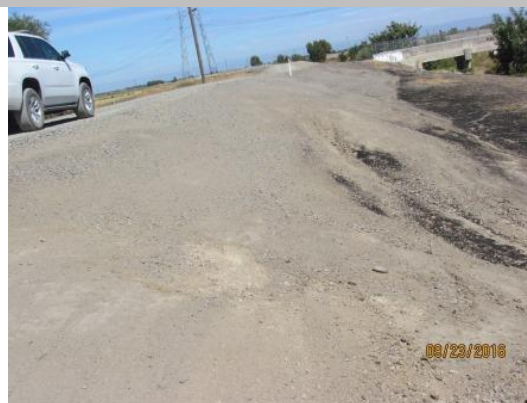
Photo 1 of 1 : SP\_2019\_ST0010\_43\_21\_20190327\_00010.jpg

View of the ramp encroaching into the levee.

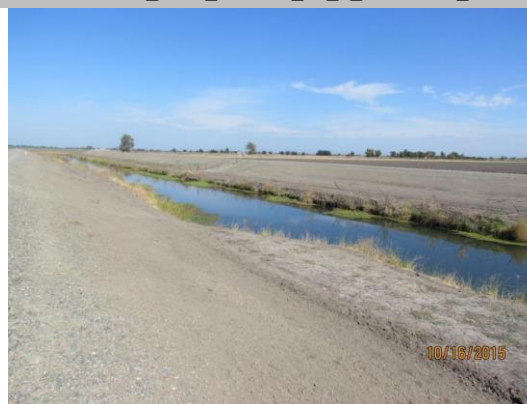
Photo 1 of 2 : SP\_2019\_ST0010\_43\_9\_20190327\_00003.jpg

View of the erosion along the waterside toe.

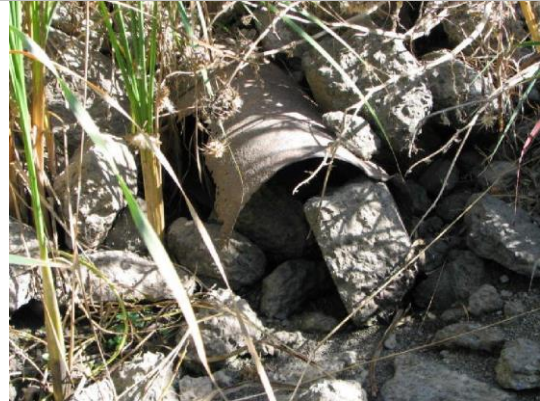
Photo 2 of 3 : UCIP\_SP\_2019\_53615\_64760.jpg

Rusted outlet at LS channel. Unclear if this is same pipe as one under investigation.

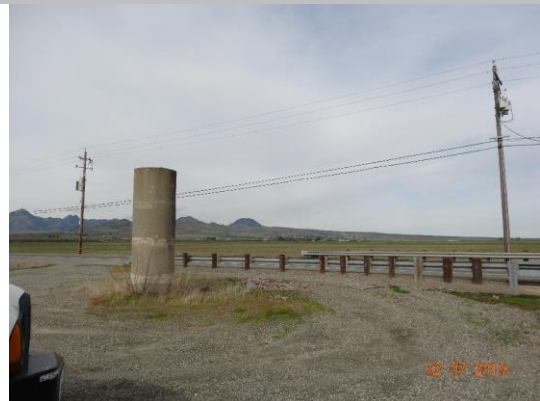
Photo 2 of 3 : UCIP\_SP\_2019\_53618\_78805.jpg

WS view: aerial power lines present but no markers of communication line, photo 1 of 2.

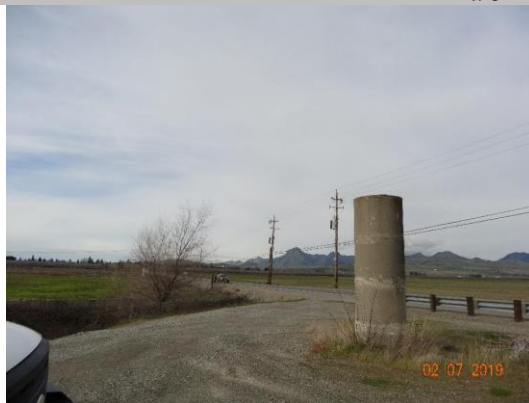
Photo 3 of 3 : UCIP\_SP\_2019\_53618\_78806.jpg

WS view: aerial power lines present but no markers of communication line, photo 2 of 2.
