**Flood Control Project Maintenance
Levee Inspections**
LMA District Cover Sheet
Spring 2020 Levee Inspection Results

Spring 2020 Levee Inspection Results

Sutter Maintenance Yard Wadsworth Canal

Waterway			Bank	Unit Miles
Unit No. 01 Wadsworth Canal			Left	4.63
	Spring (March - May)	Summer (June - August)	(September - November) Fall	Winter (December - February)
Unit Maintenance Rating (Fall Only)				
Date of Inspection	3/19/2020 - 3/19/2020			
DWR Inspector	Makar Sokol			
Accompanied By

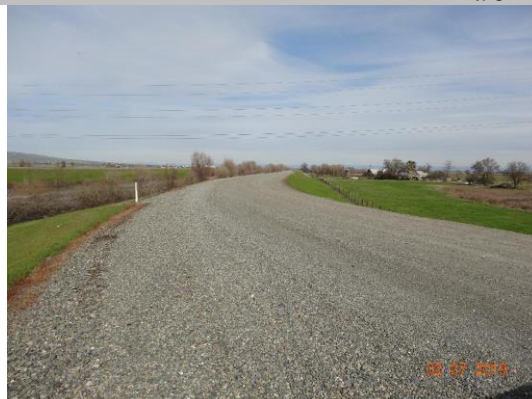
Photo 2 of 3 : UCIP_SP_2020_55976_78654.jpg

DS_ID:17068
FS_ID:55976
EP_NO: 5296
Repair Type: Non-Urgent
Crossing Status: Not Found
UCIP Comments: 02/07/2019 Record remains Non-Urgent, unable to locate pipe or any appurtenances on the levee. LMA superintendent, Joel Farias, mentioned that this line has been abandoned and line is only referenced in old PG&E facility maps. Owner to this pipe has been changed at least 4 times. No maintenance records were available to determine the status of the pipe. Unable to confirm how pipe was abandoned. Will need to contact owner. (O. Magana - DWR UCIP)04/10/2017 Unable to locate. (DWR Sutter Yard-AFreitag)10/12/2016 Unable to locate.(DWR Sutter Yard - afreitag)04/19/2016 Unable to locate.05/12/2015 Unable to locate.11/18/2014 Unable to locate.05/13/2014 Same as last inspection.10/29/2013 Same as last inspection.05/16/2013 Same as last inspection.10/09/2012 Need to determine disposition of pipe, contact pipe owner if possible. (W. Wylie - DWR UCIP)

Overview of levee crown at location where crossing should be.

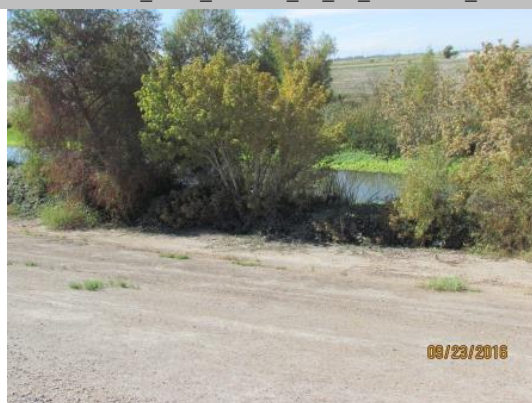
Photo 1 of 1 : SP_2020_ST0010_42_19_20200226_00010.jpg

View of the erosion along the waterside toe.

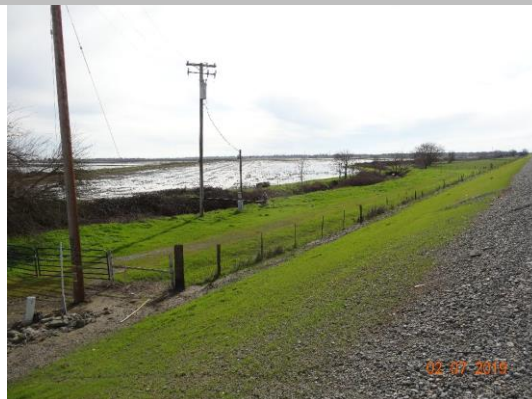
Photo 1 of 3 : UCIP_SP_2020_55977_78658.jpg

Comment Code						
Inspector Comment						
DS_ID:17059 FS_ID:55977 EP_NO: 1605 Repair Type: Non-Urgent Crossing Status: Found UCIP Comments: 02/07/2019 Record remains Non-Urgent, pipe and appurtenances have been abandoned at this location. The pump and power meter have been removed from this location. Owner will need to coordinate with CVFPB to remove pipe according to Title 23 requirements. (O. Magana - DWR UCIP)04/10/2017 Abandoned. (DWR Sutter Yard- A Freitag)10/12/2016 Abandoned crossing.(DWR Sutter Yard - a Freitag)04/16/2016 Abandoned crossing. Ws pipe end is open and should be capped.05/12/2015 Abandoned crossing. Needs to be properly abandoned.11/18/2014 Same as last inspection.05/13/2014 Same as last inspection.10/29/2013 Same as last inspection.05/16/2013 Same as last inspection.10/09/2012 No pump on Pier and power lines cut. Apparently abandoned-should be abandoned properly. (W. Wylie - DWR UCIP) FIELD_STRUCT_DESC: *ABANDONED* 18-inch steel irrigation pipe (permit records indicate 16-inch pipe, 18-inch diameter field verified) through the levee, 3.7 feet below the crown. Siphon breaker on the waterside (WS) slope. Pump on channel bank on steel structure. (16-inch pipe authorized under Permit No. 1605, 1959 - Schnabel; Aerial 12 KV power line extension for pump authorized under Permit No. 1631, 1959 - Pacific Gas and Electric Company [PG&E]). [Additional Reference(s): DWR Levee Log, 2005]. FS Date: 2/7/2019 2:48:00 PM

LS view: overview of LS looking downstream.

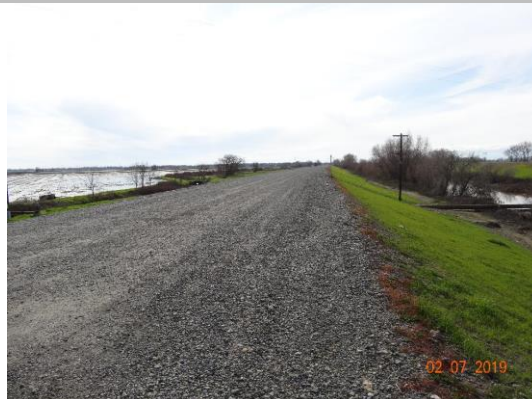
Photo 2 of 3 : UCIP_SP_2020_55978_78662.jpg

Overview of levee crown at pipe crossing.

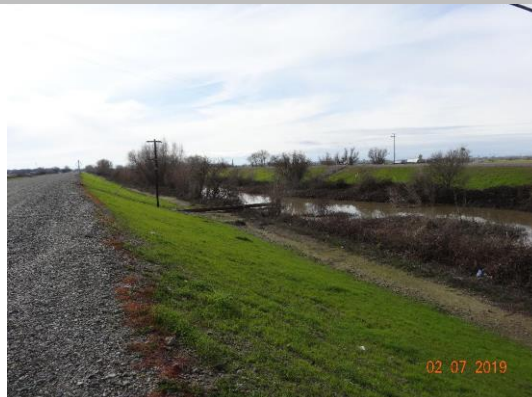
Photo 3 of 3 : UCIP_SP_2020_55978_78663.jpg

WS view: marker just immediately upstream from 18-inch pipe crossing.

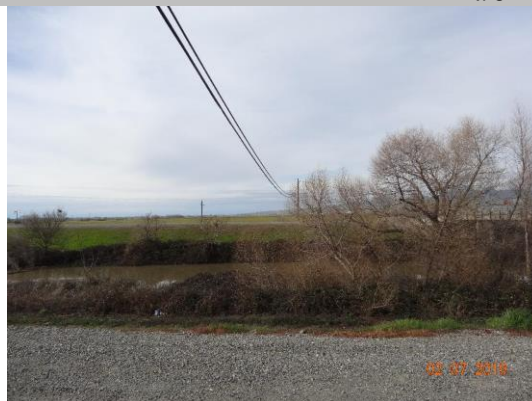
Photo 1 of 3 : UCIP_SP_2020_55979_78669.jpg

Comment Code					
Inspector Comment					
DS_ID:17060 FS_ID:55979 EP_NO: 13362 Repair Type: Non-Urgent Crossing Status: Indicator Found UCIP Comments: 02/07/2019 Record has been updated from No Action Needed to Non-Urgent, unable to determine whether the old authorized conduit line was abandoned through the levee. The conduit appears to be modified to an aerial conduit. Need to contact owner to determine status of authorized line and determine permit issued for modification of the aerial line at the same location. (O. Magana - DWR UCIP)04/11/2017 Aerial lines. (DWR Sutter Yard-AFreitag)10/12/2016 Crossing appears to be in good condition.(DWR Sutter Yard - afreitag)04/19/2016 Crossing appears to be in good condition.05/12/2015 Crossing appears in good condition. No noticeable issues to report.11/18/2014 Same as last inspection.05/13/2014 Same as last inspection.10/29/2013 Same as last inspection.05/16/2013 Same as last inspection.10/09/2012 No pipe on downstream side of bridge. It is likely that this com line is now an aerial. See photos. (W. Wylie - DWR UCIP) FIELD_STRUCT_DESC: 4-inch steel communication conduit with multiple telephone cables inside through the levee, 2.6 feet below the crown. Telephone cables sleeved through existing 4-inch conduit. The conduit is no longer attached to downstream side of bridge. It is likely that this communication line is now an aerial. (4-inch conduit authorized under Permit No. 6906, 1970 - Pacific Telephone and Telegraph Company [PT&T]. Telephone cables were installed through existing conduit authorized under Permit No. 13362, 1982 - PT&T). [Additional Reference(s): DWR Levee Log, 2005]. FS Date: 2/7/2019 2:49:00 PM

WS view: only overhead power lines visible at this location.

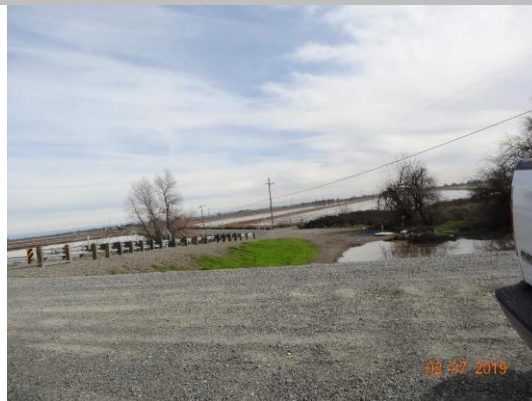
Photo 3 of 3 : UCIP_SP_2020_55979_78668.jpg

LS view: no markers visible along LS or county road.

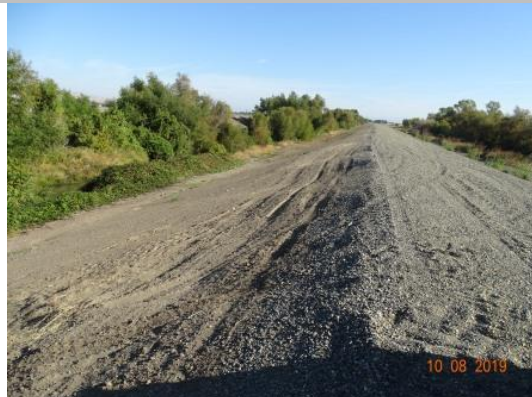
Photo 1 of 1 : SP_2020_ST0010_42_29_20200226_00014.jpg

LM Start	1.28	Rating **	M	Issue No.	29
LM End	1.28	Issue Type +	Ma	Location *	WS
Category	Earthen Levee			GPS Latitude/Longitude	
				Start	End
Item	Slope Stability			39.128352 °	39.128352 °
				-121.754575 °	-121.754575 °
DWR ID	DWR_ST0010_01_f_2019_29				
Comment Code					
S3 : Repair the levee slope damaged by vehicle traffic and prevent access where possible.					
Inspector Comment

View of the slope erosion due to vehicle traffic. Fall 2019.

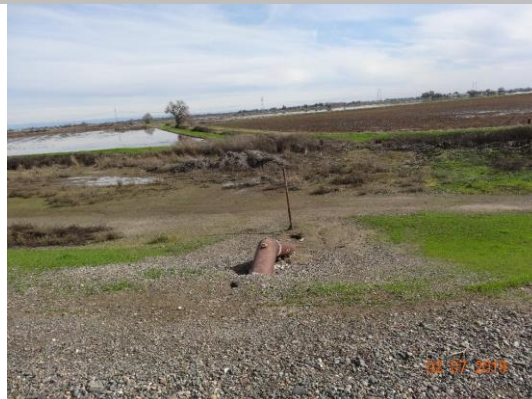
Photo 1 of 3 : UCIP_SP_2020_55500_78675.jpg

DS_ID:17063
FS_ID:55500
EP_NO: N/A
Repair Type: Urgent
Crossing Status: Found
UCIP Comments: 02/07/2019 Pipe has been upgraded from Non-Urgent to Urgent due to the pipe failure (sink hole) observed on the LS. Need to determine pipe integrity through the levee. Pipe and appurtenances have been abandoned. Power meter has been removed from the WS. Scour hole has developed on the WS berm edge located about 15 feet from WS toe. Owner will need to coordinate with CVFPB to properly remove pipe per Title 23. (O. Magana - DWR UCIP)04/10/2017 Abandoned. 10/12/2016 Abandoned crossing.(DWR Sutter Yard - afreitag)04/19/2016 Abandoned crossing. No noticeable issues to report.05/12/2015 Abandoned crossing. Cap was made and installed on WS open end of pipe.11/18/2014 Same as last inspection.05/13/2014 Cap was made and bolted on to WS open end of pipe.10/29/2013 Same as last inspection.05/16/2013 Same as last inspection. Steve Beckley is looking into finding pipe owner to properly abandon pipe.10/09/2012 Pipe abandoned. Pipe open and not plugged. Pipe should be removed or abandoned properly. Extensive animal burrowing occurring along pipe alignment. (W. Wylie - DWR UCIP)

LS view: overview of LS.

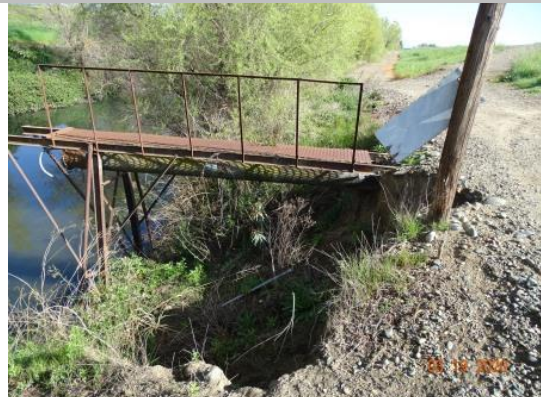
Photo 1 of 3 : SP_2020_ST0010_42_107_20200319_00053.jpg

LM Start	1.85	Rating **	U	Issue No.	107
LM End	1.85	Issue Type +	Ma	Location *	WS
Category	Earthen Levee			GPS Latitude/Longitude	
				Start	End
Item	Erosion / Bank Caving			39.135110 °	39.135110 °
				-121.748230 °	-121.748230 °
DWR ID	DWR_ST0010_01_f_2013_107				
Comment Code					
E2 : Schedule repair of erosion site prior to the next inspection.					
Inspector Comment					
Significant erosion is present at this site and should be addressed.

View of erosion along both sides of the abandoned pump. Spring 2020.

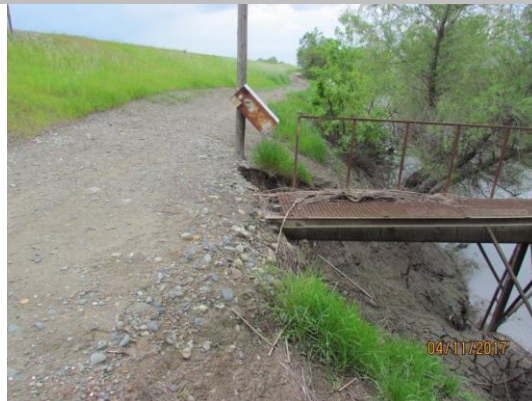
Photo 3 of 3 : SP_2020_ST0010_42_107_20200226_00018.jpg

View of erosion along both sides of the abandoned pipe. Spring 2017

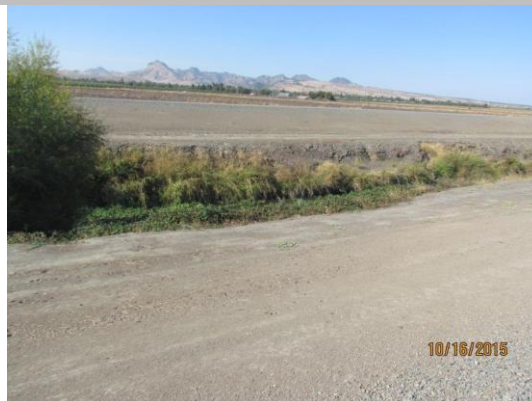
Photo 2 of 4 : SP_2020_ST0010_42_6_20200226_00005.jpg

View of the erosion along the waterside toe.

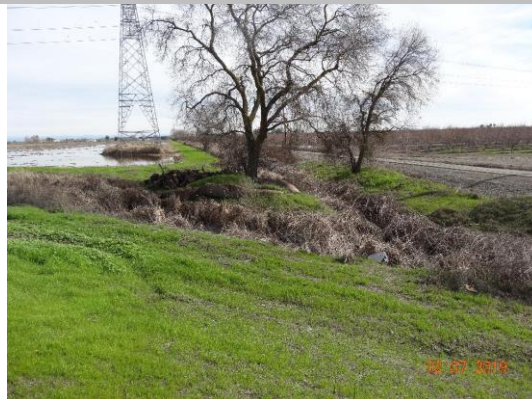
Photo 1 of 3 : UCIP_SP_2020_55502_78688.jpg

DS_ID:17065
FS_ID:55502
EP_NO: 7209
Repair Type: Non-Urgent
Crossing Status: Found
UCIP Comments: 02/07/2019 Record remains Non-Urgent due to of few maintenance issues observed during inspection. Pipe is being used as a shooting target. Multiple holes are visible on the exposed WS section of the pipe. The inlet pipe section located on the LS has been damaged (pipe wall section pulled). This pipe qualifies as an LMA responsible crossing as it was originally listed in the USACE O&M manual as a drainage pipe. The CVFPB issued a permit in 1970 for the replacement of the original USACE drainage pipe. (O. Magana - DWR UCIP)04/10/2017 WS pipe end is in good condition. LS pipe end is still deformed and vegetated. (DWR Sutter Yard - AFreitag)10/12/2016 LS inlet is still deformed and being overgrown by vegetation.(DWR Sutter Yard - afreitag)04/19/2016 Crossing appears to be in good condition.05/12/2015 LS inlet still deformed a little but does not affect the crossing function.11/18/2014 Same as last inspection.05/13/2014 Same as last inspection.10/29/2013 Same as last inspection.05/16/2013 Pipe intake on LS appears to be bent and damaged but that does not appear to be affecting water flow or channel bank.

LS view: overview of LS.

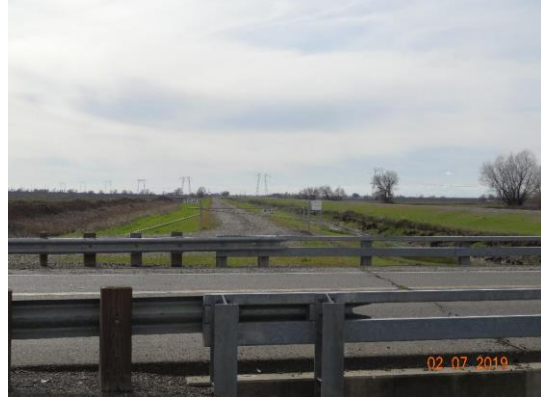
Photo 1 of 3 : UCIP_SP_2020_55505_78705.jpg

Comment Code					
Inspector Comment					
DS_ID:17067 FS_ID:55505 EP_NO: 4680 Repair Type: Non-Urgent Crossing Status: Indicator Found UCIP Comments: 02/07/2019 Record has been updated from No Action Needed to Non-Urgent, buried line appears to have been changed to an aerial line. No signs were present of the buried conduit instead there appears to be an aerial line at this location now. Need to coordinate with owner to determine if 4-inch conduit was properly abandoned or removed per Title 23. If modifications were not approved by the CVFPB, owner will need to coordinate with the CVFPB to comply with Title 23 requirements. (O. Magana - DWR UCIP)04/10/2017 Aerial lines. (DWR Sutter Yard- A Freitag)10/12/2016 Crossing appears to be in good condition.(DWR Sutter Yard - a Freitag)04/19/2016 Crossing appears to be in good condition.05/12/2015 Crossing appears in good condition. No noticeable issues to report.11/18/2014 Same as last inspection.05/13/2014 Same as last inspection.10/29/2013 Same as last inspection.05/16/2013 Same as last inspection.10/09/2012 Communication line on Pole 400-feet west of canal. Likely now an aerial on North side of roadway. (W. Wylie - DWR UCIP) FIELD_STRUCT_DESC: 4-inch steel communication conduit (telephone cable inside) through the levee, 2.3 feet below the crown. Conduit line goes through Wadsworth Canal and its levees. Annular space between pipe and conduit grouted. Line is attached to south side of the Butte House Road bridge (no longer attached in 2012). (4-inch conduit authorized under Permit No. 4680, 1964 - Pacific Telephone and Telegraph Company [PT&T]). [Additional Reference(s): DWR Levee Log, 2005]. FS Date: 2/7/2019 2:54:00 PM

No markers visible on levee crown for conduit, photo 1 of 2.

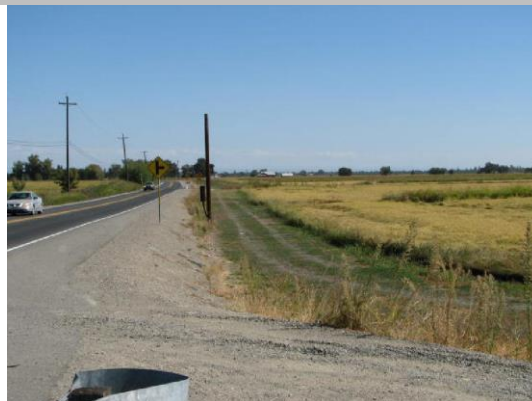
Photo 3 of 3 : UCIP_SP_2020_55505_64725.jpg

Telephone pole on east side of canal with underground line attached.
This is a good indicator of where crossing is or was located.

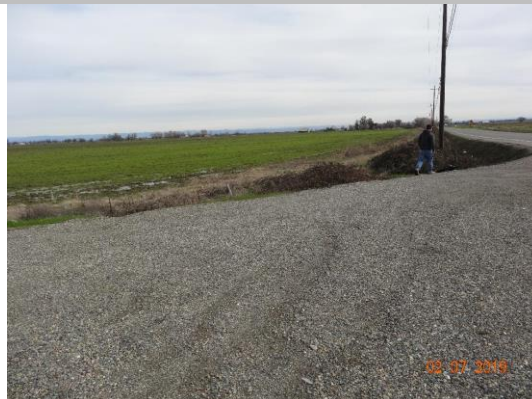
Photo 3 of 3 : UCIP_SP_2020_55506_78709.jpg

LS view: overview of LS, no signs of pipe.

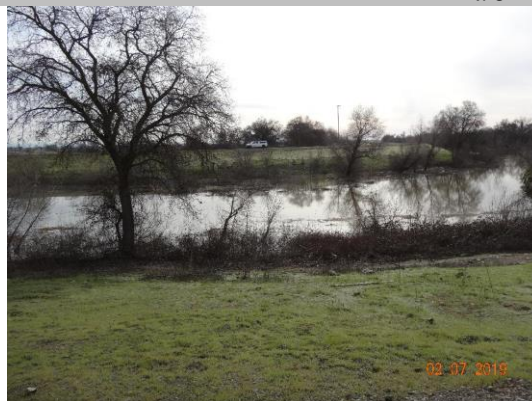
Photo 3 of 3 : UCIP_SP_2020_55507_78710.jpg

WS view: overview of WS; no markers visible of gas line.

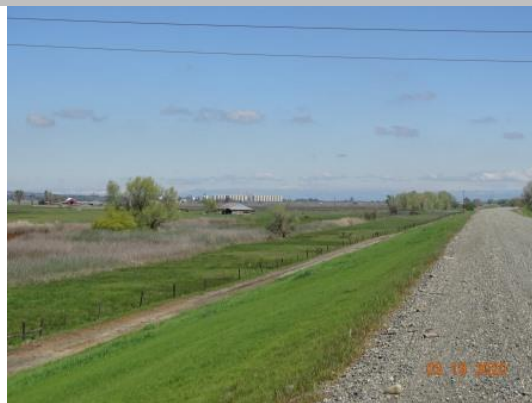
Photo 1 of 1 : SP_2020_ST0010_43_25_20200319_00054.jpg

View of the vegetation along the landside slope. Spring 2020.

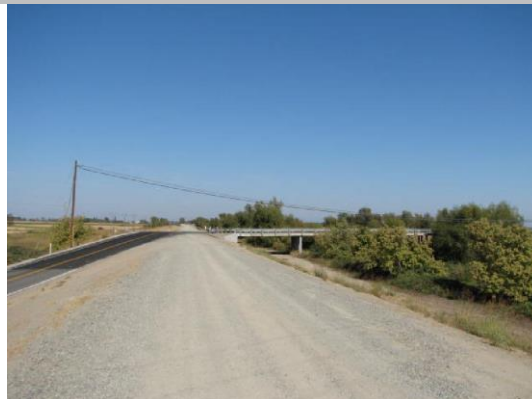
Photo 1 of 3 : UCIP_SP_2020_55510_64732.jpg

Aerial communication line over levee where underground communication line once was.

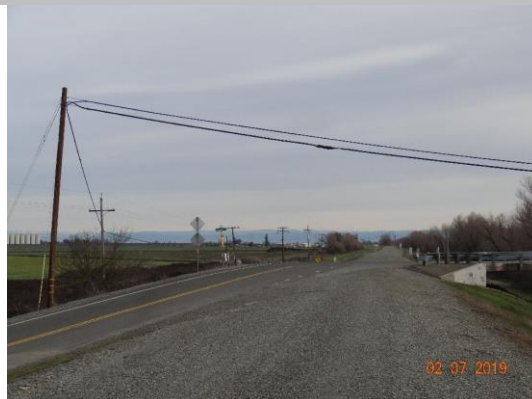
Photo 3 of 3 : UCIP_SP_2020_55510_78728.jpg

Aerial lines visible only no signs of communication line.

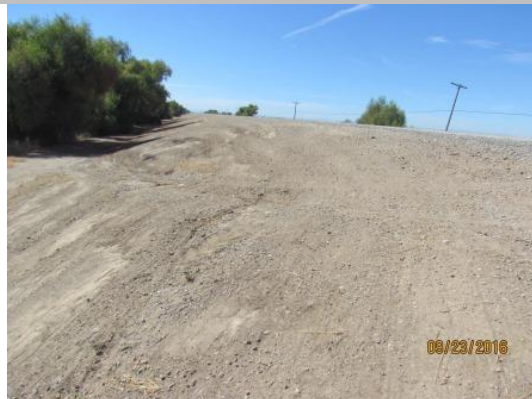
Photo 1 of 1 : SP_2020_ST0010_43_20_20200226_00009.jpg

View of the ramp encroaching into the levee.

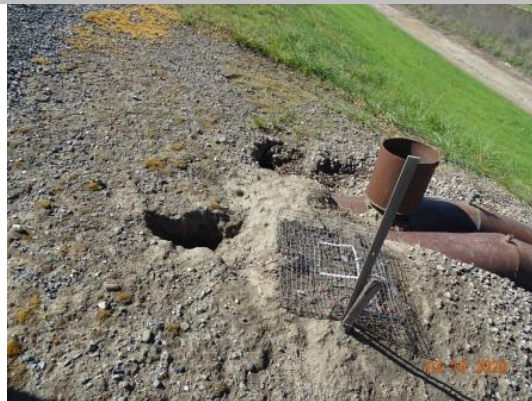
Photo 1 of 1 : SP_2020_ST0010_43_11_20200319_00055.jpg

View of the rodent holes above the irrigation pipe. Spring 2020.

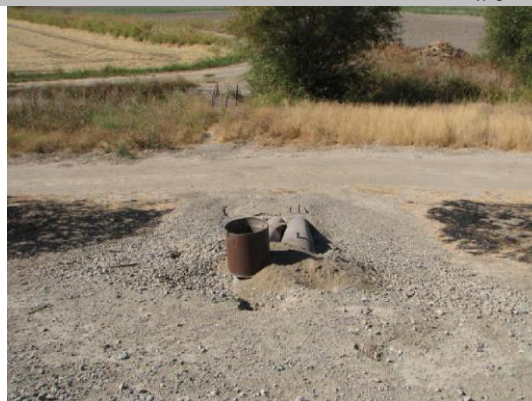
Photo 1 of 3 : UCIP_SP_2020_55514_64736.jpg

Pipe on LS showing rodent activity.

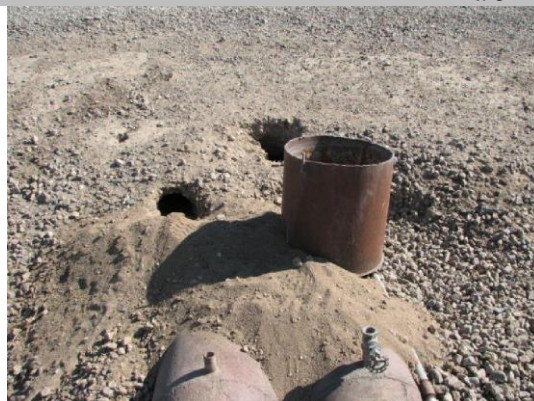
Photo 2 of 3 : UCIP_SP_2020_55514_64735.jpg

Pipe on LS showing rodent activity.

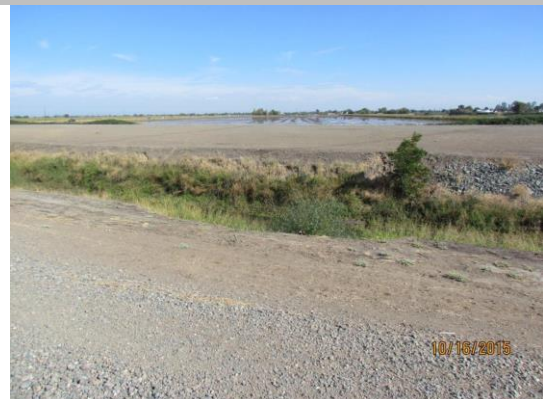
Photo 1 of 2 : SP_2020_ST0010_43_8_20200226_00001.jpg

View of erosion along the waterside toe.

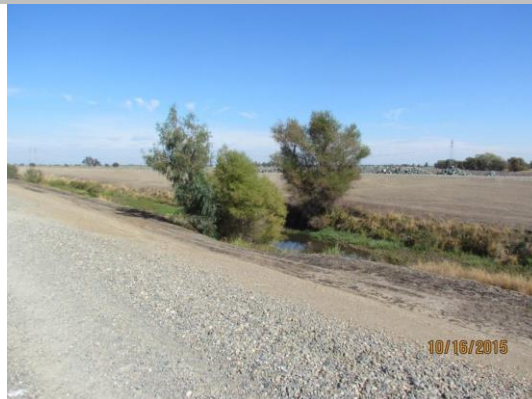
Photo 2 of 2 : SP_2020_ST0010_43_8_20200226_00002.jpg

View of the erosion along the landside toe.

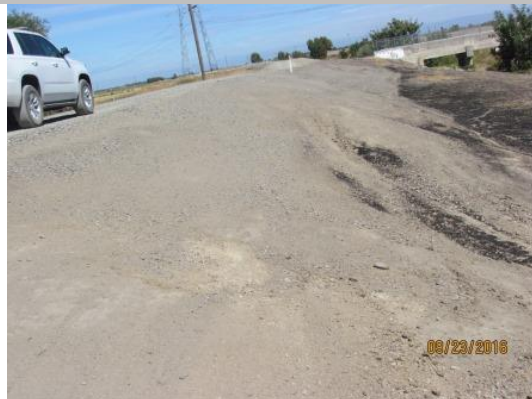
Photo 1 of 1 : SP_2020_ST0010_43_21_20200226_00010.jpg

View of the ramp encroaching into the levee.

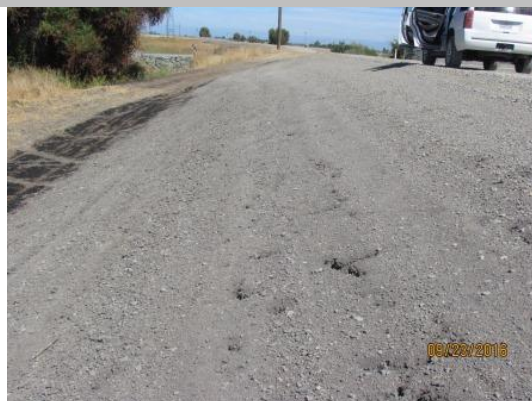
Photo 1 of 1 : SP_2020_ST0010_43_22_20200226_00011.jpg

View of the longitudinal cracks along the landside slope.

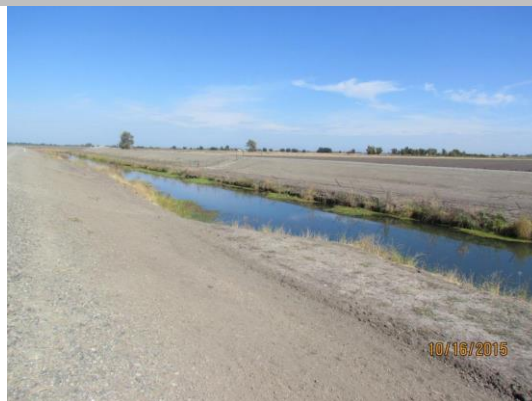
Photo 1 of 2 : SP_2020_ST0010_43_9_20200226_00003.jpg

View of the erosion along the waterside toe.

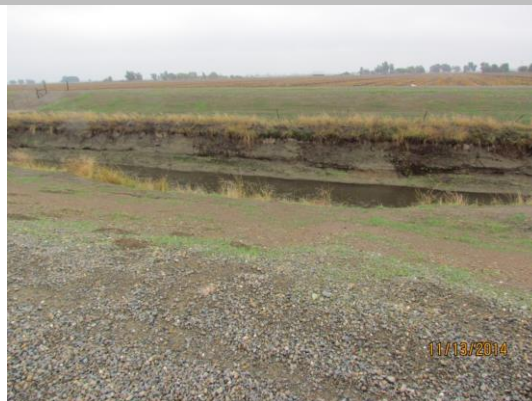
Photo 2 of 2 : SP_2020_ST0010_43_9_20200226_00004.jpg

View of the erosion along the waterside toe.

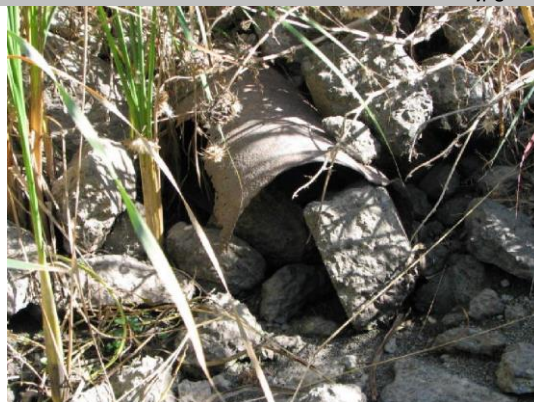
Photo 2 of 3 : UCIP_SP_2020_55519_64760.jpg

Rusted outlet at LS channel. Unclear if this is same pipe as one under investigation.

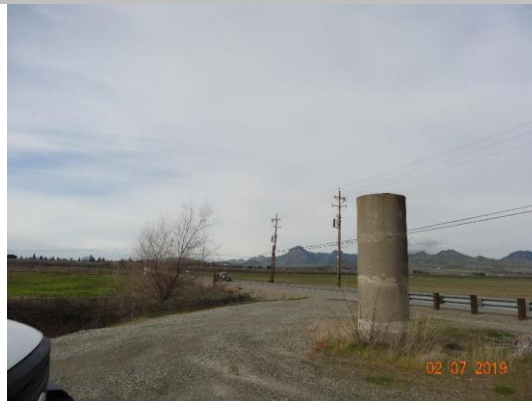
Photo 3 of 3 : UCIP_SP_2020_55523_78806.jpg

WS view: aerial power lines present but no markers of communication line, photo 2 of 2.
