**Flood Control Project Maintenance
Levee Inspections
Unit Cover Sheet**

Sutter Maintenance Yard Wadsworth Canal

Levee Inspection Report By Mile - Spring 2021

Waterway	Bank	Unit Miles	Inspection Start/End	Inspector
Unit No. 01 Wadsworth Canal	Left	4.63	03/30/2021 03/30/2021	Makar Sokol

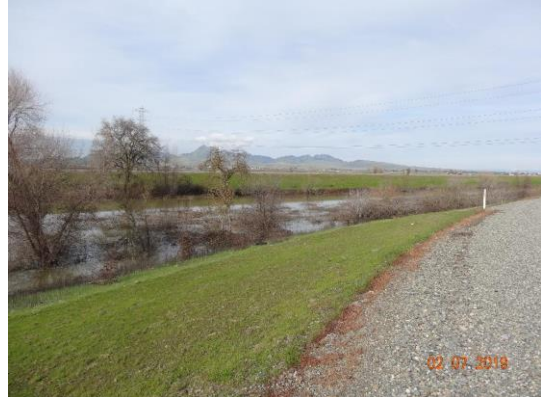
Photo 1 of 3 : UCIP_SP_2021_60105_78653.jpg

Comment Code						
Inspector Comment						
FS_ID:60105 DS_ID:17068 EP_NO: 5296 Repair Type: Non-Urgent Crossing Status: Not Found UCIP Comments: 02/07/2019 Record remains Non-Urgent, unable to locate pipe or any appurtenances on the levee. LMA superintendent, Joel Farias, mentioned that this line has been abandoned and line is only referenced in old PG&E facility maps. Owner to this pipe has been changed at least 4 times. No maintenance records were available to determine the status of the pipe. Unable to confirm how pipe was abandoned. Will need to contact owner. (O. Magana - DWR UCIP)04/10/2017 Unable to locate. (A. Freitag - DWR Sutter Yard)10/12/2016 Unable to locate. (A. Freitag - DWR Sutter Yard)04/19/2016 Unable to locate. (A. Freitag - DWR Sutter Yard)05/12/2015 Unable to locate. (A. Freitag - DWR Sutter Yard)11/18/2014 Unable to locate. (A. Freitag - DWR Sutter Yard)05/13/2014 Same as last inspection. (A. Freitag - DWR Sutter Yard)10/29/2013 Same as last inspection. (A. Freitag - DWR Sutter Yard)05/16/2013 Same as last inspection. (A. Freitag - DWR Sutter Yard)10/09/2012 Need to determine disposition of pipe, contact pipe owner if possible. (W. Wylie - DWR UCIP) FIELD_STRUCT_DESC: 3.5-inch steel gas line through the levee, 3 feet below the crown. Gas line goes through both levees and Wadsworth Canal. Waterside (WS) bank protected by rock. (3-inch line authorized under Permit No. 5296, 1966 - Atlantic Oil Company). [Additional Reference(s): DWR Levee Log, 2005 (HLM 0.02, listed as 3.5-inch gas line)]. FS Date: 2/7/2019 2:48:00 PM

WS view: Clean slope with no evidence of line present.

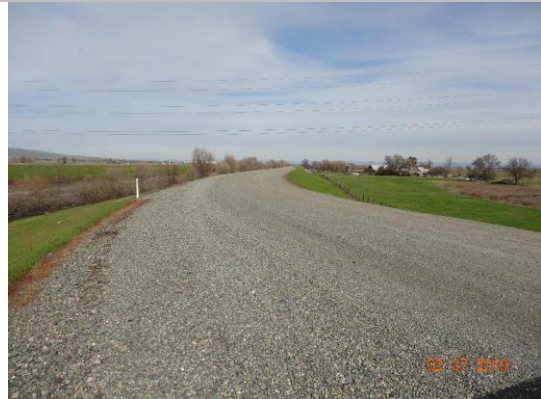
Photo 2 of 3 : UCIP_SP_2021_60105_78654.jpg

Overview of levee crown at location where crossing should be.

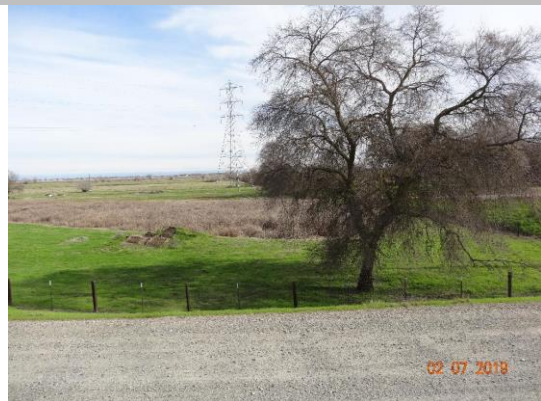
Photo 3 of 3 : UCIP_SP_2021_60105_78655.jpg

LS view: No markers visible on LS.

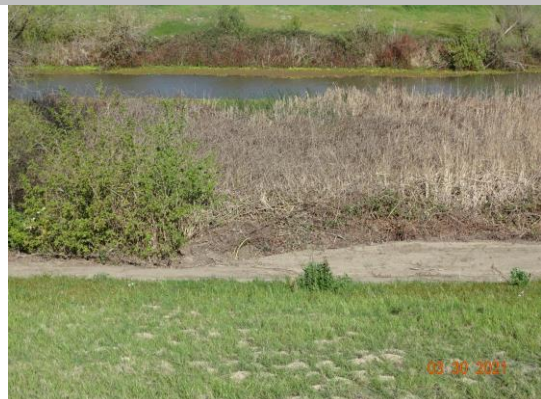
Photo 1 of 1 : SP_2021_ST0010_42_20_20210407_00040.jpg

LM Start	0.06	Rating **	A/W	Issue No.	20
LM End	0.12	Issue Type +	Ma	Location *	WS
Category	Earthen Levee			GPS Latitude/Longitude	
				Start	End
Item	Erosion / Bank Caving			39.114203 °	39.114842 °
				-121.768015 °	-121.767382 °
DWR ID	DWR_ST0010_01_f_2016_20				
Comment Code					
E1 : Note and monitor erosion site.					
Inspector Comment

View of the erosion along the waterside toe. Spring 2021.

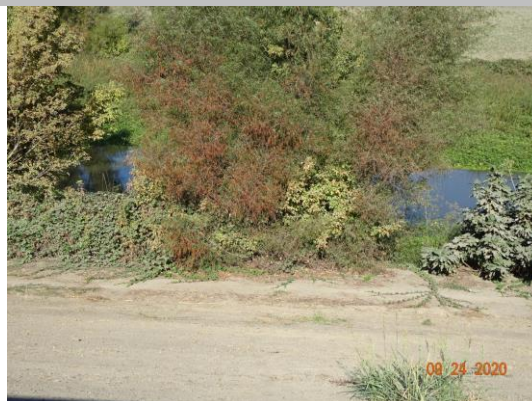
Photo 1 of 1 : SP_2021_ST0010_42_19_20210224_00005.jpg

View of the erosion along the waterside toe. Fall 2020.

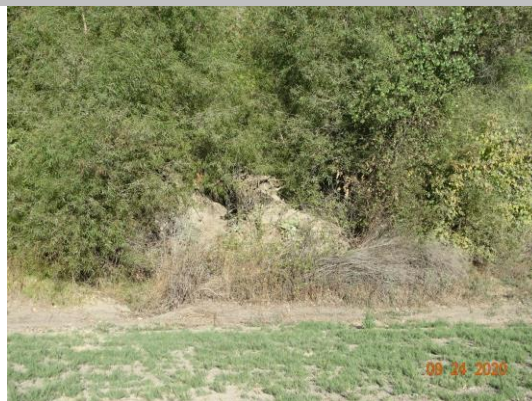
Photo 1 of 1 : SP_2021_ST0010_42_18_20210224_00004.jpg

LM Start	0.56	Rating **	M	Issue No.	18
LM End	0.56	Issue Type +	Ma	Location *	WS
Category	Earthen Levee			GPS Latitude/Longitude	
				Start	End
Item	Erosion / Bank Caving			39.119985 °	39.119985 °
				-121.762600 °	-121.762600 °
DWR ID	DWR_ST0010_01_s _ 2017_18				
Comment Code					
E2 : Schedule repair of erosion site prior to the next inspection.					
Inspector Comment

View of the erosion along the waterside toe. Fall 2020.

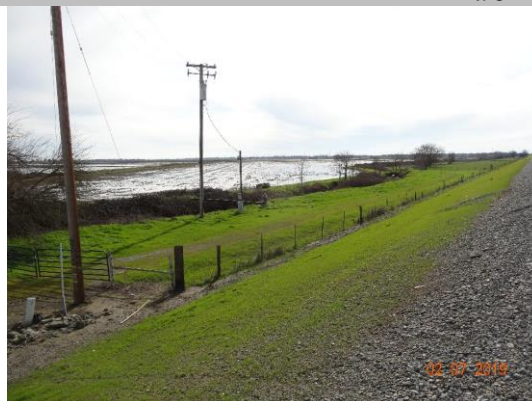
Photo 1 of 3 : UCIP_SP_2021_60106_78658.jpg

Comment Code						
Inspector Comment						
FS_ID:60106 DS_ID:17059 EP_NO: 1605 Repair Type: Non-Urgent Crossing Status: Found UCIP Comments: 02/07/2019 Record remains Non-Urgent, pipe and appurtenances have been abandoned at this location. The pump and power meter have been removed from this location. Owner will need to coordinate with CVFPB to remove pipe according to Title 23 requirements. (O. Magana - DWR UCIP)04/10/2017 Abandoned. (A. Freitag - DWR Sutter Yard)10/12/2016 Abandoned crossing. (A. Freitag - DWR Sutter Yard)04/16/2016 Abandoned crossing. Ws pipe end is open and should be capped. (A. Freitag - DWR Sutter Yard)05/12/2015 Abandoned crossing. Needs to be properly abandoned. (A. Freitag - DWR Sutter Yard)11/18/2014 Same as last inspection. (A. Freitag - DWR Sutter Yard)05/13/2014 Same as last inspection. (A. Freitag - DWR Sutter Yard)10/29/2013 Same as last inspection. (A. Freitag - DWR Sutter Yard)05/16/2013 Same as last inspection. (A. Freitag - DWR Sutter Yard)10/09/2012 No pump on Pier and power lines cut. Apparently abandoned-should be abandoned properly. (W. Wylie - DWR UCIP) FIELD_STRUCT_DESC: 18-inch steel irrigation pipe (permit records indicate 16-inch pipe, 18-inch diameter field verified) through the levee, 3.7 feet below the crown. Siphon breaker on the waterside (WS) slope. Pump on channel bank on steel structure. (16-inch pipe authorized under Permit No. 1605, 1959 - Schnabel; Aerial 12 KV power line extension for pump authorized under Permit No. 1631, 1959 - Pacific Gas and Electric Company [PG&E]). [Additional Reference(s): DWR Levee Log, 2005 (HLM 1.20, listed as 18-inch steel pipe)]. FS Date: 2/7/2019 2:48:00 PM

LS view: overview of LS looking downstream.

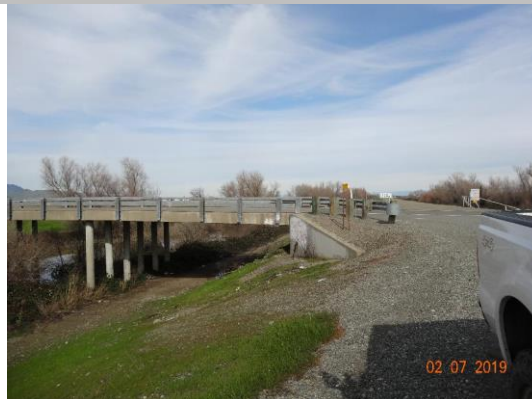
Photo 2 of 3 : UCIP_SP_2021_60107_78667.jpg

Overview of levee crown and WS.

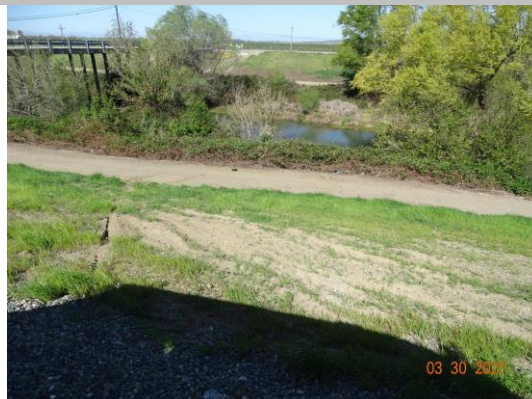
Photo 1 of 1 : SP_2021_ST0010_42_21_20210407_00041.jpg

LM Start	1.27	Rating **	M	Issue No.	21
LM End	1.27	Issue Type +	Ma	Location *	WS
Category	Earthen Levee			GPS Latitude/Longitude	
				Start	End
Item	Slope Stability			39.128324 °	39.128324 °
				-121.754619 °	-121.754619 °
DWR ID	DWR_ST0010_01_s_2021_21				
Comment Code					
S3 : Repair the levee slope damaged by vehicle traffic and prevent access where possible.					
Inspector Comment

View of the waterside slope damaged by vehicle traffic. Spring 2021.

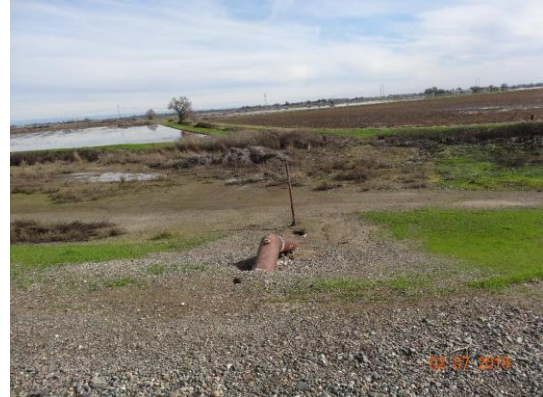
Photo 1 of 3 : UCIP_SP_2021_60148_78675.jpg

FS_ID:60148
DS_ID:17063
EP_NO: N/A
Repair Type: Urgent
Crossing Status: Found
UCIP Comments: 02/07/2019 Pipe has been upgraded from Non-Urgent to Urgent due to the pipe failure (sink hole) observed on the LS. Need to determine pipe integrity through the levee. Pipe and appurtenances have been abandoned. Power meter has been removed from the WS. Scour hole has developed on the WS berm edge located about 15 feet from WS toe. Owner will need to coordinate with CVFPB to properly remove pipe per Title 23. (O. Magana - DWR UCIP)04/10/2017 Abandoned. (A. Freitag - DWR Sutter Yard)

LS view: overview of LS.

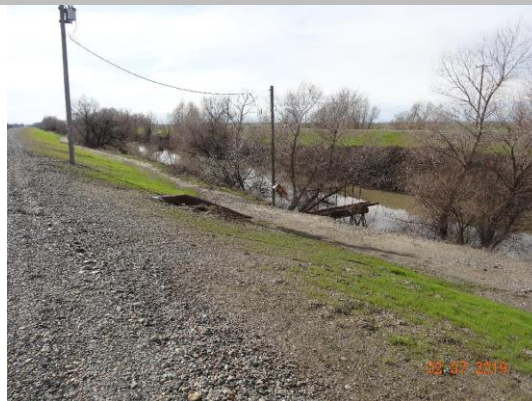
Photo 3 of 3 : UCIP_SP_2021_60148_78677.jpg

WS view: overview of WS.

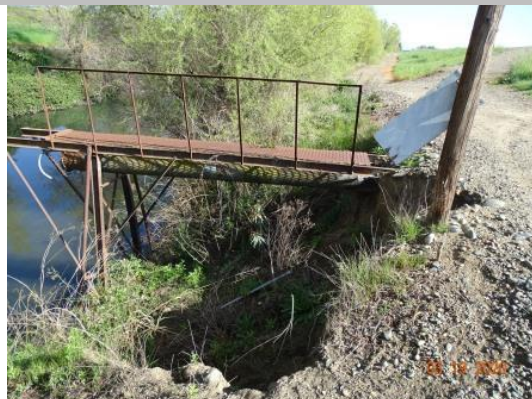
Photo 1 of 1 : SP_2021_ST0010_42_107_20210224_00008.jpg

LM Start	1.85	Rating **	U	Issue No.	107
LM End	1.85	Issue Type +	Ma	Location *	WS
Category	Earthen Levee			GPS Latitude/Longitude	
				Start	End
Item	Erosion / Bank Caving			39.135110 °	39.135110 °
				-121.748230 °	-121.748230 °
DWR ID	DWR_ST0010_01_f_2013_107				
Comment Code					
E2 : Schedule repair of erosion site prior to the next inspection.					
Inspector Comment					
Significant erosion is present at this site and should be addressed.

View of erosion along both sides of the abandoned pump. Spring 2020.

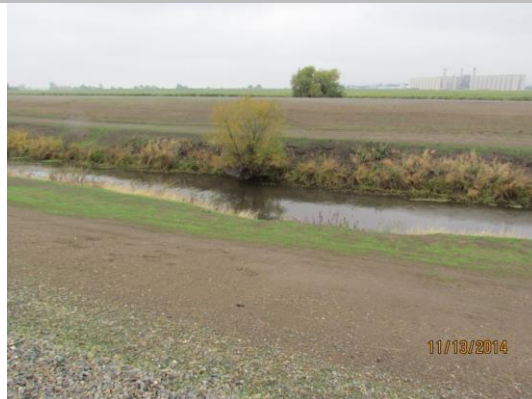
Photo 2 of 2 : SP_2021_ST0010_42_6_20210224_00002.jpg

View of the erosion along the waterside toe.

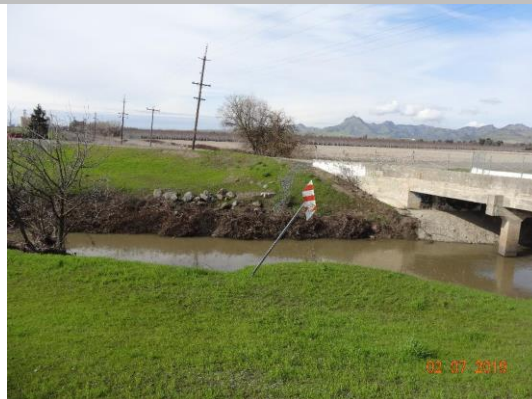
Photo 1 of 3 : UCIP_SP_2021_60112_78683.jpg

Comment Code					
Inspector Comment					
FS_ID:60112					
DS_ID:17064					
EP_NO: 9191					
Repair Type: Non-Urgent					
Crossing Status: Indicator Found					
UCIP Comments: 02/07/2019 Record has been updated from No					
Action Needed to Non-Urgent, no maintenance records were made					
available to determine condition of line. Need to contact owner to					
determine status of line through the levee. (O. Magana - DWR					
UCIP)04/10/2017 Crossing appears to be in good condition. (A.					
Freitag - DWR Sutter Yard)10/12/2016 Crossing appears to be in					
good condition. (A. Freitag - DWR Sutter Yard)04/19/2016 Crossing					
appears to be in good condition. (A. Freitag - DWR Sutter					
Yard)05/12/2015 Crossing appears in good condition. No noticeable					
issues to report. (A. Freitag - DWR Sutter Yard)11/18/2014 Same as					
last inspection. (A. Freitag - DWR Sutter Yard)05/13/2014 Same as					
last inspection. (A. Freitag - DWR Sutter Yard)05/16/2013 Same as

WS view: line crosses both left and right bank, markers visible on opposite levee.

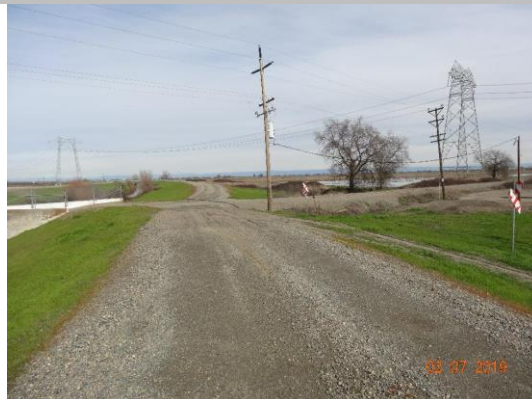
Photo 2 of 3 : UCIP_SP_2021_60112_78681.jpg

Overview of levee crown at pipe crossing.

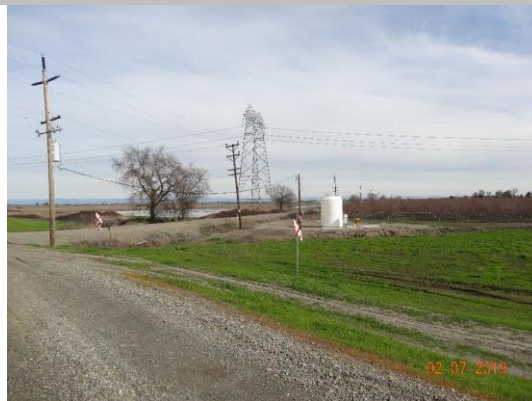
Photo 3 of 3 : UCIP_SP_2021_60112_78682.jpg

LS view: overview of LS looking upstream towards crossing.

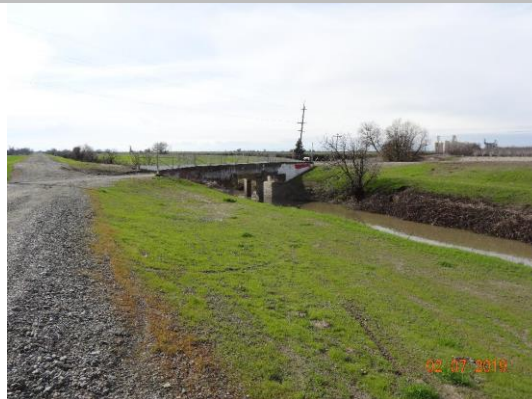
Photo 3 of 3 : UCIP_SP_2021_60113_78686.jpg

WS view: overview of WS.

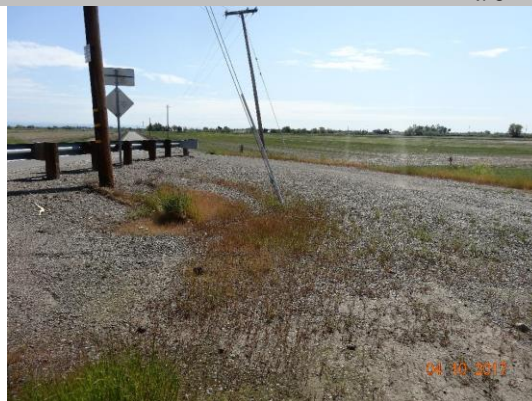
Photo 1 of 3 : UCIP_SP_2021_57985_76957.jpg

FS_ID:57985
DS_ID:23097
EP_NO: N/A
Repair Type: Non-Urgent
Crossing Status: Found
UCIP Comments: 02/07/2019 Record remains Non-Urgent due to no permit found authorizing conduit through the levee. Carsonite marker lists CVIN as owner. Contact phone number listed on marker to be used before digging is 855-442-6010. Need to contact owner to determine permit used for installation of buried fiber optic cable. (O. Magana - DWR UCIP)04/10/2017 Crossing appears to be in good condition. Photos added. (A. Freitag - DWR Sutter Yard)10/12/2016 Crossing appears to be in good condition. (A. Freitag - DWR Sutter Yard)05/31/2016 Need photos markers and levee overview (O. Magana - DWR UCIP)04/19/2016 Crossing appears to be in good condition. No permit on file. (A. Freitag - DWR Sutter Yard)05/12/2015 No noticeable issues with crossing but no permit on file for it. (A. Freitag - DWR Sutter Yard)11/18/2014 Same as last inspection. (A. Freitag - DWR Sutter Yard)05/13/2014 Same as last inspection. (A. Freitag - DWR Sutter Yard)10/29/2013 Same as last inspection. (A. Freitag - DWR Sutter Yard)05/16/2013 No known permit for work. (A. Freitag - DWR Sutter Yard)

LS overview

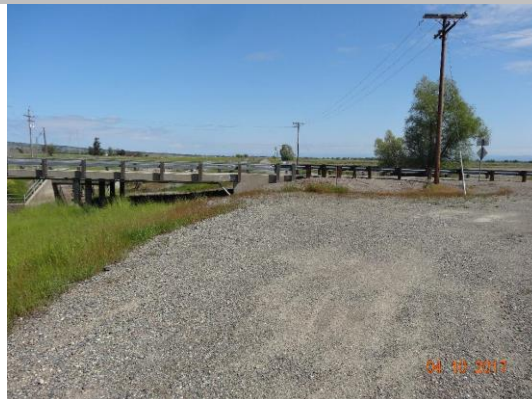
Photo 2 of 3 : UCIP_SP_2021_57985_76953.jpg

Levee overview looking upstream.

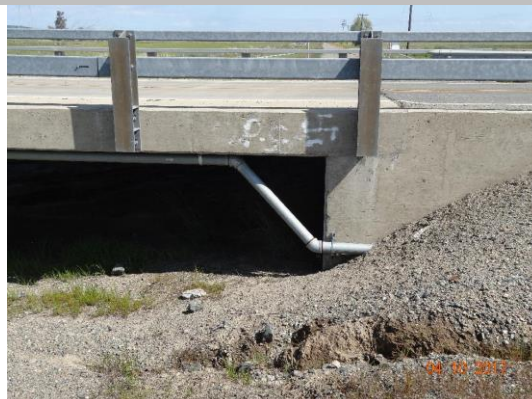
Photo 3 of 3 : UCIP_SP_2021_57985_76954.jpg

Conduit exiting WS slope and attaching to the downstream side of South Butte Rd bridge.

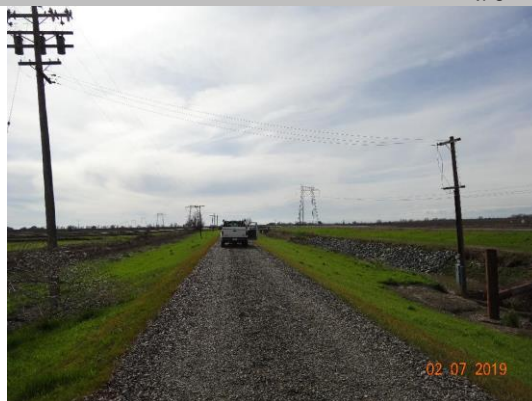
Photo 1 of 3 : UCIP_SP_2021_60147_78704.jpg

UCIP Comments: 02/07/2019 Record remains Non-Urgent, this crossing has been modified. Also, unable to determine if the 24-inch pipe referenced in the levee logs still exists through the levee. There is a 14-inch steel pipe on the WS, a 16-inch steel riser on the WS, and a 16-inch PVC pipe located on the LS. No permit was found authorizing the modifications at this location. The 4-foot by 6-foot concrete distribution box has been removed from the WS. Some settling (minor depression) is present where the distribution box might have been previously located. Need to contact owner to determine CVFPB permit issued for the modifications at this location. (O. Magana - DWR UCIP)01/28/2019 USACE O&M dwg shows 12-inch and 24-inch on LS. (O. Magana - DWR UCIP)

04/10/2017 LS heavily vegetated but nothing appears to have changed with the crossing. LS headwall still silted in and pipe discharges directly into the rice field. (A. Freitag - DWR Sutter Yard)10/12/2016 Crossing appears to be in good condition. (A. Freitag - DWR Sutter Yard)04/19/2016 Crossing has not changed since the last inspection. LS headwall is silted in and not being used. LS pipe end discharges into the rice field. (A. Freitag - DWR Sutter Yard)05/12/2015 Concrete headwall on LS is completely silted in. LS pipe end is located near the edge of rice field. No issues seen on WS. (A. Freitag - DWR Sutter Yard)11/18/2014 Same as last inspection. (A. Freitag - DWR Sutter Yard)05/13/2014 Same as last inspection. (A. Freitag - DWR Sutter Yard)10/29/2013 Concrete headwall is silted in and appears to be abandoned. Discharge end of pipe is approx. 100ft. from LS toe on the edge of the rice field. (A. Freitag - DWR Sutter Yard)05/16/2013 Same as last inspection. (A. Freitag - DWR Sutter Yard)

Overview of levee crown looking downstream towards crossing.

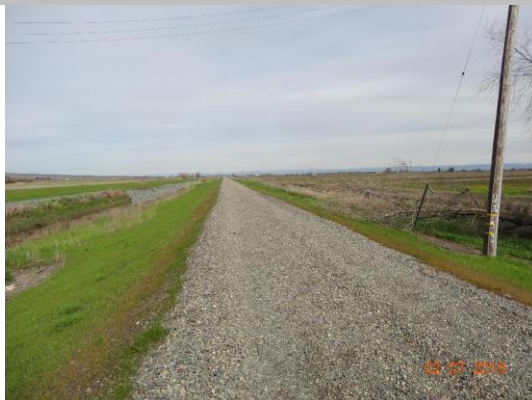
Photo 2 of 3 : UCIP_SP_2021_60147_78701.jpg

Overview of levee crown looking upstream towards crossing.

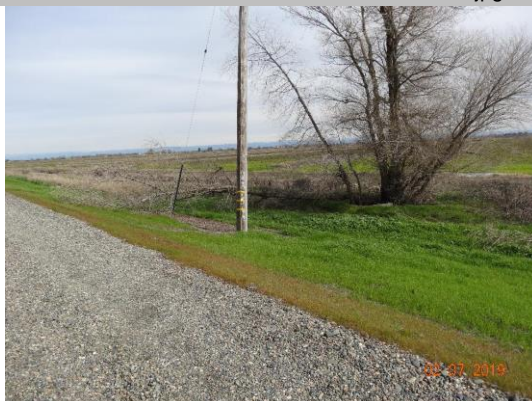
Photo 3 of 3 : UCIP_SP_2021_60147_78702.jpg

LS view: power pole located on LS.

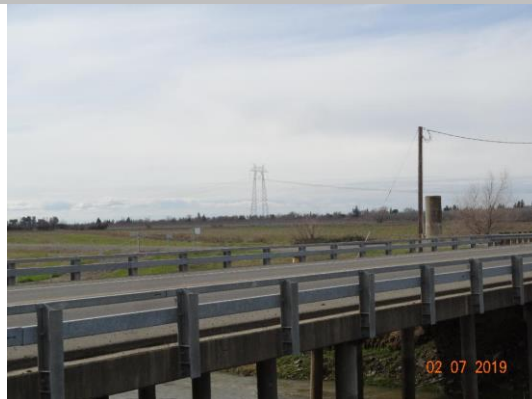
Photo 2 of 3 : UCIP_SP_2021_60115_78706.jpg

FS_ID:60115
DS_ID:17067
EP_NO: 4680
Repair Type: Non-Urgent
Crossing Status: Indicator Found
UCIP Comments: 02/07/2019 Record has been updated from No Action Needed to Non-Urgent, buried line appears to have been changed to an aerial line. No signs were present of the buried conduit instead there appears to be an aerial line at this location now. Need to coordinate with owner to determine if 4-inch conduit was properly abandoned or removed per Title 23. If modifications were not approved by the CVFPB, owner will need to coordinate with the CVFPB to comply with Title 23 requirements. (O. Magana - DWR UCIP)04/10/2017 Aerial lines. (A. Freitag - DWR Sutter Yard)10/12/2016 Crossing appears to be in good condition. (A. Freitag - DWR Sutter Yard)04/19/2016 Crossing appears to be in good condition. (A. Freitag - DWR Sutter Yard)05/12/2015 Crossing appears in good condition. No noticeable issues to report. (A. Freitag - DWR Sutter Yard)11/18/2014 Same as last inspection. (A. Freitag - DWR Sutter Yard)05/13/2014 Same as last inspection. (A. Freitag - DWR Sutter Yard)10/29/2013 Same as last inspection. (A. Freitag - DWR Sutter Yard)05/16/2013 Same as last inspection. (A. Freitag - DWR Sutter Yard)10/09/2012 Communication line on Pole 400-feet west of canal. Likely now an aerial on North side of roadway. (W. Wylie - DWR UCIP)

No markers visible on levee crown for conduit, photo 2 of 2.

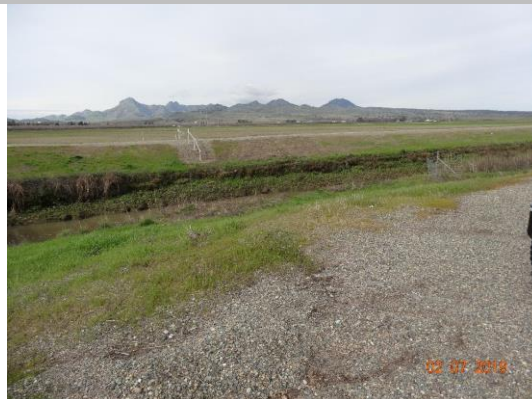
Photo 1 of 3 : UCIP_SP_2021_60116_78707.jpg

Comment Code						
Inspector Comment						
FS_ID:60116 DS_ID:17058 EP_NO: N/A Repair Type: Non-Urgent Crossing Status: Not Found UCIP Comments: 02/07/2019 Record has been updated from No Action Needed to Non-Urgent, unable to confirm status of pipe through the levee. Unable to locate pipe or appurtenances through this section of the levee. The DWR DMP geophysical investigation report indicates no signal received of suggestive target. Record will remain in UCIP's inspection records until future Levee Improvement Project can confirm no crossing was found through the levee. Also there is no permit identified for the authorization of this pipe. (O. Magana - DWR UCIP)04/10/2017 Unable to locate. (A. Freitag - DWR Sutter Yard)10/12/2016 Unable to locate. (A. Freitag - DWR Sutter Yard)04/19/2016 Unable to locate. (A. Freitag - DWR Sutter Yard)05/12/2015 Unable to locate. (A. Freitag - DWR Sutter Yard)11/18/2014 Unable to locate. (A. Freitag - DWR Sutter Yard)05/13/2014 Same as last inspection. (A. Freitag - DWR Sutter Yard)10/29/2013 Same as last inspection. (A. Freitag - DWR Sutter Yard)05/16/2013 Same as last inspection. (A. Freitag - DWR Sutter Yard)10/09/2012 unable to locate. (W. Wylie - DWR UCIP) FIELD_STRUCT_DESC: 12-inch corrugated metal drainage pipe through the levee, 8.7 feet below the crown. Pipe is open at both the waterside (WS) and landside (LS) ends. [Additional Reference(s): DWR Levee Log, 2005 (HLM 4.38, listed as 12-inch CMP). USACE Sacramento O&M Manual, Unit 135, May 1953, (Station 228+00), listed as 12-inch CMP, USACE Drawing No. 50-04-1949, Drawing No. 2, Sheet 3, March 1952, page 2 of 3, 12-inch CMP referenced at 228+25]. FS Date: 2/7/2019 12:13:00 PM

WS view: overview of WS, no signs of pipe.

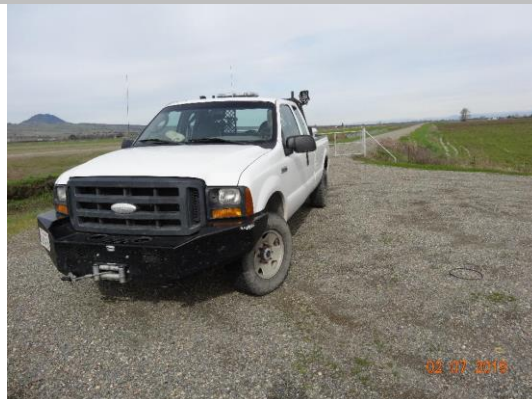
Photo 2 of 3 : UCIP_SP_2021_60116_78708.jpg

Overview of levee crown where crossing should be.

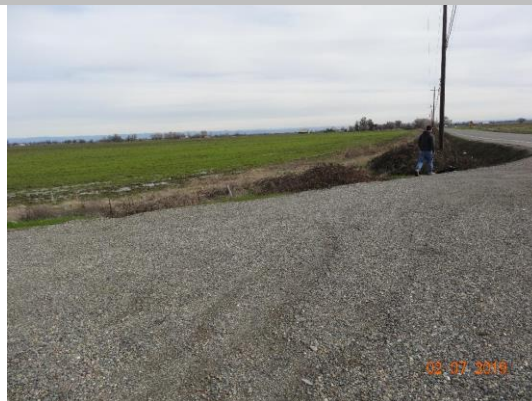
Photo 3 of 3 : UCIP_SP_2021_60116_78709.jpg

LS view: overview of LS, no signs of pipe.

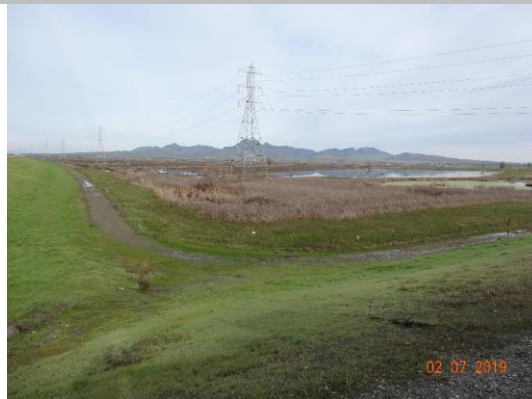
Photo 1 of 3 : UCIP_SP_2021_60117_78711.jpg

LS view: overview of LS; no markers present on LS.

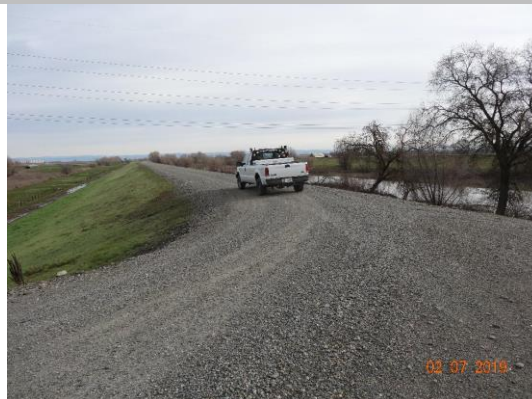
Photo 2 of 3 : UCIP_SP_2021_60117_78712.jpg

Overview of levee crown where crossing should be.

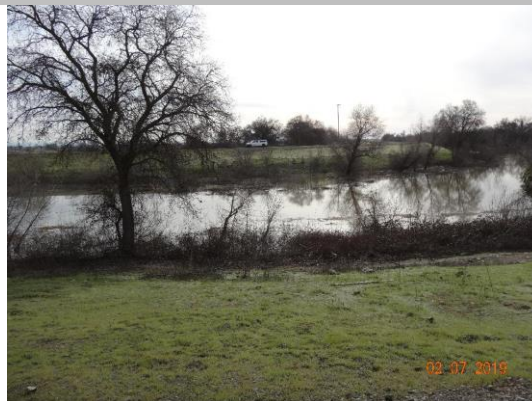
Photo 3 of 3 : UCIP_SP_2021_60117_78710.jpg

WS view: overview of WS; no markers visible of gas line.

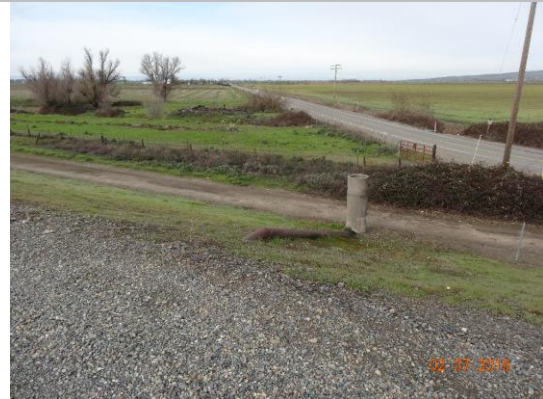
Photo 1 of 3 : UCIP_SP_2021_60118_78718.jpg

LS view: overview of LS.

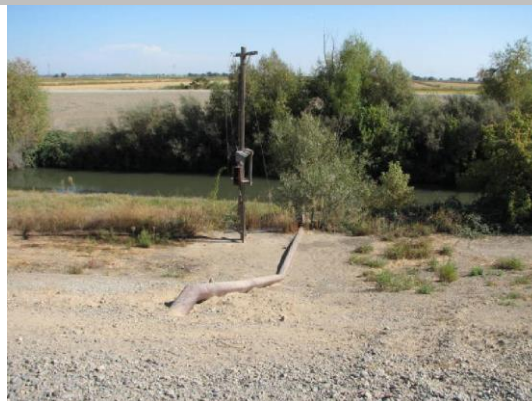
Photo 3 of 3 : UCIP_SP_2021_60118_64727.jpg

Pipe and pump facilities on WS slope.

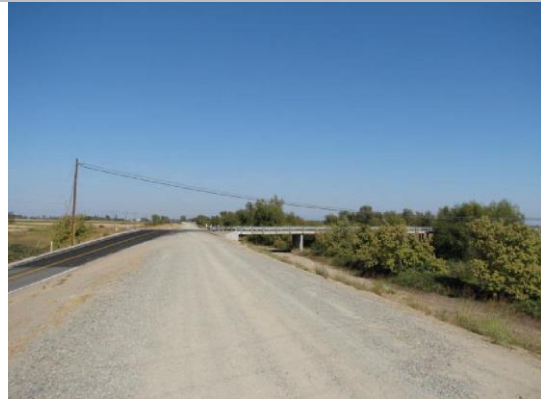
Photo 1 of 3 : UCIP_SP_2021_60120_64732.jpg

Aerial communication line over levee where underground communication line once was.

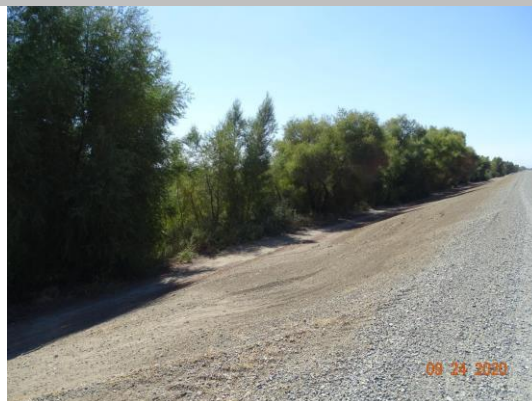
Photo 1 of 1 : SP_2021_ST0010_43_20_20210224_00006.jpg

View of the ramp encroaching into the levee. Fall 2020.

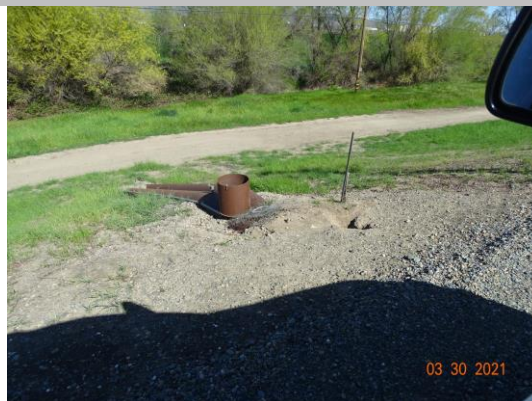
Photo 1 of 1 : SP_2021_ST0010_43_11_20210407_00048.jpg

View of the rodent holes above the irrigation pipe. Spring 2021.

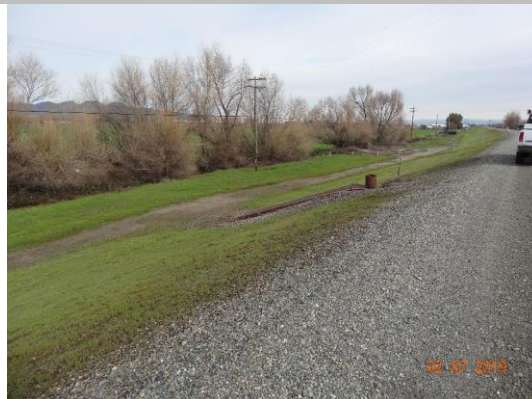
Photo 1 of 3 : UCIP_SP_2021_60150_78743.jpg

LS view: overview of LS looking upstream towards pipe.

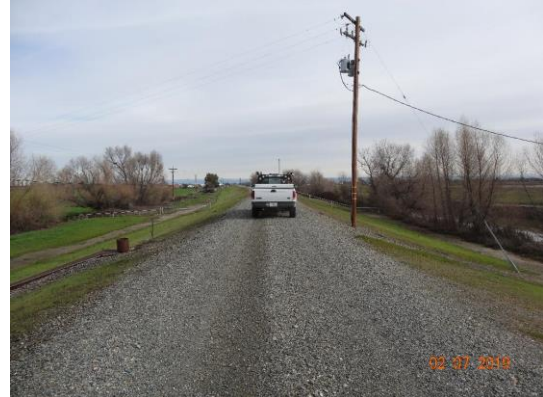
Photo 2 of 3 : UCIP_SP_2021_60150_78742.jpg

Overview of levee crown at pipe crossing.

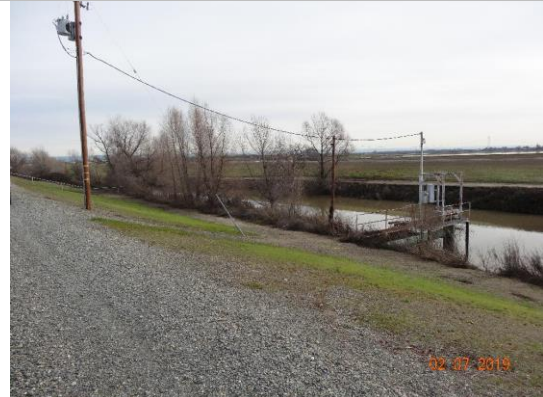
Photo 3 of 3 : UCIP_SP_2021_60150_78744.jpg

WS view: overview of WS looking upstream towards pipe.

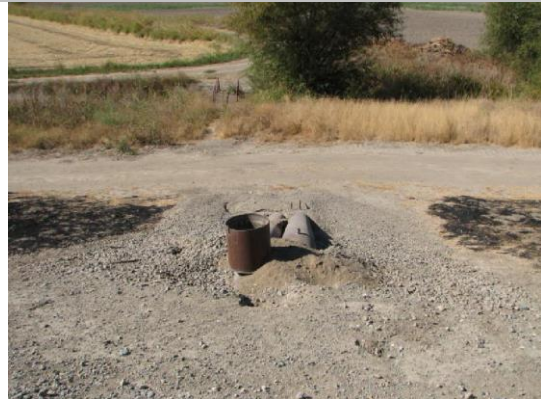
Photo 1 of 3 : UCIP_SP_2021_60125_64736.jpg

Pipe on LS showing rodent activity.

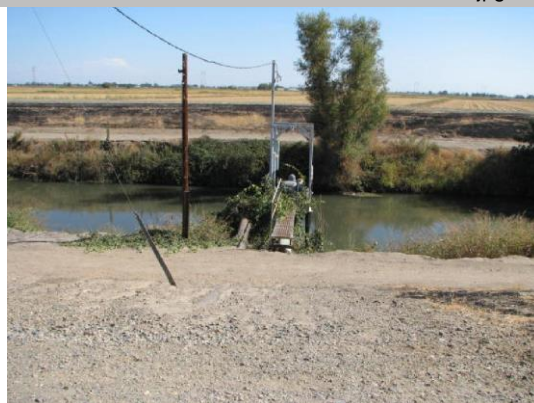
Photo 3 of 3 : UCIP_SP_2021_60125_64734.jpg

Pipe on left without pump.

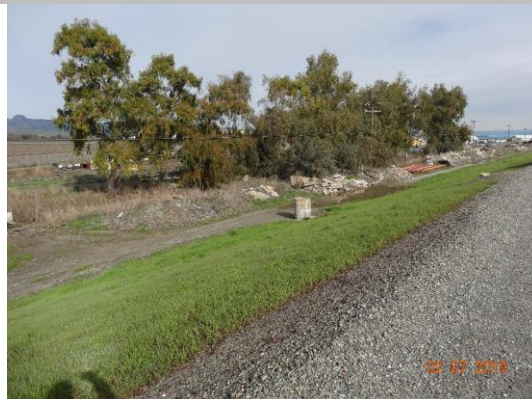
Photo 1 of 3 : UCIP_SP_2021_60126_78759.jpg

LS view: overview of LS.

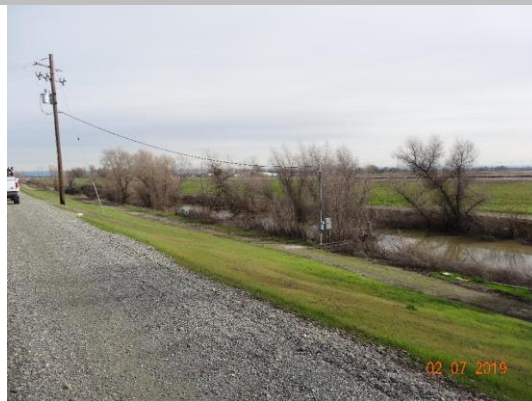
Photo 3 of 3 : UCIP_SP_2021_60126_78758.jpg

WS view: overview of WS.

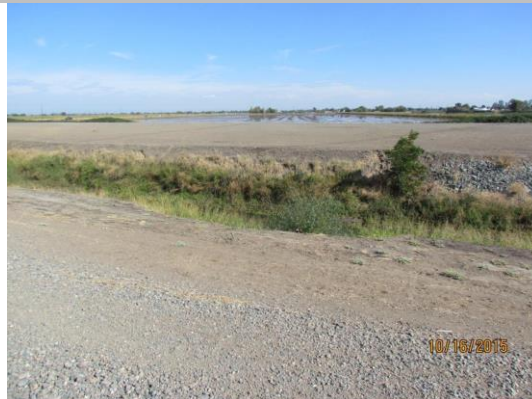
Photo 1 of 2 : SP_2021_ST0010_43_8_20210224_00001.jpg

View of erosion along the waterside toe.

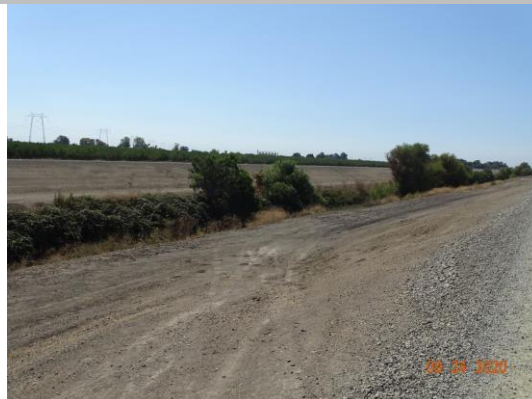
Photo 1 of 1 : SP_2021_ST0010_43_21_20210224_00007.jpg

View of the ramp encroaching into the levee. Fall 2020.

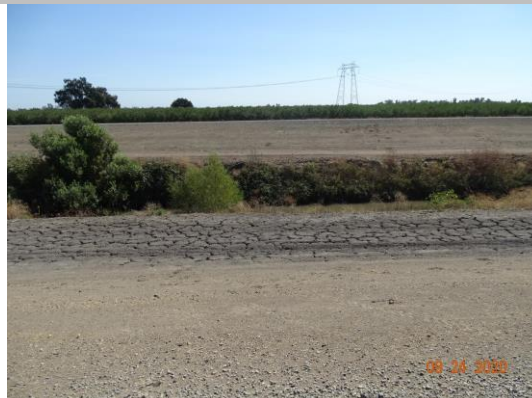
Photo 1 of 1 : SP_2021_ST0010_43_22_20210224_00008.jpg

View of the cracking along the waterside toe. Fall 2020.

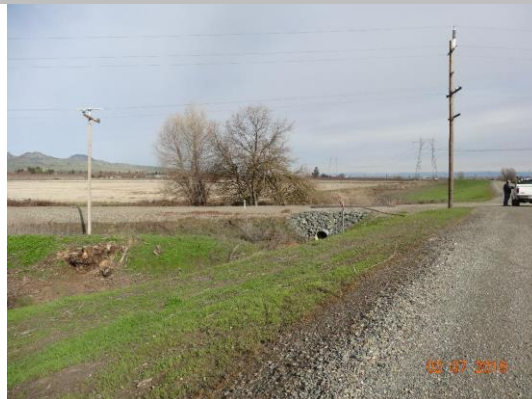
Photo 1 of 3 : UCIP_SP_2021_60127_78767.jpg

LS view: overview of LS.

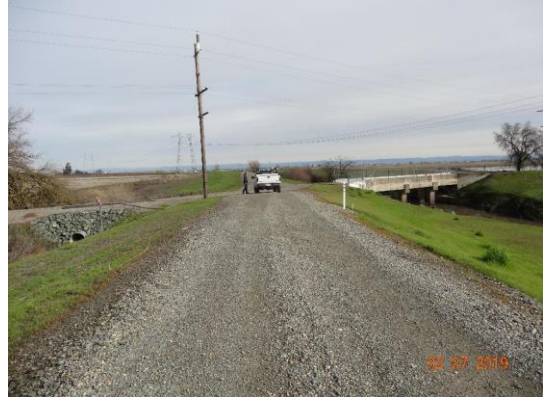
Photo 2 of 3 : UCIP_SP_2021_60127_78765.jpg

Overview of levee crown looking upstream towards crossing.

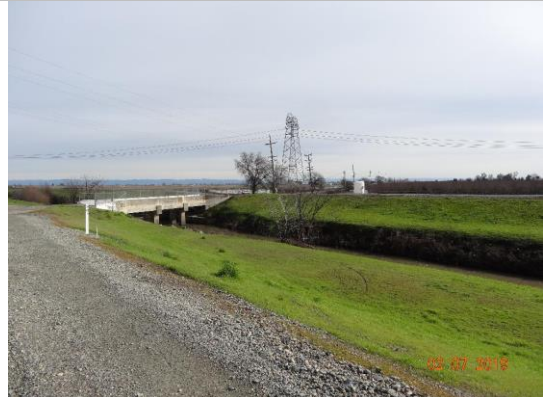
Photo 3 of 3 : UCIP_SP_2021_60127_78766.jpg

WS view: overview of WS.

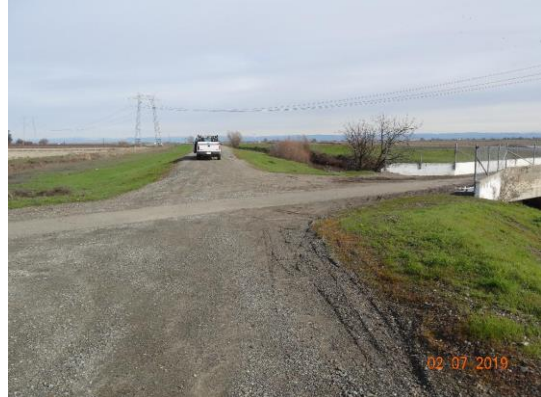
Photo 1 of 3 : UCIP_SP_2021_60129_78776.jpg

Overview of levee crown looking upstream towards crossing.

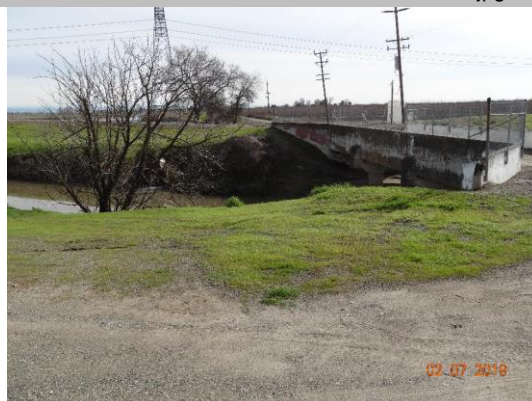
Photo 3 of 3 : UCIP_SP_2021_60129_78771.jpg

WS view: overview of WS.

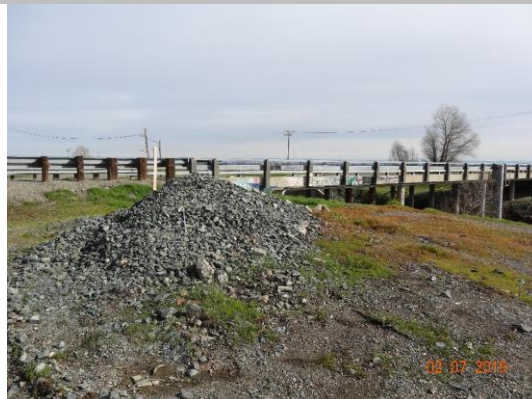
Photo 1 of 3 : UCIP_SP_2021_58005_78779.jpg

WS view: overview of WS.

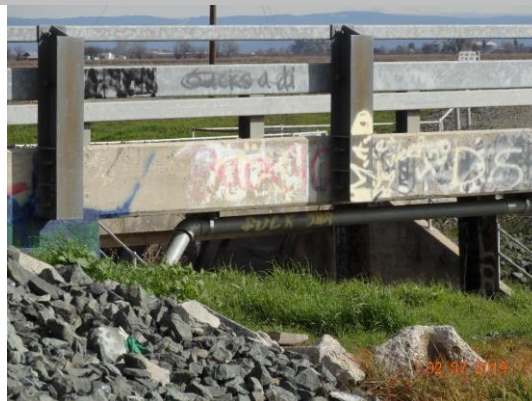
Photo 3 of 3 : UCIP_SP_2021_58005_78780.jpg

WS view: conduit attached to bridge.

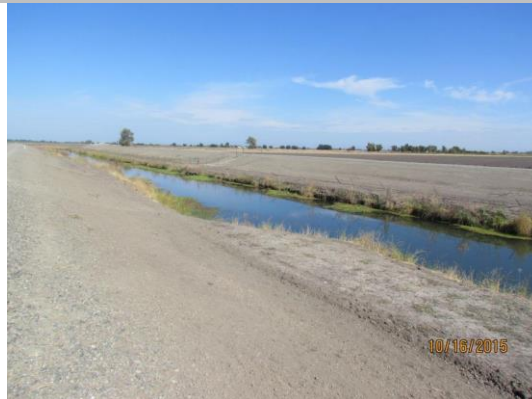
Photo 1 of 2 : SP_2021_ST0010_43_9_20210224_00003.jpg

View of the erosion along the waterside toe.

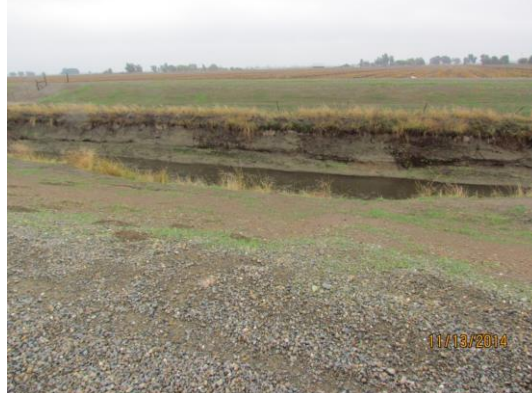
Photo 2 of 2 : SP_2021_ST0010_43_9_20210224_00004.jpg

View of the erosion along the waterside toe.

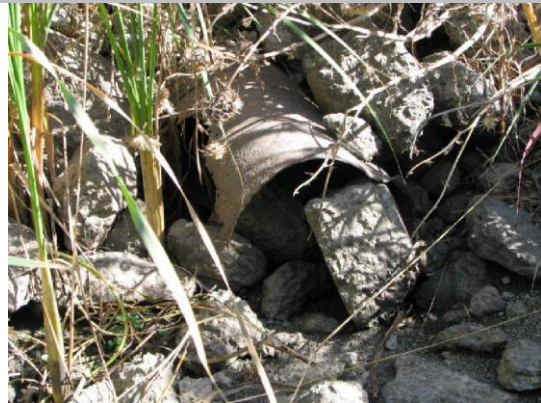
Photo 2 of 3 : UCIP_SP_2021_60131_64760.jpg

Rusted outlet at LS channel. Unclear if this is same pipe as one under investigation.

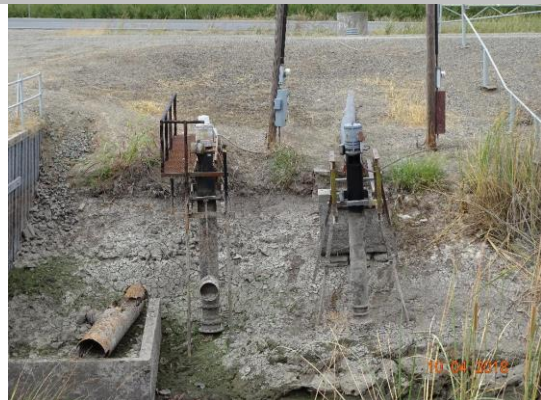
Photo 3 of 3 : UCIP_SP_2021_60131_78288.jpg

Overview photo of crossings from opposite bank. Pipe to left is associated with dsid 17078 and pipe to right is dsid 17081.

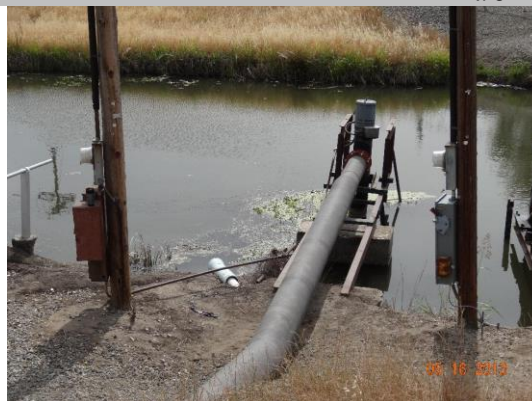
Photo 1 of 3 : UCIP_SP_2021_60133_64764.jpg

Pump station in channel on WS

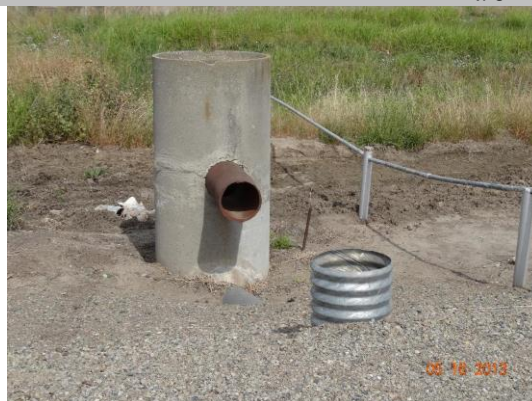
Photo 2 of 3 : UCIP_SP_2021_60133_64763.jpg

36in. concrete standpipe and 12in. cm riser on LS.

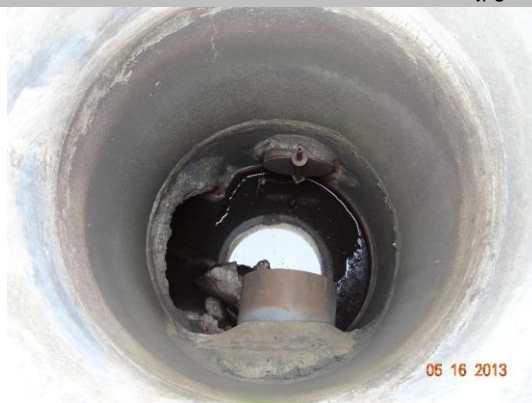
Photo 3 of 3 : UCIP_SP_2021_60133_64762.jpg

Inside of 36in. concrete riser

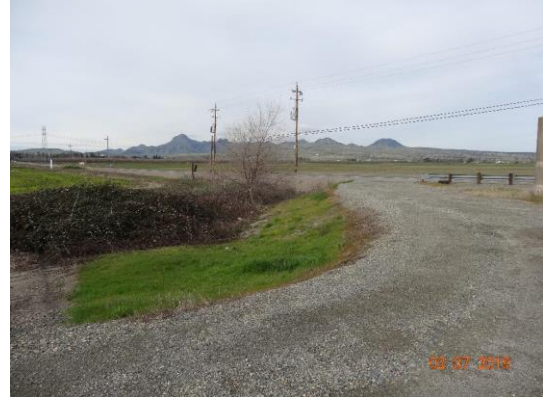
Photo 1 of 3 : UCIP_SP_2021_60135_78795.jpg

LS view: overview of LS.

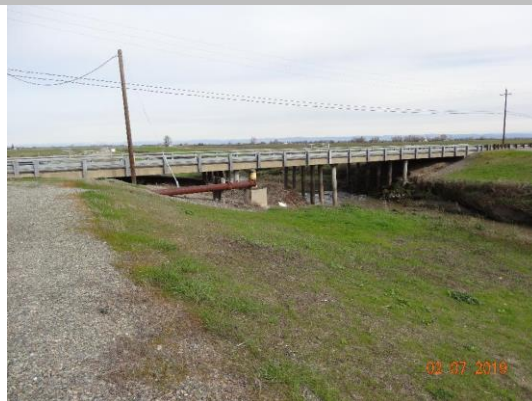
Photo 3 of 3 : UCIP_SP_2021_60135_78796.jpg

WS view: overview of WS.

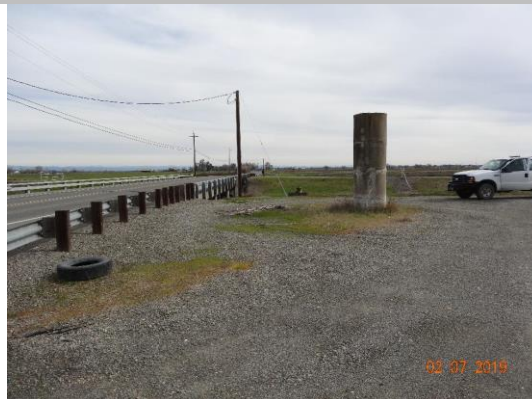
Photo 1 of 3 : UCIP_SP_2021_60136_78803.jpg

Overview of levee crown where crossing goes through levee.
