**Flood Control Project Maintenance
Levee Inspections
LMA District Cover Sheet**

Sutter Maintenance Yard Wadsworth Canal

**Flood Control Project Maintenance
Levee Inspections
Unit Cover Sheet**

Waterway			Bank	Unit Miles
Unit No. 01 Wadsworth Canal			Left	4.63
	Spring (March - May)	Summer (June - August)	(September - November) Fall	Winter (December - February)
Unit Maintenance Rating (Fall Only)				
Date of Inspection	3/9/2022 - 3/9/2022			
DWR Inspector	Makar Sokol			
Accompanied By	Cory Hutton DWR Sutter Yard

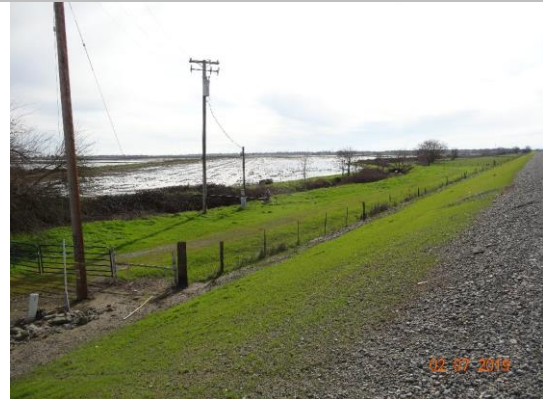
Photo 1 of 3 : UCIP_SP_2022_60106_78658.jpg

Comment Code						
Inspector Comment						
FS_ID:60106 DS_ID:17059 EP_NO: 1605 Repair Type: Non-Urgent Crossing Status: Found UCIP Comments: 02/07/2019 Record remains Non-Urgent, pipe and appurtenances have been abandoned at this location. The pump and power meter have been removed from this location. Owner will need to coordinate with CVFPB to remove pipe according to Title 23 requirements. (O. Magana - DWR UCIP)04/10/2017 Abandoned. (A. Freitag - DWR Sutter Yard)10/12/2016 Abandoned crossing. (A. Freitag - DWR Sutter Yard)04/16/2016 Abandoned crossing. Ws pipe end is open and should be capped. (A. Freitag - DWR Sutter Yard)05/12/2015 Abandoned crossing. Needs to be properly abandoned. (A. Freitag - DWR Sutter Yard)11/18/2014 Same as last inspection. (A. Freitag - DWR Sutter Yard)05/13/2014 Same as last inspection. (A. Freitag - DWR Sutter Yard)10/29/2013 Same as last inspection. (A. Freitag - DWR Sutter Yard)05/16/2013 Same as last inspection. (A. Freitag - DWR Sutter Yard)10/09/2012 No pump on Pier and power lines cut. Apparently abandoned-should be abandoned properly. (W. Wylie - DWR UCIP) FIELD_STRUCT_DESC: 18-inch steel irrigation pipe (permit records indicate 16-inch pipe, 18-inch diameter field verified) through the levee, 3.7 feet below the crown. Siphon breaker on the waterside (WS) slope. Pump on channel bank on steel structure. (16-inch pipe authorized under Permit No. 1605, 1959 - Schnabel; Aerial 12 KV power line extension for pump authorized under Permit No. 1631, 1959 - Pacific Gas and Electric Company [PG&E]). [Additional Reference(s): DWR Levee Log, 2005 (HLM 1.20, listed as 18-inch steel pipe)]. FS Date: 2/7/2019 2:48:00 PM

LS view: overview of LS looking downstream.

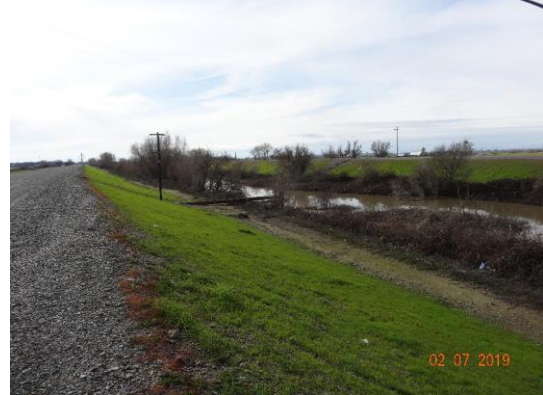
Photo 3 of 3 : UCIP_SP_2022_60106_78657.jpg

WS view: overview of WS looking downstream.

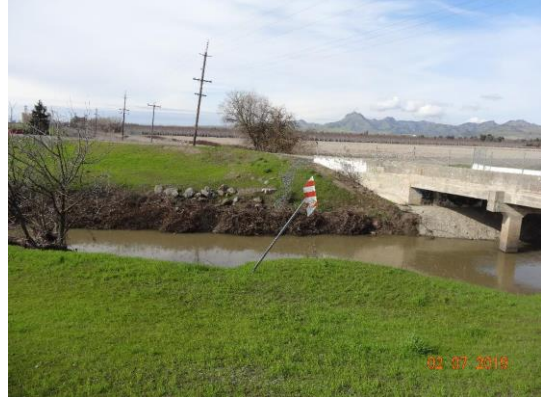
Photo 1 of 3 : UCIP_SP_2022_60112_78683.jpg

Comment Code					
Inspector Comment					
FS_ID:60112 DS_ID:17064 EP_NO: 9191 Repair Type: Non-Urgent Crossing Status: Indicator Found UCIP Comments: 02/07/2019 Record has been updated from No Action Needed to Non-Urgent, no maintenance records were made available to determine condition of line. Need to contact owner to determine status of line through the levee. (O. Magana - DWR UCIP)04/10/2017 Crossing appears to be in good condition. (A. Freitag - DWR Sutter Yard)10/12/2016 Crossing appears to be in good condition. (A. Freitag - DWR Sutter Yard)04/19/2016 Crossing appears to be in good condition. (A. Freitag - DWR Sutter Yard)05/12/2015 Crossing appears in good condition. No noticeable issues to report. (A. Freitag - DWR Sutter Yard)11/18/2014 Same as last inspection. (A. Freitag - DWR Sutter Yard)05/13/2014 Same as last inspection. (A. Freitag - DWR Sutter Yard)05/16/2013 Same as last inspection. (A. Freitag - DWR Sutter Yard)10/29/2013 Same as last inspection. (A. Freitag - DWR Sutter Yard) FIELD_STRUCT_DESC: 6-inch asphalt coated steel gas line through the levee, 1.1 feet below the crown. Gas line crosses the Wadsworth Canal and its levees. Gas line markers located on the landside (LS) and waterside (WS) toes. (6-inch gas line authorized under Permit No. 764, 1939 - Pacific Gas and Electric Company [PG&E]. Pipe reconstructed under Permit No. 9191, 1974 - PG&E). [Additional Reference(s): DWR Levee Log, 2005 (HLM 3.04, listed as 7-inch gas line). USACE Sacramento O&M Manual, Unit 135, May 1953, (Station 159+38), listed as 6-inch steel gas line, USACE As-built Drawing No. 50-04-1949, Drawing No. 2, Sheet 3, March 1952, page 2 of 3]. FS Date: 2/7/2019 2:52:00 PM

WS view: line crosses both left and right bank, markers visible on opposite levee.

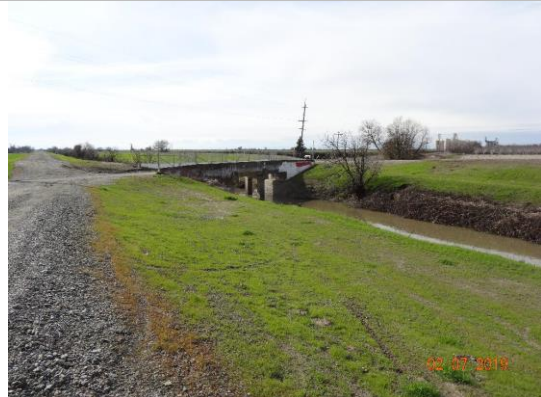
Photo 3 of 3 : UCIP_SP_2022_60113_78686.jpg

WS view: overview of WS.

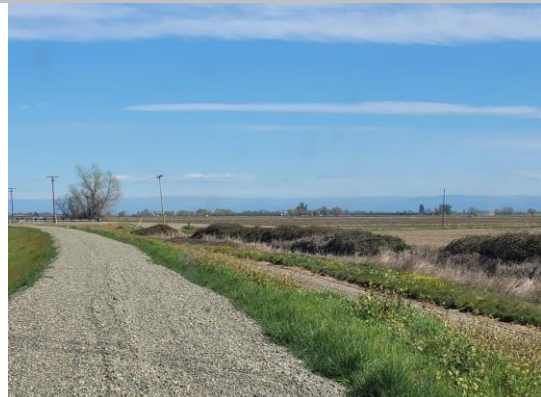
Photo 1 of 1 : SP_2022_ST0010_42_15_20220310_00032.jpg

LM Start	3.08	Rating **	M	Issue No.	15
LM End	3.23	Issue Type +	Ma	Location *	LS
Category	Earthen Levee			GPS Latitude/Longitude	
				Start	End
Item	Vegetation			39.150046 °	39.152111 °
				-121.736031 °	-121.734719 °
DWR ID	DWR_ST0010_01_s_2022_15				
Comment Code					
V1 : Control annual grass and weeds on the levee slopes and easements.					
Inspector Comment

View of the vegetation along the landside slope. Spring 2022.

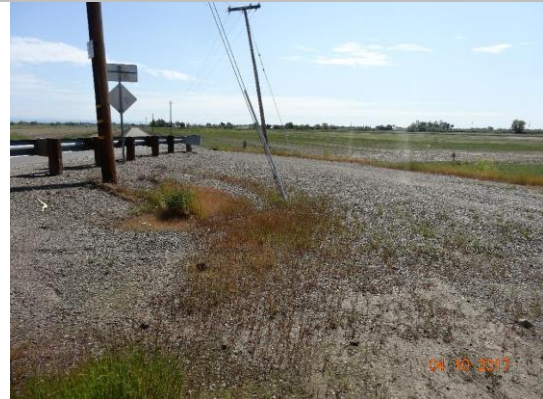
Photo 1 of 3 : UCIP_SP_2022_57985_76957.jpg

Comment Code						
Inspector Comment						
FS_ID:57985 DS_ID:23097 EP_NO: N/A Repair Type: Non-Urgent Crossing Status: Found UCIP Comments: 02/07/2019 Record remains Non-Urgent due to no permit found authorizing conduit through the levee. Carsonite marker lists CVIN as owner. Contact phone number listed on marker to be used before digging is 855-442-6010. Need to contact owner to determine permit used for installation of buried fiber optic cable. (O. Magana - DWR UCIP)04/10/2017 Crossing appears to be in good condition. Photos added. (A. Freitag - DWR Sutter Yard)10/12/2016 Crossing appears to be in good condition. (A. Freitag - DWR Sutter Yard)05/31/2016 Need photos markers and levee overview (O. Magana - DWR UCIP)04/19/2016 Crossing appears to be in good condition. No permit on file. (A. Freitag - DWR Sutter Yard)05/12/2015 No noticeable issues with crossing but no permit on file for it. (A. Freitag - DWR Sutter Yard)11/18/2014 Same as last inspection. (A. Freitag - DWR Sutter Yard)05/13/2014 Same as last inspection. (A. Freitag - DWR Sutter Yard)10/29/2013 Same as last inspection. (A. Freitag - DWR Sutter Yard)05/16/2013 No known permit for work. (A. Freitag - DWR Sutter Yard) FIELD_STRUCT_DESC: 4-inch steel communication line conduit through the levee, 2 feet below the crown. Fiber optics line attached to bottom of downstream side of South Butte Road bridge. Position marked with orange markers. No permit has been identified since crossing was field discovered in 2012. FS Date: 2/7/2019 2:53:00 PM

LS overview

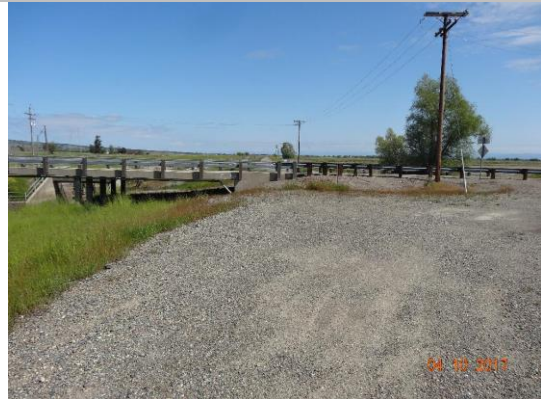
Photo 2 of 3 : UCIP_SP_2022_57985_76953.jpg

Levee overview looking upstream.

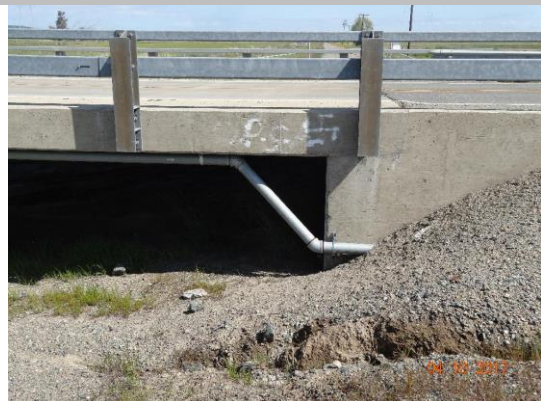
Photo 3 of 3 : UCIP_SP_2022_57985_76954.jpg

Conduit exiting WS slope and attaching to the downstream side of South Butte Rd bridge.

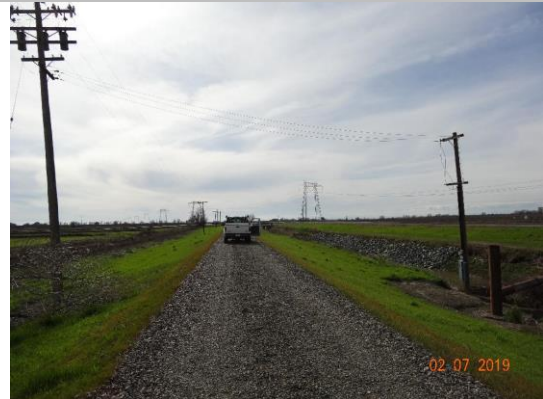
Photo 1 of 3 : UCIP_SP_2022_60147_78704.jpg

FS_ID:60147
DS_ID:17066
EP_NO: N/A
Repair Type: Non-Urgent
Crossing Status: Found
UCIP Comments: 02/07/2019 Record remains Non-Urgent, this crossing has been modified. Also, unable to determine if the 24-inch pipe referenced in the levee logs still exists through the levee. There is a 14-inch steel pipe on the WS, a 16-inch steel riser on the WS, and a 16-inch PVC pipe located on the LS. No permit was found authorizing the modifications at this location. The 4-foot by 6-foot concrete distribution box has been removed from the WS. Some settling (minor depression) is present where the distribution box might have been previously located. Need to contact owner to determine CVFPB permit issued for the modifications at this location. (O. Magana - DWR UCIP)01/28/2019 USACE O&M dwg shows 12-inch and 24-inch on LS. (O. Magana - DWR UCIP)
04/10/2017 LS heavily vegetated but nothing appears to have changed with the crossing. LS headwall still silted in and pipe discharges directly into the rice field. (A. Freitag - DWR Sutter Yard)10/12/2016 Crossing appears to be in good condition. (A. Freitag - DWR Sutter Yard)04/19/2016 Crossing has not changed since the last inspection. LS headwall is silted in and not being used. LS pipe end discharges into the rice field. (A. Freitag - DWR Sutter Yard)05/12/2015 Concrete headwall on LS is completely silted in. LS pipe end is located near the edge of rice field. No issues seen on WS. (A. Freitag - DWR Sutter Yard)11/18/2014 Same as last inspection. (A. Freitag - DWR Sutter Yard)05/13/2014 Same as last inspection. (A. Freitag - DWR Sutter Yard)10/29/2013 Concrete headwall is silted in and appears to be abandoned. Discharge end of pipe is approx. 100ft. from LS toe on the edge of the rice field. (A. Freitag - DWR Sutter Yard)05/16/2013 Same as last inspection. (A. Freitag - DWR Sutter Yard)

FIELD_STRUCT_DESC: 24-inch steel irrigation pipe (USACE O&M refers to 24-inch corrugated metal pipe, 14-inch pipe [measured] connected to pump) through the levee, 11 feet below the crown. Slide gate in 4-foot by 6-foot concrete distribution box located at the waterside (WS) toe. (not found in 2012) Vertical pump mounted on a steel structure in channel. Service pole on the berm with 16-inch (measured) standpipe located on the WS toe. Concrete "U" shaped headwall located on the landside (LS) toe. Field measurements taken during site visit (2019): 14-inch steel pipe on WS, 16-inch steel riser on the WS, and 16-inch PVC pipe on the LS. [Additional Reference(s): DWR Levee Log, 2005 (HLM 3.54, listed as 24-inch pipe). USACE Sacramento O&M Manual, Unit 135, May 1953, (Station 184+87), listed as 12-inch CMP and 24-inch CMP, USACE As-built Drawing No. 50-04-1949, Drawing No. 2, Sheet 3, March 1952, page 2 of 3].

Overview of levee crown looking downstream towards crossing.

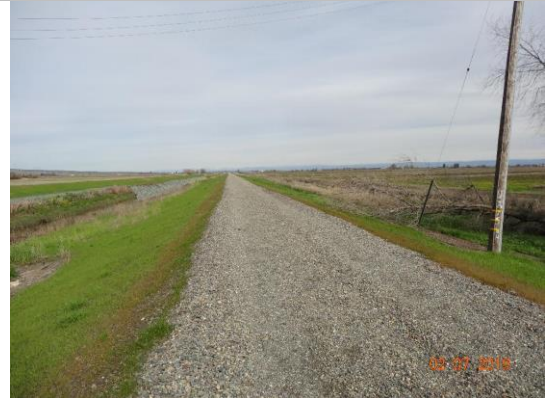
Photo 2 of 3 : UCIP_SP_2022_60147_78701.jpg

Overview of levee crown looking upstream towards crossing.

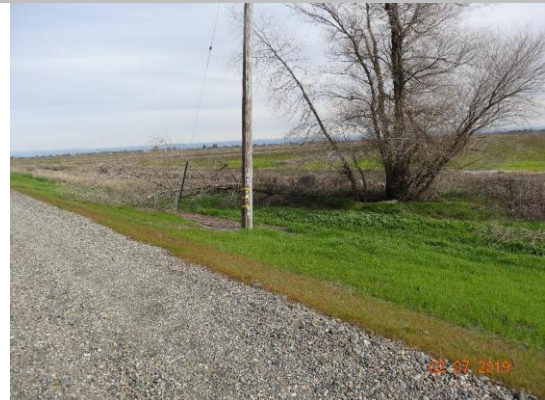
Photo 3 of 3 : UCIP_SP_2022_60147_78702.jpg

LS view: power pole located on LS.

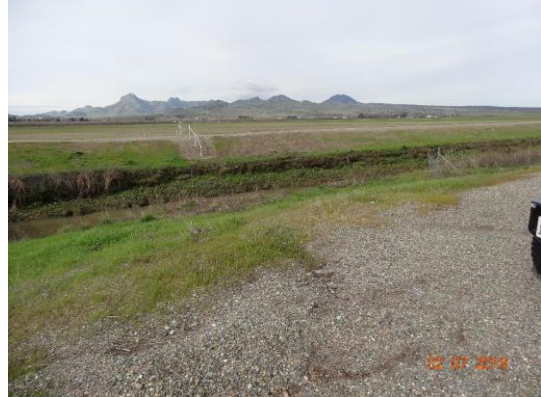
Photo 1 of 3 : UCIP_SP_2022_60116_78707.jpg

Comment Code						
Inspector Comment						
FS_ID:60116 DS_ID:17058 EP_NO: N/A Repair Type: Non-Urgent Crossing Status: Not Found UCIP Comments: 02/07/2019 Record has been updated from No Action Needed to Non-Urgent, unable to confirm status of pipe through the levee. Unable to locate pipe or appurtenances through this section of the levee. The DWR DMP geophysical investigation report indicates no signal received of suggestive target. Record will remain in UCIP's inspection records until future Levee Improvement Project can confirm no crossing was found through the levee. Also there is no permit identified for the authorization of this pipe. (O. Magana - DWR UCIP)04/10/2017 Unable to locate. (A. Freitag - DWR Sutter Yard)10/12/2016 Unable to locate. (A. Freitag - DWR Sutter Yard)04/19/2016 Unable to locate. (A. Freitag - DWR Sutter Yard)05/12/2015 Unable to locate. (A. Freitag - DWR Sutter Yard)11/18/2014 Unable to locate. (A. Freitag - DWR Sutter Yard)05/13/2014 Same as last inspection. (A. Freitag - DWR Sutter Yard)10/29/2013 Same as last inspection. (A. Freitag - DWR Sutter Yard)05/16/2013 Same as last inspection. (A. Freitag - DWR Sutter Yard)10/09/2012 unable to locate. (W. Wylie - DWR UCIP) FIELD_STRUCT_DESC: 12-inch corrugated metal drainage pipe through the levee, 8.7 feet below the crown. Pipe is open at both the waterside (WS) and landside (LS) ends. [Additional Reference(s): DWR Levee Log, 2005 (HLM 4.38, listed as 12-inch CMP). USACE Sacramento O&M Manual, Unit 135, May 1953, (Station 228+00), listed as 12-inch CMP, USACE Drawing No. 50-04-1949, Drawing No. 2, Sheet 3, March 1952, page 2 of 3, 12-inch CMP referenced at 228+25]. FS Date: 2/7/2019 12:13:00 PM

WS view: overview of WS, no signs of pipe.

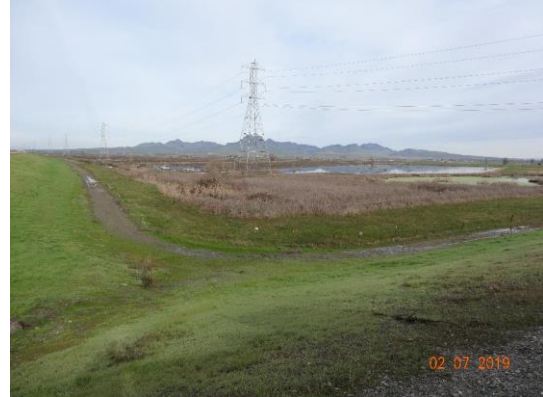
Photo 1 of 3 : UCIP_SP_2022_60117_78711.jpg

Comment Code						
Inspector Comment						
FS_ID:60117 DS_ID:17080 EP_NO: 5296 Repair Type: Non-Urgent Crossing Status: Not Found UCIP Comments: 02/07/2019 Record remains Non-Urgent, no maintenance records were made available by owner. No signs of line was present through this section of the levee. Need to contact owner to determine current status of line. If pipe is still in use, owner will need to provide maintenance records. If pipe is no longer in use, owner will need to coordinate with the CVFPB to comply with Title 23 requirements for proper removal or abandonment. (O. Magana - DWR UCIP)04/10/2017 Unable to locate. (A. Freitag - DWR Sutter Yard)10/12/2016 Unable to locate. (A. Freitag - DWR Sutter Yard)04/19/2016 Unable to locate. (A. Freitag - DWR Sutter Yard)05/12/2015 Unable to locate. (A. Freitag - DWR Sutter Yard)11/18/2014 Same as last inspection. (A. Freitag - DWR Sutter Yard)05/13/2014 Same as last inspection. (A. Freitag - DWR Sutter Yard)10/29/2013 Same as last inspection. (A. Freitag - DWR Sutter Yard)05/16/2013 Same as last inspection. (A. Freitag - DWR Sutter Yard)10/09/2012 Unable to locate any signage. Call owner to determine disposition of pipeline. (W. Wylie - DWR UCIP) FIELD_STRUCT_DESC: 3.5-inch steel gas line through the levee, 3 feet below the crown. Gas line goes through both levees and Wadsworth Canal. (3-inch line authorized under Permit No. 5296, 1966 - Atlantic Oil Company). [Additional Reference(s): DWR Levee Log, 2005 (HLM 0.02)]. FS Date: 2/7/2019 11:10:00 AM

LS view: overview of LS; no markers present on LS.

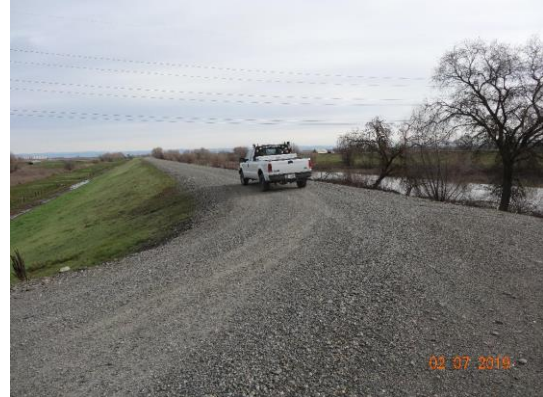
Photo 2 of 3 : UCIP_SP_2022_60117_78712.jpg

Overview of levee crown where crossing should be.

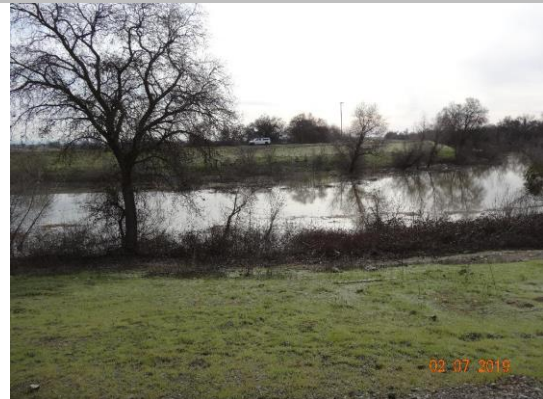
Photo 3 of 3 : UCIP_SP_2022_60117_78710.jpg

WS view: overview of WS; no markers visible of gas line.

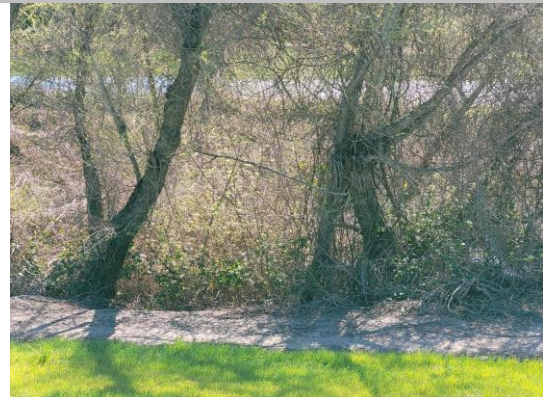
Photo 1 of 1 : SP_2022_ST0010_43_24_20220310_00045.jpg

LM Start	0.35	Rating **	M	Issue No.	24
LM End	0.35	Issue Type +	Ma	Location *	WS
Category	Earthen Levee			GPS Latitude/Longitude	
				Start	End
Item	Erosion / Bank Caving			39.118178 °	39.118178 °
				-121.765500 °	-121.765500 °
DWR ID	DWR_ST0010_02_s_2022_24				
Comment Code					
E2 : Schedule repair of erosion site prior to the next inspection.					
Inspector Comment					
Erosion is present at the toe of the levee. Patrol road is cutting into the levee prism.

View of the erosion at the waterside toe/patrol road. Spring 2022.

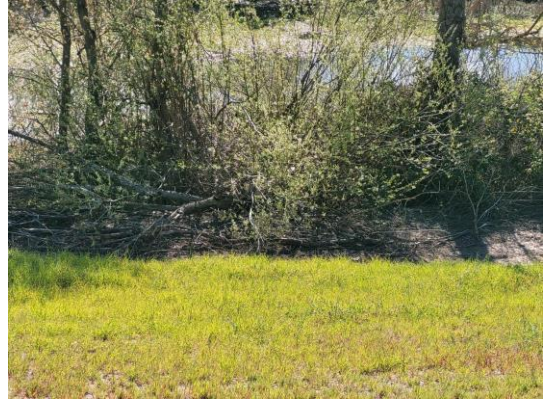
Photo 1 of 1 : SP_2022_ST0010_43_23_20220310_00046.jpg

View of a tree at the waterside toe. Spring 2022.

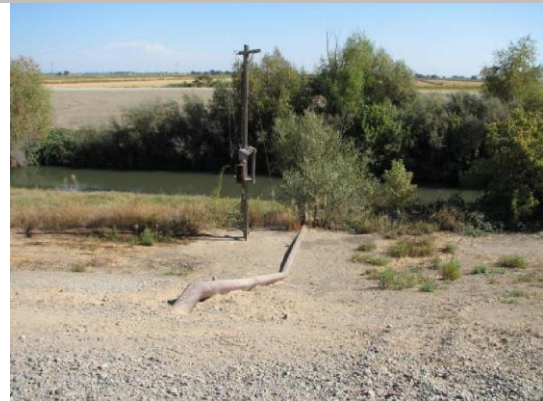
Photo 3 of 3 : UCIP_SP_2022_60118_64727.jpg

Pipe and pump facilities on WS slope.

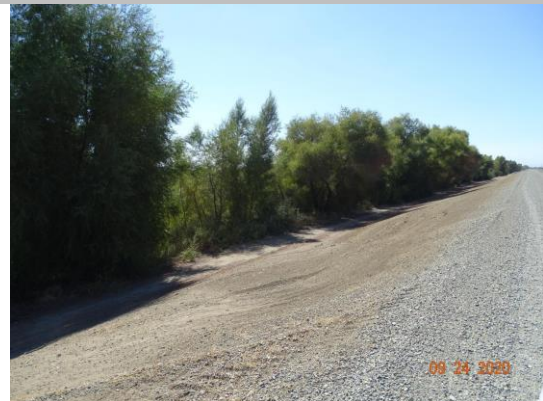
Photo 1 of 1 : SP_2022_ST0010_43_20_20220307_00003.jpg

View of the ramp encroaching into the levee. Fall 2020.

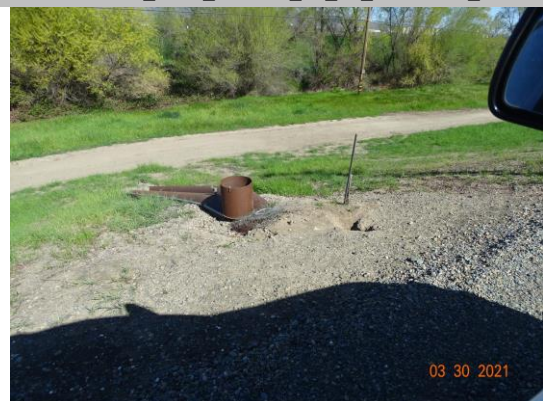
Photo 1 of 1 : SP_2022_ST0010_43_11_20220307_00001.jpg

View of the rodent holes above the irrigation pipe. Spring 2021.

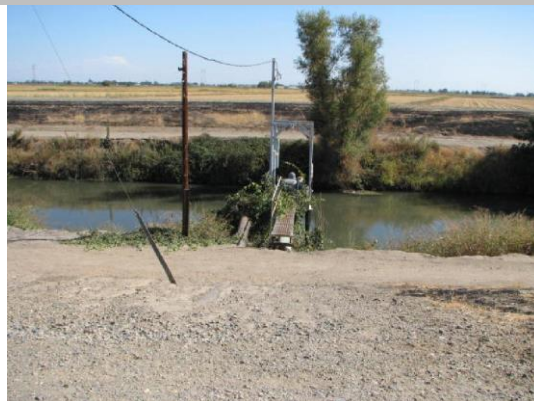
Photo 3 of 3 : UCIP_SP_2022_60125_64734.jpg

Pipe on left without pump.

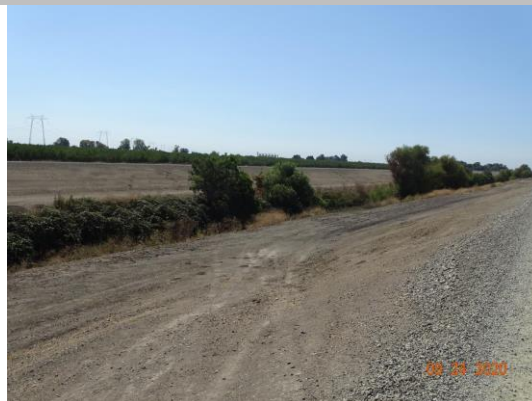
Photo 1 of 1 : SP_2022_ST0010_43_21_20220307_00004.jpg

View of the ramp encroaching into the levee. Fall 2020.

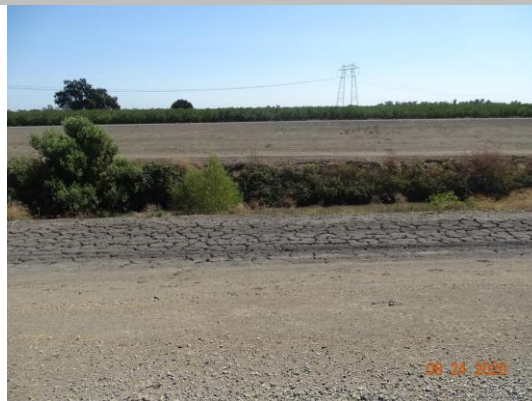
Photo 1 of 1 : SP_2022_ST0010_43_22_20220307_00005.jpg

View of the cracking along the waterside toe. Fall 2020.

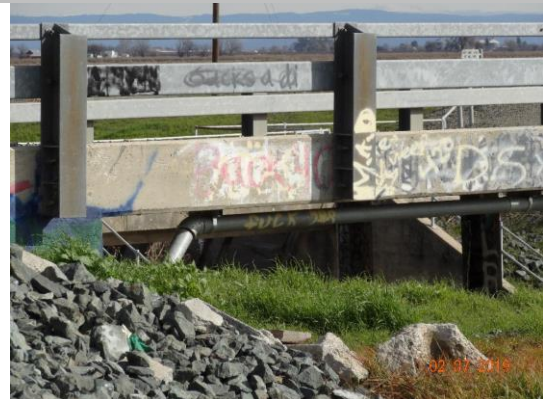
Photo 3 of 3 : UCIP_SP_2022_58005_78780.jpg

WS view: conduit attached to bridge.
