**Flood Control Project Maintenance  
Levee Inspections  
LMA District Cover Sheet**

**Sutter Maintenance Yard Wadsworth Canal**

**Flood Control Project Maintenance  
Levee Inspections**

**Levee Inspection Report By Mile - Spring 2023**

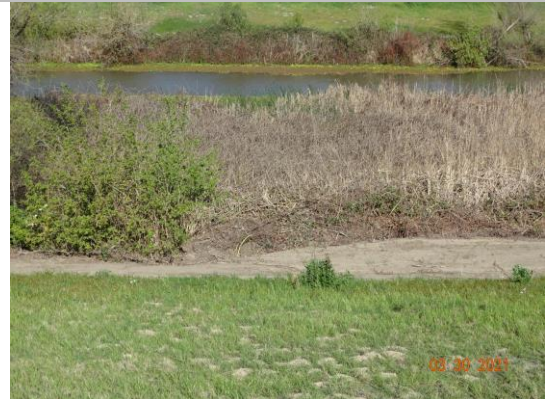
Photo 1 of 1 : SP\_2023\_ST0010\_42\_20\_20230509\_00003.jpg

View of the erosion along the waterside toe. Spring 2021.

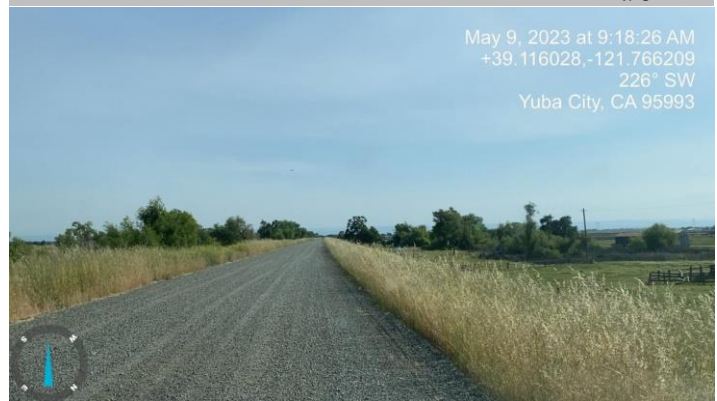
Photo 1 of 1 : SP\_2023\_ST0010\_42\_8\_20230509\_00020.jpg

LM Start	0.18	Rating **	U	Issue No.	8
LM End	4.63	Issue Type +	Ma	Location *	LS
Category	Earthen Levee			GPS Latitude/Longitude	
				Start	End
Item	Vegetation			39.115574°	39.171120°
				-121.766614°	-121.726488°
DWR ID	DWR_ST0010_01_s_2023_8				
Comment Code					
V1 : Control annual grass and weeds on the levee slopes and easements.					
Inspector Comment

View of landside vegetation (Spring 2023).

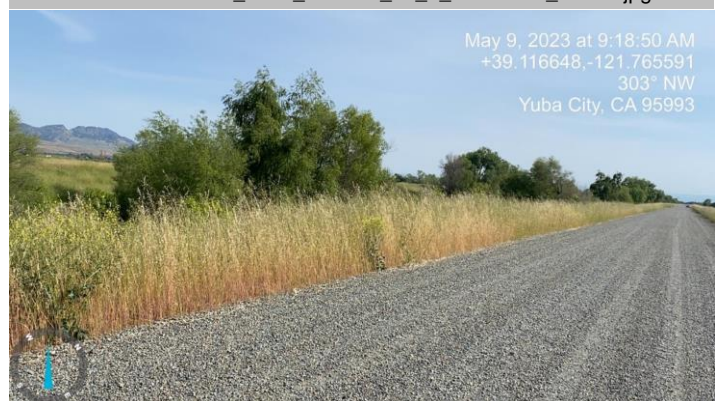
Photo 1 of 1 : SP\_2023\_ST0010\_42\_9\_20230509\_00021.jpg

LM Start	0.18	Rating **	U	Issue No.	9
LM End	4.63	Issue Type +	Ma	Location *	WS
Category	Earthen Levee			GPS Latitude/Longitude	
				Start	End
Item	Vegetation			39.115580°	39.171120°
				-121.766617°	-121.726488°
DWR ID	DWR_ST0010_01_s_2023_9				
Comment Code					
V1 : Control annual grass and weeds on the levee slopes and easements.					
Inspector Comment

View of waterside vegetation (Spring 2023).

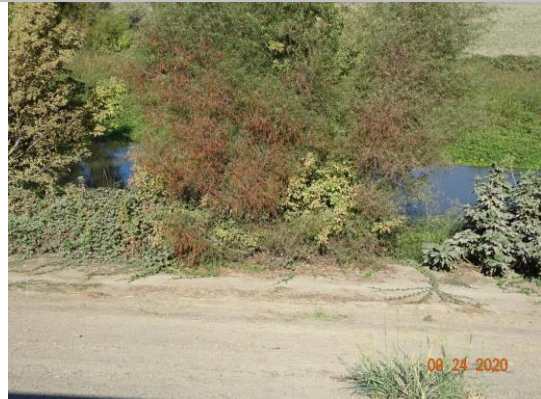
Photo 1 of 1 : SP\_2023\_ST0010\_42\_19\_20230509\_00002.jpg

View of the erosion along the waterside toe. Fall 2020.

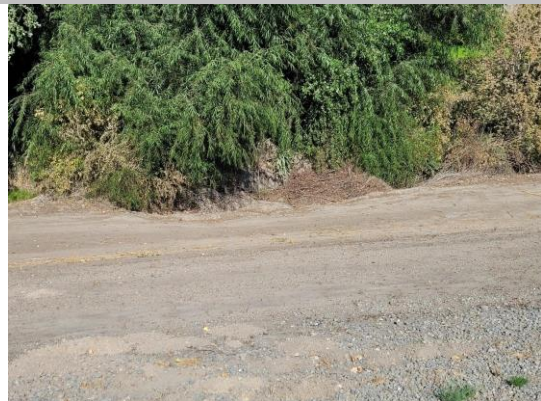
Photo 1 of 1 : SP\_2023\_ST0010\_42\_18\_20230509\_00001.jpg

LM Start	0.56	Rating **	M	Issue No.	18
LM End	0.56	Issue Type +	Ma	Location *	WS
Category	Earthen Levee			GPS Latitude/Longitude	
				Start	End
Item	Erosion / Bank Caving			39.119985°	39.119985°
				-121.762600°	-121.762600°
DWR ID	DWR_ST0010_01_s_2017_18				
Comment Code					
E2 : Schedule repair of erosion site prior to the next inspection.					
Inspector Comment

View of the erosion along the waterside toe. Fall 2021.

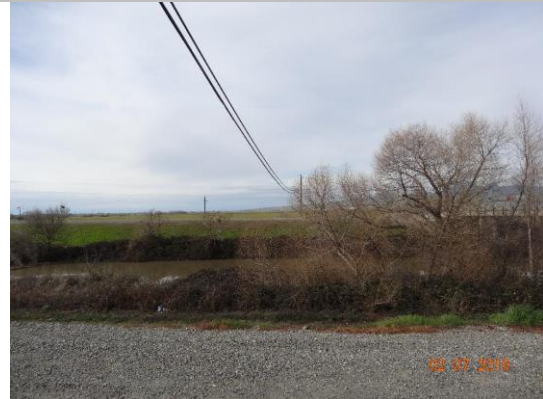
Photo 1 of 3 : UCIP\_SP\_2023\_60107\_78669.jpg

Comment Code						
Inspector Comment						
DS_ID:17060 FS_ID:60107 EP_NO: 13362 Repair Type: Non-Urgent EVAL Issue: 10, Unauthorized Modification or Non-Compliant Permit Crossing Status: Indicator Found UCIP Comments: 02/07/2019 Record has been updated from No Action Needed to Non-Urgent, unable to determine whether the old authorized conduit line was abandoned through the levee. The conduit appears to be modified to an aerial conduit. Need to contact owner to determine status of authorized line and determine permit issued for modification of the aerial line at the same location. (O. Magana - DWR UCIP)04/11/2017 Aerial lines. (A. Freitag - DWR Sutter Yard)10/12/2016 Crossing appears to be in good condition. (A. Freitag - DWR Sutter Yard)04/19/2016 Crossing appears to be in good condition. (A. Freitag - DWR Sutter Yard)05/12/2015 Crossing appears in good condition. No noticeable issues to report. (A. Freitag - DWR Sutter Yard)11/18/2014 Same as last inspection. (A. Freitag - DWR Sutter Yard)05/13/2014 Same as last inspection. (A. Freitag - DWR Sutter Yard)10/29/2013 Same as last inspection. (A. Freitag - DWR Sutter Yard)05/16/2013 Same as last inspection. (A. Freitag - DWR Sutter Yard)10/09/2012 No pipe on downstream side of bridge. It is likely that this com line is now an aerial. See photos. (W. Wylie - DWR UCIP) FIELD_STRUCT_DESC: 4-inch steel communication conduit with multiple telephone cables inside through the levee, 2.6 feet below the crown. Telephone cables sleeved through existing 4-inch conduit. The conduit is no longer attached to downstream side of bridge. It is likely that this communication line is now an aerial. (4-inch conduit authorized under Permit No. 6906, 1970 - Pacific Telephone and Telegraph Company [PT&T]. Telephone cables were installed through existing conduit authorized under Permit No. 13362, 1982 - PT&T). [Additional Reference(s): DWR Levee Log, 2005 (HLM 1.24, listed as 4-inch steel conduit)]. FS Date: 2/7/2019 2:49:00 PM

WS view: only overhead power lines visible at this location.

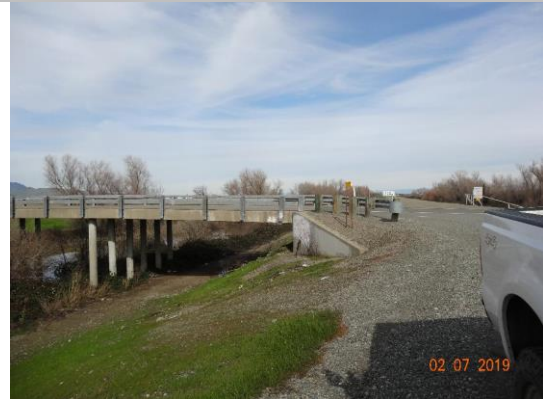
Photo 2 of 3 : UCIP\_SP\_2023\_60107\_78667.jpg

Overview of levee crown and WS.

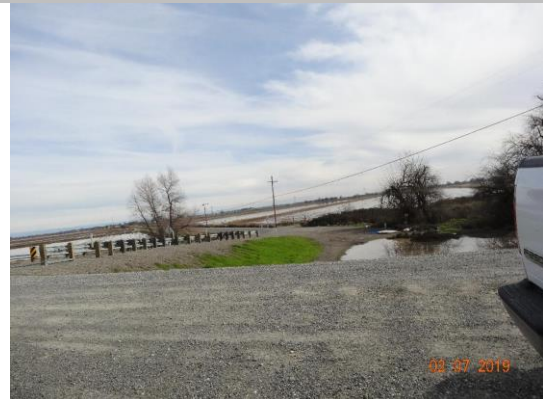
Photo 3 of 3 : UCIP\_SP\_2023\_60107\_78668.jpg

LS view: no markers visible along LS or county road.

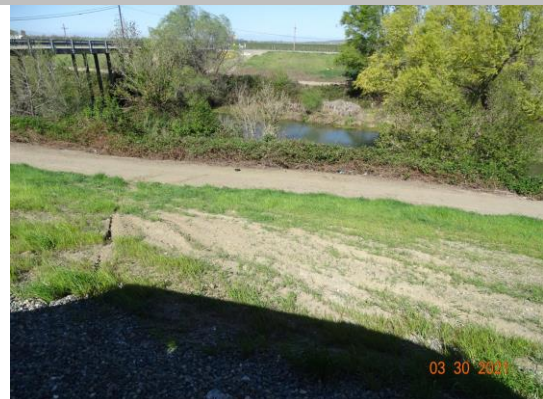
Photo 1 of 1 : SP\_2023\_ST0010\_42\_21\_20230509\_00004.jpg

LM Start	1.27	Rating **	M	Issue No.	21
LM End	1.27	Issue Type +	Ma	Location *	WS
Category	Earthen Levee			GPS Latitude/Longitude	
				Start	End
Item	Erosion / Vehicle Traffic			39.128324°	39.128324°
				-121.754619°	-121.754619°
DWR ID	DWR_ST0010_01_s_2021_21				
Comment Code					
E6 : Repair the levee slope damaged by vehicle traffic and prevent access where possible.					
Inspector Comment

View of the waterside slope damaged by vehicle traffic. Spring 2021.

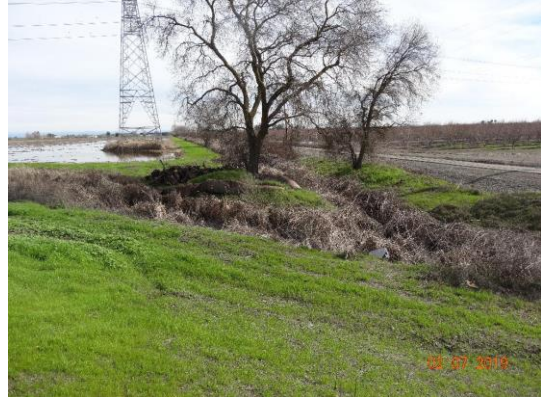
Photo 1 of 3 : UCIP\_SP\_2023\_60113\_78688.jpg

DS\_ID:17065  
FS\_ID:60113  
EP\_NO: 7209  
Repair Type: Non-Urgent  
EVAL Issue: 11, Maintenance Compliance Issue  
Crossing Status: Found  
UCIP Comments: 01/06/2022 LoF of crossing is 5.2 due to pin size holes less than 10 feet from pipe end. Crossing remains Non-Urgent because pipe damage located outside of levee prism and does not pose a threat to levee. (O.Yakimov - DWR UCIP)  
02/07/2019 Record remains Non-Urgent due to of few maintenance issues observed during inspection. Pipe is being used as a shooting target. Multiple holes are visible on the exposed WS section of the pipe. The inlet pipe section located on the LS has been damaged (pipe wall section pulled). This pipe qualifies as an LMA responsible crossing as it was originally listed in the USACE O&M manual as a drainage pipe. The CVFPB issued a permit in 1970 for the replacement of the original USACE drainage pipe. (O. Magana - DWR UCIP)04/10/2017 WS pipe end is in good condition. LS pipe end is still deformed and vegetated. (A. Freitag - DWR Sutter Yard)10/12/2016 LS inlet is still deformed and being overgrown by vegetation. (A. Freitag - DWR Sutter Yard)04/19/2016 Crossing appears to be in good condition. (A. Freitag - DWR Sutter Yard)05/12/2015 LS inlet still deformed a little but does not affect the crossing function. (A. Freitag - DWR Sutter Yard)11/18/2014 Same as last inspection. (A. Freitag - DWR Sutter Yard)05/13/2014 Same as last inspection. (A. Freitag - DWR Sutter Yard)10/29/2013 Same as last inspection. (A. Freitag - DWR Sutter Yard)05/16/2013 Pipe intake on LS appears to be bent and damaged but that does not appear to be affecting water flow or channel bank. (A. Freitag - DWR Sutter Yard)

FIELD\_STRUCT\_DESC: 36-inch corrugated metal drainage pipe (permit records indicate 30-inch, USACE O&M pipe replaced with new 30-inch pipe) through the levee, 9 feet below the crown. Flap gate located on the waterside (WS) end. (36-inch pipe removed and replaced under Permit No. 7209, 1970 - Department of Water Resources [DWR], replacement pipe size not referenced drawing shows pipe is 9-feet 2-inches below the levee crown) [Additional Reference(s): DWR Levee Log, 2005 (HLM 3.06, listed as 36-inch CMP 14-feet below the crown). USACE Sacramento O&M Manual, Unit 135, May 1953, (Station 160+25), listed as 36-inch CMP w/ steel flap valve, USACE As-built Drawing No. 50-04-1949, Drawing No. 2, Sheet 3, March 1952, sheet 2 of 3].  
FS Date: 2/7/2019 2:53:00 PM

LS view: overview of LS.

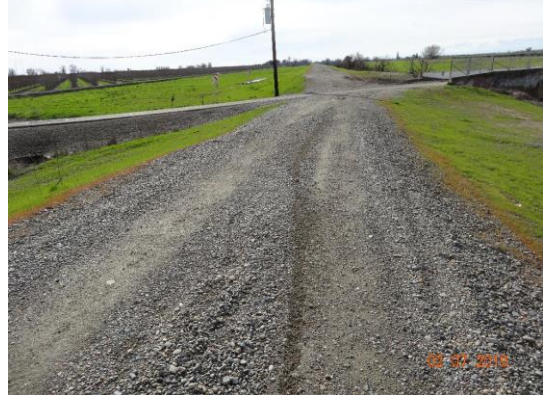
Photo 2 of 3 : UCIP\_SP\_2023\_60113\_78687.jpg

Overview of levee crown looking downstream at crossing.

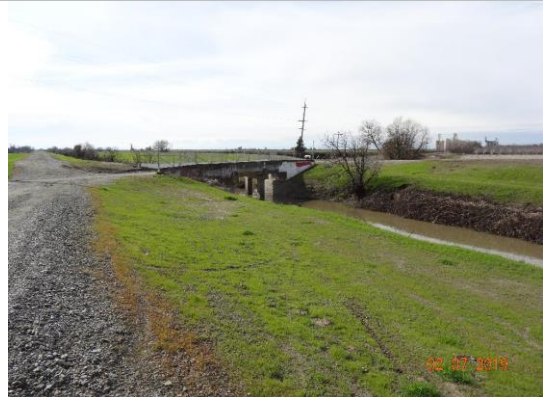
Photo 3 of 3 : UCIP\_SP\_2023\_60113\_78686.jpg

WS view: overview of WS.

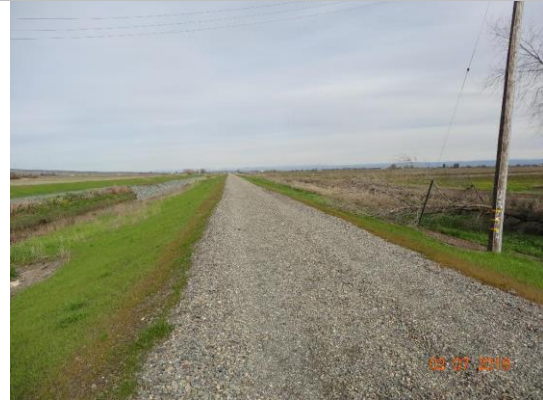
Photo 2 of 3 : UCIP\_SP\_2023\_60147\_78701.jpg

Overview of levee crown looking upstream towards crossing.

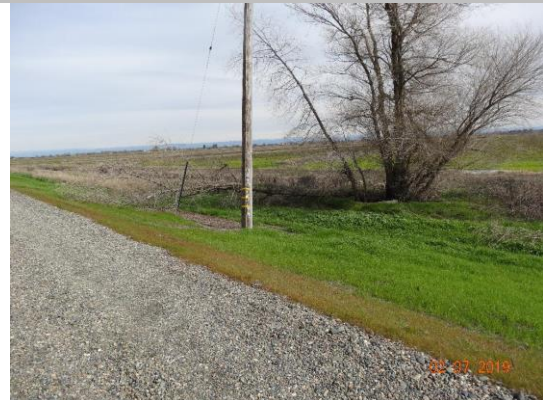
Photo 3 of 3 : UCIP\_SP\_2023\_60147\_78702.jpg

LS view: power pole located on LS.

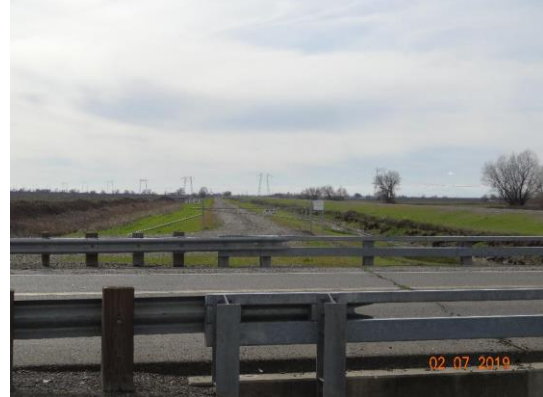
Photo 1 of 3 : UCIP\_SP\_2023\_60115\_78705.jpg

Comment Code					
Inspector Comment					
DS_ID:17067 FS_ID:60115 EP_NO: 4680 Repair Type: Non-Urgent EVAL Issue: 10, Unauthorized Modification or Non-Compliant Permit Crossing Status: Indicator Found UCIP Comments: 02/07/2019 Record has been updated from No Action Needed to Non-Urgent, buried line appears to have been changed to an aerial line. No signs were present of the buried conduit instead there appears to be an aerial line at this location now. Need to coordinate with owner to determine if 4-inch conduit was properly abandoned or removed per Title 23. If modifications were not approved by the CVFPB, owner will need to coordinate with the CVFPB to comply with Title 23 requirements. (O. Magana - DWR UCIP)04/10/2017 Aerial lines. (A. Freitag - DWR Sutter Yard)10/12/2016 Crossing appears to be in good condition. (A. Freitag - DWR Sutter Yard)04/19/2016 Crossing appears to be in good condition. (A. Freitag - DWR Sutter Yard)05/12/2015 Crossing appears in good condition. No noticeable issues to report. (A. Freitag - DWR Sutter Yard)11/18/2014 Same as last inspection. (A. Freitag - DWR Sutter Yard)05/13/2014 Same as last inspection. (A. Freitag - DWR Sutter Yard)10/29/2013 Same as last inspection. (A. Freitag - DWR Sutter Yard)05/16/2013 Same as last inspection. (A. Freitag - DWR Sutter Yard)10/09/2012 Communication line on Pole 400-feet west of canal. Likely now an aerial on North side of roadway. (W. Wylie - DWR UCIP) FIELD_STRUCT_DESC: 4-inch steel communication conduit (telephone cable inside) through the levee, 2.3 feet below the crown. Conduit line goes through Wadsworth Canal and its levees. Annular space between pipe and conduit grouted. Line is attached to south side of the Butte House Road bridge (no longer attached in 2012). (4-inch conduit authorized under Permit No. 4680, 1964 - Pacific Telephone and Telegraph Company [PT&T]). [Additional Reference(s): DWR Levee Log, 2005 (HLM 4.37, listed as 4-inch steel conduit)]. FS Date: 2/7/2019 2:54:00 PM

No markers visible on levee crown for conduit, photo 1 of 2.

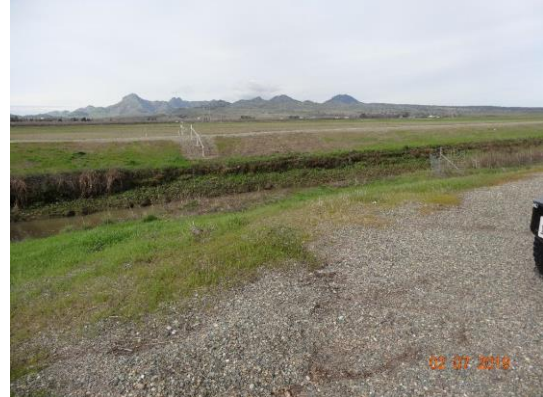
Photo 1 of 3 : UCIP\_SP\_2023\_60116\_78707.jpg

Comment Code						
Inspector Comment						
DS_ID:17058						
FS_ID:60116						
EP_NO: N/A						
Repair Type: Non-Urgent						
EVAL Issue:						
Crossing Status: Not Found						
UCIP Comments: 02/07/2019 Record has been updated from No						
Action Needed to Non-Urgent, unable to confirm status of pipe through						
the levee. Unable to locate pipe or appurtenances through this section						
of the levee. The DWR DMP geophysical investigation report indicates						
no signal received of suggestive target. Record will remain in UCIP's						
inspection records until future Levee Improvement Project can confirm						
no crossing was found through the levee. Also there is no permit						
identified for the authorization of this pipe. (O. Magana - DWR						
UCIP)04/10/2017 Unable to locate. (A. Freitag - DWR Sutter						
Yard)10/12/2016 Unable to locate. (A. Freitag - DWR Sutter						
Yard)04/19/2016 Unable to locate. (A. Freitag - DWR Sutter

WS view: overview of WS, no signs of pipe.

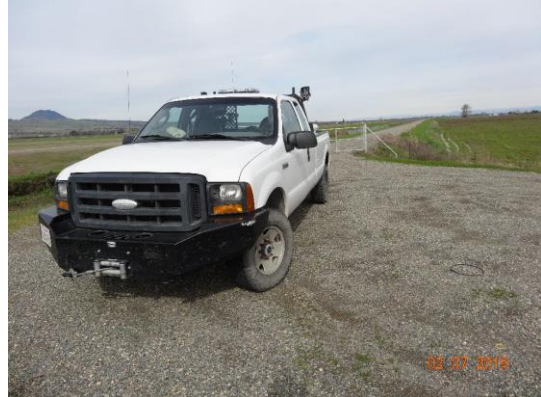
Photo 2 of 3 : UCIP\_SP\_2023\_60116\_78708.jpg

Overview of levee crown where crossing should be.

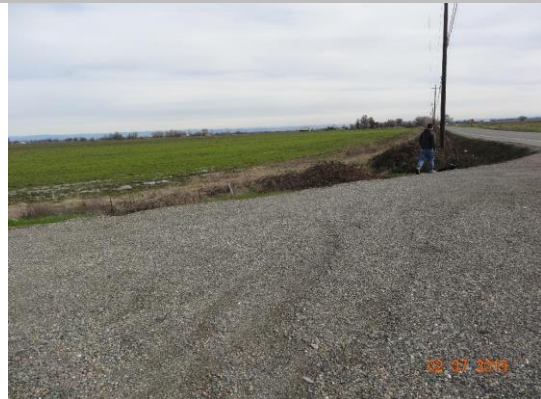
Photo 3 of 3 : UCIP\_SP\_2023\_60116\_78709.jpg

LS view: overview of LS, no signs of pipe.

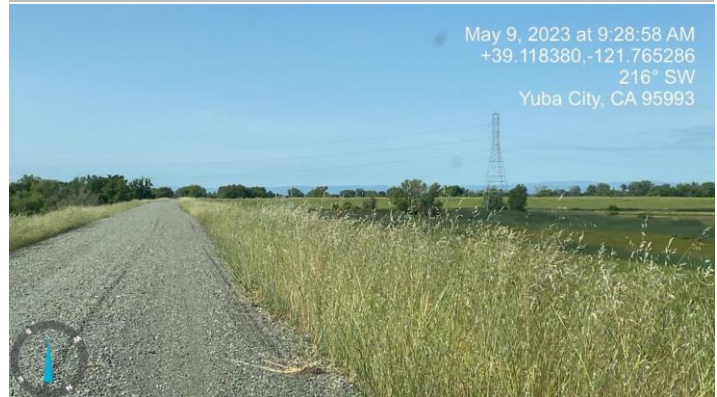
Photo 1 of 1 : SP\_2023\_ST0010\_43\_13\_20230509\_00032.jpg

View of landside vegetation (Spring 2023).

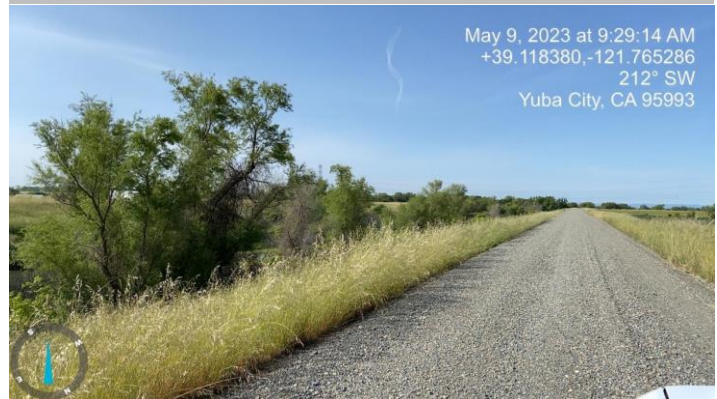
Photo 1 of 1 : SP\_2023\_ST0010\_43\_14\_20230509\_00033.jpg

LM Start	0.01	Rating **	U	Issue No.	14
LM End	4.57	Issue Type +	Ma	Location *	WS
Category	Earthen Levee			GPS Latitude/Longitude	
				Start	End
Item	Vegetation			39.114282°	39.170967°
				-121.769396°	-121.727275°
DWR ID	DWR_ST0010_02_s_2023_14				
Comment Code					
V1 : Control annual grass and weeds on the levee slopes and easements.					
Inspector Comment

View of waterside vegetation (Spring 2023).

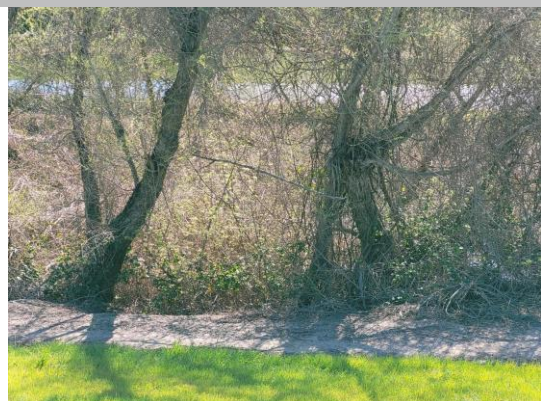
Photo 1 of 1 : SP\_2023\_ST0010\_43\_24\_20230509\_00005.jpg

LM Start	0.35	Rating **	M	Issue No.	24
LM End	0.35	Issue Type +	Ma	Location *	WS
Category	Earthen Levee			GPS Latitude/Longitude	
				Start	End
Item	Erosion / Bank Caving			39.118178°	39.118178°
				-121.765500°	-121.765500°
DWR ID	DWR_ST0010_02_s_2022_24				
Comment Code					
E2 : Schedule repair of erosion site prior to the next inspection.					
Inspector Comment					
Erosion is present at the toe of the levee. Erosion is cutting into the patrol road.

View of the erosion at the waterside toe/patrol road. Spring 2022.

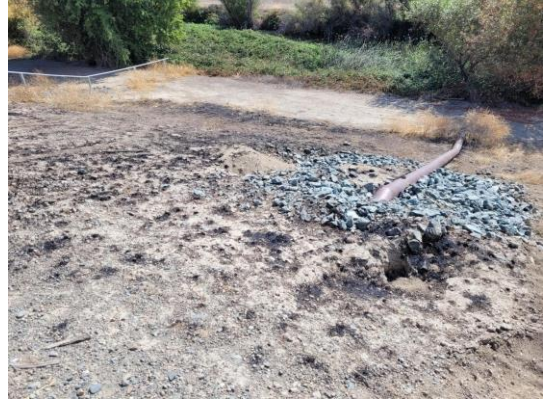
Photo 1 of 1 : SP\_2023\_ST0010\_43\_27\_20230509\_00006.jpg

View of animal burrows along the waterside slope. Fall 2022.

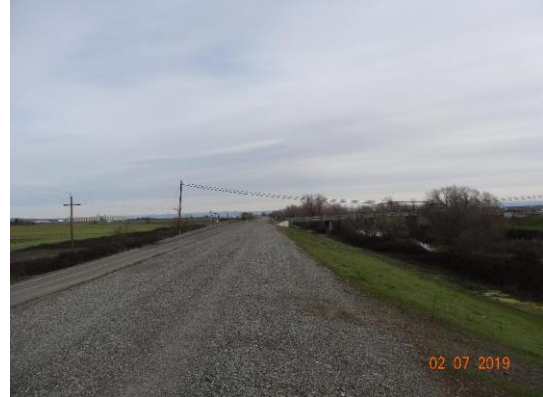
Photo 2 of 3 : UCIP\_SP\_2023\_60120\_78727.jpg

Overview of levee crown looking towards where crossing should be.

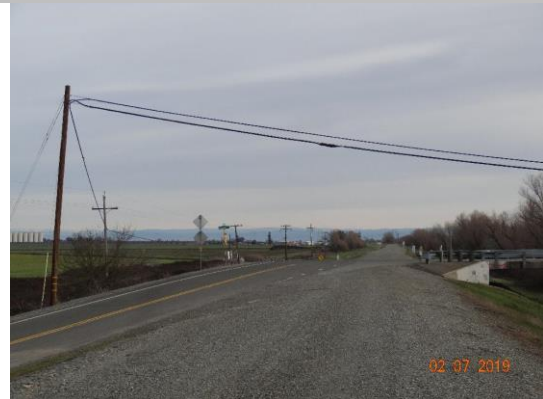
Photo 3 of 3 : UCIP\_SP\_2023\_60120\_78728.jpg

Aerial lines visible only no signs of communication line.

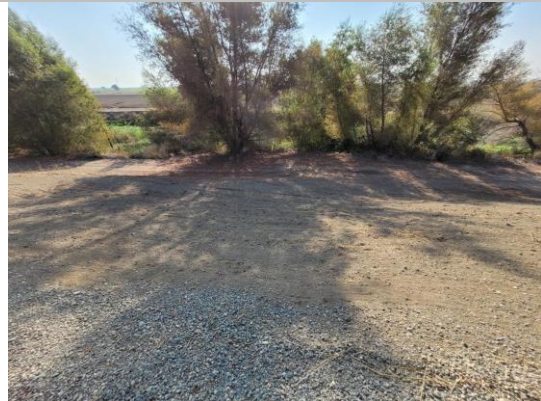
Photo 1 of 1 : SP\_2023\_ST0010\_43\_20\_20230509\_00002.jpg

LM Start	1.75	Rating **	M	Issue No.	20
LM End	1.75	Issue Type +	Ma	Location *	WS
Category	Earthen Levee			GPS Latitude/Longitude	
				Start	End
Item	Erosion / Vehicle Traffic			39.134378°	39.134378°
				-121.749803°	-121.749803°
DWR ID	DWR_ST0010_02_f_2016_20				
Comment Code					
E6 : Repair the levee slope damaged by vehicle traffic and prevent access where possible.					
Inspector Comment					
Ramp is causing depression in the levee slope.

View of the slope erosion along the waterside slope. Fall 2022.

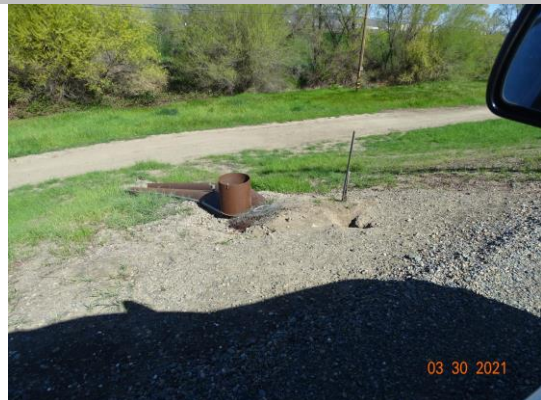
Photo 1 of 1 : SP\_2023\_ST0010\_43\_11\_20230509\_00001.jpg

LM Start	1.76	Rating **	A/W	Issue No.	11
LM End	1.76	Issue Type +	Ma	Location *	LS
Category	Earthen Levee			GPS Latitude/Longitude	
				Start	End
Item	Animal Control			39.134490°	39.134490°
				-121.749716°	-121.749716°
DWR ID	DWR_ST0010_02_f_2012_11				
Comment Code					
A3 : No rodents visible, but rodent burrows visible; need to backfill and compact or grout burrows.					
Inspector Comment					
Monitor for new activity.

View of the rodent holes above the irrigation pipe. Spring 2021.

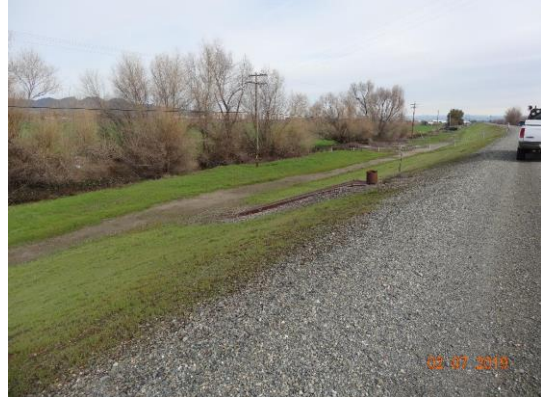
Photo 1 of 3 : UCIP\_SP\_2023\_60150\_78743.jpg

DS\_ID:17074  
FS\_ID:60150  
EP\_NO: 1096  
Repair Type: Non-Urgent  
EVAL Issue: 10, Unauthorized Modification or Non-Compliant Permit  
Crossing Status: Found  
UCIP Comments: 02/07/2019 Record has been updated from No Action Needed to Non-Urgent issue. Modification were noted at this location without authorization. Concrete standpipe previously located on the LS is no longer present. Pipe on LS measures 16-inch and 20-inches on the WS near pump. Need to contact owner to determine permit authorizing modifications to this structure. (O. Magana - DWR UCIP)04/10/2017 Crossing appears to be in good condition. It measure to be 16" on LS and 20" on WS where visible near pump. (A. Freitag - DWR Sutter Yard)10/12/2016 Crossing appears to be in good condition. Minor rodent activity nearby. (A. Freitag - DWR Sutter Yard)04/19/2016 No signs of pipe leaks. Still some minor rodent activity under the pipe on LS slope. (A. Freitag - DWR Sutter Yard)05/12/2015 Rodent activity near pipe on LS. (A. Freitag - DWR Sutter Yard)11/18/2014 Levee inspection is aware of problem and repairs seem to have been made. Slope has also been rocked to prevent erosion. (A. Freitag - DWR Sutter Yard)05/13/2014 Air vent on LS shoulder leaks and is causing minor erosion to the LS slope. (A. Freitag - DWR Sutter Yard)10/29/2013 Same as last inspection. (A. Freitag - DWR Sutter Yard)05/16/2013 Same as last inspection. (A. Freitag - DWR Sutter Yard)10/09/2012 Heavy rodent activity on LS slope along pipe alignment. (W. Wylie - DWR UCIP)

LS view: overview of LS looking upstream towards pipe.

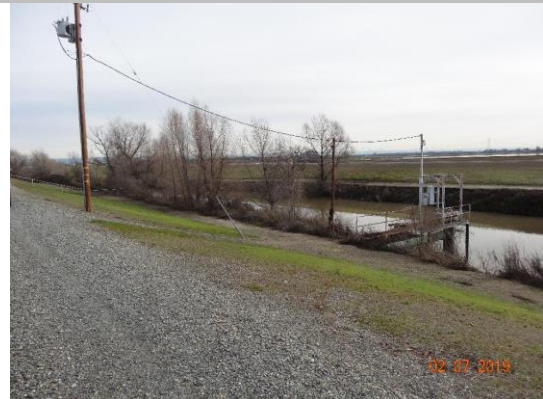
Photo 3 of 3 : UCIP\_SP\_2023\_60150\_78744.jpg

WS view: overview of WS looking upstream towards pipe.

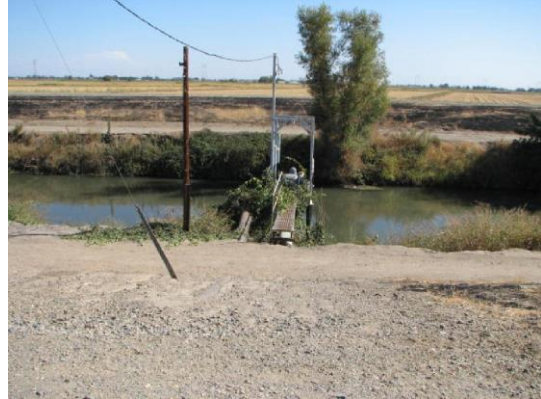
Photo 2 of 3 : UCIP\_SP\_2023\_60125\_64734.jpg

Pipe on left without pump.

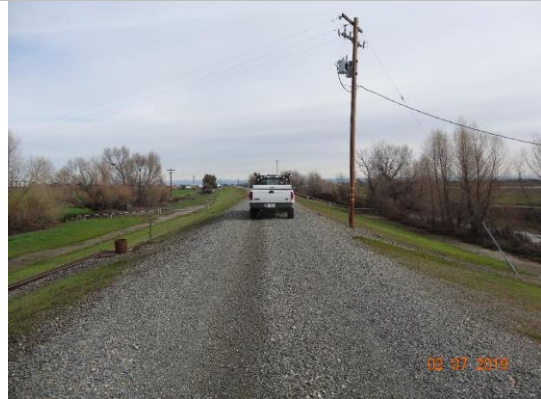
Photo 3 of 3 : UCIP\_SP\_2023\_60125\_78749.jpg

Overview of levee crown.

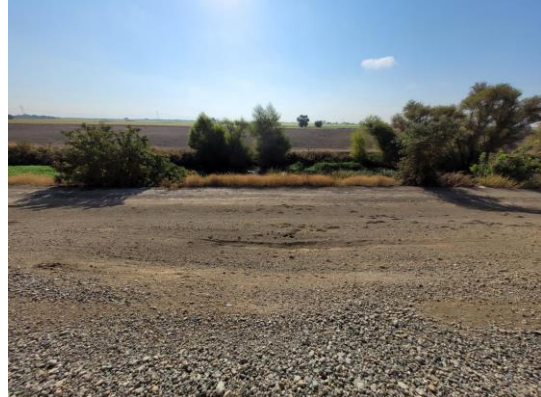
Photo 1 of 1 : SP\_2023\_ST0010\_43\_28\_20230509\_00007.jpg

View of a depression in the waterside slope. Fall 2022.

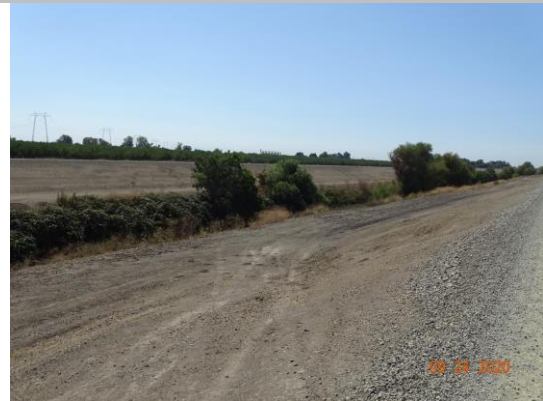
Photo 1 of 1 : SP\_2023\_ST0010\_43\_21\_20230509\_00003.jpg

View of the ramp encroaching into the levee. Fall 2020.

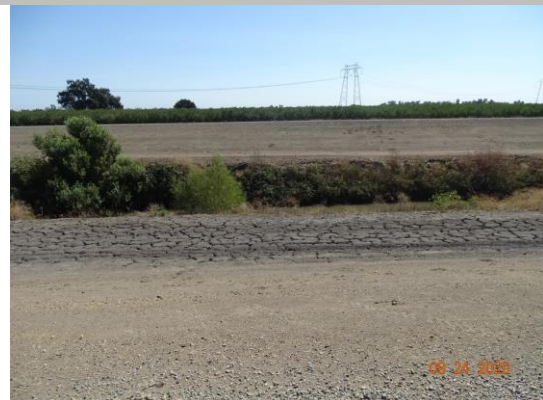
Photo 1 of 1 : SP\_2023\_ST0010\_43\_22\_20230509\_00004.jpg

View of the cracking along the waterside toe. Fall 2020.

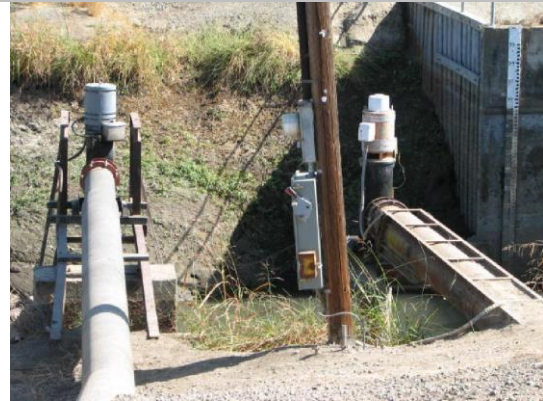
Photo 1 of 3 : UCIP\_SP\_2023\_60131\_64761.jpg

Pump on steel pier at WS toe.

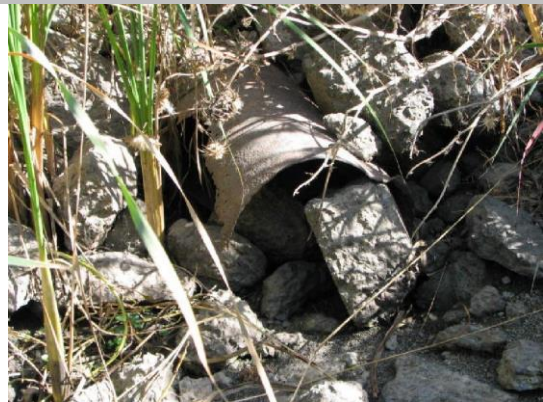
Photo 2 of 3 : UCIP\_SP\_2023\_60131\_64760.jpg

Rusted outlet at LS channel. Unclear if this is same pipe as one under investigation.

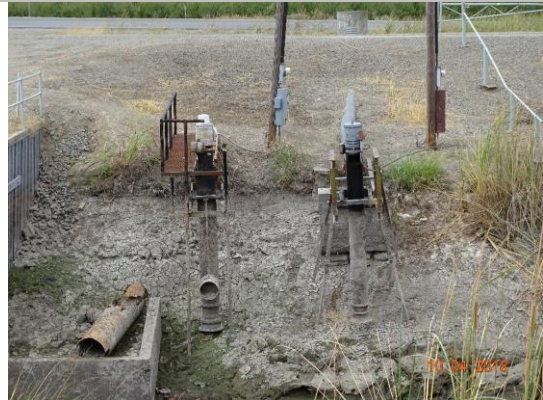
Photo 3 of 3 : UCIP\_SP\_2023\_60131\_78288.jpg

Overview photo of crossings from opposite bank. Pipe to left is associated with dsid 17078 and pipe to right is dsid 17081.

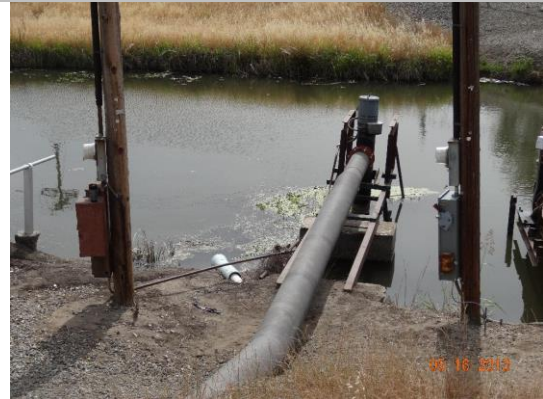
Photo 1 of 3 : UCIP\_SP\_2023\_60133\_64764.jpg

Pump station in channel on WS

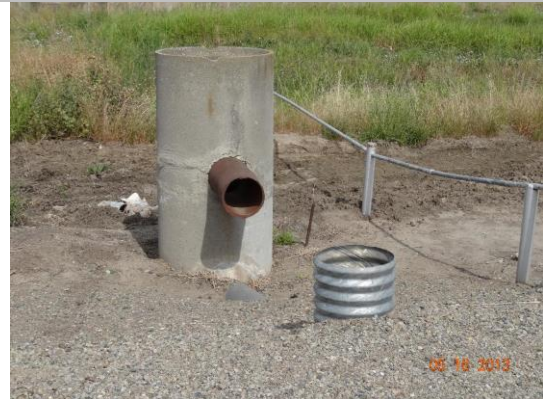
Photo 2 of 3 : UCIP\_SP\_2023\_60133\_64763.jpg

36in. concrete standpipe and 12in. cm riser on LS.

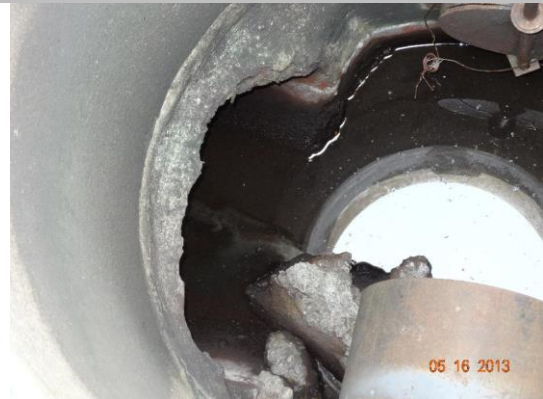
Photo 3 of 3 : UCIP\_SP\_2023\_60133\_64767.jpg

Approx 24in. diameter concrete pipe tees from bottom of standpipe and heads south towards Southbutte road to unknow location.

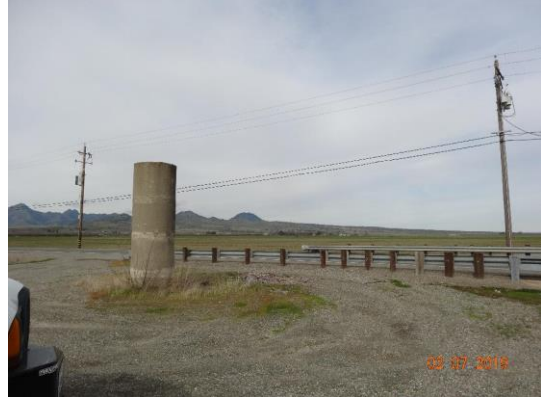
Photo 2 of 3 : UCIP\_SP\_2023\_60136\_78805.jpg

WS view: aerial power lines present but no markers of communication line, photo 1 of 2.

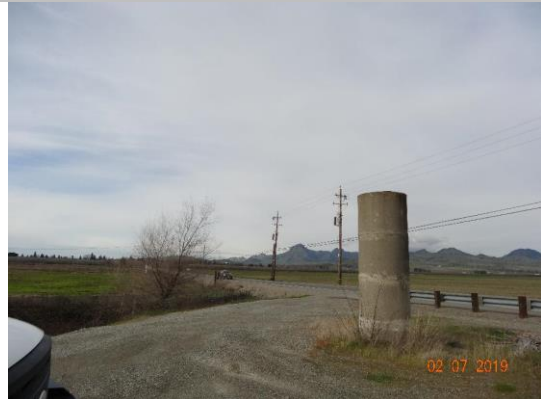
Photo 3 of 3 : UCIP\_SP\_2023\_60136\_78806.jpg

WS view: aerial power lines present but no markers of communication line, photo 2 of 2.
