Flood Control Project Maintenance
Levee Inspections
LMA District Cover Sheet

Sutter Maintenance Yard Wadsworth Canal

Levee Inspection Report By Mile - Spring 2024

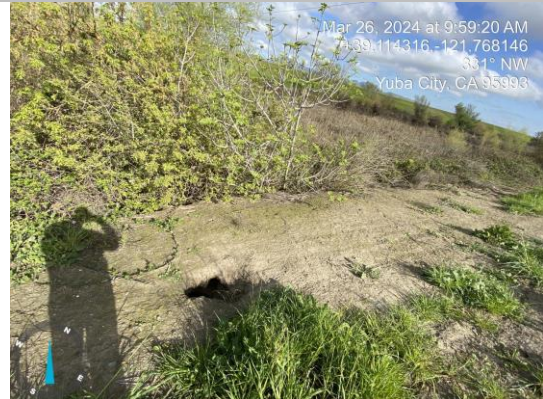
Photo 1 of 1 : SP_2024_ST0010_42_24_20240402_00021.jpg

View of animal burrow along the waterside toe road (Spring 2024).

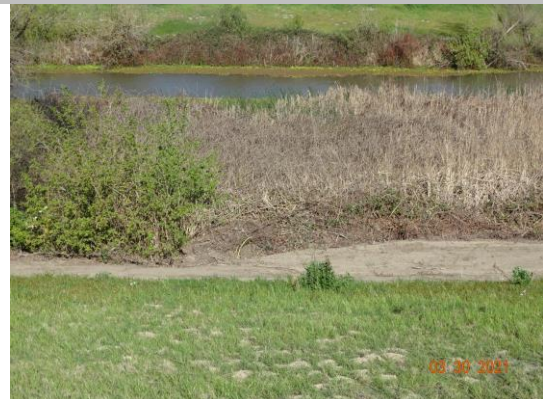
Photo 1 of 1 : SP_2024_ST0010_42_20_20240308_00004.jpg

LM Start	0.06	Rating **	A/W	Issue No.	20
LM End	0.19	Issue Type +	Ma	Location *	WS
Category	Earthen Levee			GPS Latitude/Longitude	
				Start	End
Item	Erosion / Bank Caving			39.114203°	39.115719°
				-121.768015°	-121.766517°
DWR ID	DWR_ST0010_01_f_2016_20				
Comment Code					
E1 : Note and monitor erosion site.					
Inspector Comment

View of the erosion along the waterside toe. Spring 2021.

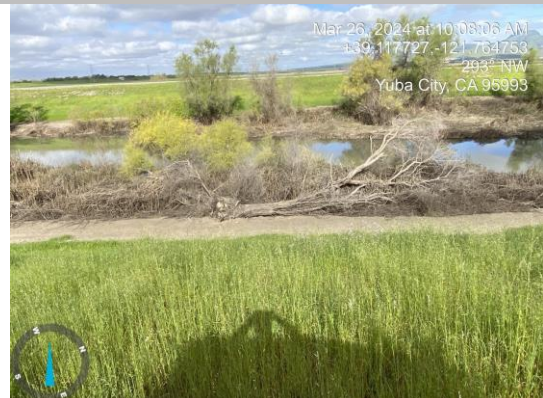
Photo 1 of 1 : SP_2024_ST0010_42_9_20240402_00022.jpg

LM Start	0.36	Rating **	M	Issue No.	9
LM End	0.36	Issue Type +	Ma	Location *	WS
Category	Earthen Levee			GPS Latitude/Longitude	
				Start	End
Item	Trim / Thin Trees			39.117622°	39.117622°
				-121.764763°	-121.764763°
DWR ID	DWR_ST0010_01_s_2024_9				
Comment Code					
T3 : Fallen tree with root ball.					
Inspector Comment					
Fallen tree with exposed root ball on the waterside toe road may lead to future erosion.

View of fallen tree with exposed root ball on the waterside toe road (Spring 2024).

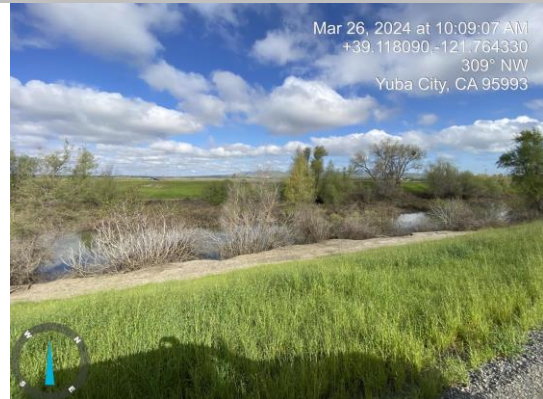
Photo 1 of 1 : SP_2024_ST0010_42_19_20240402_00023.jpg

View of the erosion along the waterside toe road (Spring 2024).

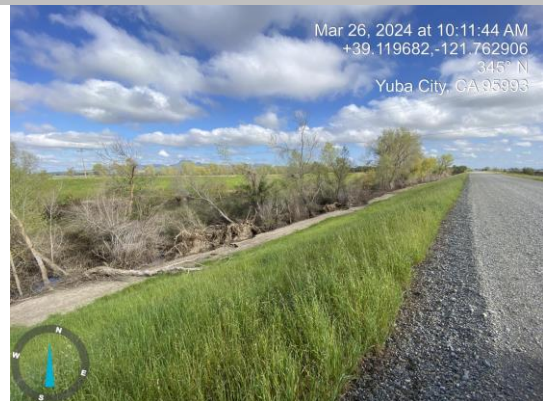
Photo 1 of 1 : SP_2024_ST0010_42_13_20240402_00024.jpg

LM Start	0.53	Rating **	M	Issue No.	13
LM End	0.56	Issue Type +	Ma	Location *	WS
Category	Earthen Levee			GPS Latitude/Longitude	
				Start	End
Item	Trim / Thin Trees			39.119634°	39.120052°
				-121.762851°	-121.762469°
DWR ID	DWR_ST0010_01_s_2024_13				
Comment Code					
T3 : Fallen tree with root ball.					
Inspector Comment					
Fallen trees along the waterside toe road have damaged the waterside toe road and may lead to future erosion.

View of fallen trees and erosion along the waterside toe road (Spring 2024).

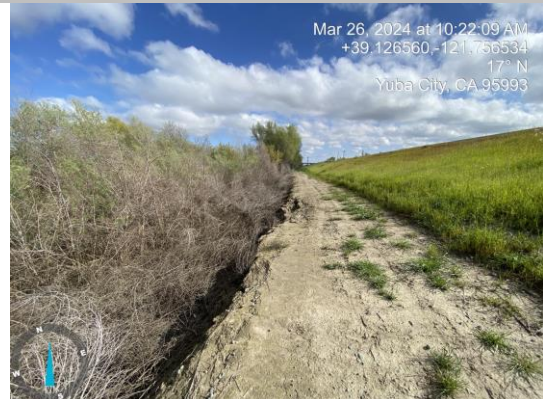
Photo 1 of 1 : SP_2024_ST0010_42_15_20240402_00026.jpg

LM Start	1.10	Rating **	M	Issue No.	15
LM End	1.13	Issue Type +	Ma	Location *	WS
Category	Earthen Levee			GPS Latitude/Longitude	
				Start	End
Item	Erosion / Bank Caving			39.126265°	39.126657°
				-121.756561°	-121.756178°
DWR ID	DWR_ST0010_01_s_2024_15				
Comment Code					
E2 : Schedule repair of erosion site prior to the next inspection.					
Inspector Comment					
There is erosion along the waterside toe road.

View of erosion along the waterside toe road (Spring 2024).

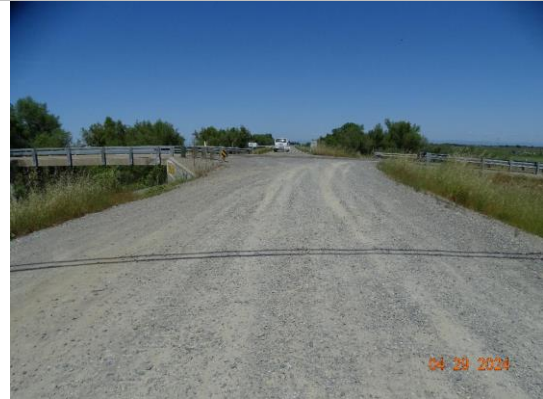
Photo 1 of 3 : UCIP_SP_2024_83609_122534.jpg

DS_ID:17060
FS_ID:83609
EP_NO: 13362
Repair Type: Non-Urgent
EVAL Issue: 10, Unauthorized Modification or Non-Compliant Permit Crossing Status: Indicator Found
UCIP Comments: 04/29/2024 Record remains Non-Urgent. Unable to determine if old conduit was abandoned through the levee or if it was modified to become an aerial crossing now. Communication pedestal boxes located near toe is indicative that the 4-inch steel conduit is still present within the levee. (M. Thao - DWR UCIP)
02/07/2019 Record has been updated from No Action Needed to Non-Urgent, unable to determine whether the old authorized conduit line was abandoned through the levee. The conduit appears to be modified to an aerial conduit. Need to contact owner to determine status of authorized line and determine permit issued for modification of the aerial line at the same location. (O. Magana - DWR UCIP)04/11/2017 Aerial lines. (A. Freitag - DWR Sutter Yard)10/12/2016 Crossing appears to be in good condition. (A. Freitag - DWR Sutter Yard)04/19/2016 Crossing appears to be in good condition. (A. Freitag - DWR Sutter Yard)05/12/2015 Crossing appears in good condition. No noticeable issues to report. (A. Freitag - DWR Sutter Yard)11/18/2014 Same as last inspection. (A. Freitag - DWR Sutter Yard)05/13/2014 Same as last inspection. (A. Freitag - DWR Sutter Yard)10/29/2013 Same as last inspection. (A. Freitag - DWR Sutter Yard)05/16/2013 Same as last inspection. (A. Freitag - DWR Sutter Yard)10/09/2012 No pipe on downstream side of bridge. It is likely that this com line is now an aerial. See photos. (W. Wylie - DWR UCIP)

Levee crown looking upstream.

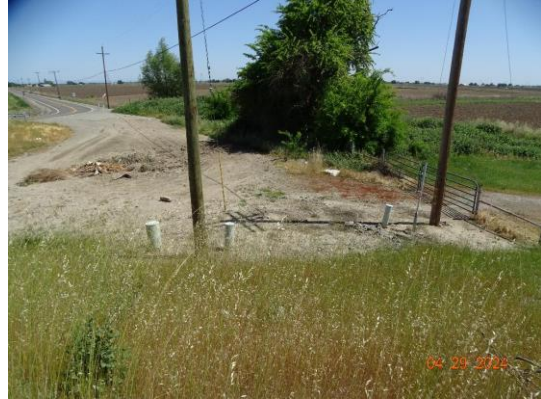
Photo 2 of 3 : UCIP_SP_2024_83609_122535.jpg

LS view: Utility poles and communication pedestal boxes located near toe.

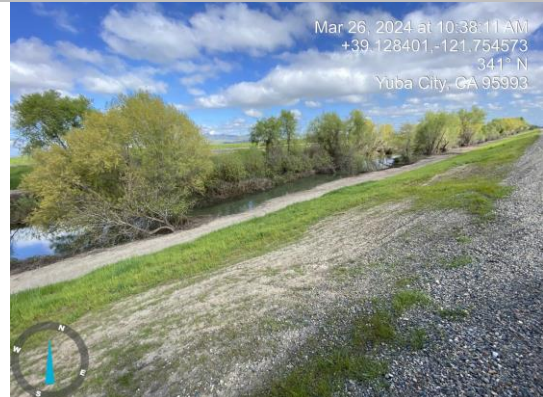
Photo 1 of 1 : SP_2024_ST0010_42_22_20240402_00027.jpg

LM Start	1.27	Rating **	M	Issue No.	22
LM End	1.31	Issue Type +	Ma	Location *	WS
Category	Earthen Levee			GPS Latitude/Longitude	
				Start	End
Item	Erosion / Bank Caving			39.128319°	39.128730°
				-121.754581°	-121.754187°
DWR ID	DWR_ST0010_01_s _ 2024_22				
Comment Code					
E2 : Schedule repair of erosion site prior to the next inspection.					
Inspector Comment					
There is erosion along the waterside toe road.

View of erosion along the waterside toe road (Spring 2024).

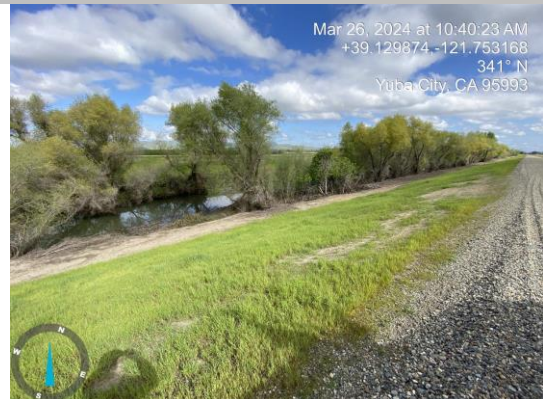
Photo 1 of 1 : SP_2024_ST0010_42_23_20240402_00028.jpg

LM Start	1.40	Rating **	M	Issue No.	23
LM End	1.42	Issue Type +	Ma	Location *	WS
Category	Earthen Levee			GPS Latitude/Longitude	
				Start	End
Item	Erosion / Bank Caving			39.129831°	39.130027°
				-121.753145°	-121.752950°
DWR ID	DWR_ST0010_01_s _ 2024_23				
Comment Code					
E2 : Schedule repair of erosion site prior to the next inspection.					
Inspector Comment					
There is erosion along the waterside toe road.

View of erosion along the waterside toe road (Spring 2024).

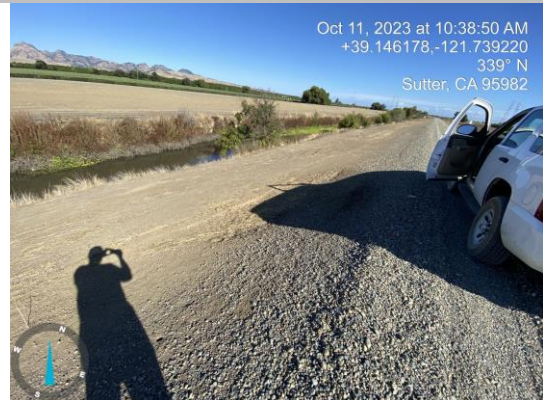
Photo 1 of 1 : SP_2024_ST0010_42_8_20240308_00001.jpg

LM Start	2.76	Rating **	M	Issue No.	8
LM End	2.76	Issue Type +	Ma	Location *	WS
Category	Earthen Levee			GPS Latitude/Longitude	
				Start	End
Item	Slope Stability			39.146163°	39.146163°
				-121.739181°	-121.739181°
DWR ID	DWR_ST0010_01_f _ 2023_8				
Comment Code					
S1 : Repair slope instability.					
Inspector Comment

View of indentation along the waterside slope (Fall 2023).

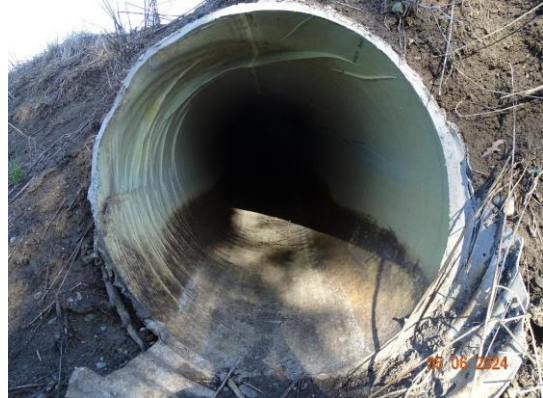
Photo 3 of 3 : UCIP_SP_2024_83620_122558.jpg

DS_ID:17065
FS_ID:83620
EP_NO: 7209
Repair Type: No Action Needed
EVAL Issue:
Crossing Status: Found
UCIP Comments: 05/06/2024 Record remains No Action Needed. Pipe was CIPP lined. DMP internal video inspection has found none or minor pipe defects. No issues observed during inspection. (M. Thao - DWR UCIP)
09/25/2023 DMP internal video inspection has found none or minor pipe defects. Recommend next video inspection in 5 years. (J. Taylor - DWR UCIP)01/06/2022 LoF of crossing is 5.2 due to pin size holes less than 10 feet from pipe end. Crossing remains Non-Urgent because pipe damage located outside of levee prism and does not pose a threat to levee. (O. Yakimov - DWR UCIP) 02/07/2019 Record remains Non-Urgent due to of few maintenance issues observed during inspection. Pipe is being used as a shooting target. Multiple holes are visible on the exposed WS section of the pipe. The inlet pipe section located on the LS has been damaged (pipe wall section pulled). This pipe qualifies as an LMA responsible crossing as it was originally listed in the USACE O&M manual as a drainage pipe. The CVFPB issued a permit in 1970 for the replacement of the original USACE drainage pipe. (O. Magana - DWR UCIP)04/10/2017 WS pipe end is in good condition. LS pipe end is still deformed and vegetated. (A. Freitag - DWR Sutter Yard)10/12/2016 LS inlet is still deformed and being overgrown by vegetation. (A. Freitag - DWR Sutter Yard)04/19/2016 Crossing appears to be in good condition. (A. Freitag - DWR Sutter Yard)05/12/2015 LS inlet still deformed a little but does not affect the crossing function. (A. Freitag - DWR Sutter Yard)11/18/2014 Same as last inspection. (A. Freitag - DWR Sutter Yard)05/13/2014 Same as last inspection. (A. Freitag - DWR Sutter Yard)10/29/2013 Same as last inspection. (A. Freitag - DWR Sutter Yard)05/16/2013 Pipe intake on LS appears to be bent and damaged but that does not appear to be affecting water flow or channel bank. (A. Freitag - DWR Sutter Yard)

LS view: Looking into pipe inlet located at the toe; pipe has been CIPP lined.

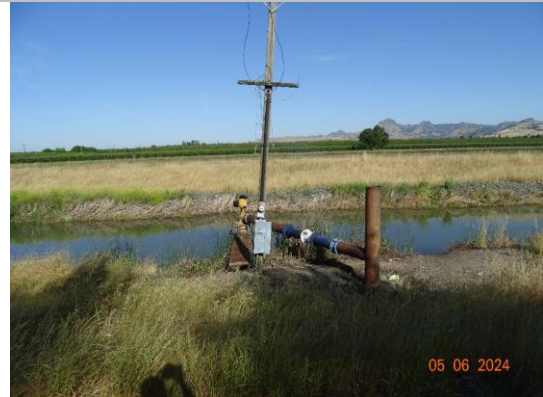
Photo 1 of 2 : UCIP_SP_2024_83622_122569.jpg

DS_ID:17066
FS_ID:83622
EP_NO: N/A
Repair Type: Non-Urgent
EVAL Issue: 10, Unauthorized Modification or Non-Compliant Permit
Crossing Status: Found
UCIP Comments: 05/06/2024 Record remains Non-Urgent. 14-inch steel pipe on the WS instead of a 24-inch pipe as referenced in the O&M Manual; unable to find a permit for modification. Crossing appears abandoned and no longer be in use due to the debris and growing tree that have completely covered the outlet pipe at the LS headwall. No permit has been identified authorizing pipe. (M. Thao - DWR UCIP) 02/07/2019 Record remains Non-Urgent, this crossing has been modified. Also, unable to determine if the 24-inch pipe referenced in the levee logs still exists through the levee. There is a 14-inch steel pipe on the WS, a 16-inch steel riser on the WS, and a 16-inch PVC pipe located on the LS. No permit was found authorizing the modifications at this location. The 4-foot by 6-foot concrete distribution box has been removed from the WS. Some settling (minor depression) is present where the distribution box might have been previously located. Need to contact owner to determine CVFPB permit issued for the modifications at this location. (O. Magana - DWR UCIP)01/28/2019 USACE O&M dwg shows 12-inch and 24-inch on LS. (O. Magana - DWR UCIP)04/10/2017 LS heavily vegetated but nothing appears to have changed with the crossing. LS headwall still silted in and pipe discharges directly into the rice field. (A. Freitag - DWR Sutter Yard)10/12/2016 Crossing appears to be in good condition. (A. Freitag - DWR Sutter Yard)04/19/2016 Crossing has not changed since the last inspection. LS headwall is silted in and not being used. LS pipe end discharges into the rice field. (A. Freitag - DWR Sutter Yard)05/12/2015 Concrete headwall on LS is completely silted in. LS pipe end is located near the edge of rice field. No issues seen on WS. (A. Freitag - DWR Sutter Yard)11/18/2014 Same as last inspection. (A. Freitag - DWR Sutter Yard)05/13/2014 Same as last inspection. (A. Freitag - DWR Sutter Yard)10/29/2013 Concrete headwall is silted in and appears to be abandoned. Discharge end of pipe is approx. 100ft. from LS toe on the edge of the rice field. (A. Freitag - DWR Sutter Yard)05/16/2013 Same as last inspection. (A. Freitag - DWR Sutter Yard)

WS view: 14-inch intake pipe, pump, utility pole, and meter; looking from crown.

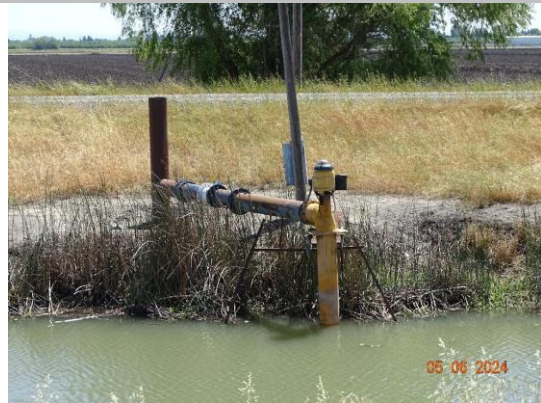
Photo 2 of 2 : UCIP_SP_2024_83622_122567.jpg

WS view: 14-inch intake pipe and pump looking from across channel.

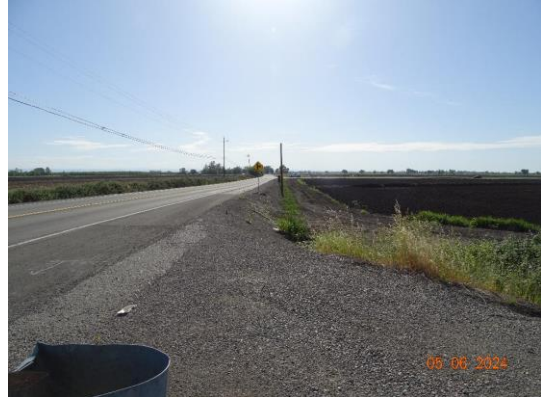
Photo 2 of 3 : UCIP_SP_2024_83668_122719.jpg

Comment Code						
Inspector Comment						
DS_ID:17067 FS_ID:83668 EP_NO: 4680 Repair Type: Non-Urgent EVAL Issue: 10, Unauthorized Modification or Non-Compliant Permit Crossing Status: Indicator Found UCIP Comments: 05/06/2024 Record remains Non-Urgent. No indication of buried conduit crossing levee; however, utility pole with electric box located approximately 225 feet from levee centerline. Buried line may have been modified to an aerial crossing located on the north side of Butte House Road. (M. Thao - DWR UCIP) 02/07/2019 Record has been updated from No Action Needed to Non-Urgent, buried line appears to have been changed to an aerial line. No signs were present of the buried conduit instead there appears to be an aerial line at this location now. Need to coordinate with owner to determine if 4-inch conduit was properly abandoned or removed per Title 23. If modifications were not approved by the CVFPB, owner will need to coordinate with the CVFPB to comply with Title 23 requirements. (O. Magana - DWR UCIP)04/10/2017 Aerial lines. (A. Freitag - DWR Sutter Yard)10/12/2016 Crossing appears to be in good condition. (A. Freitag - DWR Sutter Yard)04/19/2016 Crossing appears to be in good condition. (A. Freitag - DWR Sutter Yard)05/12/2015 Crossing appears in good condition. No noticeable issues to report. (A. Freitag - DWR Sutter Yard)11/18/2014 Same as last inspection. (A. Freitag - DWR Sutter Yard)05/13/2014 Same as last inspection. (A. Freitag - DWR Sutter Yard)10/29/2013 Same as last inspection. (A. Freitag - DWR Sutter Yard)05/16/2013 Same as last inspection. (A. Freitag - DWR Sutter Yard)10/09/2012 Communication line on Pole 400-feet west of canal. Likely now an aerial on North side of roadway. (W. Wylie - DWR UCIP) FIELD_STRUCT_DESC: 4-inch steel communication conduit (telephone cable inside) through the levee, 2.3 feet below the crown. Conduit line goes through Wadsworth Canal and its levees. Annular space between pipe and conduit grouted. Line is attached to south side of the Butte House Road bridge (no longer attached in 2012). (4-inch conduit authorized under Permit No. 4680, 1964 - Pacific Telephone and Telegraph Company [PT&T]). [Additional Reference(s): DWR Levee Log, 2005 (HLM 4.37, listed as 4-inch steel conduit)]. FS Date: 5/6/2024 2:15:06 PM

LS view: General overview looking from crown; utility pole with electric box located approximately 225 feet from levee centerline.

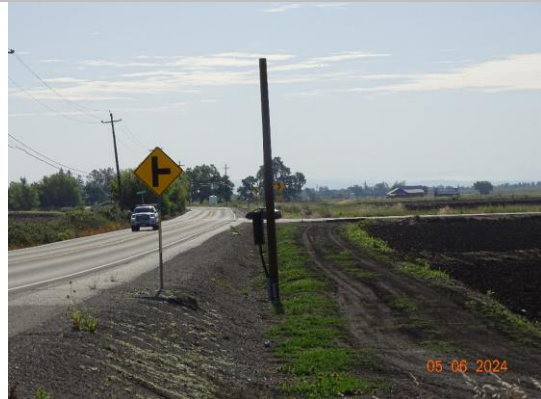
Photo 3 of 3 : UCIP_SP_2024_83668_122720.jpg

LS view: Close-up view of utility pole with electric box located approximately 225 feet from levee centerline.

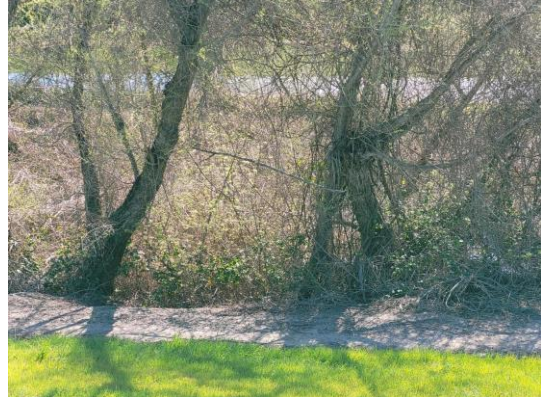
Photo 1 of 1 : SP_2024_ST0010_43_24_20240308_00005.jpg

LM Start	0.35	Rating **	M	Issue No.	24
LM End	0.35	Issue Type +	Ma	Location *	WS
Category	Earthen Levee			GPS Latitude/Longitude	
				Start	End
Item	Erosion / Bank Caving			39.118178°	39.118178°
				-121.765500°	-121.765500°
DWR ID	DWR_ST0010_02_s_2022_24				
Comment Code					
E2 : Schedule repair of erosion site prior to the next inspection.					
Inspector Comment					
Erosion is present at the toe of the levee. Erosion is cutting into the patrol road.

View of the erosion at the waterside toe/patrol road. Spring 2022.

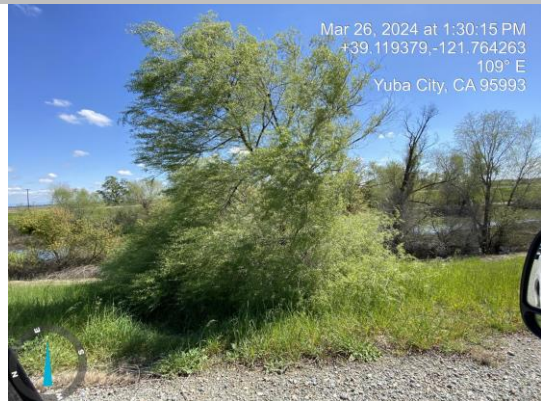
Photo 1 of 1 : SP_2024_ST0010_43_16_20240402_00031.jpg

View of tree limbs on waterside slope (Spring 2024).

LM Start	0.45	Rating **	U	Issue No.	16
LM End	0.45	Issue Type +	Ma	Location *	WS
Category	Earthen Levee			GPS Latitude/Longitude	
				Start	End
Item	Trim / Thin Trees			39.119381°	39.119381°
				-121.764372°	-121.764372°
DWR ID	DWR_ST0010_02_s_2024_16				
Comment Code					
T1 : Trim and thin trees to at least five feet above ground level to allow visibility of the ground and room to flood fight.					
Inspector Comment					
Remove tree off the waterside slope and toe road.

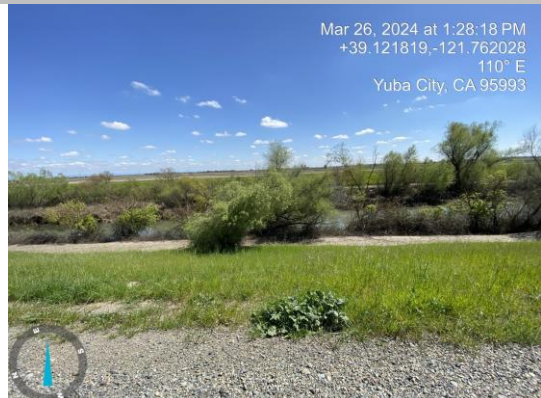
Photo 1 of 1 : SP_2024_ST0010_43_15_20240402_00032.jpg

View of tree limbs on waterside slope and toe road (Spring 2024).

LM Start	0.66	Rating **	M	Issue No.	15
LM End	0.66	Issue Type +	Ma	Location *	WS
Category	Earthen Levee			GPS Latitude/Longitude	
				Start	End
Item	Trim / Thin Trees			39.121813°	39.121813°
				-121.762018°	-121.762018°
DWR ID	DWR_ST0010_02_s_2024_15				
Comment Code					
T1 : Trim and thin trees to at least five feet above ground level to allow visibility of the ground and room to flood fight.					
Inspector Comment					
Trim tree off the waterside slope and toe road.

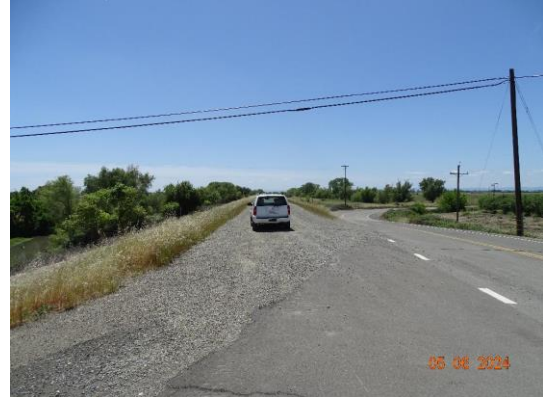
Photo 1 of 3 : UCIP_SP_2024_83686_122775.jpg

Comment Code						
Inspector Comment						
DS_ID:17071 FS_ID:83686 EP_NO: 13362 Repair Type: Non-Urgent EVAL Issue: 10, Unauthorized Modification or Non-Compliant Permit Crossing Status: Indicator Found UCIP Comments: 04/29/2024 Record remains Non-Urgent. No indication of buried communication conduit. Unable to determine if conduit was abandoned through the levee or if it was modified to become an aerial crossing now. Two aerial lines cross over levee and attach to a wooden utility pole on the LS. (M. Thao - DWR UCIP) 02/07/2019 Record has been updated from No Action Need to Non-Urgent evaluation. Unable to find evidence of conduit through the levee. Need to contact owner to obtain permit authorizing the removal or abandonment of conduit through the levee. Unable to confirm if the buried conduit was replaced by new aerial line within this section of the levee. Need to contact owner to obtain permit authorizing the modifications of the permit associated with the communication line. (O. Magana - DWR UCIP)04/10/2017 Aerial lines. (A. Freitag - DWR Sutter Yard)10/12/2016 Crossing appears to be in good condition. (A. Freitag - DWR Sutter Yard)04/19/2016 Crossing appears to be in good condition. (A. Freitag - DWR Sutter Yard)05/12/2015 Crossing now appears to be the aerial line. No noticeable issues to report. (A. Freitag - DWR Sutter Yard)11/18/2014 Same as last inspection. (A. Freitag - DWR Sutter Yard)05/13/2014 Same as last inspection. (A. Freitag - DWR Sutter Yard)10/29/2013 Same as last inspection. (A. Freitag - DWR Sutter Yard)05/16/2013 Same as last inspection. (A. Freitag - DWR Sutter Yard) FIELD_STRUCT_DESC: 4-inch steel communication conduit with multiple telephone cables inside through the levee, 2.6 feet below the crown. Telephone cables installed inside existing 4-inch conduit. The conduit is no longer attached to the downstream side of the bridge. It is likely that this communication line is now an aerial. (Original 4-inch conduit was installed under Permit No. 6906, 1970 - Pacific Telephone and Telegraph Company [PT&T]. Telephone cables through existing conduit were authorized under Permit No. 13362, 1982 - PT&T). [Additional Reference(s): DWR Levee Log, 2005 (HLM 1.25)]. FS Date: 5/6/2024 4:01:28 PM

Levee crown looking downstream; aerial lines crossing over levee.

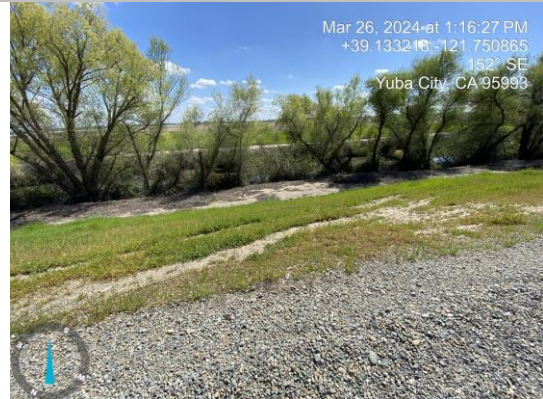
Photo 1 of 1 : SP_2024_ST0010_43_14_20240402_00033.jpg

View of vehicle erosion on the waterside slope (Spring 2024).

LM Start	1.65	Rating **	M	Issue No.	14
LM End	1.65	Issue Type +	Ma	Location *	WS
Category	Earthen Levee			GPS Latitude/Longitude	
				Start	End
Item	Erosion / Vehicle Traffic			39.133252°	39.133252°
				-121.750926°	-121.750926°
DWR ID	DWR_ST0010_02_s_2024_14				
Comment Code					
E6 : Repair the levee slope damaged by vehicle traffic and prevent access where possible.					
Inspector Comment

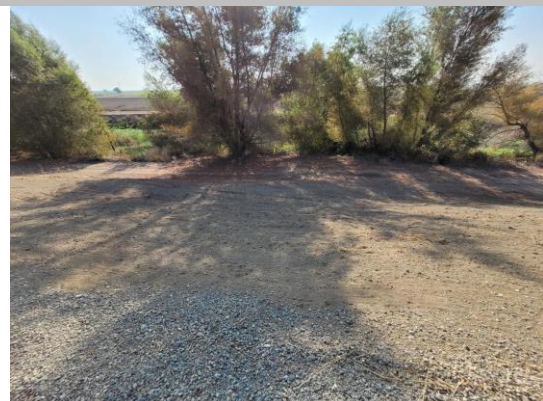
Photo 1 of 1 : SP_2024_ST0010_43_20_20240308_00002.jpg

LM Start	1.75	Rating **	M	Issue No.	20
LM End	1.75	Issue Type +	Ma	Location *	WS
Category	Earthen Levee			GPS Latitude/Longitude	
				Start	End
Item	Erosion / Vehicle Traffic			39.134378°	39.134378°
				-121.749803°	-121.749803°
DWR ID	DWR_ST0010_02_f_2016_20				
Comment Code					
E6 : Repair the levee slope damaged by vehicle traffic and prevent access where possible.					
Inspector Comment					
Vehicle traffic has caused what appears to be an unpermitted ramp to form on the waterside slope.

View of the slope erosion along the waterside slope. Fall 2022.

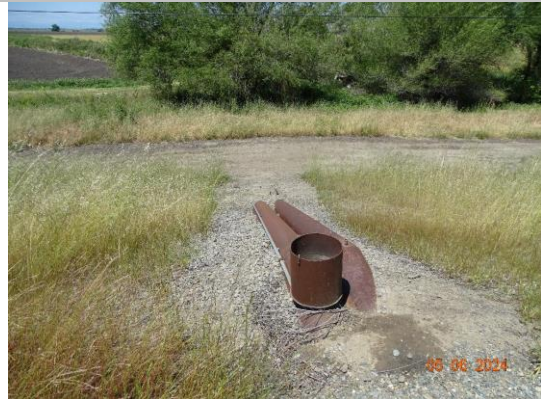
Photo 1 of 2 : UCIP_SP_2024_83690_122780.jpg

DS_ID:17074
FS_ID:83690
EP_NO: 1096
Repair Type: Non-Urgent
EVAL Issue: 10, Unauthorized Modification or Non-Compliant Permit
Crossing Status: Found
UCIP Comments: 05/06/2024 Record remains Non-Urgent. Crossing appears to be modified; concrete standpipe is no longer present on LS and pipe near pump on WS is 20-inch instead of 16-inch. Unable to find a permit for modification. LS shoulder is damp which is indicative of a leak; recommend repairing leak if there is one. (M. Thao - DWR UCIP) 02/07/2019 Record has been updated from No Action Needed to Non-Urgent issue. Modification were noted at this location without authorization. Concrete standpipe previously located on the LS is no longer present. Pipe on LS measures 16-inch and 20-inches on the WS near pump. Need to contact owner to determine permit authorizing modifications to this structure. (O. Magana - DWR UCIP)04/10/2017 Crossing appears to be in good condition. It measure to be 16" on LS and 20" on WS where visible near pump. (A. Freitag - DWR Sutter Yard)10/12/2016 Crossing appears to be in good condition. Minor rodent activity nearby. (A. Freitag - DWR Sutter Yard)04/19/2016 No signs of pipe leaks. Still some minor rodent activity under the pipe on LS slope. (A. Freitag - DWR Sutter Yard)05/12/2015 Rodent activity near pipe on LS. (A. Freitag - DWR Sutter Yard)11/18/2014 Levee inspection is aware of problem and repairs seem to have been made. Slope has also been rocked to prevent erosion. (A. Freitag - DWR Sutter Yard)05/13/2014 Air vent on LS shoulder leaks and is causing minor erosion to the LS slope. (A. Freitag - DWR Sutter Yard)10/29/2013 Same as last inspection. (A. Freitag - DWR Sutter Yard)05/16/2013 Same as last inspection. (A. Freitag - DWR Sutter Yard)10/09/2012 Heavy rodent activity on LS slope along pipe alignment. (W. Wylie - DWR UCIP)

LS view: Levee shoulder is damp; pipe on left is associated with this record.

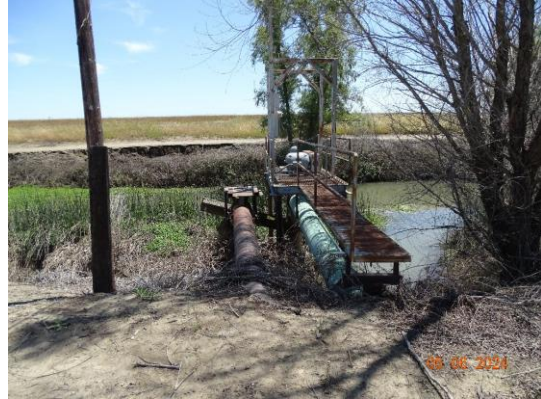
Photo 2 of 2 : UCIP_SP_2024_83690_122782.jpg

WS view: Pump on steel pile structure; pipe on right and appurtenances are associated with this record.

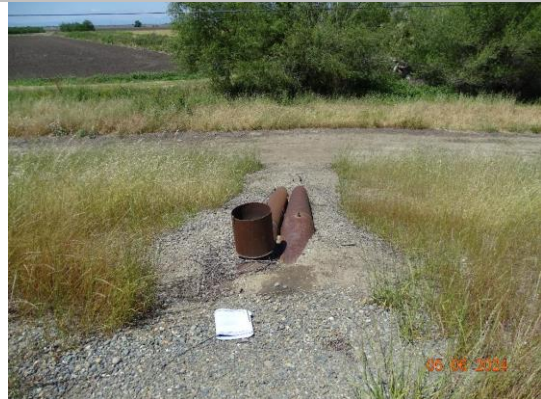
Photo 1 of 1 : UCIP_SP_2024_83696_122796.jpg

LS view: Levee shoulder is damp; pipe on right is associated with this record.

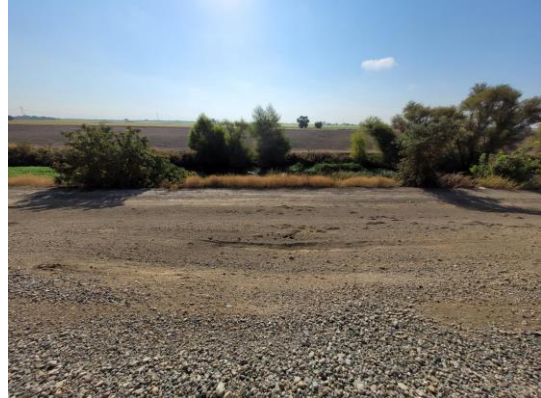
Photo 1 of 1 : SP_2024_ST0010_43_28_20240308_00006.jpg

View of a depression in the waterside slope. Fall 2022.

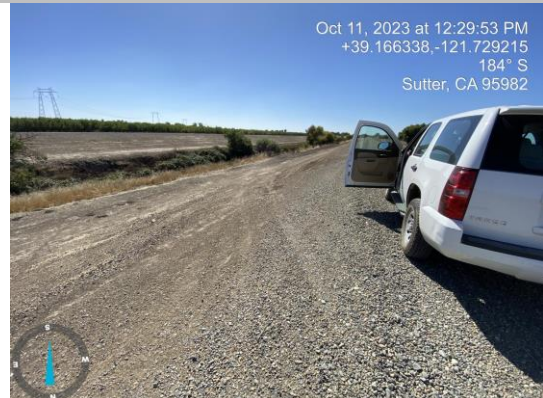
Photo 1 of 1 : SP_2024_ST0010_43_21_20240308_00003.jpg

View of the ramp encroaching into the levee (Fall 2023).

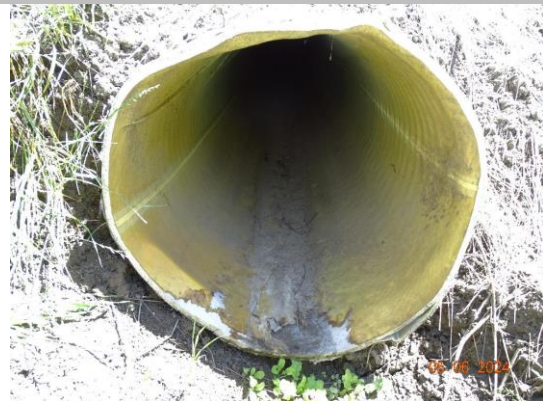
Photo 3 of 3 : UCIP_SP_2024_83700_122812.jpg

LS view: Looking into pipe inlet near toe.

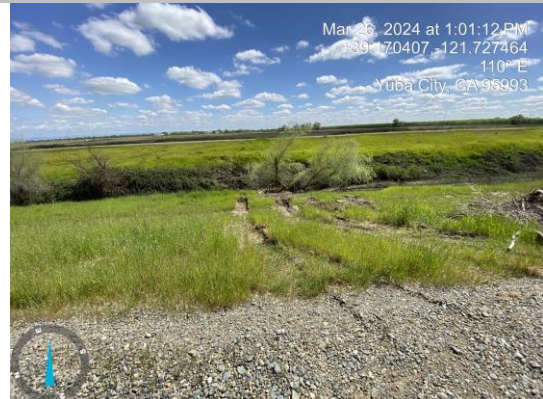
Photo 1 of 1 : SP_2024_ST0010_43_13_20240402_00034.jpg

View of vehicle ruts on the waterside slope (Spring 2024).

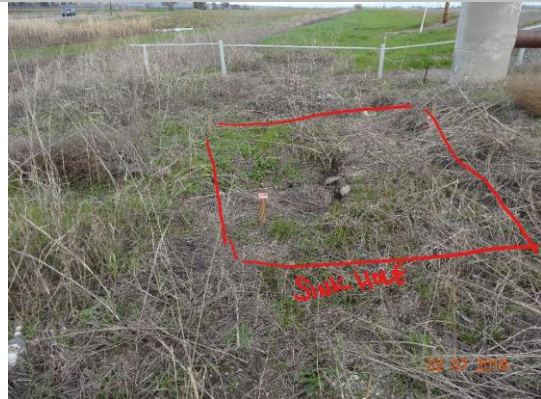
Photo 1 of 2 : UCIP_SP_2024_83715_78784.jpg

LS view: section LMA has sectioned off due to evidence of sink hole.

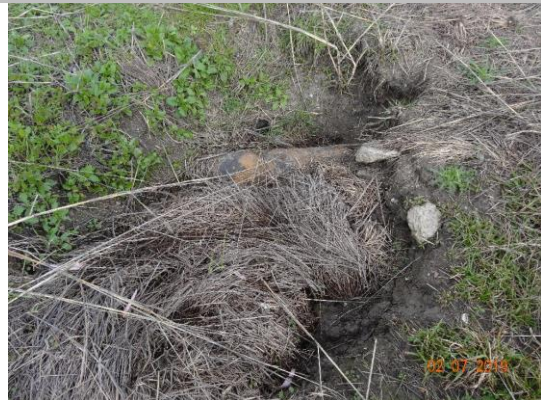
Photo 2 of 2 : UCIP_SP_2024_83715_78785.jpg

LS view: close up of exposed pipe section where sink hole is present.

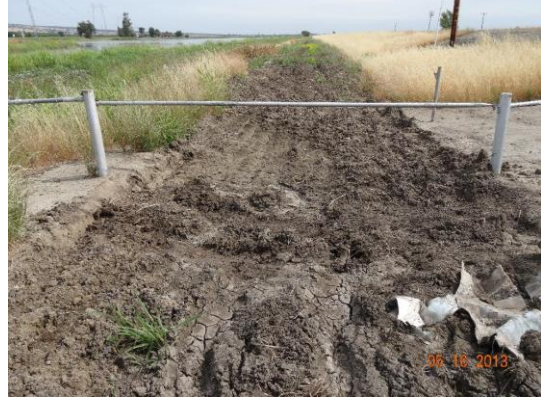
Photo 1 of 2 : UCIP_SP_2024_83716_64765.jpg

Wet spot on LS toe-road. Suspect seepage from concrete standpipe.

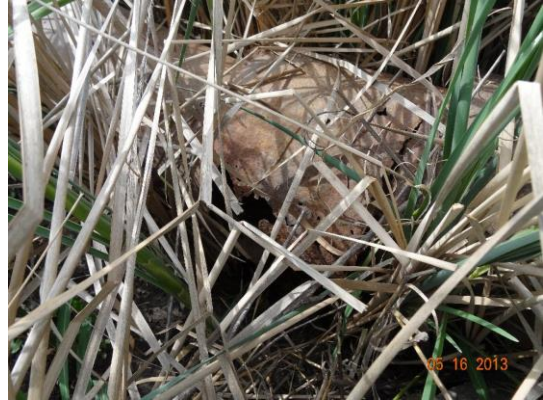
Photo 2 of 2 : UCIP_SP_2024_83716_64769.jpg

Hole rusted through 12in. pipe on west side of LS channel. Pipe has split into two pieces and is no longer continuous.

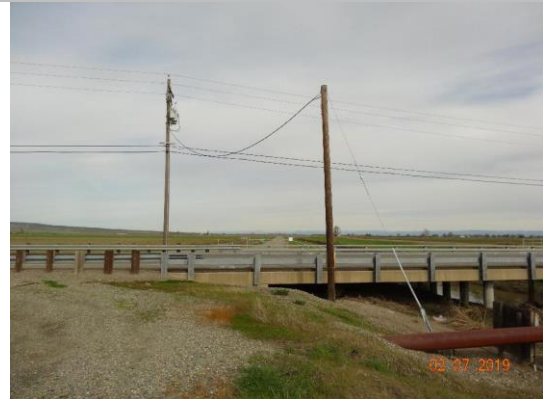
Photo 1 of 1 : UCIP_SP_2024_83724_78804.jpg

WS view: no conduit is attached to bridge.
