**Flood Control Project Maintenance
Levee Inspections**

Maintenance Issue Types Only, Levee Inspection Report By Mile - Fall 2014

Sutter Maintenance Yard Wadsworth Canal

Waterway	Bank	Unit Miles	Inspection Start/End	Inspector
Unit No. 01 Wadsworth Canal	Left	4.63	11/13/2014 11/13/2014	Bob Duffey

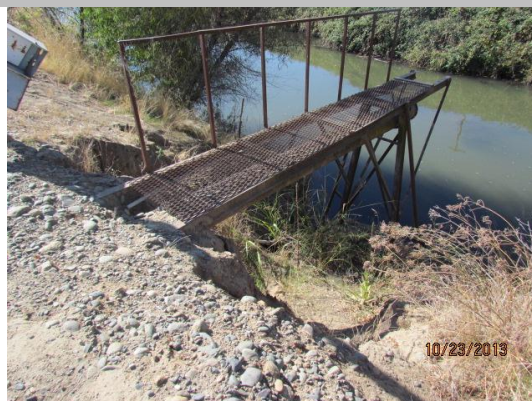
Photo 1 of 1 : FA_2014_ST0010_42_107_20141013_00006.jpg

LM Start	1.85	Rating **	M	Issue No.	107
LM End	1.85	Issue Type +	Ma	Location *	WS
Category	Earthen Levee			GPS Latitude/Longitude	
				Start	End
Item	Erosion / Bank Caving			39.135110 °	39.135110 °
				-121.748230 °	-121.748230 °
DWR ID	DWR_ST0010_01_f_2013_107				
Action/Comments					
Note and monitor erosion site.

View of the erosion along both sides of the abandoned pump.

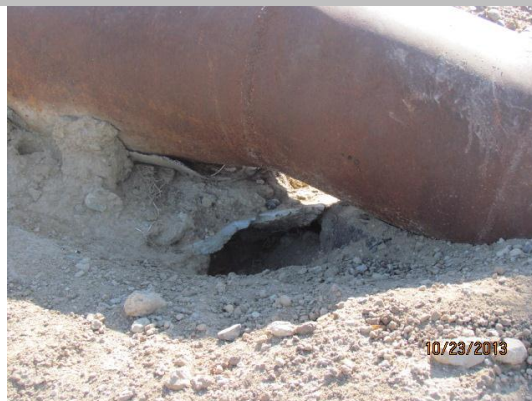
Photo 1 of 1 : FA_2014_ST0010_42_106_20141013_00005.jpg

LM Start	1.85	Rating **	M	Issue No.	106
LM End	1.85	Issue Type +	Ma	Location *	WS
Category	Earthen Levee			GPS Latitude/Longitude	
				Start	End
Item	Animal Control			39.135110 °	39.135110 °
				-121.748229 °	-121.748229 °
DWR ID	DWR_ST0010_01_f_2013_106				
Action/Comments					
No rodents visible, but rodent burrows visible; need to backfill and compact or grout burrows.

View of the rodent holes under the irrigation pipe.

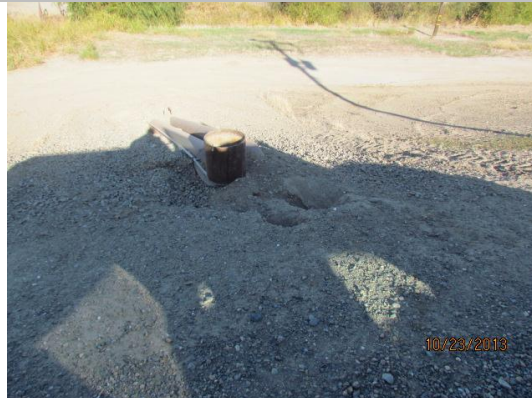
Photo 1 of 1 : FA_2014_ST0010_43_11_20141013_00006.jpg

LM Start	1.77	Rating **	M	Issue No.	11
LM End	1.77	Issue Type +	Ma	Location *	LS
Category	Earthen Levee			GPS Latitude/Longitude	
				Start	End
Item	Animal Control			39.134490 °	39.134490 °
				-121.749716 °	-121.749716 °
DWR ID	DWR_ST0010_02_f_2012_11				
Action/Comments					
No rodents visible, but rodent burrows visible; need to backfill and compact or grout burrows.

View of the rodent holes above the irrigation pipe.

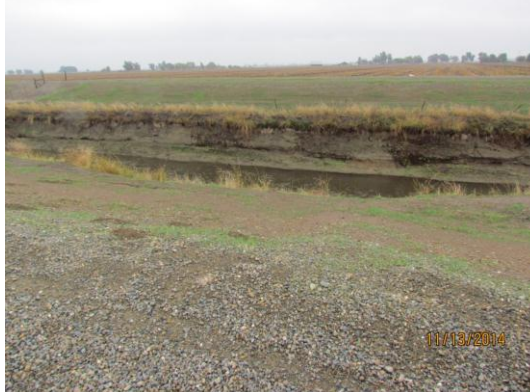
Photo 1 of 1 : FA_2014_ST0010_43_6_20141113_00013.jpg

LM Start	4.49	Rating **	M	Issue No.	6
LM End	4.49	Issue Type +	Ma	Location *	WS
Category	Earthen Levee			GPS Latitude/Longitude	
				Start	End
Item	Erosion / Bank Caving			39.168848 °	39.168848 °
				-121.728130 °	-121.728130 °
DWR ID	DWR_ST0010_02_s _ 2012_6				
Action/Comments					
Note and monitor erosion site.

View of the erosion along the waterside toe.

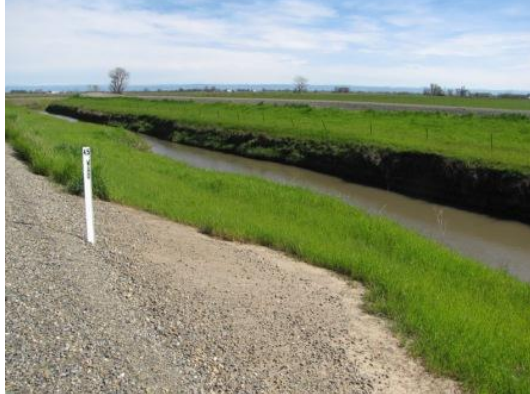
Photo 1 of 1 : FA_2014_ST0010_43_7_20141013_00005.jpg

LM Start	4.55	Rating **	A/W	Issue No.	7
LM End	4.55	Issue Type +	Ma	Location *	WS
Category	Earthen Levee			GPS Latitude/Longitude	
				Start	End
Item	Erosion / Bank Caving			39.169670 °	39.169670 °
				-121.727787 °	-121.727787 °
DWR ID	DWR_ST0010_02_s_2012_7				
Action/Comments					
Note and monitor erosion site.

View of the erosion along the W/S toe.
