**Flood Control Project Maintenance
Levee Inspections**

Maintenance Issue Types Only, Levee Inspection Report By Mile - Fall 2015

Sutter Maintenance Yard Wadsworth Canal

Waterway	Bank	Unit Miles	Inspection Start/End	Inspector
Unit No. 01 Wadsworth Canal	Left	4.63	11/04/2015 11/04/2015	Bob Duffey

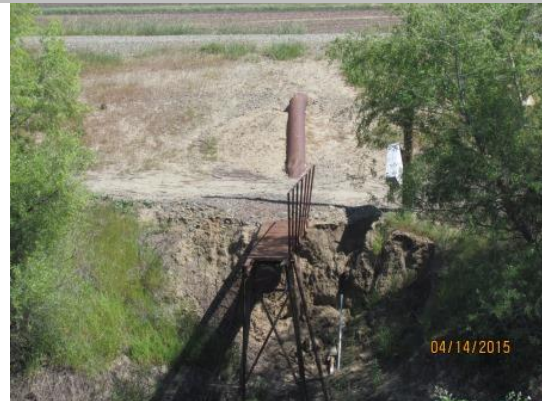
Photo 1 of 2 : FA_2015_ST0010_42_107_20150910_00008.jpg

LM Start	1.85	Rating **	U	Issue No.	107
LM End	1.85	Issue Type +	Ma	Location *	WS
Category	Earthen Levee			GPS Latitude/Longitude	
				Start	End
Item	Erosion / Bank Caving			39.135110 °	39.135110 °
				-121.748230 °	-121.748230 °
DWR ID	DWR_ST0010_01_f_2013_107				
Action/Comments					
Schedule repair of erosion site prior to the next inspection.					
Inspector Comments: Repair the erosion under the abandoned pump.

View of the erosion along both sides of the abandoned pump.

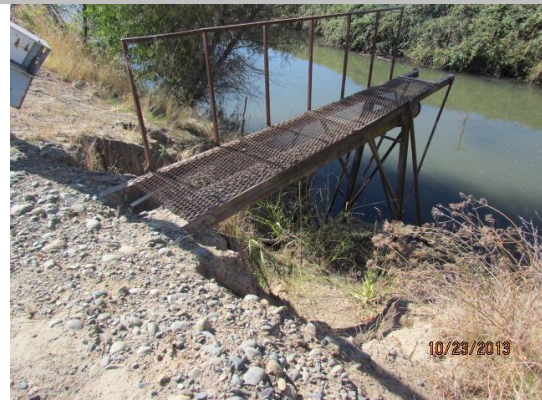
Photo 2 of 2 : FA_2015_ST0010_42_107_20150910_00009.jpg

View of the erosion along both sides of the abandoned pump.

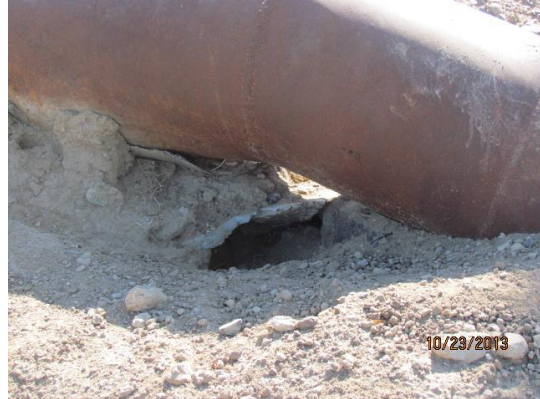
Photo 1 of 1 : FA_2015_ST0010_42_106_20150910_00007.jpg

LM Start	1.85	Rating **	M	Issue No.	106
LM End	1.85	Issue Type +	Ma	Location *	WS
Category	Earthen Levee			GPS Latitude/Longitude	
				Start	End
Item	Animal Control			39.135110 °	39.135110 °
				-121.748229 °	-121.748229 °
DWR ID	DWR_ST0010_01_f_2013_106				
Action/Comments					
No rodents visible, but rodent burrows visible; need to backfill and compact or grout burrows.

View of the rodent holes under the irrigation pipe.

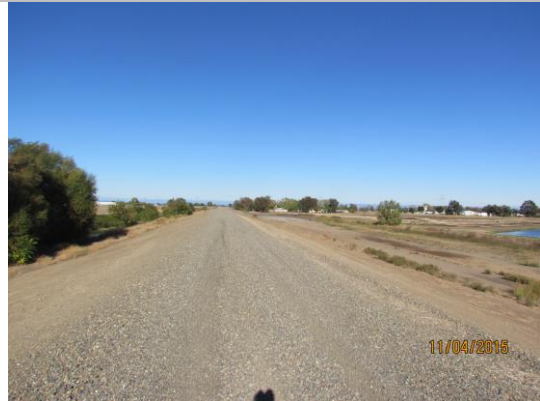
Photo 1 of 1 : FA_2015_ST0010_42_20_20151109_00010.jpg

LM Start	2.14	Rating **	A	Issue No.	20
LM End	2.14	Issue Type +	Ma	Location *	LS
Category	Earthen Levee			GPS Latitude/Longitude	
				Start	End
Item	Vegetation			39.138568 °	39.138568 °
				-121.745360 °	-121.745360 °
DWR ID	DWR_ST0010_01_f_2015_20				
Action/Comments					
Control annual grass and weeds on the levee slopes and easements. Inspector Comments: Sutter Yard burned and dragged both slopes.

View of no vegetation on both slopes.

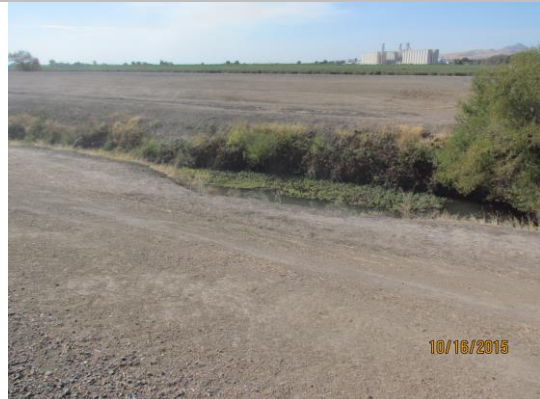
Photo 1 of 4 : FA_2015_ST0010_42_6_20151210_00019.jpg

LM Start	2.43	Rating **	M	Issue No.	6
LM End	3.30	Issue Type +	Ma	Location *	WS
Category	Supplemental			GPS Latitude/Longitude	
				Start	End
Item	2015 USACE Erosion Survey, DRAFT			39.142235 °	39.153095 °
				-121.742609 °	-121.734390 °
DWR ID	DWR_ST0010_01_f_2015_6				
Action/Comments					
Inspector Comments: 2010 - Over steepened levees, some slumping, reach-wide problem. 2011 - Still a reach-wide problem. 2015: Site is part of the extended inventory, last inspected 2011. [2015 Site ID: WAD_2-4_L]

View of the erosion along the waterside toe.

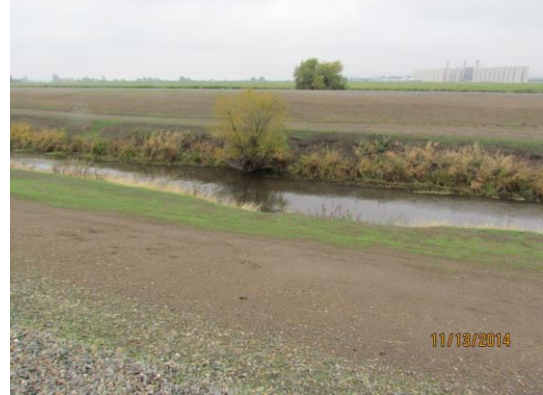
Photo 2 of 4 : FA_2015_ST0010_42_6_20151210_00020.jpg

View of the erosion along the waterside toe.

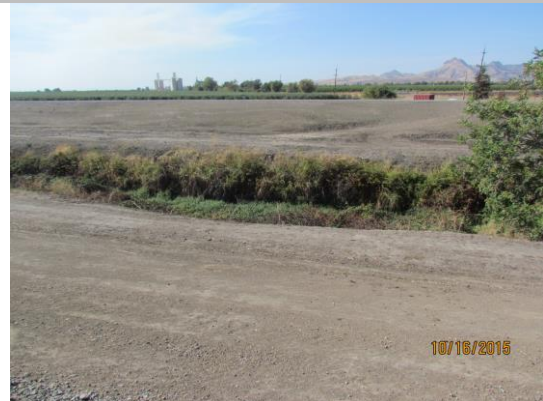
Photo 3 of 4 : FA_2015_ST0010_42_6_20151210_00021.jpg

View of the erosion along the waterside toe.

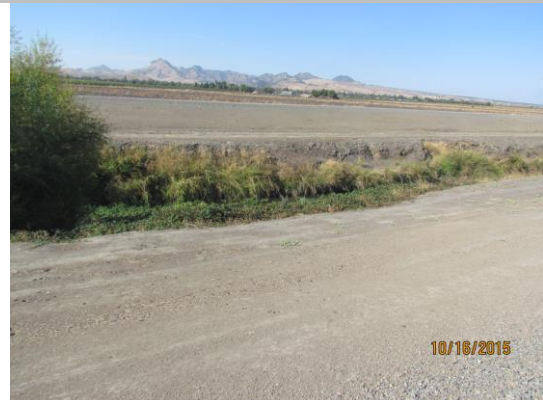
Photo 4 of 4 : FA_2015_ST0010_42_6_20151210_00022.jpg

View of the erosion along the waterside toe.

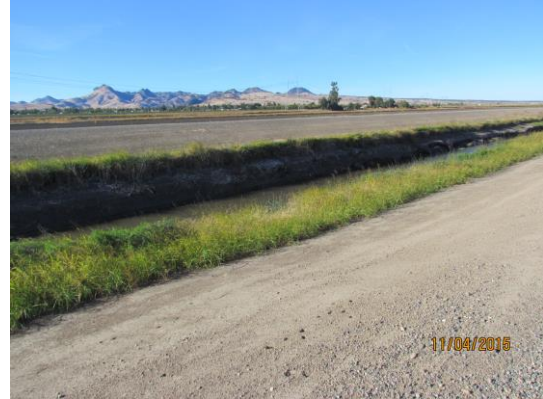
Photo 1 of 1 : FA_2015_ST0010_42_3_20151109_00011.jpg

LM Start	3.53	Rating **	M	Issue No.	3
LM End	3.56	Issue Type +	Ma	Location *	WS
Category	Earthen Levee			GPS Latitude/Longitude	
				Start	End
Item	Erosion / Bank Caving			39.156225 °	39.156639 °
				-121.732930 °	-121.732755 °
DWR ID	DWR_ST0010_01_s_2012_3				
Action/Comments					
Note and monitor erosion site.					
Inspector Comments: Monitor the erosion along the waterside toe.

View of the erosion along the waterside toe.

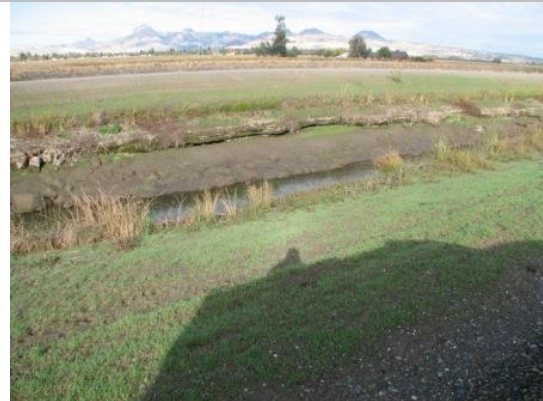
Photo 1 of 2 : FA_2015_ST0010_42_4_20150910_00003.jpg

LM Start	3.65	Rating **	M	Issue No.	4
LM End	3.65	Issue Type +	Ma	Location *	WS
Category	Earthen Levee			GPS Latitude/Longitude	
				Start	End
Item	Erosion / Bank Caving			39.157861 °	39.157861 °
				-121.732238 °	-121.732238 °
DWR ID	DWR_ST0010_01_s_2012_4				
Action/Comments					
Note and monitor erosion site.					
Inspector Comments: Monitor the erosion along the waterside toe.

View of the erosion along the waterside toe of the levee.

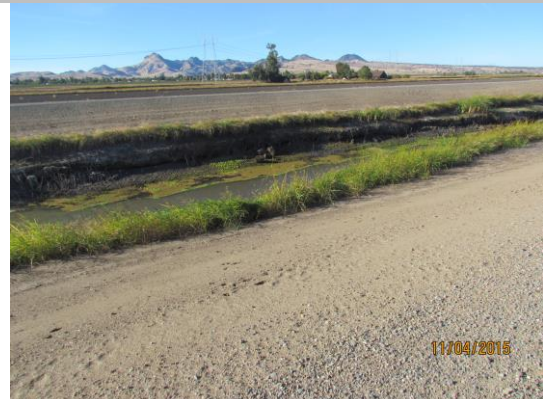
Photo 2 of 2 : FA_2015_ST0010_42_4_20151109_00012.jpg

View of the erosion along the waterside toe.

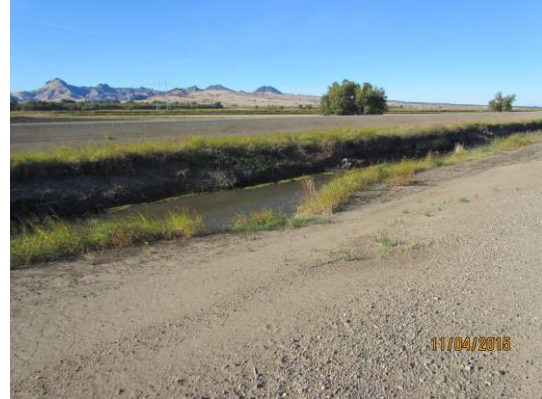
Photo 1 of 1 : FA_2015_ST0010_42_17_20151109_00013.jpg

LM Start	3.84	Rating **	M	Issue No.	17
LM End	3.84	Issue Type +	Ma	Location *	WS
Category	Earthen Levee			GPS Latitude/Longitude	
				Start	End
Item	Erosion / Bank Caving			39.160442 °	39.160442 °
				-121.731067 °	-121.731067 °
DWR ID	DWR_ST0010_01_f_2014_17				
Action/Comments					
Note and monitor erosion site.					
Inspector Comments: Monitor the erosion along the waterside toe.

View of the erosion along the waterside toe.

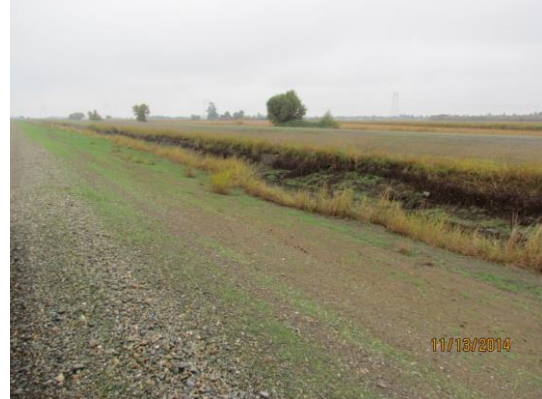
Photo 1 of 2 : FA_2015_ST0010_42_5_20150910_00004.jpg

LM Start	4.23	Rating **	M	Issue No.	5
LM End	4.23	Issue Type +	Ma	Location *	WS
Category	Earthen Levee			GPS Latitude/Longitude	
				Start	End
Item	Erosion / Bank Caving			39.165845 °	39.165845 °
				-121.728877 °	-121.728877 °
DWR ID	DWR_ST0010_01_s_2012_5				
Action/Comments					
Note and monitor erosion site.					
Inspector Comments: Monitor the erosion along the waterside toe.

View of the erosion along the waterside toe.

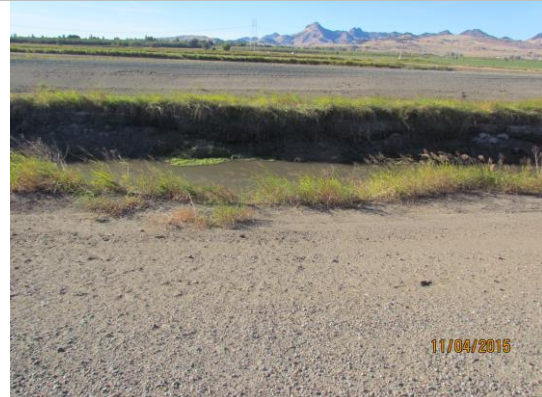
Photo 2 of 2 : FA_2015_ST0010_42_5_20151109_00014.jpg

View of the erosion along the waterside toe.

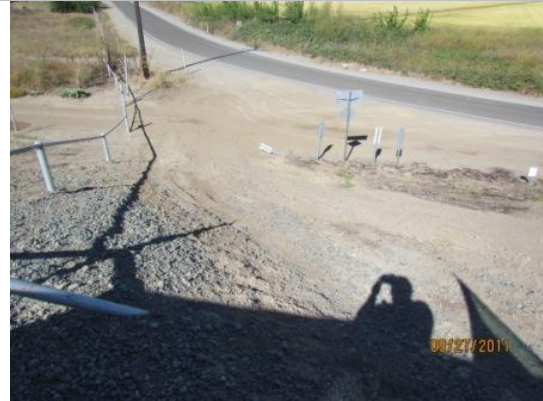
Photo 1 of 1 : FA_2015_ST0010_43_3_20150910_00001.jpg

LM Start	1.17	Rating **	M	Issue No.	3
LM End	1.17	Issue Type +	Ma	Location *	LS
Category	Earthen Levee			GPS Latitude/Longitude	
				Start	End
Item	Slope Stability			39.127648 °	39.127648
				-121.756345 °	-121.756345
DWR ID	DWR_ST0010_02_s_2012_3				
Action/Comments					
Repair the levee slope damaged by vehicle traffic and prevent access where possible.

View of vehicle erosion along L/S slope.

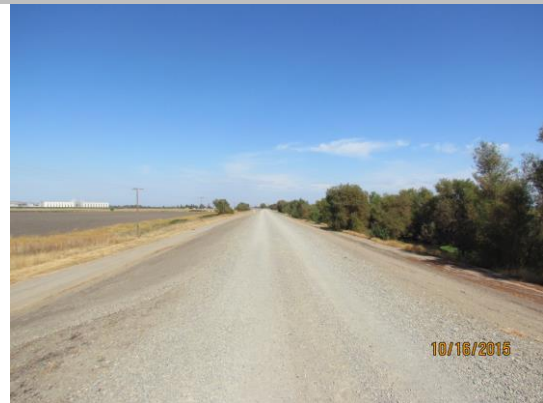
Photo 1 of 1 : FA_2015_ST0010_43_20_20151109_00012.jpg

LM Start	1.38	Rating **	A	Issue No.	20
LM End	1.38	Issue Type +	Ma	Location *	LS
Category	Earthen Levee			GPS Latitude/Longitude	
				Start	End
Item	Vegetation			39.130125 °	39.130125
				-121.753912 °	-121.753912
DWR ID	DWR_ST0010_02_f_2015_20				
Action/Comments					
Control annual grass and weeds on the levee slopes and easements.					
Inspector Comments: Sutter Yard burned and dragged both slopes.

View of no vegetation on both slopes.

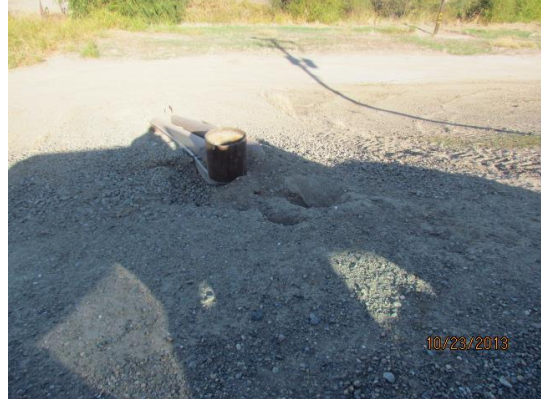
Photo 1 of 2 : FA_2015_ST0010_43_11_20150910_00006.jpg

LM Start	1.76	Rating **	A/W	Issue No.	11
LM End	1.76	Issue Type +	Ma	Location *	LS
Category	Earthen Levee			GPS Latitude/Longitude	
				Start	End
Item	Animal Control			39.134490 °	39.134490 °
				-121.749716 °	-121.749716 °
DWR ID	DWR_ST0010_02_f_2012_11				
Action/Comments					
No rodents visible, but rodent burrows visible; need to backfill and compact or grout burrows. Inspector Comments: Repair the rodent hole.

View of the rodent holes above the irrigation pipe.

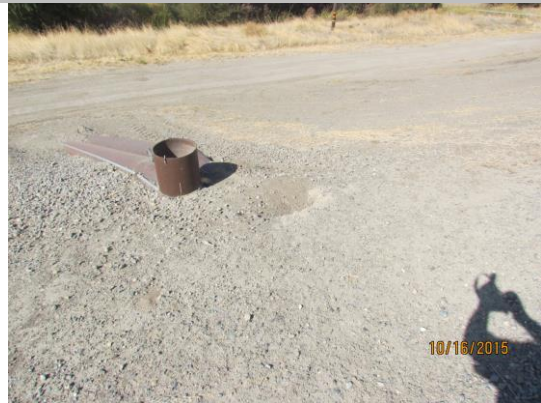
Photo 2 of 2 : FA_2015_ST0010_43_11_20151109_00013.jpg

View of the rodent hole above the irrigation pipe.

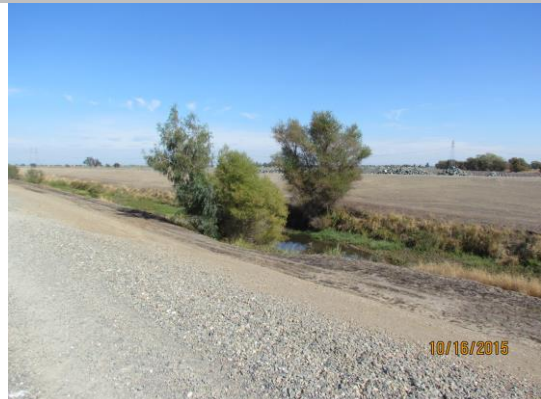
Photo 1 of 2 : FA_2015_ST0010_43_8_20151210_00016.jpg

LM Start	2.41	Rating **	M	Issue No.	8
LM End	3.28	Issue Type +	Ma	Location *	WS
Category	Supplemental			GPS Latitude/Longitude	
				Start	End
Item	2015 USACE Erosion Survey, DRAFT			39.142254 °	39.153150 °
				-121.742847 °	-121.734611 °
DWR ID					
Action/Comments					
Inspector Comments: 2010 - Over steepened levees, some slumping, reach-wide problem. 2011 - Still a reach-wide problem. 2015: Site is part of the extended inventory, last inspected 2011. [2015 Site ID: WAD_2-4_R]

View of the erosion along the landside toe.

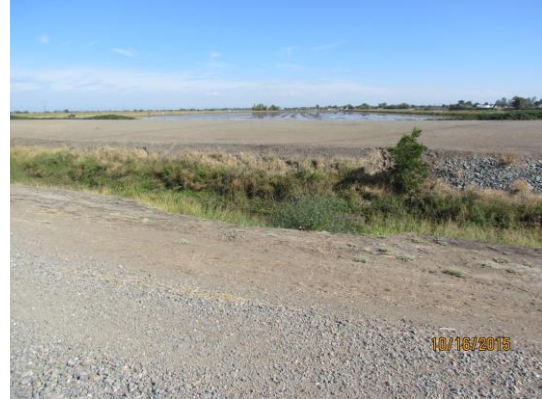
Photo 2 of 2 : FA_2015_ST0010_43_8_20151210_00017.jpg

LM Start	2.41	Rating **	M	Issue No.	8 (cont)	
LM End	3.28	Issue Type +	Ma	Location *	WS	
Category	Supplemental			GPS Latitude/Longitude		
				Start		End
Item	2015 USACE Erosion Survey, DRAFT			39.142254 °		39.153150 °
				-121.742847 °		-121.734611 °
DWR ID						
Action/Comments						
Inspector Comments: 2010 - Over steepened levees, some slumping, reach-wide problem. 2011 - Still a reach-wide problem. 2015: Site is part of the extended inventory, last inspected 2011. [2015 Site ID: WAD_2-4_R]

View of erosion along the waterside toe.

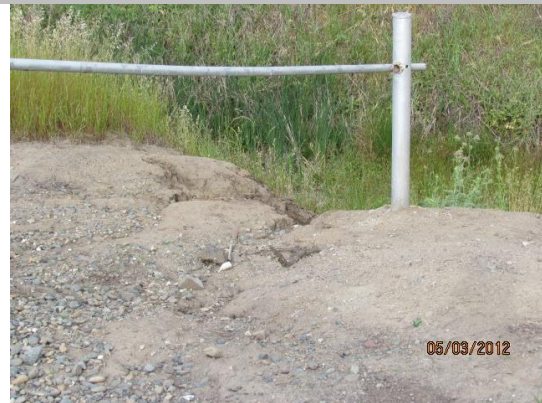
Photo 1 of 1 : FA_2015_ST0010_43_14_20150910_00007.jpg

LM Start	3.26	Rating **	M	Issue No.	14
LM End	3.26	Issue Type +	Ma	Location *	LS
Category	Earthen Levee			GPS Latitude/Longitude	
				Start	End
Item	Erosion / Bank Caving			39.152903 °	39.152903 °
				-121.734906 °	-121.734906 °
DWR ID	DWR_ST0010_02_s_2012_14				
Action/Comments					
Note and monitor erosion site.					
Inspector Comments: The erosion is scheduled for repair in 2015

View of the erosion along the W/S toe.

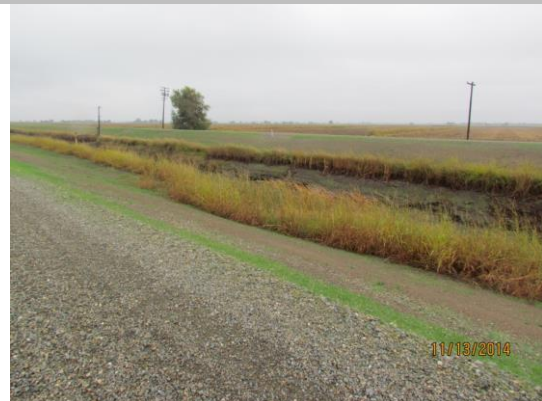
Photo 1 of 2 : FA_2015_ST0010_43_4_20150910_00002.jpg

LM Start	3.42	Rating **	M	Issue No.	4
LM End	3.42	Issue Type +	Ma	Location *	WS
Category	Earthen Levee			GPS Latitude/Longitude	
				Start	End
Item	Erosion / Bank Caving			39.155057 °	39.155057 °
				-121.733985 °	-121.733985 °
DWR ID	DWR_ST0010_02_s_2012_4				
Action/Comments					
Note and monitor erosion site.					
Inspector Comments: Monitor the erosion at the waterside toe.

View of the erosion at the waterside toe.

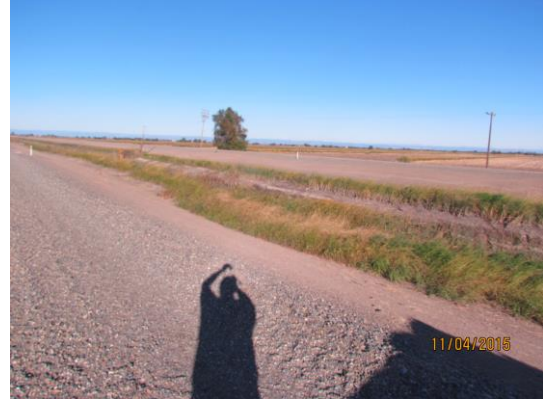
Photo 2 of 2 : FA_2015_ST0010_43_4_20151109_00008.jpg

LM Start	3.42	Rating **	M	Issue No.	4 (cont)
LM End	3.42	Issue Type +	Ma	Location *	WS
Category	Earthen Levee			GPS Latitude/Longitude	
				Start	End
Item	Erosion / Bank Caving			39.155057 °	39.155057 °
				-121.733985 °	-121.733985 °
DWR ID	DWR_ST0010_02_s _ 2012_4				
Action/Comments					
Note and monitor erosion site.					
Inspector Comments: Monitor the erosion at the waterside toe.

View of the erosion at the waterside toe.

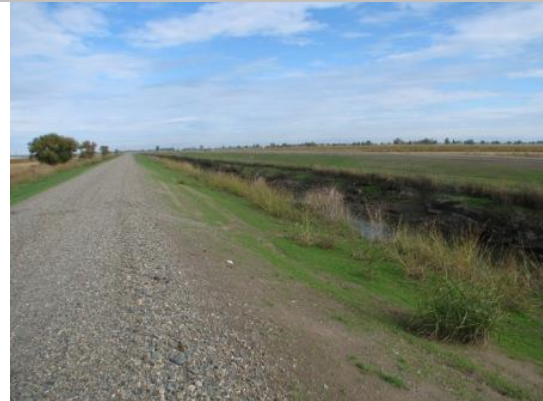
Photo 1 of 2 : FA_2015_ST0010_43_5_20150910_00003.jpg

LM Start	3.54	Rating **	M	Issue No.	5
LM End	3.93	Issue Type +	Ma	Location *	WS
Category	Earthen Levee			GPS Latitude/Longitude	
				Start	End
Item	Erosion / Bank Caving			39.156753 °	39.162113 °
				-121.733267 °	-121.730997 °
DWR ID	DWR_ST0010_02_s _ 2012_5				
Action/Comments					
Note and monitor erosion site.					
Inspector Comments: Monitor is the erosion at the waterside toe.

View of the erosion along the waterside toe.

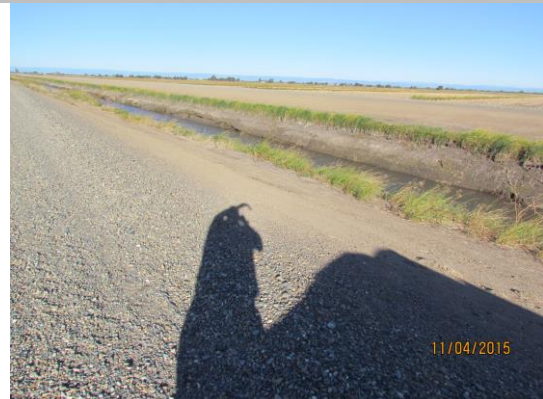
Photo 2 of 2 : FA_2015_ST0010_43_5_20151109_00009.jpg

View of erosion at the waterside toe

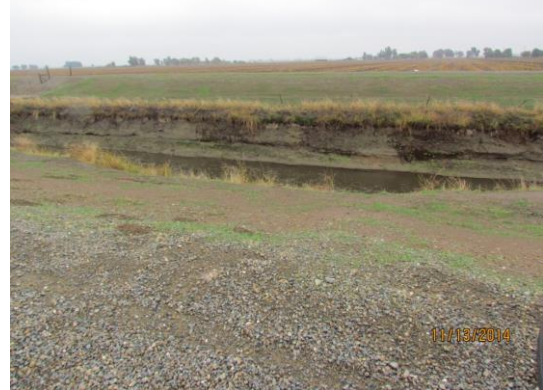
Photo 1 of 2 : FA_2015_ST0010_43_9_20151210_00018.jpg

LM Start	4.41	Rating **	M	Issue No.	9
LM End	4.43	Issue Type +	Ma	Location *	WS
Category	Supplemental			GPS Latitude/Longitude	
				Start	End
Item	2015 USACE Erosion Survey, DRAFT			39.168659 °	39.168937 °
				-121.728016 °	-121.727905 °
DWR ID					
Action/Comments					
Inspector Comments: 2011 - Small erosion pocket. 2015: Site is part of the extended inventory, last inspected 2011. [2015 Site ID: WAD_4-3_R]

View of the erosion along the waterside toe.

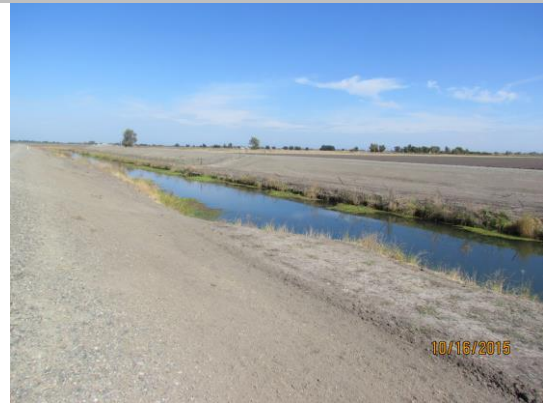
Photo 2 of 2 : FA_2015_ST0010_43_9_20151210_00019.jpg

View of the erosion along the waterside toe.

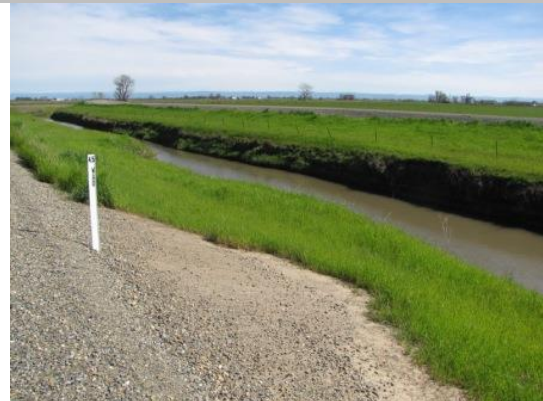
Photo 1 of 2 : FA_2015_ST0010_43_7_20150910_00005.jpg

LM Start	4.48	Rating **	M	Issue No.	7
LM End	4.48	Issue Type +	Ma	Location *	WS
Category	Earthen Levee			GPS Latitude/Longitude	
				Start	End
Item	Erosion / Bank Caving			39.169670 °	39.169670 °
				-121.727787 °	-121.727787 °
DWR ID	DWR_ST0010_02_s_2012_7				
Action/Comments					
Note and monitor erosion site.					
Inspector Comments: Monitor the erosion along the waterside toe.

View of the erosion along the W/S toe.

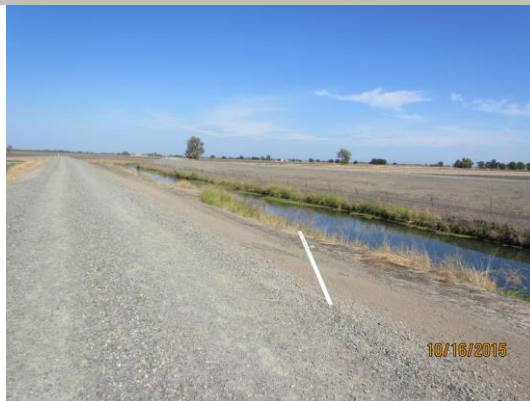
Photo 2 of 2 : FA_2015_ST0010_43_7_20151109_00011.jpg

LM Start	4.48	Rating **	M	Issue No.	7 (cont)	
LM End	4.48	Issue Type +	Ma	Location *	WS	
Category	Earthen Levee			GPS Latitude/Longitude		
				Start		End
Item	Erosion / Bank Caving			39.169670 °	39.169670 °	
				-121.727787 °	-121.727787 °	
DWR ID	DWR_ST0010_02_s _ 2012_7					
Action/Comments						
Note and monitor erosion site.						
Inspector Comments: Monitor the erosion along the waterside toe.

View of the erosion along the waterside toe.
