**Flood Control Project Maintenance
Levee Inspections**

Maintenance Issue Types Only, Levee Inspection Report By Mile - Fall 2016

Sutter Maintenance Yard Wadsworth Canal

Waterway	Bank	Unit Miles	Inspection Start/End	Inspector
Unit No. 01 Wadsworth Canal	Left	4.63	09/23/2016 09/23/2016	Tariq Chechi

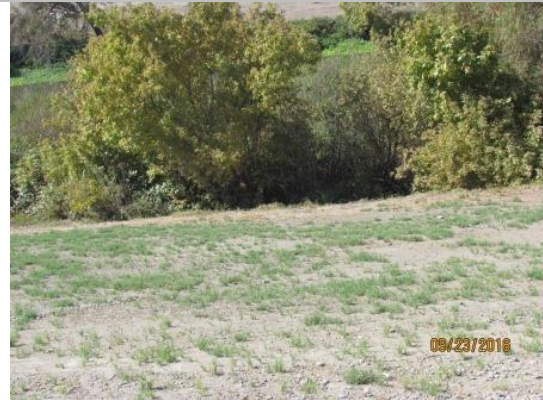
Photo 1 of 1 : FA_2016_ST0010_42_20_20161003_00026.jpg

View of the erosion along the waterside toe.

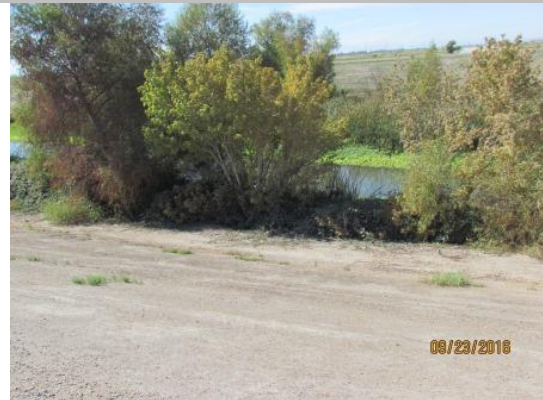
Photo 1 of 1 : FA_2016_ST0010_42_19_20161003_00025.jpg

View of the erosion along the waterside toe.

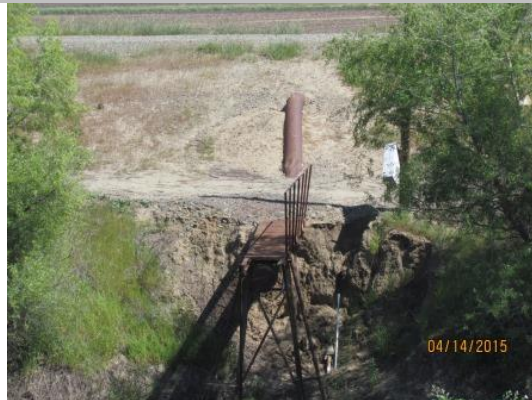
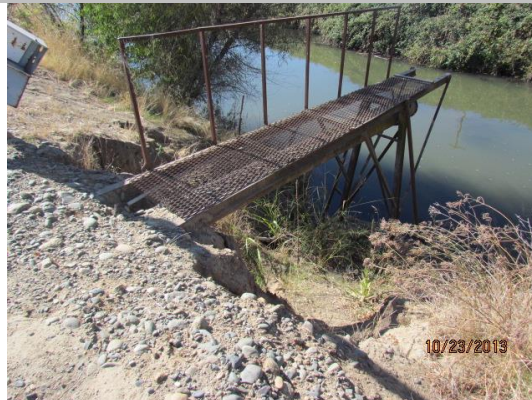
LM Start	1.85	Rating **	U	Issue No.	107
LM End	1.85	Issue Type +	Ma	Location *	WS
Category	Earthen Levee			GPS Latitude/Longitude	
				Start	End
Item	Erosion / Bank Caving			39.135110°	39.135110°
				-121.748230°	-121.748230°
DWR ID	DWR_ST0010_01_f_2013_107				
Comment Code					
E2 : Schedule repair of erosion site prior to the next inspection.					
Inspector Comment					
Repair the erosion under the abandoned pump.

View of the erosion along both sides of the abandoned pump.

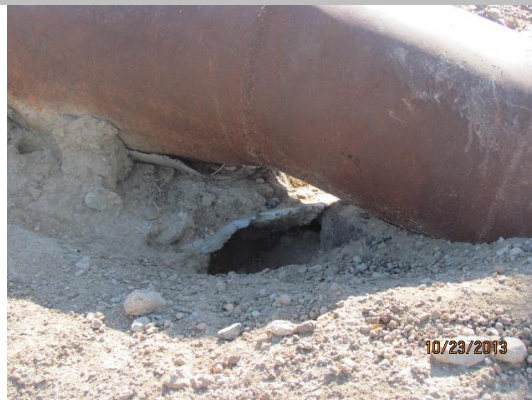
Photo 1 of 1 : FA_2016_ST0010_42_106_20160823_00011.jpg

LM Start	1.85	Rating **	M	Issue No.	106
LM End	1.85	Issue Type +	Ma	Location *	WS
Category	Earthen Levee			GPS Latitude/Longitude	
				Start	End
Item	Animal Control			39.135110°	39.135110°
				-121.748229°	-121.748229°
DWR ID	DWR_ST0010_01_f_2013_106				
Comment Code					
A3 : No rodents visible, but rodent burrows visible; need to backfill and compact or grout burrows.					
Inspector Comment

View of the rodent holes under the irrigation pipe.

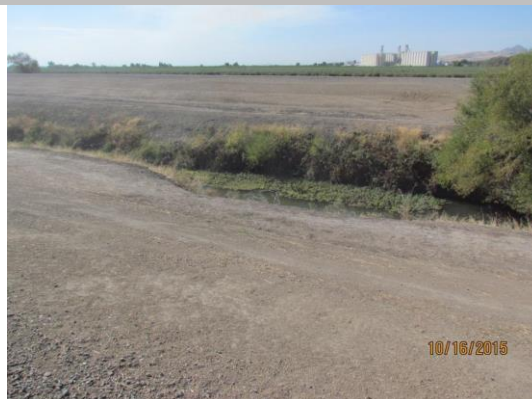
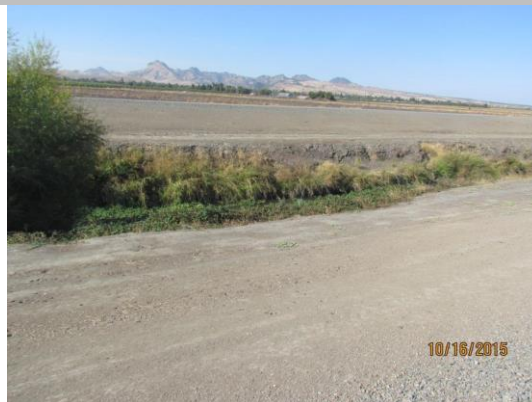
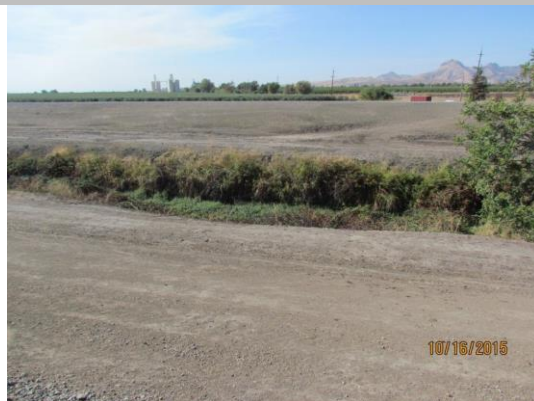
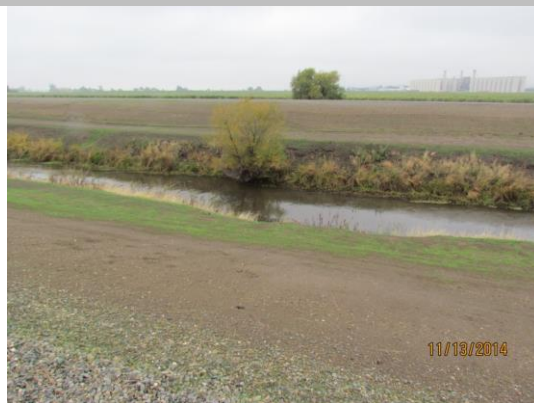
LM Start	2.43	Rating **	M	Issue No.	6
LM End	3.30	Issue Type +	Ma	Location *	WS
Category	Supplemental			GPS Latitude/Longitude	
				Start	End
Item	2015 USACE Erosion Survey, DRAFT			39.142235 °	39.153095 °
				-121.742609 °	-121.734390 °
DWR ID	DWR_ST0010_01_f_2015_6				
Comment Code					
Inspector Comment					
2010 - Over steepened levees, some slumping, reach-wide problem. 2011 - Still a reach-wide problem. 2015: Site is part of the extended inventory, last inspected 2011. [2015 Site ID: WAD_2-4_L]

View of the erosion along the waterside toe.

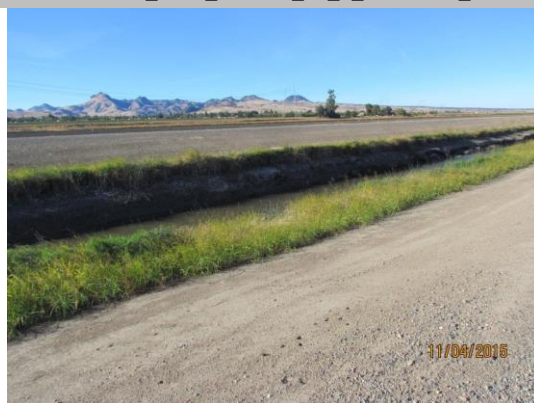
Photo 1 of 1 : FA_2016_ST0010_42_3_20160823_00001.jpg

LM Start	3.53	Rating **	M	Issue No.	3
LM End	3.56	Issue Type +	Ma	Location *	WS
Category	Earthen Levee			GPS Latitude/Longitude	
				Start	End
Item	Erosion / Bank Caving			39.156225 °	39.156639 °
				-121.732930 °	-121.732755 °
DWR ID	DWR_ST0010_01_s_2012_3				
Comment Code					
E1 : Note and monitor erosion site.					
Inspector Comment					
Monitor the erosion along the waterside toe.

View of the erosion along the waterside toe.

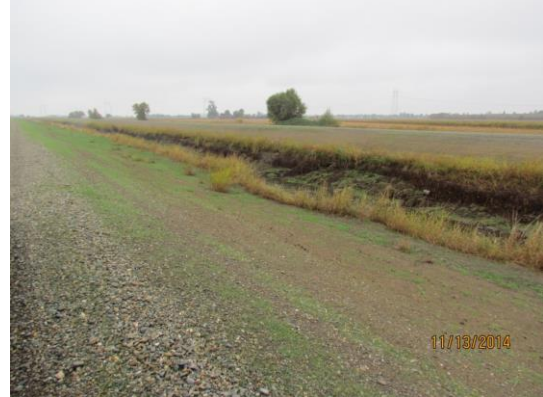
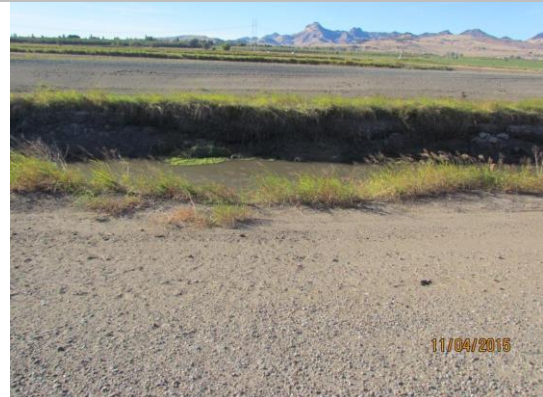
LM Start	4.23	Rating **	M	Issue No.	5
LM End	4.23	Issue Type +	Ma	Location *	WS
Category	Earthen Levee			GPS Latitude/Longitude	
				Start	End
Item	Erosion / Bank Caving			39.165845°	39.165845°
				-121.728877°	-121.728877°
DWR ID	DWR_ST0010_01_s_2012_5				
Comment Code					
E1 : Note and monitor erosion site.					
Inspector Comment					
Monitor the erosion along the waterside toe.

View of the erosion along the waterside toe.

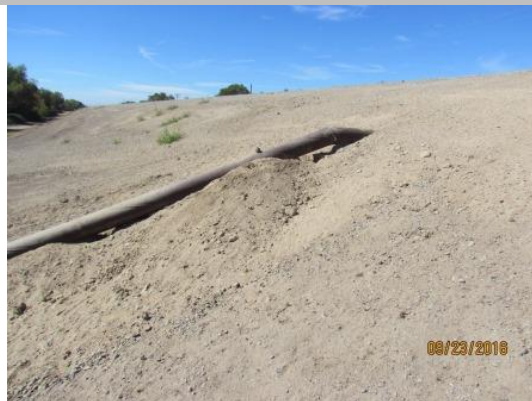
Photo 1 of 1 : FA_2016_ST0010_43_19_20161003_00031.jpg

LM Start	1.16	Rating **	U	Issue No.	19
LM End	1.16	Issue Type +	Ma	Location *	WS
Category	Earthen Levee			GPS Latitude/Longitude	
				Start	End
Item	Animal Control			39.127527°	39.127527°
				-121.756493°	-121.756493°
DWR ID	DWR_ST0010_02_f_2016_19				
Comment Code					
A3 : No rodents visible, but rodent burrows visible; need to backfill and compact or grout burrows.					
Inspector Comment

View of the rodent holes along the landside slope.

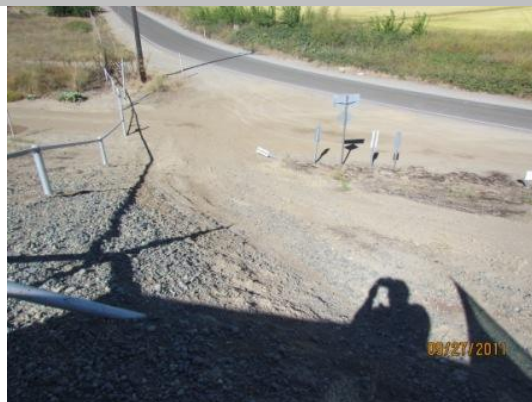
Photo 1 of 1 : FA_2016_ST0010_43_3_20160823_00001.jpg

LM Start	1.17	Rating **	M	Issue No.	3
LM End	1.17	Issue Type +	Ma	Location *	LS
Category	Earthen Levee			GPS Latitude/Longitude	
				Start	End
Item	Slope Stability			39.127648 °	39.127648 °
				-121.756345 °	-121.756345 °
DWR ID	DWR_ST0010_02_s_2012_3				
Comment Code					
S3 : Repair the levee slope damaged by vehicle traffic and prevent access where possible.					
Inspector Comment

View of vehicle erosion along L/S slope.

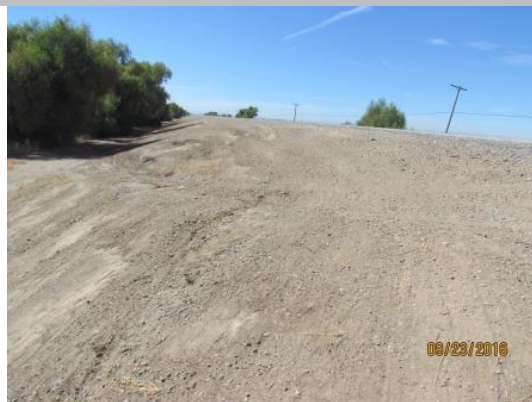
Photo 1 of 1 : FA_2016_ST0010_43_20_20161003_00032.jpg

LM Start	1.75	Rating **	M	Issue No.	20
LM End	1.75	Issue Type +	Ma	Location *	WS
Category	Earthen Levee			GPS Latitude/Longitude	
				Start	End
Item	Slope Stability			39.134378 °	39.134378 °
				-121.749803 °	-121.749803 °
DWR ID	DWR_ST0010_02_f _ 2016_20				
Comment Code					
S3 : Repair the levee slope damaged by vehicle traffic and prevent access where possible.					
Inspector Comment					
Ramp is causing depression in the levee slope.

View the ramp encroaching into the levee.

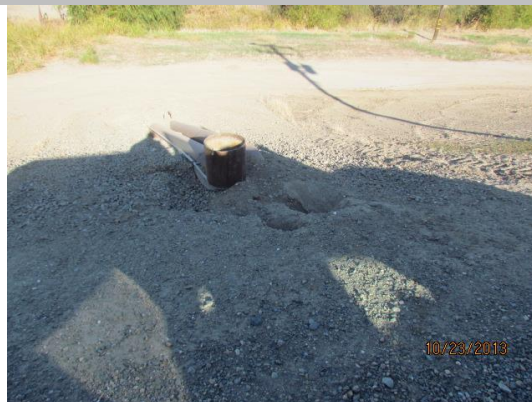
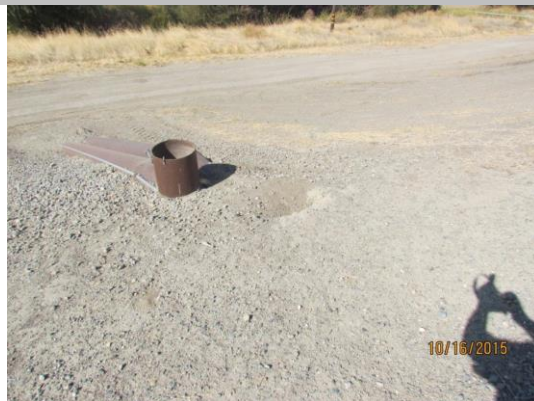
LM Start	1.76	Rating **	M	Issue No.	11
LM End	1.76	Issue Type +	Ma	Location *	LS
Category	Earthen Levee			GPS Latitude/Longitude	
				Start	End
Item	Animal Control			39.134490 °	39.134490 °
				-121.749716 °	-121.749716 °
DWR ID	DWR_ST0010_02_f_2012_11				
Comment Code					
A3 : No rodents visible, but rodent burrows visible; need to backfill and compact or grout burrows.					
Inspector Comment					
Repair the rodent hole.

View of the rodent holes above the irrigation pipe.

View of the rodent hole above the irrigation pipe.

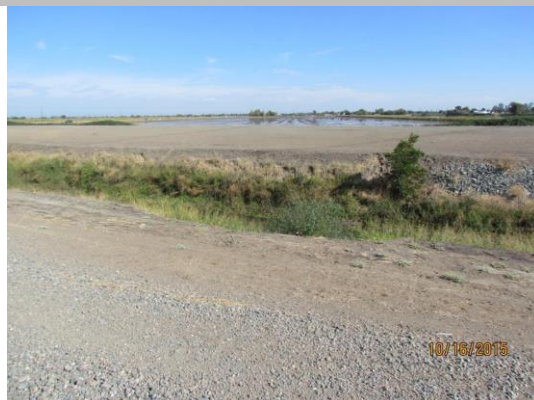
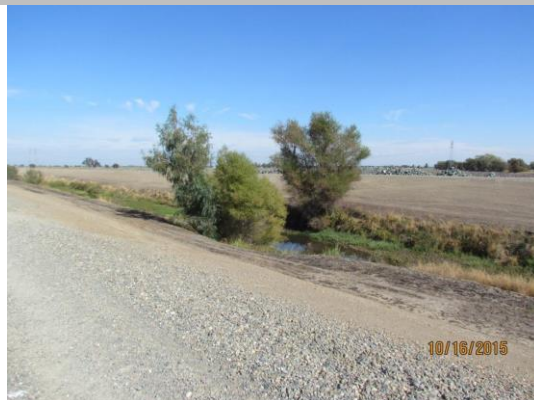
LM Start	2.41	Rating **	M	Issue No.	8
LM End	3.28	Issue Type +	Ma	Location *	WS
Category	Supplemental			GPS Latitude/Longitude	
				Start	End
Item	2015 USACE Erosion Survey, DRAFT			39.142254 °	39.153150 °
				-121.742847 °	-121.734611 °
DWR ID	DWR_ST0010_02_s_2016_8				
Comment Code					
Inspector Comment					
2010 - Over steepened levees, some slumping, reach-wide problem. 2011 - Still a reach-wide problem. 2015: Site is part of the extended inventory, last inspected 2011. [2015 Site ID: WAD_2-4_R]

View of erosion along the waterside toe.

View of the erosion along the landside toe.

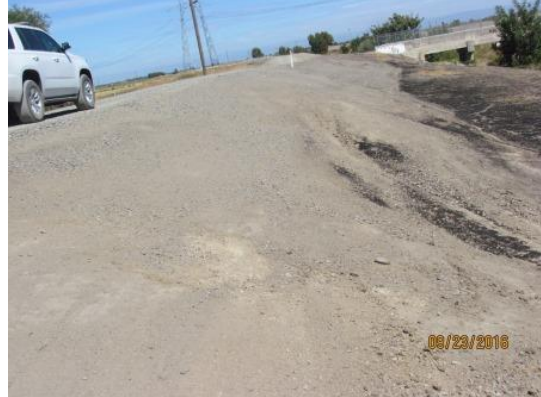
Photo 1 of 1 : FA_2016_ST0010_43_21_20161003_00033.jpg

View the ramp encroaching into the levee.

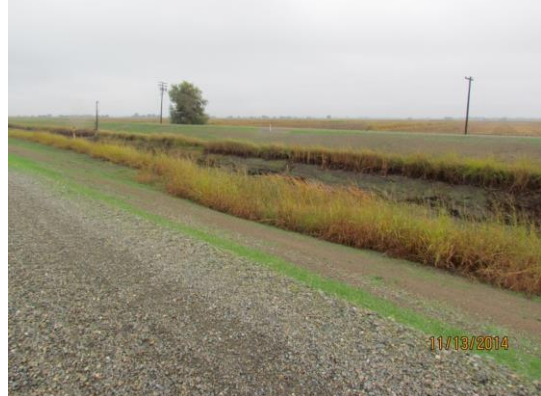
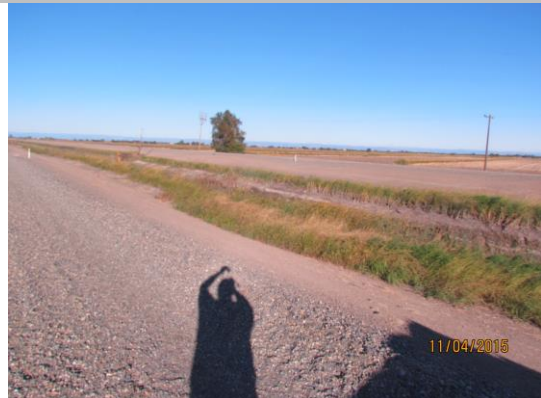
View of the erosion at the waterside toe.

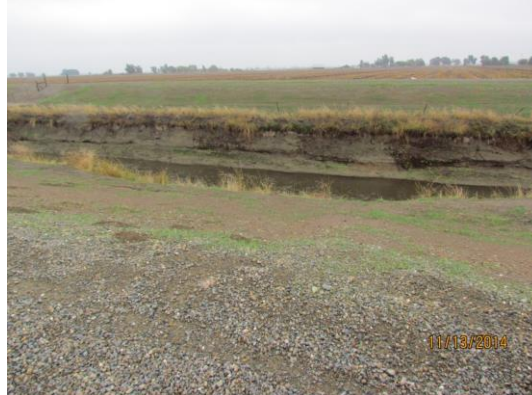
Photo 2 of 2 : FA_2016_ST0010_43_9_20160823_00011.jpg

LM Start	4.41	Rating **	M	Issue No.	9 (cont)	
LM End	4.43	Issue Type +	Ma	Location *	WS	
Category	Supplemental			GPS Latitude/Longitude		
				Start		End
Item	2015 USACE Erosion Survey, DRAFT			39.168659 °		39.168937 °
				-121.728016 °		-121.727905 °
DWR ID	DWR_ST0010_02_s _ 2016_9					
Comment Code						
Inspector Comment						
2011 - Small erosion pocket. 2015: Site is part of the extended inventory, last inspected 2011. [2015 Site ID: WAD_4-3_R]

View of the erosion along the waterside toe.

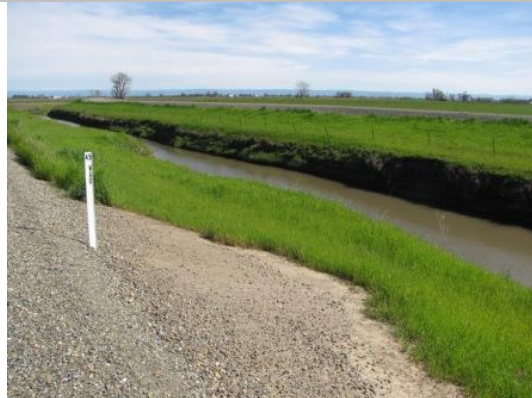
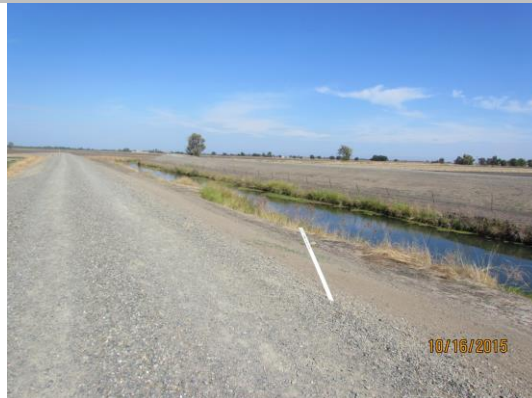
LM Start	4.47	Rating **	M	Issue No.	7
LM End	4.49	Issue Type +	Ma	Location *	WS
Category	Earthen Levee			GPS Latitude/Longitude	
				Start	End
Item	Erosion / Bank Caving			39.169532 °	39.169800 °
				-121.727860 °	-121.727703 °
DWR ID	DWR_ST0010_02_s_2012_7				
Comment Code					
E1 : Note and monitor erosion site.					
Inspector Comment					
Monitor the erosion along the waterside toe.

View of the erosion along the W/S toe.

View of the erosion along the waterside toe.
