**Flood Control Project Maintenance  
Levee Inspections**

**Maintenance Issue Types Only, Levee Inspection Report By Mile - Fall 2017**

**Sutter Maintenance Yard Wadsworth Canal**

Waterway	Bank	Unit Miles	Inspection Start/End	Inspector
Unit No. 01 Wadsworth Canal	Left	4.63	10/04/2017 10/04/2017	Bob Duffey

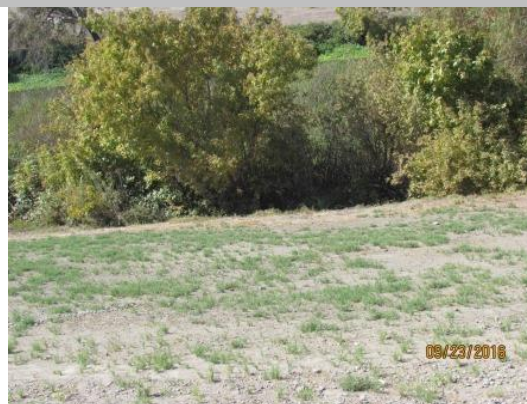
Photo 1 of 1 : FA\_2017\_ST0010\_42\_20\_20170911\_00013.jpg

LM Start	0.06	Rating **	M	Issue No.	20
LM End	0.12	Issue Type +	Ma	Location *	WS
Category	Earthen Levee			GPS Latitude/Longitude	
				Start	End
Item	Erosion / Bank Caving			39.114203 °	39.114842 °
				-121.768015 °	-121.767382 °
DWR ID	DWR_ST0010_01_f_2016_20				
Comment Code					
E1 : Note and monitor erosion site.					
Inspector Comment					
Monitor the erosion along the waterside toe.

View of the erosion along the waterside toe.

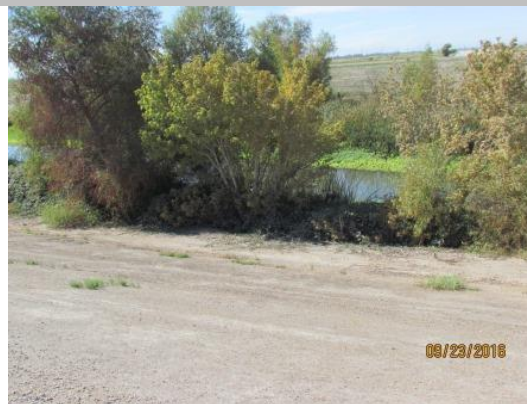
Photo 1 of 1 : FA\_2017\_ST0010\_42\_19\_20170911\_00012.jpg

LM Start	0.38	Rating **	M	Issue No.	19
LM End	0.38	Issue Type +	Ma	Location *	WS
Category	Earthen Levee			GPS Latitude/Longitude	
				Start	End
Item	Erosion / Bank Caving			39.117910 °	39.117910 °
				-121.764497 °	-121.764497 °
DWR ID	DWR_ST0010_01_f_2016_19				
Comment Code					
E1 : Note and monitor erosion site.					
Inspector Comment					
Monitor the erosion along the waterside toe.

View of the erosion along the waterside toe.

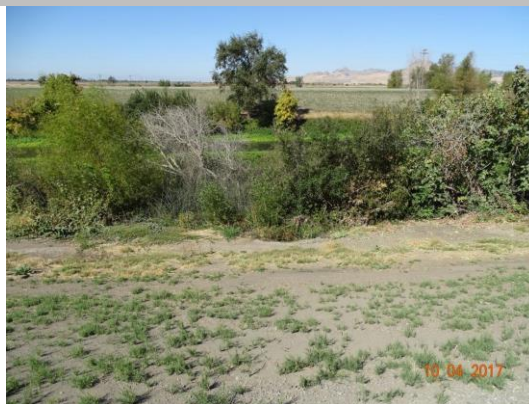
Photo 1 of 1 : FA\_2017\_ST0010\_42\_22\_20171020\_00037.jpg

LM Start	0.50	Rating **	U	Issue No.	22
LM End	0.50	Issue Type +	Ma	Location *	WS
Category	Earthen Levee			GPS Latitude/Longitude	
				Start	End
Item	Erosion / Bank Caving			39.119348 °	39.119348 °
				-121.763120 °	-121.763120 °
DWR ID	DWR_ST0010_01_f_2017_22				
Comment Code					
E2 : Schedule repair of erosion site prior to the next inspection.					
Inspector Comment					
Repair the beaver hole along the waterside berm.

View of the beaver hole along the waterside berm.

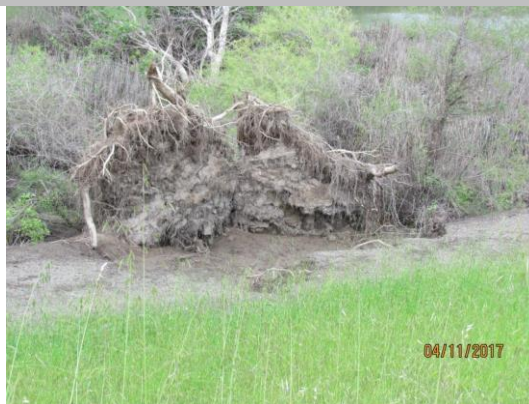
Photo 1 of 1 : FA\_2017\_ST0010\_42\_18\_20170911\_00011.jpg

LM Start	0.56	Rating **	U	Issue No.	18
LM End	0.56	Issue Type +	Ma	Location *	WS
Category	Earthen Levee			GPS Latitude/Longitude	
				Start	End
Item	Erosion / Bank Caving			39.119985 °	39.119985 °
				-121.762600 °	-121.762600 °
DWR ID	DWR_ST0010_01_s_2017_18				
Comment Code					
E2 : Schedule repair of erosion site prior to the next inspection.					
Inspector Comment					
Repair the erosion along the water side toe.

View of the erosion along the waterside toe caused by a tree that fell into the water.

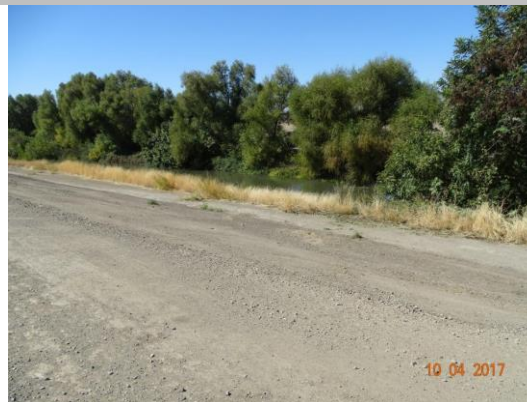
Photo 1 of 1 : FA\_2017\_ST0010\_42\_23\_20171020\_00038.jpg

LM Start	1.76	Rating **	M	Issue No.	23
LM End	1.76	Issue Type +	Ma	Location *	WS
Category	Earthen Levee			GPS Latitude/Longitude	
				Start	End
Item	Animal Control			39.133978 °	39.133978 °
				-121.749327 °	-121.749327 °
DWR ID	DWR_ST0010_01_f_2017_23				
Comment Code					
A3 : No rodents visible, but rodent burrows visible; need to backfill and compact or grout burrows.					
Inspector Comment					
Repair the rodent holes along the waterside slope.

View of the rodent holes along the waterside slope.

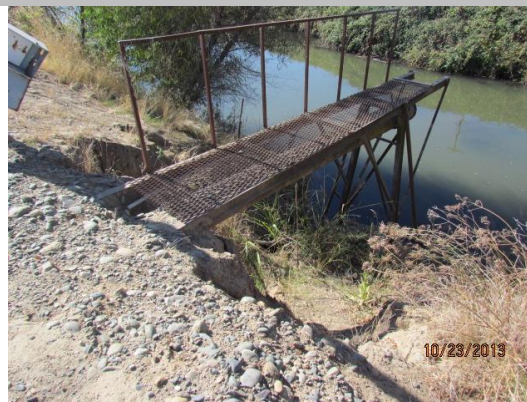
Photo 1 of 3 : FA\_2017\_ST0010\_42\_107\_20170911\_00015.jpg

LM Start	1.85	Rating **	U	Issue No.	107
LM End	1.85	Issue Type +	Ma	Location *	WS
Category	Earthen Levee			GPS Latitude/Longitude	
				Start	End
Item	Erosion / Bank Caving			39.135110 °	39.135110 °
				-121.748230 °	-121.748230 °
DWR ID	DWR_ST0010_01_f_2013_107				
Comment Code					
E2 : Schedule repair of erosion site prior to the next inspection.					
Inspector Comment					
Repair the erosion under the abandoned pump.

View of the erosion along both sides of the abandoned pump.

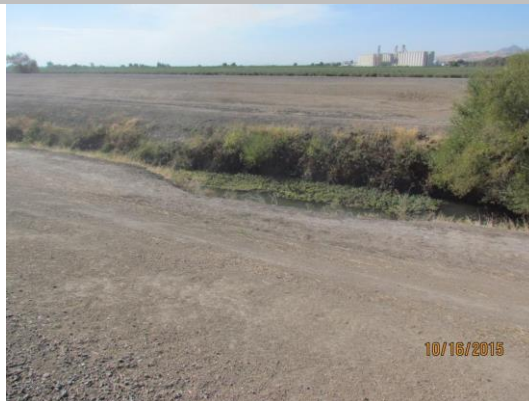
Photo 1 of 4 : FA\_2017\_ST0010\_42\_6\_20170911\_00006.jpg

LM Start	2.43	Rating **	M	Issue No.	6
LM End	3.30	Issue Type +	Ma	Location *	WS
Category	Supplemental			GPS Latitude/Longitude	
				Start	End
Item	2015 USACE Erosion Survey, DRAFT			39.142235 °	39.153095 °
				-121.742609 °	-121.734390 °
DWR ID	DWR_ST0010_01_f_2015_6				
Comment Code					
Inspector Comment					
2010 - Over steepened levees, some slumping, reach-wide problem. 2011 - Still a reach-wide problem. 2015: Site is part of the extended inventory, last inspected 2011. [2015 Site ID: WAD_2-4_L]

View of the erosion along the waterside toe.

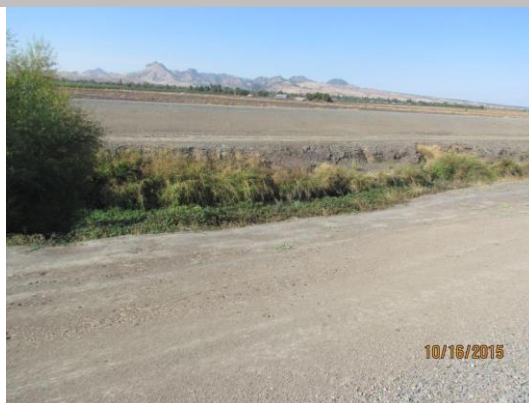
Photo 2 of 4 : FA\_2017\_ST0010\_42\_6\_20170911\_00007.jpg

View of the erosion along the waterside toe.

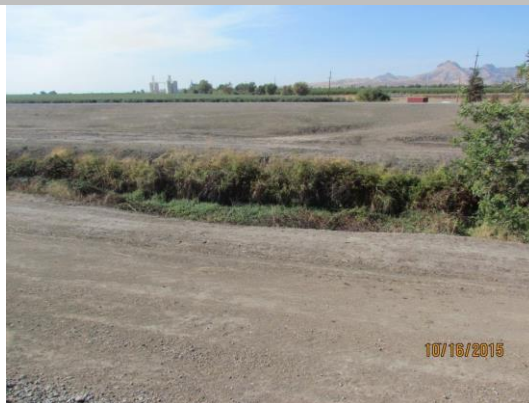
Photo 3 of 4 : FA\_2017\_ST0010\_42\_6\_20170911\_00008.jpg

View of the erosion along the waterside toe.

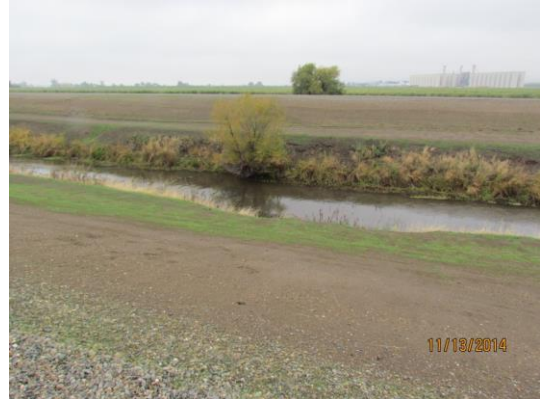
Photo 4 of 4 : FA\_2017\_ST0010\_42\_6\_20170911\_00009.jpg

View of the erosion along the waterside toe.

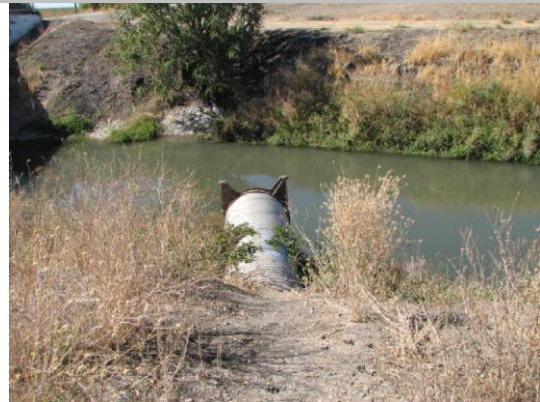
Photo 1 of 3 : UCIP\_FA\_2017\_51500\_64718.jpg

Comment Code						
Inspector Comment						
FS_ID:51500 DS_ID:17065 EP_NO: 7209 Repair Type: Non-Urgent Crossing Status: Found UCIP Comments: 4/10/2017 Ws pipe end is in good condition. LS pipe end is still deformed and vegetated. (DWR Sutter Yard-AFreitag)10/12/2016 LS inlet is still deformed and being overgrown by vegetation.(DWR Sutter Yard - a/freitag)4/19/2016 Crossing appears to be in good condition.5/12/2015 LS inlet still deformed a little but does not affect the crossing function.11/18/2014 Same as last inspection.5/13/2014 Same as last inspection.10/29/2013 Same as last inspection.5/16/2013 Pipe intake on LS appears to be bent and damaged but that does not appear to be affecting water flow or channel bank. FIELD_STRUCT_DESC: 36-inch corrugated metal drainage pipe (permit records indicate 30-inch, USACE O&M pipe replaced with new 30-inch pipe) through the levee, 9 feet below the crown. Flap gate located on the waterside (WS) end. (Original O&M manual crossing was replaced under Permit No. 7209, 1970 - Department of Water Resources [DWR]) [Additional Reference(s): DWR Levee Log, 2005. USACE Sacramento O&M Manual 135, May 1953, (Station 160+25)]. FS Date: 4/12/2017 9:39:10 AM

36-inch pipe with flapgate on WS slope.

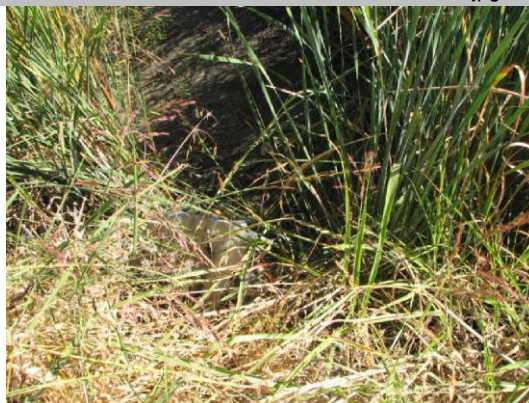
Photo 2 of 3 : UCIP\_FA\_2017\_51500\_64717.jpg

FS\_ID:51500  
DS\_ID:17065  
EP\_NO: 7209  
Repair Type: Non-Urgent  
Crossing Status: Found  
UCIP Comments: 4/10/2017 Ws pipe end is in good condition. LS pipe end is still deformed and vegetated. (DWR Sutter Yard - AFreitag)10/12/2016 LS inlet is still deformed and being overgrown by vegetation.(DWR Sutter Yard - afreitag)4/19/2016 Crossing appears to be in good condition.5/12/2015 LS inlet still deformed a little but does not affect the crossing function.11/18/2014 Same as last inspection.5/13/2014 Same as last inspection.10/29/2013 Same as last inspection.5/16/2013 Pipe intake on LS appears to be bent and damaged but that does not appear to be affecting water flow or channel bank.  
FIELD\_STRUCT\_DESC: 36-inch corrugated metal drainage pipe (permit records indicate 30-inch, USACE O&M pipe replaced with new 30-inch pipe) through the levee, 9 feet below the crown. Flap gate located on the waterside (WS) end. (Original O&M manual crossing was replaced under Permit No. 7209, 1970 - Department of Water Resources [DWR]) [Additional Reference(s): DWR Levee Log, 2005. USACE Sacramento O&M Manual 135, May 1953, (Station 160+25)].

Inlet in weeds on LS toe.

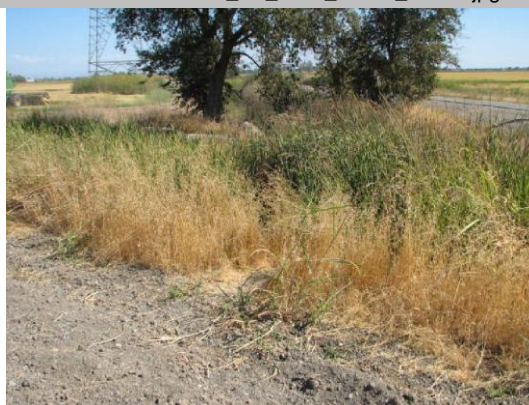
Photo 3 of 3 : UCIP\_FA\_2017\_51500\_64716.jpg

Pipe inlet heavily shielded by vegetation.

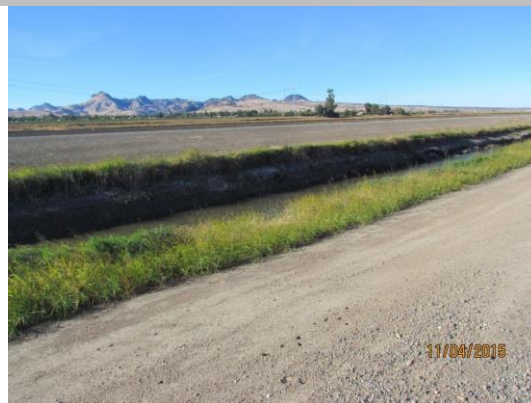
Photo 1 of 1 : FA\_2017\_ST0010\_42\_3\_20170911\_00001.jpg

LM Start	3.53	Rating **	M	Issue No.	3
LM End	3.56	Issue Type +	Ma	Location *	WS
Category	Earthen Levee			GPS Latitude/Longitude	
				Start	End
Item	Erosion / Bank Caving			39.156225 °	39.156639 °
				-121.732930 °	-121.732755 °
DWR ID	DWR_ST0010_01_s _ 2012_3				
Comment Code					
E1 : Note and monitor erosion site.					
Inspector Comment					
Monitor the erosion along the waterside toe.

View of the erosion along the waterside toe.

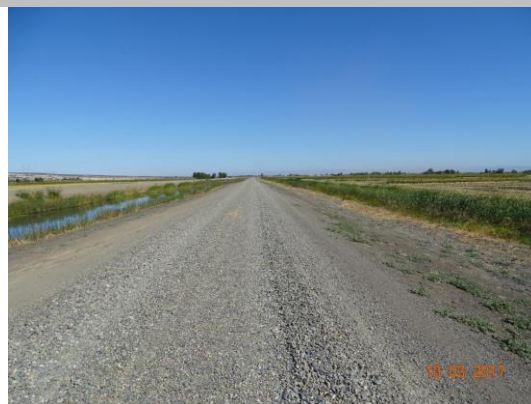
Photo 1 of 1 : FA\_2017\_ST0010\_42\_21\_20171020\_00036.jpg

LM Start	3.59	Rating **	A	Issue No.	21
LM End	3.59	Issue Type +	Ma	Location *	LS
Category	Earthen Levee			GPS Latitude/Longitude	
				Start	End
Item	Vegetation			39.156995 °	39.156995 °
				-121.732630 °	-121.732630 °
DWR ID	DWR_ST0010_01_f _ 2017_21				
Comment Code					
V1 : Control annual grass and weeds on the levee slopes and easements.					
Inspector Comment					
The vegetation was removed from both slopes.

View of no vegetation on both slopes.

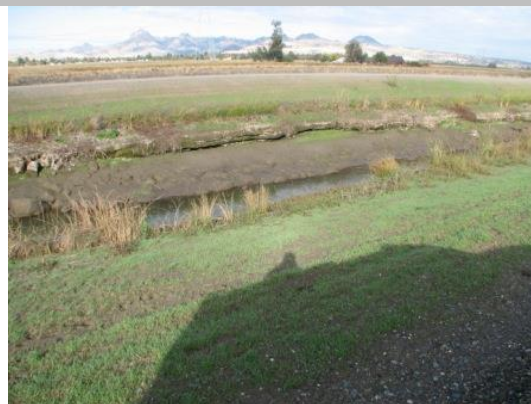
Photo 1 of 2 : FA\_2017\_ST0010\_42\_4\_20170911\_00002.jpg

LM Start	3.65	Rating **	M	Issue No.	4
LM End	3.65	Issue Type +	Ma	Location *	WS
Category	Earthen Levee			GPS Latitude/Longitude	
				Start	End
Item	Erosion / Bank Caving			39.157861 °	39.157861 °
				-121.732238 °	-121.732238 °
DWR ID	DWR_ST0010_01_s _ 2012_4				
Comment Code					
E1 : Note and monitor erosion site.					
Inspector Comment					
Monitor the erosion along the waterside toe.

View of the erosion along the waterside toe of the levee.

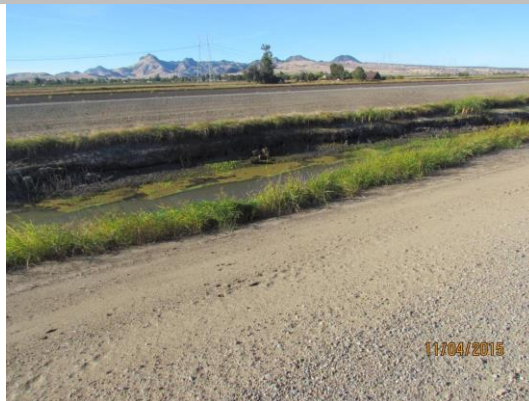
Photo 2 of 2 : FA\_2017\_ST0010\_42\_4\_20170911\_00003.jpg

LM Start	3.65	Rating **	M	Issue No.	4 (cont)	
LM End	3.65	Issue Type +	Ma	Location *	WS	
Category	Earthen Levee			GPS Latitude/Longitude		
				Start		End
Item	Erosion / Bank Caving			39.157861 °		39.157861 °
				-121.732238 °		-121.732238 °
DWR ID	DWR_ST0010_01_s_2012_4					
Comment Code						
E1 : Note and monitor erosion site.						
Inspector Comment						
Monitor the erosion along the waterside toe.

View of the erosion along the waterside toe.

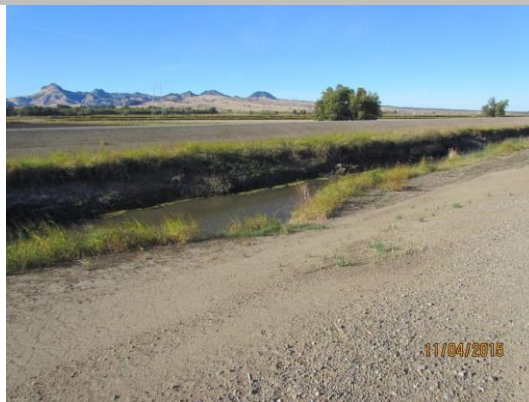
Photo 1 of 1 : FA\_2017\_ST0010\_42\_17\_20170911\_00010.jpg

LM Start	3.84	Rating **	M	Issue No.	17
LM End	3.85	Issue Type +	Ma	Location *	WS
Category	Earthen Levee			GPS Latitude/Longitude	
				Start	End
Item	Erosion / Bank Caving			39.160442 °	39.160517 °
				-121.731067 °	-121.731137 °
DWR ID	DWR_ST0010_01_f_2014_17				
Comment Code					
E1 : Note and monitor erosion site.					
Inspector Comment					
Monitor the erosion along the waterside toe.

View of the erosion along the waterside toe.

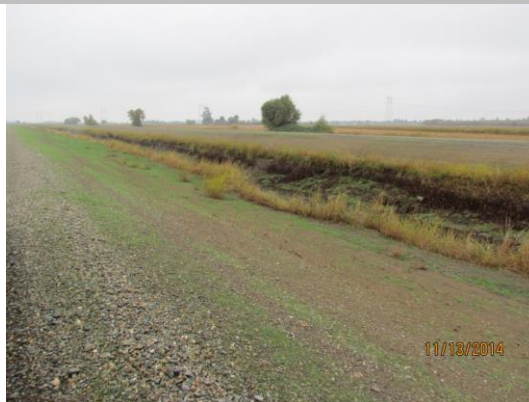
Photo 1 of 2 : FA\_2017\_ST0010\_42\_5\_20170911\_00004.jpg

LM Start	4.23	Rating **	M	Issue No.	5
LM End	4.23	Issue Type +	Ma	Location *	WS
Category	Earthen Levee			GPS Latitude/Longitude	
				Start	End
Item	Erosion / Bank Caving			39.165845 °	39.165845 °
				-121.728877 °	-121.728877 °
DWR ID	DWR_ST0010_01_s_2012_5				
Comment Code					
E1 : Note and monitor erosion site.					
Inspector Comment					
Monitor the erosion along the waterside toe.

View of the erosion along the waterside toe.

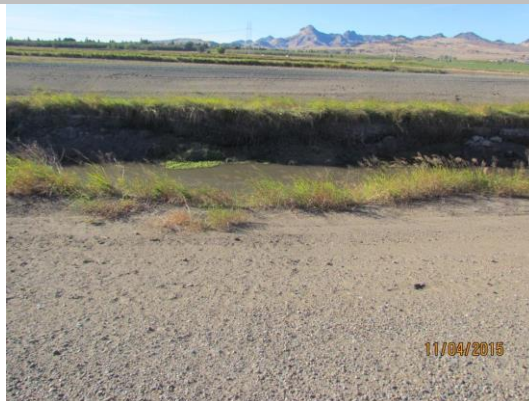
Photo 2 of 2 : FA\_2017\_ST0010\_42\_5\_20170911\_00005.jpg

View of the erosion along the waterside toe.

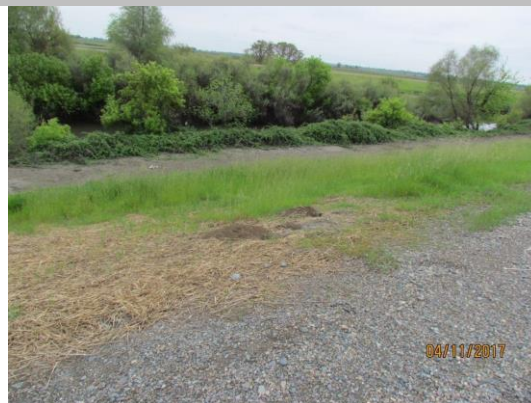
Photo 1 of 2 : FA\_2017\_ST0010\_43\_19\_20170911\_00013.jpg

LM Start	1.16	Rating **	U	Issue No.	19
LM End	1.16	Issue Type +	Ma	Location *	WS
Category	Earthen Levee			GPS Latitude/Longitude	
				Start	End
Item	Animal Control			39.127527 °	39.127527 °
				-121.756493 °	-121.756493 °
DWR ID	DWR_ST0010_02_f_2016_19				
Comment Code					
A3 : No rodents visible, but rodent burrows visible; need to backfill and compact or grout burrows.					
Inspector Comment					
Repair the rodent holes along the waterside slope.

View of the rodent holes along the waterside slope.

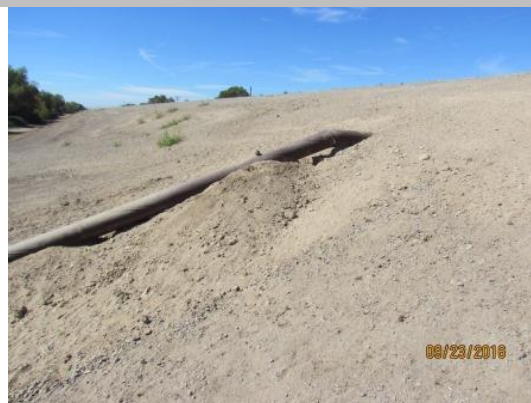
Photo 2 of 2 : FA\_2017\_ST0010\_43\_19\_20170911\_00014.jpg

View of the rodent holes along the waterside slope.

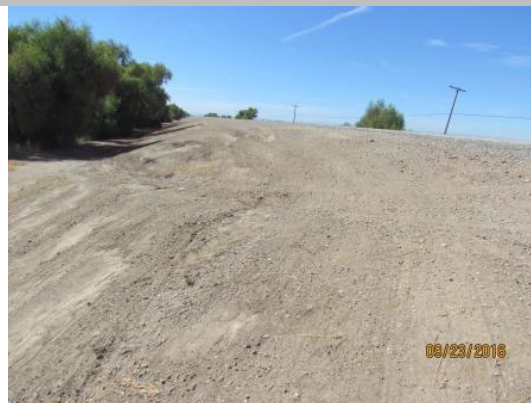
Photo 1 of 1 : FA\_2017\_ST0010\_43\_20\_20170911\_00015.jpg

LM Start	1.75	Rating **	M	Issue No.	20
LM End	1.75	Issue Type +	Ma	Location *	WS
Category	Earthen Levee			GPS Latitude/Longitude	
				Start	End
Item	Slope Stability			39.134378 °	39.134378 °
				-121.749803 °	-121.749803 °
DWR ID	DWR_ST0010_02_f_2016_20				
Comment Code					
S3 : Repair the levee slope damaged by vehicle traffic and prevent access where possible.					
Inspector Comment					
Ramp is causing depression in the levee slope.

View the ramp encroaching into the levee.

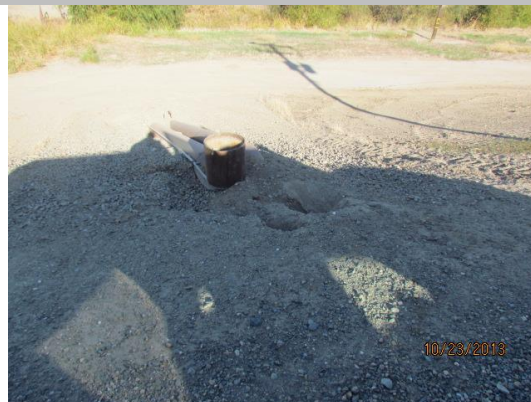
Photo 1 of 2 : FA\_2017\_ST0010\_43\_11\_20170911\_00011.jpg

LM Start	1.76	Rating **	M	Issue No.	11	
LM End	1.76	Issue Type +	Ma	Location *	LS	
Category	Earthen Levee			GPS Latitude/Longitude		
				Start		End
Item	Animal Control			39.134490 °		39.134490 °
				-121.749716 °		-121.749716 °
DWR ID	DWR_ST0010_02_f_2012_11					
Comment Code						
A3 : No rodents visible, but rodent burrows visible; need to backfill and compact or grout burrows.						
Inspector Comment						
Repair the rodent hole.

View of the rodent holes above the irrigation pipe.

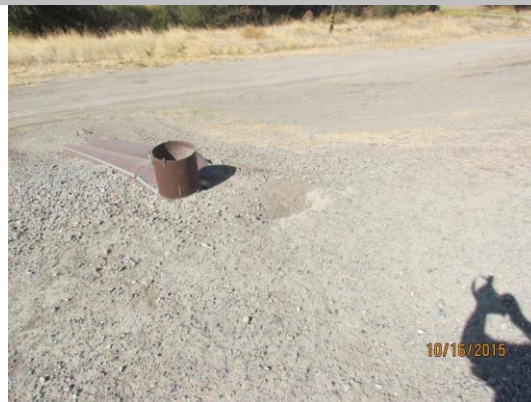
Photo 2 of 2 : FA\_2017\_ST0010\_43\_11\_20170911\_00012.jpg

View of the rodent hole above the irrigation pipe.

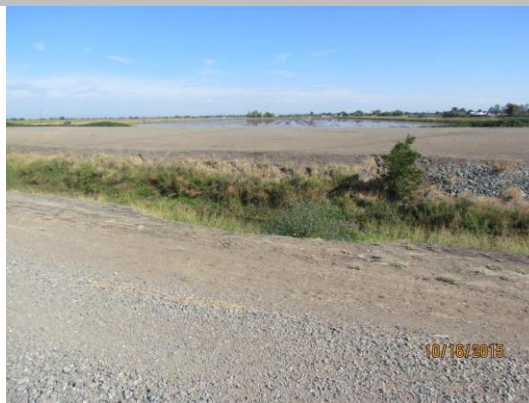
Photo 1 of 2 : FA\_2017\_ST0010\_43\_8\_20170911\_00007.jpg

View of erosion along the waterside toe.

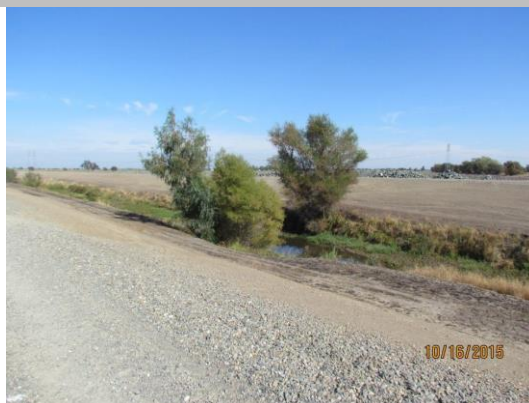
Photo 2 of 2 : FA\_2017\_ST0010\_43\_8\_20170911\_00008.jpg

View of the erosion along the landside toe.

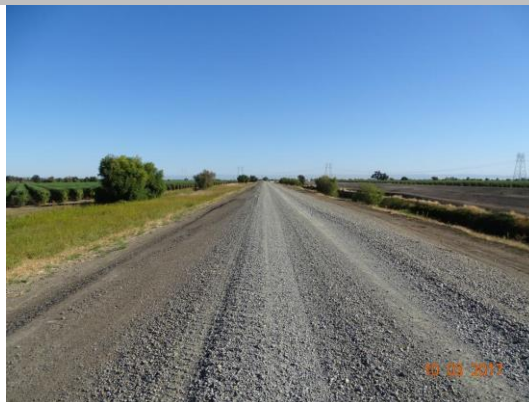
Photo 1 of 1 : FA\_2017\_ST0010\_43\_17\_20171020\_00043.jpg

LM Start	2.54	Rating **	A	Issue No.	17
LM End	2.54	Issue Type +	Ma	Location *	LS
Category	Earthen Levee			GPS Latitude/Longitude	
				Start	End
Item	Vegetation			39.143902 °	39.143902 °
				-121.741805 °	-121.741805 °
DWR ID	DWR_ST0010_02_f_2017_17				
Comment Code					
V1 : Control annual grass and weeds on the levee slopes and easements.					
Inspector Comment					
The vegetation was removed from both slopes.

View of no vegetation on both slopes.

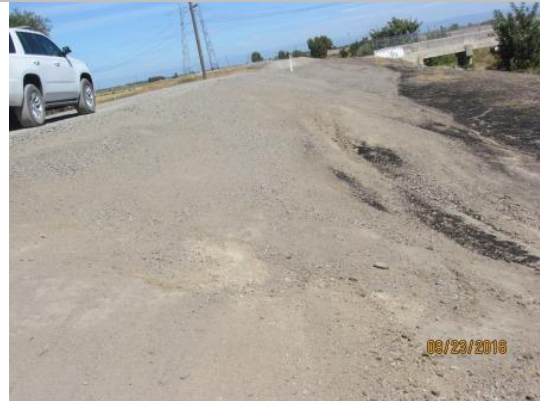
Photo 1 of 1 : FA\_2017\_ST0010\_43\_21\_20170911\_00016.jpg

LM Start	2.95	Rating **	M	Issue No.	21
LM End	2.95	Issue Type +	Ma	Location *	WS
Category	Earthen Levee			GPS Latitude/Longitude	
				Start	End
Item	Slope Stability			39.148938 °	39.148938 °
				-121.737620 °	-121.737620 °
DWR ID	DWR_ST0010_02_f_2016_21				
Comment Code					
S3 : Repair the levee slope damaged by vehicle traffic and prevent access where possible.					
Inspector Comment					
Ramp is causing depression in the levee slope.

View the ramp encroaching into the levee.

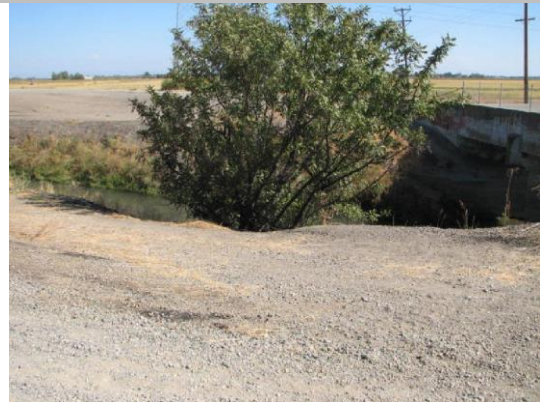
Photo 1 of 3 : UCIP\_FA\_2017\_51515\_64744.jpg

Comment Code					
Inspector Comment					
FS_ID:51515 DS_ID:17077 EP_NO: 7209 Repair Type: Non-Urgent Crossing Status: Found UCIP Comments: 4/10/2017 Tree still present and a problem at the WS pipe outlet. LS inlet is still vegetated. (DWR Sutter Yard-AFreitag)10/12/2016 Tree at the WS pipe end is still an issue and needs to be cut away. LS inlet is also being overgrown with vegetation.(DWR Sutter Yard - afreitag)4/19/2016 Tree at WS pipe end needs to be trimmed back and/or removed. 5/12/2015 Tree growing near WS pipe end is getting too big and will affect the crossing. It needs to be cut back or removed.11/18/2014 Same as last inspection.5/13/2014 Same as last inspection.10/29/2013 Same as last inspection.5/16/2013 Same as last inspection. FIELD_STRUCT_DESC: 36-inch corrugated metal drainage pipe (permit records indicate 30-inch pipe, O&M pipe replaced with new 30-inch pipe) through the levee, 14 feet below the crown. Flap gate located on the waterside (WS) end. (Original O&M manual crossing was replaced under Permit No. 7209, 1970 - Department of Water Resources [DWR]). [Additional Reference(s): DWR Levee Log, 2005. USACE Sacramento O&M Manual 135, May 1953, (Station 158+35)]. FS Date: 4/12/2017 10:16:27 AM

Bush camouflaging outlet of pipe on WS slope.

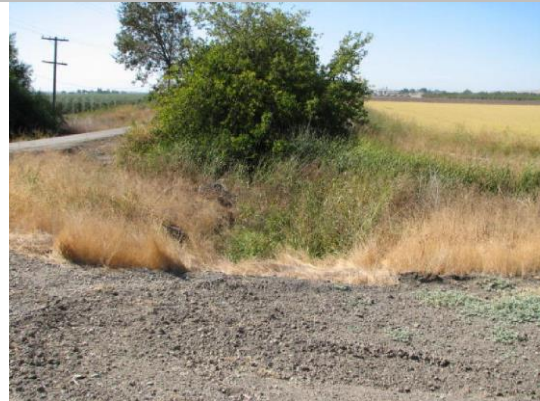
Photo 2 of 3 : UCIP\_FA\_2017\_51515\_64743.jpg

FS\_ID:51515  
DS\_ID:17077  
EP\_NO: 7209  
Repair Type: Non-Urgent  
Crossing Status: Found  
UCIP Comments: 4/10/2017 Tree still present and a problem at the WS pipe outlet. LS inlet is still vegetated. (DWR Sutter Yard-AFreitag)10/12/2016 Tree at the WS pipe end is still an issue and needs to be cut away. LS inlet is also being overgrown with vegetation.(DWR Sutter Yard - afreitag)4/19/2016 Tree at WS pipe end needs to be trimmed back and/or removed. 5/12/2015 Tree growing near WS pipe end is getting too big and will affect the crossing. It needs to be cut back or removed.11/18/2014 Same as last inspection.5/13/2014 Same as last inspection.10/29/2013 Same as last inspection.5/16/2013 Same as last inspection.  
FIELD\_STRUCT\_DESC: 36-inch corrugated metal drainage pipe (permit records indicate 30-inch pipe, O&M pipe replaced with new 30-inch pipe) through the levee, 14 feet below the crown. Flap gate located on the waterside (WS) end. (Original O&M manual crossing was replaced under Permit No. 7209, 1970 - Department of Water Resources [DWR]). [Additional Reference(s): DWR Levee Log, 2005. USACE Sacramento O&M Manual 135, May 1953, (Station 158+35)].

Heavy vegetation at LS inlet at channel.

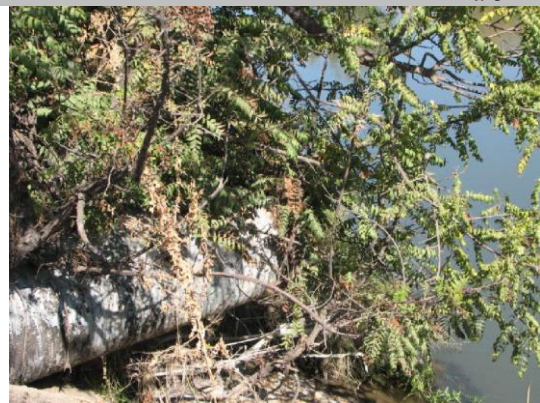
Photo 3 of 3 : UCIP\_FA\_2017\_51515\_64742.jpg

Pipe and flap gate at WS outlet.

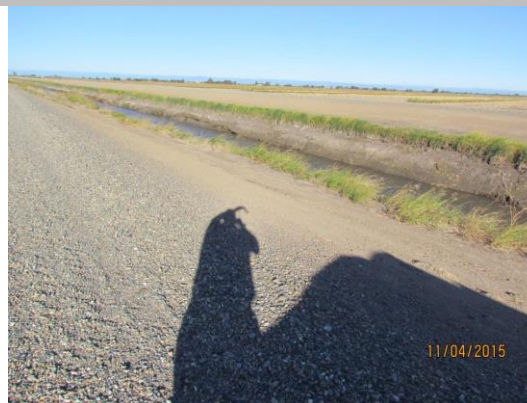
Photo 2 of 2 : FA\_2017\_ST0010\_43\_5\_20170911\_00004.jpg

View of erosion at the waterside toe

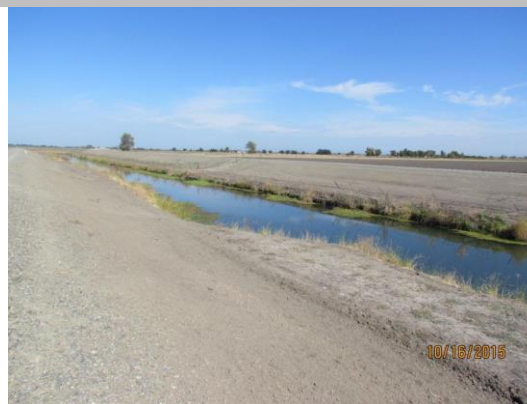
Photo 1 of 2 : FA\_2017\_ST0010\_43\_9\_20170911\_00009.jpg

LM Start	4.41	Rating **	M	Issue No.	9
LM End	4.43	Issue Type +	Ma	Location *	WS
Category	Supplemental			GPS Latitude/Longitude	
				Start	End
Item	2015 USACE Erosion Survey, DRAFT			39.168659 °	39.168937 °
				-121.728016 °	-121.727905 °
DWR ID	DWR_ST0010_02_s_2016_9				
Comment Code					
Inspector Comment					
2011 - Small erosion pocket. 2015: Site is part of the extended inventory, last inspected 2011. [2015 Site ID: WAD_4-3_R]

View of the erosion along the waterside toe.

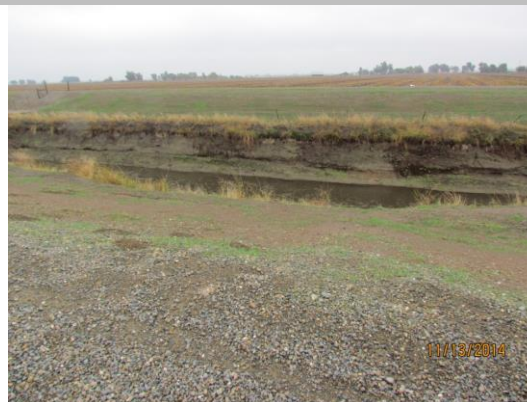
Photo 2 of 2 : FA\_2017\_ST0010\_43\_9\_20170911\_00010.jpg

View of the erosion along the waterside toe.

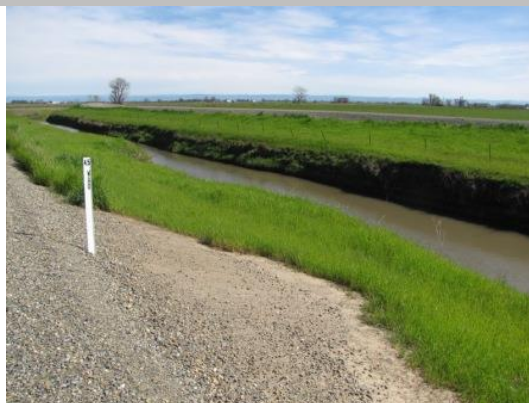
Photo 1 of 2 : FA\_2017\_ST0010\_43\_7\_20170911\_00005.jpg

View of the erosion along the W/S toe.

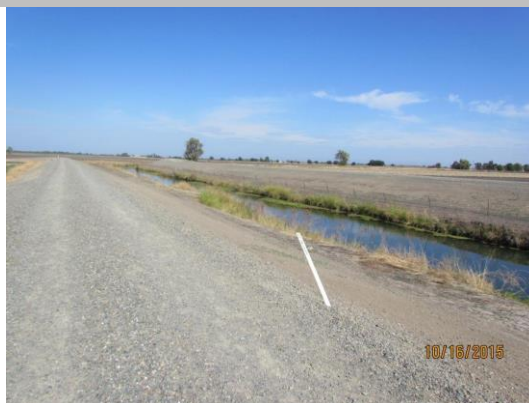
Photo 2 of 2 : FA\_2017\_ST0010\_43\_7\_20170911\_00006.jpg

View of the erosion along the waterside toe.
