**Flood Control Project Maintenance
Levee Inspections**

Maintenance Issue Types Only, Levee Inspection Report By Mile - Fall 2018

Sutter Maintenance Yard Wadsworth Canal

Waterway	Bank	Unit Miles	Inspection Start/End	Inspector
Unit No. 01 Wadsworth Canal	Left	4.63	11/06/2018 11/06/2018	Bob Duffey

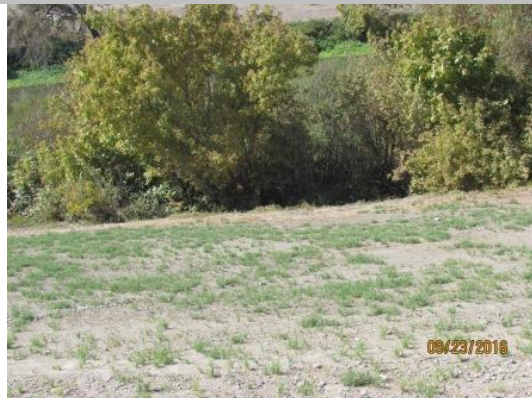
Photo 1 of 1 : FA_2018_ST0010_42_20_20180905_00013.jpg

LM Start	0.06	Rating **	A/W	Issue No.	20
LM End	0.12	Issue Type +	Ma	Location *	WS
Category	Earthen Levee			GPS Latitude/Longitude	
				Start	End
Item	Erosion / Bank Caving			39.114203 °	39.114842 °
				-121.768015 °	-121.767382 °
DWR ID	DWR_ST0010_01_f _2016_20				
Comment Code					
E1 : Note and monitor erosion site.					
Inspector Comment					
Monitor the erosion along the waterside toe.

View of the erosion along the waterside toe.

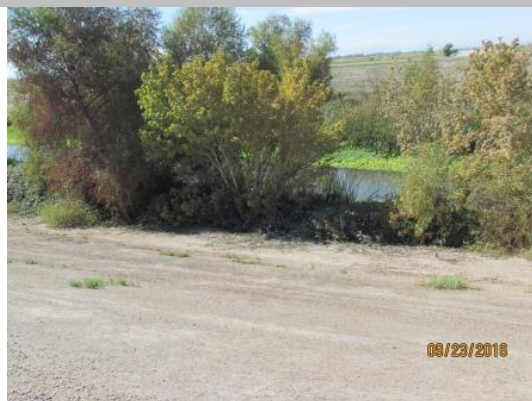
Photo 1 of 1 : FA_2018_ST0010_42_19_20180905_00012.jpg

LM Start	0.38	Rating **	A/W	Issue No.	19
LM End	0.38	Issue Type +	Ma	Location *	WS
Category	Earthen Levee			GPS Latitude/Longitude	
				Start	End
Item	Erosion / Bank Caving			39.117910 °	39.117910 °
				-121.764497 °	-121.764497 °
DWR ID	DWR_ST0010_01_f _2016_19				
Comment Code					
E1 : Note and monitor erosion site.					
Inspector Comment					
Monitor the erosion along the waterside toe.

View of the erosion along the waterside toe.

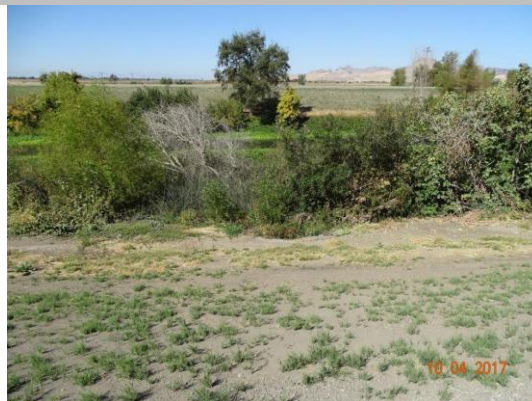
Photo 1 of 1 : FA_2018_ST0010_42_22_20180905_00014.jpg

LM Start	0.50	Rating **	U	Issue No.	22
LM End	0.50	Issue Type +	Ma	Location *	WS
Category	Earthen Levee			GPS Latitude/Longitude	
				Start	End
Item	Erosion / Bank Caving			39.119348 °	39.119348 °
				-121.763120 °	-121.763120 °
DWR ID	DWR_ST0010_01_f_2017_22				
Comment Code					
E2 : Schedule repair of erosion site prior to the next inspection.					
Inspector Comment					
Repair the beaver hole along the waterside berm.

View of the beaver hole along the waterside berm.

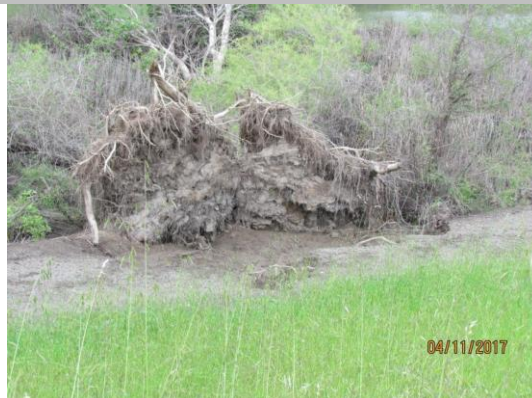
Photo 1 of 1 : FA_2018_ST0010_42_18_20180905_00011.jpg

LM Start	0.56	Rating **	M	Issue No.	18
LM End	0.56	Issue Type +	Ma	Location *	WS
Category	Earthen Levee			GPS Latitude/Longitude	
				Start	End
Item	Erosion / Bank Caving			39.119985°	39.119985°
				-121.762600°	-121.762600°
DWR ID	DWR_ST0010_01_s_2017_18				
Comment Code					
E2 : Schedule repair of erosion site prior to the next inspection.					
Inspector Comment					
Repair the erosion along the water side toe.

View of the erosion along the waterside toe caused by a tree that fell into the water.

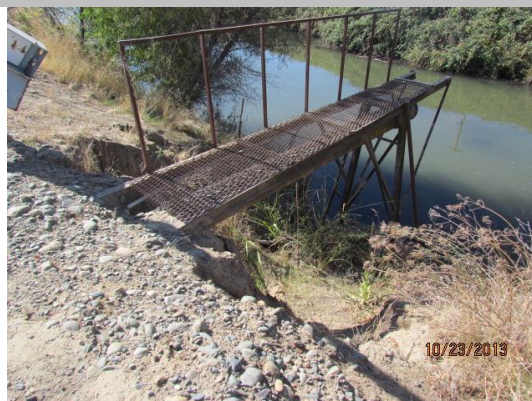
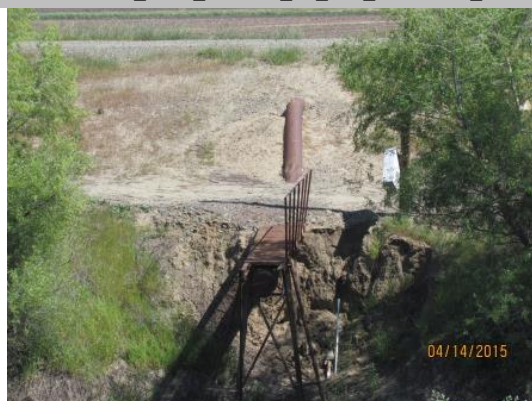
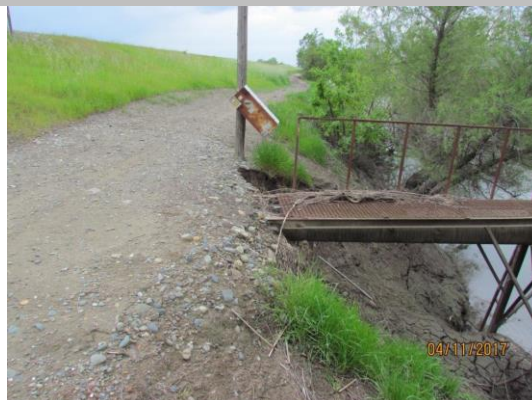
LM Start	1.85	Rating **	U	Issue No.	107
LM End	1.85	Issue Type +	Ma	Location *	WS
Category	Earthen Levee			GPS Latitude/Longitude	
				Start	End
Item	Erosion / Bank Caving			39.135110°	39.135110°
				-121.748230°	-121.748230°
DWR ID	DWR_ST0010_01_f_2013_107				
Comment Code					
E2 : Schedule repair of erosion site prior to the next inspection.					
Inspector Comment					
Repair the erosion under the abandoned pump.

View of the erosion along both sides of the abandoned pump.

View of erosion along both sides of the abandoned pipe.

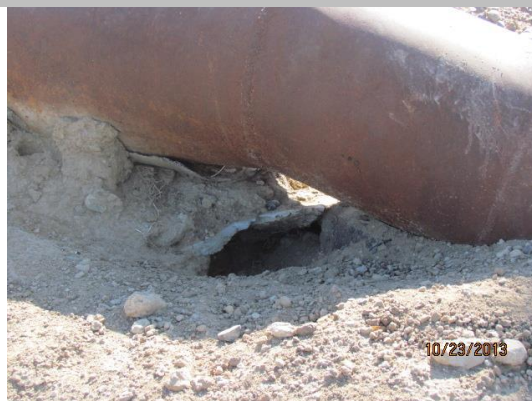
Photo 1 of 1 : FA_2018_ST0010_42_106_20180905_00016.jpg

LM Start	1.85	Rating **	M	Issue No.	106
LM End	1.85	Issue Type +	Ma	Location *	WS
Category	Earthen Levee			GPS Latitude/Longitude	
				Start	End
Item	Animal Control			39.135110 °	39.135110 °
				-121.748229 °	-121.748229 °
DWR ID	DWR_ST0010_01_f_2013_106				
Comment Code					
A3 : No rodents visible, but rodent burrows visible; need to backfill and compact or grout burrows.					
Inspector Comment

View of the rodent holes under the irrigation pipe.

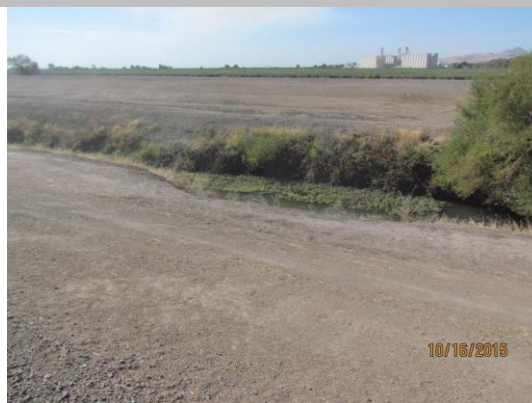
Photo 1 of 4 : FA_2018_ST0010_42_6_20180905_00006.jpg

LM Start	2.43	Rating **	M	Issue No.	6
LM End	3.30	Issue Type +	Ma	Location *	WS
Category	Supplemental			GPS Latitude/Longitude	
				Start	End
Item	2017 USACE Erosion Survey, DRAFT			39.142235 °	39.153095 °
				-121.742609 °	-121.734390 °
DWR ID	DWR_ST0010_01_f_2018_6				
Comment Code					
Inspector Comment					
2017 Site ID: WAC 2.4 L					
Status: Eroding					
2017 Field Notes: Significant new erosion along lower bank.					
Site History: 2010 - Over steepened levees, some slumping, reach-wide problem. 2011 - Still a reach-wide problem.

View of the erosion along the waterside toe.

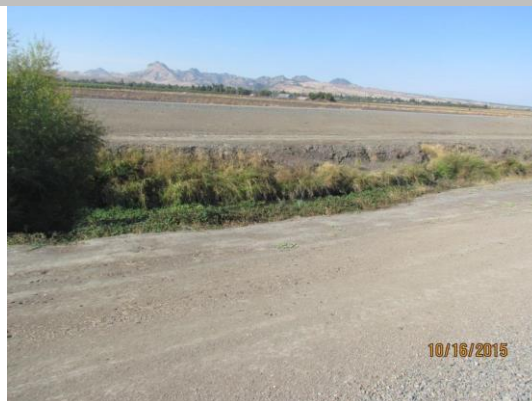
Photo 2 of 4 : FA_2018_ST0010_42_6_20180905_00007.jpg

View of the erosion along the waterside toe.

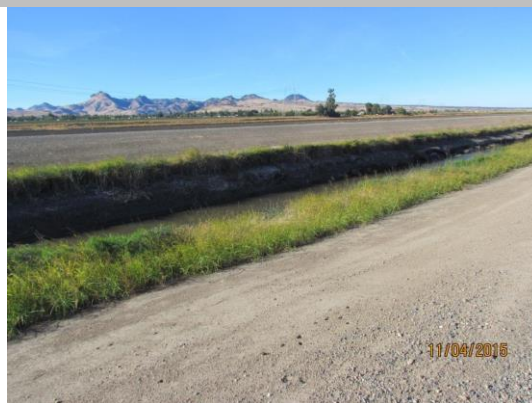
Photo 1 of 1 : FA_2018_ST0010_42_3_20180905_00001.jpg

LM Start	3.53	Rating **	A/W	Issue No.	3
LM End	3.56	Issue Type +	Ma	Location *	WS
Category	Earthen Levee			GPS Latitude/Longitude	
				Start	End
Item	Erosion / Bank Caving			39.156225 °	39.156639 °
				-121.732930 °	-121.732755 °
DWR ID	DWR_ST0010_01_s _ 2012_3				
Comment Code					
E1 : Note and monitor erosion site.					
Inspector Comment					
Monitor the erosion along the waterside toe.

View of the erosion along the waterside toe.

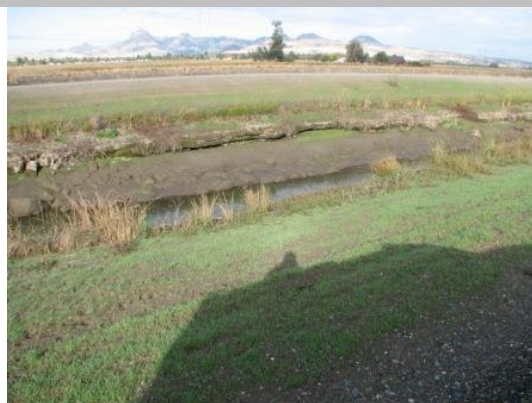
Photo 1 of 2 : FA_2018_ST0010_42_4_20180905_00002.jpg

LM Start	3.65	Rating **	A/W	Issue No.	4
LM End	3.65	Issue Type +	Ma	Location *	WS
Category	Earthen Levee			GPS Latitude/Longitude	
				Start	End
Item	Erosion / Bank Caving			39.157861 °	39.157861 °
				-121.732238 °	-121.732238 °
DWR ID	DWR_ST0010_01_s_2012_4				
Comment Code					
E1 : Note and monitor erosion site.					
Inspector Comment					
Monitor the erosion along the waterside toe.

View of the erosion along the waterside toe of the levee.

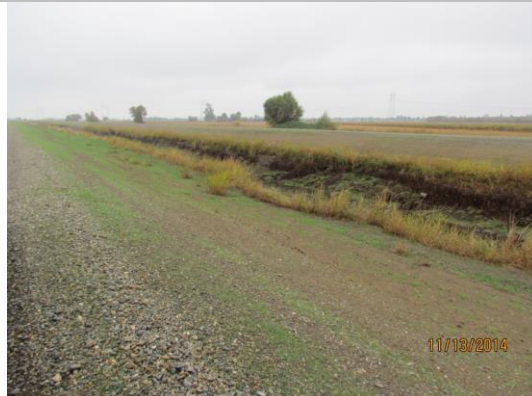
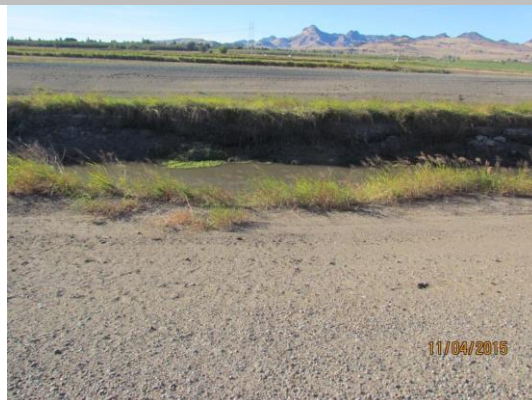
LM Start	4.23	Rating **	A/W	Issue No.	5
LM End	4.23	Issue Type +	Ma	Location *	WS
Category	Earthen Levee			GPS Latitude/Longitude	
				Start	End
Item	Erosion / Bank Caving			39.165845 °	39.165845 °
				-121.728877 °	-121.728877 °
DWR ID	DWR_ST0010_01_s_2012_5				
Comment Code					
E1 : Note and monitor erosion site.					
Inspector Comment					
Monitor the erosion along the waterside toe.

View of the erosion along the waterside toe.

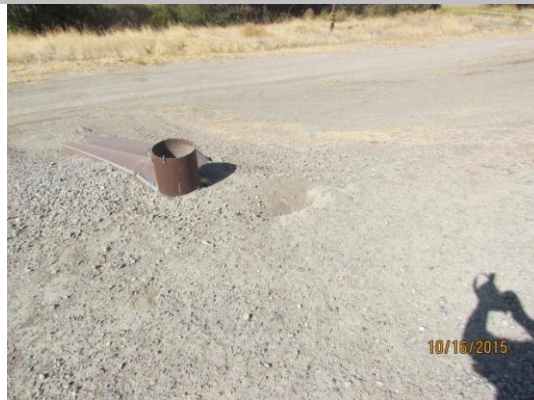
Photo 2 of 2 : FA_2018_ST0010_43_11_20180905_00012.jpg

LM Start	1.76	Rating **	M	Issue No.	11 (cont)	
LM End	1.76	Issue Type +	Ma	Location *	LS	
Category	Earthen Levee			GPS Latitude/Longitude		
				Start	End	
Item	Animal Control			39.134490 °	39.134490 °	
				-121.749716 °	-121.749716 °	
DWR ID	DWR_ST0010_02_f_2012_11					
Comment Code						
A3 : No rodents visible, but rodent burrows visible; need to backfill and compact or grout burrows.						
Inspector Comment						
Repair the rodent hole.

View of the rodent hole above the irrigation pipe.

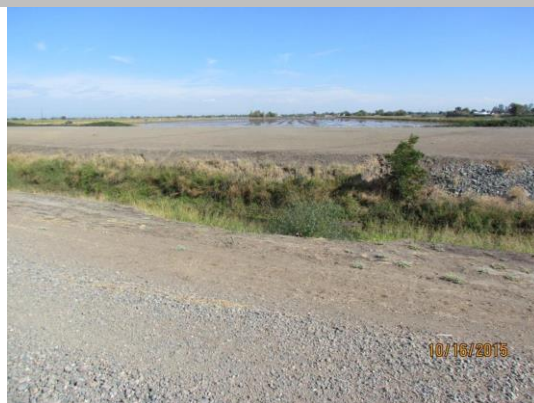
Photo 1 of 2 : FA_2018_ST0010_43_8_20180905_00007.jpg

LM Start	2.41	Rating **	M	Issue No.	8
LM End	3.28	Issue Type +	Ma	Location *	WS
Category	Supplemental			GPS Latitude/Longitude	
				Start	End
Item	2017 USACE Erosion Survey, DRAFT			39.142254 °	39.153150 °
				-121.742847 °	-121.734611 °
DWR ID	DWR_ST0010_02_f_2018_8				
Comment Code					
Inspector Comment					
2017 Site ID: WAC 2.4 R					
Status: Eroding					
2017 Field Notes: Significant new erosion along lower bank.					
Site History: 2010 - Over steepened levees, some slumping, reach-wide problem. 2011 - Still a reach-wide problem.

View of erosion along the waterside toe.

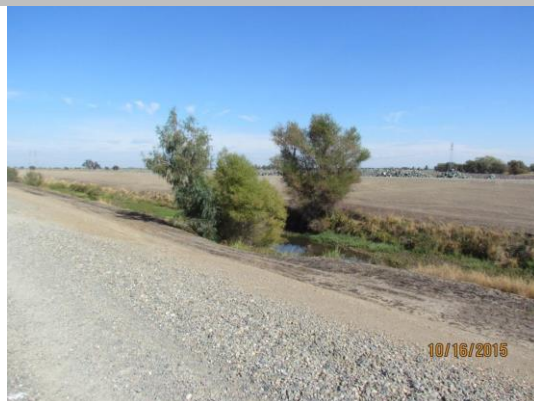
Photo 2 of 2 : FA_2018_ST0010_43_8_20180905_00008.jpg

View of the erosion along the landside toe.

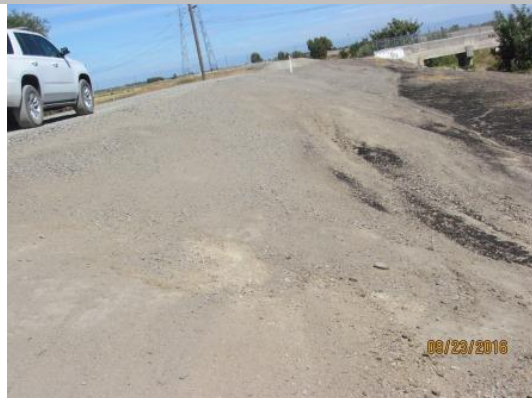
Photo 1 of 1 : FA_2018_ST0010_43_21_20180905_00015.jpg

LM Start	2.95	Rating **	M	Issue No.	21
LM End	2.95	Issue Type +	Ma	Location *	WS
Category	Earthen Levee			GPS Latitude/Longitude	
				Start	End
Item	Slope Stability			39.148938 °	39.148938 °
				-121.737620 °	-121.737620 °
DWR ID	DWR_ST0010_02_f _ 2016_21				
Comment Code					
S3 : Repair the levee slope damaged by vehicle traffic and prevent access where possible.					
Inspector Comment					
Ramp is causing depression in the levee slope.

View of the ramp encroaching into the levee.

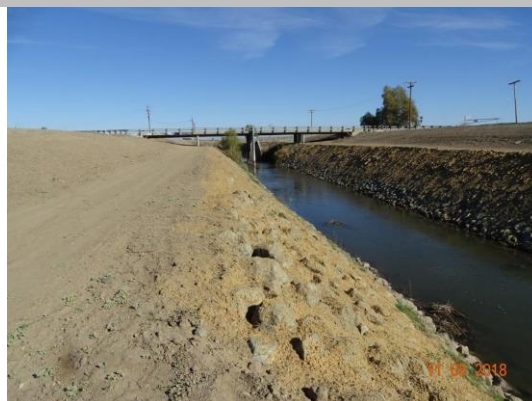
Photo 1 of 1 : FA_2018_ST0010_43_18_20181106_00036.jpg

LM Start	3.24	Rating **	A	Issue No.	18
LM End	3.27	Issue Type +	Ma	Location *	WS
Category	Earthen Levee			GPS Latitude/Longitude	
				Start	End
Item	Erosion / Bank Caving			39.152560 °	39.153087 °
				-121.735032 °	-121.734822 °
DWR ID	DWR_ST0010_02_f _ 2018_18				
Comment Code					
E1 : Note and monitor erosion site.					
Inspector Comment					
The erosion along the waterside channel was repaired.

View of the repaired erosion along the waterside channel.

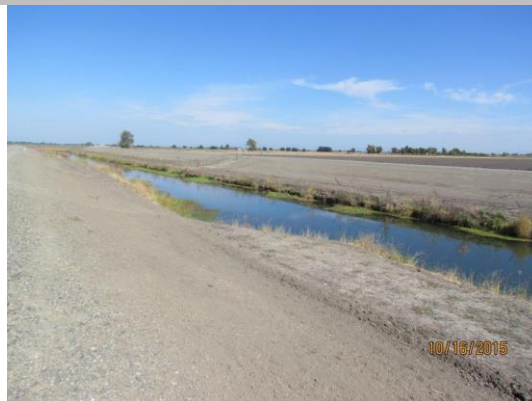
Photo 1 of 2 : FA_2018_ST0010_43_9_20180905_00009.jpg

LM Start	3.30	Rating **	M	Issue No.	9
LM End	4.58	Issue Type +	Ma	Location *	WS
Category	Supplemental			GPS Latitude/Longitude	
				Start	End
Item	2017 USACE Erosion Survey, DRAFT			39.153320 °	39.171031 °
				-121.734573 °	-121.727040 °
DWR ID	DWR_ST0010_02_f_2018_9				
Comment Code					
Inspector Comment					
2017 Site ID: WAC 4.3 R					
Status: Eroding					
2017 Field Notes: Site extended downstream. Significant lower bank erosion.					
Site History: 2011 - Small erosion pocket.

View of the erosion along the waterside toe.

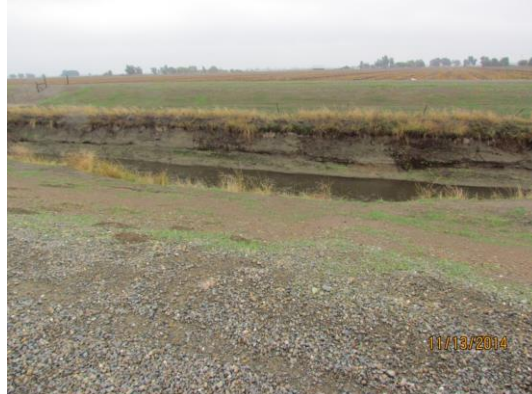
Photo 2 of 2 : FA_2018_ST0010_43_9_20180905_00010.jpg

View of the erosion along the waterside toe.

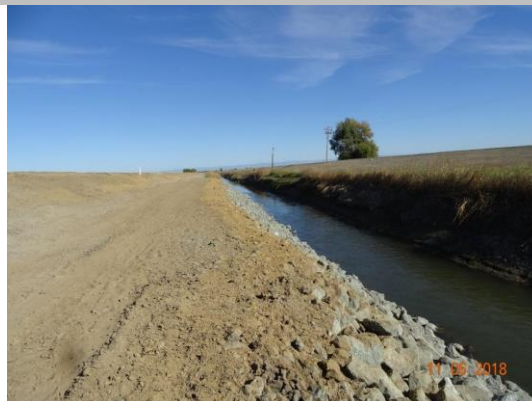
Photo 1 of 2 : FA_2018_ST0010_43_4_20181106_00037.jpg

LM Start	3.42	Rating **	A	Issue No.	4
LM End	3.46	Issue Type +	Ma	Location *	WS
Category	Earthen Levee			GPS Latitude/Longitude	
				Start	End
Item	Erosion / Bank Caving			39.155057°	39.155590°
				-121.733985°	-121.733733°
DWR ID	DWR_ST0010_02_s_2012_4				
Comment Code					
E1 : Note and monitor erosion site.					
Inspector Comment					
The erosion along the waterside channel was repaired by Sutter Maintenance Yard.

View of the repaired erosion along the waterside channel.

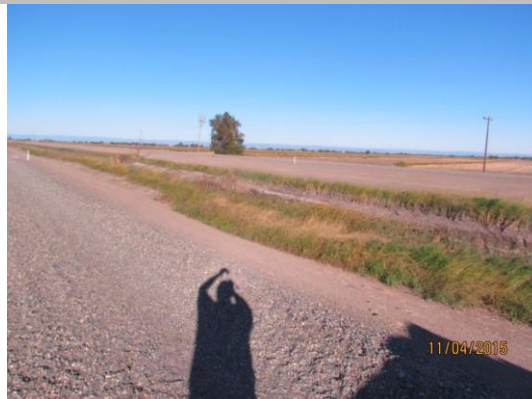
Photo 2 of 2 : FA_2018_ST0010_43_4_20180905_00002.jpg

View of the erosion at the waterside toe.

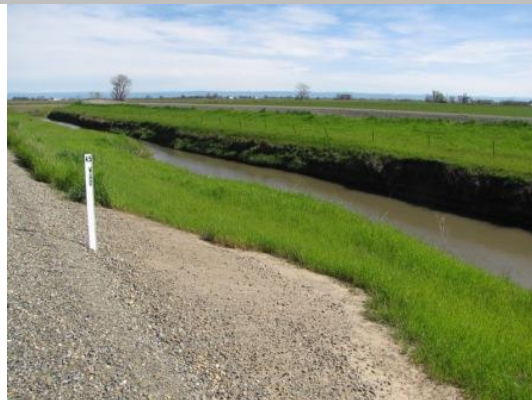
Photo 2 of 2 : FA_2018_ST0010_43_7_20180905_00005.jpg

LM Start	4.41	Rating **	A	Issue No.	7 (cont)	
LM End	4.51	Issue Type +	Ma	Location *	WS	
Category	Earthen Levee			GPS Latitude/Longitude		
				Start		End
Item	Erosion / Bank Caving			39.168652 °		39.170110 °
				-121.728202 °		-121.727608 °
DWR ID	DWR_ST0010_02_s_2012_7					
Comment Code						
E1 : Note and monitor erosion site.						
Inspector Comment						
The erosion along the waterside channel was repaired by Sutter Maintenance Yard.

View of the erosion along the WS toe.
