**Flood Control Project Maintenance
Levee Inspections**

Maintenance Issue Types Only, Levee Inspection Report By Mile - Fall 2019

Sutter Maintenance Yard Wadsworth Canal

Waterway	Bank	Unit Miles	Inspection Start/End	Inspector
Unit No. 01 Wadsworth Canal	Left	4.63	10/08/2019 10/08/2019	Makar Sokol

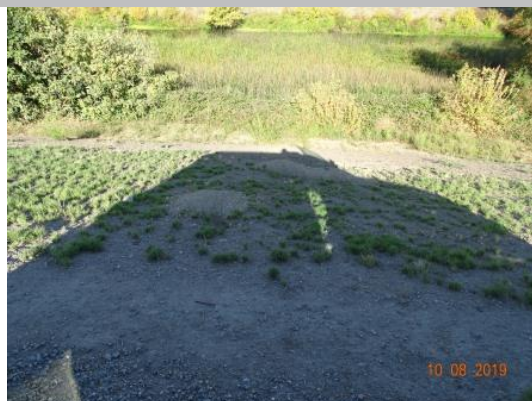
Photo 1 of 1 : FA_2019_ST0010_42_26_20191011_00052.jpg

LM Start	0.29	Rating **	M	Issue No.	26
LM End	0.29	Issue Type +	Ma	Location *	WS
Category	Earthen Levee			GPS Latitude/Longitude	
				Start	End
Item	Animal Control			39.116873 °	39.116873 °
				-121.765493 °	-121.765493 °
DWR ID	DWR_ST0010_01_f_2019_26				
Comment Code					
A3 : No rodents visible, but rodent burrows visible; need to backfill and compact or grout burrows.					
Inspector Comment

View of the rodent burrows on the waterside slope. Fall 2019.

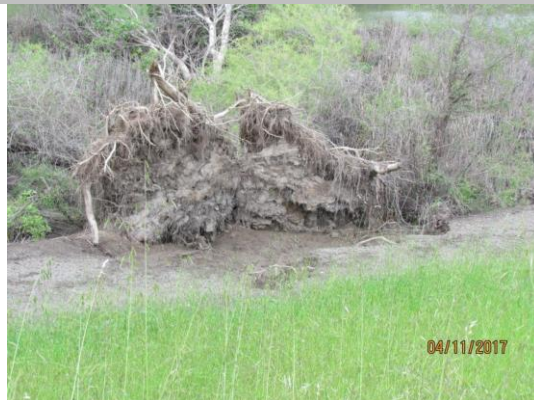
Photo 1 of 1 : FA_2019_ST0010_42_18_20190822_00011.jpg

LM Start	0.56	Rating **	M	Issue No.	18
LM End	0.56	Issue Type +	Ma	Location *	WS
Category	Earthen Levee			GPS Latitude/Longitude	
				Start	End
Item	Erosion / Bank Caving			39.119985 °	39.119985 °
				-121.762600 °	-121.762600 °
DWR ID	DWR_ST0010_01_s_2017_18				
Comment Code					
E2 : Schedule repair of erosion site prior to the next inspection.					
Inspector Comment

View of the erosion along the waterside toe caused by a tree that fell into the water.

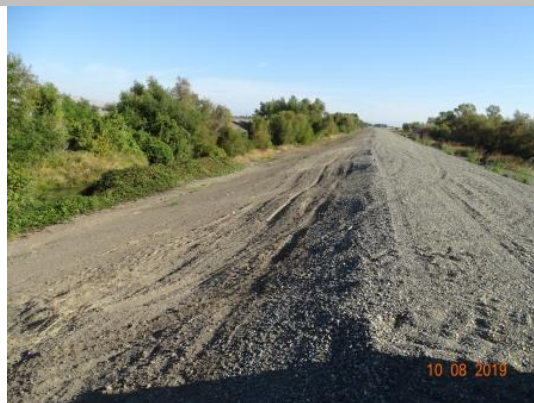
Photo 1 of 1 : FA_2019_ST0010_42_29_20191011_00053.jpg

LM Start	1.28	Rating **	M	Issue No.	29
LM End	1.28	Issue Type +	Ma	Location *	WS
Category	Earthen Levee			GPS Latitude/Longitude	
				Start	End
Item	Slope Stability			39.128352 °	39.128352 °
				-121.754575 °	-121.754575 °
DWR ID	DWR_ST0010_01_f_2019_29				
Comment Code					
S3 : Repair the levee slope damaged by vehicle traffic and prevent access where possible.					
Inspector Comment

View of the slope erosion due to vehicle traffic. Fall 2019.

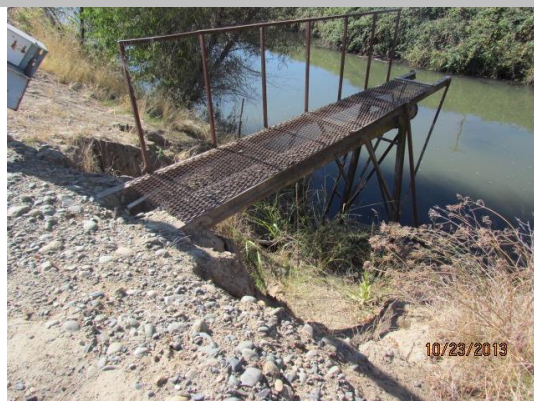
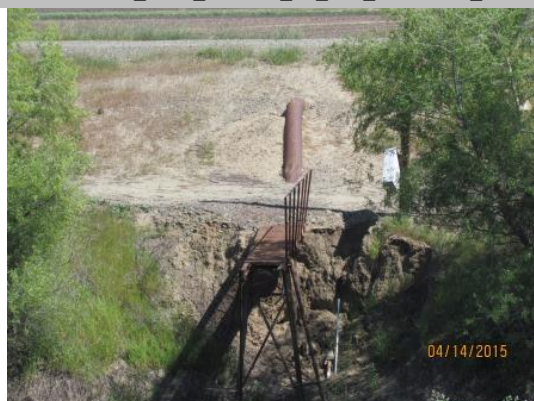
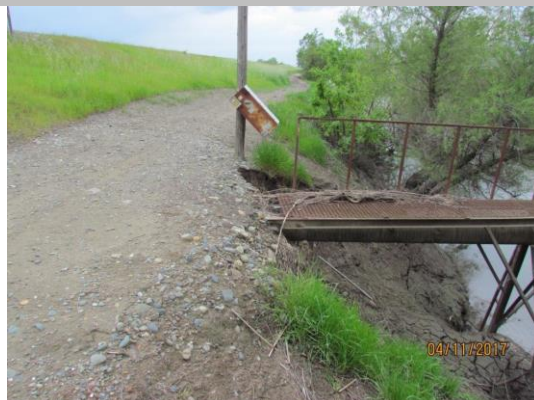
LM Start	1.85	Rating **	U	Issue No.	107
LM End	1.85	Issue Type +	Ma	Location *	WS
Category	Earthen Levee			GPS Latitude/Longitude	
				Start	End
Item	Erosion / Bank Caving			39.135110°	39.135110°
				-121.748230°	-121.748230°
DWR ID	DWR_ST0010_01_f_2013_107				
Comment Code					
E2 : Schedule repair of erosion site prior to the next inspection.					
Inspector Comment					
Significant erosion is present at this site and should be addressed.

View of the erosion along both sides of the abandoned pump.

View of erosion along both sides of the abandoned pipe.

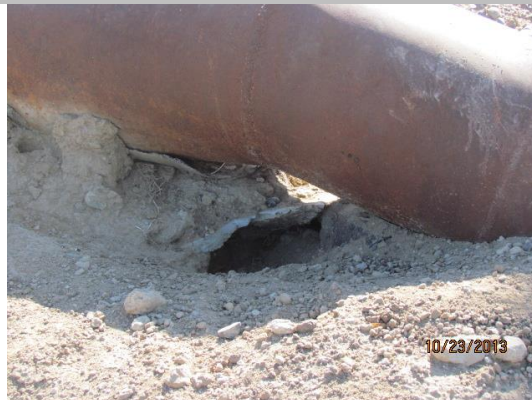
Photo 1 of 1 : FA_2019_ST0010_42_106_20190822_00015.jpg

LM Start	1.85	Rating **	M	Issue No.	106
LM End	1.85	Issue Type +	Ma	Location *	WS
Category	Earthen Levee			GPS Latitude/Longitude	
				Start	End
Item	Animal Control			39.135110 °	39.135110 °
				-121.748229 °	-121.748229 °
DWR ID	DWR_ST0010_01_f_2013_106				
Comment Code					
A3 : No rodents visible, but rodent burrows visible; need to backfill and compact or grout burrows.					
Inspector Comment

View of the rodent holes under the irrigation pipe.

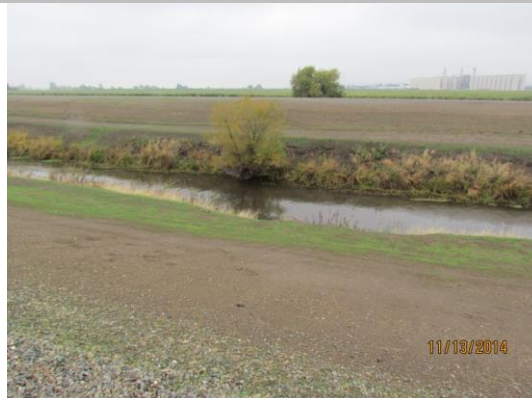
LM Start	2.43	Rating **	M	Issue No.	6
LM End	3.30	Issue Type +	Ma	Location *	WS
Category	Supplemental			GPS Latitude/Longitude	
				Start	End
Item	2017 USACE Erosion Survey			39.142235 °	39.153095 °
				-121.742609 °	-121.734390 °
DWR ID	DWR_ST0010_01_f_2018_6				
Comment Code					
Inspector Comment					
2017 Site ID: WAC 2.4 L					
Status: Eroding					
2017 Field Notes: Significant new erosion along lower bank.					
Site History: 2010 - Over steepened levees, some slumping, reach-wide problem. 2011 - Still a reach-wide problem.

View of the erosion along the waterside toe.

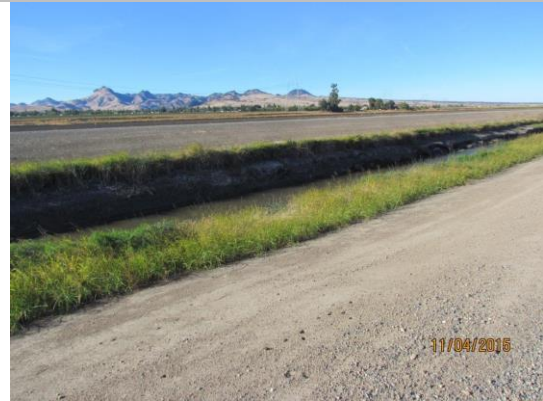
Photo 1 of 1 : FA_2019_ST0010_42_3_20190822_00001.jpg

LM Start	3.53	Rating **	A/W	Issue No.	3
LM End	3.56	Issue Type +	Ma	Location *	WS
Category	Earthen Levee			GPS Latitude/Longitude	
				Start	End
Item	Erosion / Bank Caving			39.156225°	39.156639°
				-121.732930°	-121.732755°
DWR ID	DWR_ST0010_01_s_2012_3				
Comment Code					
E1 : Note and monitor erosion site.					
Inspector Comment

View of the erosion along the waterside toe.

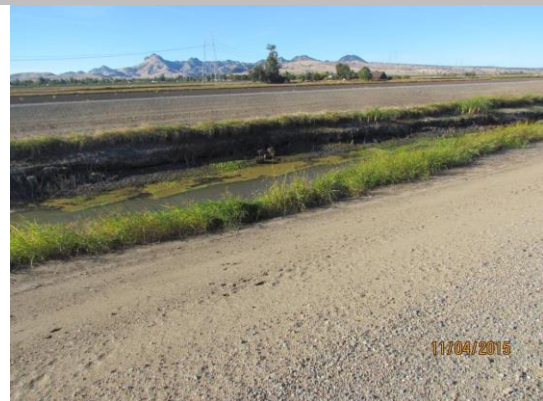
Photo 1 of 1 : FA_2019_ST0010_42_4_20190822_00003.jpg

LM Start	3.65	Rating **	A/W	Issue No.	4
LM End	3.65	Issue Type +	Ma	Location *	WS
Category	Earthen Levee			GPS Latitude/Longitude	
				Start	End
Item	Erosion / Bank Caving			39.157861°	39.157861°
				-121.732238°	-121.732238°
DWR ID	DWR_ST0010_01_s_2012_4				
Comment Code					
E1 : Note and monitor erosion site.					
Inspector Comment

View of the erosion along the waterside toe.

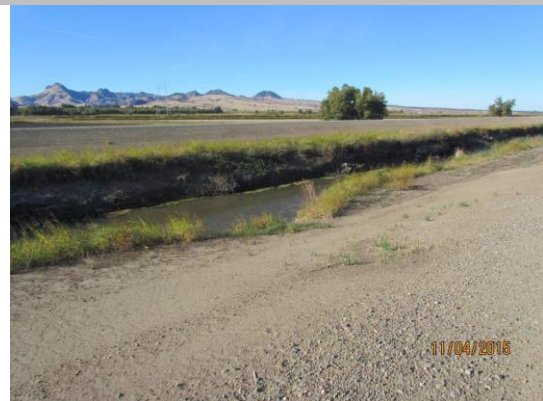
Photo 1 of 1 : FA_2019_ST0010_42_17_20190822_00010.jpg

LM Start	3.84	Rating **	A/W	Issue No.	17
LM End	3.96	Issue Type +	Ma	Location *	WS
Category	Earthen Levee			GPS Latitude/Longitude	
				Start	End
Item	Erosion / Bank Caving			39.160442°	39.162235°
				-121.731067°	-121.730912°
DWR ID	DWR_ST0010_01_f_2014_17				
Comment Code					
E1 : Note and monitor erosion site.					
Inspector Comment

View of the erosion along the waterside toe.

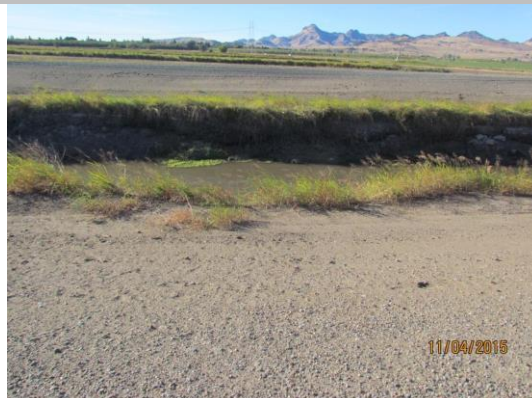
Photo 1 of 1 : FA_2019_ST0010_42_5_20190822_00005.jpg

LM Start	4.23	Rating **	A/W	Issue No.	5
LM End	4.23	Issue Type +	Ma	Location *	WS
Category	Earthen Levee			GPS Latitude/Longitude	
				Start	End
Item	Erosion / Bank Caving			39.165845°	39.165845°
				-121.728877°	-121.728877°
DWR ID	DWR_ST0010_01_s_2012_5				
Comment Code					
E1 : Note and monitor erosion site.					
Inspector Comment

View of the erosion along the waterside toe.

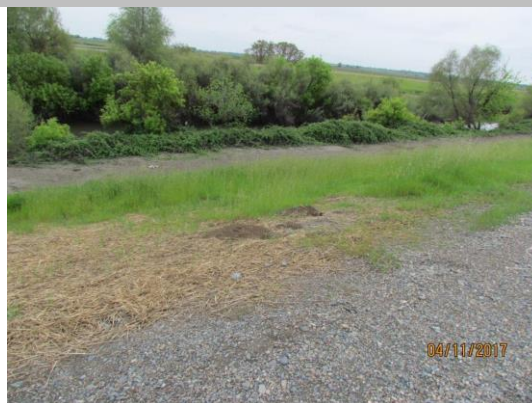
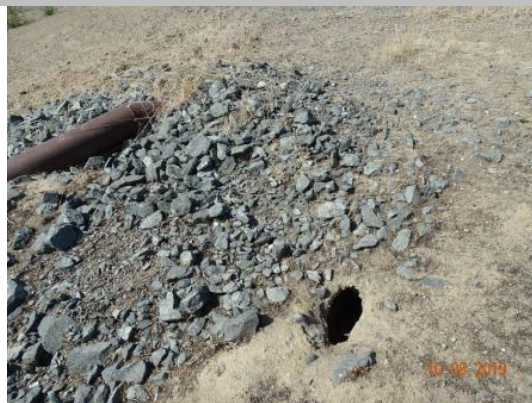
LM Start	1.16	Rating **	U	Issue No.	19
LM End	1.16	Issue Type +	Ma	Location *	WS
Category	Earthen Levee			GPS Latitude/Longitude	
				Start	End
Item	Animal Control			39.127527 °	39.127527 °
				-121.756493 °	-121.756493 °
DWR ID	DWR_ST0010_02_f_2016_19				
Comment Code					
A3 : No rodents visible, but rodent burrows visible; need to backfill and compact or grout burrows.					
Inspector Comment

View of the rodent holes along the waterside slope.

View of a rodent hole on the waterside slope. Fall 2019.

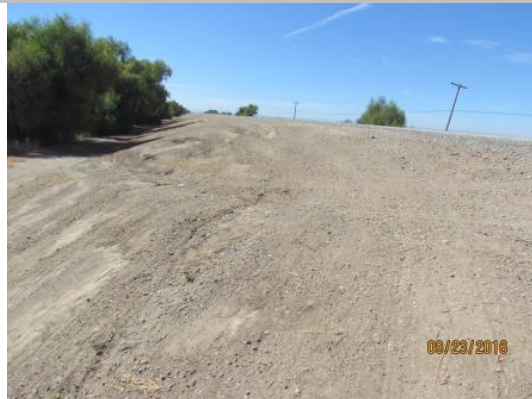
Photo 1 of 1 : FA_2019_ST0010_43_20_20190822_00009.jpg

LM Start	1.75	Rating **	M	Issue No.	20
LM End	1.75	Issue Type +	Ma	Location *	WS
Category	Earthen Levee			GPS Latitude/Longitude	
				Start	End
Item	Slope Stability			39.134378 °	39.134378 °
				-121.749803 °	-121.749803 °
DWR ID	DWR_ST0010_02_f_2016_20				
Comment Code					
S3 : Repair the levee slope damaged by vehicle traffic and prevent access where possible.					
Inspector Comment					
Ramp is causing depression in the levee slope.

View of the ramp encroaching into the levee.

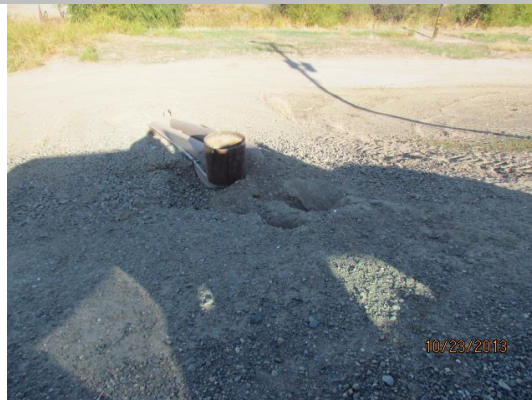
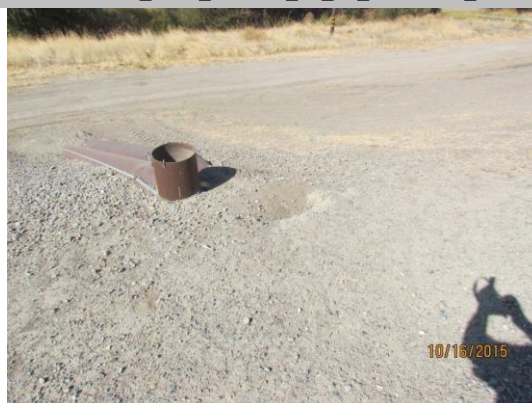
LM Start	1.76	Rating **	M	Issue No.	11
LM End	1.76	Issue Type +	Ma	Location *	LS
Category	Earthen Levee			GPS Latitude/Longitude	
				Start	End
Item	Animal Control			39.134490 °	39.134490 °
				-121.749716 °	-121.749716 °
DWR ID	DWR_ST0010_02_f_2012_11				
Comment Code					
A3 : No rodents visible, but rodent burrows visible; need to backfill and compact or grout burrows.					
Inspector Comment

View of the rodent holes above the irrigation pipe.

View of the rodent hole above the irrigation pipe.

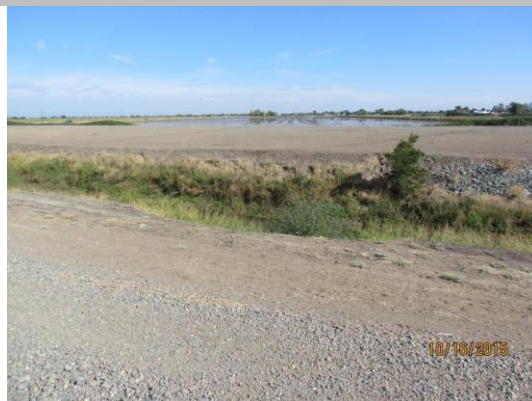
Photo 1 of 2 : FA_2019_ST0010_43_8_20190822_00001.jpg

LM Start	2.41	Rating **	A/W	Issue No.	8
LM End	3.28	Issue Type +	Ma	Location *	WS
Category	Supplemental			GPS Latitude/Longitude	
				Start	End
Item	2017 USACE Erosion Survey			39.142254 °	39.153150 °
				-121.742847 °	-121.734611 °
DWR ID	DWR_ST0010_02_f_2018_8				
Comment Code					
Inspector Comment					
2017 Site ID: WAC 2.4 R					
Status: Eroding					
2017 Field Notes: Significant new erosion along lower bank.					
Site History: 2010 - Over steepened levees, some slumping, reach-wide problem. 2011 - Still a reach-wide problem.

View of erosion along the waterside toe.

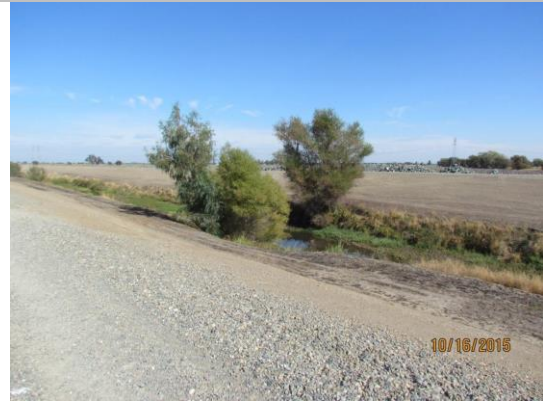
Photo 2 of 2 : FA_2019_ST0010_43_8_20190822_00002.jpg

LM Start	2.41	Rating **	A/W	Issue No.	8 (cont)
LM End	3.28	Issue Type +	Ma	Location *	WS
Category	Supplemental			GPS Latitude/Longitude	
				Start	End
Item	2017 USACE Erosion Survey			39.142254 °	39.153150 °
				-121.742847 °	-121.734611 °
DWR ID	DWR_ST0010_02_f_2018_8				
Comment Code					
Inspector Comment					
2017 Site ID: WAC 2.4 R					
Status: Eroding					
2017 Field Notes: Significant new erosion along lower bank.					
Site History: 2010 - Over steepened levees, some slumping, reach-wide problem. 2011 - Still a reach-wide problem.

View of the erosion along the landside toe.

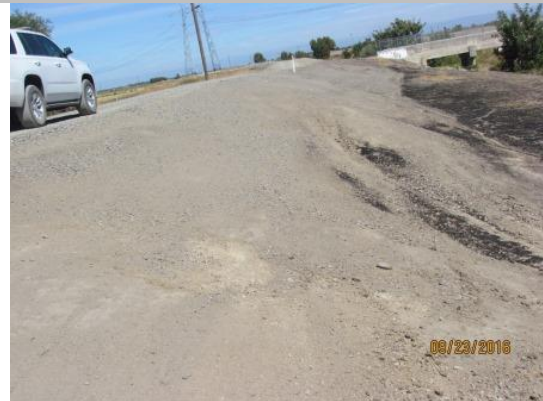
Photo 1 of 1 : FA_2019_ST0010_43_21_20190822_00010.jpg

LM Start	2.95	Rating **	M	Issue No.	21
LM End	2.95	Issue Type +	Ma	Location *	WS
Category	Earthen Levee			GPS Latitude/Longitude	
				Start	End
Item	Slope Stability			39.148938 °	39.148938 °
				-121.737620 °	-121.737620 °
DWR ID	DWR_ST0010_02_f_2016_21				
Comment Code					
S3 : Repair the levee slope damaged by vehicle traffic and prevent access where possible.					
Inspector Comment					
Ramp is causing depression in the levee slope.

View of the ramp encroaching into the levee.

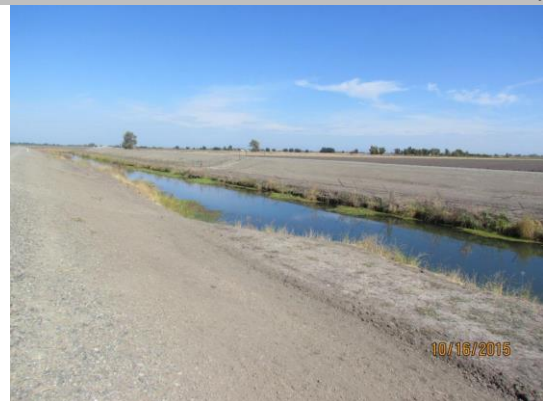
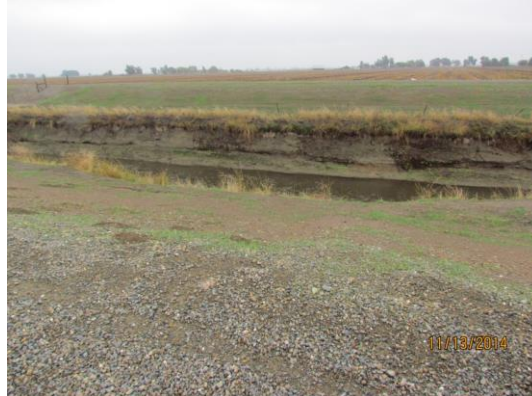
LM Start	3.30	Rating **	A/W	Issue No.	9
LM End	4.58	Issue Type +	Ma	Location *	WS
Category	Supplemental			GPS Latitude/Longitude	
				Start	End
Item	2017 USACE Erosion Survey			39.153320 °	39.171031 °
				-121.734573 °	-121.727040 °
DWR ID	DWR_ST0010_02_f_2018_9				
Comment Code					
Inspector Comment					
2017 Site ID: WAC 4.3 R					
Status: Eroding					
2017 Field Notes: Site extended downstream. Significant lower bank erosion.					
Site History: 2011 - Small erosion pocket.

View of the erosion along the waterside toe.
