**Flood Control Project Maintenance
Levee Inspections**

Maintenance Issue Types Only, Levee Inspection Report By Mile - Fall 2020

Sutter Maintenance Yard Wadsworth Canal

Waterway	Bank	Unit Miles	Inspection Start/End	Inspector
Unit No. 01 Wadsworth Canal	Left	4.63	09/24/2020 09/24/2020	Makar Sokol

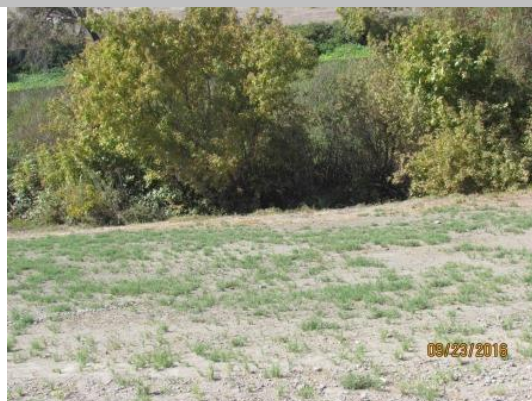
Photo 1 of 1 : FA_2020_ST0010_42_20_20200915_00007.jpg

LM Start	0.06	Rating **	A/W	Issue No.	20
LM End	0.12	Issue Type +	Ma	Location *	WS
Category	Earthen Levee			GPS Latitude/Longitude	
				Start	End
Item	Erosion / Bank Caving			39.114203 °	39.114842 °
				-121.768015 °	-121.767382 °
DWR ID	DWR_ST0010_01_f_2016_20				
Comment Code					
E1 : Note and monitor erosion site.					
Inspector Comment

View of the erosion along the waterside toe.

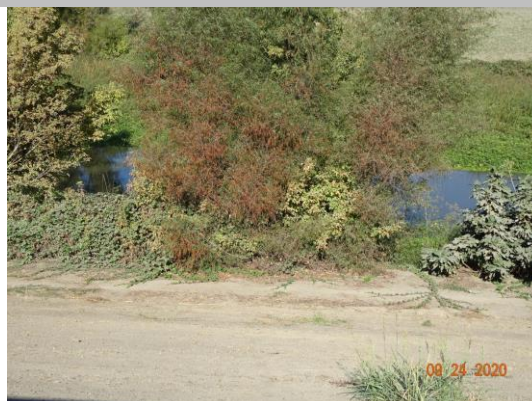
Photo 1 of 1 : FA_2020_ST0010_42_19_20201014_00043.jpg

LM Start	0.38	Rating **	A/W	Issue No.	19
LM End	0.38	Issue Type +	Ma	Location *	WS
Category	Earthen Levee			GPS Latitude/Longitude	
				Start	End
Item	Erosion / Bank Caving			39.117910 °	39.117910 °
				-121.764497 °	-121.764497 °
DWR ID	DWR_ST0010_01_f_2016_19				
Comment Code					
E1 : Note and monitor erosion site.					
Inspector Comment

View of the erosion along the waterside toe. Fall 2020.

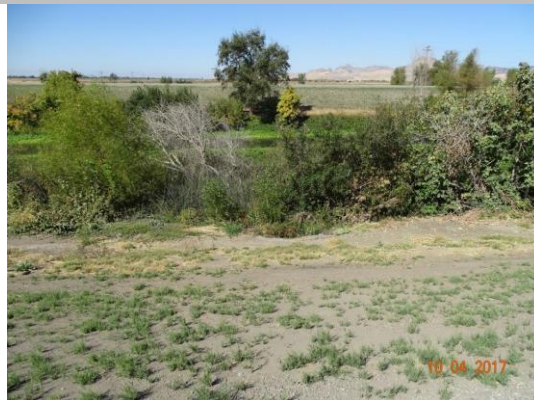
Photo 1 of 1 : FA_2020_ST0010_42_22_20200915_00008.jpg

LM Start	0.50	Rating **	U	Issue No.	22
LM End	0.50	Issue Type +	Ma	Location *	WS
Category	Earthen Levee			GPS Latitude/Longitude	
				Start	End
Item	Erosion / Bank Caving			39.119348 °	39.119348 °
				-121.763120 °	-121.763120 °
DWR ID	DWR_ST0010_01_f_2017_22				
Comment Code					
E2 : Schedule repair of erosion site prior to the next inspection.					
Inspector Comment					
Repair the beaver hole along the waterside berm.

View of the beaver hole along the waterside berm.

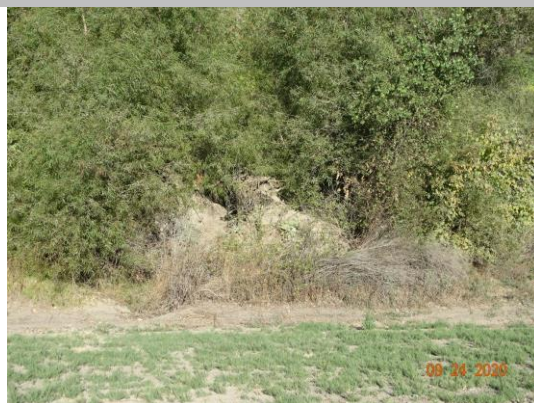
Photo 1 of 1 : FA_2020_ST0010_42_18_20201014_00044.jpg

LM Start	0.56	Rating **	M	Issue No.	18
LM End	0.56	Issue Type +	Ma	Location *	WS
Category	Earthen Levee			GPS Latitude/Longitude	
				Start	End
Item	Erosion / Bank Caving			39.119985 °	39.119985 °
				-121.762600 °	-121.762600 °
DWR ID	DWR_ST0010_01_s_2017_18				
Comment Code					
E2 : Schedule repair of erosion site prior to the next inspection.					
Inspector Comment

View of the erosion along the waterside toe. Fall 2020.

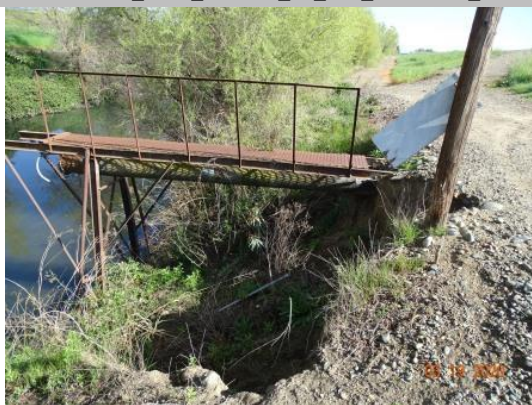
Photo 1 of 2 : FA_2020_ST0010_42_107_20200915_00010.jpg

LM Start	1.85	Rating **	U	Issue No.	107
LM End	1.85	Issue Type +	Ma	Location *	WS
Category	Earthen Levee			GPS Latitude/Longitude	
				Start	End
Item	Erosion / Bank Caving			39.135110 °	39.135110 °
				-121.748230 °	-121.748230 °
DWR ID	DWR_ST0010_01_f_2013_107				
Comment Code					
E2 : Schedule repair of erosion site prior to the next inspection.					
Inspector Comment					
Significant erosion is present at this site and should be addressed.

View of erosion along both sides of the abandoned pump. Spring 2020.

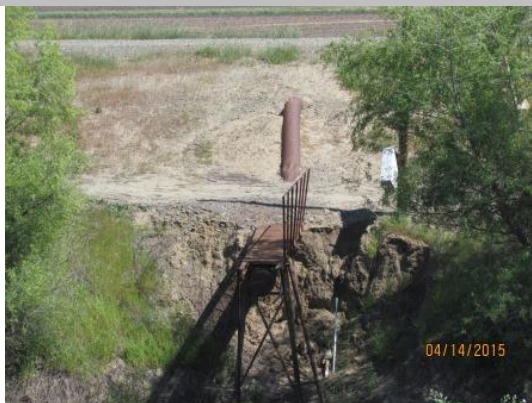
Photo 2 of 2 : FA_2020_ST0010_42_107_20200915_00011.jpg

View of the erosion along both sides of the abandoned pump. Spring 2015.

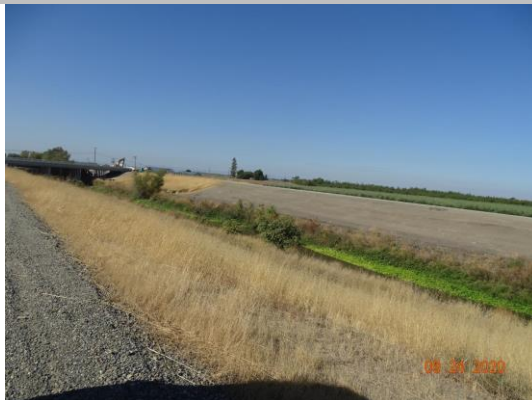
Photo 1 of 1 : FA_2020_ST0010_42_16_20201014_00045.jpg

LM Start	2.36	Rating **	M	Issue No.	16
LM End	2.52	Issue Type +	Ma	Location *	WS
Category	Earthen Levee			GPS Latitude/Longitude	
				Start	End
Item	Vegetation			39.141275 °	39.143205 °
				-121.743207 °	-121.741605 °
DWR ID	DWR_ST0010_01_f_2020_16				
Comment Code					
V1 : Control annual grass and weeds on the levee slopes and easements.					
Inspector Comment

View of the vegetation along the waterside slope. Fall 2020.

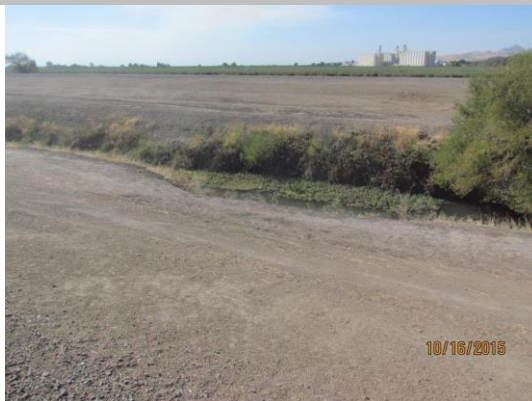
Photo 1 of 2 : FA_2020_ST0010_42_6_20200915_00001.jpg

LM Start	2.43	Rating **	M	Issue No.	6
LM End	3.30	Issue Type +	Ma	Location *	WS
Category	Supplemental			GPS Latitude/Longitude	
				Start	End
Item	2017 USACE Erosion Survey			39.142235 °	39.153095 °
				-121.742609 °	-121.734390 °
DWR ID	DWR_ST0010_01_f _2018_6				
Comment Code					
Inspector Comment					
2017 Site ID: WAC 2.4 L					
Status: Eroding					
2017 Field Notes: Significant new erosion along lower bank.					
Site History: 2010 - Over steepened levees, some slumping, reach-wide problem. 2011 - Still a reach-wide problem.

View of the erosion along the waterside toe.

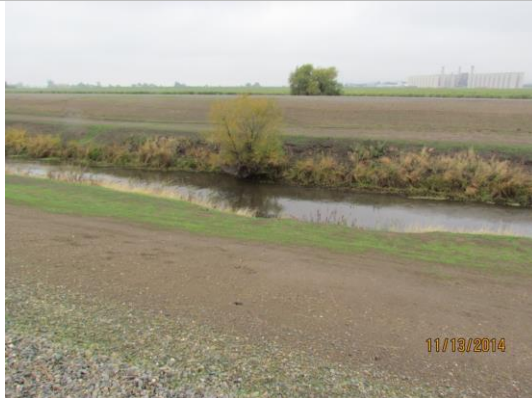
Photo 2 of 2 : FA_2020_ST0010_42_6_20200915_00004.jpg

View of the erosion along the waterside toe.

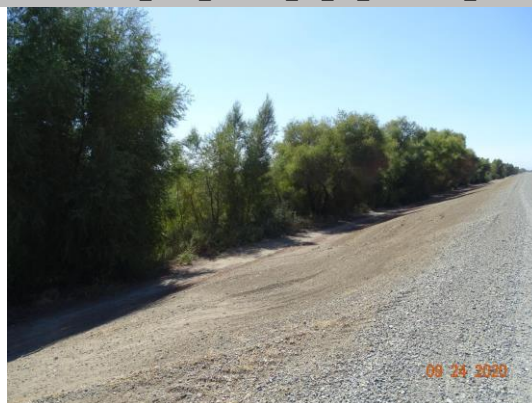
Photo 1 of 1 : FA_2020_ST0010_43_20_20201014_00048.jpg

LM Start	1.75	Rating **	M	Issue No.	20
LM End	1.75	Issue Type +	Ma	Location *	WS
Category	Earthen Levee			GPS Latitude/Longitude	
				Start	End
Item	Slope Stability			39.134378 °	39.134378 °
				-121.749803 °	-121.749803 °
DWR ID	DWR_ST0010_02_f_2016_20				
Comment Code					
S3 : Repair the levee slope damaged by vehicle traffic and prevent access where possible.					
Inspector Comment					
Ramp is causing depression in the levee slope.

View of the ramp encroaching into the levee. Fall 2020.

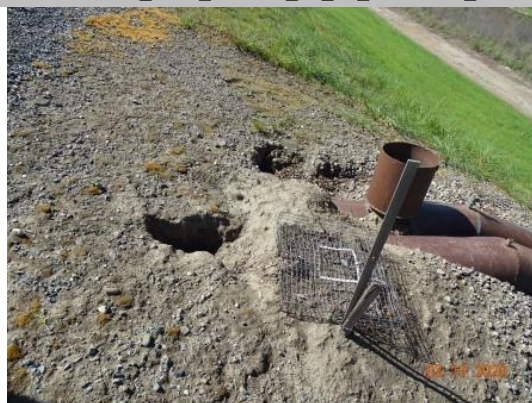
Photo 1 of 1 : FA_2020_ST0010_43_11_20200915_00005.jpg

LM Start	1.76	Rating **	M	Issue No.	11	
LM End	1.76	Issue Type +	Ma	Location *	LS	
Category	Earthen Levee			GPS Latitude/Longitude		
				Start		End
Item	Animal Control			39.134490 °		39.134490 °
				-121.749716 °		-121.749716 °
DWR ID	DWR_ST0010_02_f_2012_11					
Comment Code						
A3 : No rodents visible, but rodent burrows visible; need to backfill and compact or grout burrows.						
Inspector Comment

View of the rodent holes above the irrigation pipe. Spring 2020.

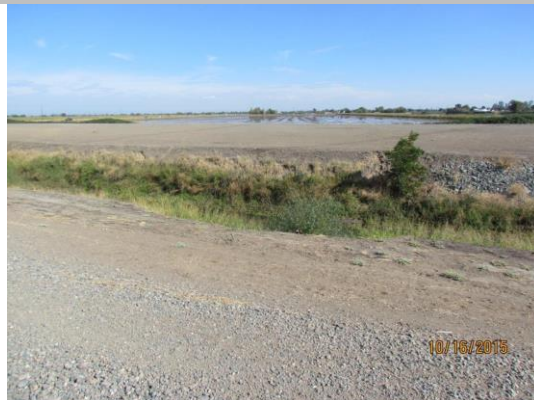
Photo 1 of 2 : FA_2020_ST0010_43_8_20200915_00001.jpg

LM Start	2.41	Rating **	A/W	Issue No.	8
LM End	3.28	Issue Type +	Ma	Location *	WS
Category	Supplemental			GPS Latitude/Longitude	
				Start	End
Item	2017 USACE Erosion Survey			39.142254 °	39.153150 °
				-121.742847 °	-121.734611 °
DWR ID	DWR_ST0010_02_f_2018_8				
Comment Code					
Inspector Comment					
2017 Site ID: WAC 2.4 R					
Status: Eroding					
2017 Field Notes: Significant new erosion along lower bank.					
Site History: 2010 - Over steepened levees, some slumping, reach-wide problem. 2011 - Still a reach-wide problem.

View of erosion along the waterside toe.

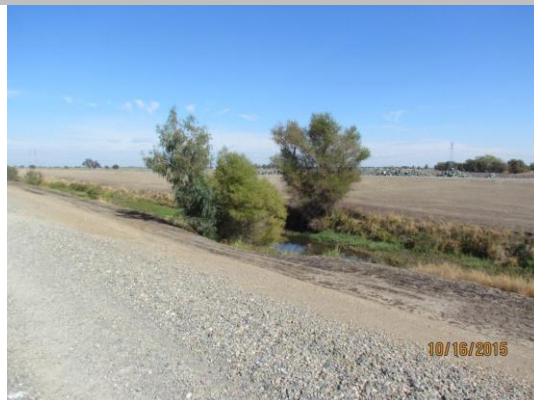
Photo 2 of 2 : FA_2020_ST0010_43_8_20200915_00002.jpg

View of the erosion along the landside toe.

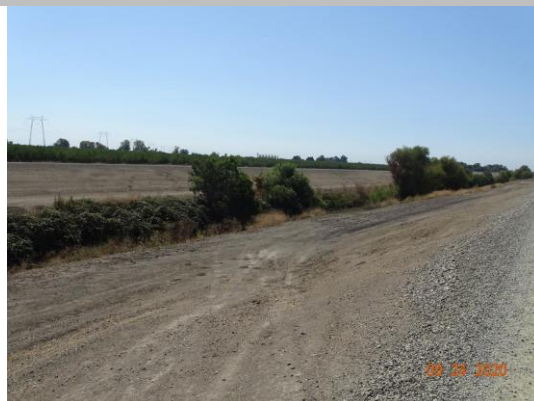
Photo 1 of 1 : FA_2020_ST0010_43_21_20201014_00050.jpg

LM Start	2.95	Rating **	M	Issue No.	21
LM End	2.95	Issue Type +	Ma	Location *	WS
Category	Earthen Levee			GPS Latitude/Longitude	
				Start	End
Item	Slope Stability			39.148938 °	39.148938 °
				-121.737620 °	-121.737620 °
DWR ID	DWR_ST0010_02_f_2016_21				
Comment Code					
S3 : Repair the levee slope damaged by vehicle traffic and prevent access where possible.					
Inspector Comment					
Ramp is causing a depression in the levee slope.

View of the ramp encroaching into the levee. Fall 2020.

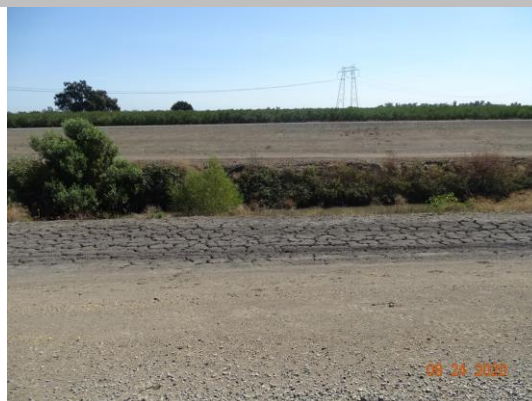
Photo 1 of 1 : FA_2020_ST0010_43_22_20201014_00049.jpg

LM Start	2.95	Rating **	A/W	Issue No.	22
LM End	2.95	Issue Type +	Ma	Location *	WS
Category	Earthen Levee			GPS Latitude/Longitude	
				Start	End
Item	Cracking			39.148938 °	39.148938 °
				-121.737620 °	-121.737620 °
DWR ID	DWR_ST0010_02_f_2016_22				
Comment Code					
CR1 : Monitor and have inspected by geotechnical engineer.					
Inspector Comment

View of the cracking along the waterside toe. Fall 2020.

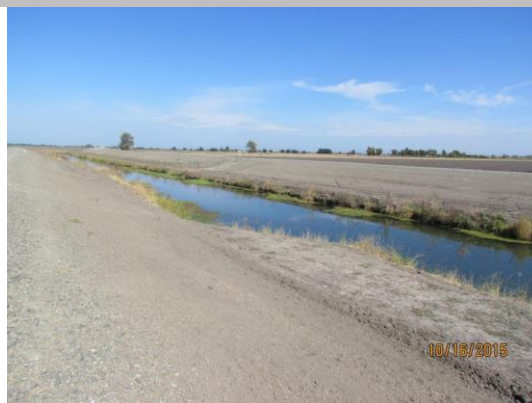
Photo 1 of 2 : FA_2020_ST0010_43_9_20200915_00003.jpg

LM Start	3.30	Rating **	A/W	Issue No.	9
LM End	4.58	Issue Type +	Ma	Location *	WS
Category	Supplemental			GPS Latitude/Longitude	
				Start	End
Item	2017 USACE Erosion Survey			39.153320 °	39.171031 °
				-121.734573 °	-121.727040 °
DWR ID	DWR_ST0010_02_f_2018_9				
Comment Code					
Inspector Comment					
2017 Site ID: WAC 4.3 R					
Status: Eroding					
2017 Field Notes: Site extended downstream. Significant lower bank erosion.					
Site History: 2011 - Small erosion pocket.

View of the erosion along the waterside toe.

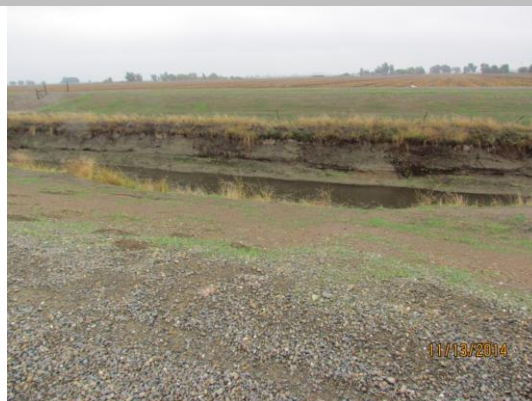
Photo 2 of 2 : FA_2020_ST0010_43_9_20200915_00004.jpg

View of the erosion along the waterside toe.
