**Flood Control Project Maintenance  
Levee Inspections**

**Maintenance Issue Types Only, Levee Inspection Report By Mile - Fall 2021**

**Sutter Maintenance Yard Wadsworth Canal**

Waterway	Bank	Unit Miles	Inspection Start/End	Inspector
Unit No. 01 Wadsworth Canal	Left	4.63	10/01/2021 10/01/2021	Makar Sokol

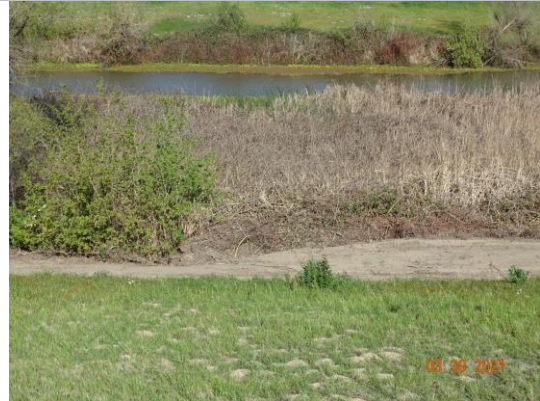
Photo 1 of 1 : FA\_2021\_ST0010\_42\_20\_20210928\_00005.jpg

LM Start	0.06	Rating **	A/W	Issue No.	20
LM End	0.12	Issue Type +	Ma	Location *	WS
Category	Earthen Levee			GPS Latitude/Longitude	
				Start	End
Item	Erosion / Bank Caving			39.114203 °	39.114842 °
				-121.768015 °	-121.767382 °
DWR ID	DWR_ST0010_01_f_2016_20				
Comment Code					
E1 : Note and monitor erosion site.					
Inspector Comment

View of the erosion along the waterside toe. Spring 2021.

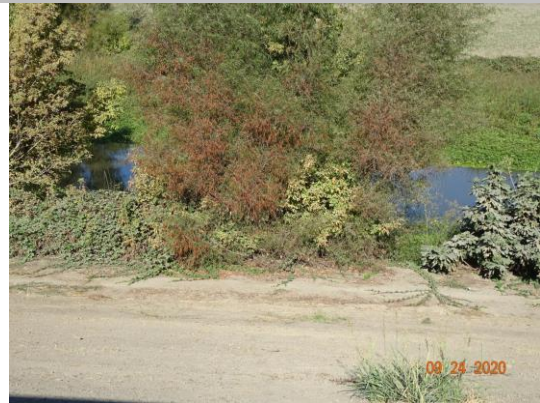
Photo 1 of 1 : FA\_2021\_ST0010\_42\_19\_20210928\_00004.jpg

LM Start	0.38	Rating **	A/W	Issue No.	19
LM End	0.38	Issue Type +	Ma	Location *	WS
Category	Earthen Levee			GPS Latitude/Longitude	
				Start	End
Item	Erosion / Bank Caving			39.117910 °	39.117910 °
				-121.764497 °	-121.764497 °
DWR ID	DWR_ST0010_01_f_2016_19				
Comment Code					
E1 : Note and monitor erosion site.					
Inspector Comment

View of the erosion along the waterside toe. Fall 2020.

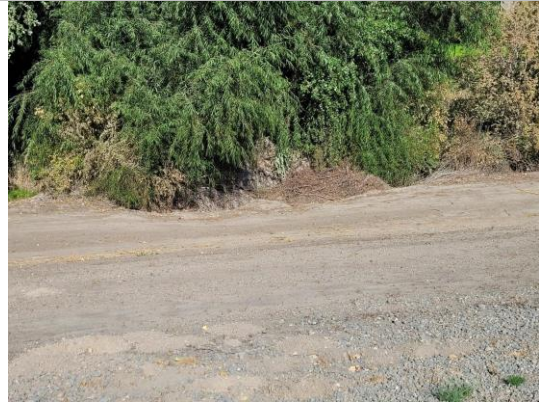
Photo 1 of 1 : FA\_2021\_ST0010\_42\_18\_20211006\_00038.jpg

LM Start	0.56	Rating **	M	Issue No.	18
LM End	0.56	Issue Type +	Ma	Location *	WS
Category	Earthen Levee			GPS Latitude/Longitude	
				Start	End
Item	Erosion / Bank Caving			39.119985 °	39.119985 °
				-121.762600 °	-121.762600 °
DWR ID	DWR_ST0010_01_s_2017_18				
Comment Code					
E2 : Schedule repair of erosion site prior to the next inspection.					
Inspector Comment

View of the erosion along the waterside toe. Fall 2021.

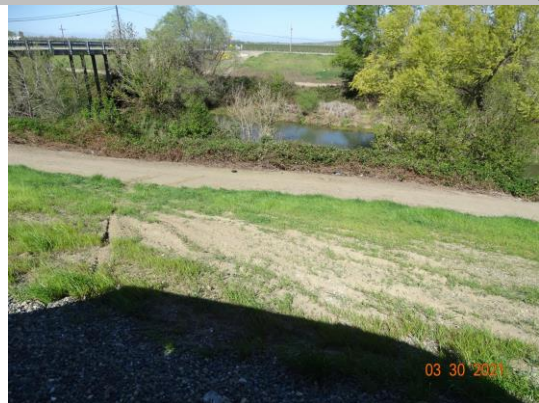
Photo 1 of 1 : FA\_2021\_ST0010\_42\_21\_20210928\_00006.jpg

LM Start	1.27	Rating **	M	Issue No.	21
LM End	1.27	Issue Type +	Ma	Location *	WS
Category	Earthen Levee			GPS Latitude/Longitude	
				Start	End
Item	Slope Stability			39.128324 °	39.128324 °
				-121.754619 °	-121.754619 °
DWR ID	DWR_ST0010_01_s_2021_21				
Comment Code					
S3 : Repair the levee slope damaged by vehicle traffic and prevent access where possible.					
Inspector Comment

View of the waterside slope damaged by vehicle traffic. Spring 2021.

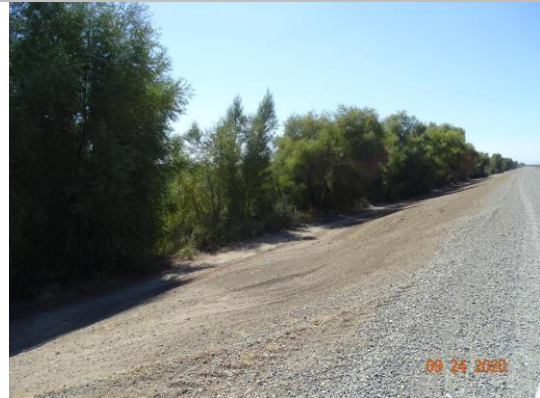
Photo 1 of 1 : FA\_2021\_ST0010\_43\_20\_20210928\_00006.jpg

LM Start	1.75	Rating **	M	Issue No.	20
LM End	1.75	Issue Type +	Ma	Location *	WS
Category	Earthen Levee			GPS Latitude/Longitude	
				Start	End
Item	Slope Stability			39.134378 °	39.134378 °
				-121.749803 °	-121.749803 °
DWR ID	DWR_ST0010_02_f_2016_20				
Comment Code					
S3 : Repair the levee slope damaged by vehicle traffic and prevent access where possible.					
Inspector Comment					
Ramp is causing depression in the levee slope.

View of the ramp encroaching into the levee. Fall 2020.

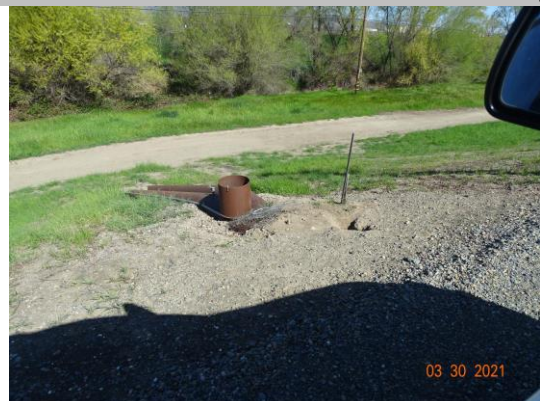
Photo 1 of 1 : FA\_2021\_ST0010\_43\_11\_20210928\_00005.jpg

LM Start	1.76	Rating **	M	Issue No.	11
LM End	1.76	Issue Type +	Ma	Location *	LS
Category	Earthen Levee			GPS Latitude/Longitude	
				Start	End
Item	Animal Control			39.134490 °	39.134490 °
				-121.749716 °	-121.749716 °
DWR ID	DWR_ST0010_02_f_2012_11				
Comment Code					
A3 : No rodents visible, but rodent burrows visible; need to backfill and compact or grout burrows.					
Inspector Comment

View of the rodent holes above the irrigation pipe. Spring 2021.

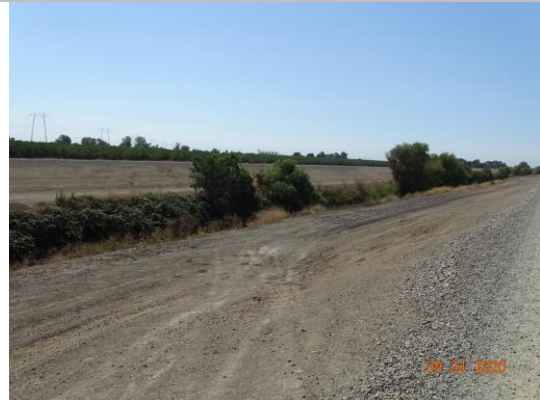
Photo 1 of 1 : FA\_2021\_ST0010\_43\_21\_20210928\_00007.jpg

LM Start	2.95	Rating **	M	Issue No.	21
LM End	2.95	Issue Type +	Ma	Location *	WS
Category	Earthen Levee			GPS Latitude/Longitude	
				Start	End
Item	Slope Stability			39.148938 °	39.148938 °
				-121.737620 °	-121.737620 °
DWR ID	DWR_ST0010_02_f_2016_21				
Comment Code					
S3 : Repair the levee slope damaged by vehicle traffic and prevent access where possible.					
Inspector Comment					
Ramp is causing a depression in the levee slope.

View of the ramp encroaching into the levee. Fall 2020.

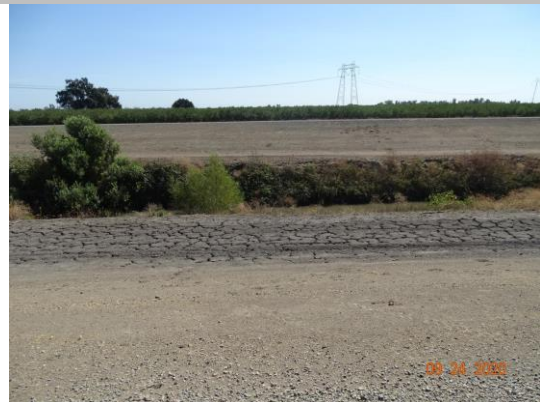
Photo 1 of 1 : FA\_2021\_ST0010\_43\_22\_20210928\_00008.jpg

LM Start	2.95	Rating **	A/W	Issue No.	22
LM End	2.95	Issue Type +	Ma	Location *	WS
Category	Earthen Levee			GPS Latitude/Longitude	
				Start	End
Item	Cracking			39.148938 °	39.148938 °
				-121.737620 °	-121.737620 °
DWR ID	DWR_ST0010_02_f_2016_22				
Comment Code					
CR1 : Monitor and have inspected by geotechnical engineer.					
Inspector Comment

View of the cracking along the waterside toe. Fall 2020.

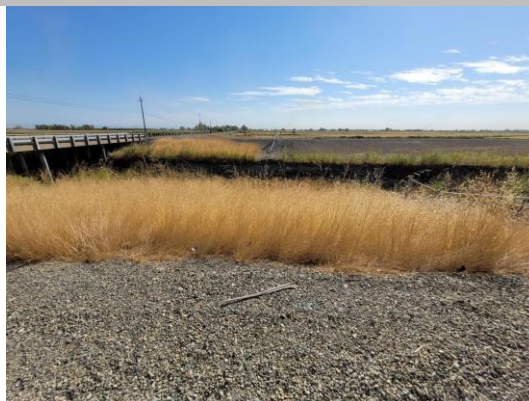
Photo 1 of 1 : FA\_2021\_ST0010\_43\_19\_20211006\_00048.jpg

LM Start	4.27	Rating **	M	Issue No.	19	
LM End	4.27	Issue Type +	Ma	Location *	WS	
Category	Earthen Levee			GPS Latitude/Longitude		
				Start		End
Item	Vegetation			39.166793 °		39.166793 °
				-121.729018 °		-121.729018 °
DWR ID	DWR_ST0010_02_f_2021_19					
Comment Code						
V1 : Control annual grass and weeds on the levee slopes and easements.						
Inspector Comment

View of the vegetation along the waterside slope. Fall 2021.
