**Flood Control Project Maintenance  
Levee Inspections**

**Maintenance Issue Types Only, Levee Inspection Report By Mile - Fall 2022**

**Sutter Maintenance Yard Wadsworth Canal**

Waterway	Bank	Unit Miles	Inspection Start/End	Inspector
Unit No. 01 Wadsworth Canal	Left	4.63	09/14/2022 09/15/2022	Makar Sokol

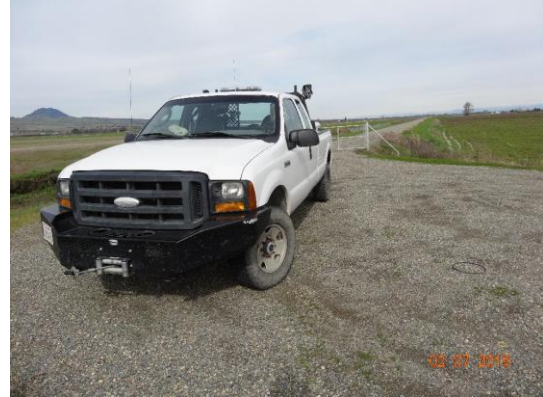
Photo 2 of 3 : UCIP\_FA\_2022\_60116\_78708.jpg

Overview of levee crown where crossing should be.

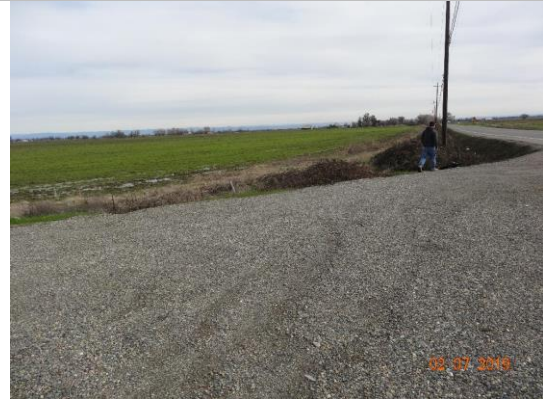
Photo 3 of 3 : UCIP\_FA\_2022\_60116\_78709.jpg

LS view: overview of LS, no signs of pipe.

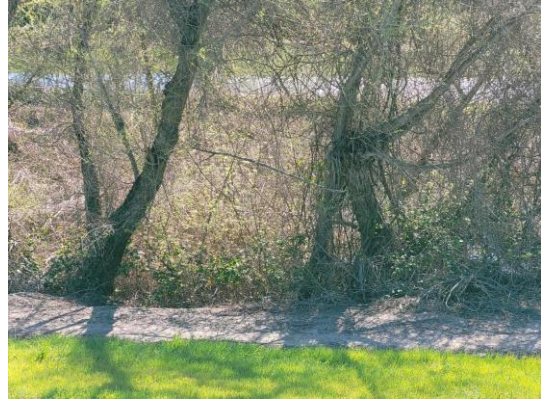
Photo 1 of 1 : FA\_2022\_ST0010\_43\_24\_20220906\_00006.jpg

LM Start	0.35	Rating **	M	Issue No.	24
LM End	0.35	Issue Type +	Ma	Location *	WS
Category	Earthen Levee			GPS Latitude/Longitude	
				Start	End
Item	Erosion / Bank Caving			39.118178 °	39.118178 °
				-121.765500 °	-121.765500 °
DWR ID	DWR_ST0010_02_s_2022_24				
Comment Code					
E2 : Schedule repair of erosion site prior to the next inspection.					
Inspector Comment					
Erosion is present at the toe of the levee. Patrol road is cutting into the levee prism.

View of the erosion at the waterside toe/patrol road. Spring 2022.

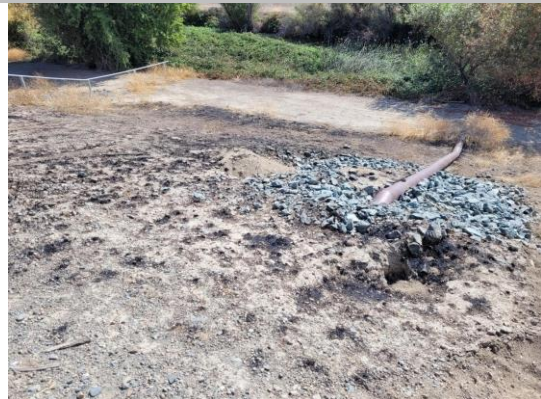
Photo 1 of 1 : FA\_2022\_ST0010\_43\_27\_20220919\_00046.jpg

LM Start	1.15	Rating **	M	Issue No.	27
LM End	1.15	Issue Type +	Ma	Location *	WS
Category	Earthen Levee			GPS Latitude/Longitude	
				Start	End
Item	Animal Control			39.127457 °	39.127457 °
				-121.756527 °	-121.756527 °
DWR ID	DWR_ST0010_02_f_2022_27				
Comment Code					
A3 : No rodents visible, but rodent burrows visible; need to backfill and compact or grout burrows.					
Inspector Comment

View of animal burrows along the waterside slope. Fall 2022.

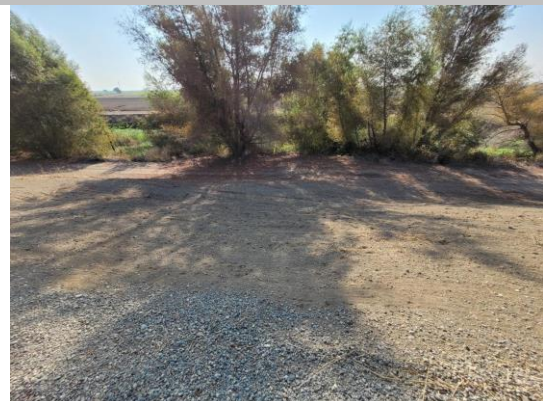
Photo 1 of 1 : FA\_2022\_ST0010\_43\_20\_20220919\_00048.jpg

LM Start	1.75	Rating **	M	Issue No.	20
LM End	1.75	Issue Type +	Ma	Location *	WS
Category	Earthen Levee			GPS Latitude/Longitude	
				Start	End
Item	Erosion / Vehicle Traffic			39.134378 °	39.134378 °
				-121.749803 °	-121.749803 °
DWR ID	DWR_ST0010_02_f_2016_20				
Comment Code					
E6 : Repair the levee slope damaged by vehicle traffic and prevent access where possible.					
Inspector Comment					
Ramp is causing depression in the levee slope.

View of the slope erosion along the waterside slope. Fall 2022.

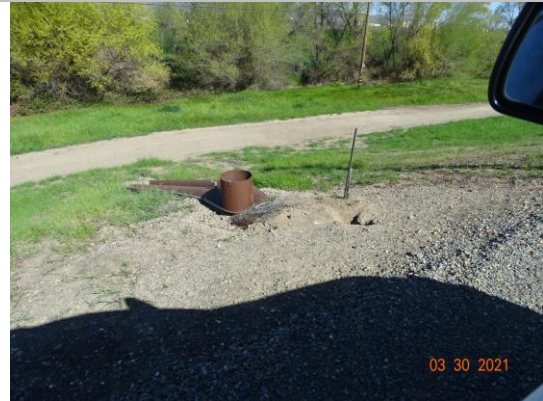
Photo 1 of 1 : FA\_2022\_ST0010\_43\_11\_20220906\_00001.jpg

LM Start	1.76	Rating **	A/W	Issue No.	11
LM End	1.76	Issue Type +	Ma	Location *	LS
Category	Earthen Levee			GPS Latitude/Longitude	
				Start	End
Item	Animal Control			39.134490 °	39.134490 °
				-121.749716 °	-121.749716 °
DWR ID	DWR_ST0010_02_f_2012_11				
Comment Code					
A3 : No rodents visible, but rodent burrows visible; need to backfill and compact or grout burrows.					
Inspector Comment

View of the rodent holes above the irrigation pipe. Spring 2021.

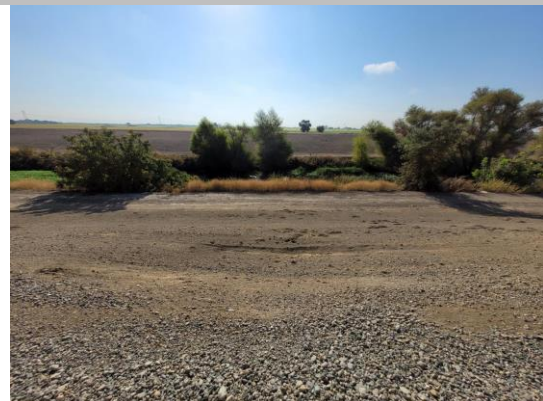
Photo 1 of 1 : FA\_2022\_ST0010\_43\_28\_20220919\_00049.jpg

LM Start	1.91	Rating **	M	Issue No.	28
LM End	1.91	Issue Type +	Ma	Location *	WS
Category	Earthen Levee			GPS Latitude/Longitude	
				Start	End
Item	Slope Stability			39.136275 °	39.136275 °
				-121.748134 °	-121.748134 °
DWR ID	DWR_ST0010_02_f_2022_28				
Comment Code					
S1 : Repair slope instability.					
Inspector Comment

View of a depression in the waterside slope. Fall 2022.

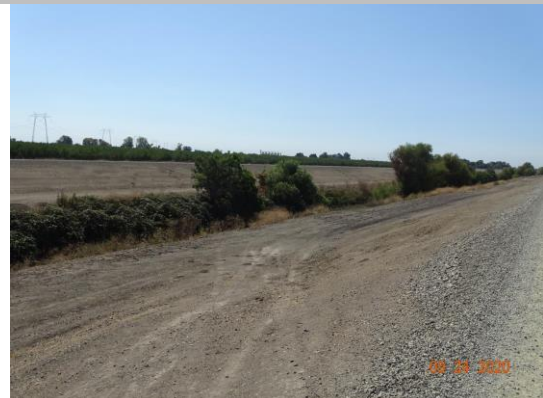
Photo 1 of 1 : FA\_2022\_ST0010\_43\_21\_20220906\_00003.jpg

LM Start	2.95	Rating **	M	Issue No.	21
LM End	2.95	Issue Type +	Ma	Location *	WS
Category	Earthen Levee			GPS Latitude/Longitude	
				Start	End
Item	Erosion / Vehicle Traffic			39.148938 °	39.148938 °
				-121.737620 °	-121.737620 °
DWR ID	DWR_ST0010_02_f_2016_21				
Comment Code					
E6 : Repair the levee slope damaged by vehicle traffic and prevent access where possible.					
Inspector Comment					
Ramp is causing a depression in the levee slope.

View of the ramp encroaching into the levee. Fall 2020.

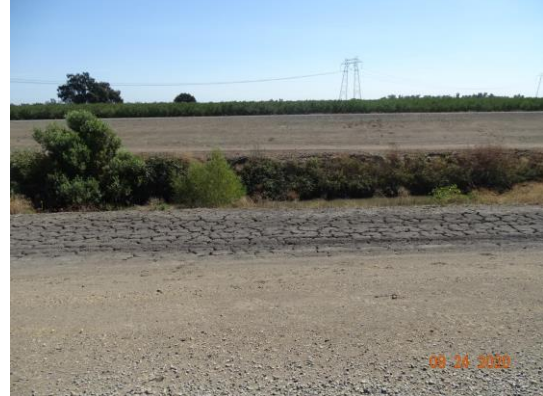
Photo 1 of 1 : FA\_2022\_ST0010\_43\_22\_20220906\_00004.jpg

LM Start	2.95	Rating **	A/W	Issue No.	22
LM End	2.95	Issue Type +	Ma	Location *	WS
Category	Earthen Levee			GPS Latitude/Longitude	
				Start	End
Item	Cracking			39.148938 °	39.148938 °
				-121.737620 °	-121.737620 °
DWR ID	DWR_ST0010_02_f_2016_22				
Comment Code					
CR1 : Monitor and have inspected by geotechnical engineer.					
Inspector Comment

View of the cracking along the waterside toe. Fall 2020.
