**Flood Control Project Maintenance  
Levee Inspections**

**Maintenance Issue Types Only, Levee Inspection Report By Mile - Fall 2023**

**Sutter Maintenance Yard Wadsworth Canal**

Waterway	Bank	Unit Miles	Inspection Start/End	Inspector
Unit No. 01 Wadsworth Canal	Left	4.63	10/11/2023 10/11/2023	Nate Hicks

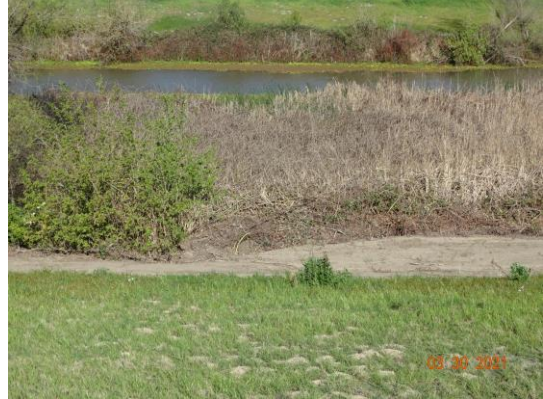
Photo 1 of 1 : FA\_2023\_ST0010\_42\_20\_20231010\_00003.jpg

LM Start	0.06	Rating **	A/W	Issue No.	20
LM End	0.12	Issue Type +	Ma	Location *	WS
Category	Earthen Levee			GPS Latitude/Longitude	
				Start	End
Item	Erosion / Bank Caving			39.114203°	39.114842°
				-121.768015°	-121.767382°
DWR ID	DWR_ST0010_01_f_2016_20				
Comment Code					
E1 : Note and monitor erosion site.					
Inspector Comment

View of the erosion along the waterside toe. Spring 2021.

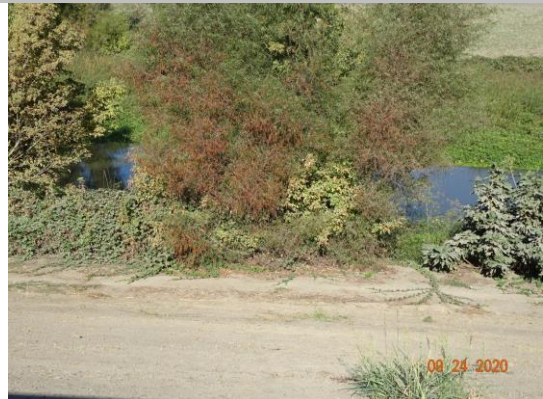
Photo 1 of 1 : FA\_2023\_ST0010\_42\_19\_20231010\_00002.jpg

LM Start	0.38	Rating **	A/W	Issue No.	19
LM End	0.38	Issue Type +	Ma	Location *	WS
Category	Earthen Levee			GPS Latitude/Longitude	
				Start	End
Item	Erosion / Bank Caving			39.117910°	39.117910°
				-121.764497°	-121.764497°
DWR ID	DWR_ST0010_01_f_2016_19				
Comment Code					
E1 : Note and monitor erosion site.					
Inspector Comment

View of the erosion along the waterside toe. Fall 2020.

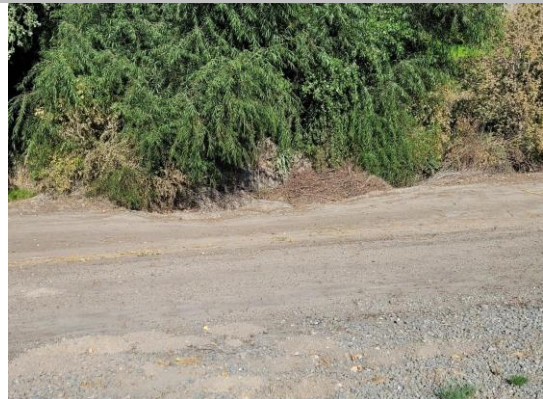
Photo 1 of 1 : FA\_2023\_ST0010\_42\_18\_20231010\_00001.jpg

LM Start	0.56	Rating **	M	Issue No.	18
LM End	0.56	Issue Type +	Ma	Location *	WS
Category	Earthen Levee			GPS Latitude/Longitude	
				Start	End
Item	Erosion / Bank Caving			39.119985°	39.119985°
				-121.762600°	-121.762600°
DWR ID	DWR_ST0010_01_s_2017_18				
Comment Code					
E2 : Schedule repair of erosion site prior to the next inspection.					
Inspector Comment

View of the erosion along the waterside toe. Fall 2021.

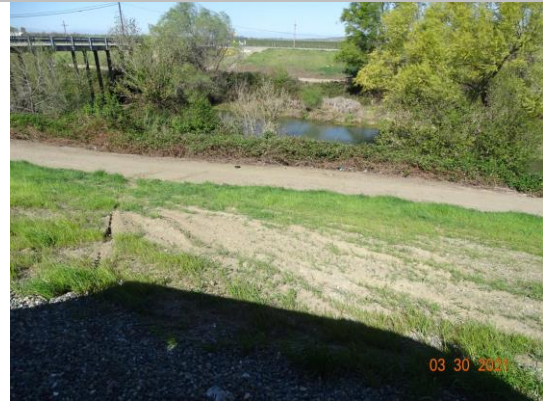
Photo 1 of 1 : FA\_2023\_ST0010\_42\_21\_20231010\_00004.jpg

LM Start	1.27	Rating **	M	Issue No.	21
LM End	1.27	Issue Type +	Ma	Location *	WS
Category	Earthen Levee			GPS Latitude/Longitude	
				Start	End
Item	Erosion / Vehicle Traffic			39.128324°	39.128324°
				-121.754619°	-121.754619°
DWR ID	DWR_ST0010_01_s_2021_21				
Comment Code					
E6 : Repair the levee slope damaged by vehicle traffic and prevent access where possible.					
Inspector Comment

View of the waterside slope damaged by vehicle traffic. Spring 2021.

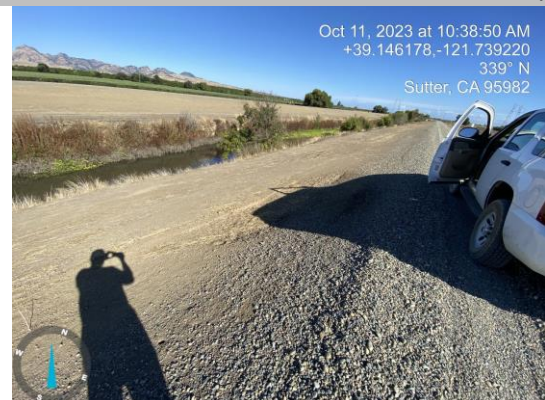
Photo 1 of 1 : FA\_2023\_ST0010\_42\_8\_20231020\_00020.jpg

LM Start	2.76	Rating **	M	Issue No.	8
LM End	2.76	Issue Type +	Ma	Location *	WS
Category	Earthen Levee			GPS Latitude/Longitude	
				Start	End
Item	Slope Stability			39.146163°	39.146163°
				-121.739181°	-121.739181°
DWR ID	DWR_ST0010_01_f_2023_8				
Comment Code					
S1 : Repair slope instability.					
Inspector Comment

View of indentation along the waterside slope (Fall 2023).

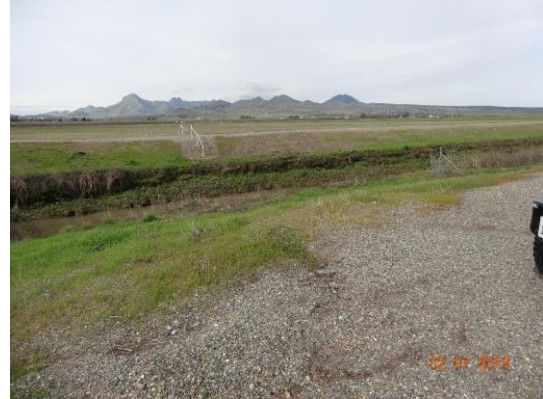
Photo 1 of 3 : UCIP\_FA\_2023\_60116\_78707.jpg

Comment Code					
Inspector Comment					
DS_ID:17058 FS_ID:60116 EP_NO: N/A Repair Type: Non-Urgent EVAL Issue: Crossing Status: Not Found UCIP Comments: 02/07/2019 Record has been updated from No Action Needed to Non-Urgent, unable to confirm status of pipe through the levee. Unable to locate pipe or appurtenances through this section of the levee. The DWR DMP geophysical investigation report indicates no signal received of suggestive target. Record will remain in UCIP's inspection records until future Levee Improvement Project can confirm no crossing was found through the levee. Also there is no permit identified for the authorization of this pipe. (O. Magana - DWR UCIP)04/10/2017 Unable to locate. (A. Freitag - DWR Sutter Yard)10/12/2016 Unable to locate. (A. Freitag - DWR Sutter Yard)04/19/2016 Unable to locate. (A. Freitag - DWR Sutter Yard)05/12/2015 Unable to locate. (A. Freitag - DWR Sutter Yard)11/18/2014 Unable to locate. (A. Freitag - DWR Sutter Yard)05/13/2014 Same as last inspection. (A. Freitag - DWR Sutter Yard)10/29/2013 Same as last inspection. (A. Freitag - DWR Sutter Yard)05/16/2013 Same as last inspection. (A. Freitag - DWR Sutter Yard)10/09/2012 unable to locate. (W. Wylie - DWR UCIP) FIELD_STRUCT_DESC: 12-inch corrugated metal drainage pipe through the levee, 8.7 feet below the crown. Pipe is open at both the waterside (WS) and landside (LS) ends. [Additional Reference(s): DWR Levee Log, 2005 (HLM 4.38, listed as 12-inch CMP). USACE Sacramento O&M Manual, Unit 135, May 1953, (Station 228+00), listed as 12-inch CMP, USACE Drawing No. 50-04-1949, Drawing No. 2, Sheet 3, March 1952, page 2 of 3, 12-inch CMP referenced at 228+25]. FS Date: 2/7/2019 12:13:00 PM

WS view: overview of WS, no signs of pipe.

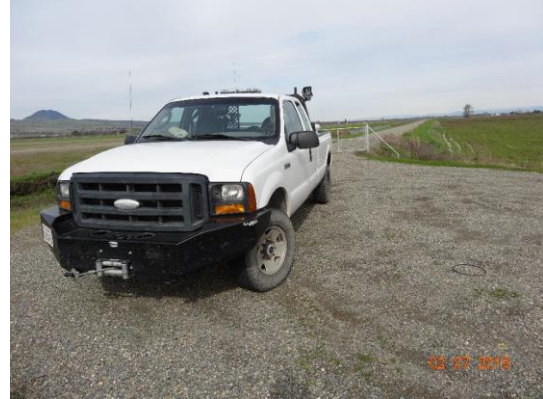
Photo 2 of 3 : UCIP\_FA\_2023\_60116\_78708.jpg

Overview of levee crown where crossing should be.

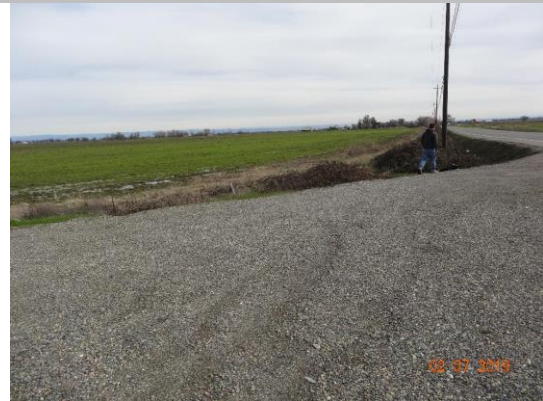
Photo 3 of 3 : UCIP\_FA\_2023\_60116\_78709.jpg

LS view: overview of LS, no signs of pipe.

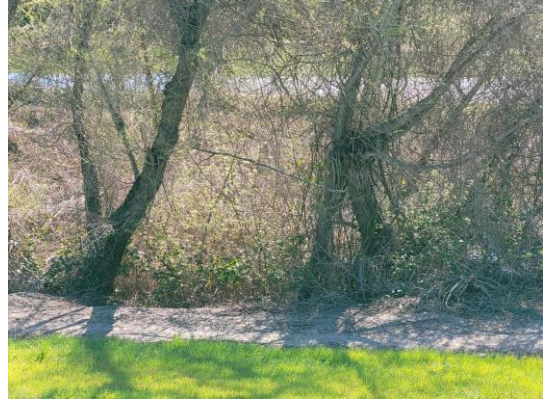
Photo 1 of 1 : FA\_2023\_ST0010\_43\_24\_20231010\_00005.jpg

LM Start	0.35	Rating **	M	Issue No.	24
LM End	0.35	Issue Type +	Ma	Location *	WS
Category	Earthen Levee			GPS Latitude/Longitude	
				Start	End
Item	Erosion / Bank Caving			39.118178°	39.118178°
				-121.765500°	-121.765500°
DWR ID	DWR_ST0010_02_s_2022_24				
Comment Code					
E2 : Schedule repair of erosion site prior to the next inspection.					
Inspector Comment					
Erosion is present at the toe of the levee. Erosion is cutting into the patrol road.

View of the erosion at the waterside toe/patrol road. Spring 2022.

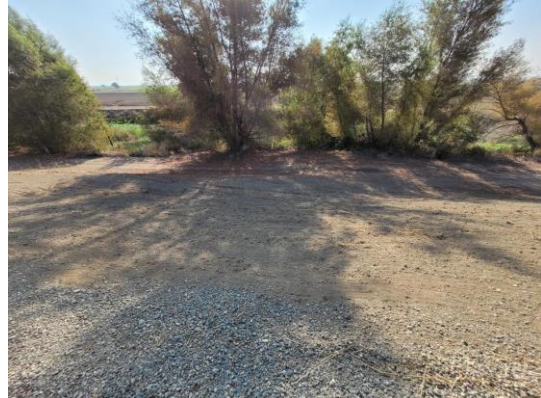
Photo 1 of 1 : FA\_2023\_ST0010\_43\_20\_20231010\_00002.jpg

LM Start	1.75	Rating **	M	Issue No.	20
LM End	1.75	Issue Type +	Ma	Location *	WS
Category	Earthen Levee			GPS Latitude/Longitude	
				Start	End
Item	Erosion / Vehicle Traffic			39.134378°	39.134378°
				-121.749803°	-121.749803°
DWR ID	DWR_ST0010_02_f_2016_20				
Comment Code					
E6 : Repair the levee slope damaged by vehicle traffic and prevent access where possible.					
Inspector Comment					
Ramp is causing depression in the levee slope.

View of the slope erosion along the waterside slope. Fall 2022.

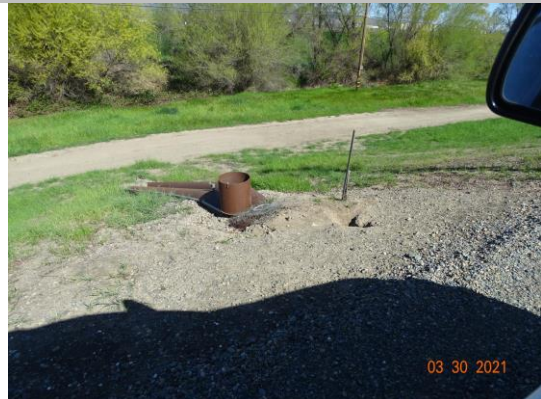
Photo 1 of 1 : FA\_2023\_ST0010\_43\_11\_20231010\_00001.jpg

LM Start	1.76	Rating **	A/W	Issue No.	11
LM End	1.76	Issue Type +	Ma	Location *	LS
Category	Earthen Levee			GPS Latitude/Longitude	
				Start	End
Item	Animal Control			39.134490°	39.134490°
				-121.749716°	-121.749716°
DWR ID	DWR_ST0010_02_f_2012_11				
Comment Code					
A3 : No rodents visible, but rodent burrows visible; need to backfill and compact or grout burrows.					
Inspector Comment					
Monitor for new activity.

View of the rodent holes above the irrigation pipe. Spring 2021.

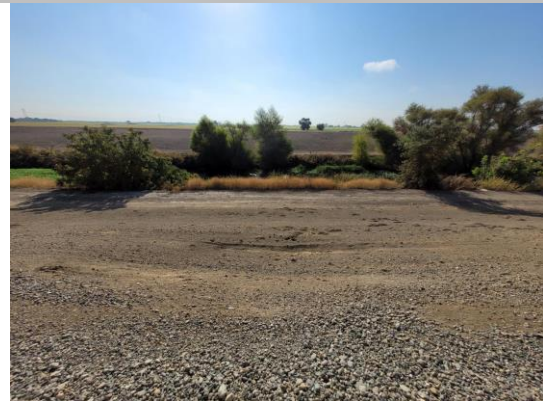
Photo 1 of 1 : FA\_2023\_ST0010\_43\_28\_20231010\_00007.jpg

LM Start	1.91	Rating **	M	Issue No.	28
LM End	1.91	Issue Type +	Ma	Location *	WS
Category	Earthen Levee			GPS Latitude/Longitude	
				Start	End
Item	Slope Stability			39.136275°	39.136275°
				-121.748134°	-121.748134°
DWR ID	DWR_ST0010_02_f_2022_28				
Comment Code					
S1 : Repair slope instability.					
Inspector Comment

View of a depression in the waterside slope. Fall 2022.

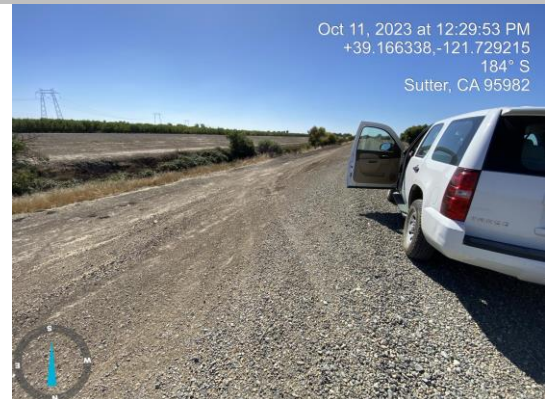
Photo 1 of 1 : FA\_2023\_ST0010\_43\_21\_20231020\_00029.jpg

LM Start	2.95	Rating **	M	Issue No.	21
LM End	2.95	Issue Type +	Ma	Location *	WS
Category	Earthen Levee			GPS Latitude/Longitude	
				Start	End
Item	Erosion / Vehicle Traffic			39.148938°	39.148938°
				-121.737620°	-121.737620°
DWR ID	DWR_ST0010_02_f_2016_21				
Comment Code					
E6 : Repair the levee slope damaged by vehicle traffic and prevent access where possible.					
Inspector Comment					
Ramp is causing a depression in the levee slope.

View of the ramp encroaching into the levee (Fall 2023).

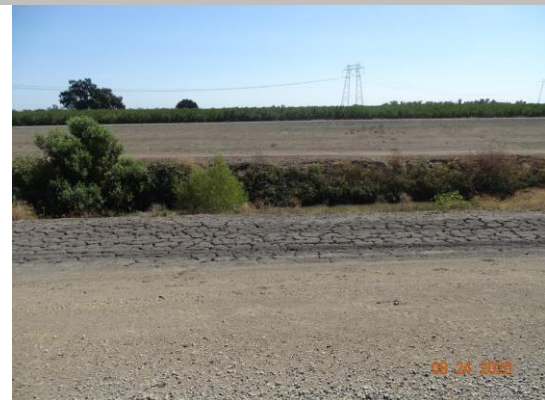
Photo 1 of 1 : FA\_2023\_ST0010\_43\_22\_20231010\_00004.jpg

LM Start	2.95	Rating **	A/W	Issue No.	22
LM End	2.95	Issue Type +	Ma	Location *	WS
Category	Earthen Levee			GPS Latitude/Longitude	
				Start	End
Item	Cracking			39.148938°	39.148938°
				-121.737620°	-121.737620°
DWR ID	DWR_ST0010_02_f_2016_22				
Comment Code					
CR1 : Monitor and have inspected by geotechnical engineer.					
Inspector Comment

View of the cracking along the waterside toe. Fall 2020.
