**Flood Control Project Maintenance
Levee Inspections**

Maintenance Issue Types Only, Levee Inspection Report By Mile - Fall 2024

Sutter Maintenance Yard Wadsworth Canal

Waterway	Bank	Unit Miles	Inspection Start/End	Inspector
Unit No. 01 Wadsworth Canal	Left	4.63	09/26/2024 09/26/2024	Nate Hicks

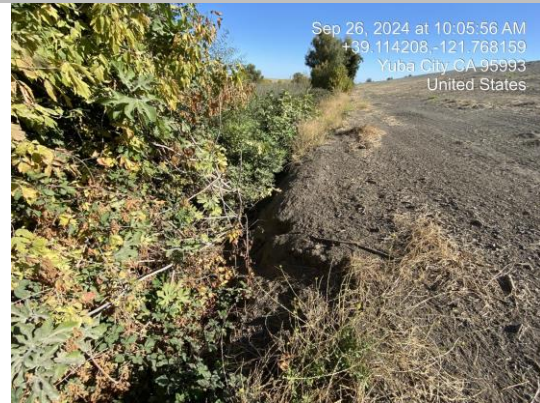
Photo 1 of 1 : FA_2024_ST0010_42_20_20241001_00024.jpg

LM Start	0.06	Rating **	M	Issue No.	20
LM End	0.19	Issue Type +	Ma	Location *	WS
Category	Earthen Levee			GPS Latitude/Longitude	
				Start	End
Item	Erosion / Bank Caving			39.114203°	39.115719°
				-121.768015°	-121.766517°
DWR ID	DWR_ST0010_01_f_2016_20				
Comment Code					
E2 : Schedule repair of erosion site prior to the next inspection.					
Inspector Comment

View of erosion on the waterside toe (Fall 2024).

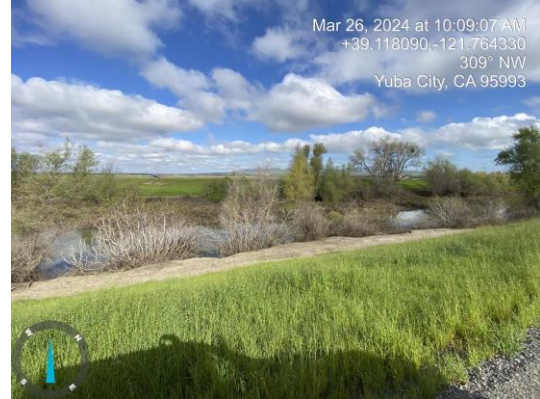
Photo 1 of 1 : FA_2024_ST0010_42_19_20240923_00005.jpg

LM Start	0.37	Rating **	A/W	Issue No.	19
LM End	0.41	Issue Type +	Ma	Location *	WS
Category	Earthen Levee			GPS Latitude/Longitude	
				Start	End
Item	Erosion / Bank Caving			39.117805°	39.118276°
				-121.764588°	-121.764151°
DWR ID	DWR_ST0010_01_f_2016_19				
Comment Code					
E1 : Note and monitor erosion site.					
Inspector Comment

View of the erosion along the waterside toe road (Spring 2024).

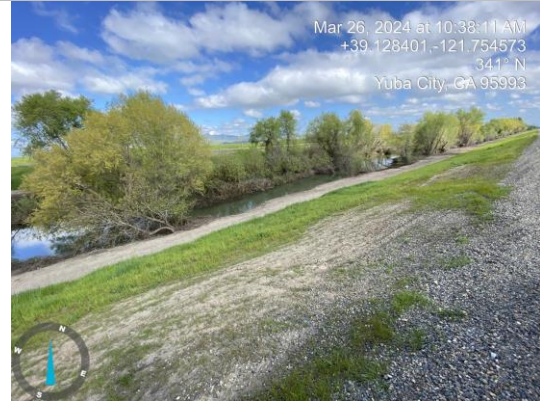
Photo 1 of 1 : FA_2024_ST0010_42_22_20240923_00007.jpg

LM Start	1.27	Rating **	M	Issue No.	22
LM End	1.31	Issue Type +	Ma	Location *	WS
Category	Earthen Levee			GPS Latitude/Longitude	
				Start	End
Item	Erosion / Bank Caving			39.128319°	39.128730°
				-121.754581°	-121.754187°
DWR ID	DWR_ST0010_01_s_2024_22				
Comment Code					
E2 : Schedule repair of erosion site prior to the next inspection.					
Inspector Comment					
There is erosion along the waterside toe road.

View of erosion along the waterside toe road (Spring 2024).

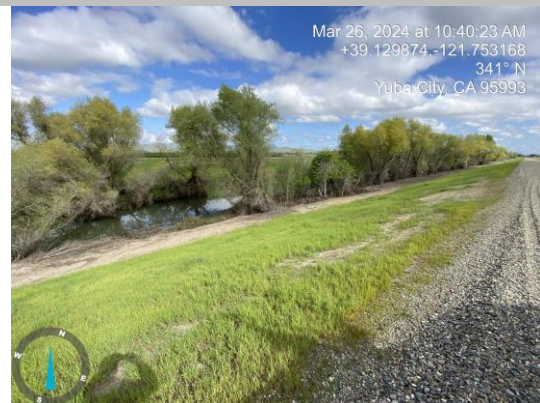
Photo 1 of 1 : FA_2024_ST0010_42_23_20240923_00008.jpg

LM Start	1.40	Rating **	M	Issue No.	23
LM End	1.42	Issue Type +	Ma	Location *	WS
Category	Earthen Levee			GPS Latitude/Longitude	
				Start	End
Item	Erosion / Bank Caving			39.129831°	39.130027°
				-121.753145°	-121.752950°
DWR ID	DWR_ST0010_01_s_2024_23				
Comment Code					
E2 : Schedule repair of erosion site prior to the next inspection.					
Inspector Comment					
There is erosion along the waterside toe road.

View of erosion along the waterside toe road (Spring 2024).

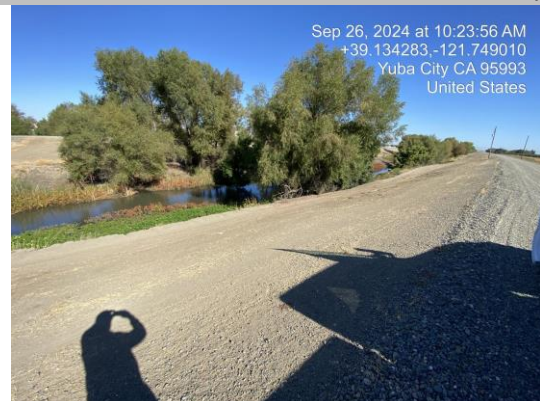
Photo 1 of 1 : FA_2024_ST0010_42_6_20241001_00025.jpg

LM Start	1.74	Rating **	M	Issue No.	6
LM End	2.39	Issue Type +	Ma	Location *	WS
Category	Supplemental			GPS Latitude/Longitude	
				Start	End
Item	2018 USACE Erosion Survey			39.133887°	39.141757°
				-121.749526°	-121.742939°
DWR ID	DWR_ST0010_01_s_2024_6				
Comment Code					
Inspector Comment					
2018 Site ID: WAC 2.1 L					
Status: Eroding					
2018 Field Notes: Last observed in 2017.					
Site History: 2011 - Whole bank is starting to unravel, with failure from poor soils. 2017 - Minor new erosion observed.

View of erosion on the waterside toe road (Fall 2024).

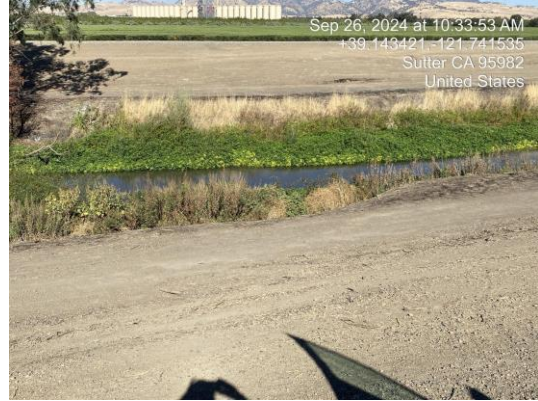
Photo 1 of 1 : FA_2024_ST0010_42_7_20241001_00026.jpg

LM Start	2.43	Rating **	M	Issue No.	7
LM End	3.30	Issue Type +	Ma	Location *	WS
Category	Supplemental			GPS Latitude/Longitude	
				Start	End
Item	2018 USACE Erosion Survey			39.142235°	39.153095°
				-121.742609°	-121.734390°
DWR ID	DWR_ST0010_01_s_2022_7				
Comment Code					
Inspector Comment					
2018 Site ID: WAC 2.4 L					
Status: Eroding					
2018 Field Notes: Last observed in 2017.					
Site History: 2010 - Over steepened levees, some slumping, reach-wide problem. 2011 - Still a reach-wide problem. 2017 - Significant new erosion lower bank.

View of erosion on the waterside toe road (Fall 2024).

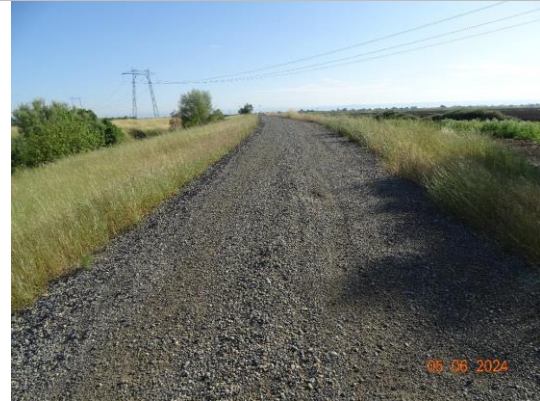
Photo 1 of 3 : UCIP_FA_2024_83620_122556.jpg

DS_ID:17065
FS_ID:83620
EP_NO: 7209
Repair Type: No Action Needed
EVAL Issue:
Crossing Status: Found
UCIP Comments: 05/06/2024 Record remains No Action Needed. Pipe was CIPP lined. DMP internal video inspection has found none or minor pipe defects. No issues observed during inspection. (M. Thao - DWR UCIP)
09/25/2023 DMP internal video inspection has found none or minor pipe defects. Recommend next video inspection in 5 years. (J. Taylor - DWR UCIP)
01/06/2022 LoF of crossing is 5.2 due to pin size holes less than 10 feet from pipe end. Crossing remains Non-Urgent because pipe damage located outside of levee prism and does not pose a threat to levee. (O. Yakimov - DWR UCIP)
02/07/2019 Record remains Non-Urgent due to of few maintenance issues observed during inspection. Pipe is being used as a shooting target. Multiple holes are visible on the exposed WS section of the pipe. The inlet pipe section located on the LS has been damaged (pipe wall section pulled). This pipe qualifies as an LMA responsible crossing as it was originally listed in the USACE O&M manual as a drainage pipe. The CVFPB issued a permit in 1970 for the replacement of the original USACE drainage pipe. (O. Magana - DWR UCIP)

Levee crown looking upstream.

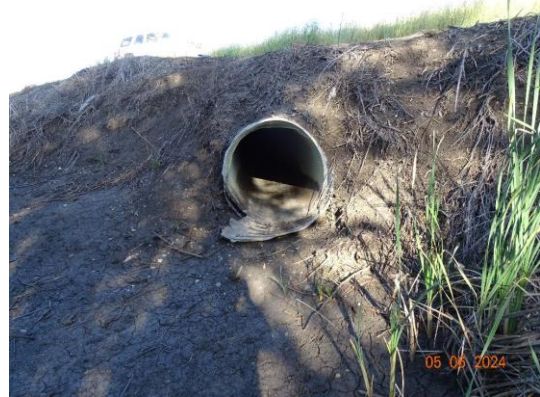
Photo 2 of 3 : UCIP_FA_2024_83620_122557.jpg

LS view: Pipe inlet located at the toe; looking toward levee.

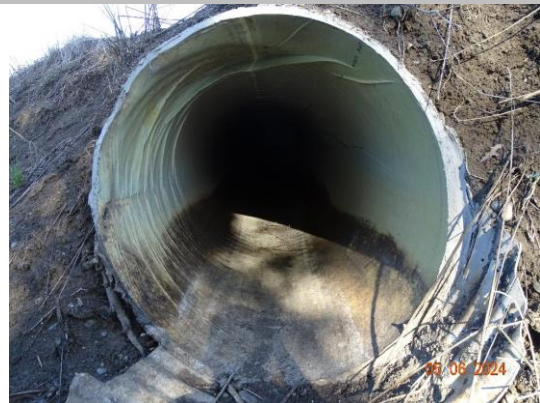
Photo 3 of 3 : UCIP_FA_2024_83620_122558.jpg

LS view: Looking into pipe inlet located at the toe; pipe has been CIPP lined.

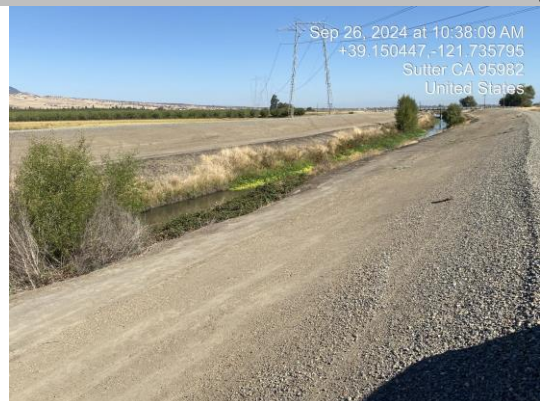
Photo 1 of 1 : FA_2024_ST0010_42_16_20241001_00027.jpg

LM Start	3.32	Rating **	M	Issue No.	16
LM End	4.60	Issue Type +	Ma	Location *	WS
Category	Supplemental			GPS Latitude/Longitude	
				Start	End
Item	2018 USACE Erosion Survey			39.153296°	39.170973°
				-121.734304°	-121.726852°
DWR ID	DWR_ST0010_01_s_2022_16				
Comment Code					
Inspector Comment					
2018 Site ID: WAC 4.4 L					
Status: Eroding					
2018 Field Notes: Last observed in 2017.					
Site History: Significant lower bank erosion and overall slumping.

View of erosion on the waterside toe road (Fall 2024).

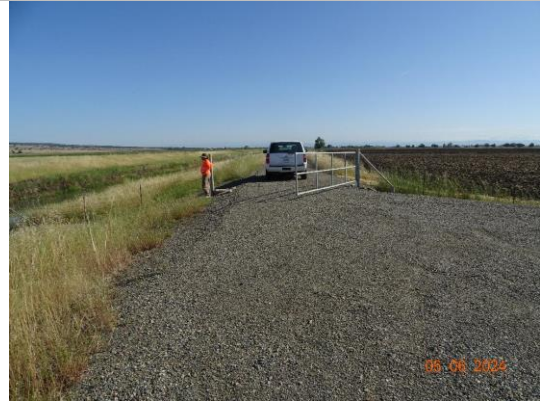
Photo 1 of 3 : UCIP_FA_2024_83673_122741.jpg

DS_ID:17058
FS_ID:83673
EP_NO: N/A
Repair Type: Non-Urgent
EVAL Issue:
Crossing Status: Not Found
UCIP Comments: 05/06/2024 Record remains Non-Urgent. Crossing not found. Geophysical results did not confirm presence of pipe through levee. Record will remain in UCIP's inspection records until future Levee Improvement Project can confirm no crossing was found through the levee. (M. Thao - DWR UCIP)
02/07/2019 Record has been updated from No Action Needed to Non-Urgent, unable to confirm status of pipe through the levee. Unable to locate pipe or appurtenances through this section of the levee. The DWR DMP geophysical investigation report indicates no signal received of suggestive target. Record will remain in UCIP's inspection records until future Levee Improvement Project can confirm no crossing was found through the levee. Also there is no permit identified for the authorization of this pipe. (O. Magana - DWR UCIP)

Levee crown looking upstream.

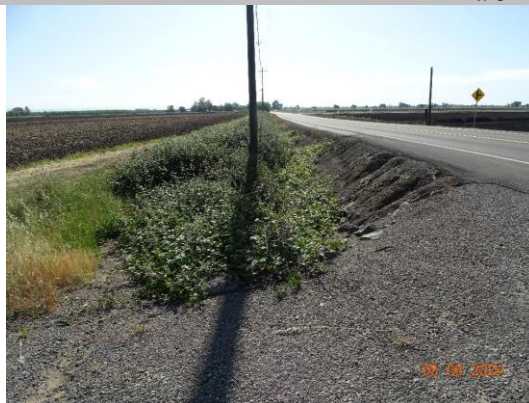
Photo 2 of 3 : UCIP_FA_2024_83673_122740.jpg

LS view: General overview looking from crown.

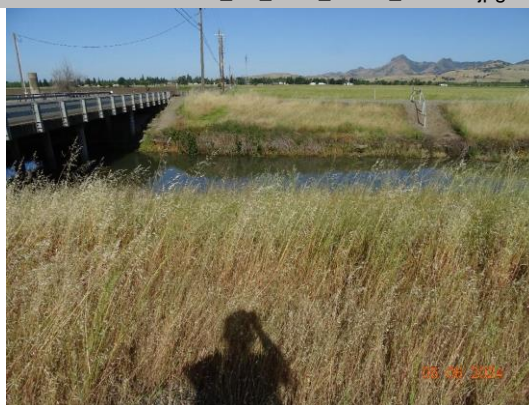
Photo 3 of 3 : UCIP_FA_2024_83673_122742.jpg

WS view: General overview looking from crown.

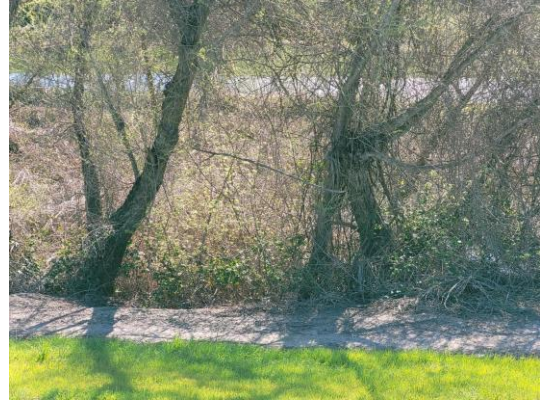
Photo 1 of 1 : FA_2024_ST0010_43_24_20240923_00007.jpg

LM Start	0.32	Rating **	M	Issue No.	24
LM End	0.35	Issue Type +	Ma	Location *	WS
Category	Earthen Levee			GPS Latitude/Longitude	
				Start	End
Item	Erosion / Bank Caving			39.117776°	39.118178°
				-121.765901°	-121.765500°
DWR ID	DWR_ST0010_02_s_2022_24				
Comment Code					
E2 : Schedule repair of erosion site prior to the next inspection.					
Inspector Comment					
Erosion is present at the toe of the levee. Erosion is cutting into the patrol road.

View of the erosion at the waterside toe/patrol road. Spring 2022.

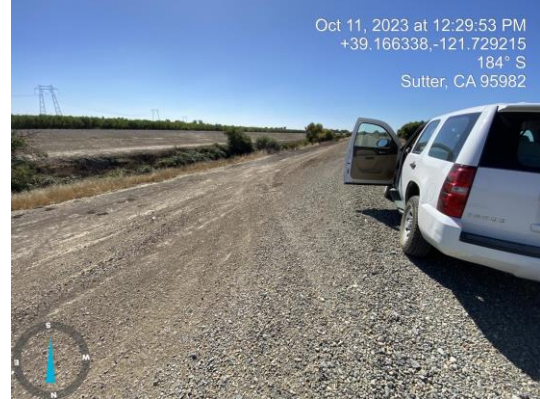
Photo 1 of 1 : FA_2024_ST0010_43_21_20240923_00006.jpg

LM Start	2.95	Rating **	M	Issue No.	21
LM End	2.95	Issue Type +	Ma	Location *	WS
Category	Earthen Levee			GPS Latitude/Longitude	
				Start	End
Item	Erosion / Vehicle Traffic			39.148938°	39.148938°
				-121.737620°	-121.737620°
DWR ID	DWR_ST0010_02_f_2016_21				
Comment Code					
E6 : Repair the levee slope damaged by vehicle traffic and prevent access where possible.					
Inspector Comment					
Vehicle traffic has created what appears to be a ramp on the waterside slope.

View of the ramp caused by vehicle traffic on the waterside slope (Fall 2023).

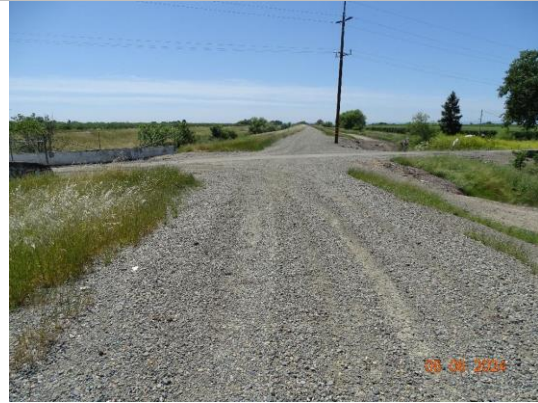
Photo 1 of 3 : UCIP_FA_2024_83700_122809.jpg

DS_ID:17077
FS_ID:83700
EP_NO: 7209
Repair Type: No Action Needed
EVAL Issue:
Crossing Status: Found
UCIP Comments: 05/06/2024 Record remains No Action Needed. DMP internal video inspection has found none or minor pipe defects. No issues observed during inspection. (M. Thao - DWR UCIP)
09/15/2023 Record updated from Urgent to No Action Needed. Pipe was CIPP lined on April 21, 2021. DMP internal video inspection has found none or minor pipe defects. Recommend next video inspection in 5 years. (O. Yakimov - DWR UCIP)
01/06/2022 Record updated from Non-Urgent to Urgent. DMP internal video inspection has found pipe integrity issues. LoF of crossing is 5.1 due to holes less than 10 feet from pipe end and deformation less or equal 10%. Crossing will be monitored until funding becomes available to address the issues. (O. Yakimov - DWR UCIP)
02/07/2019 Record remains Non-Urgent due to the tree obstructing access to the WS pipe outlet. Maintenance will need to be performed to clear some of the vegetation preventing access to the flap gate. This pipe qualifies as an LMA responsible crossing as it was originally listed in the USACE O&M manual as a drainage pipe. The CVFPB issued a permit in 1970 for the replacement of the original USACE drainage pipe. (O. Magana - DWR UCIP)

Levee crown looking downstream.

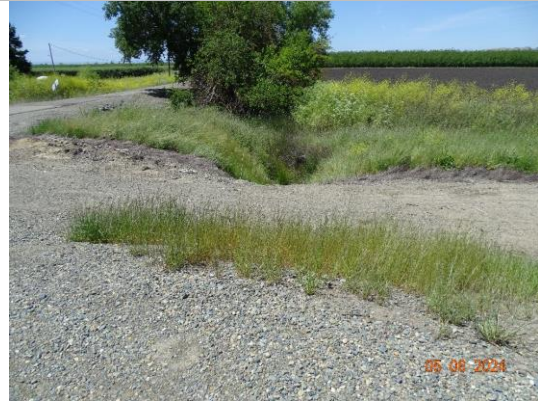
Photo 2 of 3 : UCIP_FA_2024_83700_122811.jpg

LS view: General overview looking from crown.

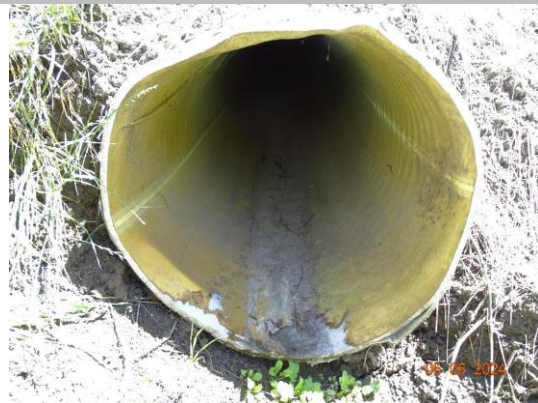
Photo 3 of 3 : UCIP_FA_2024_83700_122812.jpg

LS view: Looking into pipe inlet near toe.
