**Flood Control Project Maintenance  
Levee Inspections**

**Fall 2009 Levee Maintenance Deficiency Summary Report**

**Sacramento Maintenance Yard West Levee Yolo Bypass**

**Levee Inspection Report By Mile - Fall 2009**

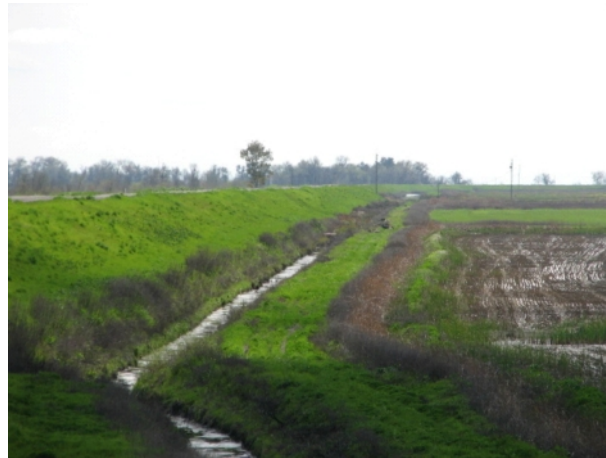
johngw\_20090924\_26.jpg

Levee Mile Report Line	1
Start Levee Mile	1.78
End Levee Mile	2.70
Location	Land Side
Category	Earthen Levee
Item	Encroachments

ag drain LM 1.78-2.70

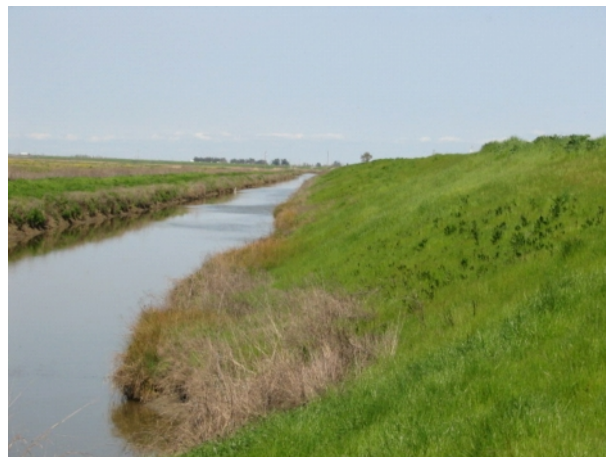
johngw\_20090924\_27.jpg

Levee Mile Report Line	2
Start Levee Mile	2.76
End Levee Mile	3.60
Location	Land Side
Category	Earthen Levee
Item	Encroachments

ag drain LM 2.76-3.60
