**Flood Control Project Maintenance
Levee Inspections**

Fall 2010 Levee Maintenance Deficiency Summary Report

Sacramento Maintenance Yard West Levee Yolo Bypass

Levee Inspection Report By Mile - Fall 2010

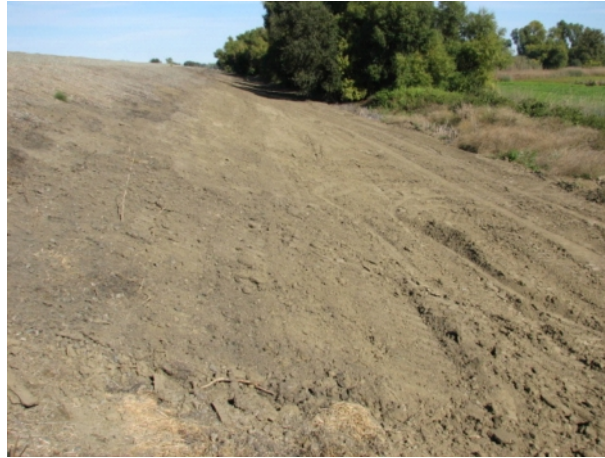
johngw_f_20101117_361.jpg

| Waterway | | | | | | | Bank | Unit Miles | Inspection Start/End | Inspector |
|---|---|---|---|---|---|---|--|---|---|---|
| 8 | 2.38 | 2.42 | Earthen Levee | Erosion / Bank Caving | WS | A | | 38.726897 ° -121.660380 ° | 38.726394 ° -121.660391 ° | 11 Y |

The erosion has been reggraded to meet the contour of the slope.

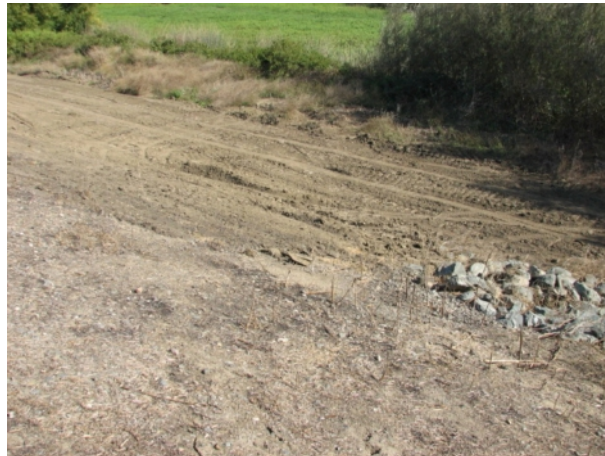
johngw_f_20101117_362.jpg

Regraded to tie into the rip rap at the corner of the by pass.

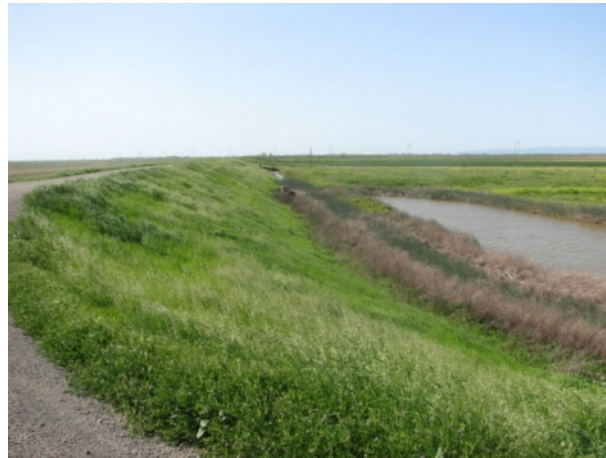
| johngw_f_20101012_221.jpg | |

| Waterway | | | | | | | Bank | Unit Miles | Inspection Start/End | Inspector |
|---|---|---|---|---|---|---|---|---|---|---|
| 1 | 0.08 | 0.21 | Earthen Levee | Encroachments | LS | PO | Agricultural Ditch | 38.718005 ° -121.664496 ° | 38.716140 ° -121.665460 ° | 4 Y |

| borrow pit and agricultural ditch | |

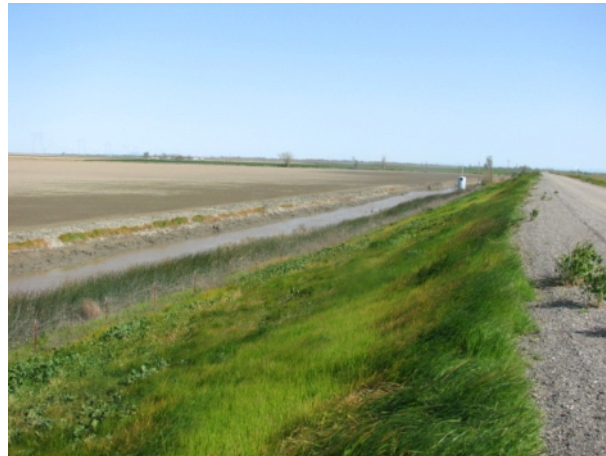
| johngw_f_20101012_220.jpg | |

| Waterway | | | | | | | Bank | Unit Miles | Inspection Start/End | Inspector |
|---|---|---|---|---|---|---|---|---|---|---|
| 2 | 0.47 | 0.97 | Earthen Levee | Encroachments | LS | PO | Agricultural Ditch | 38.712813 ° -121.667349 ° | 38.706018 ° -121.670831 ° | 3 Y |

| Agricultural ditch | |

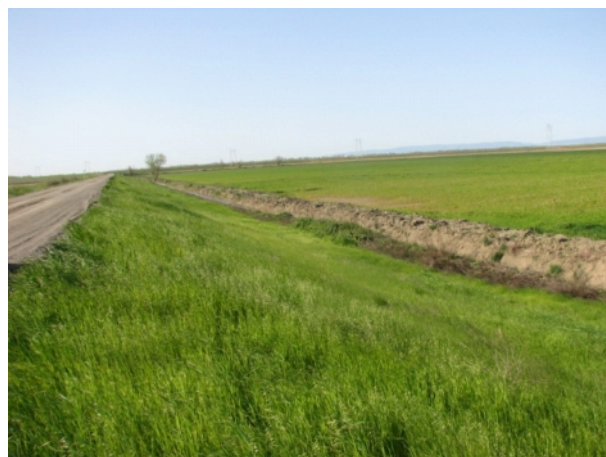
| johngw_f_20101012_222.jpg | |

| Waterway | | | | | | | Bank | Unit Miles | Inspection Start/End | Inspector |
|---|---|---|---|---|---|---|---|---|---|---|
| 3 | 1.15 | 1.44 | Earthen Levee | Encroachments | LS | PO | Agricultural Ditch | 38.703681 ° -121.672090 ° | 38.699637 ° -121.674112 ° | 5 Y |

| Agricultural ditch | |

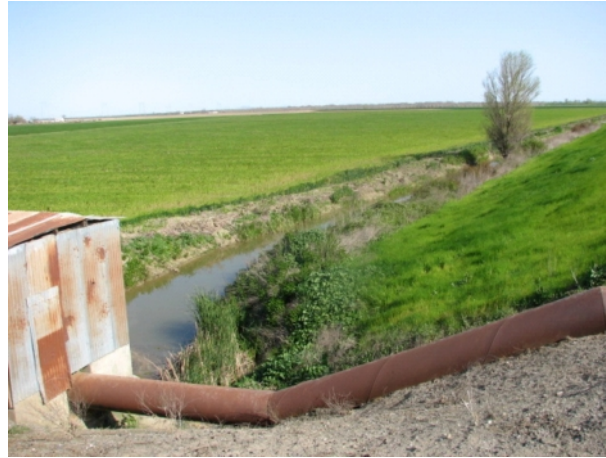
johngw_f_20101012_223.jpg

agricultural ditch and pump

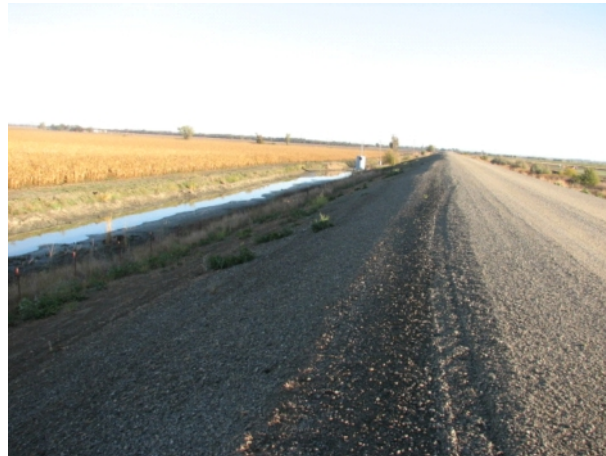
johngw_f_20101117_357.jpg

Levee has been burned and dragged for the season.

| Waterway | | | | | | | Bank | Unit Miles | Inspection Start/End | Inspector |
|---|---|---|---|---|---|---|---|---|---|---|
| 4 | 1.50 | 1.50 | Earthen Levee | Vegetation | LS | A | Remove the wild growth other than native grasses from the levee slopes. | 38.698889 ° -121.674118 ° | 38.698889 ° -121.674118 ° | 1 Y |

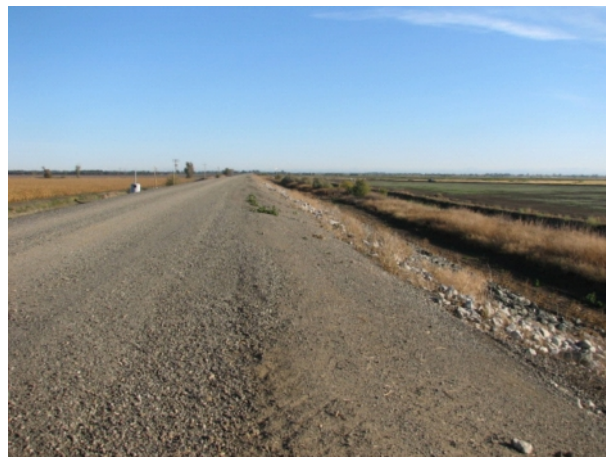
johngw_f_20101117_358.jpg

Levee after being burned and dragged.

| Waterway | | | | | | | Bank | Unit Miles | Inspection Start/End | Inspector |
|---|---|---|---|---|---|---|---|---|---|---|
| 5 | 1.50 | 1.50 | Earthen Levee | Vegetation | WS | A | Remove the wild growth other than native grasses from the levee slopes. | 38.698889 ° -121.674118 ° | 38.698889 ° -121.674118 ° | 2 Y |

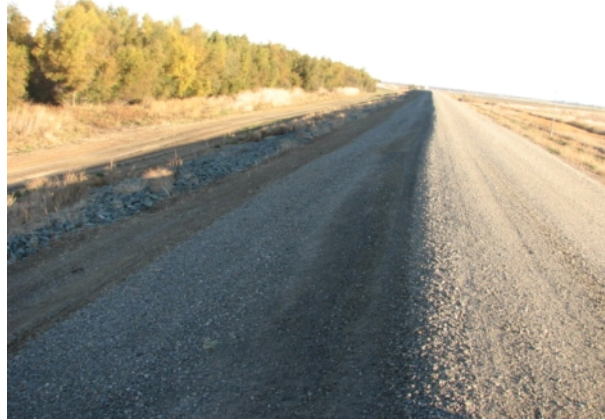
johngw_f_20101117_360.jpg

Levee after burning and dragging.

| LMR No. | Levee Mile | | Category | Item | * Location | ** Rating | Action/Comment | GPS Latitude/Longitude | | Issue No. |
|---|---|---|---|---|---|---|---|---|---|---|
| 1 | 1.30 | 1.30 | Earthen Levee | Vegetation | LS | A | Remove the wild growth other than native grasses from the levee slopes. | 38.679764 ° -121.672923 ° | 38.679764 ° -121.672923 ° | 1 Y |

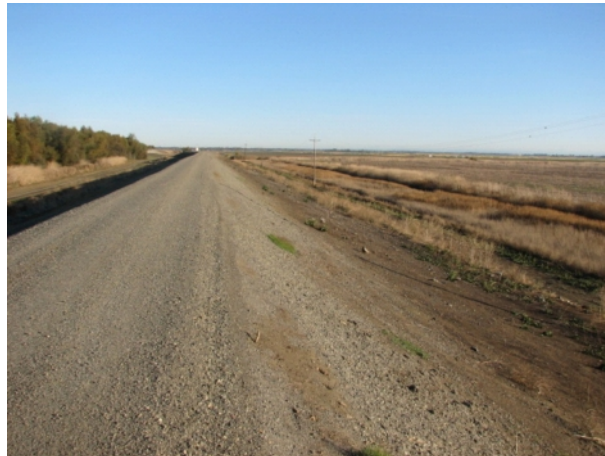
johngw_f_20101117_359.jpg

Levee after burning and dragging.

| LMR No. | Levee Mile | | Category | Item | * Location | ** Rating | Action/Comment | GPS Latitude/Longitude | | Issue No. |
|---|---|---|---|---|---|---|---|---|---|---|
| 2 | 1.30 | 1.30 | Earthen Levee | Vegetation | WS | A | Remove the wild growth other than native grasses from the levee slopes. | 38.679764 ° -121.672923 ° | 38.679764 ° -121.672923 ° | 2 Y |

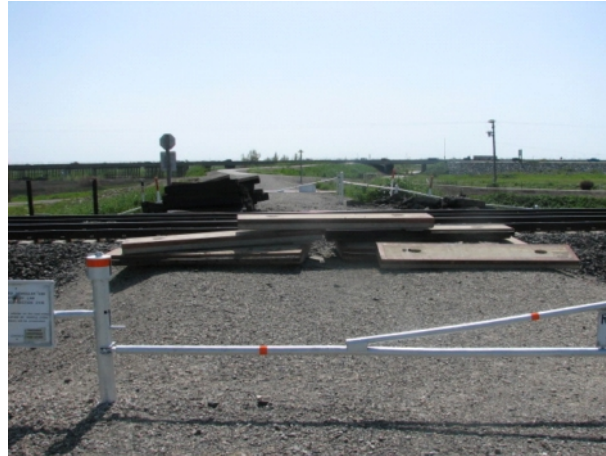
| johngw_f_20101012_228.jpg | |

| Waterway | | | | | | | Bank | Unit Miles | Inspection Start/End | Inspector |
|---|---|---|---|---|---|---|--|---|---|---|
| 1 | 0.57 | 0.57 | Earthen Levee | Encroachments | CR | U | Material Inspector Comments: railroad tracks being repaired; material blocking levee crown no access across tracks and it appears that work is not being performed at this time. Disrtict gate is broken and needs to be repaired. | 38.566349 ° -121.638873 ° | 38.566349 ° -121.638873 ° | 5 Y |

| changing railroad ties out; crown blocked | |

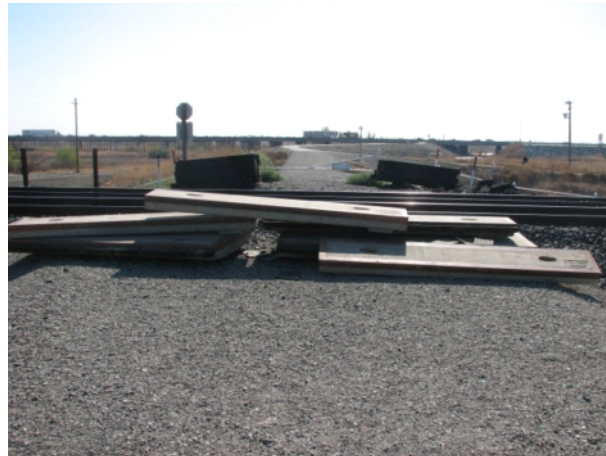
| johngw_f_20101025_246.jpg | |

| This photo was taken 10/19/10, levee is still blocked. | |

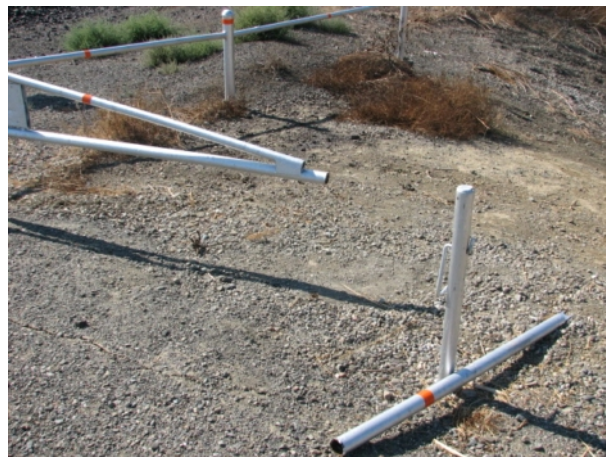
| johngw_f_20101025_250.jpg | |

| The gate at the railroad tracks has been cut. Need to remove railroad ties and repair gate. | |

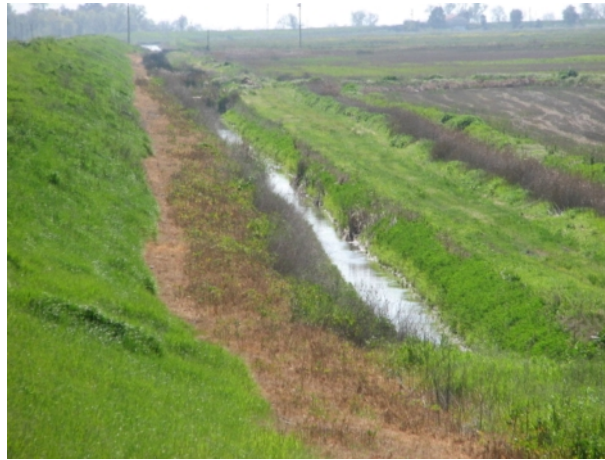
johngw_f_20101012_225.jpg

landside toe

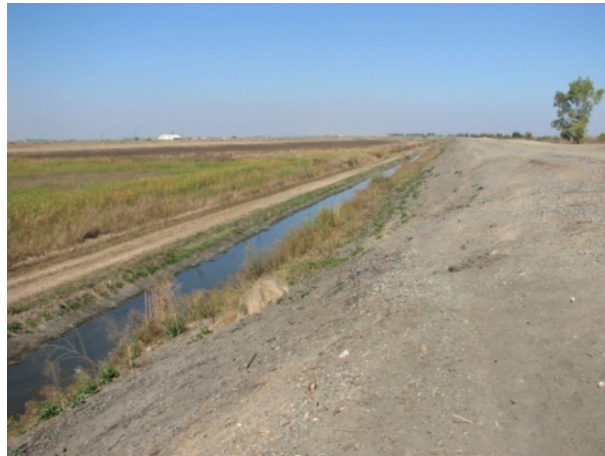
johngw_f_20101025_247.jpg

ag ditch along WYBP unit 4

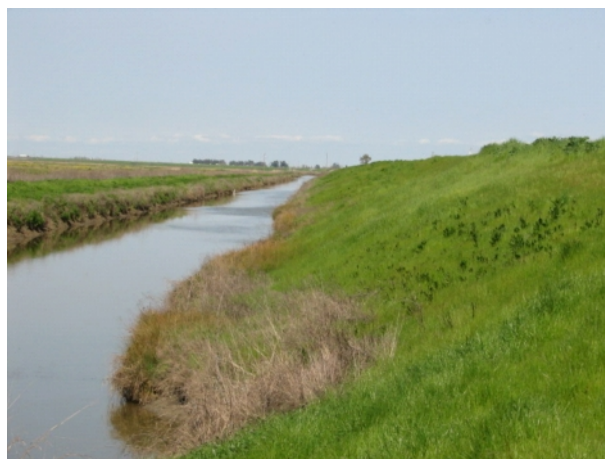
johngw_f_20101012_226.jpg

ag drain LM 2.76-3.60

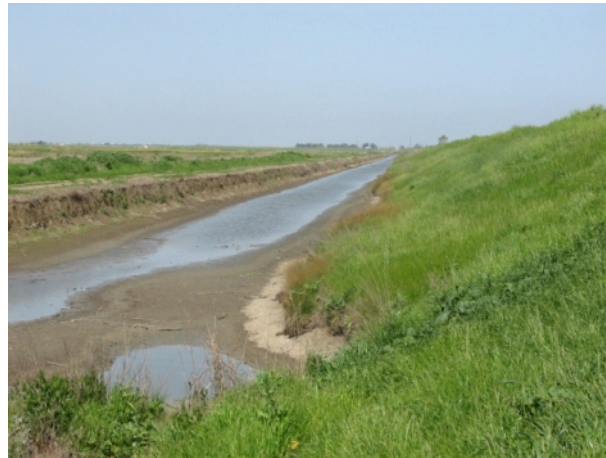
johngw_f_20101012_227.jpg

landside toe

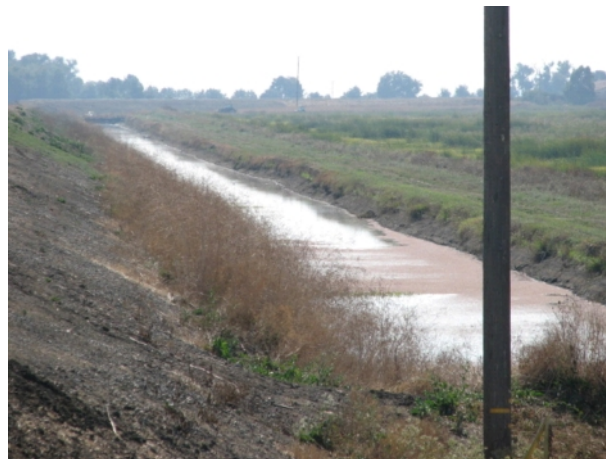
johngw_f_20101025_248.jpg

ag ditch in the fall 2010

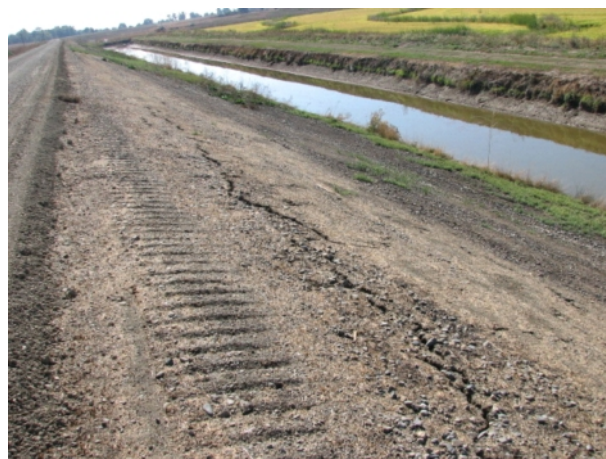
johngw_f_20101025_249.jpg

| Waterway | | | | | | | Bank | Unit Miles | Inspection Start/End | Inspector |
|---|---|---|---|---|---|---|--|---|---|---|
| 4 | 3.36 | 3.43 | Earthen Levee | Cracking | LS | M | Monitor and have inspected by geotechnical engineer. Inspector Comments: viewed the cracks while driving back to hwy. There is cracking along the length of the entire ag. ditch. | 38.527302 ° -121.631455 ° | 38.525952 ° -121.631467 ° | 1 Y |

There are cracks running along the landside shoulder. They run off and on the distance of the ditch.
