**Flood Control Project Maintenance  
Levee Inspections**

**Fall 2011 Levee Maintenance Deficiency Summary Report**

**Sacramento River Basin**

**Sacramento Maintenance Yard West Levee Yolo Bypass**

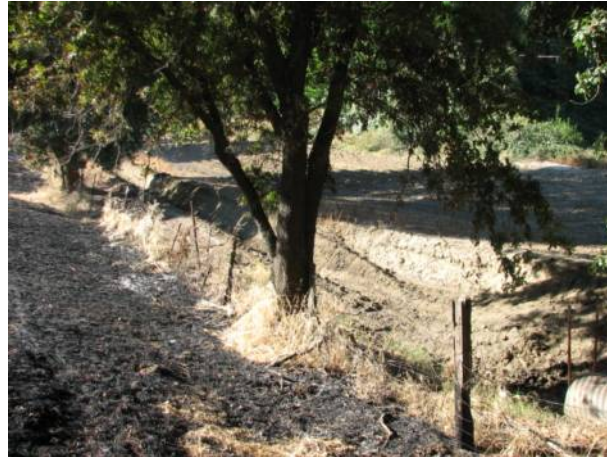
Levee Mile Report Line	1
Start Levee Mile	0.36
End Levee Mile	0.43
Location	Land Side
Category	Earthen Levee
Item	Encroachments

The end of the agricultural ditch along the toe of the levee. Photo taken fall 2011.

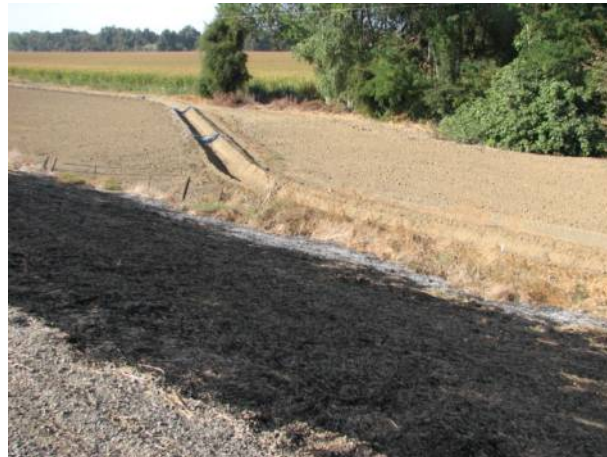
Levee Mile Report Line	1
Start Levee Mile	0.36
End Levee Mile	0.43
Location	Land Side
Category	Earthen Levee
Item	Encroachments

This photo shows the agricultural ditch as it turns towards the levee toe. Photo taken fall 2011.

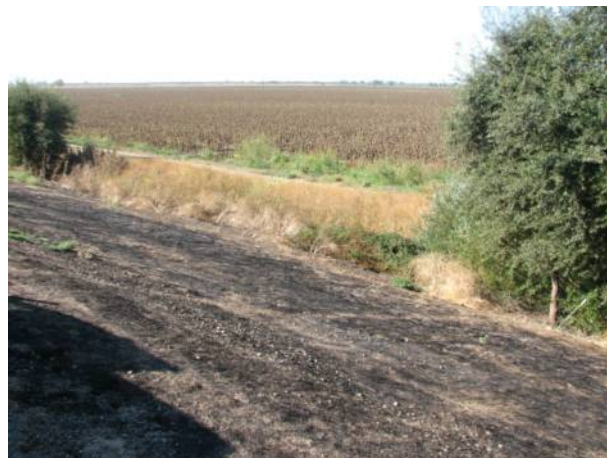
Levee Mile Report Line	2
Start Levee Mile	0.93
End Levee Mile	1.63
Location	Land Side
Category	Earthen Levee
Item	Encroachments

A photo of the agricultural ditch along the toe. Photo taken fall 2011.

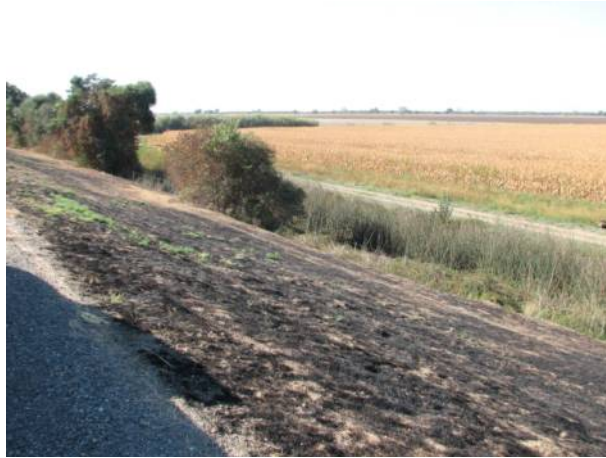
Levee Mile Report Line	2
Start Levee Mile	0.93
End Levee Mile	1.63
Location	Land Side
Category	Earthen Levee
Item	Encroachments

This is another view of the agricultural ditch along the toe. Photo taken fall 2011.

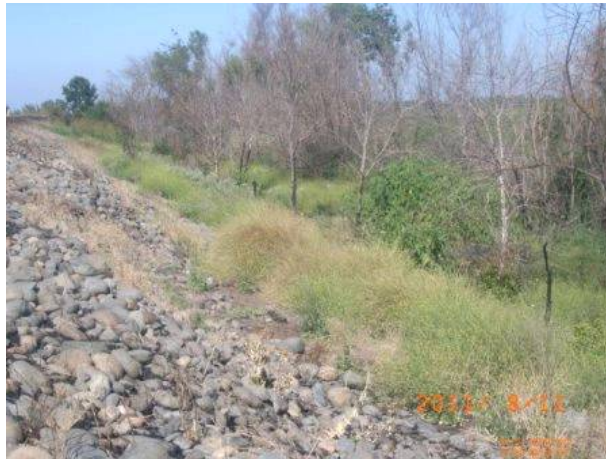
Levee Mile Report Line	3
Start Levee Mile	2.53
End Levee Mile	2.68
Location	Water Side
Category	Supplemental
Item	USACE Erosion Survey

USACE 2011 Photo #1

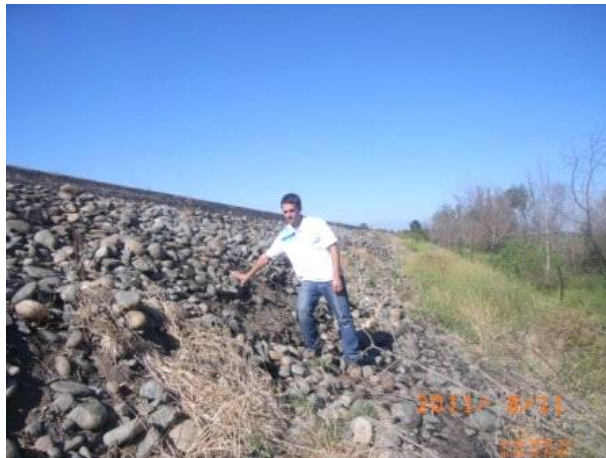
Levee Mile Report Line	3
Start Levee Mile	2.53
End Levee Mile	2.68
Location	Water Side
Category	Supplemental
Item	USACE Erosion Survey

USACE 2011 Photo #2

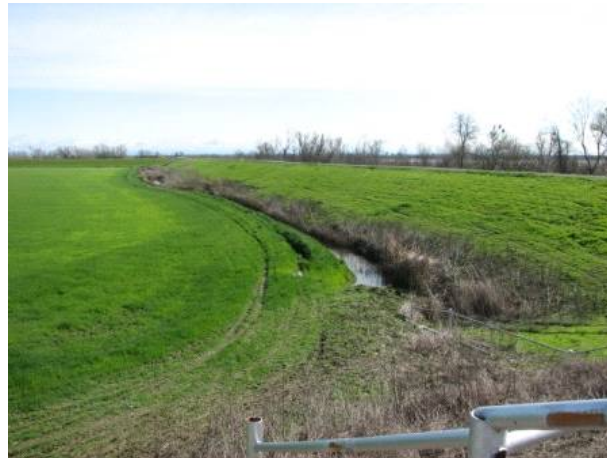
Levee Mile Report Line	4
Start Levee Mile	2.63
End Levee Mile	2.70
Location	Land Side
Category	Earthen Levee
Item	Encroachments
Agricultural ditch running along toe landside. 3-7-11	
johngw_f_20110923_793.jpg

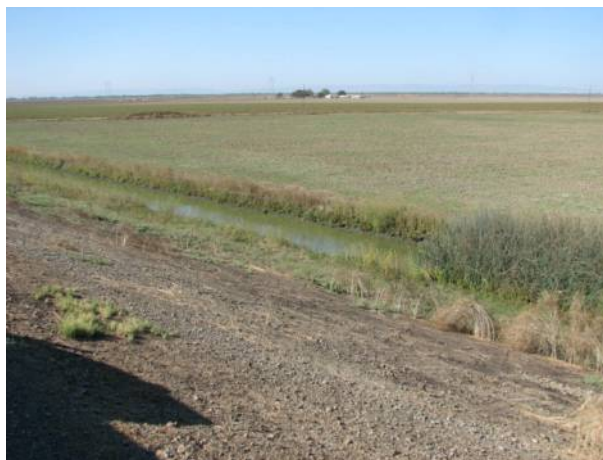
Levee Mile Report Line	1
Start Levee Mile	0.08
End Levee Mile	0.21
Location	Land Side
Category	Earthen Levee
Item	Encroachments

Agricultural ditch full of water runs along the toe of the levee. Photo taken fall 2011.

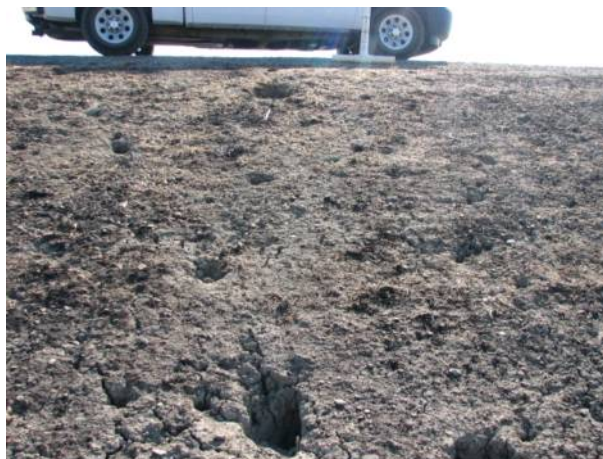
Levee Mile Report Line	2
Start Levee Mile	0.39
End Levee Mile	0.39
Location	Land Side
Category	Earthen Levee
Item	Animal Control

There are old rodent holes on the levee slope. Animal control program is working need to backfill holes. Photo taken fall 2011.

Waterway						Bank	Unit Miles	Inspection Start/End	Inspector	
Unit No. 02 West Levee						Right	1.52	09/29/2011 09/29/2011	John Williamson	
LMR No.	Levee Mile		Category	Item	Location *	Rating **	Action/Comment	GPS Latitude/Longitude		Issue No.
	Start	End						Start	End	Photo
1	0.08	0.21	Earthen Levee	Encroachments	LS	PO	Agricultural Ditch	38.718005 ° -121.664496 °	38.716140 ° -121.665460 °	4 Y
2	0.39	0.39	Earthen Levee	Animal Control	LS	A	No rodents visible, but rodent burrows visible; need to backfill and compact or grout burrows.	38.713799 ° -121.666805 °	38.713799 ° -121.666805 °	1 Y
3	0.47	0.97	Earthen Levee	Encroachments	LS	PO	Agricultural Ditch	38.712813 ° -121.667349 °	38.706018 ° -121.670831 °	3 Y
4	1.15	1.44	Earthen Levee	Encroachments	LS	PO	Agricultural Ditch	38.703681 ° -121.672090 °	38.699637 ° -121.674112 °	5 Y
5	1.43	1.43	Earthen Levee	Animal Control	LS	M	No rodents visible, but rodent burrows visible; need to backfill and compact or grout burrows.	38.699942 ° -121.674026 °	38.699942 ° -121.674026 °	2 Y

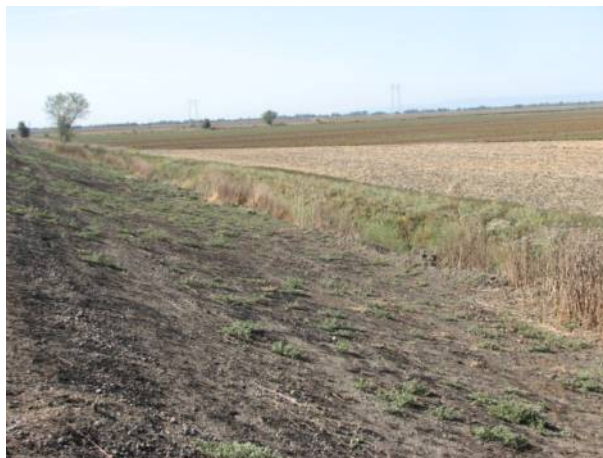
Levee Mile Report Line	3
Start Levee Mile	0.47
End Levee Mile	0.97
Location	Land Side
Category	Earthen Levee
Item	Encroachments

Agricultural ditch runs along the toe of the levee. Photo taken fall 2011.

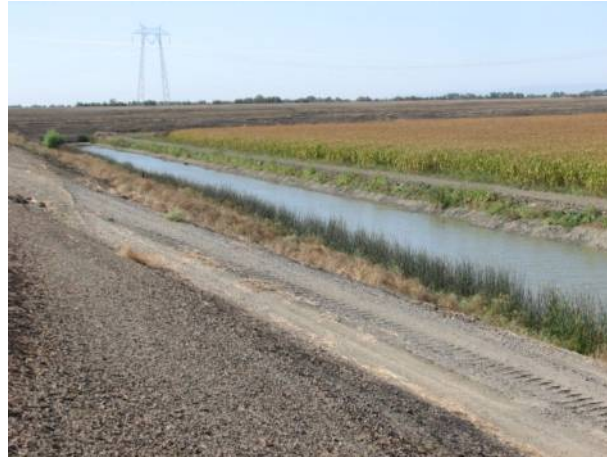
Levee Mile Report Line	4
Start Levee Mile	1.15
End Levee Mile	1.44
Location	Land Side
Category	Earthen Levee
Item	Encroachments

Agricultural ditch runs along the toe of the levee. It varies in distance from toe from 1-10 feet away. Photo taken fall 2011.

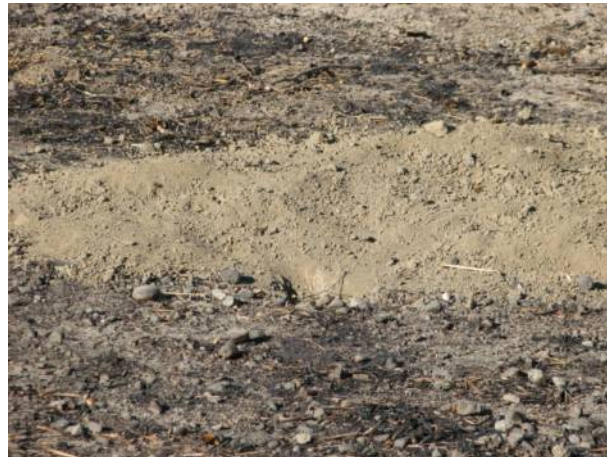
Levee Mile Report Line	5
Start Levee Mile	1.43
End Levee Mile	1.43
Location	Land Side
Category	Earthen Levee
Item	Animal Control

A rodent hole at toe of levee. Photo taken fall 2011.

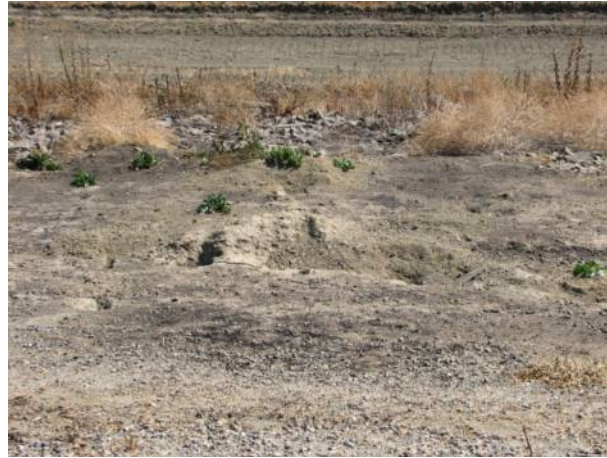
Levee Mile Report Line	1
Start Levee Mile	0.40
End Levee Mile	0.40
Location	Water Side
Category	Earthen Levee
Item	Animal Control

LMR No.	Levee Mile		Category	Item	Location *	Rating **	Action/Comment	GPS Latitude/Longitude		Issue No.
	Start	End						Start	End	Photo
1	0.40	0.40	Earthen Levee	Animal Control	WS	A	No rodents visible, but rodent burrows visible; need to backfill and compact or grout burrows.	38.692822 ° -121.673777 °	38.692822 ° -121.673777 °	3 Y

A rodent hole near the toe of the levee. Photo taken fall 2011.

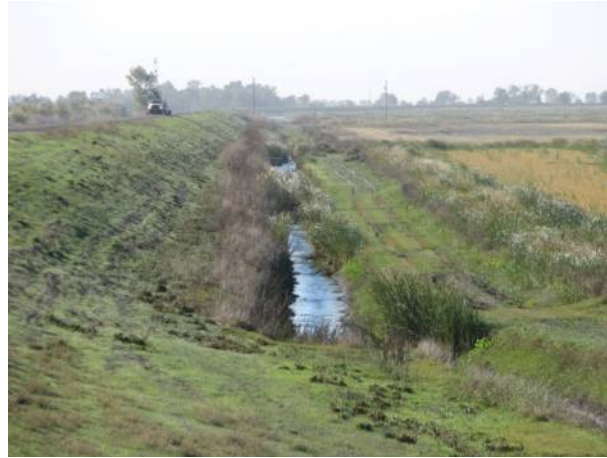
Levee Mile Report Line	2
Start Levee Mile	1.78
End Levee Mile	2.70
Location	Land Side
Category	Earthen Levee
Item	Encroachments

The argricultural ditch runs along the landside toe.  
Fall 2011

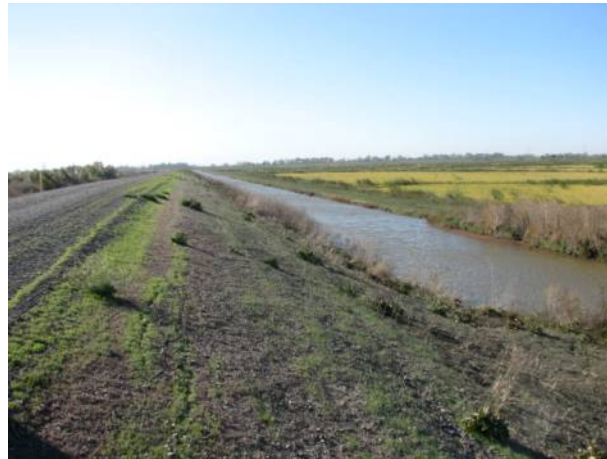
Levee Mile Report Line	3
Start Levee Mile	2.76
End Levee Mile	3.60
Location	Land Side
Category	Earthen Levee
Item	Encroachments

The argricultural ditch runs along the toe of the  
landside. Fall 2011

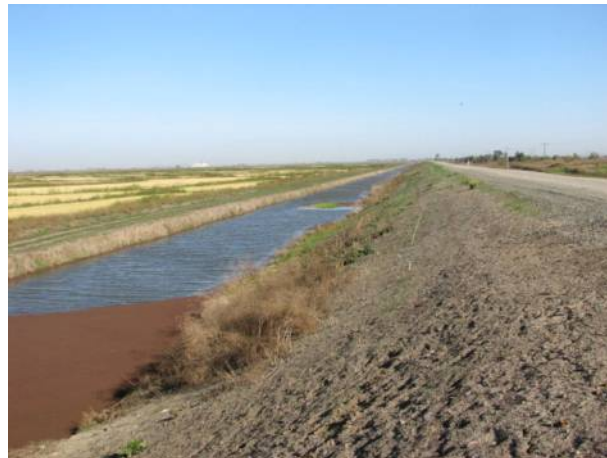
Levee Mile Report Line	3
Start Levee Mile	2.76
End Levee Mile	3.60
Location	Land Side
Category	Earthen Levee
Item	Encroachments

This view is looking to the north. Fasll 2011

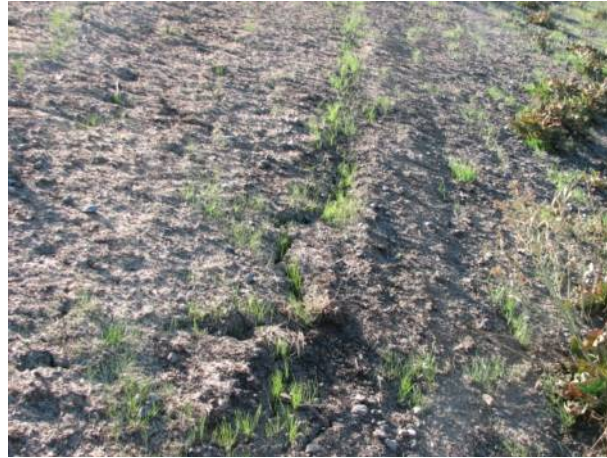
Levee Mile Report Line	4
Start Levee Mile	3.36
End Levee Mile	3.43
Location	Land Side
Category	Earthen Levee
Item	Cracking

There are cracks running along the landside shoulder. They run off and on the distance of the ditch. Fall 2011
