**Flood Control Project Maintenance
Levee Inspections**

Fall 2012 Levee Maintenance Deficiency Summary Report

Sacramento River Basin

Sacramento Maintenance Yard West Levee Yolo Bypass

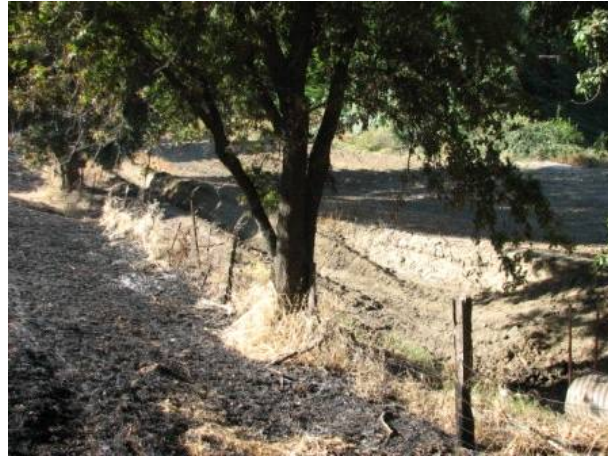
Levee Mile Report Line	4
Start Levee Mile	0.36
End Levee Mile	0.43
Location	Land Side
Category	Earthen Levee
Item	Encroachments

The end of the agricultural ditch along the toe of the levee. Photo taken Fall 2011.

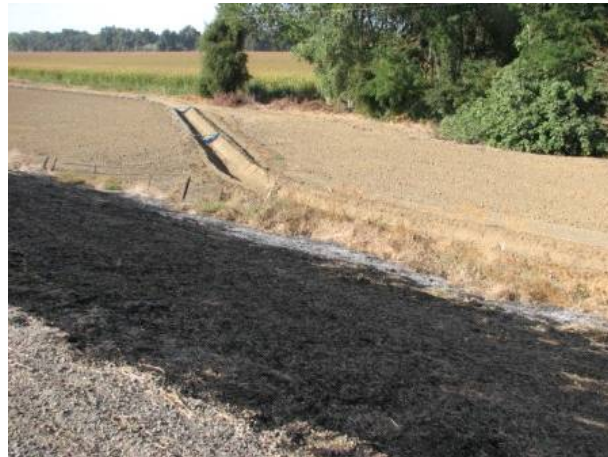
Levee Mile Report Line	4
Start Levee Mile	0.36
End Levee Mile	0.43
Location	Land Side
Category	Earthen Levee
Item	Encroachments

This photo shows the agricultural ditch as it turns towards the levee toe. Photo taken Fall 2011.

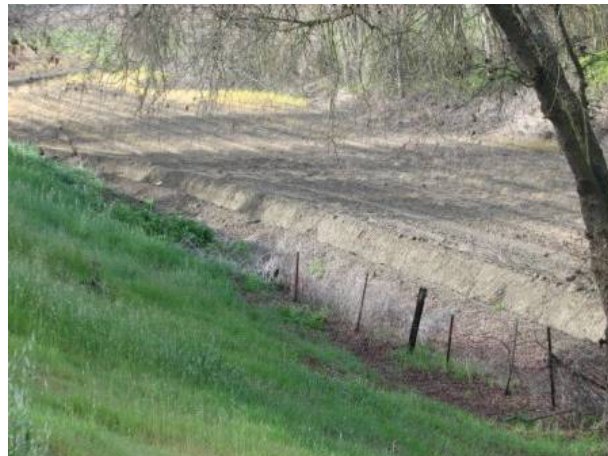
Levee Mile Report Line	4
Start Levee Mile	0.36
End Levee Mile	0.43
Location	Land Side
Category	Earthen Levee
Item	Encroachments

Photo taken spring 2012, agricultural ditch runs along toe of levee.

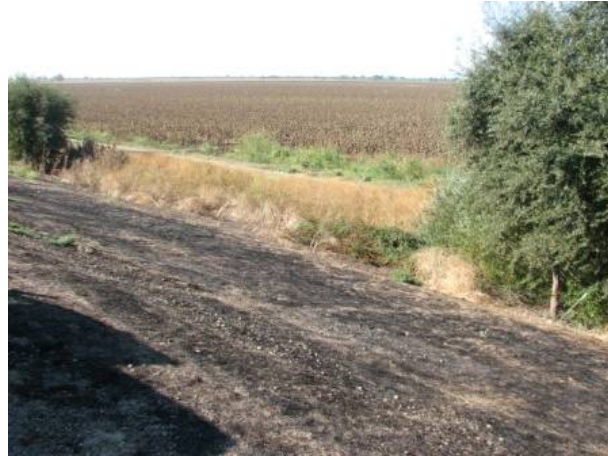
Levee Mile Report Line	5
Start Levee Mile	0.93
End Levee Mile	1.63
Location	Land Side
Category	Earthen Levee
Item	Encroachments

A photo of the agricultural ditch along the toe.
Photo taken fall 2011.

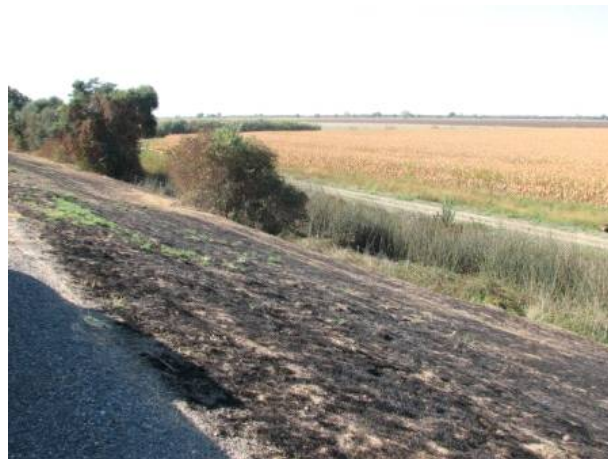
Levee Mile Report Line	5
Start Levee Mile	0.93
End Levee Mile	1.63
Location	Land Side
Category	Earthen Levee
Item	Encroachments

This is another view of the agricultural ditch along
the toe. Photo taken fall 2011.

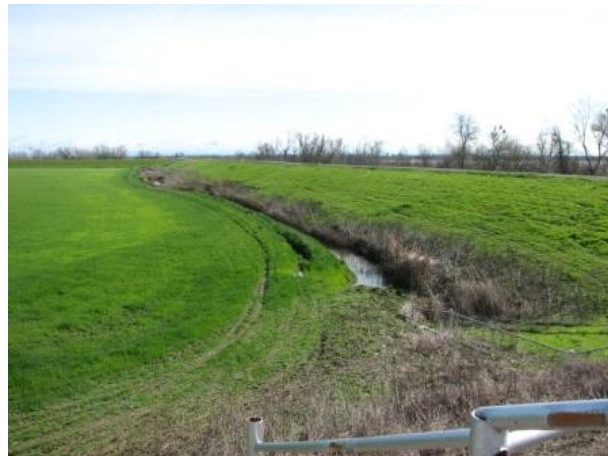
Levee Mile Report Line	7
Start Levee Mile	2.63
End Levee Mile	2.70
Location	Land Side
Category	Earthen Levee
Item	Encroachments

Agricultural ditch running along toe landside. 3-7-
11

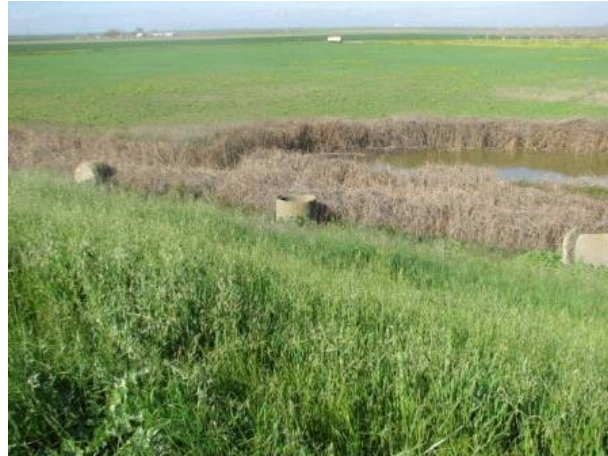
Levee Mile Report Line	1
Start Levee Mile	0.07
End Levee Mile	0.07
Location	Land Side
Category	Earthen Levee
Item	Encroachments
Photo taken spring 2012, concrete stand pipe laying at toe of levee.	
johngw_f_20120911_681.jpg

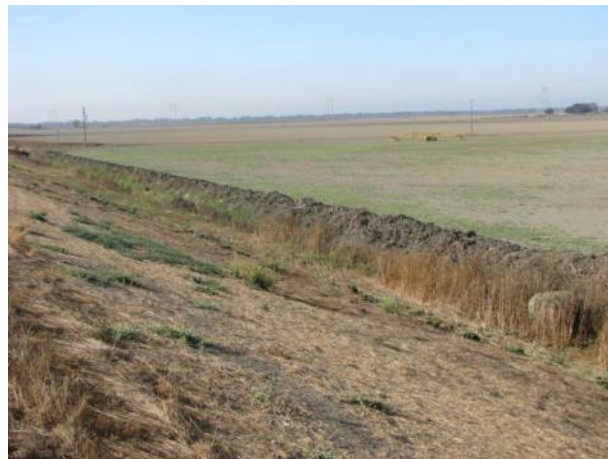
Levee Mile Report Line	2
Start Levee Mile	0.08
End Levee Mile	0.21
Location	Land Side
Category	Earthen Levee
Item	Encroachments
The agricultural ditch is at the toe of the levee. Photo fall 2012.	
johngw_f_20121022_762.jpg

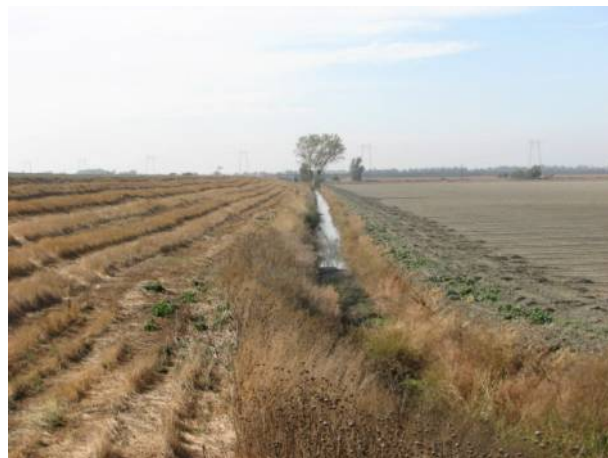
Levee Mile Report Line	3
Start Levee Mile	0.47
End Levee Mile	0.97
Location	Land Side
Category	Earthen Levee
Item	Encroachments
The agricultural ditch is at the toe of the levee. Photo 2012.	
johngw_f_20121022_763.jpg

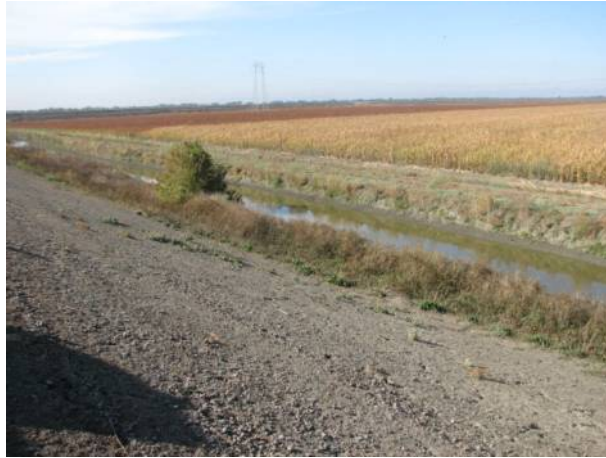
Levee Mile Report Line	4
Start Levee Mile	1.15
End Levee Mile	1.44
Location	Land Side
Category	Earthen Levee
Item	Encroachments

The agricultural ditch is at the toe of the levee.
Photo fall 2012.

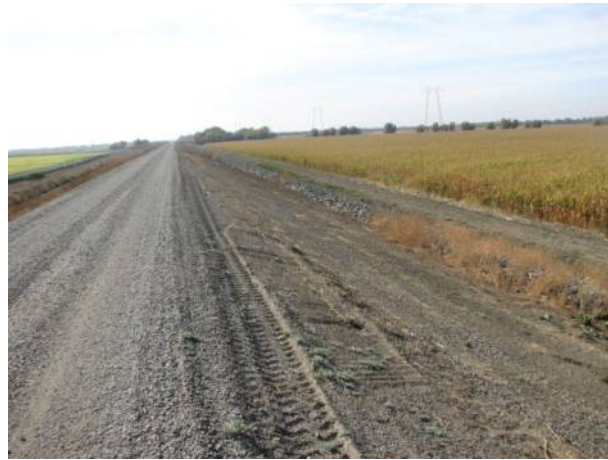
Levee Mile Report Line	1
Start Levee Mile	0.01
End Levee Mile	1.41
Location	Land Side
Category	Earthen Levee
Item	Vegetation

The levee slope complies with USACE standards.

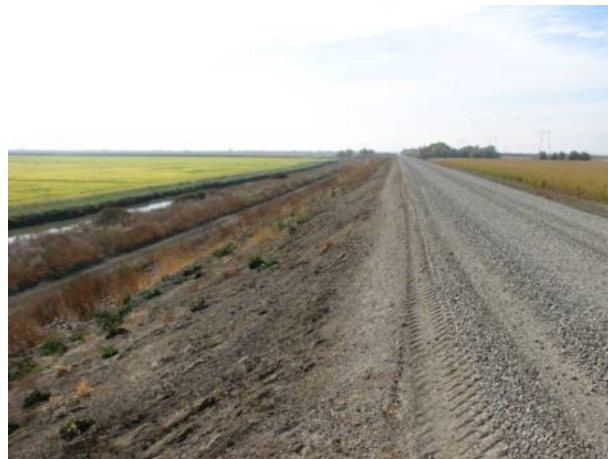
Levee Mile Report Line	2
Start Levee Mile	0.01
End Levee Mile	1.41
Location	Water Side
Category	Earthen Levee
Item	Vegetation

The levee slope complies with USACE standards.

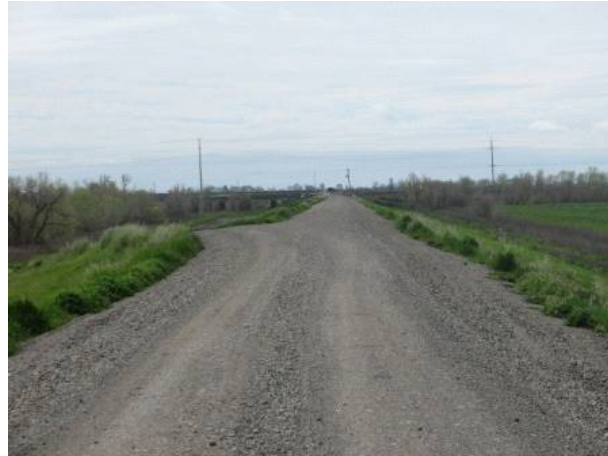
Levee Mile Report Line	1
Start Levee Mile	0.02
End Levee Mile	3.61
Location	Water Side
Category	Earthen Levee
Item	Vegetation

Photo taken spring 2012, both landside and waterside slopes are mostly grasses.

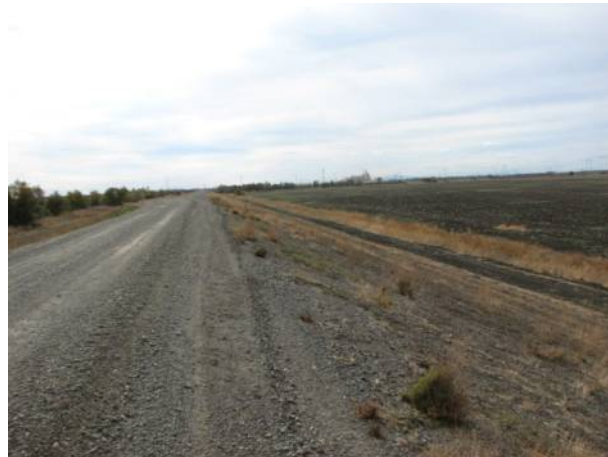
Levee Mile Report Line	2
Start Levee Mile	0.02
End Levee Mile	3.61
Location	Land Side
Category	Earthen Levee
Item	Vegetation

The slope complies with standards mostly grasses. Fall 2012

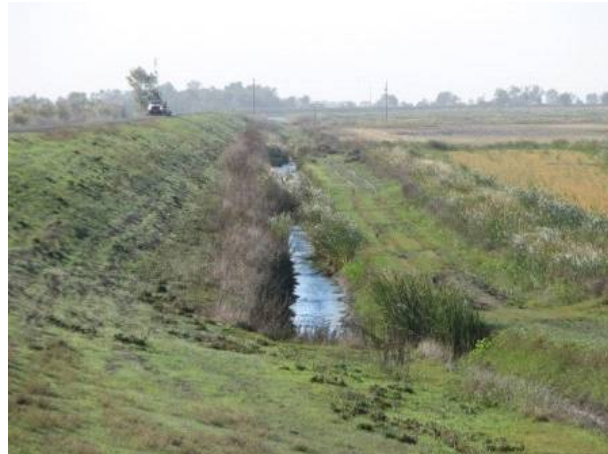
Levee Mile Report Line	3
Start Levee Mile	1.78
End Levee Mile	2.70
Location	Land Side
Category	Earthen Levee
Item	Encroachments

The argricultural ditch runs along the landside toe. Fall 2011

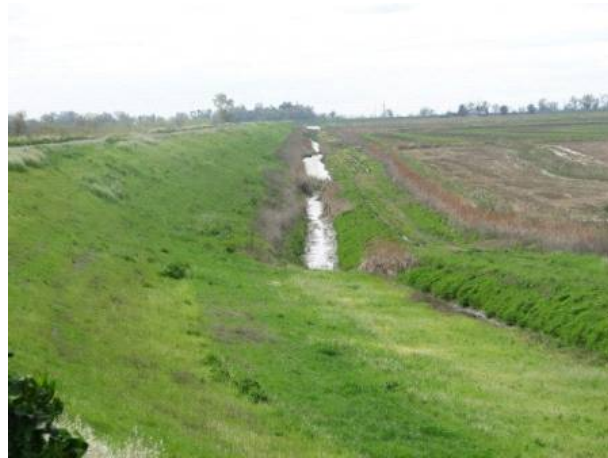
Levee Mile Report Line	3
Start Levee Mile	1.78
End Levee Mile	2.70
Location	Land Side
Category	Earthen Levee
Item	Encroachments
Photo taken spring 2012, agricultural ditch runs along toe of levee.	
johngw_f_20120911_688.jpg

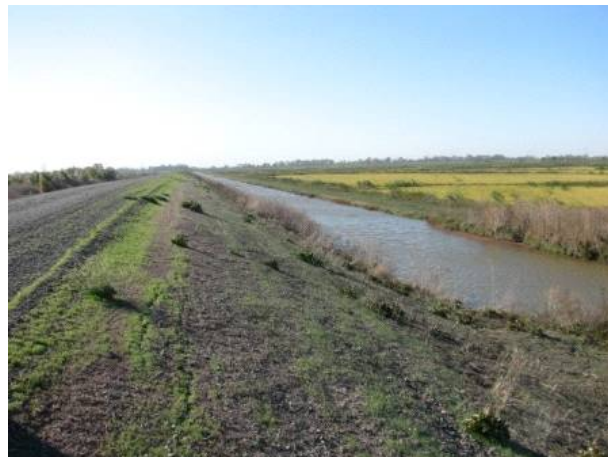
Levee Mile Report Line	4
Start Levee Mile	2.76
End Levee Mile	3.60
Location	Land Side
Category	Earthen Levee
Item	Encroachments
The agricultural ditch runs along the toe of the landside. Fall 2011	
johngw_f_20120911_689.jpg

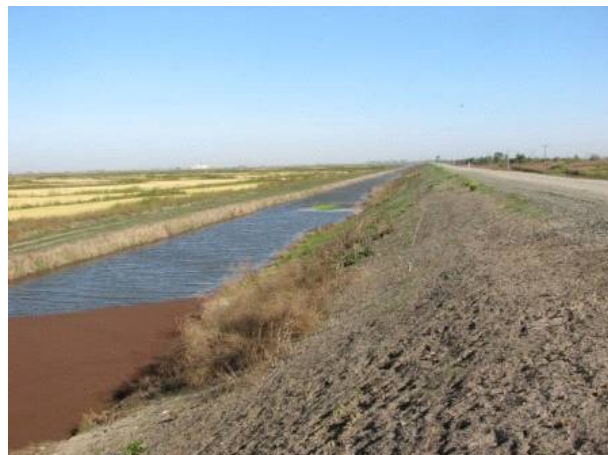
Levee Mile Report Line	4
Start Levee Mile	2.76
End Levee Mile	3.60
Location	Land Side
Category	Earthen Levee
Item	Encroachments
This view is looking to the north. Fall 2011	
johngw_f_20120911_690.jpg

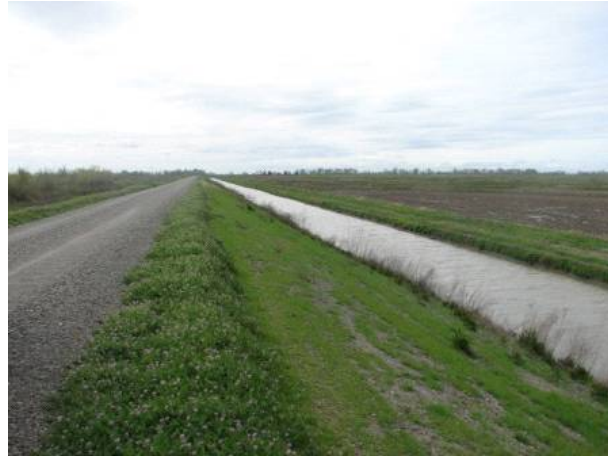
Levee Mile Report Line	4
Start Levee Mile	2.76
End Levee Mile	3.60
Location	Land Side
Category	Earthen Levee
Item	Encroachments
Photo taken spring 2012, agricultural ditch runs along toe of levee.	
johngw_f_20120911_691.jpg
