**Flood Control Project Maintenance
Levee Inspections**

Fall 2013 Levee Maintenance Deficiency Summary Report

Sacramento Maintenance Yard West Levee Yolo Bypass

Levee Inspection Report By Mile - Fall 2013

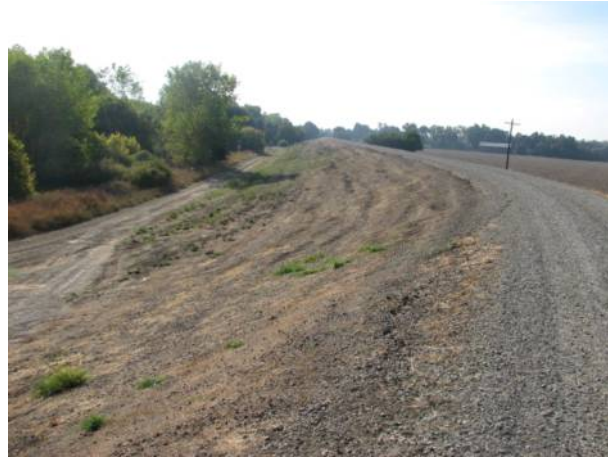
Levee Mile Report Line	1
Start Levee Mile	
End Levee Mile	
Location	Land Side
Category	Earthen Levee
Item	Operations & Maintenance Manuals
The levee slope is mostly grasses. Photo fall 2012.	
johngw_f_20130924_748.jpg

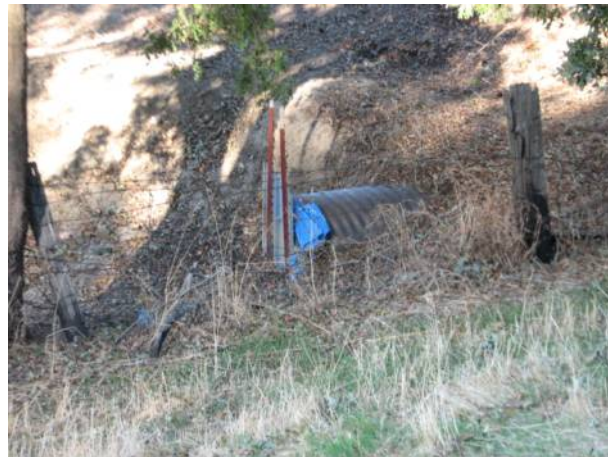
Levee Mile Report Line	4
Start Levee Mile	0.36
End Levee Mile	0.43
Location	Land Side
Category	Earthen Levee
Item	Encroachments
The culvert at the end of the agricultural ditch. Fall 2013	
johngw_f_20131014_972.JPG

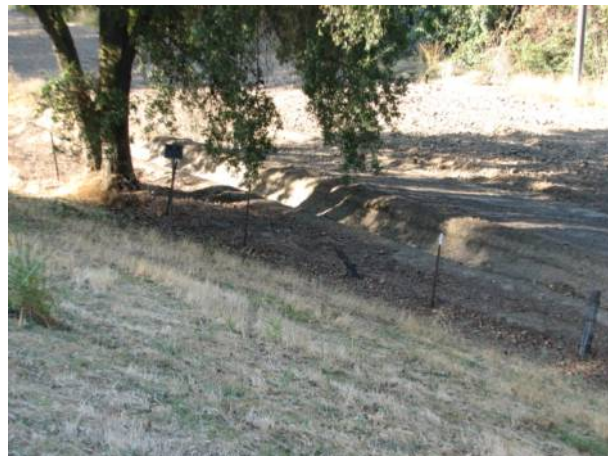
Levee Mile Report Line	4
Start Levee Mile	0.36
End Levee Mile	0.43
Location	Land Side
Category	Earthen Levee
Item	Encroachments
The agricultural ditch along the levee toe. Fall 2013	
johngw_f_20131014_973.JPG

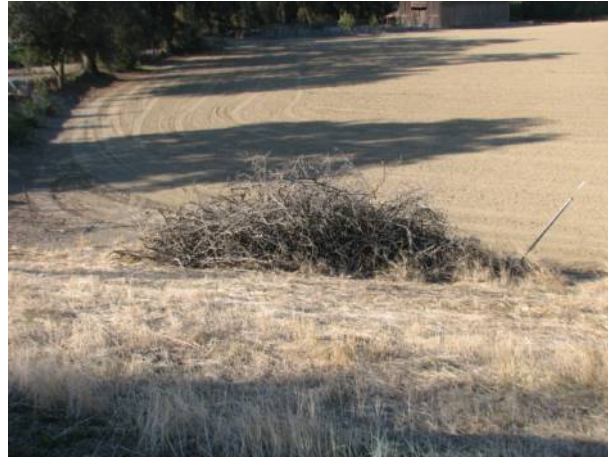
Levee Mile Report Line	5
Start Levee Mile	0.83
End Levee Mile	0.83
Location	Land Side
Category	Earthen Levee
Item	Encroachments
A pruning pile on the landside levee slope. Fall 2013	
johngw_f_20131014_974.JPG

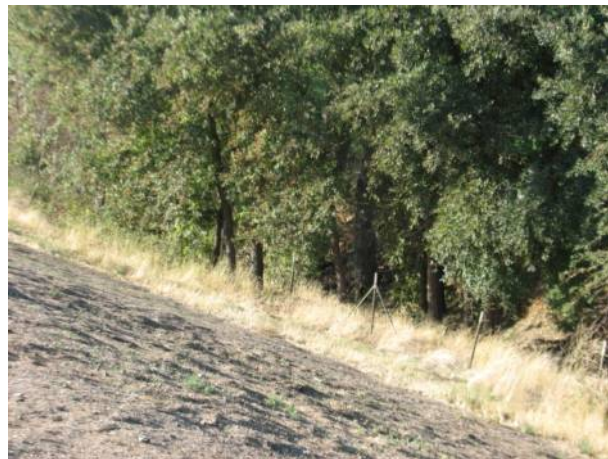
Levee Mile Report Line	6
Start Levee Mile	0.93
End Levee Mile	1.63
Location	Land Side
Category	Earthen Levee
Item	Encroachments
The agricultural ditch runs along the toe of the levee. Fall 2013	
johngw_f_20131014_975.JPG

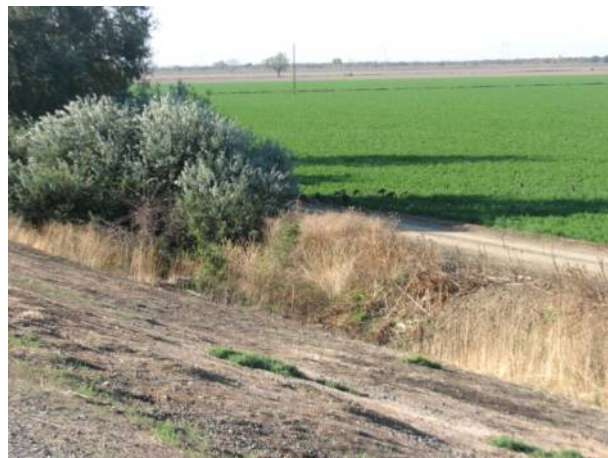
Levee Mile Report Line	6
Start Levee Mile	0.93
End Levee Mile	1.63
Location	Land Side
Category	Earthen Levee
Item	Encroachments
Another view of the agricultural ditch at the toe. Fall 2013	
johngw_f_20131014_976.JPG

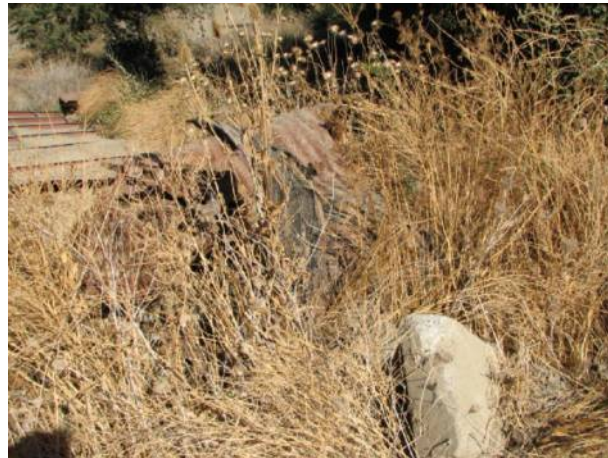
Levee Mile Report Line	7
Start Levee Mile	1.85
End Levee Mile	1.85
Location	Water Side
Category	Supplemental
Item	DWR UCIP Field Study

DWR ID: DWR_ST0011_01_s_2012_8										
7	1.85	1.85	Supplemental	DWR UCIP Field Study	LS	M En	Inspector Comments: FS_ID:13970 EP_NO: 10284 Repair Type: Non-Urgent Crossing Status: Indicator Found UCIP Comments: Found abandoned 42-inch CM pipe on LS berm of the levee. This was abandoned by farmer, how Unknown. need to have verified if removed or concreted FIELD_STRUCT_DESC: 42-inch CM drainpipe through levee 25.0 feet below crown. Slide gate on waterward end. (ABO No. 10284 - Hershey). O&M manual 127, Revision Year 2011 FS Date: 5/28/2013 2:39:00 PM	38.734568 °	38.734568 °	169
								-121.660264 °	-121.660264 °	Y
DWR ID: DWR_ST0011_01_f_2013_169										
8	1.85	1.85	Supplemental	DWR UCIP Field Study	LS	M En	Inspector Comments: FS_ID:6848 EP_NO: 6306 Repair Type: Non-Urgent Crossing Status: Found UCIP Comments: The pipe is about 18-ft below the crown. Seems pump has been used for dual purpose. There is another pipe (approx. 12-inch) found near the pump crossing the ditch. Two closing valves also found in pumping system. FIELD_STRUCT_DESC: 20-inch steel drainpipe through levee 5.8 feet below crown. Pump and switch panel at toe of landward slope. Siphon breaker on landward slope. (App. No. 6306 - Hershey). O&M manual 127, Revision Year 2011. FS Date: 10/17/2012	38.734543 °	38.734543 °	170

Landside view: an abandoned CM pipe on LS berm of the levee.

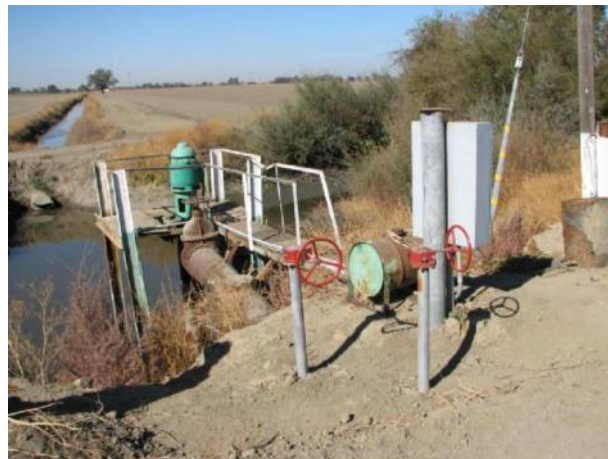
Levee Mile Report Line	9
Start Levee Mile	1.85
End Levee Mile	1.85
Location	Water Side
Category	Supplemental
Item	DWR UCIP Field Study

LMR No.	Levee Mile		Category	Item	Location	Rating	Action/Comment	GPS Latitude/Longitude		Issue No.
	Start	End						Start	End	
9	1.85	1.85	Supplemental	DWR UCIP Field Study	LS	M En	Inspector Comments: FS_ID:6860 EP_NO: 6306 Repair Type: Non-Urgent Crossing Status: Found UCIP Comments: The pipe is about 18-ft below the crown. Seems pump has been used for dual purpose. There is another pipe (approx. 12-inch) found near the pump crossing the ditch. Two closing valves also found in pumping station. FIELD_STRUCT_DESC: 20-inch steel drainpipe through levee 5.8 feet below crown. Pump and switch panel at toe of landward slope. Siphon breaker on landward slope. (App. No. 6306 - Hershey). O&M manual 127, Revision Year 2011. FS Date: 10/17/2012	38.734543 ° -121.660264 °	38.734543 ° -121.660264 °	171 Y
DWR ID: DWR_ST0011_01_f_2013_171										
10	2.53	2.68	Earthen Levee	Erosion / Bank Caving	WS	A Ma	Inspector Comments: This area has been repaired and the USACE entry should be removed.	38.725550 ° -121.662077 °	38.724482 ° -121.664563 °	174 Y

Landside view: overview of pumping station (walkway, valves, powerline, oil barrel etc)

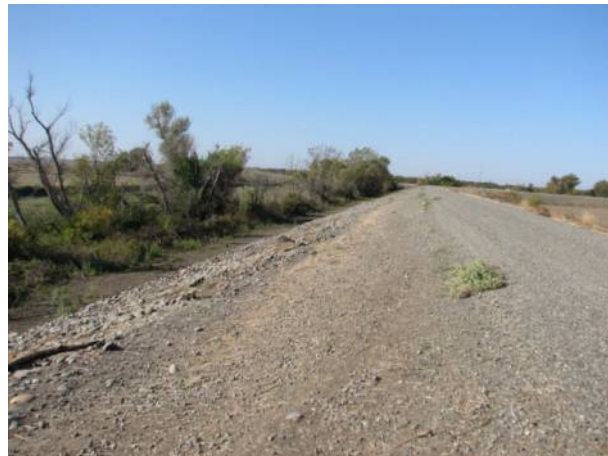
Levee Mile Report Line	10
Start Levee Mile	2.53
End Levee Mile	2.68
Location	Water Side
Category	Earthen Levee
Item	Erosion / Bank Caving

DWR ID: DWR_ST0011_01_f_2013_174										
11	2.53	2.68	Supplemental	USACE Erosion Survey	WS	M Ma	Inspector Comments: 2006 - Slow wave wash and general fluvial erosion of the toe area under river cobbles. Erosion is creating a scarp and cobble covered wave-cut bench. 2011 - Site appears better than it looked in 2006, but still eroding. 2012: Site is part of the extended inventory, last inspected 2011. [2012 Site ID: YOL_2-6_R]	38.725505 ° -121.662041 °	38.724385 ° -121.664564 °	2
DWR ID:										
12	2.63	2.70	Earthen Levee	Encroachments	LS	M En	DT : Ditch	38.724800 ° -121.663710 °	38.724230 ° -121.664873 °	4 Y
DWR ID: DWR_ST0011_01_s_2012_4

The waterside slope has been resloped and the cobble rock has been placed back. Fall 2013

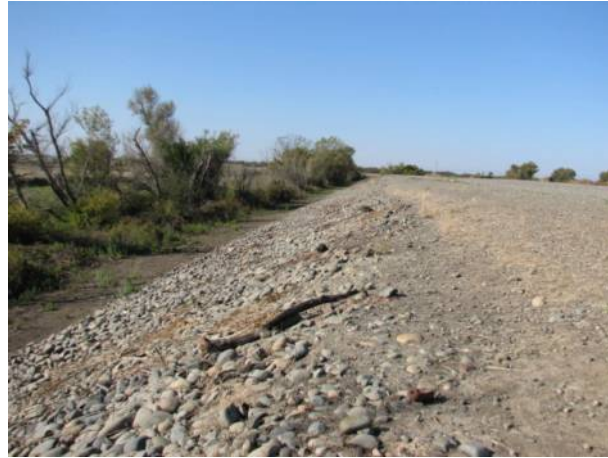
Levee Mile Report Line	10
Start Levee Mile	2.53
End Levee Mile	2.68
Location	Water Side
Category	Earthen Levee
Item	Erosion / Bank Caving

The erosion site has been corrected. Fall 2013

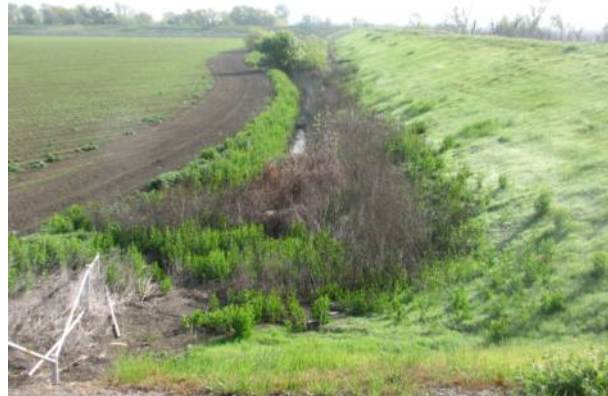
Levee Mile Report Line	12
Start Levee Mile	2.63
End Levee Mile	2.70
Location	Land Side
Category	Earthen Levee
Item	Encroachments

The agricultural ditch runs along the toe of the levee. Spring 2013

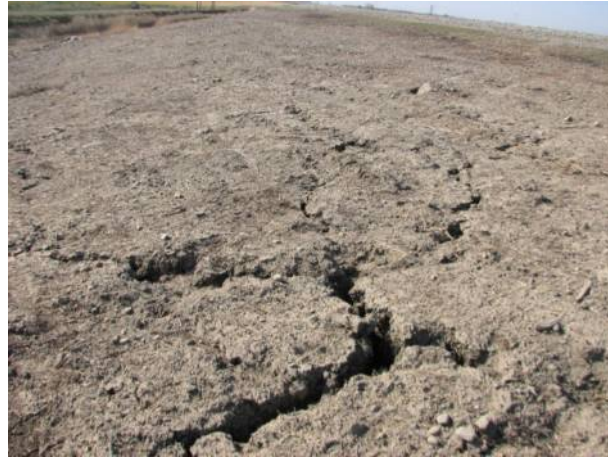
Levee Mile Report Line	1
Start Levee Mile	0.00
End Levee Mile	0.04
Location	Water Side
Category	Earthen Levee
Item	Cracking

Cracks were observed that are between 2 and 6 inches deep and 2-4 inches wide. Fall 2013

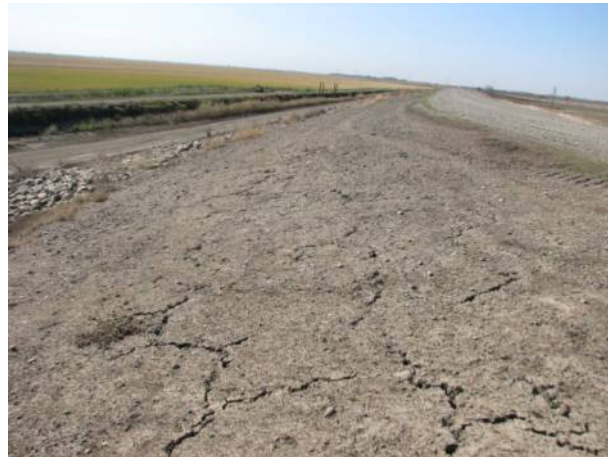
Levee Mile Report Line	1
Start Levee Mile	0.00
End Levee Mile	0.04
Location	Water Side
Category	Earthen Levee
Item	Cracking

The cracks are between 1-2 inches wide and 2-4 inches deep. Fall 2013

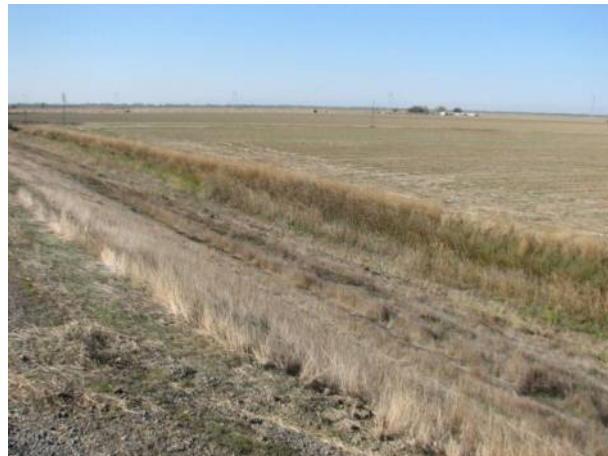
Levee Mile Report Line	4
Start Levee Mile	0.08
End Levee Mile	0.21
Location	Land Side
Category	Earthen Levee
Item	Encroachments

The agricultural ditch is at the toe of the levee. Fall 2013

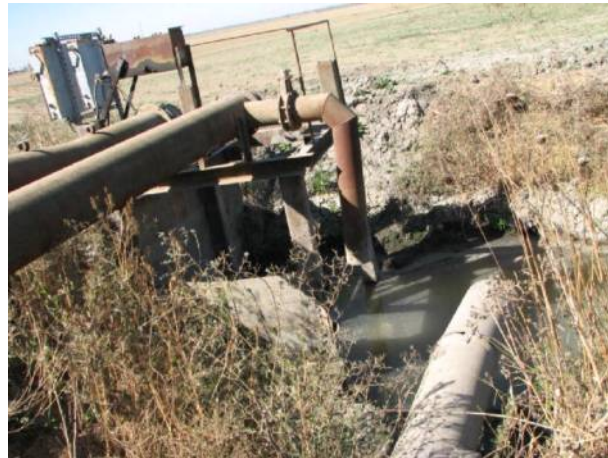
Landside view: overview of abandoned structure.

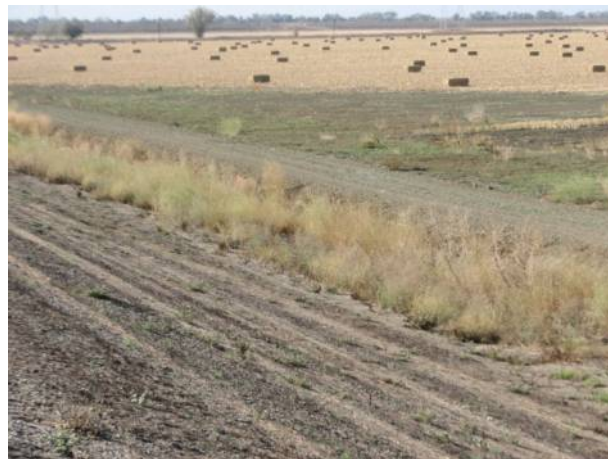
Levee Mile Report Line	7
Start Levee Mile	0.47
End Levee Mile	0.97
Location	Land Side
Category	Earthen Levee
Item	Encroachments

The agricultural ditch is within the easement of the levee. Fall 2013

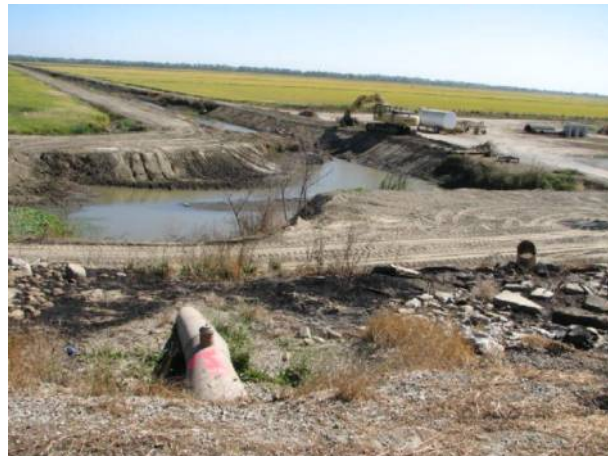
Levee Mile Report Line	10
Start Levee Mile	0.98
End Levee Mile	0.98
Location	Land Side
Category	Supplemental
Item	DWR UCIP Field Study

10	0.98	0.98	Supplemental	DWR UCIP Field Study	LS En	M	Inspector Comments: FS_ID:14090 EP_NO: 10288 Repair Type: Non-Urgent Crossing Status: Found UCIP Comments: Sloughing at pipe day light on WS slope. A 8-inch pipe was not visible during field survey. Air vent leaking water when pump activated causing erosion around pipe on slope. FIELD_STRUCT_DESC: 24 inch pipe through levee 5.2 feet below crown; a 8-inch pipe sleeved through the 24-inch pipe with the annular space grouted, a pump in a pumphouse at the toe of the landward slope, and a siphon breaker on the waterside slope. (ABO No. 10288 - Cache Creek Ranch). FS Date: 5/29/2013 2:21:16 PM	38.705952 ° -121.670875 °	38.705952 ° -121.670875 °	12 Y
----	------	------	--------------	-------------------------	----------	---	--	------------------------------	------------------------------	---------

Waterside view: overview of pipe and water channel

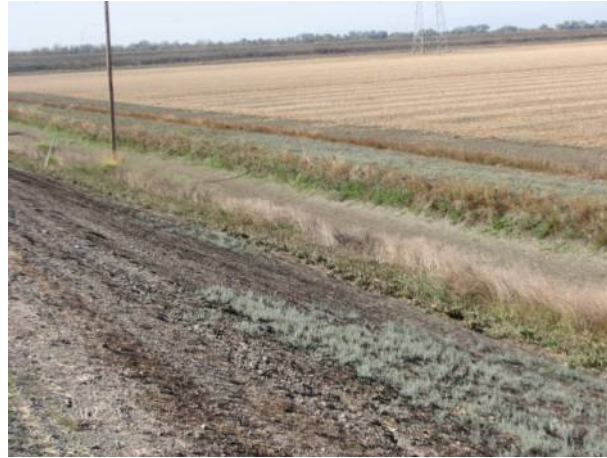
The agricultural ditch is within the easement of the levee. Fall 2013

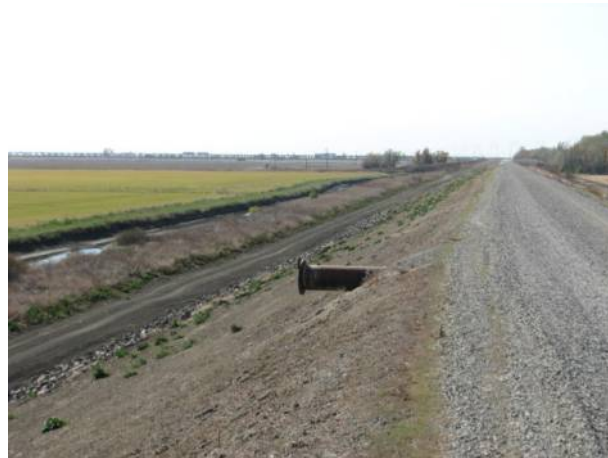
Levee Mile Report Line	1
Start Levee Mile	0.01
End Levee Mile	1.41
Location	Water Side
Category	Earthen Levee
Item	Vegetation
The levee has greater then 50% grasses on the slope. Fall 2013	
johngw_f_20131014_987.JPG

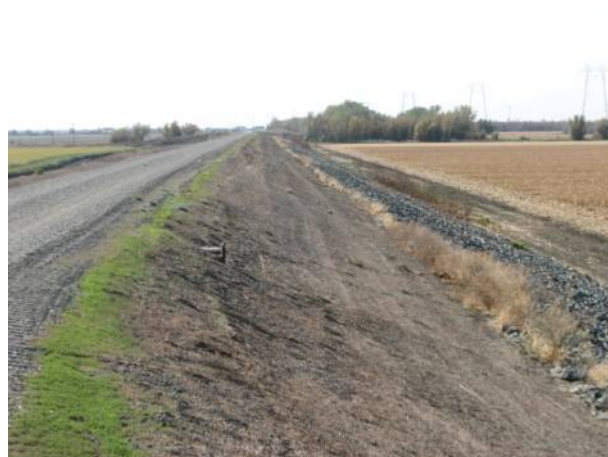
Levee Mile Report Line	2
Start Levee Mile	0.01
End Levee Mile	1.41
Location	Land Side
Category	Earthen Levee
Item	Vegetation
The levee slope has been burned. Fall 2013	
johngw_f_20131014_986.JPG

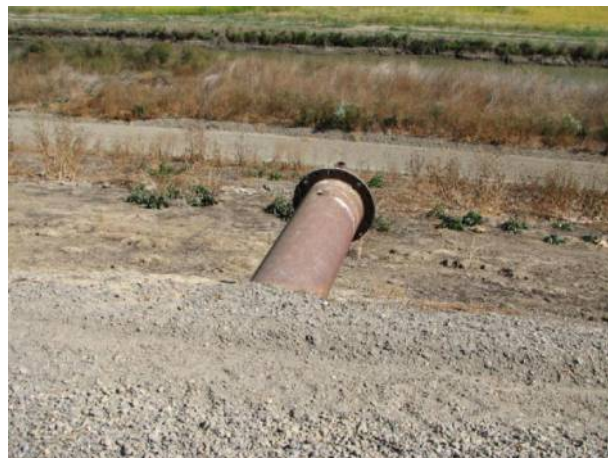
Levee Mile Report Line	3
Start Levee Mile	0.03
End Levee Mile	0.03
Location	Land Side
Category	Supplemental
Item	DWR UCIP Field Study
Waterside view: an abandned steel pipe.	
UCIP_3024.jpg

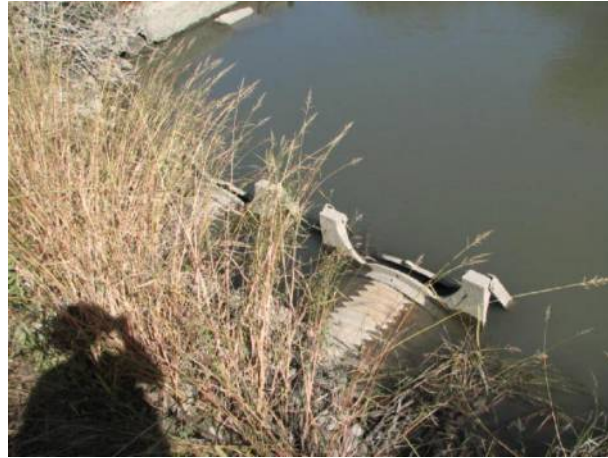
Waterside view: CM pipes and flap gates.

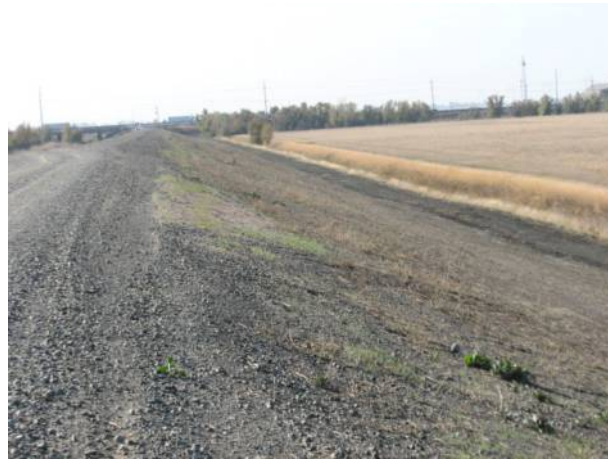
The levee has been burned and the grasses are beginning to grow. Fall 2013

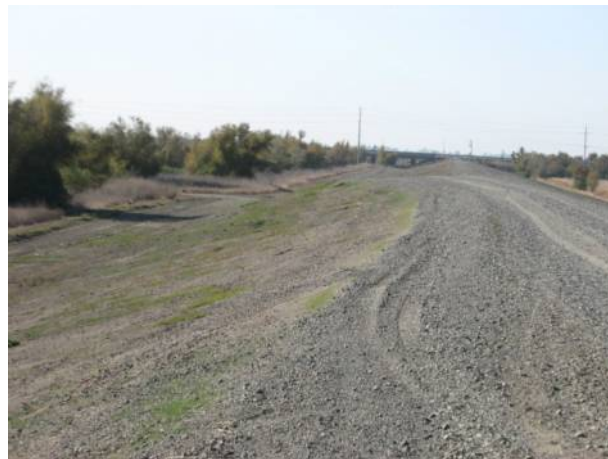
Levee Mile Report Line	2
Start Levee Mile	0.02
End Levee Mile	3.60
Location	Water Side
Category	Earthen Levee
Item	Vegetation

The grasses are beginning to grow on the slope. Fall 2013

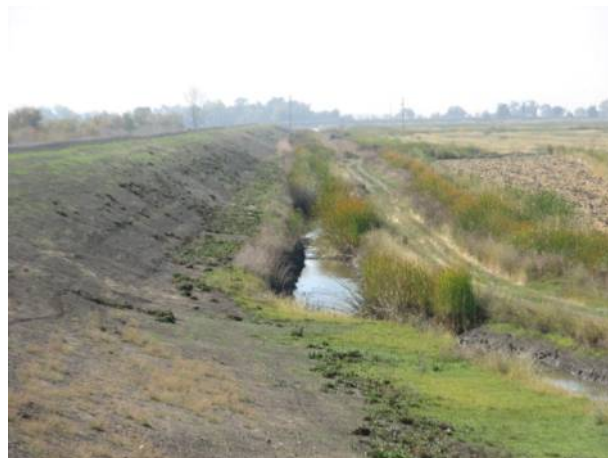
Levee Mile Report Line	3
Start Levee Mile	1.78
End Levee Mile	2.70
Location	Land Side
Category	Earthen Levee
Item	Encroachments

The agricultural ditch is within the easement of the levee. Fall 2013

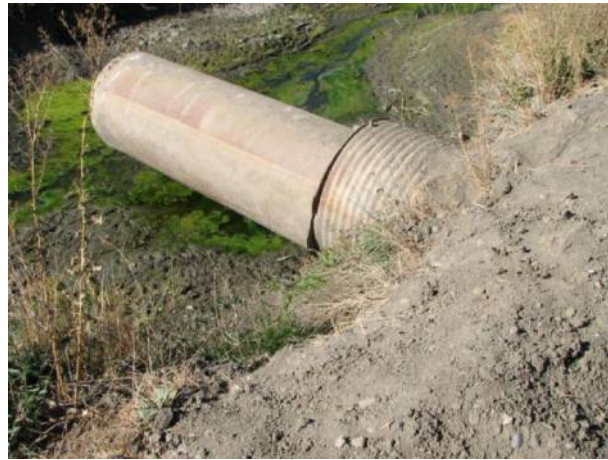
Landside view: 42-inch steel pipe inside a 48-inch CMP

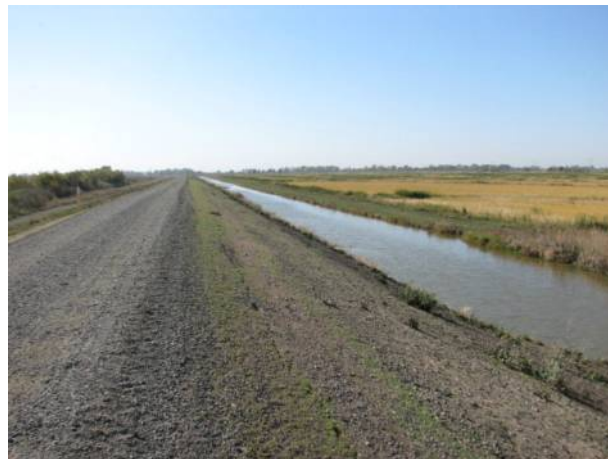
Levee Mile Report Line	5
Start Levee Mile	2.76
End Levee Mile	3.60
Location	Land Side
Category	Earthen Levee
Item	Encroachments

The agricultural ditch is within the easement of the levee. Fall 2013

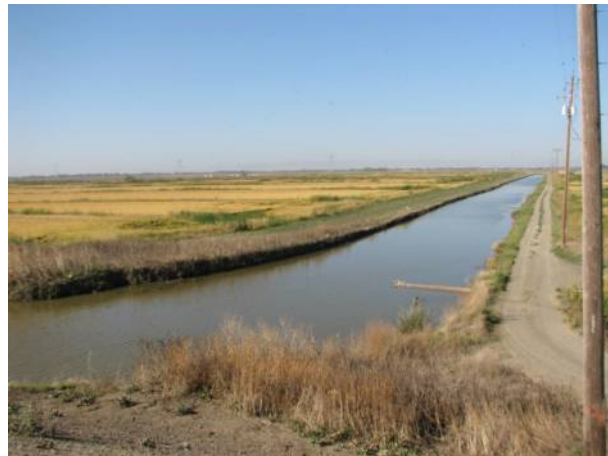
Levee Mile Report Line	5
Start Levee Mile	2.76
End Levee Mile	3.60
Location	Land Side
Category	Earthen Levee
Item	Encroachments

Looking west at the agricultural ditch. Fall 2013
