**Flood Control Project Maintenance
Levee Inspections**

Fall 2014 Levee Maintenance Deficiency Summary Report

Sacramento Maintenance Yard West Levee Yolo Bypass

Levee Inspection Report By Mile - Fall 2014

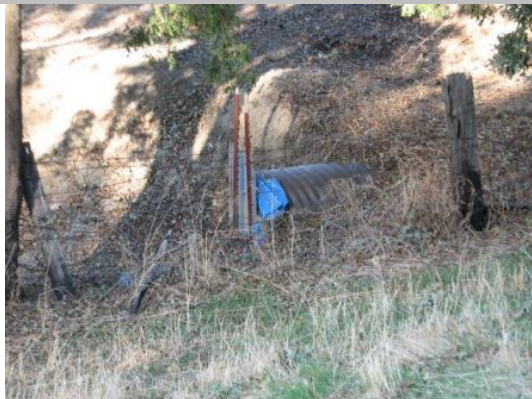
Photo 1 of 3 : FA_2014_ST0011_291_1_20141014_00001.jpg

LM Start	0.36	Rating **	M	Issue No.	1
LM End	0.43	Issue Type +	En	Location *	LS
Category	Earthen Levee			GPS Latitude/Longitude	
				Start	End
Item	Encroachments			38.755535 °	38.754512 °
				-121.664127 °	-121.663907 °
DWR ID	DWR_ST0011_01_s_2012_1				
Action/Comments					
Ditch

The culvert at the end of the agricultural ditch. Fall 2013

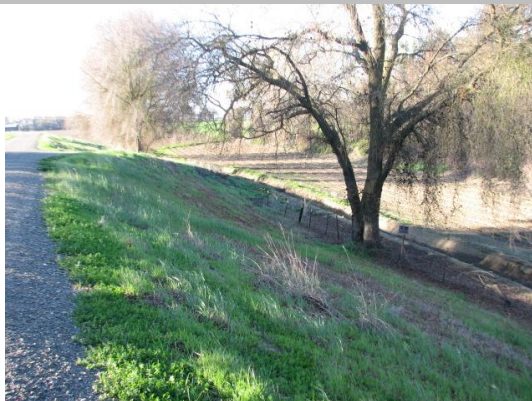
Photo 2 of 3 : FA_2014_ST0011_291_1_20141014_00002.jpg

The drain ditch runs along the toe of the levee. Spring 2014

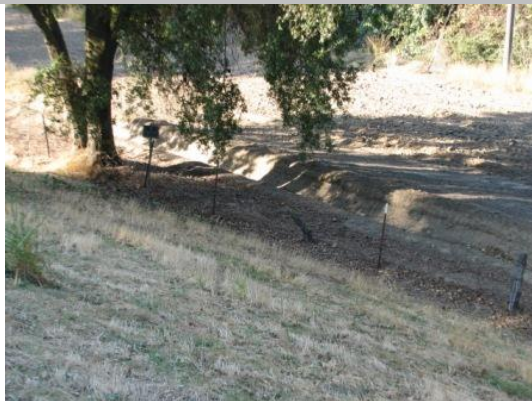
Photo 3 of 3 : FA_2014_ST0011_291_1_20141014_00003.jpg

The agricultural ditch along the levee toe. Fall 2013

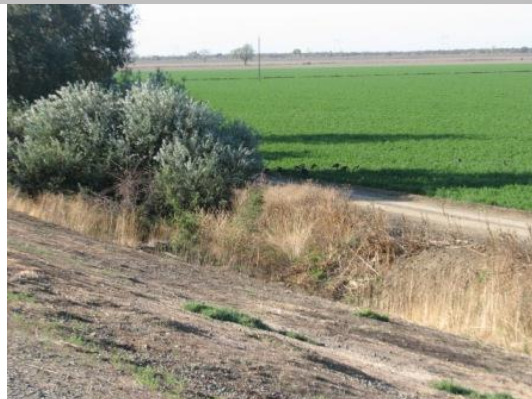
Photo 1 of 2 : FA_2014_ST0011_291_8_20141014_00006.jpg

LM Start	0.93	Rating **	M	Issue No.	8
LM End	1.63	Issue Type +	En	Location *	LS
Category	Earthen Levee			GPS Latitude/Longitude	
				Start	End
Item	Encroachments			38.747888 °	38.737688 °
				-121.660202 °	-121.660235 °
DWR ID	DWR_ST0011_01_s_ 2012_8				
Action/Comments					
Ditch

Another view of the agricultural ditch at the toe. Fall 2013

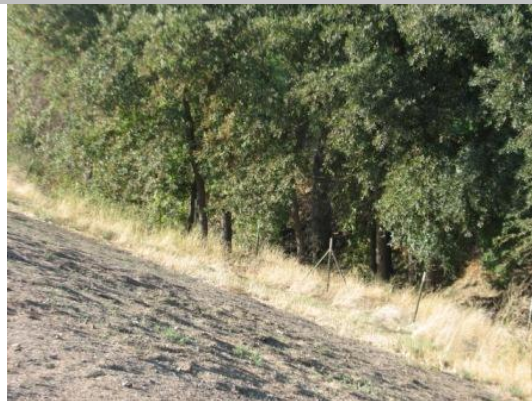
Photo 2 of 2 : FA_2014_ST0011_291_8_20141014_00007.jpg

The agricultural ditch runs along the toe of the levee. Fall 2013

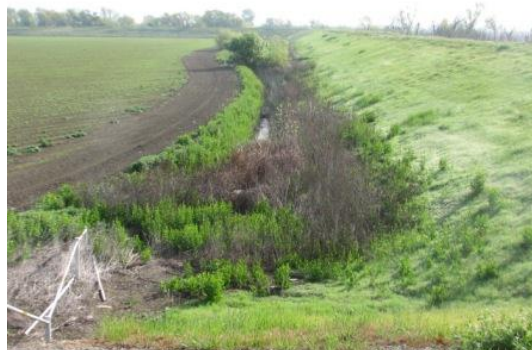
Photo 2 of 2 : FA_2014_ST0011_291_4_20141014_00005.jpg

LM Start	2.63	Rating **	M	Issue No.	4 (cont)	
LM End	2.70	Issue Type +	En	Location *	LS	
Category	Earthen Levee			GPS Latitude/Longitude		
				Start		End
Item	Encroachments			38.724800 °		38.724230 °
				-121.663710 °		-121.664873 °
DWR ID	DWR_ST0011_01_s_2012_4					
Action/Comments						
Ditch

The agricultural ditch runs along the toe of the levee. Spring 2013

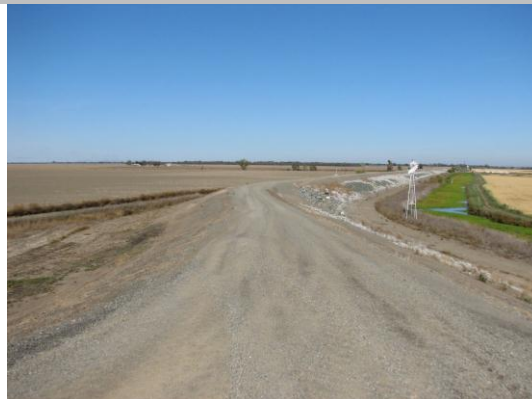
Photo 1 of 1 : FA_2014_ST0011_292_80_20141106_00116.jpg

LM Start	0.00	Rating **	A	Issue No.	80
LM End	1.52	Issue Type +	Ma	Location *	LS
Category	Earthen Levee			GPS Latitude/Longitude	
				Start	End
Item	Vegetation				°
					°
DWR ID	DWR_ST0011_02_f_2014_80				
Action/Comments					
Control annual grass and weeds on the levee slopes and easements.

Levee mile 1.50, levee slopes and crown. Fall 2014.

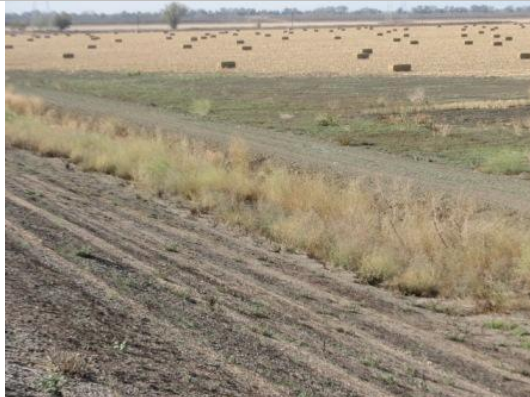
Photo 1 of 1 : FA_2014_ST0011_292_3_20141014_00002.jpg

LM Start	0.47	Rating **	M	Issue No.	3
LM End	0.97	Issue Type +	En	Location *	LS
Category	Earthen Levee			GPS Latitude/Longitude	
				Start	End
Item	Encroachments			38.712813 °	38.706018 °
				-121.667349 °	-121.670831 °
DWR ID	DWR_ST0011_02_s _ 2012_3				
Action/Comments					
Ditch

The agricultural ditch is within the easement of the levee. Fall 2013

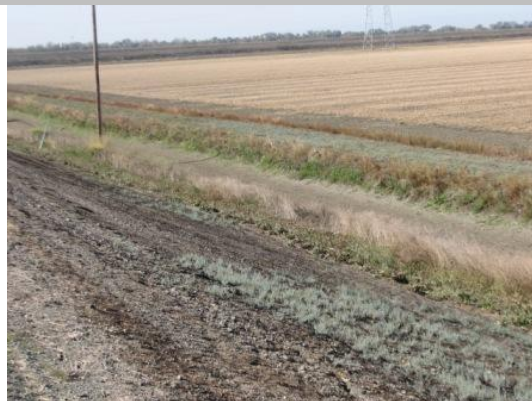
Photo 1 of 1 : FA_2014_ST0011_292_5_20141014_00004.jpg

LM Start	1.15	Rating **	M	Issue No.	5
LM End	1.44	Issue Type +	En	Location *	LS
Category	Earthen Levee			GPS Latitude/Longitude	
				Start	End
Item	Encroachments			38.703681 °	38.699637 °
				-121.672090 °	-121.674112 °
DWR ID	DWR_ST0011_02 s 2012 5

The agricultural ditch is within the easement of the levee. Fall 2013

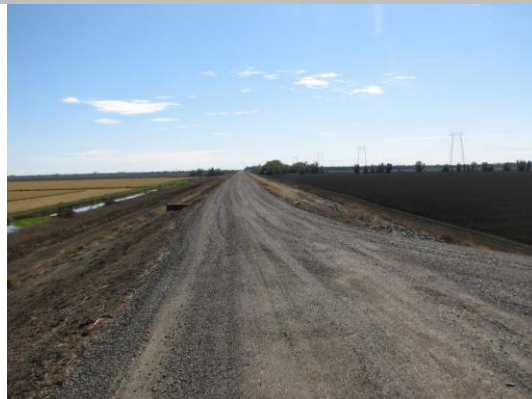
Photo 1 of 1 : FA_2014_ST0011_293_58_20141106_00090.jpg

LM Start	0.00	Rating **	A	Issue No.	58
LM End	1.48	Issue Type +	Ma	Location *	LS
Category	Earthen Levee			GPS Latitude/Longitude	
				Start	End
Item	Vegetation				°
					°
DWR ID	DWR_ST0011_03_f_2014_58				
Action/Comments					
Control annual grass and weeds on the levee slopes and easements.

Levee mile 0.00, vegetation on levee slopes. Fall 2014.

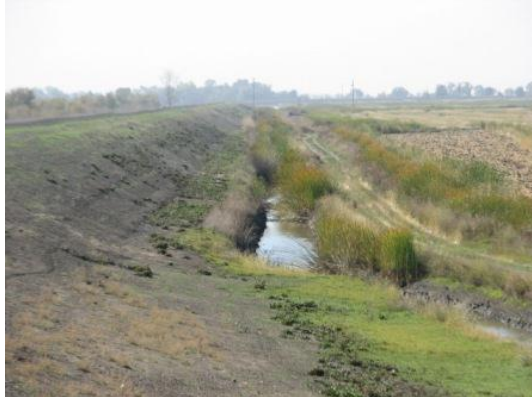
Photo 2 of 2 : FA_2014_ST0011_294_3_20141014_00002.jpg

LM Start	1.78	Rating **	M	Issue No.	3 (cont)	
LM End	2.70	Issue Type +	En	Location *	LS	
Category	Earthen Levee			GPS Latitude/Longitude		
				Start		End
Item	Encroachments			38.550387 °		38.536958 °
				-121.631257 °		-121.631450 °
DWR ID	DWR_ST0011_04_s_2012_3					
Action/Comments						
Ditch

The agricultural ditch is within the easement of the levee. Fall 2013

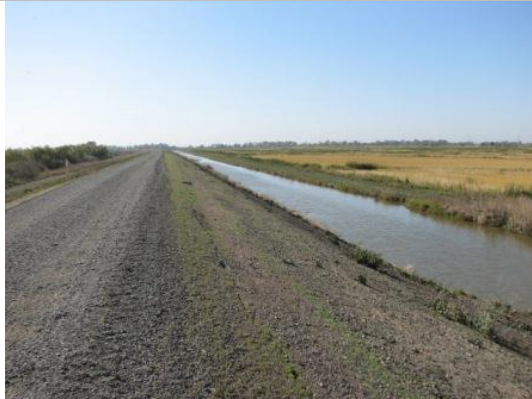
Photo 1 of 4 : FA_2014_ST0011_294_4_20141014_00003.jpg

LM Start	2.76	Rating **	M	Issue No.	4
LM End	3.60	Issue Type +	En	Location *	LS
Category	Earthen Levee			GPS Latitude/Longitude	
				Start	End
Item	Encroachments			38.536100 °	38.523807 °
				-121.631425 °	-121.631535 °
DWR ID	DWR_ST0011_04_s_2012_4				
Action/Comments					
Ditch

The agricultural ditch is within the easement of the levee. Fall 2013

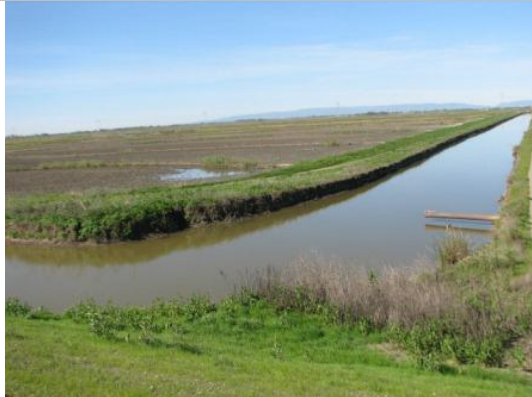
Photo 2 of 4 : FA_2014_ST0011_294_4_20141014_00004.jpg

The ditch runs west for about a quarter of a mile. Spring 2014

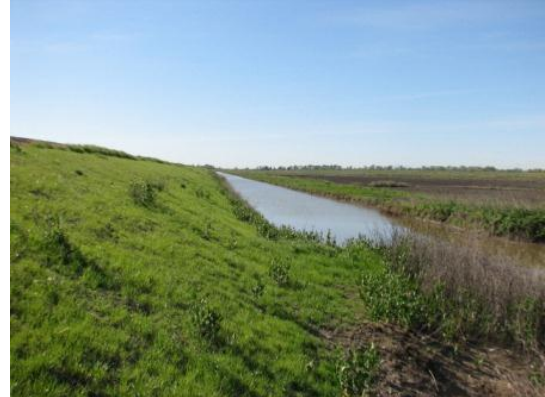
Photo 3 of 4 : FA_2014_ST0011_294_4_20141014_00005.jpg

LM Start	2.76	Rating **	M	Issue No.	4 (cont)	
LM End	3.60	Issue Type +	En	Location *	LS	
Category	Earthen Levee			GPS Latitude/Longitude		
				Start		End
Item	Encroachments			38.536100 °		38.523807 °
				-121.631425 °		-121.631535 °
DWR ID	DWR_ST0011_04_s_ 2012_4					
Action/Comments						
Ditch

The ditch is in the profile of the levee slope. Spring 2014

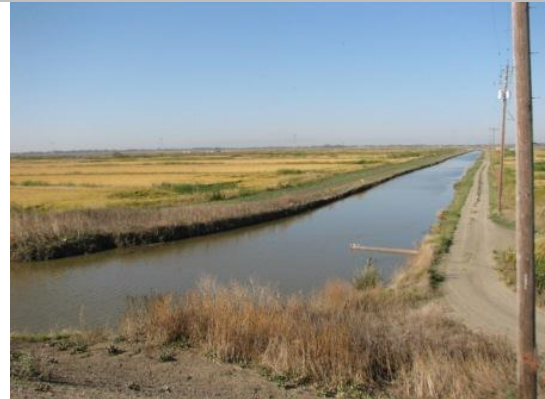
Photo 4 of 4 : FA_2014_ST0011_294_4_20141014_00006.jpg

Looking west at the agricultural ditch. Fall 2013
