**Flood Control Project Maintenance
Levee Inspections**

Fall 2015 Levee Maintenance Deficiency Summary Report

Sacramento Maintenance Yard West Levee Yolo Bypass

Levee Inspection Report By Mile - Fall 2015

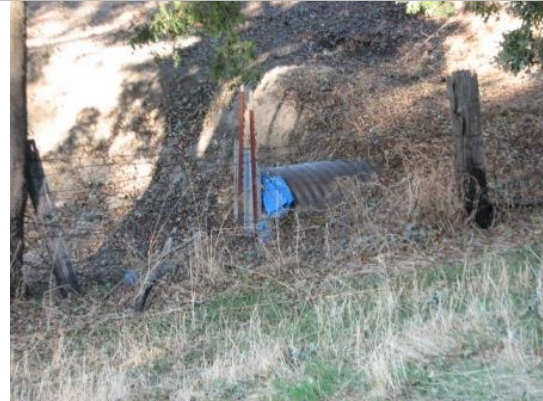
Photo 1 of 3 : FA_2015_ST0011_291_1_20150914_00001.jpg

LM Start	0.36	Rating **	M	Issue No.	1 (cont)
LM End	0.43	Issue Type +	En	Location *	LS

The culvert at the end of the agricultural ditch. Fall 2013

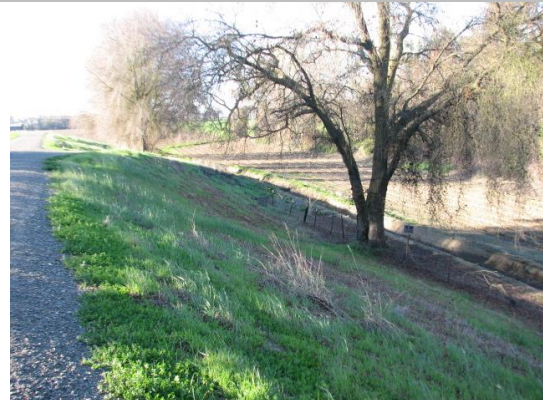
Photo 2 of 3 : FA_2015_ST0011_291_1_20150914_00002.jpg

The drain ditch runs along the toe of the levee. Spring 2014

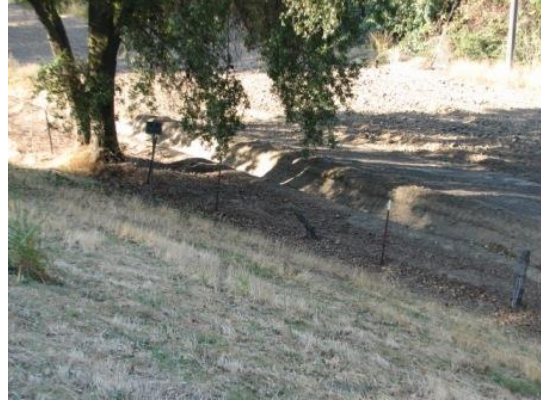
Photo 3 of 3 : FA_2015_ST0011_291_1_20150914_00003.jpg

LM Start	0.36	Rating **	M	Issue No.	1 (cont)
LM End	0.43	Issue Type +	En	Location *	LS
Category	Earthen Levee			GPS Latitude/Longitude	
				Start	End
Item	Encroachments			38.755535 °	38.754512 °
				-121.664127 °	-121.663907 °
DWR ID	DWR_ST0011_01_s _ 2012_1				
Action/Comments					
Ditch

The agricultural ditch along the levee toe. Fall 2013

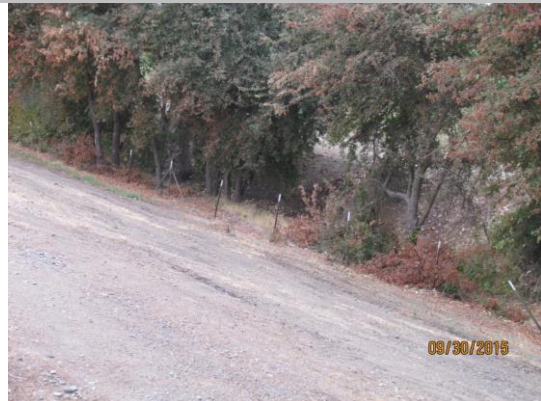
Photo 1 of 1 : FA_2015_ST0011_291_8_20151005_00010.jpg

LM Start	0.94	Rating **	M	Issue No.	8
LM End	1.83	Issue Type +	En	Location *	LS
Category	Earthen Levee			GPS Latitude/Longitude	
				Start	End
Item	Encroachments			38.747888 °	38.734972 °
				-121.660202 °	-121.660265 °
DWR ID	DWR_ST0011_01_s _ 2012_8				
Action/Comments					
Ditch Inspector Comments: The ditch is at the toe of the levee.

View of the ditch on the landward side of the levee. Fall 2015.

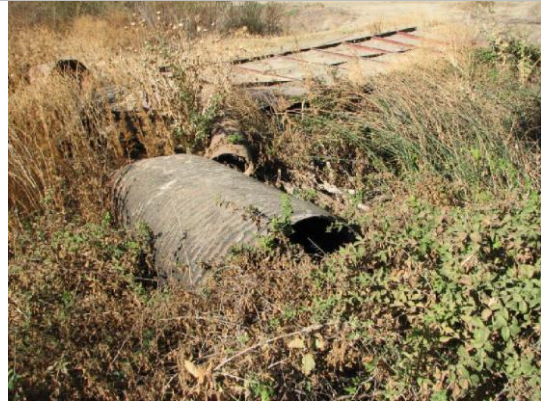
Photo 1 of 2 : UCIP_FA_2015_4222.jpg

LM Start	1.85	Rating **	M	Issue No.	14
LM End	1.85	Issue Type +	En	Location *	LS
Category	Supplemental			GPS Latitude/Longitude	
				Start	End
Item	DWR UCIP Field Study			38.734568 °	38.734568 °
				-121.660264 °	-121.660264 °
DWR ID					
Action/Comments					
Inspector Comments: FS_ID:46746					
DS_ID:17744					
EP_NO: 10284					
FS_HLM: 1.85					
Repair Type: Non-Urgent					
Crossing Status: Indicator Found					
UCIP Comments: Found abandoned 42-inch CM pipe on LS berm of the levee. This was abandoned by farmer, how Unknown. need to have verified if removed or concreted					
FIELD_STRUCT_DESC: 42-inch CM drainpipe through levee 25.0 feet below crown. Slide gate on waterward end. (ABO No. 10284 - Hershey).					
O&M manual 127, Revision Year 2011					
FS Date: 10/06/2015

Landside view: an abandoned CM pipe on LS berm of the levee.

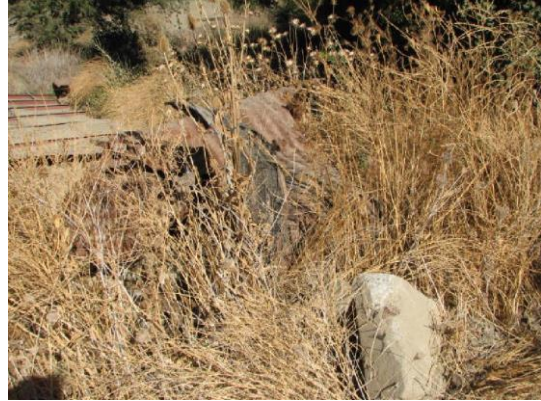
Photo 2 of 2 : UCIP_FA_2015_4223.jpg

LM Start	1.85	Rating **	M	Issue No.	14 (cont)	
LM End	1.85	Issue Type +	En	Location *	LS	
Category	Supplemental			GPS Latitude/Longitude		
				Start	End	
Item	DWR UCIP Field Study			38.734568 °	38.734568 °	
				-121.660264 °	-121.660264 °	
DWR ID						
Action/Comments						
Inspector Comments: FS_ID:46746						
DS_ID:17744						
EP_NO: 10284						
FS_HLM: 1.85						
Repair Type: Non-Urgent						
Crossing Status: Indicator Found						
UCIP Comments: Found abandoned 42-inch CM pipe on LS berm of the levee. This was abandoned by farmer, how Unknown. need to have verified if removed or concreted						
FIELD_STRUCT_DESC: 42-inch CM drainpipe through levee 25.0 feet below crown. Slide gate on waterward end. (ABO No. 10284 - Hershey).						
O&M manual 127, Revision Year 2011						
FS Date: 10/06/2015

Landside view: an abandoned CM pipe on LS berm of the levee.

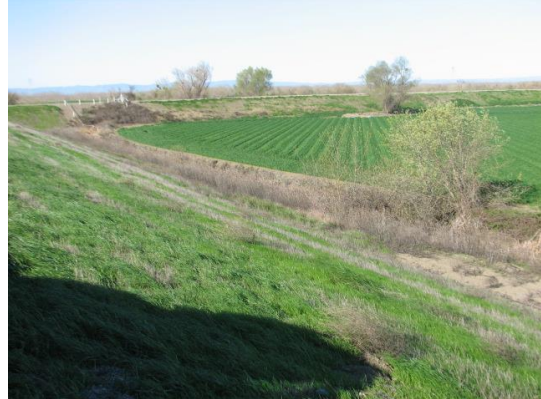
Photo 1 of 2 : FA_2015_ST0011_291_4_20150914_00004.jpg

LM Start	2.63	Rating **	M	Issue No.	4
LM End	2.71	Issue Type +	En	Location *	LS
Category	Earthen Levee			GPS Latitude/Longitude	
				Start	End
Item	Encroachments			38.724800 °	38.724230 °
				-121.663710 °	-121.664873 °
DWR ID	DWR_ST0011_01_s _ 2012_4				
Action/Comments					
Ditch

The agricultural ditch runs along the toe of the levee. Spring 2014

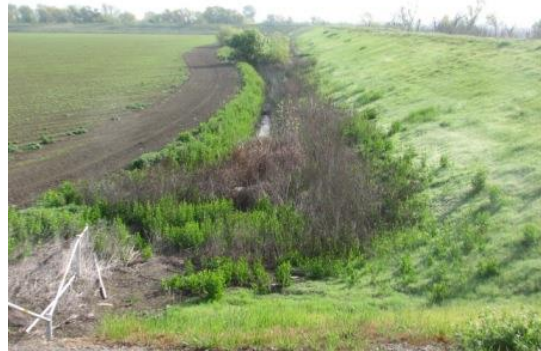
Photo 2 of 2 : FA_2015_ST0011_291_4_20150914_00005.jpg

The agricultural ditch runs along the toe of the levee. Spring 2013

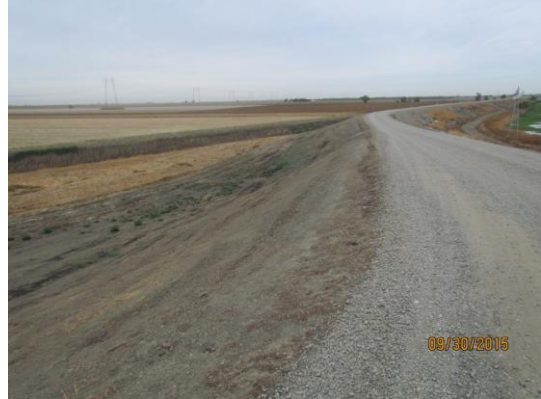
Photo 1 of 1 : FA_2015_ST0011_292_4_20151005_00003.jpg

LM Start	0.00	Rating **	A	Issue No.	4
LM End	1.51	Issue Type +	Ma	Location *	LS
Category	Earthen Levee			GPS Latitude/Longitude	
				Start	End
Item	Vegetation			38.719079 °	38.698710 °
				-121.664135 °	-121.674142 °
DWR ID	DWR_ST0011_02_f_2015_4				
Action/Comments					
Control annual grass and weeds on the levee slopes and easements. Inspector Comments: Slope has been burned and dragged.

View of the vegetation on the landward side of the levee looking upstream. Fall 2015.

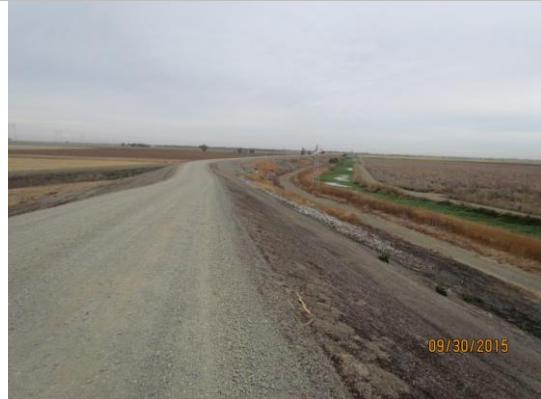
Photo 1 of 1 : FA_2015_ST0011_292_6_20151005_00004.jpg

LM Start	0.00	Rating **	A	Issue No.	6
LM End	1.51	Issue Type +	Ma	Location *	WS
Category	Earthen Levee			GPS Latitude/Longitude	
				Start	End
Item	Vegetation			38.719079 °	38.698710 °
				-121.664135 °	-121.674142 °
DWR ID	DWR_ST0011_02_f_2015_6				
Action/Comments					
Control annual grass and weeds on the levee slopes and easements. Inspector Comments: Slope has been burned and dragged.

View of the vegetation on the waterward side of the levee looking upstream. Fall 2015.

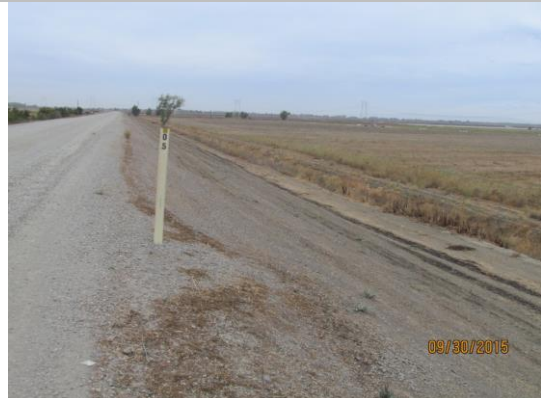
Photo 1 of 1 : FA_2015_ST0011_292_3_20151005_00006.jpg

LM Start	0.47	Rating **	M	Issue No.	3
LM End	0.97	Issue Type +	En	Location *	LS
Category	Earthen Levee			GPS Latitude/Longitude	
				Start	End
Item	Encroachments			38.712813 °	38.706018 °
				-121.667349 °	-121.670831 °
DWR ID	DWR_ST0011_02_s_2012_3				
Action/Comments					
Ditch

View of the ditch at the landward side of the levee looking downstream. Fall 2015.

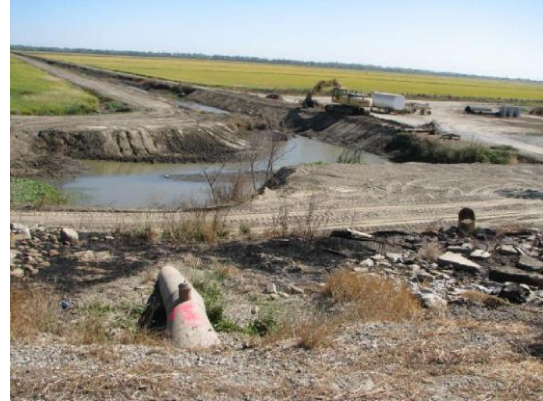
Photo 1 of 3 : UCIP_FA_2015_3167.jpg

UCIP Comments: Sloughing at pipe day light on WS slope. A 8-inch pipe was not visible during field survey. Air vent leaking water when pump activated causeing erosion around pipe on slope. summer of 2013 repaired sloughing around pipe air vent still leaking
FIELD_STRUCT_DESC: 24 inch pipe through levee 5.2 feet below crown; a 8-inch pipe sleeved through the 24-inch pipe with the annular space grouted, a pump in a pumphouse at the toe of the landward slope, and a siphon breaker on the waterside slope. (ABO No. 10288 - Cache Creek Ranch).
FS Date: 10/06/2015

Waterside view: overview of pipe and water channel

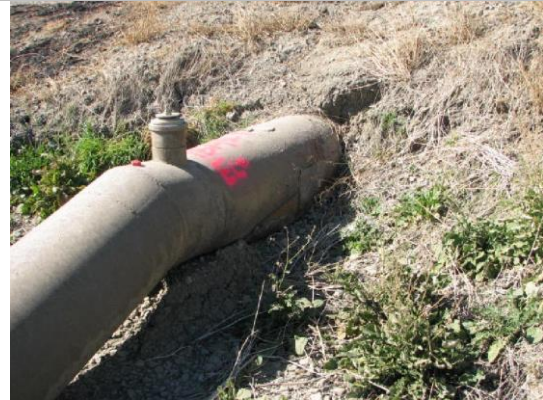
Photo 2 of 3 : UCIP_FA_2015_4280.jpg

Waterside view: closer look at pipe daylight.

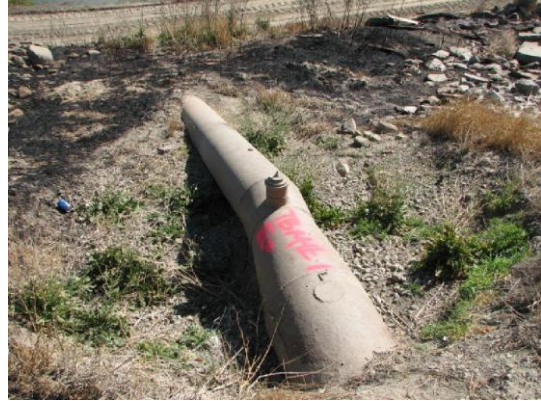
Photo 3 of 3 : UCIP_FA_2015_4281.jpg

LM Start	0.98	Rating **	U	Issue No.	7 (cont)
LM End	0.98	Issue Type +	En	Location *	LS
Category	Supplemental			GPS Latitude/Longitude	
				Start	End
Item	DWR UCIP Field Study			38.705952 °	38.705952 °
				-121.670875 °	-121.670875 °
DWR ID					
Action/Comments					
Inspector Comments: FS_ID:46742					
DS_ID:17749					
EP_NO: 10288					
FS_HLM: 0.978					
Repair Type: Urgent					
Crossing Status: Found

Waterside view: pipe and siphon breaker

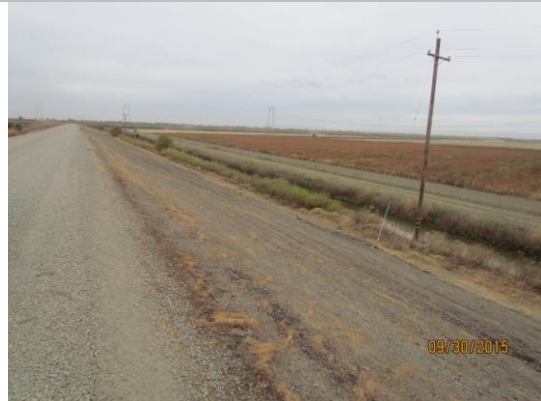
Photo 1 of 1 : FA_2015_ST0011_292_5_20151005_00005.jpg

LM Start	1.15	Rating **	M	Issue No.	5
LM End	1.44	Issue Type +	En	Location *	LS
Category	Earthen Levee			GPS Latitude/Longitude	
				Start	End
Item	Encroachments			38.703681 °	38.699637 °
				-121.672090 °	-121.674112 °
DWR ID	DWR_ST0011_02_s_2012_5				
Action/Comments					
Ditch					
Inspector Comments: The ditch is at the toe of the levee.

View of the ditch on the landward side of the levee looking downstream.
Fall 2015.

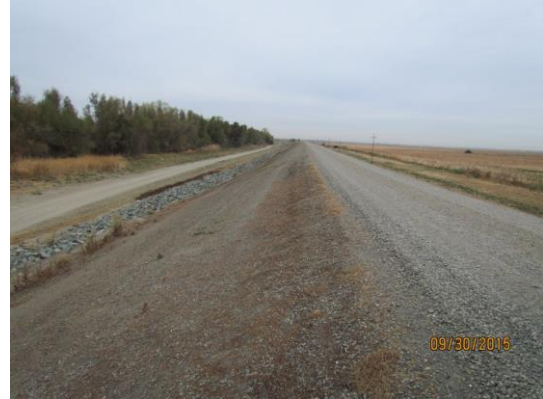
Photo 1 of 1 : FA_2015_ST0011_293_3_20151005_00001.jpg

LM Start	0.00	Rating **	A	Issue No.	3
LM End	1.48	Issue Type +	Ma	Location *	LS
Category	Earthen Levee			GPS Latitude/Longitude	
				Start	End
Item	Vegetation			38.698617 °	38.677234 °
				-121.674141 °	-121.672804 °
DWR ID	DWR_ST0011_03_f_2015_3				
Action/Comments					
Control annual grass and weeds on the levee slopes and easements. Inspector Comments: Slopes have been burned and dragged.

View of the vegetation on the landward side of the levee looking upstream. Fall 2015.

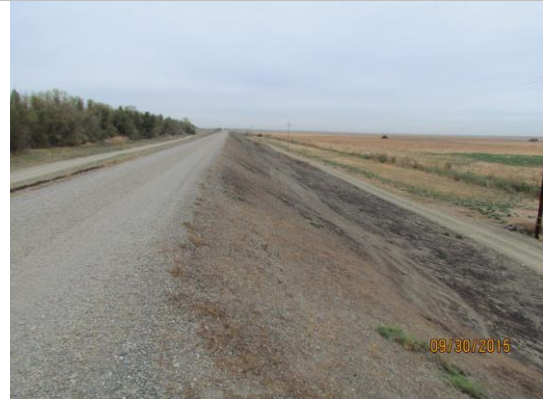
Photo 1 of 1 : FA_2015_ST0011_293_4_20151005_00002.jpg

LM Start	0.00	Rating **	A	Issue No.	4
LM End	1.48	Issue Type +	Ma	Location *	WS
Category	Earthen Levee			GPS Latitude/Longitude	
				Start	End
Item	Vegetation			38.698617 °	38.677234 °
				-121.674141 °	-121.672804 °
DWR ID	DWR_ST0011_03_f_2015_4				
Action/Comments					
Control annual grass and weeds on the levee slopes and easements. Inspector Comments: Slopes have been burned and dragged.

View of the vegetation on the waterward side of the levee looking upstream. Fall 2015.

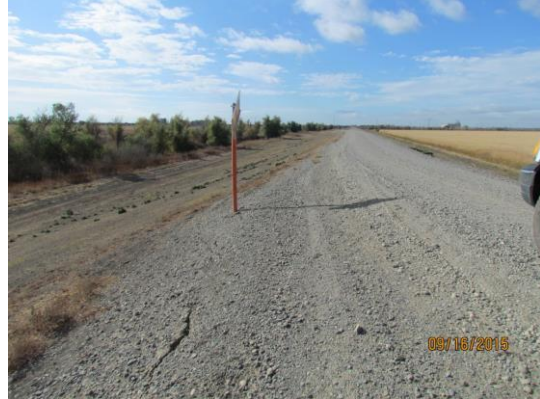
Photo 1 of 1 : FA_2015_ST0011_294_1_20150921_00010.jpg

View of the vegetation on the waterward side of the levee looking downstream. Fall 2015.

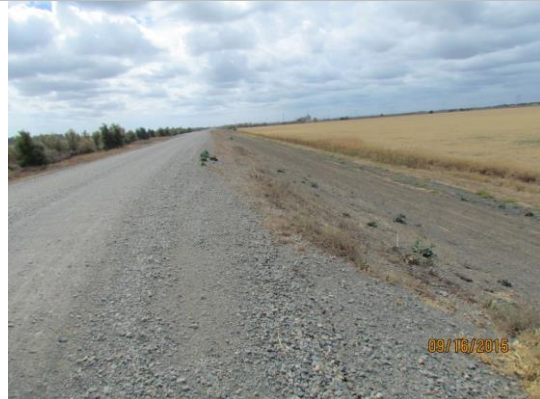
Photo 1 of 1 : FA_2015_ST0011_294_9_20150921_00015.jpg

LM Start	0.00	Rating **	A	Issue No.	9
LM End	3.61	Issue Type +	Ma	Location *	LS
Category	Earthen Levee			GPS Latitude/Longitude	
				Start	End
Item	Vegetation			38.574304 °	38.523647 °
				-121.638753 °	-121.631444 °
DWR ID	DWR_ST0011_04_f_2015_9				
Action/Comments					
Control annual grass and weeds on the levee slopes and easements. Inspector Comments: Vegetation on the landward side of the levee has been maintained.

View of the vegetation on the landward side of the levee looking downstream. Fall 2015.

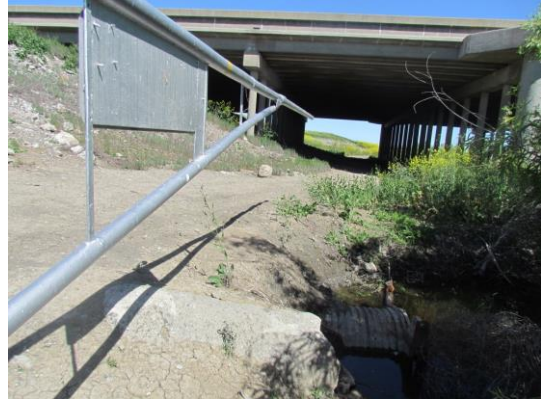
Photo 1 of 2 : FA_2015_ST0011_294_2_20150914_00001.jpg

View of a perspective on the pipe looking upstream. Spring 2015.

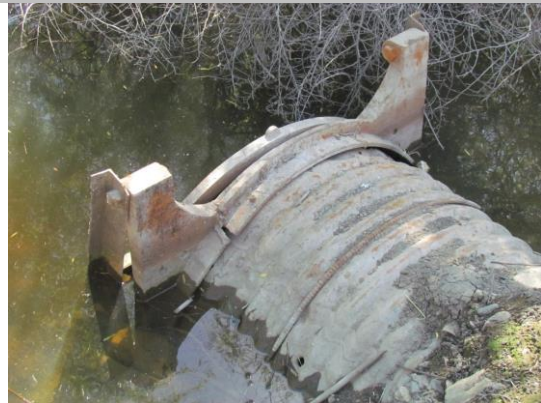
Photo 2 of 2 : FA_2015_ST0011_294_2_20150914_00002.jpg

View of the flap gate in the ditch on the water side of the levee. There seems to be debris preventing the flap gate from closing. Spring 2015.

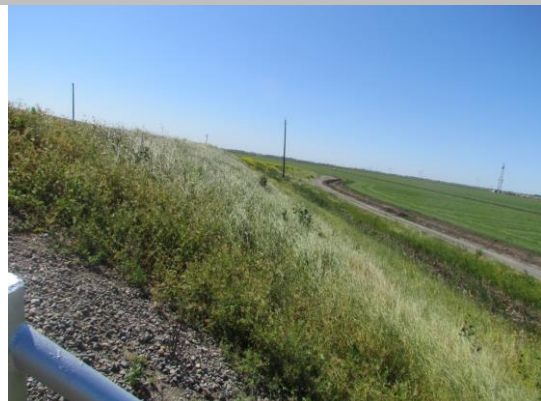
Photo 1 of 1 : FA_2015_ST0011_294_6_20150914_00009.jpg

LM Start	0.91	Rating **	M	Issue No.	6
LM End	1.03	Issue Type +	En	Location *	LS
Category	Earthen Levee			GPS Latitude/Longitude	
				Start	End
Item	Encroachments			38.561233 °	38.559502 °
				-121.638182 °	-121.637810 °
DWR ID	DWR_ST0011_04_s_2015_6				
Action/Comments					
Ditch					
Inspector Comments: The ditch is at the toe of the levee on the landward side.

View of the ditch on the landward side of the levee looking downstream. Spring 2015.

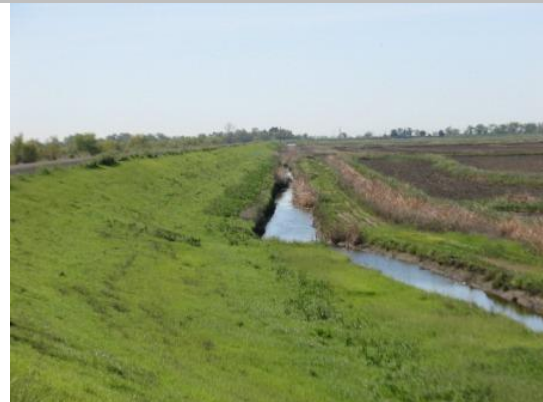
Photo 1 of 2 : FA_2015_ST0011_294_3_20150914_00003.jpg

The ditch runs along the toe of the landside levee slope. Spring 2014

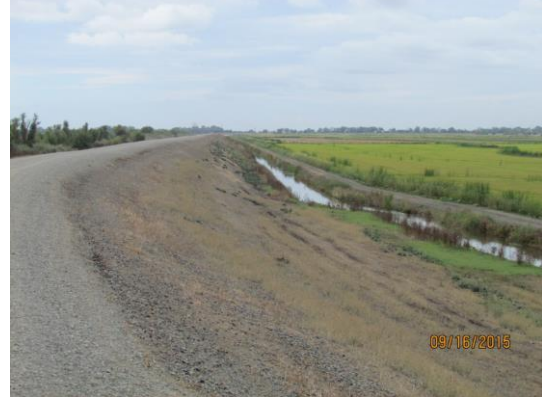
Photo 2 of 2 : FA_2015_ST0011_294_3_20150921_00011.jpg

View of the ditch along the levee toe on the landward side of the levee looking downstream. Fall 2015.

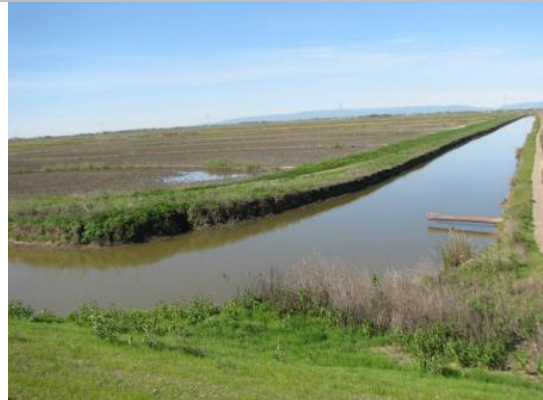
Photo 1 of 4 : FA_2015_ST0011_294_4_20150914_00006.jpg

The ditch runs west for about a quarter of a mile. Spring 2014

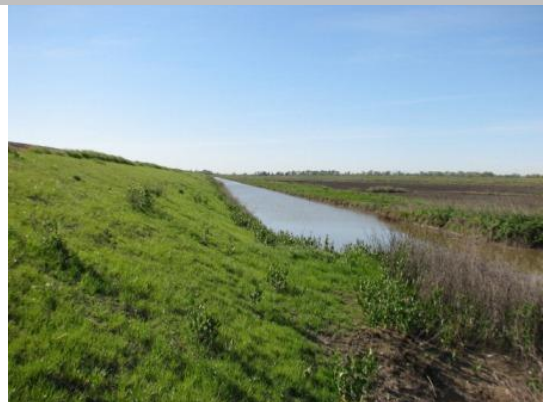
Photo 2 of 4 : FA_2015_ST0011_294_4_20150914_00007.jpg

The ditch is in the profile of the levee slope. Spring 2014

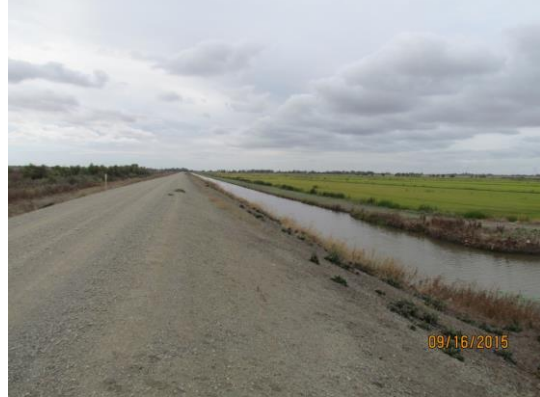
Photo 3 of 4 : FA_2015_ST0011_294_4_20150921_00012.jpg

The ditch is at the levee toe on the landward side of the levee looking downstream. Fall 2015.

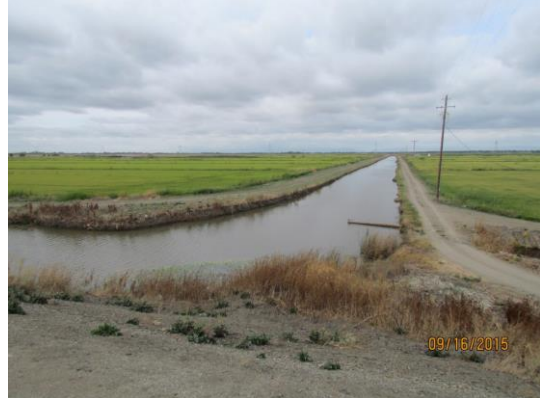
Photo 4 of 4 : FA_2015_ST0011_294_4_20150921_00014.jpg

LM Start	2.75	Rating **	M	Issue No.	4 (cont)
LM End	3.60	Issue Type +	En	Location *	LS

Looking west at the agricultural ditch. Fall 2015.
