**Flood Control Project Maintenance
Levee Inspections**

Fall 2016 Levee Maintenance Deficiency Summary Report

Sacramento Maintenance Yard West Levee Yolo Bypass

Levee Inspection Report By Mile - Fall 2016

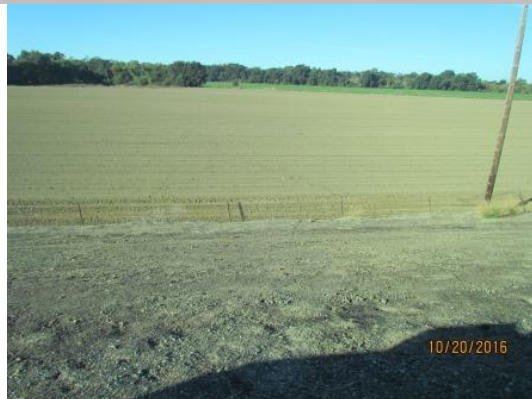
Photo 1 of 2 : FA_2016_ST0011_291_10_20161025_00010.jpg

View of fence located within 10-foot easement of landside toe. Fall 2016.

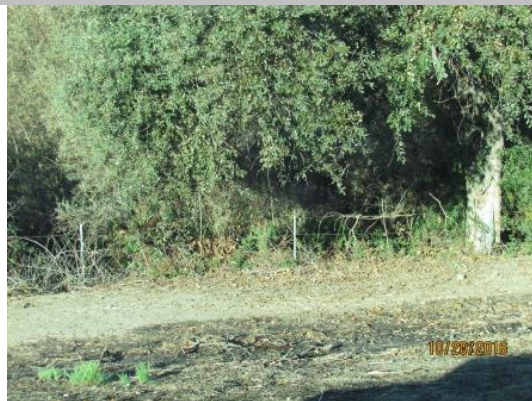
Photo 2 of 2 : FA_2016_ST0011_291_10_20161025_00009.jpg

Another view of fence located within 10-foot easement of landside toe. Fall 2016.

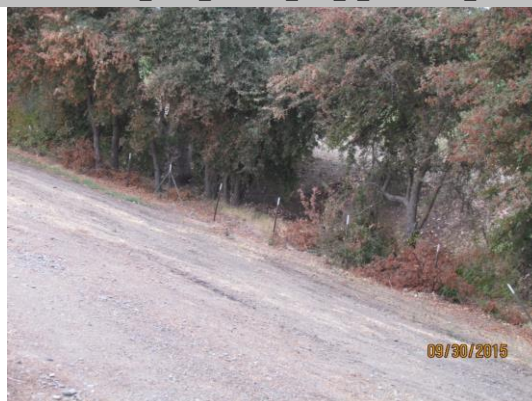
Photo 1 of 1 : FA_2016_ST0011_291_8_20160913_00002.jpg

LM Start	0.94	Rating **	M	Issue No.	8
LM End	1.83	Issue Type +	En	Location *	LS
Category	Earthen Levee			GPS Latitude/Longitude	
				Start	End
Item	Encroachments			38.747888 °	38.734972 °
				-121.660202 °	-121.660265 °
DWR ID	DWR_ST0011_01_s_2012_8				
Comment Code					
DT : Ditch					
Inspector Comment					
The ditch is at the toe of the levee.

View of the ditch on the landward side of the levee. Fall 2015.

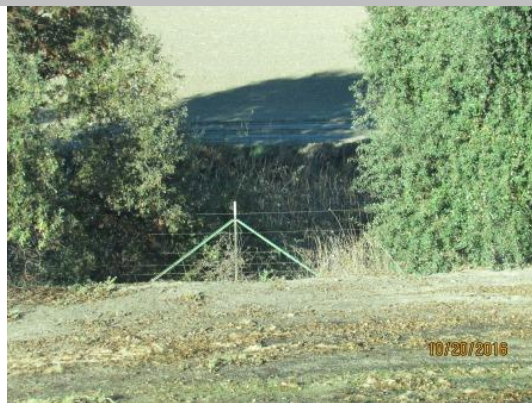
Photo 1 of 2 : FA_2016_ST0011_291_9_20161025_00008.jpg

LM Start	1.70	Rating **	M	Issue No.	9
LM End	1.79	Issue Type +	En	Location *	LS
Category	Earthen Levee			GPS Latitude/Longitude	
				Start	End
Item	Encroachments			38.736842 °	38.735498 °
				-121.660285 °	-121.660287 °
DWR ID	DWR_ST0011_01_f_2016_9				
Comment Code					
FE : Fence					
Inspector Comment

View of fence along the ditch on landside. Fall 2016.

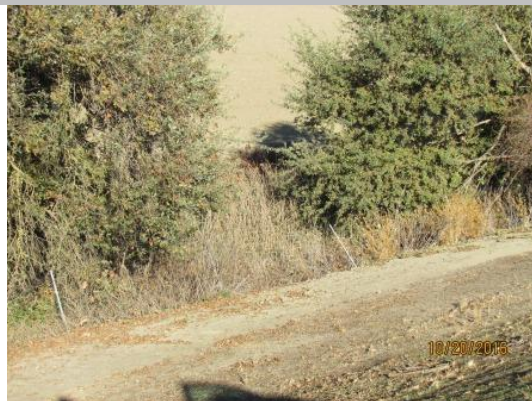
Photo 2 of 2 : FA_2016_ST0011_291_9_20161025_00007.jpg

Another view of fence along the ditch on landside. Fall 2016.

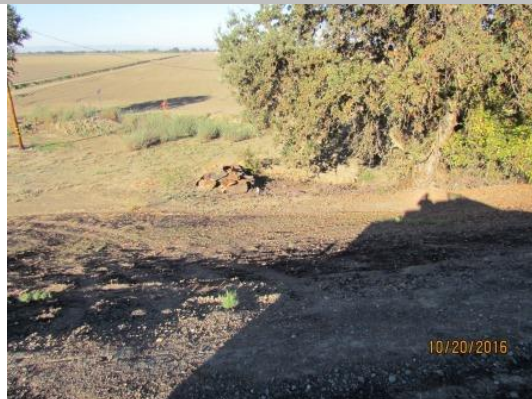
Photo 1 of 1 : FA_2016_ST0011_291_3_20161025_00006.jpg

LM Start	1.83	Rating **	M	Issue No.	3
LM End	1.83	Issue Type +	En	Location *	LS
Category	Earthen Levee			GPS Latitude/Longitude	
				Start	End
Item	Encroachments			38.734936 °	38.734936 °
				-121.660281 °	-121.660281 °
DWR ID	DWR_ST0011_01_f_2016_3				
Comment Code					
GA : Garbage					
Inspector Comment

View of garbage within 10-foot easement of LS levee toe. Fall 2016.

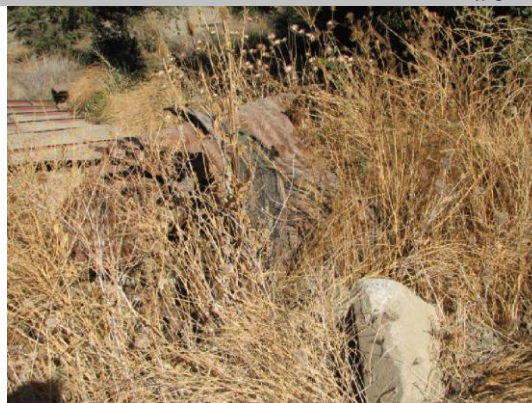
Photo 1 of 2 : UCIP_FA_2016_50785_60276.jpg

LM Start	1.85	Rating **	M	Issue No.	15
LM End	1.85	Issue Type +	En	Location *	LS
Category	Supplemental			GPS Latitude/Longitude	
				Start	End
Item	DWR UCIP Field Study			38.734568 °	38.734568 °
				-121.660264 °	-121.660264 °
DWR ID					
Comment Code					
Inspector Comment					
FS_ID:50785					
DS_ID:17744					
EP_NO: 10284					
Repair Type: Non-Urgent					
Crossing Status: Indicator Found					
UCIP Comments: Found abandoned 42-inch CM pipe on LS berm of the levee. This was abandoned by farmer, how Unknown. need to have verified if removed or concreted					
FIELD_STRUCT_DESC: 42-inch CM drainpipe through levee 25.0 feet below crown. Slide gate on waterward end. (ABO No. 10284 - Hershey).					
O&M manual 127, Revision Year 2011					
FS Date: 11/18/2016 2:55:55 PM

Landside view: an abandoned CM pipe on LS berm of the levee.

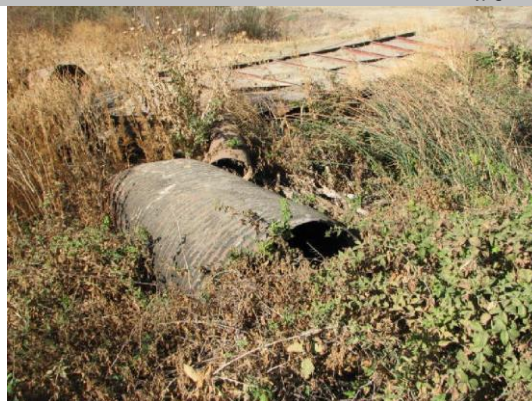
Photo 2 of 2 : UCIP_FA_2016_50785_60275.jpg

Landside view: an abandoned CM pipe on LS berm of the levee.

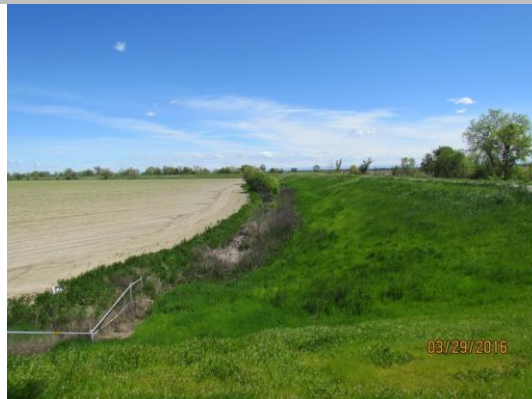
Photo 1 of 1 : FA_2016_ST0011_291_4_20160913_00001.jpg

LM Start	2.63	Rating **	M	Issue No.	4
LM End	2.72	Issue Type +	En	Location *	LS
Category	Earthen Levee			GPS Latitude/Longitude	
				Start	End
Item	Encroachments			38.724853 °	38.724228 °
				-121.663647 °	-121.665137 °
DWR ID	DWR_ST0011_01_s _ 2012_4				
Comment Code					
DT : Ditch					
Inspector Comment					
Ditch is at the toe of the levee.

View of the ditch at the toe of the levee on the landward side. Spring 2016.

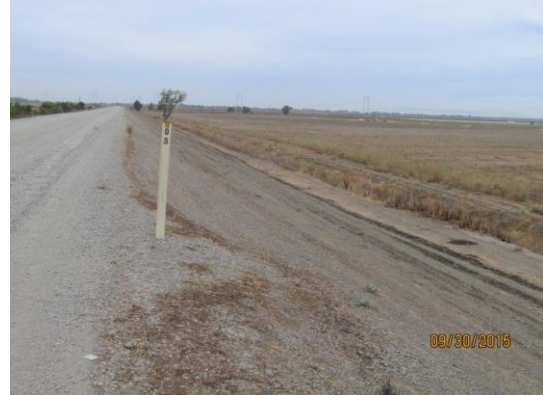
Photo 1 of 3 : FA_2016_ST0011_292_3_20160913_00001.jpg

LM Start	0.47	Rating **	M	Issue No.	3
LM End	0.97	Issue Type +	En	Location *	LS
Category	Earthen Levee			GPS Latitude/Longitude	
				Start	End
Item	Encroachments			38.712813 °	38.706018 °
				-121.667349 °	-121.670831 °
DWR ID	DWR_ST0011_02_s_2012_3				
Comment Code					
DT : Ditch					
Inspector Comment					
Ditch was deepened to approximately 10 ft.

View of the ditch at the landward side of the levee looking downstream. Fall 2015.

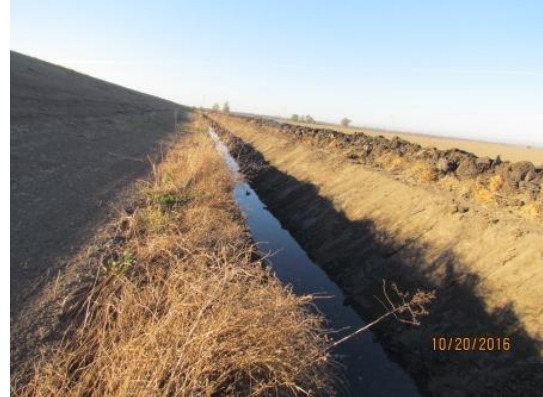
Photo 2 of 3 : FA_2016_ST0011_292_3_20161025_00007.jpg

View of the ditch on landward side. Ditch was deepened to approximately 10 ft. Fall 2016.

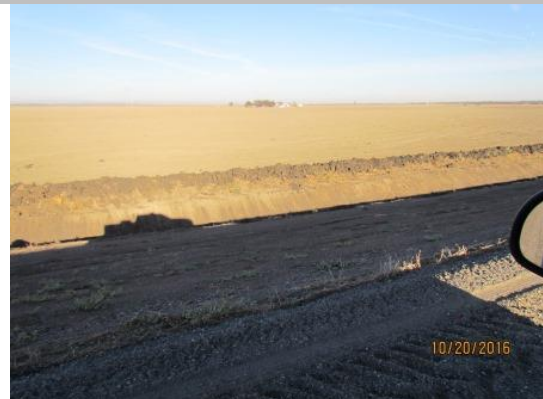
Photo 3 of 3 : FA_2016_ST0011_292_3_20161025_00006.jpg

View of the ditch on landward side. Fall 2016.

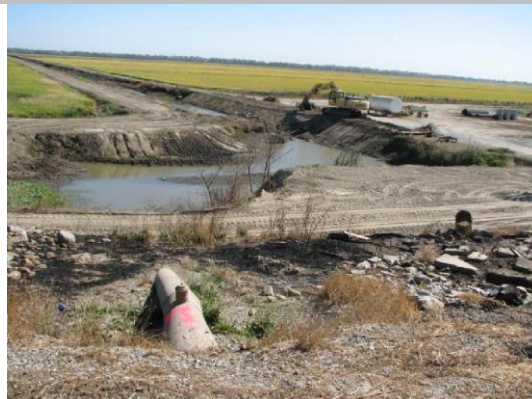
Photo 1 of 2 : UCIP_FA_2016_50782_60280.jpg

FS_ID:50782
DS_ID:17749
EP_NO: 10288
Repair Type: Urgent
Crossing Status: Found
UCIP Comments: 11/3/2016: Both slopes repaired by Sac Yard. However, siphon breaker on WS previously cited to have been leaking has not yet been repaired by Harlan Feed Co. and may continue to impact the slope. Siphon breaker also needs cover. Crossing remains Urgent. (K. Fazel - UCIP)06/28/2016: WS slope eroded along pipe alignment, having occurred since the 2013 repair due to leaky siphon breaker. Sac Yard to repair levee slope this summer. Blake Harlan agreed to repair the siphon breaker per phone conversation. (K. Fazel - UCIP)2013-2016: Sloughing at pipe day light on WS slope. A 8-inch pipe was not visible during field survey. Air vent leaking water when pump activated causing erosion around pipe on slope. summer of 2013 repaired sloughing around pipe air vent still leaking. (P. Amatya - DWR)
FIELD_STRUCT_DESC: 24-inch steel drainage pipe through the levee, 5.2 feet below the crown. 8-inch pipe sleeved through the 24-inch pipe with the annular space grouted. A pump in a pumphouse at the landside (LS) toe, with wing walls at LS ditch. Siphon breaker on the waterside (WS) slope. Pump on LS ditch collects drainage from adjacent agricultural fields and pumps it to a ditch off the WS toe. Blake Harlan of Harlan Feed Co. leases the fields (from Cache Creek Ranch) that drain to this pipe and is responsible for O&M of the pipe: 530-662-8994 bharlan@harlanfeed.com. Another pump station (labeled Knaggs Ranch) next to this crossing off WS toe is not related to this crossing. (Automatic Board Order (ABO) issued as Permit No. 10288, 1974 - Cache Creek Ranch Co.). [Additional Reference(s): DWR Levee Log, 2004].

Waterside view: overview of pipe and water channel

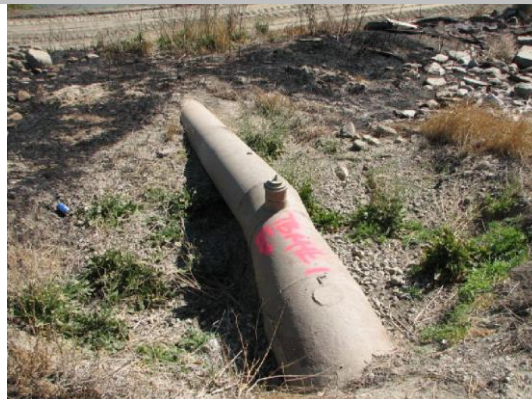
Photo 2 of 2 : UCIP_FA_2016_50782_60279.jpg

FS_ID:50782
DS_ID:17749
EP_NO: 10288
Repair Type: Urgent
Crossing Status: Found
UCIP Comments: 11/3/2016: Both slopes repaired by Sac Yard. However, siphon breaker on WS previously cited to have been leaking has not yet been repaired by Harlan Feed Co. and may continue to impact the slope. Siphon breaker also needs cover. Crossing remains Urgent. (K. Fazel - UCIP)06/28/2016: WS slope eroded along pipe alignment, having occurred since the 2013 repair due to leaky siphon breaker. Sac Yard to repair levee slope this summer. Blake Harlan agreed to repair the siphon breaker per phone conversation. (K. Fazel - UCIP)2013-2016: Sloughing at pipe day light on WS slope. A 8-inch pipe was not visible during field survey. Air vent leaking water when pump activated causing erosion around pipe on slope. summer of 2013 repaired sloughing around pipe air vent still leaking. (P. Amatya - DWR)
FIELD_STRUCT_DESC: 24-inch steel drainage pipe through the levee, 5.2 feet below the crown. 8-inch pipe sleeved through the 24-inch pipe with the annular space grouted. A pump in a pumphouse at the landside (LS) toe, with wing walls at LS ditch. Siphon breaker on the waterside (WS) slope. Pump on LS ditch collects drainage from adjacent agricultural fields and pumps it to a ditch off the WS toe. Blake Harlan of Harlan Feed Co. leases the fields (from Cache Creek Ranch) that drain to this pipe and is responsible for O&M of the pipe: 530-662-8994 bharlan@harlanfeed.com. Another pump station (labeled Knaggs Ranch) next to this crossing off WS toe is not related to this crossing. (Automatic Board Order (ABO) issued as Permit No. 10288, 1974 - Cache Creek Ranch Co.). [Additional Reference(s): DWR Levee Log, 2004].

Waterside view: pipe and siphon breaker

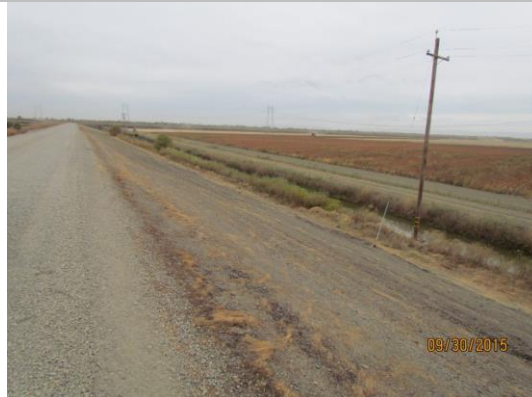
Photo 1 of 1 : FA_2016_ST0011_292_5_20160913_00002.jpg

LM Start	1.15	Rating **	M	Issue No.	5
LM End	1.44	Issue Type +	En	Location *	LS
Category	Earthen Levee			GPS Latitude/Longitude	
				Start	End
Item	Encroachments			38.703681 °	38.699637 °
				-121.672090 °	-121.674112 °
DWR ID	DWR_ST0011_02_s _ 2012_5				
Comment Code					
DT : Ditch					
Inspector Comment					
The ditch is at the toe of the levee.

View of the ditch on the landward side of the levee looking downstream.
Fall 2015.

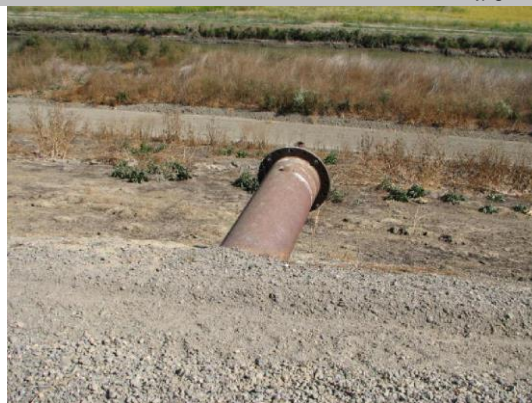
Photo 1 of 2 : UCIP_FA_2016_50772_60378.jpg

LM Start	0.03	Rating **	M	Issue No.	3
LM End	0.03	Issue Type +	En	Location *	LS
Category	Supplemental			GPS Latitude/Longitude	
				Start	End
Item	DWR UCIP Field Study			38.698204 °	38.698204 °
				-121.674080 °	-121.674080 °
DWR ID					
Comment Code					
Inspector Comment					
FS_ID:50772					
DS_ID:17756					
EP_NO: N/A					
Repair Type: Non-Urgent					
Crossing Status: Found					
UCIP Comments: Pipe not properly abandoned.					
FIELD_STRUCT_DESC: *ABANDONED* 18-inch steel irrigation or drainage pipe through the levee, 3 feet below the crown. As-Built					
FS Date: 11/18/2016 2:42:00 PM

Waterside view: an abandoned steel pipe.

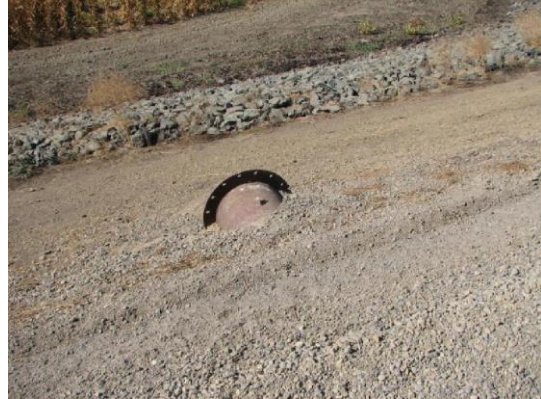
Photo 2 of 2 : UCIP_FA_2016_50772_60377.jpg

Landside view: an abandoned steel pipe.

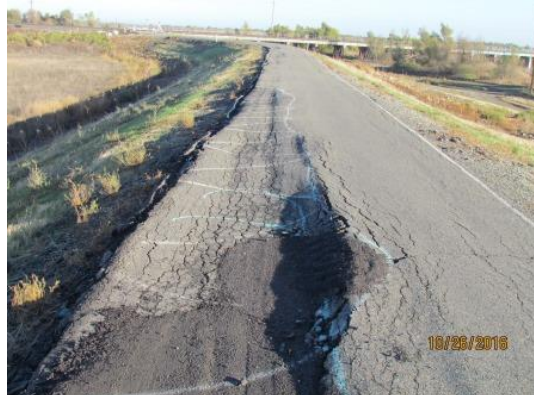
Photo 1 of 1 : FA_2016_ST0011_294_12_20161027_00009.jpg

LM Start	0.68	Rating **	M	Issue No.	12
LM End	0.69	Issue Type +	Ma	Location *	CR
Category	Earthen Levee			GPS Latitude/Longitude	
				Start	End
Item	Crown Surface / Depressions / Rutting			38.564543 °	38.564403 °
				-121.638355 °	-121.638359 °
DWR ID	DWR_ST0011_04_f_2016_12				
Comment Code					
C2 : Repair depressions or ruts in the crown or slope.					
Inspector Comment

Asphalt paved crown has depression at this site. Fall 2016.

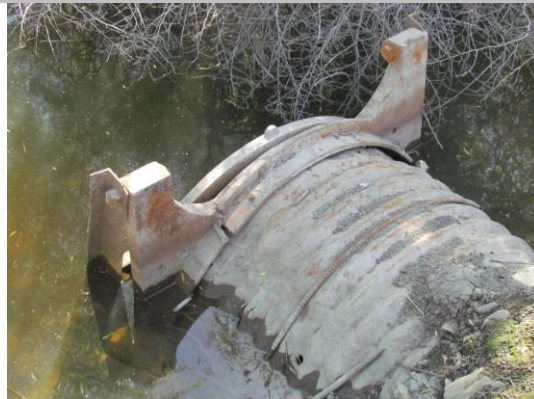
Photo 2 of 3 : FA_2016_ST0011_294_2_20160913_00002.jpg

View of the flap gate in the ditch on the water side of the levee. There seems to be debris preventing the flap gate from closing. Spring 2015.

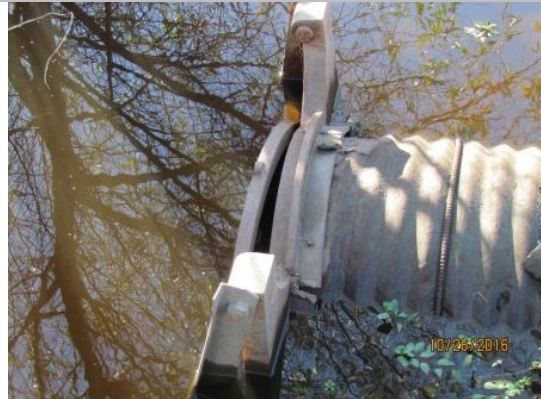
Photo 3 of 3 : FA_2016_ST0011_294_2_20161027_00011.jpg

Updated view of the flap gate not closed completely. Fall 2016.

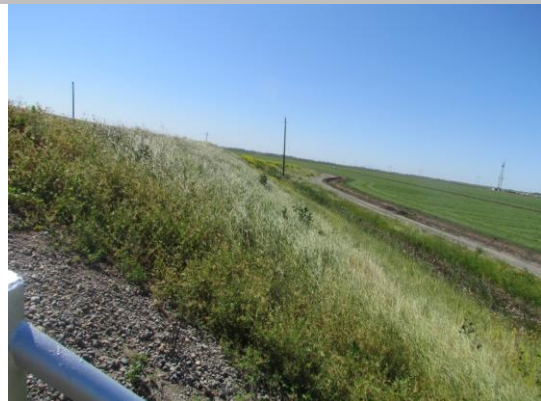
Photo 1 of 1 : FA_2016_ST0011_294_6_20160913_00006.jpg

LM Start	0.91	Rating **	M	Issue No.	6
LM End	1.03	Issue Type +	En	Location *	LS
Category	Earthen Levee			GPS Latitude/Longitude	
				Start	End
Item	Encroachments			38.561233 °	38.559502 °
				-121.638182 °	-121.637810 °
DWR ID	DWR_ST0011_04_s_2015_6				
Comment Code					
DT : Ditch					
Inspector Comment					
The ditch is at the toe of the levee on the landward side.

View of the ditch on the landward side of the levee looking downstream. Spring 2015.

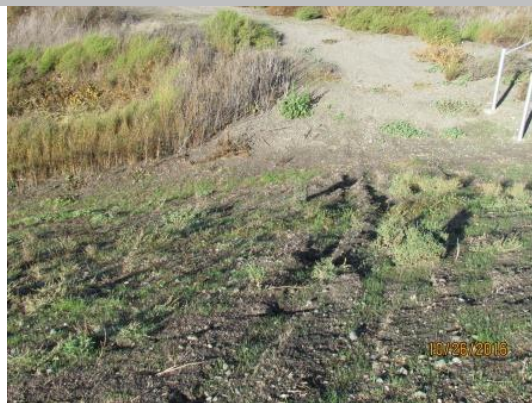
Photo 1 of 1 : FA_2016_ST0011_294_16_20161027_00012.jpg

LM Start	1.00	Rating **	M	Issue No.	16
LM End	1.00	Issue Type +	Ma	Location *	LS
Category	Earthen Levee			GPS Latitude/Longitude	
				Start	End
Item	Slope Stability			38.559998 °	38.559998 °
				-121.638014 °	-121.638014 °
DWR ID	DWR_ST0011_04_f_2016_16				
Comment Code					
S3 : Repair the levee slope damaged by vehicle traffic and prevent access where possible.					
Inspector Comment

Slope was damaged by vehicle. Fall 2016.

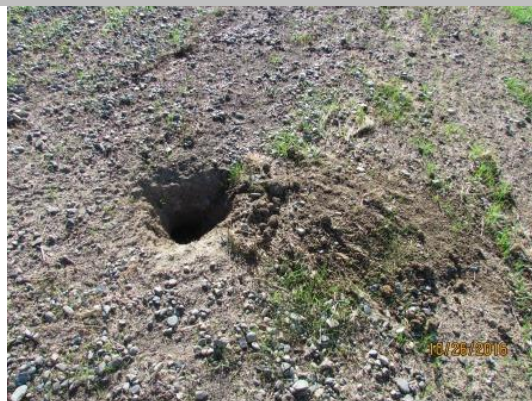
Photo 1 of 1 : FA_2016_ST0011_294_21_20161027_00018.jpg

View of an animal burrow. Fall 2016.

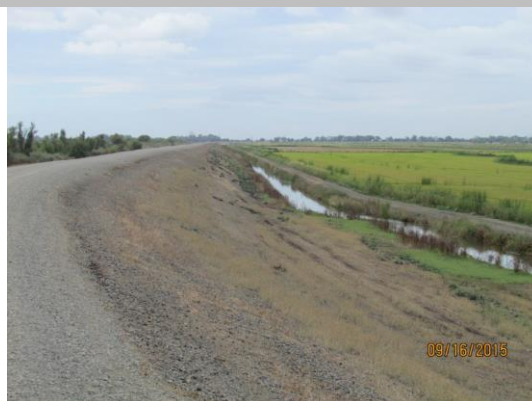
Photo 1 of 1 : FA_2016_ST0011_294_3_20160913_00003.jpg

View of the ditch along the levee toe on the landward side of the levee looking downstream. Fall 2015.

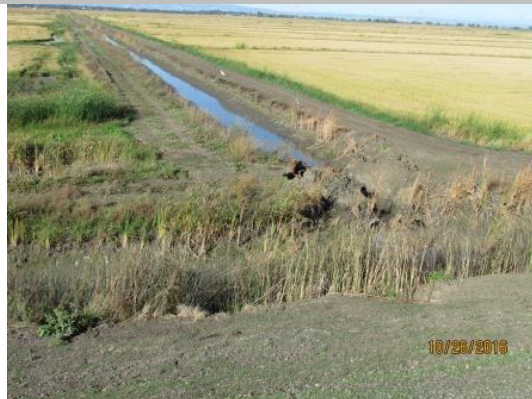
Photo 2 of 2 : FA_2016_ST0011_294_17_20161027_00014.jpg

LM Start	2.14	Rating **	M	Issue No.	17 (cont)	
LM End	2.14	Issue Type +	Ob	Location *	LS	
Category	Earthen Levee			GPS Latitude/Longitude		
				Start		End
Item	Erosion / Bank Caving			38.545022 °		38.545022 °
				-121.631209 °		-121.631209 °
DWR ID	DWR_ST0011_04_f_2016_17					
Comment Code						
E2 : Schedule repair of erosion site prior to the next inspection.						
Inspector Comment						
LS levee slope erosion on the edge of the ditch. Ditch is encroaching levee toe.

Perspective view of the erosion site. Fall 2016.

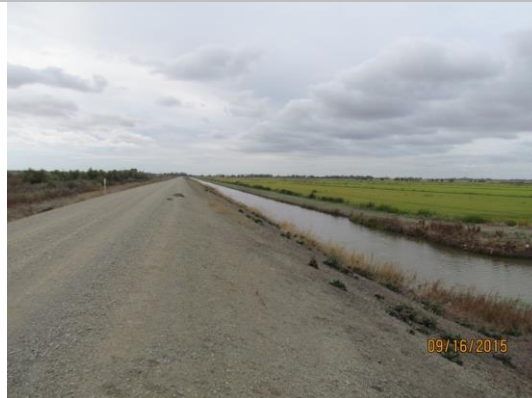
Photo 1 of 2 : FA_2016_ST0011_294_4_20160913_00004.jpg

The ditch is at the levee toe on the landward side of the levee looking downstream. Fall 2015.

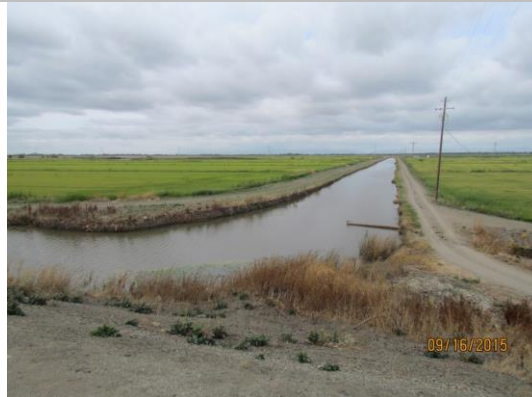
Photo 2 of 2 : FA_2016_ST0011_294_4_20160913_00005.jpg

Looking west at the agricultural ditch. Fall 2015.

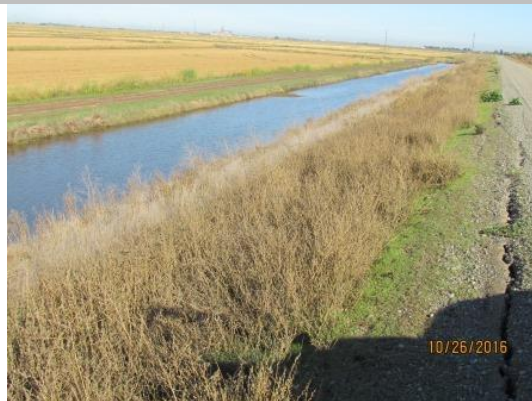
Photo 1 of 1 : FA_2016_ST0011_294_18_20161027_00015.jpg

LM Start	2.94	Rating **	M	Issue No.	18
LM End	3.00	Issue Type +	Ma	Location *	LS
Category	Earthen Levee			GPS Latitude/Longitude	
				Start	End
Item	Vegetation			38.533424 °	38.532532 °
				-121.631354 °	-121.631368 °
DWR ID	DWR_ST0011_04_f_2016_18				
Comment Code					
V2 : Remove the wild growth other than native grasses from the levee slopes.					
Inspector Comment

View of vegetation on WS slope. Fall 2016.
