**Flood Control Project Maintenance  
Levee Inspections**

**Fall 2017 Levee Maintenance Deficiency Summary Report**

## Sacramento Maintenance Yard West Levee Yolo Bypass

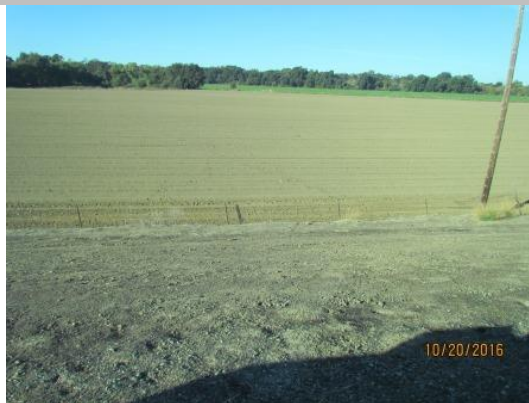
Photo 1 of 2 : FA\_2017\_ST0011\_291\_10\_20170911\_00006.jpg

View of fence located within 10-foot easement of landside toe. Fall 2016.

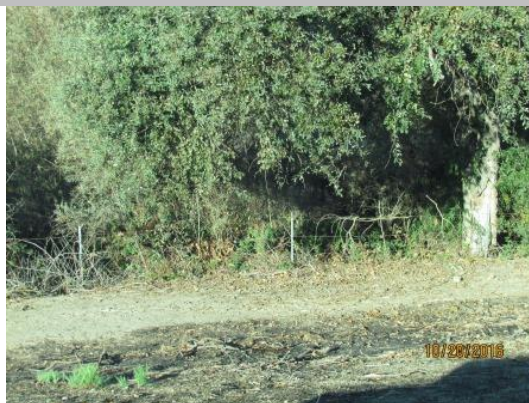
Photo 2 of 2 : FA\_2017\_ST0011\_291\_10\_20170911\_00007.jpg

Another view of fence located within 10-foot easement of landside toe. Fall 2016.

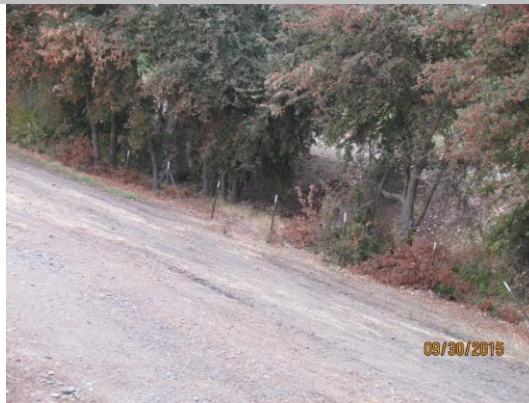
Photo 1 of 1 : FA\_2017\_ST0011\_291\_8\_20170911\_00003.jpg

LM Start	0.94	Rating **	M	Issue No.	8
LM End	1.83	Issue Type +	En	Location *	LS
Category	Earthen Levee			GPS Latitude/Longitude	
				Start	End
Item	Encroachments			38.747888 °	38.734972 °
				-121.660202 °	-121.660265 °
DWR ID	DWR_ST0011_01_s_2012_8				
Comment Code					
DT : Ditch					
Inspector Comment					
The ditch is at the toe of the levee.

View of the ditch on the landward side of the levee. Fall 2015.

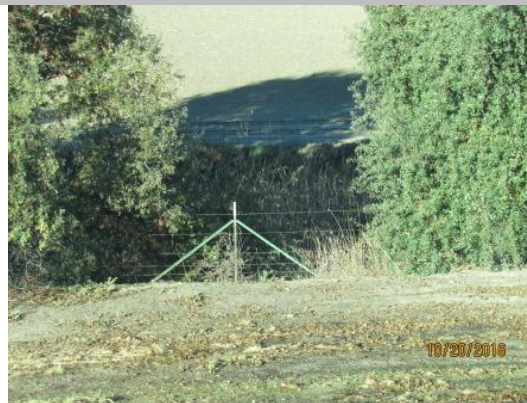
Photo 1 of 2 : FA\_2017\_ST0011\_291\_9\_20170911\_00004.jpg

View of fence along the ditch on landside. Fall 2016.

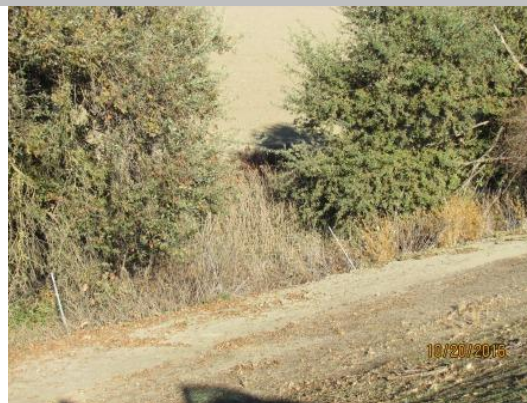
Photo 2 of 2 : FA\_2017\_ST0011\_291\_9\_20170911\_00005.jpg

Another view of fence along the ditch on landside. Fall 2016.

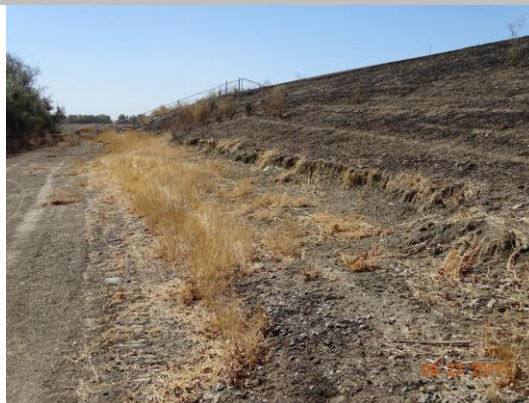
Photo 1 of 2 : FA\_2017\_ST0011\_291\_13\_20170927\_00024.jpg

Notes: This site had wave wash around a bend including on an access ramp. The site has been accepted for repair by USACE under PL84-99, but is a lower priority so will not be fixed before this flood season.

View of wave wash at waterside toe. Fall 2017.

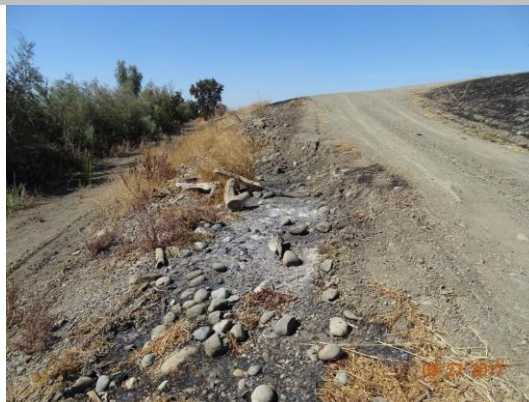
Photo 2 of 2 : FA\_2017\_ST0011\_291\_13\_20170927\_00025.jpg

View of wavewash on access ramp near waterside toe. Fall 2017.

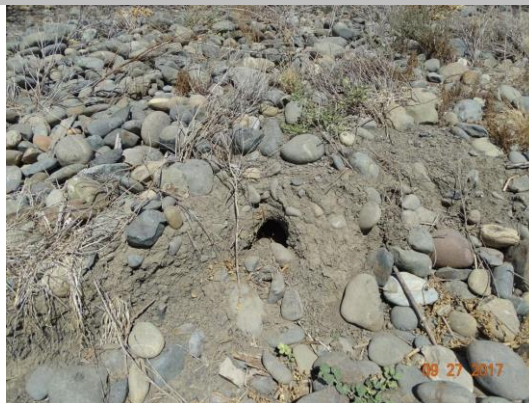
Photo 1 of 1 : FA\_2017\_ST0011\_291\_14\_20170927\_00026.jpg

View of den at waterside toe, within section of wavewash damage. Fall 2017.

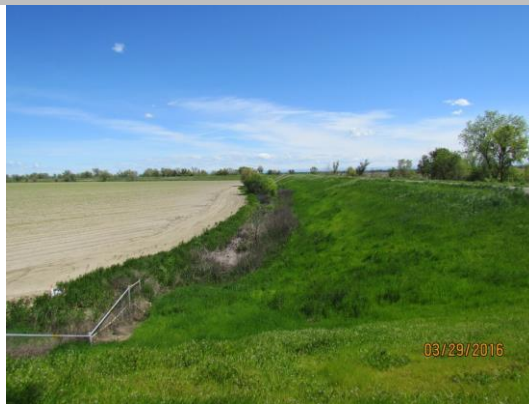
Photo 1 of 1 : FA\_2017\_ST0011\_291\_4\_20170911\_00002.jpg

View of the ditch at the toe of the levee on the landward side. Spring 2016.

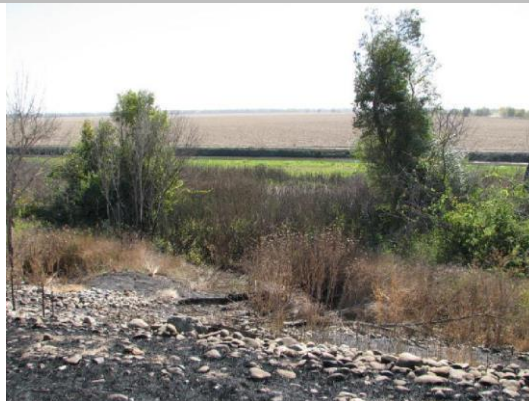
Photo 1 of 3 : UCIP\_FA\_2017\_52501\_60304.jpg

FS\_ID:52501  
DS\_ID:17742  
EP\_NO: 10284  
Repair Type: No Action Needed  
Crossing Status: Found  
UCIP Comments: Screw gates where removed and pipe was abanded by farmer, How pipe was abanded is unknown.  
FIELD\_STRUCT\_DESC: 1 of 2: 42-inch corrugated metal gravity drainage pipe through the levee, 23.6 feet below the crown. Slide gate on the waterside (WS) slope. Concrete distribution box at the landside (LS) toe. (42-inch pipe [HLM 2.63] authorized under Automatic Board Order (ABO) issued as Permit No. 10284, 1974 - La Borde and Hoover). [Additional Reference(s): DWR Levee Log, 2004. USACE Sacramento O&M Manual 127, June 1953, (Station 133+82)].  
FS Date: 11/16/2017 1:59:55 PM

Waterside view: overview (pipe not found)

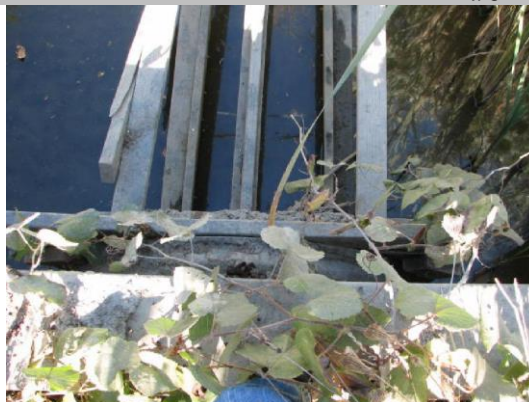
Photo 2 of 3 : UCIP\_FA\_2017\_52501\_60303.jpg

Landside view: concrete spillbox/headwall and pipe (top view)

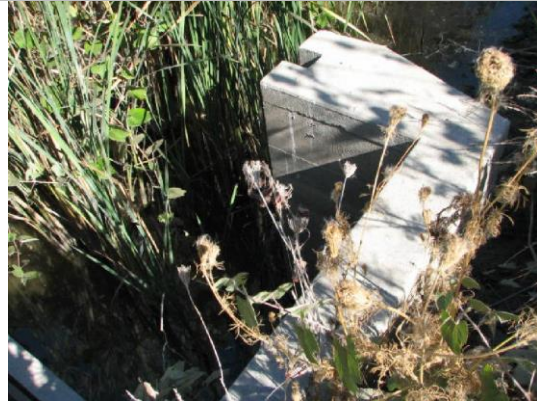
Photo 3 of 3 : UCIP\_FA\_2017\_52501\_60302.jpg

Comment Code						
Inspector Comment						
FS_ID:52501 DS_ID:17742 EP_NO: 10284 Repair Type: No Action Needed Crossing Status: Found UCIP Comments: Screw gates where removed and pipe was abanded by farmer, How pipe was abanded is unknown. FIELD_STRUCT_DESC: 1 of 2: 42-inch corrugated metal gravity drainage pipe through the levee, 23.6 feet below the crown. Slide gate on the waterside (WS) slope. Concrete distribution box at the landside (LS) toe. (42-inch pipe [HLM 2.63] authorized under Automatic Board Order (ABO) issued as Permit No. 10284, 1974 - La Borda and Hoover). [Additional Reference(s): DWR Levee Log, 2004. USACE Sacramento O&M Manual 127, June 1953, (Station 133+82)]. FS Date: 11/16/2017 1:59:55 PM

Landside view: side of concrete spillbox/headwall

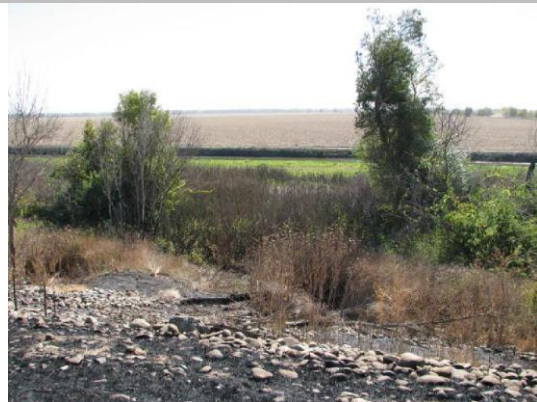
Photo 1 of 3 : UCIP\_FA\_2017\_52502\_60309.jpg

Comment Code						
Inspector Comment						
FS_ID:52502 DS_ID:17747 EP_NO: 10284 Repair Type: No Action Needed Crossing Status: Found UCIP Comments: No slide gate found. slide gates and pipes were abandon by farmer, how unknown FIELD_STRUCT_DESC: 2 of 2: 42-inch corrugated metal gravity drainage pipe through the levee, 23.6 feet below the crown. Slide gate on the waterside (WS) slope. Concrete distribution box at the landside (LS) toe. (42-inch pipe [HLM 2.63] authorized under Automatic Board Order (ABO) issued as Permit No. 10284, 1974 - La Borda and Hoover). [Additional Reference(s): DWR Levee Log, 2004. USACE Sacramento O&M Manual 127, June 1953, (Station 133+82)]. FS Date: 11/16/2017 2:01:58 PM

Waterside view: overview

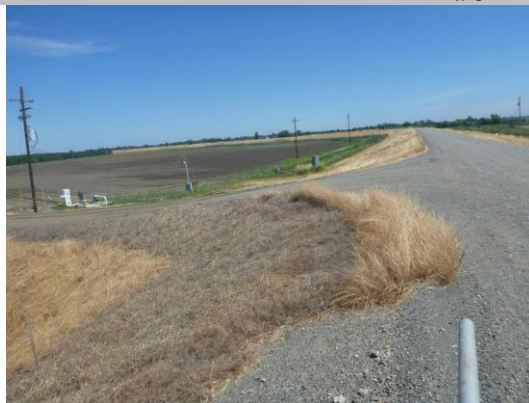
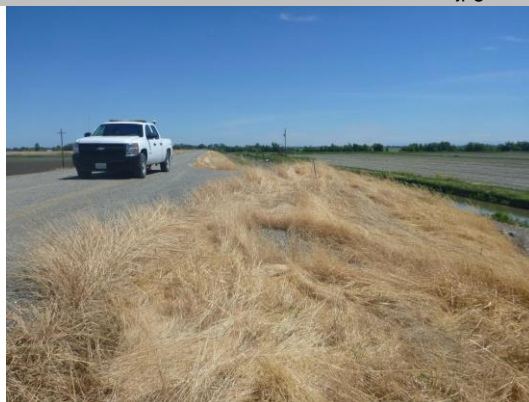
LM Start	0.23	Rating **	A/W	Issue No.	1
LM End	0.25	Issue Type +	Ma	Location *	
Category	Supplemental			GPS Latitude/Longitude	
				Start	End
Item	2017 Storm Damage			38.715815 °	38.715595 °
				-121.665344 °	-121.665432 °
DWR ID	DWR_ST0011_02_f_2017_1				
Comment Code					
Inspector Comment					
Levee Evaluation Comments					
Description:					
Site ID No:251					
Site Designation:LMA-59					
Repair Type: Stability					
Rating:Area of Concern					
Field Date:6/2/2017					
Notes: vertical cut on waterside access ramp slope about 2.5ft high, waterside berm 30'.

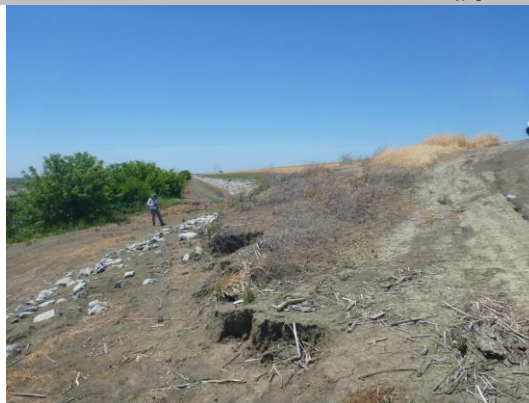
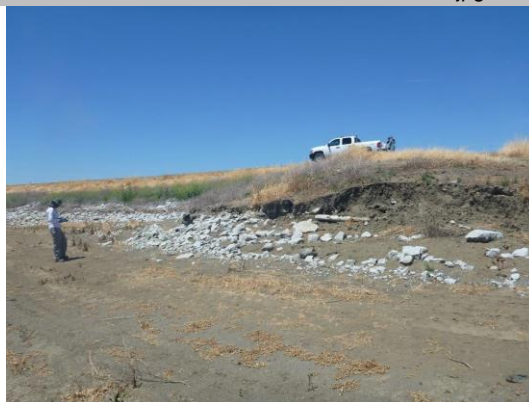
LM Start	0.44	Rating **	A/W	Issue No.	2 (cont)	
LM End	0.45	Issue Type +	Ma	Location *		
Category	Supplemental			GPS Latitude/Longitude		
				Start		End
Item	2017 Storm Damage			38.713081 °		38.712895 °
				-121.666869 °		-121.667035 °
DWR ID	DWR_ST0011_02_f_2017_2					
Comment Code						
Inspector Comment						
Levee Evaluation Comments						
Description:						
Site ID No:252						
Site Designation:LMA-60						
Repair Type: Stability						
Rating:Area of Concern						
Field Date:6/2/2017						
Notes: vertical cut on waterside access ramp slope about 3ft high, waterside berm 30'.

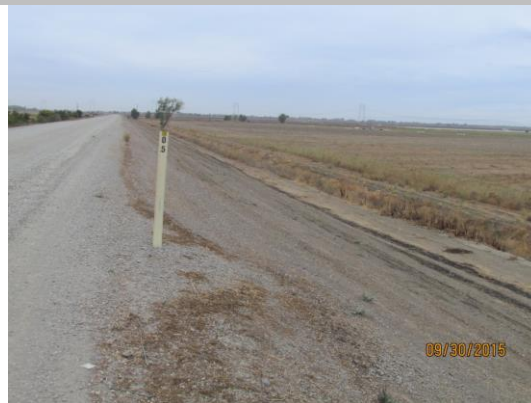
Photo 1 of 3 : FA\_2017\_ST0011\_292\_3\_20170911\_00001.jpg

View of the ditch at the landward side of the levee looking downstream.  
Fall 2015.

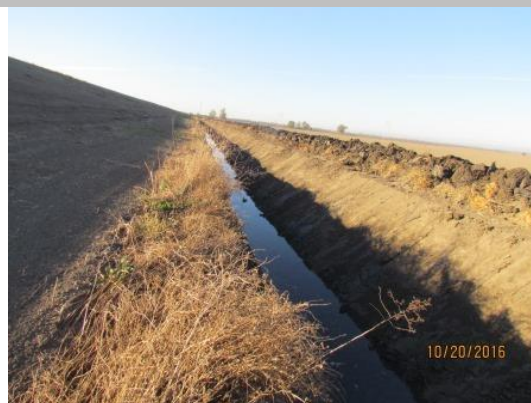
Photo 2 of 3 : FA\_2017\_ST0011\_292\_3\_20170911\_00002.jpg

View of the ditch on landward side. Ditch was deepened to approximately 10 ft. Fall 2016.

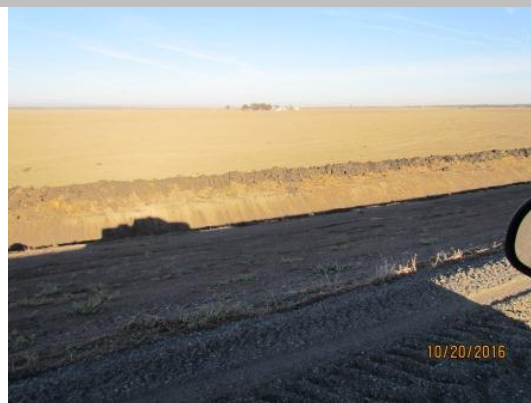
Photo 3 of 3 : FA\_2017\_ST0011\_292\_3\_20170911\_00003.jpg

View of the ditch on landward side. Fall 2016.

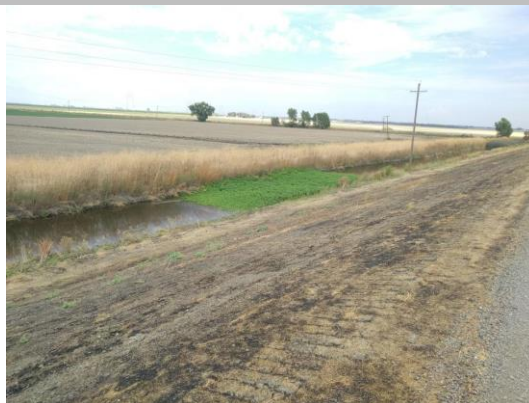
Photo 1 of 2 : FA\_2017\_ST0011\_292\_5\_20170914\_00005.jpg

View of ditch at landside toe, looking upstream. Fall 2017.

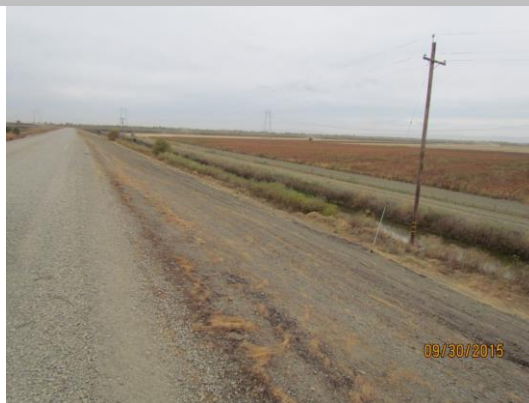
Photo 2 of 2 : FA\_2017\_ST0011\_292\_5\_20170911\_00004.jpg

View of the ditch on the landward side of the levee looking downstream. Fall 2015.

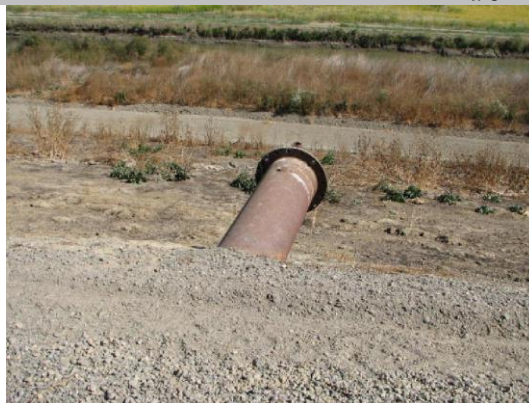
Photo 1 of 3 : UCIP\_FA\_2017\_52507\_60378.jpg

LM Start	0.03	Rating **	M	Issue No.	4	
LM End	0.03	Issue Type +	En	Location *		
Category	Supplemental			GPS Latitude/Longitude		
				Start	End	
Item	DWR UCIP Field Study			38.698204 °	38.698204 °	
				-121.674080 °	-121.674080 °	
DWR ID						
Comment Code						
Inspector Comment						
FS_ID:52507 DS_ID:17756 EP_NO: N/A Repair Type: Non-Urgent Crossing Status: Found UCIP Comments: Pipe not properly abandoned. FIELD_STRUCT_DESC: *ABANDONED* 18-inch steel irrigation or drainage pipe through the levee, 3 feet below the crown. FS Date: 11/16/2017 2:23:11 PM

Waterside view: an abandoned steel pipe.

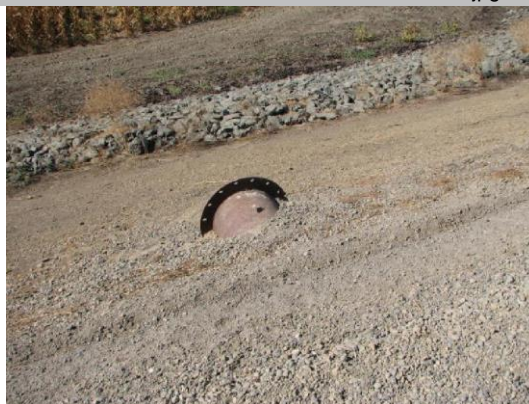
Photo 2 of 3 : UCIP\_FA\_2017\_52507\_60377.jpg

Landside view: an abandoned steel pipe.

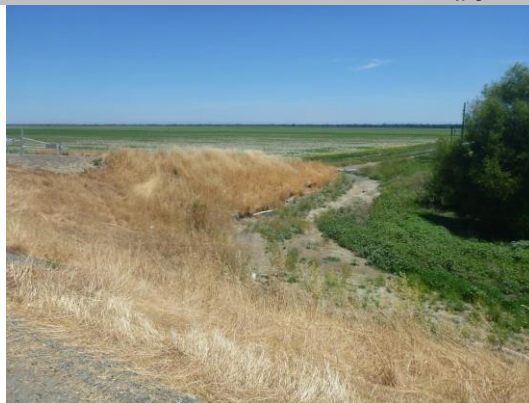
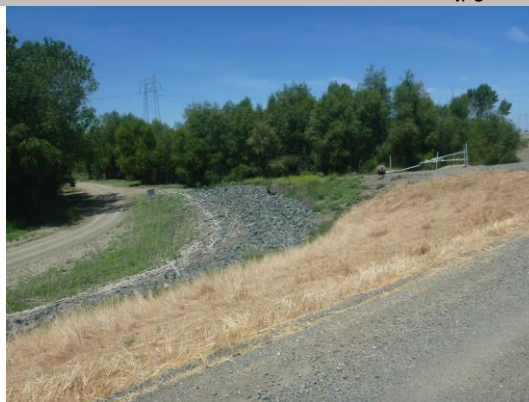
LM Start	0.50	Rating **	A/W	Issue No.	2 (cont)	
LM End	0.53	Issue Type +	Ma	Location *		
Category	Supplemental			GPS Latitude/Longitude		
				Start		End
Item	2017 Storm Damage			38.691341 °		38.690973 °
				-121.673241 °		-121.673475 °
DWR ID	DWR_ST0011_03_f_2017_2					
Comment Code						
Inspector Comment						
Levee Evaluation Comments						
Description:						
Site ID No:253						
Site Designation:LMA-61						
Repair Type: Erosion						
Rating:Area of Concern						
Field Date:6/2/2017						
Notes: WS access ramp slope erosion. No threat to the levee; ramp erosion beyond WS levee toe.

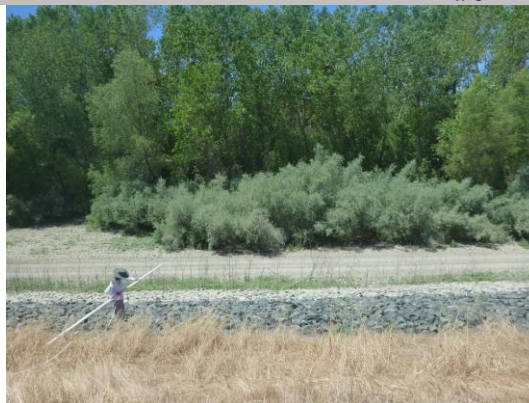
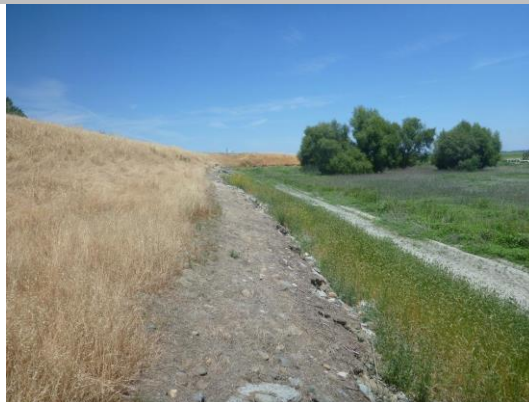
LM Start	0.53	Rating **	A/W	Issue No.	3	
LM End	0.71	Issue Type +	Ma	Location *		
Category	Supplemental			GPS Latitude/Longitude		
				Start	End	
Item	2017 Storm Damage			38.690973 °	38.688302 °	
				-121.673475 °	-121.673608 °	
DWR ID	DWR_ST0011_03_f_2017_3					
Comment Code						
Inspector Comment						
Levee Evaluation Comments						
Description:						
Site ID No:254						
Site Designation:LMA-62						
Repair Type: Erosion						
Rating:Area of Concern						
Field Date:6/2/2017						
Notes: minor erosion at toe of levee

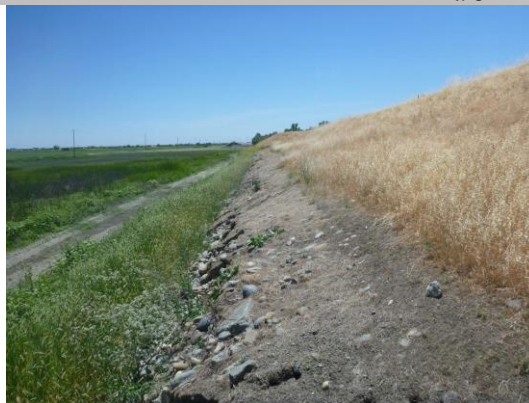
Photo 3 of 3 : LEVAL\_FA\_2017\_254\_929.jpg

LM Start	0.53	Rating **	A/W	Issue No.	3 (cont)	
LM End	0.71	Issue Type +	Ma	Location *		
Category	Supplemental			GPS Latitude/Longitude		
				Start	End	
Item	2017 Storm Damage			38.690973 °	38.688302 °	
				-121.673475 °	-121.673608 °	
DWR ID	DWR_ST0011_03_f_2017_3					
Comment Code						
Inspector Comment						
Levee Evaluation Comments						
Description:						
Site ID No:254						
Site Designation:LMA-62						
Repair Type: Erosion						
Rating:Area of Concern						
Field Date:6/2/2017						
Notes: minor erosion at toe of levee

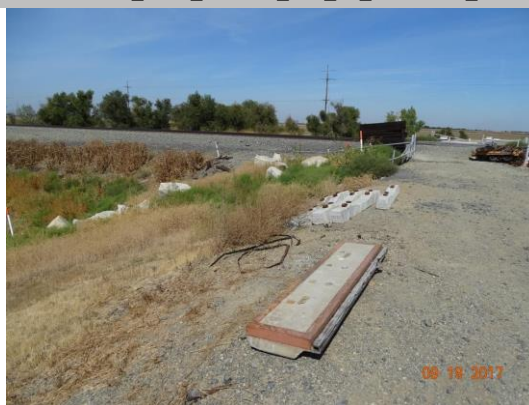
Photo 1 of 3 : FA\_2017\_ST0011\_294\_26\_20170919\_00037.jpg

View of railroad equipment on landside shoulder. Fall 2017.

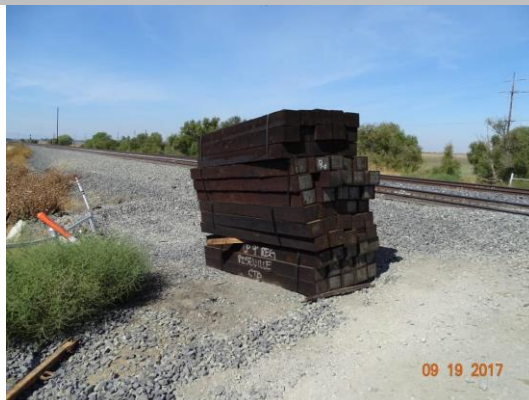
Photo 2 of 3 : FA\_2017\_ST0011\_294\_26\_20170919\_00039.jpg

Additional view of equipment on landside shoulder. Fall 2017.

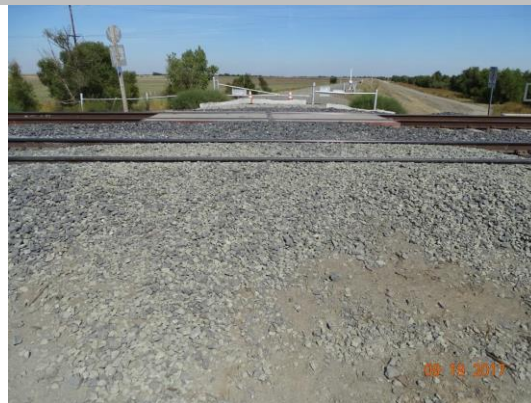
Photo 3 of 3 : FA\_2017\_ST0011\_294\_26\_20170919\_00040.jpg

View of unauthorized railroad crossing that material belongs to. Fall 2017.

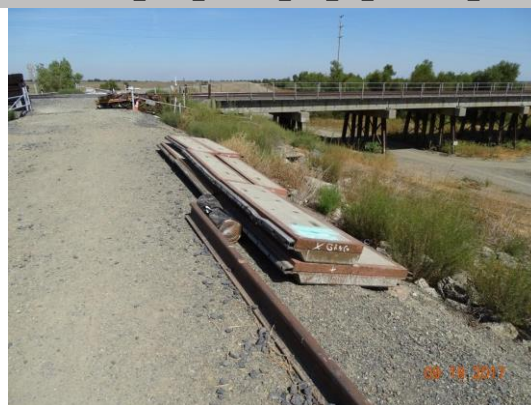
Photo 1 of 2 : FA\_2017\_ST0011\_294\_25\_20170919\_00036.jpg

View of railroad equipment on wateside shoulder. Fall 2017.

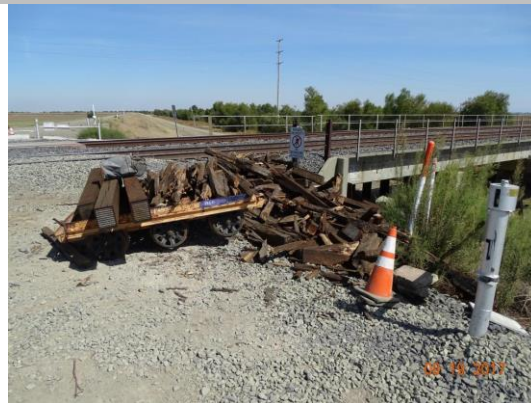
Photo 2 of 2 : FA\_2017\_ST0011\_294\_25\_20170919\_00038.jpg

Additional equipment on the wateside shoulder. Fall 2017.

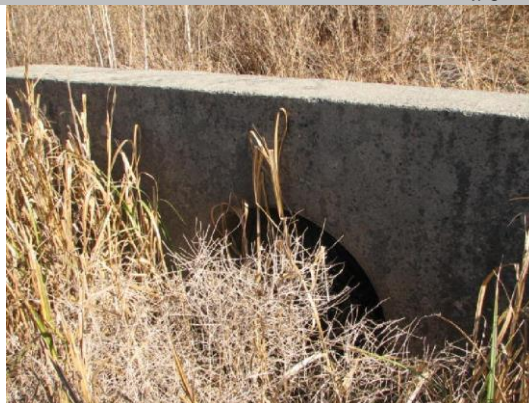
Photo 1 of 3 : UCIP\_FA\_2017\_44826\_60517.jpg

LM Start	0.60	Rating **	A/W	Issue No.	33	
LM End	0.60	Issue Type +	Ma	Location *		
Category	Supplemental			GPS Latitude/Longitude		
				Start		End
Item	DWR UCIP LMA Responsibility			38.565704 °		38.565704 °
				-121.638650 °		-121.638650 °
DWR ID						
Comment Code						
Inspector Comment						
FS_ID:44826 DS_ID:528 EP_NO: 10304 Repair Type: No Action Needed Crossing Status: Found UCIP Comments: FIELD_STRUCT_DESC: 30-inch corrugated metal gravity drainage pipe through the levee, 22 feet below the crown. Flap gate on the waterside (WS) end. (30-inch pipe [HLM 0.59] authorized under Automatic Board Order (ABO) issued as Permit No. 10304, 1974 - Southern Pacific Transportation Company). [Additional Reference(s): DWR Levee Log, 2004. USACE Sacramento O&M Manual 120, June 1952, (Station 446+08)]. FS Date: 4/28/2015 2:58:55 PM

Landside view: concrete headwall.

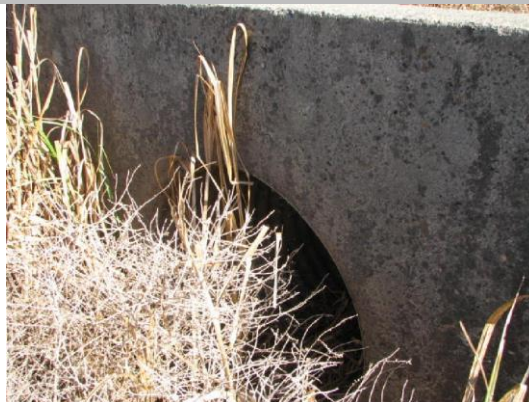
Photo 2 of 3 : UCIP\_FA\_2017\_44826\_60516.jpg

Landside view: closer look at the headwall.

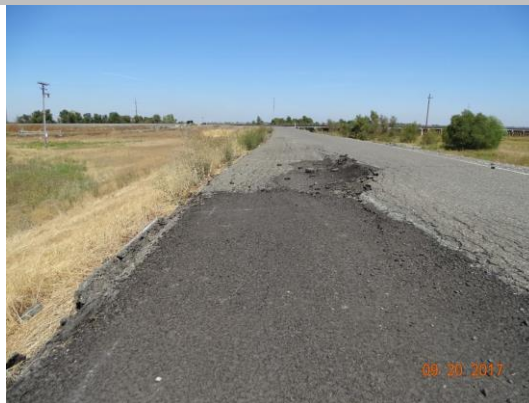
Photo 1 of 2 : FA\_2017\_ST0011\_294\_12\_20170919\_00041.jpg

Updated view of crown depression. Fall 2017.

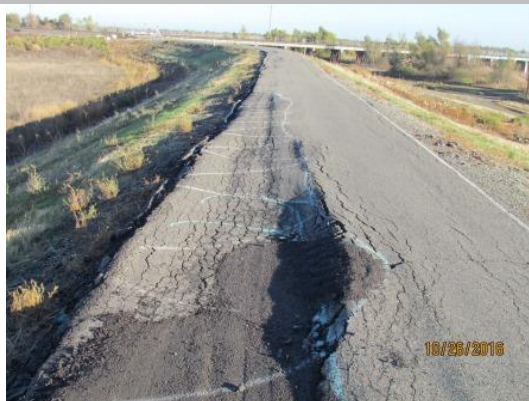
Photo 2 of 2 : FA\_2017\_ST0011\_294\_12\_20170911\_00005.jpg

Asphalt paved crown has depression at this site. Fall 2016.

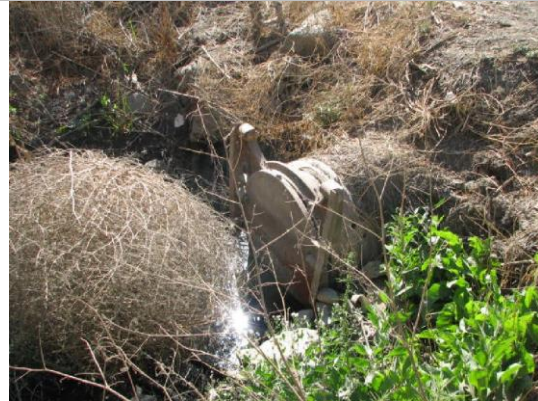
Photo 2 of 3 : UCIP\_FA\_2017\_52492\_60525.jpg

Waterside view: pipe and flap gate

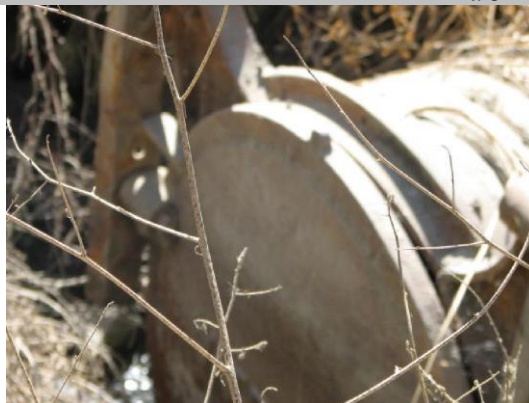
Photo 3 of 3 : UCIP\_FA\_2017\_52492\_60524.jpg

Waterside view: closer look at pipe and flap gate

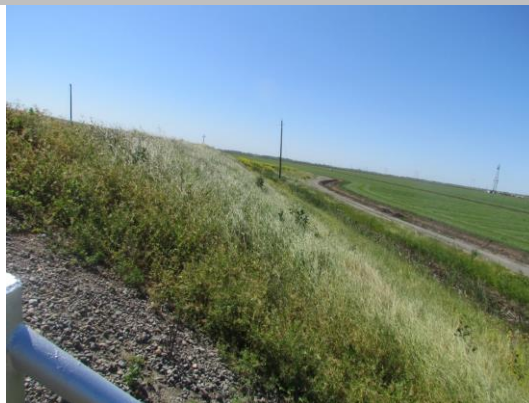
Photo 1 of 1 : FA\_2017\_ST0011\_294\_6\_20170911\_00004.jpg

View of the ditch on the landward side of the levee looking downstream.  
Spring 2015.

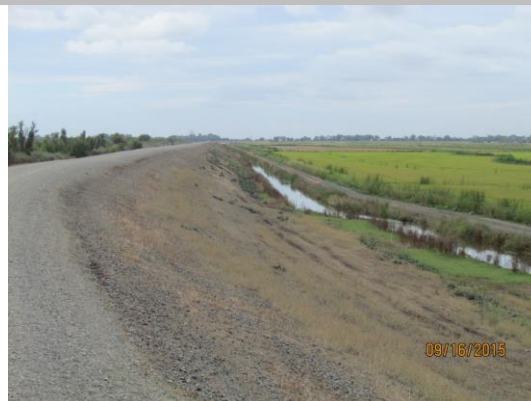
Photo 1 of 1 : FA\_2017\_ST0011\_294\_3\_20170911\_00001.jpg

View of the ditch along the levee toe on the landward side of the levee looking downstream. Fall 2015.

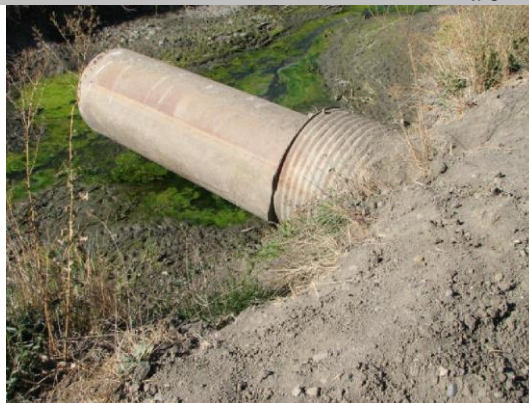
Photo 1 of 3 : UCIP\_FA\_2017\_44822\_24980.jpg

Landside view: 42-inch steel pipe inside a 48-inch CMP

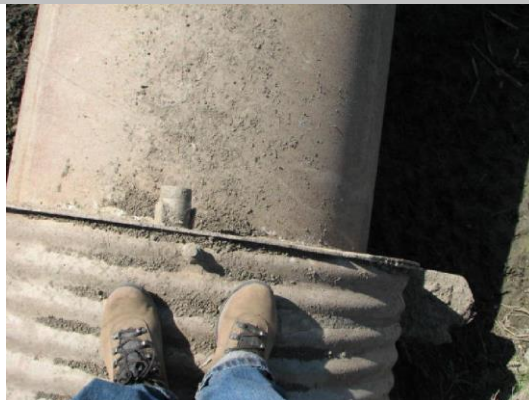
Photo 2 of 3 : UCIP\_FA\_2017\_44822\_24979.jpg

Landside view: closer look at 42-inch steel pipe and 48-inch CMP

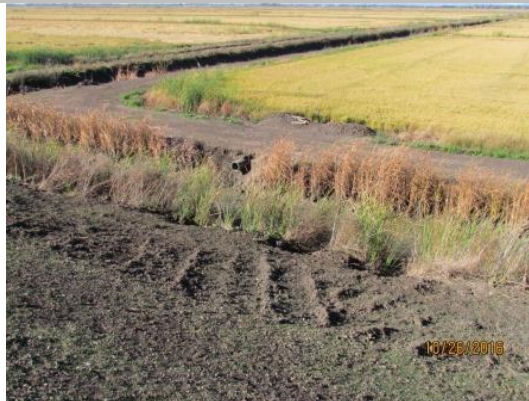
Photo 2 of 2 : FA\_2017\_ST0011\_294\_19\_20170911\_00010.jpg

View of erosion on landside levee slope. Fall 2016.

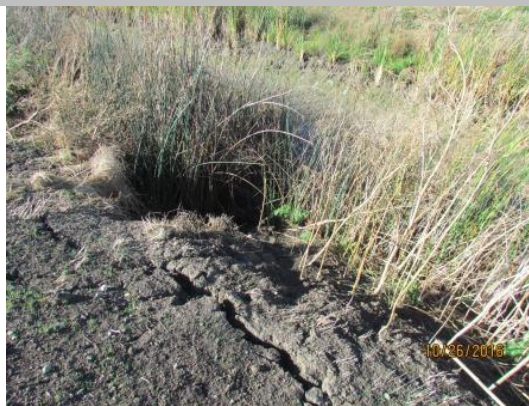
Photo 1 of 2 : FA\_2017\_ST0011\_294\_17\_20170911\_00007.jpg

Closer view of erosion. Fall 2016.

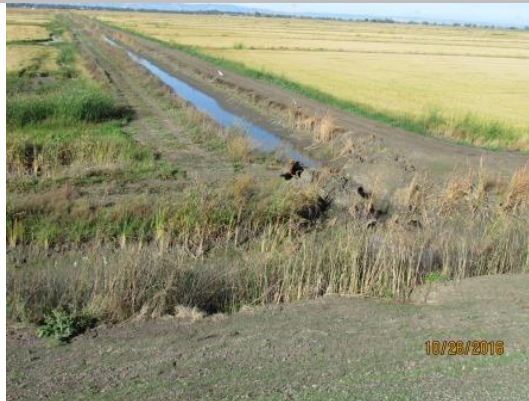
Photo 2 of 2 : FA\_2017\_ST0011\_294\_17\_20170911\_00008.jpg

View of erosion at landside levee toe. Fall 2016.

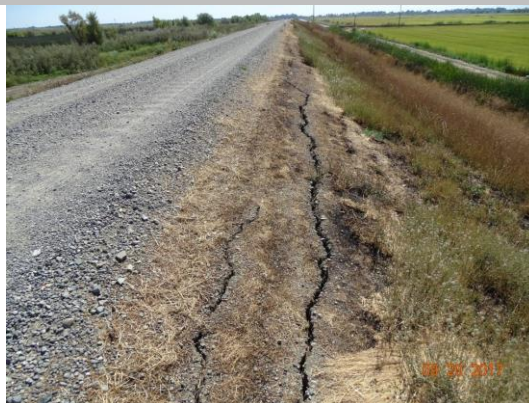
Photo 1 of 1 : FA\_2017\_ST0011\_294\_22\_20170919\_00042.jpg

View of cracking on landside hinge point. Fall 2017.

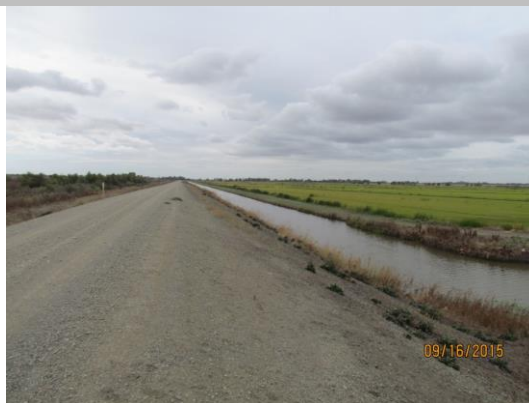
Photo 1 of 2 : FA\_2017\_ST0011\_294\_4\_20170911\_00002.jpg

The ditch is at the levee toe on the landward side of the levee looking downstream. Fall 2015.

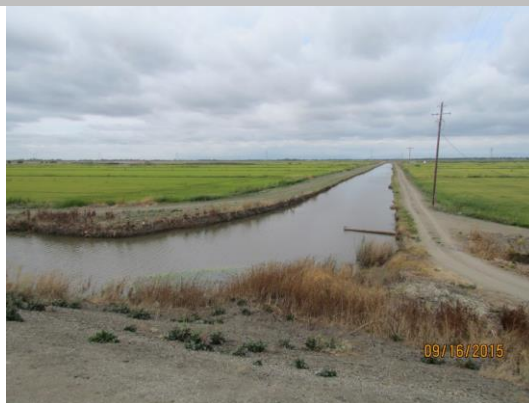
Photo 2 of 2 : FA\_2017\_ST0011\_294\_4\_20170911\_00003.jpg

Looking west at the agricultural ditch. Fall 2015.
