**Flood Control Project Maintenance
Levee Inspections**

Fall 2019 Levee Maintenance Deficiency Summary Report

**Flood Control Project Maintenance
Levee Inspections****LMA District Cover Sheet****Fall 2019 Levee Inspection Results****Sacramento Maintenance Yard West Levee Yolo Bypass**

Sacramento Maintenance Yard West Levee Yolo Bypass

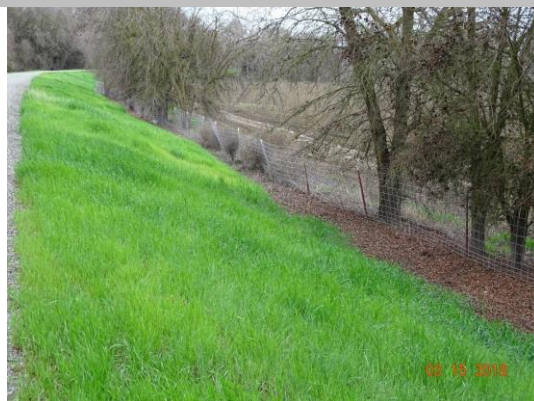
Photo 1 of 3 : FA_2019_ST0011_291_10_20190829_00005.jpg

View of fence at landside toe. Spring 2018.

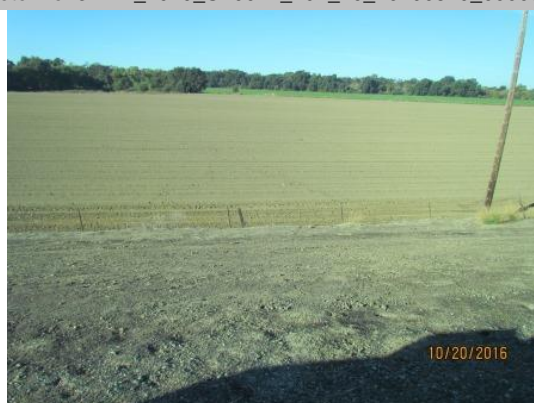
Photo 2 of 3 : FA_2019_ST0011_291_10_20190829_00006.jpg

View of fence located within 10-foot easement of landside toe. Fall 2016.

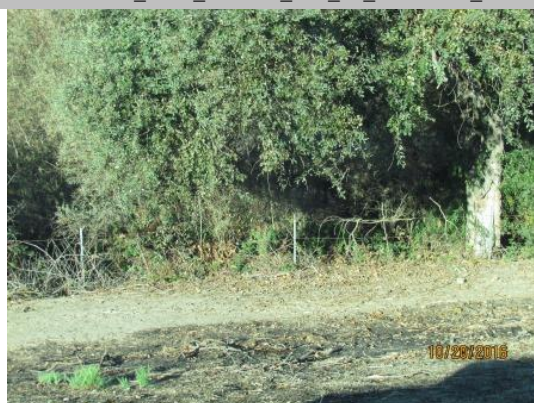
Photo 3 of 3 : FA_2019_ST0011_291_10_20190829_00007.jpg

LM Start	0.12	Rating **	M	Issue No.	10 (cont)
LM End	1.55	Issue Type +	En	Location *	LS

Another view of fence located within 10-foot easement of landside toe. Fall 2016.

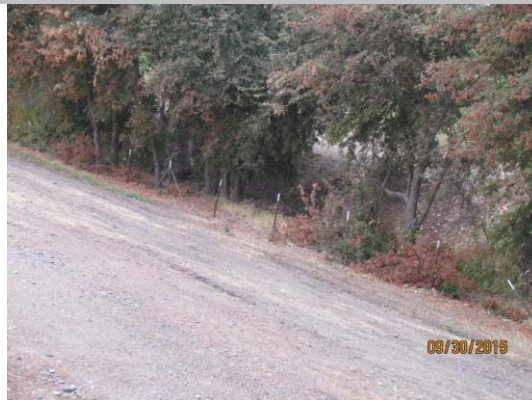
Photo 1 of 1 : FA_2019_ST0011_291_8_20190829_00002.jpg

View of the ditch on the landward side of the levee. Fall 2015.

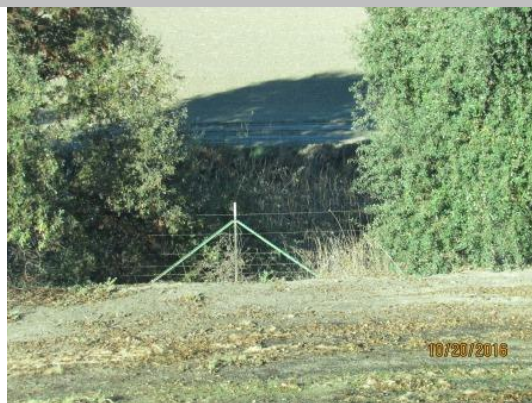
Photo 1 of 2 : FA_2019_ST0011_291_9_20190829_00003.jpg

LM Start	1.70	Rating **	M	Issue No.	9
LM End	1.79	Issue Type +	En	Location *	LS
Category	Earthen Levee			GPS Latitude/Longitude	
				Start	End
Item	Encroachments			38.736842 °	38.735498 °
				-121.660285 °	-121.660287 °
DWR ID	DWR_ST0011_01_f_2016_9				
Comment Code					
FE : Fence					
Inspector Comment

View of fence along the ditch on landside. Fall 2016.

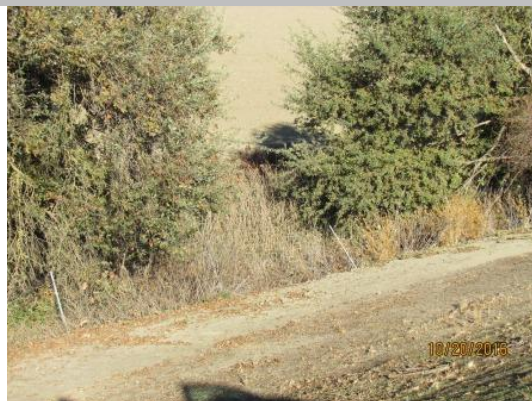
Photo 2 of 2 : FA_2019_ST0011_291_9_20190829_00004.jpg

LM Start	1.70	Rating **	M	Issue No.	9 (cont)
LM End	1.79	Issue Type +	En	Location *	LS

Another view of fence along the ditch on landside. Fall 2016.

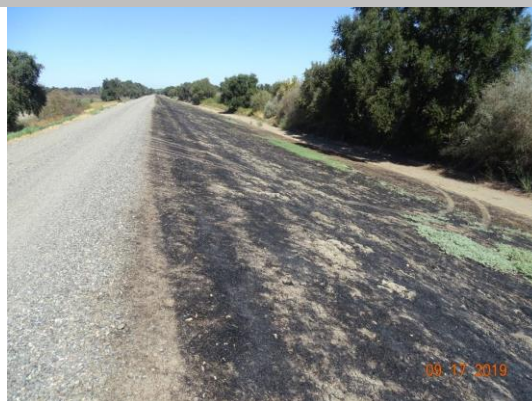
Photo 1 of 1 : FA_2019_ST0011_291_3_20190919_00016.jpg

View of the maintained waterside slope. Fall 2019.

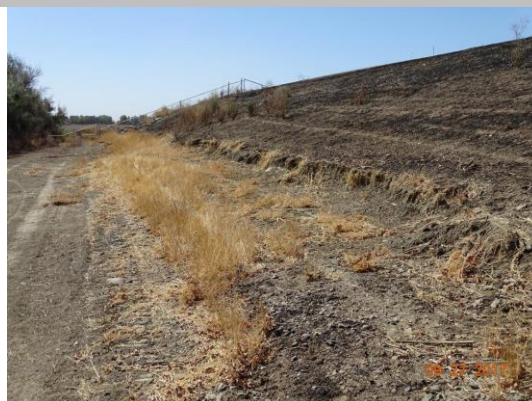
Photo 1 of 2 : FA_2019_ST0011_291_13_20190829_00008.jpg

LM Start	2.36	Rating **	A/W	Issue No.	13	
LM End	2.51	Issue Type +	Ob	Location *		
Category	Supplemental			GPS Latitude/Longitude		
				Start	End	
Item	2017 Storm Damage			38.727250 °	38.725678 °	
				-121.660234 °	-121.661697 °	
DWR ID	ST11-U1-01					
Comment Code						
Inspector Comment						
Levee Evaluation Comments						
Description:						
Site ID No:197						
Site Designation:ST11-U1-01						
Repair Type: Erosion						
Rating:Area of Concern						
Field Date:5/31/2017						
Notes: This site had wave wash around a bend including on an access ramp. The site has been accepted for repair by USACE under PL84-99. Being repaired as of this inspection date. Work should be completed within 2019.

View of wave wash at waterside toe. Fall 2017.

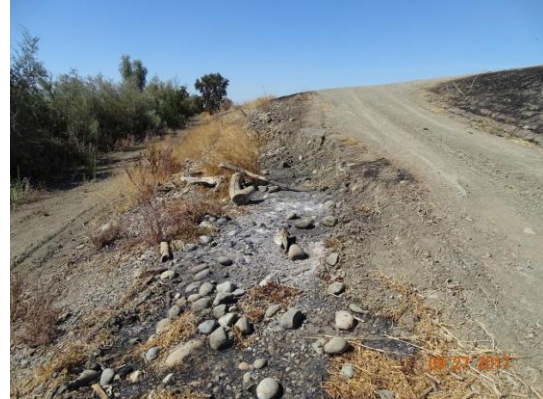
Photo 2 of 2 : FA_2019_ST0011_291_13_20190829_00009.jpg

LM Start	2.36	Rating **	A/W	Issue No.	13 (cont)	
LM End	2.51	Issue Type +	Ob	Location *		
Category	Supplemental			GPS Latitude/Longitude		
				Start	End	
Item	2017 Storm Damage			38.727250°	38.725678°	
				-121.660234°	-121.661697°	
DWR ID	ST11-U1-01					
Comment Code						
Inspector Comment						
Levee Evaluation Comments						
Description:						
Site ID No:197						
Site Designation:ST11-U1-01						
Repair Type: Erosion						
Rating:Area of Concern						
Field Date:5/31/2017						
Notes: This site had wave wash around a bend including on an access ramp. The site has been accepted for repair by USACE under PL84-99. Being repaired as of this inspection date. Work should be completed within 2019.

View of wavewash on access ramp near waterside toe. Fall 2017.

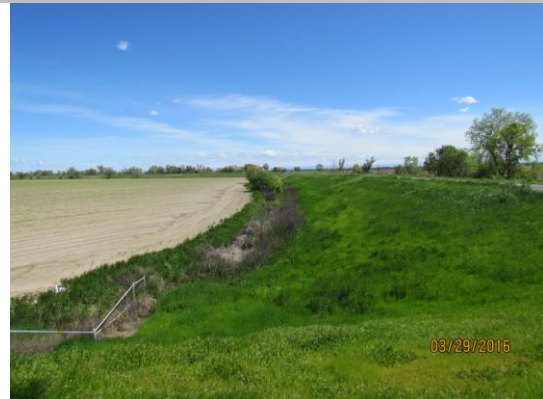
Photo 1 of 1 : FA_2019_ST0011_291_4_20190829_00001.jpg

LM Start	2.63	Rating **	M	Issue No.	4
LM End	2.72	Issue Type +	En	Location *	LS
Category	Earthen Levee			GPS Latitude/Longitude	
				Start	End
Item	Encroachments			38.724853 °	38.724228 °
				-121.663647 °	-121.665137 °
DWR ID	DWR_ST0011_01_s_2012_4				
Comment Code					
DT : Ditch					
Inspector Comment					
Ditch is at the toe of the levee.

View of the ditch at the toe of the levee on the landward side. Spring 2016.

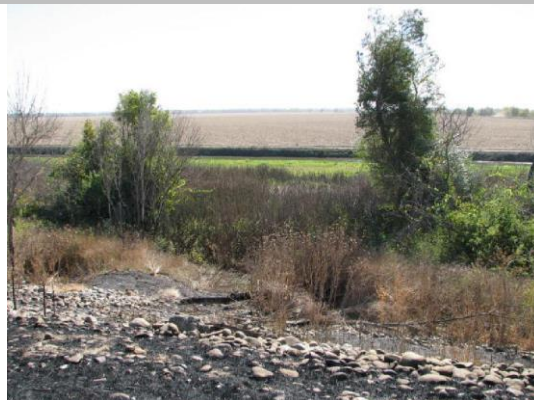
Photo 1 of 3 : UCIP_FA_2019_53232_60304.jpg

DS_ID:17742
FS_ID:53232
EP_NO: 10284
Repair Type: No Action Needed
Crossing Status: Found
UCIP Comments: Screw gates where removed and pipe was abanded by farmer, How pipe was abanded is unknown. Pipe is Grouted
FIELD_STRUCT_DESC: 1 of 2: 42-inch corrugated metal gravity drainage pipe through the levee, 23.6 feet below the crown. Slide gate on the waterside (WS) slope. Concrete distribution box at the landside (LS) toe. (42-inch pipe [HLM 2.63] authorized under Automatic Board Order (ABO) issued as Permit No. 10284, 1974 - La Borde and Hoover). [Additional Reference(s): DWR Levee Log, 2004. USACE Sacramento O&M Manual 127, June 1953, (Station 133+82)].
FS Date: 11/16/2018 2:17:55 PM

Waterside view: overview (pipe not found)

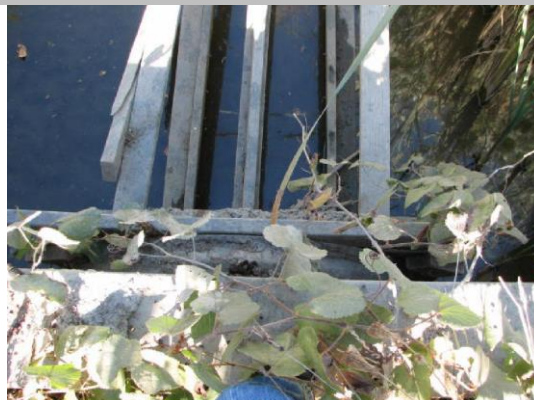
Photo 2 of 3 : UCIP_FA_2019_53232_60303.jpg

Landside view: concrete spillbox/headwall and pipe (top view)

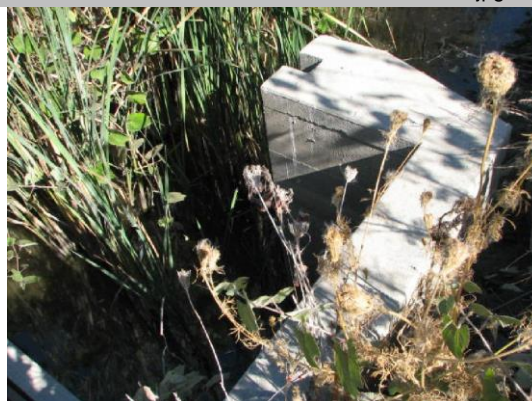
Photo 3 of 3 : UCIP_FA_2019_53232_60302.jpg

Comment Code						
Inspector Comment						
DS_ID:17742						
FS_ID:53232						
EP_NO: 10284						
Repair Type: No Action Needed						
Crossing Status: Found						
UCIP Comments: Screw gates where removed and pipe was abandoned by farmer, How pipe was abandoned is unknown. Pipe is Grouted						
FIELD_STRUCT_DESC: 1 of 2: 42-inch corrugated metal gravity drainage pipe through the levee, 23.6 feet below the crown. Slide gate on the waterside (WS) slope. Concrete distribution box at the landside (LS) toe. (42-inch pipe [HLM 2.63] authorized under Automatic Board Order (ABO) issued as Permit No. 10284, 1974 - La Borda and Hoover). [Additional Reference(s): DWR Levee Log, 2004. USACE Sacramento O&M Manual 127, June 1953, (Station 133+82)].						
FS Date: 11/16/2018 2:17:55 PM

Landside view: side of concrete spillbox/headwall

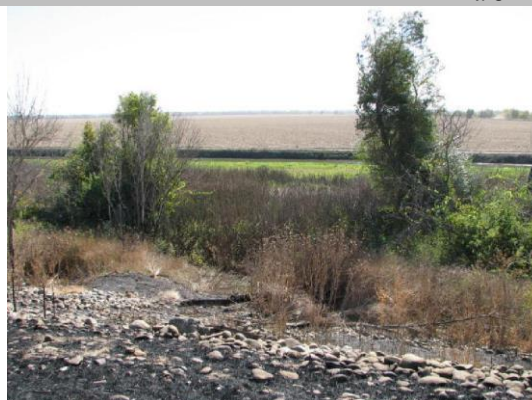
Photo 1 of 3 : UCIP_FA_2019_53233_60309.jpg

Comment Code					
Inspector Comment					
DS_ID:17747 FS_ID:53233 EP_NO: 10284 Repair Type: No Action Needed Crossing Status: Found UCIP Comments: No slide gate found. slide gates and pipes were abandon by farmer, how unknown FIELD_STRUCT_DESC: 2 of 2: 42-inch corrugated metal gravity drainage pipe through the levee, 23.6 feet below the crown. Slide gate on the waterside (WS) slope. Concrete distribution box at the landside (LS) toe. (42-inch pipe [HLM 2.63] authorized under Automatic Board Order (ABO) issued as Permit No. 10284, 1974 - La Borda and Hoover). [Additional Reference(s): DWR Levee Log, 2004. USACE Sacramento O&M Manual 127, June 1953, (Station 133+82)]. FS Date: 11/16/2018 2:19:35 PM

Waterside view: overview

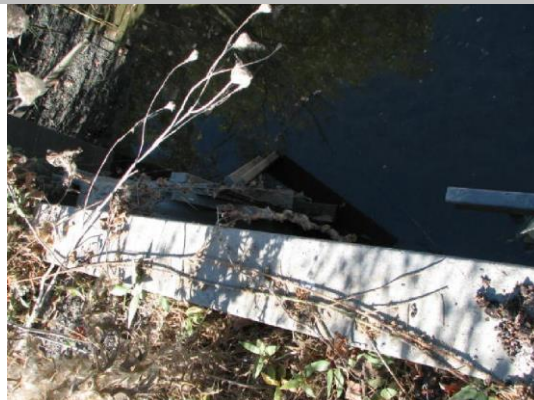
Photo 2 of 3 : UCIP_FA_2019_53233_60308.jpg

DS_ID:17747
FS_ID:53233
EP_NO: 10284
Repair Type: No Action Needed
Crossing Status: Found
UCIP Comments: No slide gate found. slide gates and pipes were abandon by farmer, how unknown
FIELD_STRUCT_DESC: 2 of 2: 42-inch corrugated metal gravity drainage pipe through the levee, 23.6 feet below the crown. Slide gate on the waterside (WS) slope. Concrete distribution box at the landside (LS) toe. (42-inch pipe [HLM 2.63] authorized under Automatic Board Order (ABO) issued as Permit No. 10284, 1974 - La Borde and Hoover). [Additional Reference(s): DWR Levee Log, 2004. USACE Sacramento O&M Manual 127, June 1953, (Station 133+82)].
FS Date: 11/16/2018 2:19:35 PM

Landside view: concrete spill box

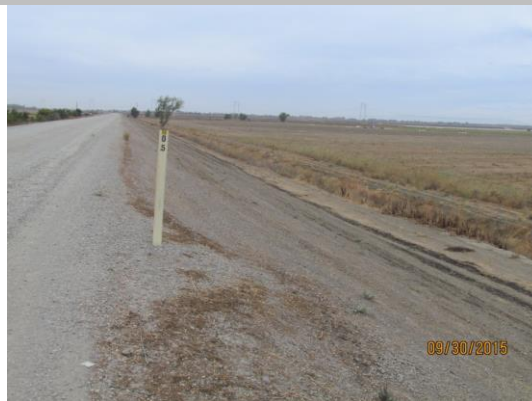
Photo 1 of 3 : FA_2019_ST0011_292_3_20190829_00001.jpg

View of the ditch at the landward side of the levee looking downstream. Fall 2015.

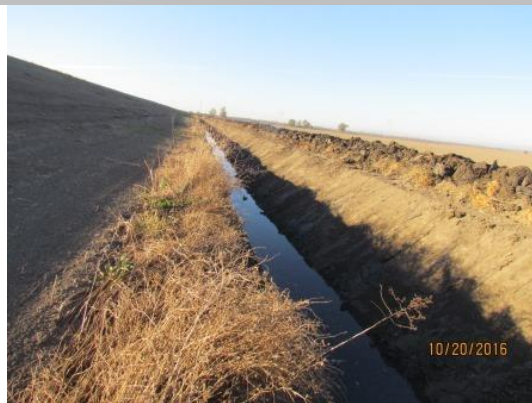
Photo 2 of 3 : FA_2019_ST0011_292_3_20190829_00002.jpg

View of the ditch on landward side. Ditch was deepened to approximately 10 ft. Fall 2016.

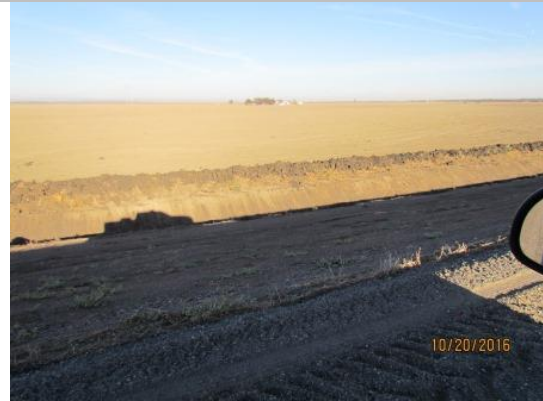
Photo 3 of 3 : FA_2019_ST0011_292_3_20190829_00003.jpg

View of the ditch on landward side. Fall 2016.

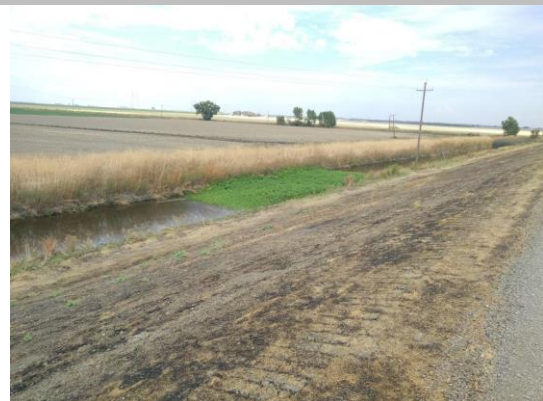
Photo 1 of 2 : FA_2019_ST0011_292_5_20190829_00004.jpg

LM Start	1.01	Rating **	M	Issue No.	5
LM End	1.44	Issue Type +	En	Location *	LS
Category	Earthen Levee			GPS Latitude/Longitude	
				Start	End
Item	Encroachments			38.705475 °	38.699637 °
				-121.671135 °	-121.674112 °
DWR ID	DWR_ST0011_02_s_2012_5				
Comment Code					
DT : Ditch					
Inspector Comment					
The ditch is at the toe of the levee.

View of ditch at landside toe, looking upstream. Fall 2017.

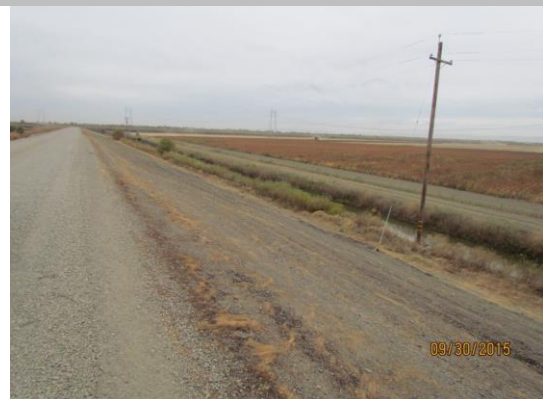
Photo 2 of 2 : FA_2019_ST0011_292_5_20190829_00005.jpg

LM Start	1.01	Rating **	M	Issue No.	5 (cont)
LM End	1.44	Issue Type +	En	Location *	LS

View of the ditch on the landward side of the levee looking downstream.
Fall 2015.

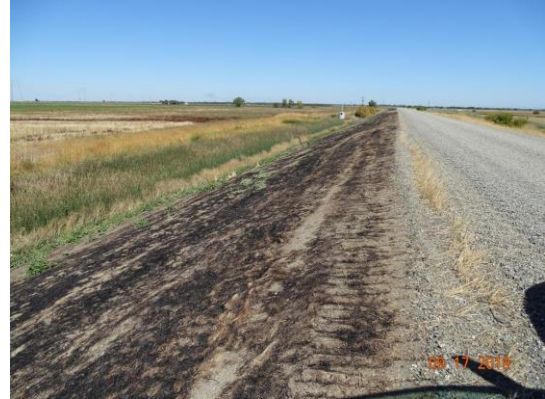
Photo 1 of 1 : FA_2019_ST0011_292_1_20190919_00006.jpg

View of the maintained landside slope. Fall 2019.

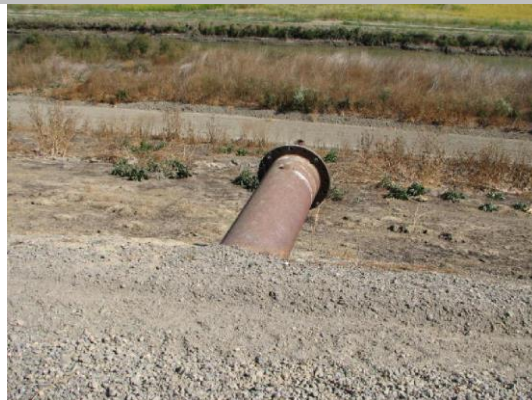
Photo 1 of 3 : UCIP_FA_2019_53252_60378.jpg

LM Start	0.03	Rating **	M	Issue No.	4	
LM End	0.03	Issue Type +	En	Location *		
Category	Supplemental			GPS Latitude/Longitude		
				Start		End
Item	DRAFT DWR UCIP Field Study			38.698204 °		38.698204 °
				-121.674080 °		-121.674080 °
DWR ID	17756					
Comment Code						
Inspector Comment						
DS_ID:17756 FS_ID:53252 EP_NO: N/A Repair Type: Non-Urgent Crossing Status: Found UCIP Comments: Pipe not properly abandoned. FIELD_STRUCT_DESC: *ABANDONED* 18-inch steel irrigation or drainage pipe through the levee, 3 feet below the crown. FS Date: 11/21/2018 8:24:23 AM

Waterside view: an abandoned steel pipe.

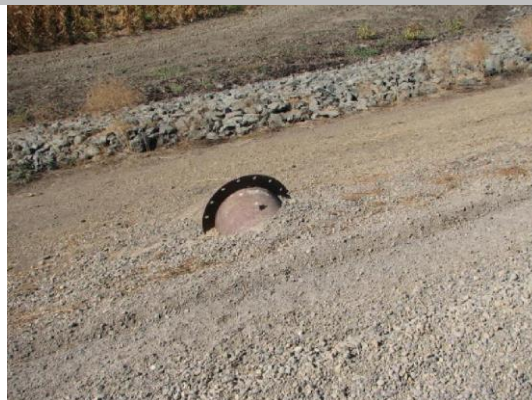
Photo 2 of 3 : UCIP_FA_2019_53252_60377.jpg

LM Start	0.03	Rating **	M	Issue No.	4 (cont)
LM End	0.03	Issue Type +	En	Location *

Landside view: an abandoned steel pipe.

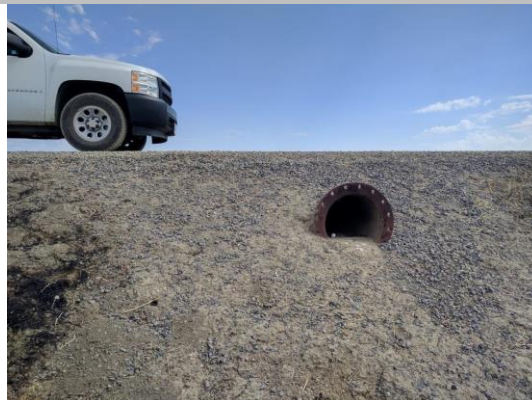
Photo 3 of 3 : UCIP_FA_2019_53252_77496.jpg

LM Start	0.03	Rating **	M	Issue No.	4 (cont)	
LM End	0.03	Issue Type +	En	Location *		
Category	Supplemental			GPS Latitude/Longitude		
				Start		End
Item	DRAFT DWR UCIP Field Study			38.698204 °		38.698204 °
				-121.674080 °		-121.674080 °
DWR ID	17756					
Comment Code						
Inspector Comment						
DS_ID:17756						
FS_ID:53252						
EP_NO: N/A						
Repair Type: Non-Urgent						
Crossing Status: Found						
UCIP Comments: Pipe not properly abandoned.						
FIELD_STRUCT_DESC: *ABANDONED* 18-inch steel irrigation or drainage pipe through the levee, 3 feet below the crown.						
FS Date: 11/21/2018 8:24:23 AM

LS: straight through pipe without any gates preventing water from WS to LS.

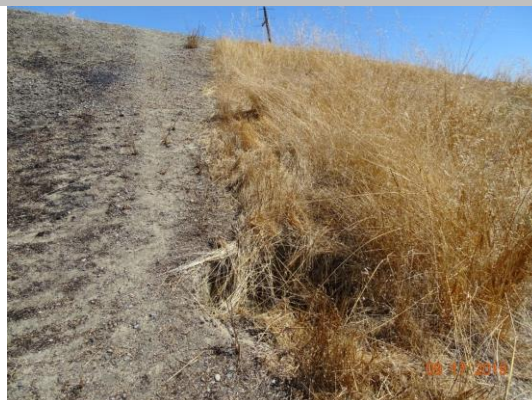
Photo 1 of 1 : FA_2019_ST0011_293_3_20190919_00007.jpg

LM Start	1.44	Rating **	M	Issue No.	3
LM End	1.44	Issue Type +	Ma	Location *	LS
Category	Earthen Levee			GPS Latitude/Longitude	
				Start	End
Item	Slope Stability			38.677792 °	38.677792 °
				-121.673098 °	-121.673098 °
DWR ID	DWR_ST0011_03_f_2019_3				
Comment Code					
S1 : Repair slope instability.					
Inspector Comment					
There is a sinkhole on the landside slope.

View of the sinkhole on the landside slope. Fall 2019.

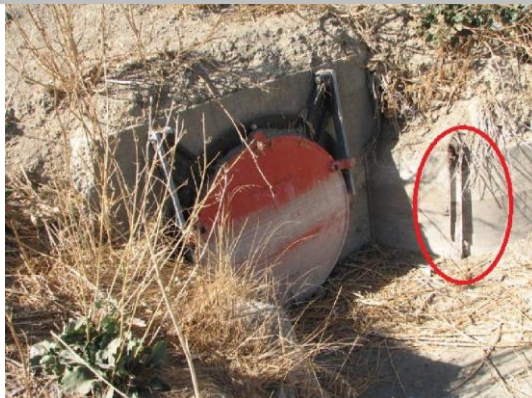
Photo 1 of 3 : UCIP_FA_2019_53860_60391.jpg

DS_ID:17754
FS_ID:53860
EP_NO: 10295
Repair Type: Urgent
Crossing Status: Found
UCIP Comments: 04/09/2019 Internal inspection was completed and the inspection shows separation of pipe at 22 degree turn. Sink hole visible on LS slope. Coordinating with DMP - Vince Rodriguez. Recommend repair or replace. (T. Skidgel - DWR Sacramento Yard) Found 48-inch CMP (not concrete culvert) and slide gate not found on LS end.
FIELD_STRUCT_DESC: 48-inch corrugated metal pipe (CMP) sewer culvert through the levee, 18 feet below the crown. Slide gate on the landside (LS) end. (48-inch concrete culvert authorized under Automatic Board Order (ABO) issued as Permit No. 10295, 1974 - City of Woodland). [Additional Reference(s): DWR Levee Log, 2004].
FS Date: 4/9/2019 8:58:01 AM

Waterside view: flap gate and concrete headwall. Abandoned slide gate on right.

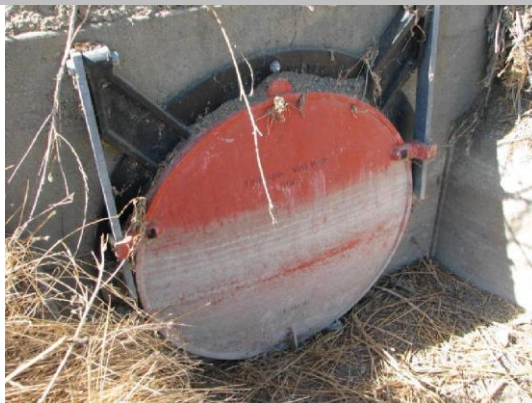
Photo 2 of 3 : UCIP_FA_2019_53860_60390.jpg

Waterside view: flap gate and concrete headwall.

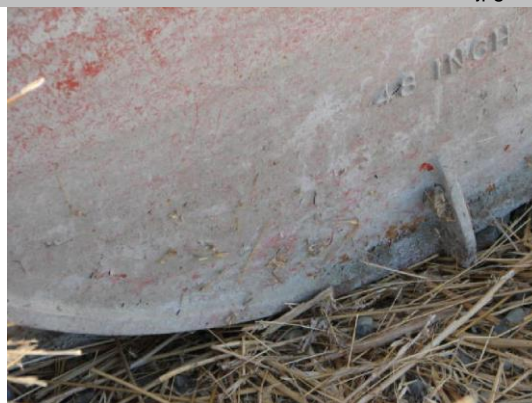
Photo 3 of 3 : UCIP_FA_2019_53860_60389.jpg

Comment Code						
Inspector Comment						
DS_ID:17754 FS_ID:53860 EP_NO: 10295 Repair Type: Urgent Crossing Status: Found UCIP Comments: 04/09/2019 Internal inspection was completed and the inspection shows separation of pipe at 22 degree turn. Sink hole visible on LS slope. Coordinating with DMP - Vince Rodriguez. Recommend repair or replace. (T. Skidgel - DWR Sacramento Yard)Found 48-inch CMP (not concrete culvert) and slide gate not found on LS end. FIELD_STRUCT_DESC: 48-inch corrugated metal pipe (CMP) sewer culvert through the levee, 18 feet below the crown. Slide gate on the landside (LS) end. (48-inch concrete culvert authorized under Automatic Board Order (ABO) issued as Permit No. 10295, 1974 - City of Woodland). [Additional Reference(s): DWR Levee Log, 2004]. FS Date: 4/9/2019 8:58:01 AM

Waterside view: 48-inch flap gate.

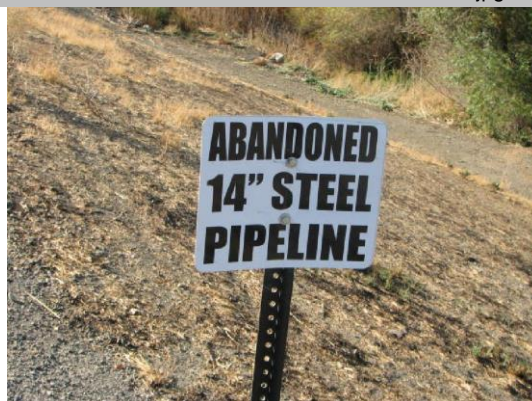
Photo 1 of 1 : UCIP_FA_2019_55937_50974.jpg

LM Start	0.53	Rating **	M	Issue No.	16	
LM End	0.53	Issue Type +	En	Location *		
Category	Supplemental			GPS Latitude/Longitude		
				Start	End	
Item	DRAFT DWR UCIP Field Study			38.566630 °	38.566630 °	
				-121.638870 °	-121.638870 °	
DWR ID	19991					
Comment Code						
Inspector Comment						
DS_ID:19991						
FS_ID:55937						
EP_NO: N/A						
Repair Type: Non-Urgent						
Crossing Status: Not Found						
UCIP Comments: 11/07/2019 Unable to locate a sign found during prior inspection on LS shoulder that mentions abandoned pipe. Updated to Not Found. (O.Yakimov - DWR UCIP)						
FIELD_STRUCT_DESC: *ABANDONED* 14-inch steel natural gas pipeline through the levee, at an unknown depth. Sign on the landside (LS) shoulder.						
FS Date: 11/7/2019 3:13:36 PM

Landside view: a sign mentioning about the pipe.

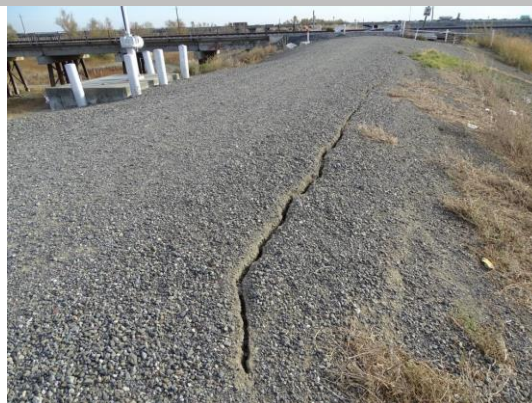
Photo 1 of 2 : FA_2019_ST0011_294_15_20191126_00016.jpg

LM Start	0.54	Rating **	M	Issue No.	15
LM End	0.54	Issue Type +	Ma	Location *	LS
Category	Earthen Levee			GPS Latitude/Longitude	
				Start	End
Item	Cracking			38.566529 °	38.566529 °
				-121.638869 °	-121.638869 °
DWR ID	DWR_ST0011_04_f_2019_15				
Comment Code					
CR1 : Monitor and have inspected by geotechnical engineer.					
Inspector Comment					
Appears to be a 50-foot crack on the landside shoulder with minor settlement.

View of the crack on the landside shoulder, facing downstream. Fall 2019.

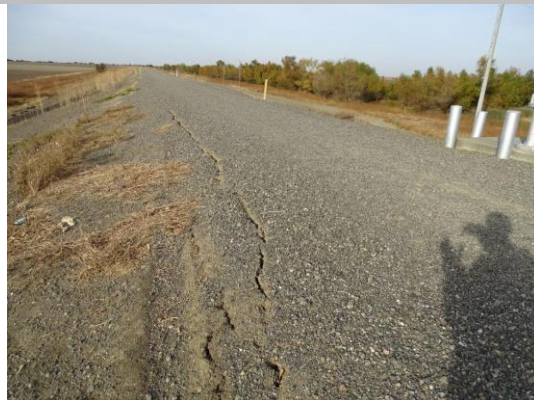
Photo 2 of 2 : FA_2019_ST0011_294_15_20191126_00017.jpg

LM Start	0.54	Rating **	M	Issue No.	15 (cont)	
LM End	0.54	Issue Type +	Ma	Location *	LS	
Category	Earthen Levee			GPS Latitude/Longitude		
				Start	End	
Item	Cracking			38.566529 °	38.566529 °	
				-121.638869 °	-121.638869 °	
DWR ID	DWR_ST0011_04_f_2019_15					
Comment Code						
CR1 : Monitor and have inspected by geotechnical engineer.						
Inspector Comment						
Appears to be a 50-foot crack on the landside shoulder with minor settlement.

View of the crack on the landside shoulder, facing upstream. Fall 2019.

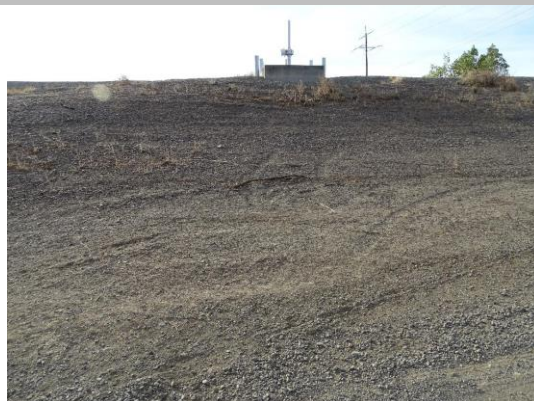
Photo 1 of 3 : UCIP_FA_2019_55938_83281.jpg

Comment Code					
Inspector Comment					
DS_ID:569 FS_ID:55938 EP_NO: 16096 Repair Type: Urgent Crossing Status: Found UCIP Comments: 11/07/2019 Flap gate at WS headwall not closing completely. A wooden stick on the top prevents flap gate closing leaving space for backflow. Provide maintenance on flap gate. About 20-foot long surface cracking observed on levee crown closer to LS shoulder. Not sure if cracking is related to this crossing. (O.Yakimov - DWR UCIP)04/28/2015 The culvert was constructed in 1993. FIELD_STRUCT_DESC: 60-inch by 60-inch reinforced concrete box gravity drainage culvert through the right bank (west) levee of the Yolo Bypass, 20 feet below the crown. 60-inch by 60-inch culvert replaced an existing 30-inch gravity drain pipeline. (60-inch by 60-inch culvert authorized under Permit No. 16096, 1993 - Yolo County Flood Control and Water Conservation District). FS Date: 11/7/2019 3:23:43 PM

View of WS slope looking towards levee

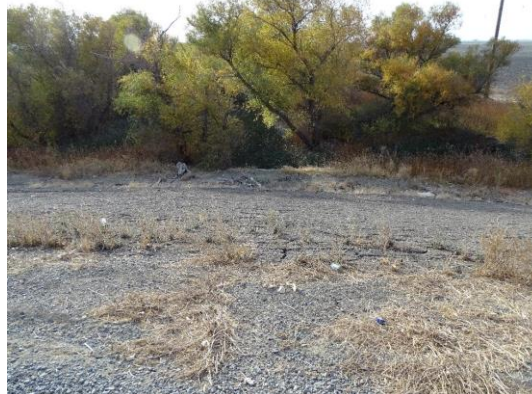
Photo 2 of 3 : UCIP_FA_2019_55938_83282.jpg

Comment Code					
Inspector Comment					
DS_ID:569 FS_ID:55938 EP_NO: 16096 Repair Type: Urgent Crossing Status: Found UCIP Comments: 11/07/2019 Flap gate at WS headwall not closing completely. A wooden stick on the top prevents flap gate closing leaving space for backflow. Provide maintenance on flap gate. About 20-foot long surface cracking observed on levee crown closer to LS shoulder. Not sure if cracking is related to this crossing. (O.Yakimov - DWR UCIP)04/28/2015 The culvert was constructed in 1993. FIELD_STRUCT_DESC: 60-inch by 60-inch reinforced concrete box gravity drainage culvert through the right bank (west) levee of the Yolo Bypass, 20 feet below the crown. 60-inch by 60-inch culvert replaced an existing 30-inch gravity drain pipeline. (60-inch by 60-inch culvert authorized under Permit No. 16096, 1993 - Yolo County Flood Control and Water Conservation District). FS Date: 11/7/2019 3:23:43 PM

View of LS looking from levee crown

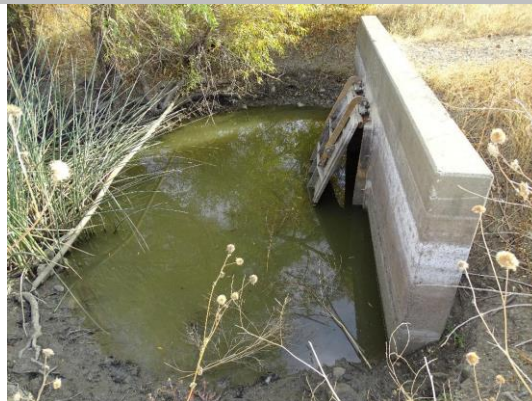
Photo 3 of 3 : UCIP_FA_2019_55938_83283.jpg

Malfunctioning flap gate at WS levee toe

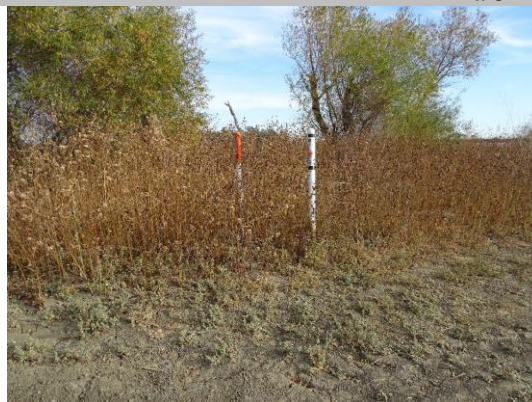
Photo 1 of 3 : UCIP_FA_2019_55940_83288.jpg

LM Start	0.57	Rating **	M	Issue No.	19	
LM End	0.57	Issue Type +	En	Location *		
Category	Supplemental			GPS Latitude/Longitude		
				Start	End	
Item	DRAFT DWR UCIP Field Study			38.566086 °	38.566086 °	
				-121.638828 °	-121.638828 °	
DWR ID	19987					
Comment Code						
Inspector Comment						
DS_ID:19987						
FS_ID:55940						
EP_NO: N/A						
Repair Type: Non-Urgent						
Crossing Status: Indicator Found						
UCIP Comments: 11/07/2019 Permit is not available for this crossing.						
(O.Yakimov - DWR UCIP)04/28/2015 Cable marker/flags found on both sides of the levee.						
FIELD_STRUCT_DESC: Communications conduit of an unknown size or material through the levee, at an unknown depth. (Sure West Communications).						
FS Date: 11/7/2019 7:44:39 AM

Line marker in the field on WS

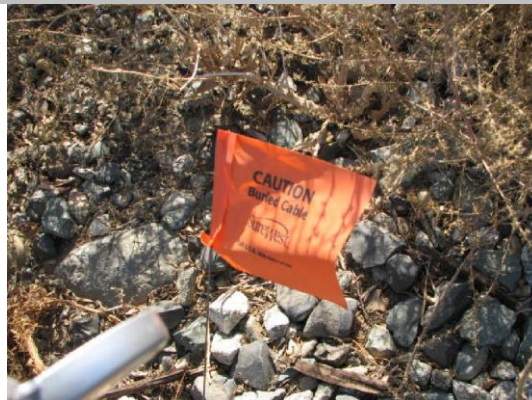
Photo 2 of 3 : UCIP_FA_2019_55940_50982.jpg

LM Start	0.57	Rating **	M	Issue No.	19 (cont)	
LM End	0.57	Issue Type +	En	Location *		
Category	Supplemental			GPS Latitude/Longitude		
				Start	End	
Item	DRAFT DWR UCIP Field Study			38.566086 °	38.566086 °	
				-121.638828 °	-121.638828 °	
DWR ID	19987					
Comment Code						
Inspector Comment						
DS_ID:19987						
FS_ID:55940						
EP_NO: N/A						
Repair Type: Non-Urgent						
Crossing Status: Indicator Found						
UCIP Comments: 11/07/2019 Permit is not available for this crossing.						
(O.Yakimov - DWR UCIP)04/28/2015 Cable marker/flags found on						
both sides of the levee.						
FIELD_STRUCT_DESC: Communications conduit of an unknown size						
or material through the levee, at an unknown depth. (Sure West						
Communications).						
FS Date: 11/7/2019 7:44:39 AM

Waterside view: mini flag/marker

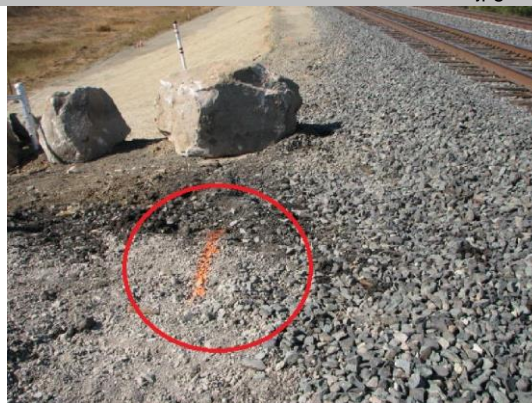
Photo 3 of 3 : UCIP_FA_2019_55940_50983.jpg

Landside view: ground marking

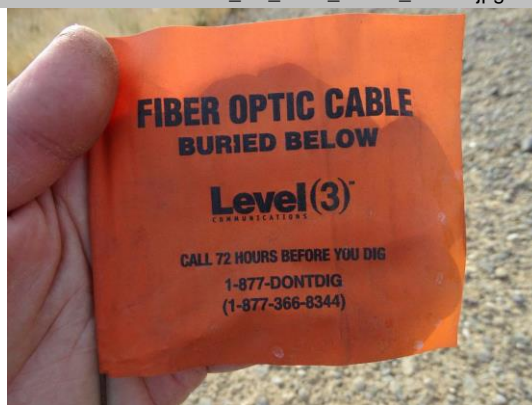
Photo 1 of 3 : UCIP_FA_2019_55944_83292.jpg

Closeup view of a marker flag

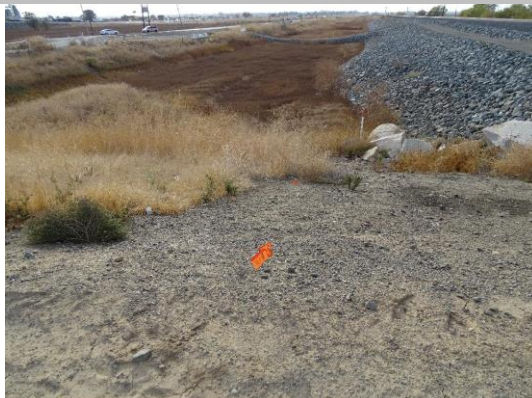
Photo 2 of 3 : UCIP_FA_2019_55944_83293.jpg

Landside view: marker flags on levee road shoulder

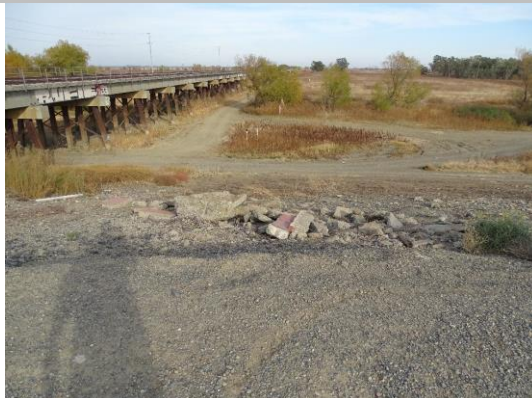
Photo 3 of 3 : UCIP_FA_2019_55944_83294.jpg

Waterside view: marker not found

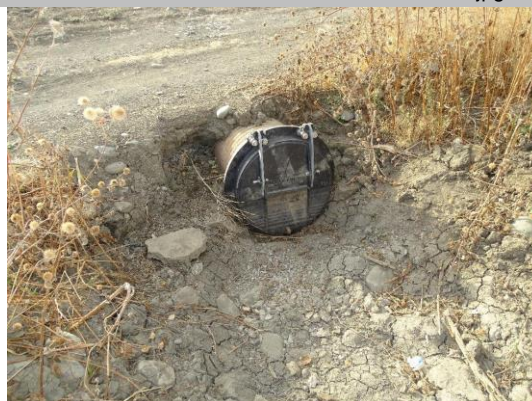
Photo 3 of 3 : UCIP_FA_2019_55949_83299.jpg

Pipe and flap gate at WS levee toe

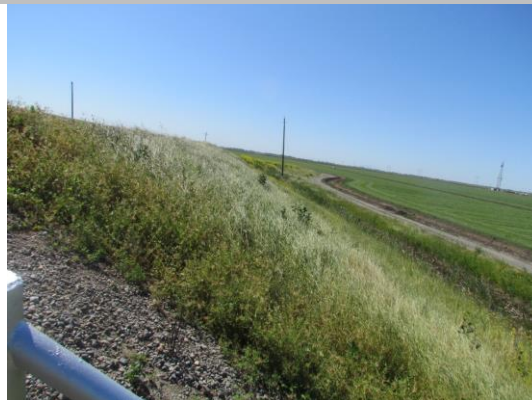
Photo 1 of 1 : FA_2019_ST0011_294_6_20190829_00007.jpg

View of the ditch on the landward side of the levee looking downstream. Spring 2015.

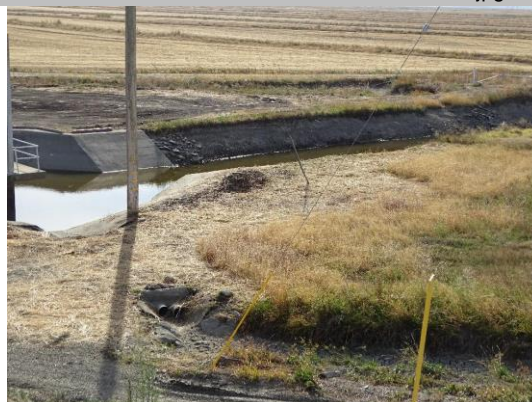
Photo 2 of 3 : UCIP_FA_2019_55957_83315.jpg

View of LS looking from levee crown. A yellow marker on LS shoulder

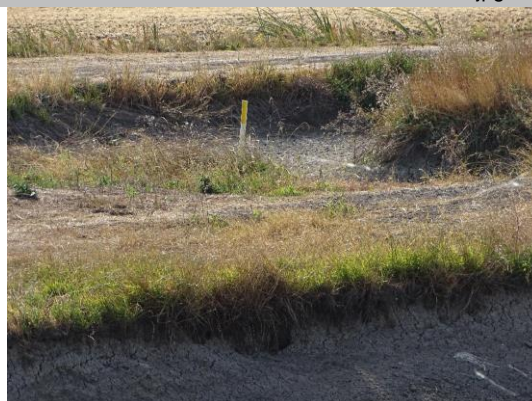
Photo 3 of 3 : UCIP_FA_2019_55957_83316.jpg

Yellow marker in the field on LS on the other side of irrigation canal

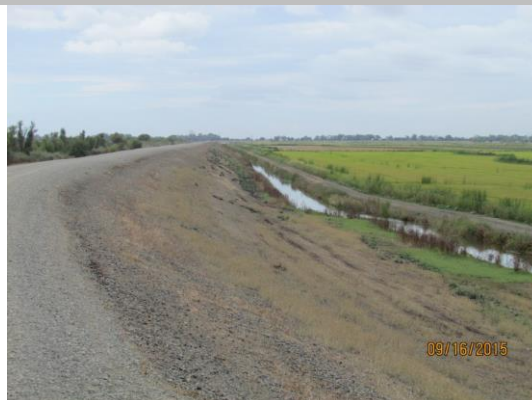
Photo 1 of 1 : FA_2019_ST0011_294_3_20190829_00004.jpg

View of the ditch along the levee toe on the landward side of the levee looking downstream. Fall 2015.

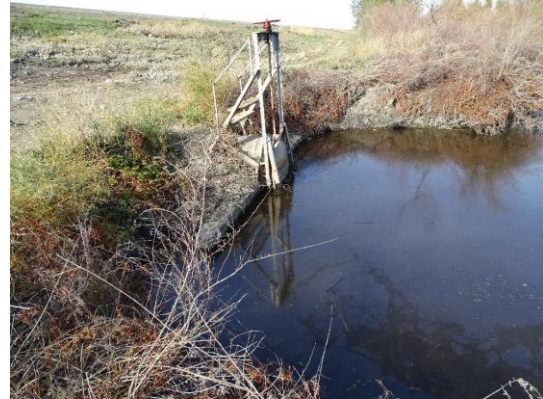
Photo 3 of 3 : UCIP_FA_2019_56030_83251.jpg

Slide gate and pipe outlet on waterside

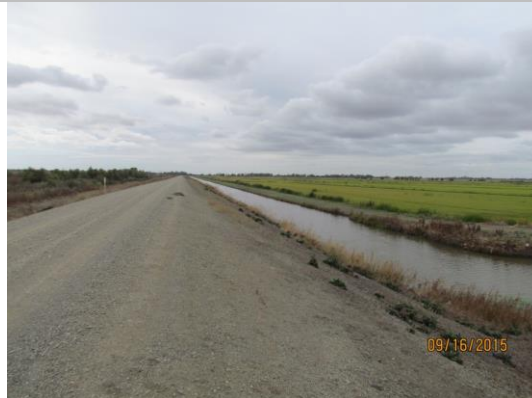
Photo 1 of 2 : FA_2019_ST0011_294_4_20190829_00005.jpg

The ditch is at the levee toe on the landward side of the levee looking downstream. Fall 2015.

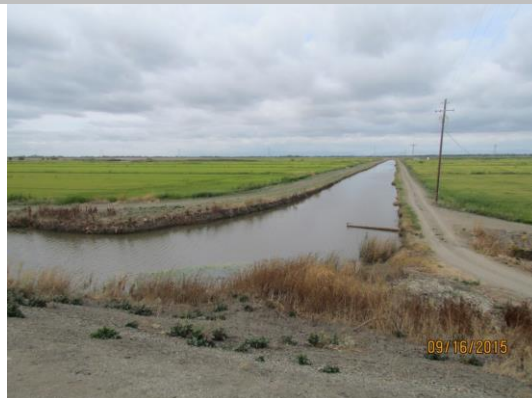
Photo 2 of 2 : FA_2019_ST0011_294_4_20190829_00006.jpg

Looking west at the agricultural ditch. Fall 2015.

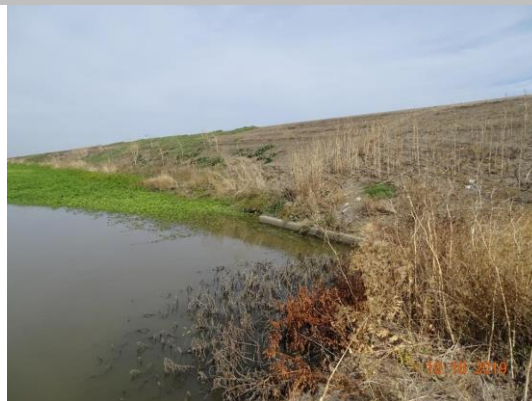
Photo 1 of 2 : FA_2019_ST0011_294_13_20191108_00015.jpg

View of erosion on the landside slope. Fall 2019.

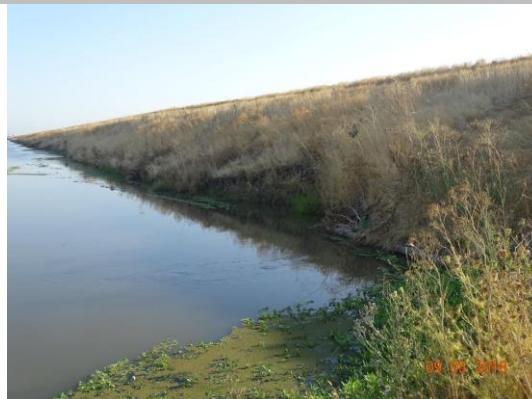
Photo 2 of 2 : FA_2019_ST0011_294_13_20190829_00008.jpg

View of erosion on the landside slope adjacent to irrigation canal. Fall 2018.

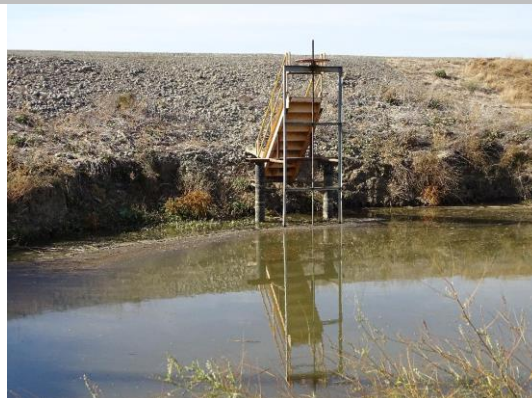
Photo 3 of 3 : UCIP_FA_2019_55963_83336.jpg

Slide gate under water at WS levee toe
