Flood Control Project Maintenance Levee Inspections

Fall 2020 Levee Maintenance Deficiency Summary Report

Sacramento River Basin

Sacramento Maintenance Yard West Levee Yolo Bypass

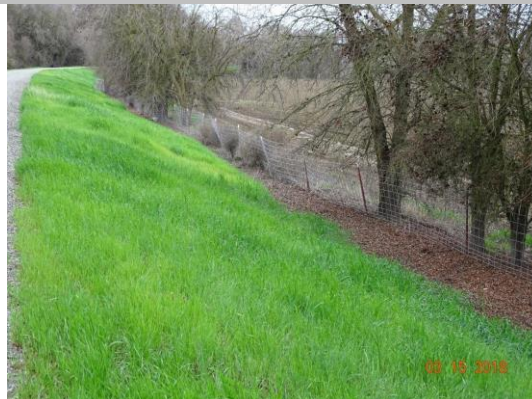
Photo 1 of 3 : FA_2020_ST0011_291_10_20200813_00005.jpg

View of fence at landside toe. Spring 2018.

LM Start	0.12	Rating **	M	Issue No.	10 (cont)
LM End	1.55	Issue Type +	En	Location *	LS

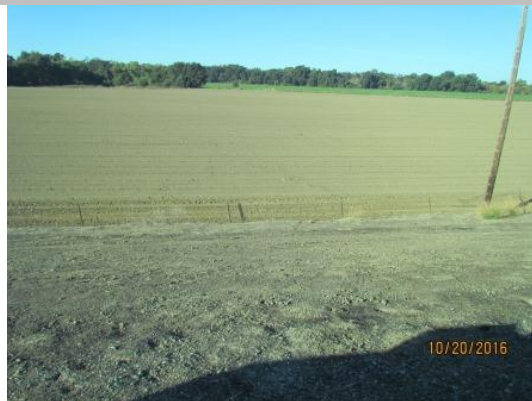
Photo 2 of 3 : FA_2020_ST0011_291_10_20200813_00006.jpg

View of fence located within 10-foot easement of landside toe. Fall 2016.

LM Start	0.12	Rating **	M	Issue No.	10 (cont)
LM End	1.55	Issue Type +	En	Location *	LS

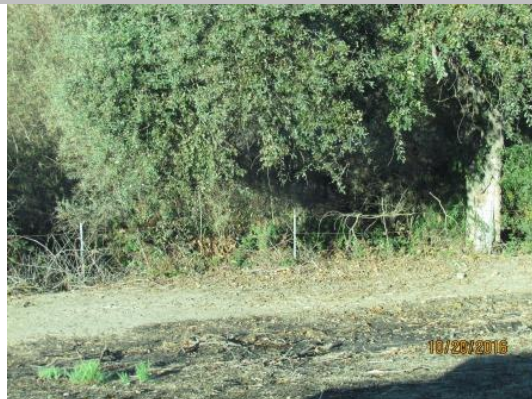
Photo 3 of 3 : FA_2020_ST0011_291_10_20200813_00007.jpg

Another view of fence located within 10-foot easement of landside toe. Fall 2016.

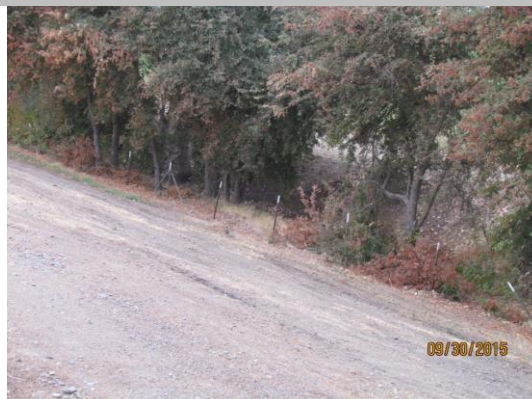
Photo 1 of 1 : FA_2020_ST0011_291_8_20200813_00002.jpg

View of the ditch on the landward side of the levee. Fall 2015.

LM Start	1.70	Rating **	M	Issue No.	9
LM End	1.79	Issue Type +	En	Location *	LS
Category	Earthen Levee			GPS Latitude/Longitude	
				Start	End
Item	Encroachments			38.736842 °	38.735498 °
				-121.660285 °	-121.660287 °
DWR ID	DWR_ST0011_01_f_2016_9				
Comment Code					
FE : Fence					
Inspector Comment

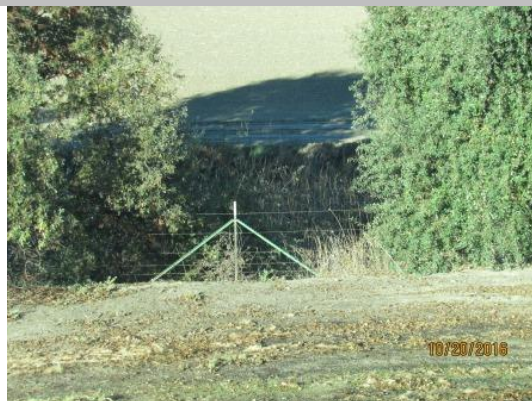
Photo 1 of 2 : FA_2020_ST0011_291_9_20200813_00003.jpg

View of fence along the ditch on landside. Fall 2016.

LM Start	1.70	Rating **	M	Issue No.	9 (cont)
LM End	1.79	Issue Type +	En	Location *	LS

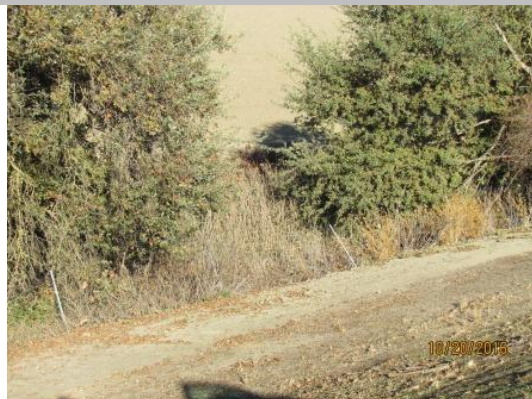
Photo 2 of 2 : FA_2020_ST0011_291_9_20200813_00004.jpg

Another view of fence along the ditch on landside. Fall 2016.

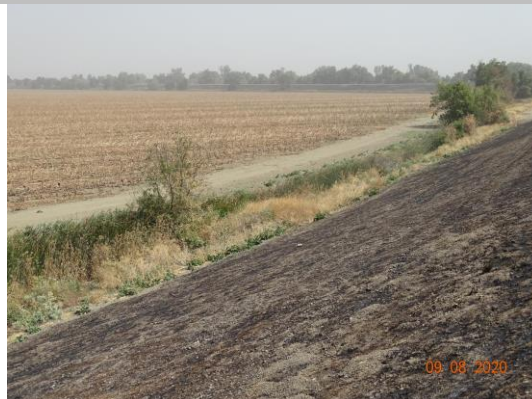
Photo 1 of 1 : FA_2020_ST0011_291_4_20200909_00014.jpg

View of the ditch at the toe of the levee on the landward side. Fall 2020.

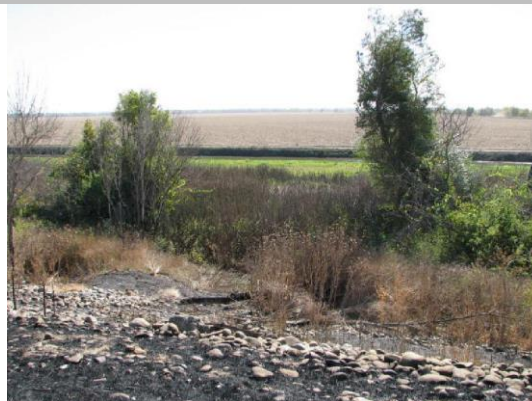
Photo 1 of 3 : UCIP_FA_2020_60644_60304.jpg

Comment Code						
Inspector Comment						
DS_ID:17742 FS_ID:60644 EP_NO: 10284 Repair Type: No Action Needed EVAL Issue: Crossing Status: Found UCIP Comments: 11/16/2018 Pipe is Grouted. (T. Skidgel - DWR Sacramento Yard)04/10/2014 Screw gates where removed and pipe was abanded by farmer, How pipe was abanded is unknown. (T. Skidgel - DWR Sacramento Yard)10/17/2012 Slide gate not found. (P. Amatya - DWR UCIP) FIELD_STRUCT_DESC: 1 of 2: 42-inch corrugated metal gravity drainage pipe through the levee, 23.6 feet below the crown. Slide gate on the waterside (WS) slope. Concrete distribution box at the landside (LS) toe. (42-inch pipe [HLM 2.63] authorized under Automatic Board Order (ABO) issued as Permit No. 10284, 1974 - La Borde and Hoover). [Additional Reference(s): DWR Levee Log, 2004 (HLM 2.63, listed as two 42-inch pipes). USACE Sacramento O&M Manual, Unit 127, June 1953, Revised 16 November 2018, (Station 133+82), listed as two 42-inch CMP]. FS Date: 11/16/2018 2:17:00 PM

Waterside view: overview (pipe not found)

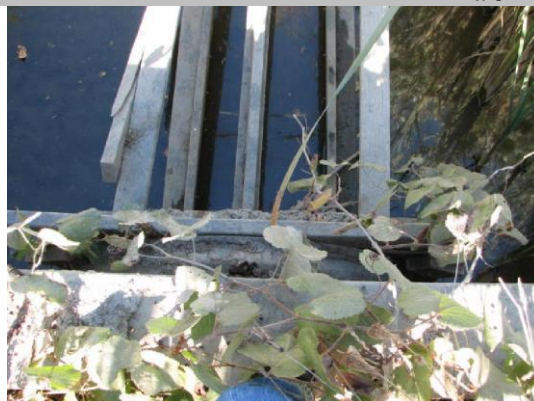
Photo 2 of 3 : UCIP_FA_2020_60644_60303.jpg

Landside view: concrete spillbox/headwall and pipe (top view)

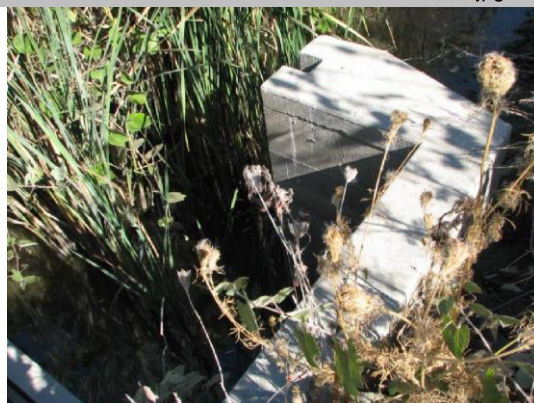
Photo 3 of 3 : UCIP_FA_2020_60644_60302.jpg

Landside view: side of concrete spillbox/headwall

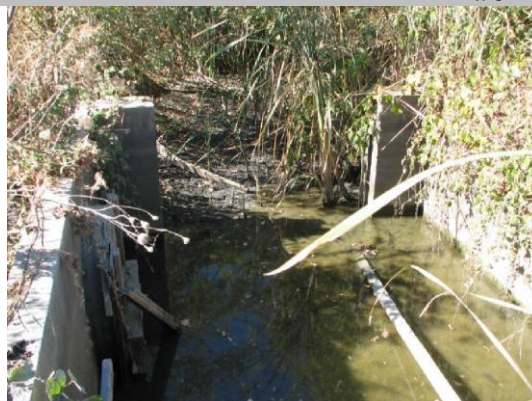
Photo 3 of 3 : UCIP_FA_2020_60648_60307.jpg

DS_ID:17747
FS_ID:60648
EP_NO: 10284
Repair Type: No Action Needed
EVAL Issue:
Crossing Status: Found
UCIP Comments: 10/14/2014 Screw gate removed and pipe abandon by farmer, How pipe was abandoned is unknown. (T. Skidgel - DWR Sacramento Yard)10/17/2012 No slide gate found. (P. Amatya - DWR UCIP)
FIELD_STRUCT_DESC: 2 of 2: 42-inch corrugated metal gravity drainage pipe through the levee, 23.6 feet below the crown. Slide gate on the waterside (WS) slope. Concrete distribution box at the landside (LS) toe. (42-inch pipe [HLM 2.63] authorized under Automatic Board Order (ABO) issued as Permit No. 10284, 1974 - La Borde and Hoover). [Additional Reference(s): DWR Levee Log, 2004 (HLM 2.63, listed as two 42-inch pipes). USACE Sacramento O&M Manual, Unit 127, June 1953, Revised 16 November 2018, (Station 133+82), listed as two 42-inch CMPs].
FS Date: 11/16/2018 2:19:00 PM

Landside view: CM pipe with flap gate

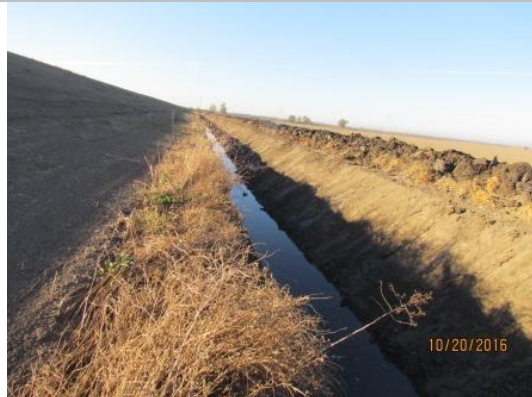
Photo 1 of 2 : FA_2020_ST0011_292_3_20200813_00002.jpg

View of the ditch on landward side. Ditch was deepened to approximately 10 ft. Fall 2016.

LM Start	0.47	Rating **	M	Issue No.	3 (cont)
LM End	0.97	Issue Type +	En	Location *	LS

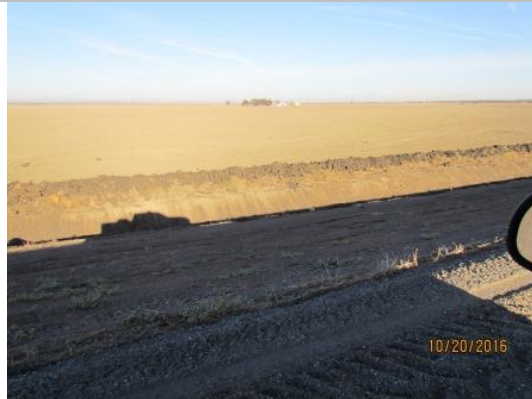
Photo 2 of 2 : FA_2020_ST0011_292_3_20200813_00003.jpg

View of the ditch on landward side. Fall 2016.

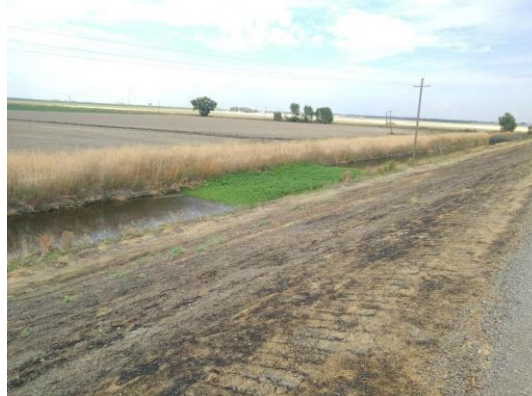
Photo 1 of 2 : FA_2020_ST0011_292_5_20200813_00004.jpg

LM Start	1.01	Rating **	M	Issue No.	5
LM End	1.44	Issue Type +	En	Location *	LS
Category	Earthen Levee			GPS Latitude/Longitude	
				Start	End
Item	Encroachments			38.705475 °	38.699637 °
				-121.671135 °	-121.674112 °
DWR ID	DWR_ST0011_02_s_2012_5				
Comment Code					
DT : Ditch					
Inspector Comment					
The ditch is at the toe of the levee.

View of ditch at landside toe, looking upstream. Fall 2017.

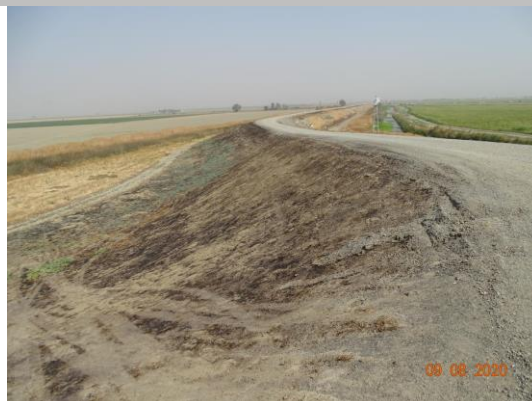
Photo 1 of 1 : FA_2020_ST0011_292_1_20200909_00006.jpg

LM Start	1.51	Rating **	A	Issue No.	1
LM End	1.51	Issue Type +	Ma	Location *	LS
Category	Earthen Levee			GPS Latitude/Longitude	
				Start	End
Item	Vegetation			38.698646 °	38.698646 °
				-121.674245 °	-121.674245 °
DWR ID	DWR_ST0011_02_f_2020_1				
Comment Code					
V1 : Control annual grass and weeds on the levee slopes and easements.					
Inspector Comment					
The LMA maintains the vegetation at a high level.

View of the maintained landside slope. Fall 2020.

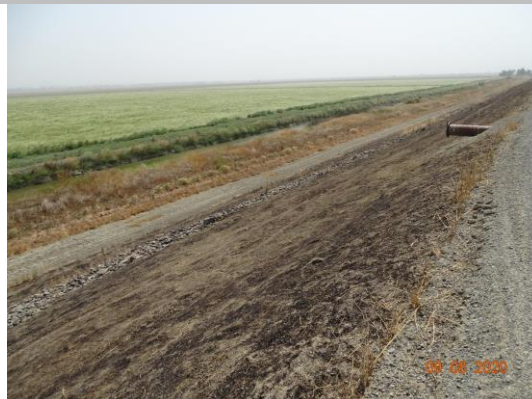
Photo 1 of 1 : FA_2020_ST0011_293_3_20200909_00007.jpg

View of the maintained waterside slope. Fall 2020.

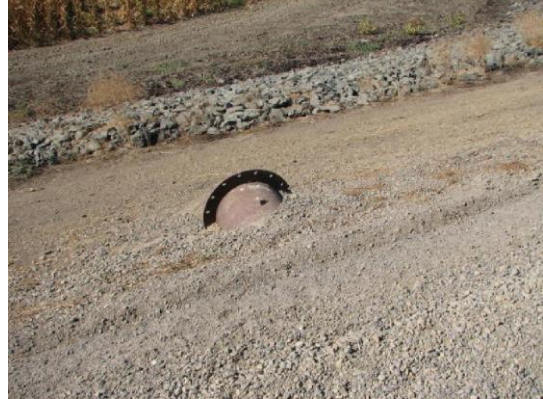
Photo 2 of 3 : UCIP_FA_2020_60672_60377.jpg

Landside view: an abandoned steel pipe.

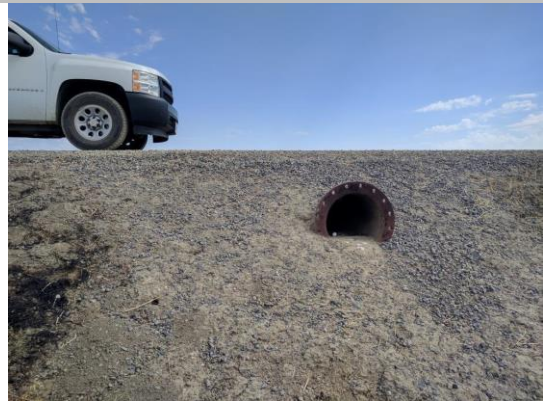
Photo 3 of 3 : UCIP_FA_2020_60672_77496.jpg

LS: straight through pipe without any gates preventing water from WS to LS.

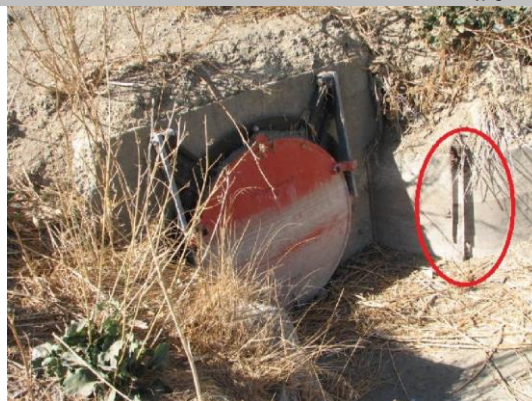
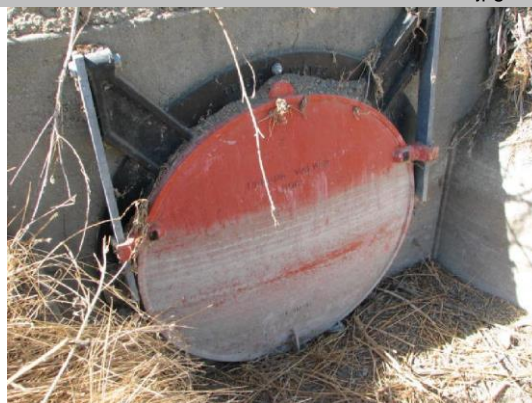
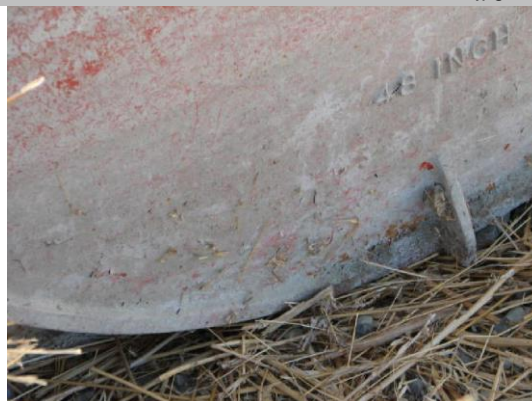
DS_ID:17754
FS_ID:60671
EP_NO: 10295
Repair Type: Urgent
EVAL Issue: Pipe Integrity
Crossing Status: Found
UCIP Comments: 08/20/2020 Need to obtain a copy of USACE Drawing As-Built listed under additional references. Drawing information was listed by previous inspector. (O. Magana - DWR UCIP)

04/09/2019 Internal inspection was completed and the inspection shows separation of pipe at 22 degree turn. Sink hole visible on LS slope. Coordinating with DMP - Vince Rodriguez. Recommend repair or replace. (T. Skidgel - DWR Sacramento Yard)10/17/2012 Found 48-inch CMP (not concrete culvert) and slide gate not found on LS end. (P. Amatya - DWR UCIP)
FIELD_STRUCT_DESC: 48-inch corrugated metal pipe (CMP) sewer culvert through the levee, 18 feet below the crown. Slide gate on the landside (LS) end. (48-inch concrete culvert authorized under Automatic Board Order (ABO) issued as Permit No. 10295, 1974 - City of Woodland). [Additional Reference(s): DWR Levee Log, 2004 (HLM 1.45, listed as 48-inch concrete culvert). USACE Drawing referenced as E-3 at Station 0+91, As-Built Drawing: USACE, Sacramento Districts. Levee Repair- Cache Creek Settling Basin, Wahler Associates, May 1991]
FS Date: 4/9/2019 8:58:00 AM

Waterside view: flap gate and concrete headwall. Abandoned slide gate on right.

Waterside view: flap gate and concrete headwall.

Waterside view: 48-inch flap gate.

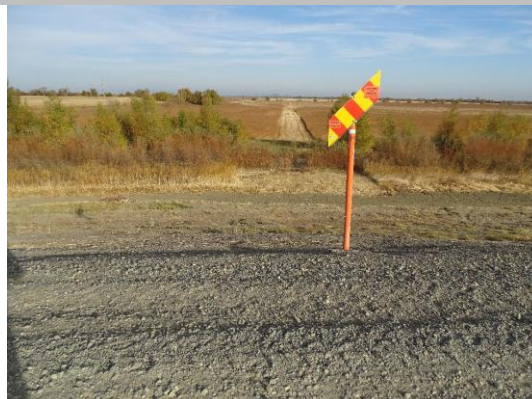
Photo 2 of 3 : UCIP_FA_2020_60245_83275.jpg

Comment Code						
Inspector Comment						
DS_ID:17695 FS_ID:60245 EP_NO: 16309 Repair Type: Non-Urgent EVAL Issue: Safety Issue Crossing Status: Indicator Found UCIP Comments: 11/07/2019 Record updated from No Action Needed to Non-Urgent. No inspection records were available to determine status of line through the levee. (O.Yakimov - DWR UCIP)09/20/2012 Indicators found on both sides of the levee. This crossing was found during field survey of ST 12 Unit 2. (P. Amatya - DWR UCIP) FIELD_STRUCT_DESC: 20-inch coated steel natural gas pipeline under both levees and within the Yolo Bypass, at an unknown depth. Indicators found on both sides of the levee. (20-inch pipeline authorized under Permit No. 16309, 1995 - Sacramento Municipal Utility District [SMUD] and Ford, Bacon, and Davis, Inc.). FS Date: 11/7/2019 1:10:00 PM

Waterside view: a gasline marker on WS slope of the levee

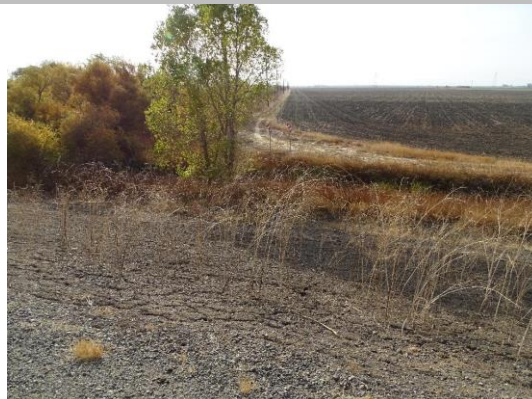
Photo 2 of 2 : UCIP_FA_2020_60246_83278.jpg

DS_ID:19990
FS_ID:60246
EP_NO: 10821
Repair Type: Non-Urgent
EVAL Issue: Safety Issue
Crossing Status: Indicator Found
UCIP Comments: 11/07/2019 Record updated from No Action Needed to Non-Urgent. No inspection records were available to determine status of line through the levee. (O. Yakimov - DWR UCIP)10/18/2012 Indicators found on both sides of the levee. (P. Amatya - DWR UCIP) FIELD_STRUCT_DESC: 12-inch steel natural gas line crossing under the right bank (west) levee of the Yolo Bypass, at an unknown depth. 5 miles northeasterly of the city of Davis. Indicators found on both sides of the levee. (16-inch gas line was authorized under Permit No. 10821, 1975 - Pacific Gas and Electric Company (PG&E) as a replacement of existing 8-inch gas line)
FS Date: 11/7/2019 3:07:00 PM

Landside view: gasline markers in LS field

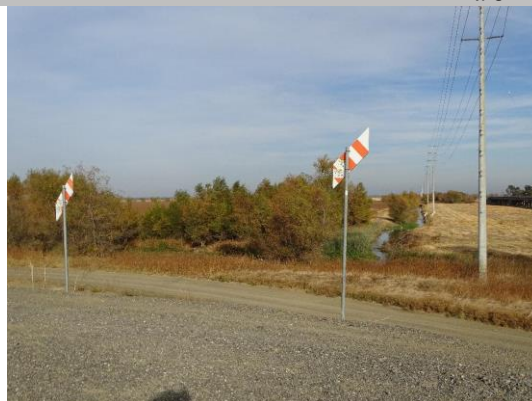
Photo 1 of 2 : UCIP_FA_2020_60277_83279.jpg

DS_ID:524
 FS_ID:60277
 EP_NO: 10821
 Repair Type: Non-Urgent
 EVAL Issue: Safety Issue
 Crossing Status: Indicator Found
 UCIP Comments: 11/07/2019 Record updated from No Action Needed to Non-Urgent. No inspection records were available to determine status of line through the levee. (O.Yakimov - DWR UCIP)10/18/2012
 Two gasline markers found on both sides of the levee. (P. Amatya - DWR Sacramento Yard)
 FIELD_STRUCT_DESC: 16-inch steel high-pressure natural gas line through the levee, 4.5 feet below the crown. It is a replacement of a portion of an existing 8-inch gas line with a 16-inch gas line and parallel to existing 12-inch steel gas line. Two gas line markers found on both sides of the levee. (Pipeline replacement authorized under Permit No. 10821, 1975 - Pacific Gas and Electric Company [PG&E]). [Additional Reference(s): DWR Levee Log, 2004 (HLM 0.55, listed as 16-inch pipe)].
 FS Date: 11/7/2019 3:09:00 PM

Waterside view: gasline marker on WS slope of the levee

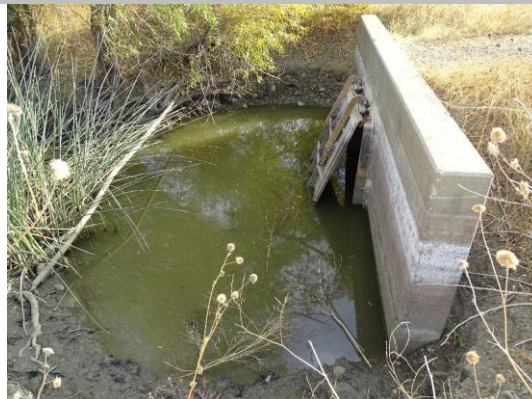
Photo 3 of 3 : UCIP_FA_2020_60250_83283.jpg

Comment Code					
Inspector Comment					
DS_ID:569 FS_ID:60250 EP_NO: 16096 Repair Type: Urgent EVAL Issue: Flood Risk Crossing Status: Found UCIP Comments: 11/07/2019 Flap gate at WS headwall not closing completely. A wooden stick on the top prevents flap gate closing leaving space for backflow. Provide maintenance on flap gate. About 20-foot long surface cracking observed on levee crown closer to LS shoulder. Not sure if cracking is related to this crossing (potential levee damage concern). (O.Yakimov - DWR UCIP)10/18/2012 The culvert was constructed in 1993. (P. Amatya - DWR UCIP) FIELD_STRUCT_DESC: 60-inch by 60-inch reinforced concrete box gravity drainage culvert through the right bank (west) levee of the Yolo Bypass, 20 feet below the crown. 60-inch by 60-inch culvert replaced an existing 30-inch gravity drain pipeline. (60-inch by 60-inch culvert authorized under Permit No. 16096, 1993 - Yolo County Flood Control and Water Conservation District, square culvert installed about 28 feet south of existing 30-inch pipe). FS Date: 11/7/2019 3:23:00 PM

Malfunctioning flap gate at WS levee toe

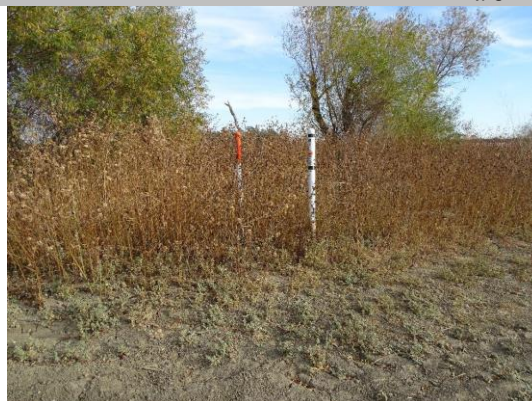
Photo 1 of 3 : UCIP_FA_2020_60252_83288.jpg

DS_ID:19987
 FS_ID:60252
 EP_NO: N/A
 Repair Type: Non-Urgent
 EVAL Issue: Unauthorized Encroachment
 Crossing Status: Indicator Found
 UCIP Comments: 11/07/2019 Record updated from No Action Needed to Non-Urgent. Permit is not available for this crossing. (O.Yakimov - DWR UCIP)
 10/18/2012 Cable marker/flags found on both sides of the levee. (P. Amatya - DWR UCIP)
 FIELD_STRUCT_DESC: Communications conduit of an unknown size or material through the levee, at an unknown depth. (Sure West Communications).
 FS Date: 11/7/2019 7:44:00 AM

Line marker in the field on WS

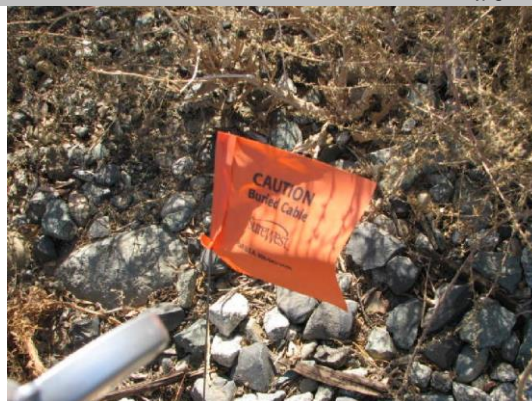
Photo 2 of 3 : UCIP_FA_2020_60252_50982.jpg

Waterside view: mini flag/marker

LM Start	0.57	Rating **	M	Issue No.	33 (cont)
LM End	0.57	Issue Type +	En	Location *

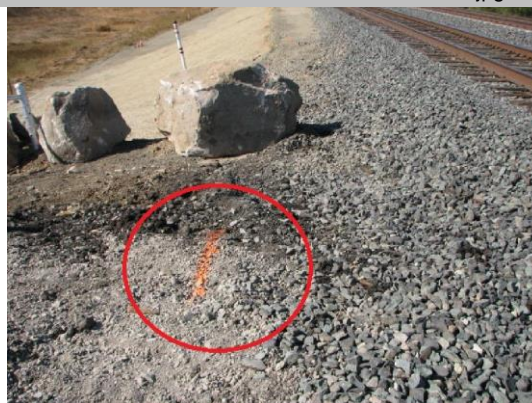
Photo 3 of 3 : UCIP_FA_2020_60252_50983.jpg

Landside view: ground marking

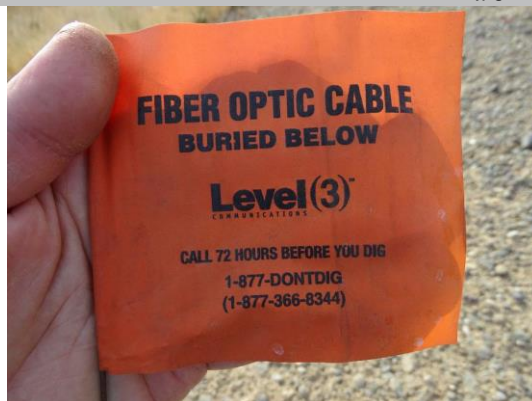
Photo 1 of 3 : UCIP_FA_2020_60278_83292.jpg

DS_ID:526
FS_ID:60278
EP_NO: 10302
Repair Type: Non-Urgent
EVAL Issue: Unauthorized Encroachment, installed decades prior
Crossing Status: Indicator Found
UCIP Comments: 11/07/2019 Record updated from No Action Needed to Non-Urgent. Need to have CVFPB review ABO and determine current owner. (O.Yakimov - DWR UCIP)10/18/2012 ATT communication marker on both sides of the levee. (P. Amatya - DWR UCIP)
FIELD_STRUCT_DESC: Telephone conduit of an unknown size or material through the levee, at an unknown depth. (Telephone conduit authorized under Automatic Board Order (ABO) issued as Permit No. 10302, 1974 - Pacific Telephone and Telegraph Company [PT&T]). [Additional Reference(s): DWR Levee Log, 2004, (HLM 0.62, listed as buried cable)].
FS Date: 11/7/2019 8:12:00 AM

Closeup view of a marker flag

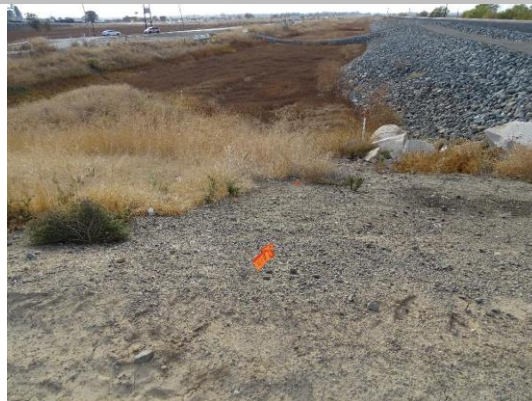
Photo 2 of 3 : UCIP_FA_2020_60278_83293.jpg

Landside view: marker flags on levee road shoulder

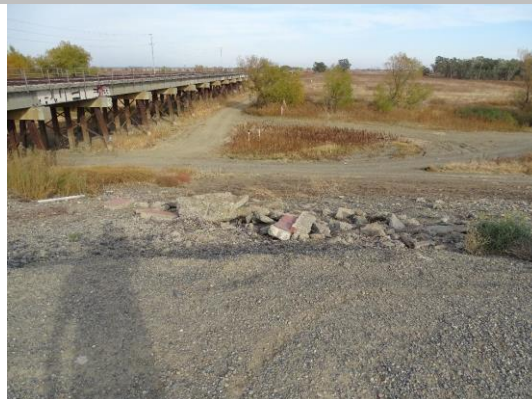
Photo 3 of 3 : UCIP_FA_2020_60278_83294.jpg

Waterside view: marker not found

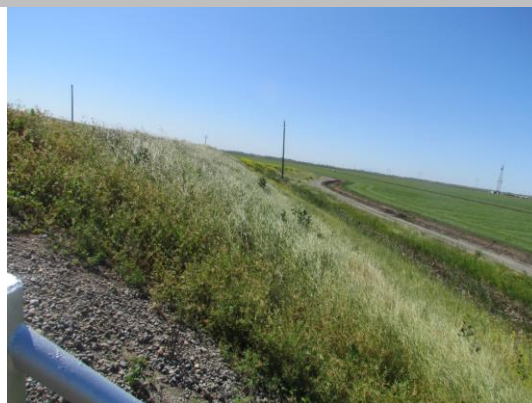
Photo 1 of 1 : FA_2020_ST0011_294_6_20200813_00003.jpg

View of the ditch on the landward side of the levee looking downstream.
Spring 2015.

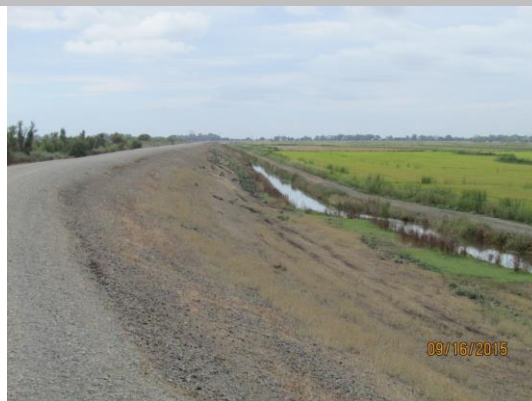
Photo 1 of 1 : FA_2020_ST0011_294_3_20200813_00001.jpg

View of the ditch along the levee toe on the landward side of the levee looking downstream. Fall 2015.

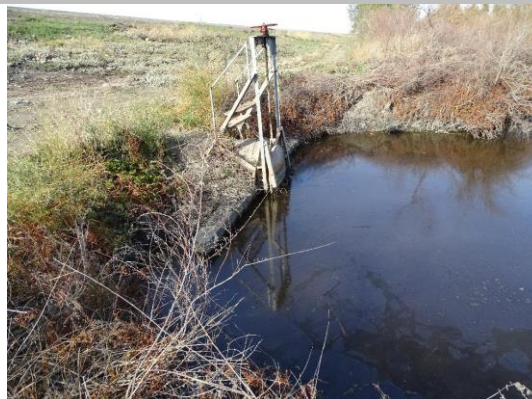
Photo 3 of 3 : UCIP_FA_2020_60661_83251.jpg

Slide gate and pipe outlet on waterside

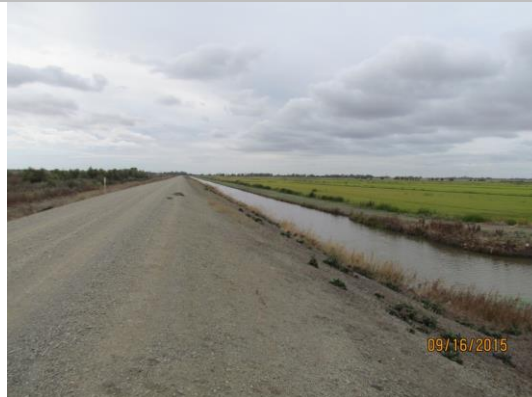
Photo 1 of 1 : FA_2020_ST0011_294_4_20200813_00002.jpg

The ditch is at the levee toe on the landward side of the levee looking downstream. Fall 2015.

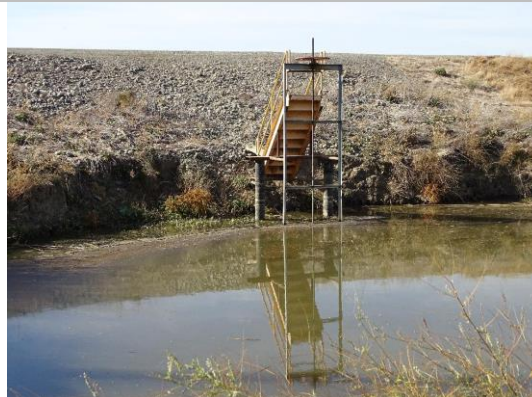
Photo 3 of 3 : UCIP_FA_2020_60659_83336.jpg

Slide gate under water at WS levee toe
