Flood Control Project Maintenance Levee Inspections

Fall 2021 Levee Maintenance Deficiency Summary Report

Sacramento River Basin

Sacramento Maintenance Yard West Levee Yolo Bypass

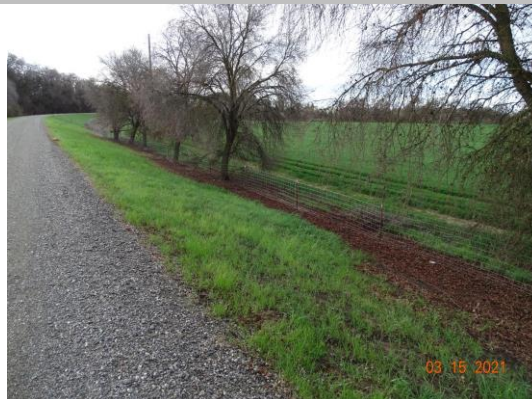
Photo 1 of 1 : FA_2021_ST0011_291_10_20210907_00004.jpg

View of fence at landside toe. Spring 2021.

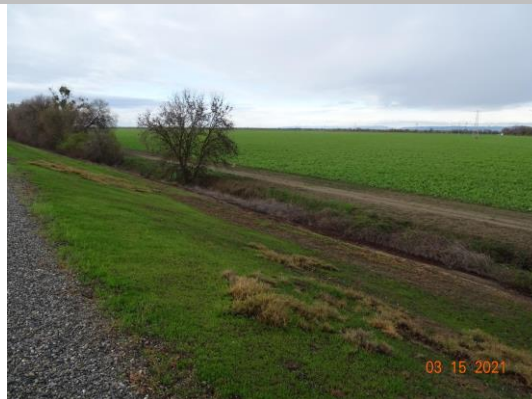
Photo 1 of 1 : FA_2021_ST0011_291_8_20210907_00002.jpg

LM Start	0.94	Rating **	M	Issue No.	8
LM End	1.83	Issue Type +	En	Location *	LS
Category	Earthen Levee			GPS Latitude/Longitude	
				Start	End
Item	Encroachments			38.747888 °	38.734972 °
				-121.660202 °	-121.660265 °
DWR ID	DWR_ST0011_01_s_2012_8				
Comment Code					
DT : Ditch					
Inspector Comment					
The ditch is at the toe of the levee.

View of ditch at landside toe. Spring 2021.

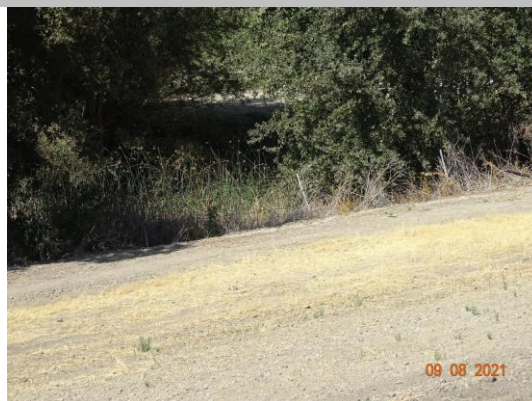
Photo 1 of 1 : FA_2021_ST0011_291_9_20210908_00011.jpg

LM Start	1.70	Rating **	M	Issue No.	9
LM End	1.79	Issue Type +	En	Location *	LS
Category	Earthen Levee			GPS Latitude/Longitude	
				Start	End
Item	Encroachments			38.736842 °	38.735498 °
				-121.660285 °	-121.660287 °
DWR ID	DWR_ST0011_01_f_2016_9				
Comment Code					
FE : Fence					
Inspector Comment

View of fence near landside ditch and toe road. Fall 2021.

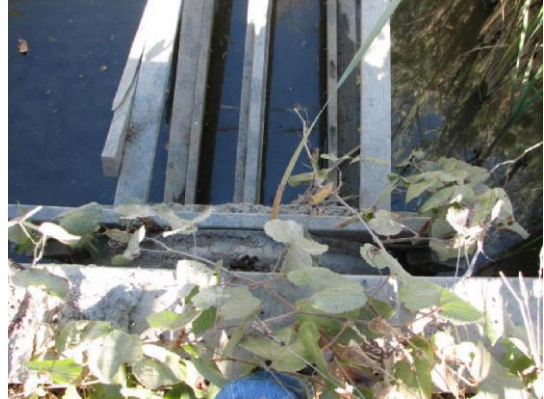
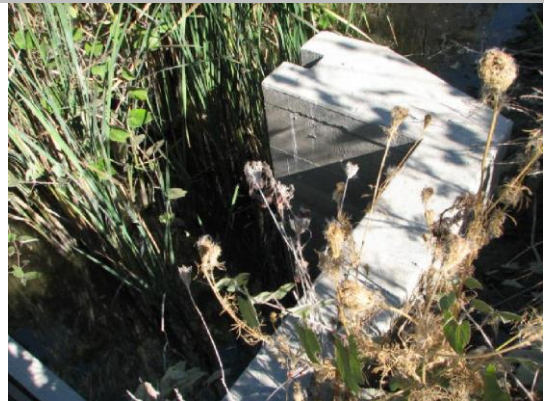
LM Start	2.63	Rating **	A/W	Issue No.	11	
LM End	2.63	Issue Type +	Ma	Location *		
Category	Supplemental			GPS Latitude/Longitude		
				Start	End	
Item	DWR UCIP LMA Responsibility			38.724824 °	38.724824 °	
				-121.663702 °	-121.663702 °	
DWR ID	17742

Comment Code						
Inspector Comment						
DS_ID:17742 FS_ID:60644 EP_NO: 10284 Repair Type: No Action Needed EVAL Issue: Crossing Status: Found UCIP Comments: 11/16/2018 Pipe is Grouted. (T. Skidgel - DWR Sacramento Yard)04/10/2014 Screw gates where removed and pipe was abanded by farmer, How pipe was abanded is unknown. (T. Skidgel - DWR Sacramento Yard)10/17/2012 Slide gate not found. (P. Amatya - DWR UCIP) FIELD_STRUCT_DESC: 1 of 2: 42-inch corrugated metal gravity drainage pipe through the levee, 23.6 feet below the crown. Slide gate on the waterside (WS) slope. Concrete distribution box at the landside (LS) toe. (42-inch pipe [HLM 2.63] authorized under Automatic Board Order (ABO) issued as Permit No. 10284, 1974 - La Borde and Hoover). [Additional Reference(s): DWR Levee Log, 2004 (HLM 2.63, listed as two 42-inch pipes). USACE Sacramento O&M Manual, Unit 127, June 1953, Revised 16 November 2018, (Station 133+82), listed as two 42-inch CMP]. FS Date: 11/16/2018 2:17:00 PM

Waterside view: overview (pipe not found)

Landside view: concrete spillbox/headwall and pipe (top view)

Landside view: side of concrete spillbox/headwall

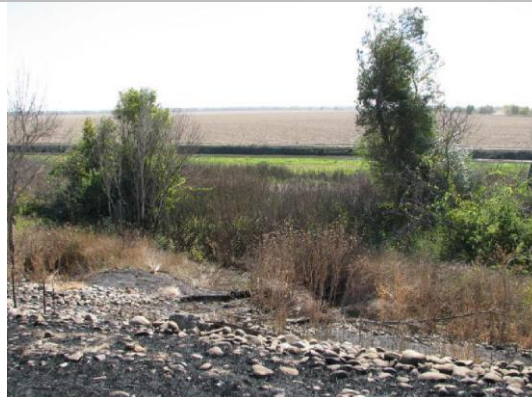
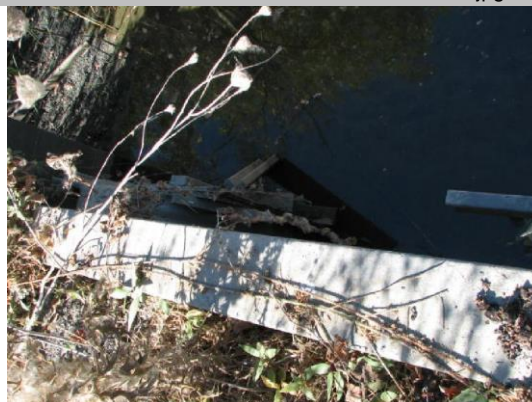
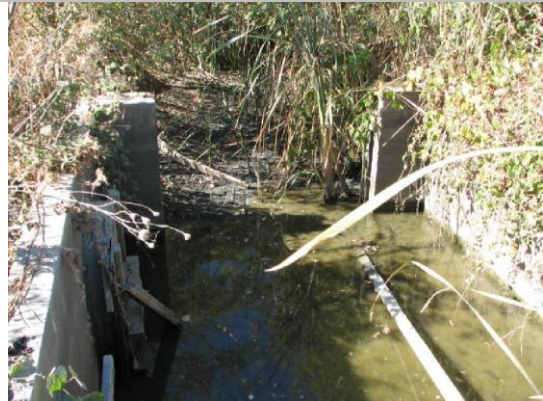
DS_ID:17747
FS_ID:60648
EP_NO: 10284
Repair Type: No Action Needed
EVAL Issue:
Crossing Status: Found
UCIP Comments: 10/14/2014 Screw gate removed and pipe abandon by farmer, How pipe was abandoned is unknown. (T. Skidgel - DWR Sacramento Yard)10/17/2012 No slide gate found. (P. Amatya - DWR UCIP)
FIELD_STRUCT_DESC: 2 of 2: 42-inch corrugated metal gravity drainage pipe through the levee, 23.6 feet below the crown. Slide gate on the waterside (WS) slope. Concrete distribution box at the landside (LS) toe. (42-inch pipe [HLM 2.63] authorized under Automatic Board Order (ABO) issued as Permit No. 10284, 1974 - La Borde and Hoover). [Additional Reference(s): DWR Levee Log, 2004 (HLM 2.63, listed as two 42-inch pipes). USACE Sacramento O&M Manual, Unit 127, June 1953, Revised 16 November 2018, (Station 133+82), listed as two 42-inch CMPs].
FS Date: 11/16/2018 2:19:00 PM

Waterside view: overview

Landside view: concrete spill box

Landside view: CM pipe with flap gate

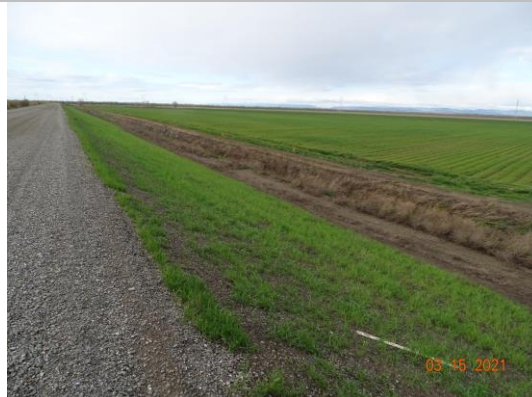
Photo 1 of 1 : FA_2021_ST0011_292_3_20210907_00002.jpg

View of ditch at landside toe. Spring 2021.

LM Start	1.01	Rating **	M	Issue No.	5
LM End	1.44	Issue Type +	En	Location *	LS
Category	Earthen Levee			GPS Latitude/Longitude	
				Start	End
Item	Encroachments			38.705475 °	38.699637 °
				-121.671135 °	-121.674112 °
DWR ID	DWR_ST0011_02_s_2012_5				
Comment Code					
DT : Ditch					
Inspector Comment					
The ditch is at the toe of the levee.

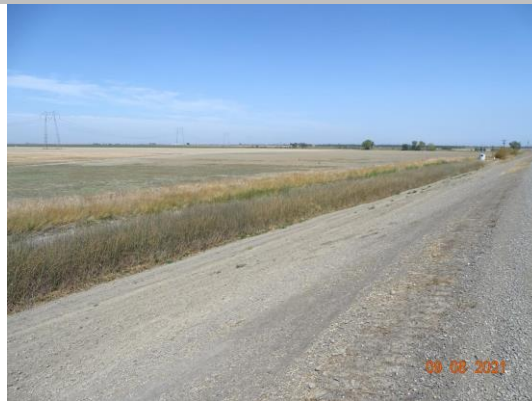
Photo 1 of 1 : FA_2021_ST0011_292_5_20210908_00003.jpg

View of ditch at landside toe. Fall 2021.

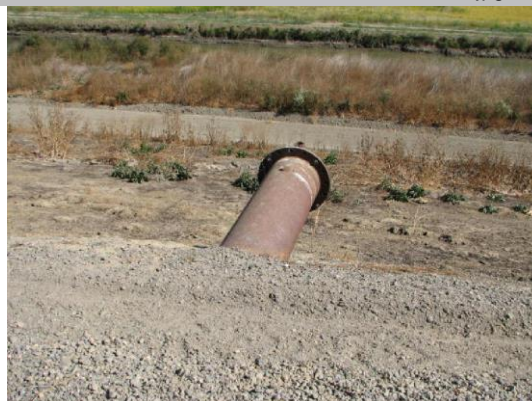
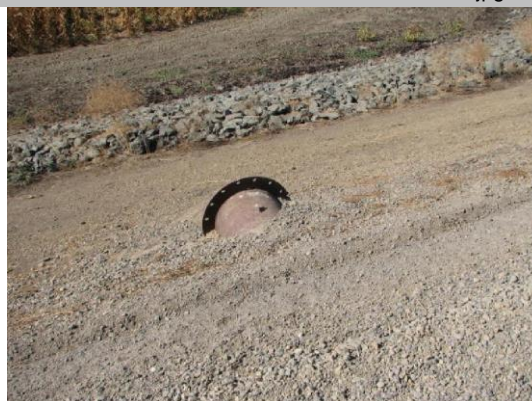
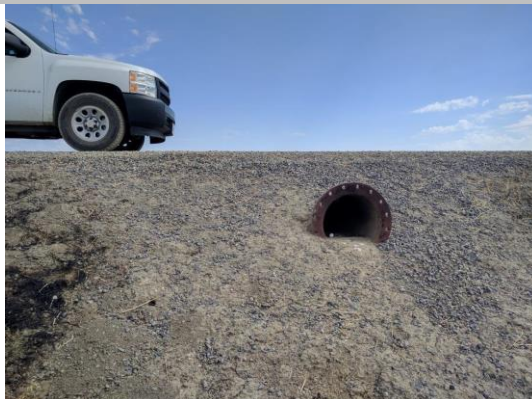
Comment Code						
Inspector Comment						
DS_ID:17756 FS_ID:60672 EP_NO: N/A Repair Type: Non-Urgent EVAL Issue: Crossing Status: Found UCIP Comments: 08/20/2020 Need to obtain a copy of USACE Drawing As-Built listed under additional references. Drawing information was listed by previous inspector. (O. Magana - DWR UCIP) 10/17/2012 Pipe not properly abandoned. (P. Amatya - DWR UCIP) FIELD_STRUCT_DESC: 18-inch steel irrigation or drainage pipe through the levee, 3 feet below the crown. [Additional Reference(s): USACE Drawing referenced as Station 74+00, As-Built Drawing: USACE, Sacramento Districts. Levee Repair- Cache Creek Settling Basin, Wahler Associates, May 1991] FS Date: 11/21/2018 8:24:00 AM

Waterside view: an abandoned steel pipe.

Landside view: an abandoned steel pipe.

LS: straight through pipe without any gates preventing water from WS to LS.

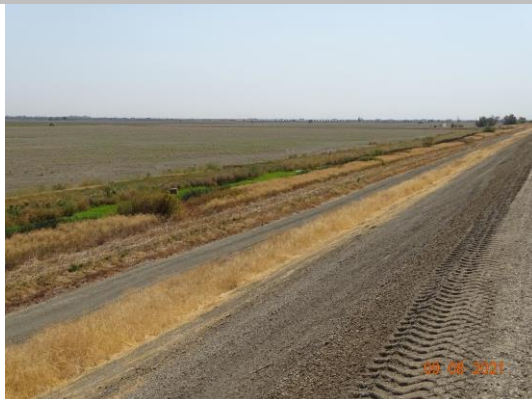
Photo 1 of 1 : FA_2021_ST0011_293_5_20210908_00008.jpg

LM Start	0.06	Rating **	A	Issue No.	5
LM End	0.06	Issue Type +	Ma	Location *	WS
Category	Earthen Levee			GPS Latitude/Longitude	
				Start	End
Item	Vegetation			38.697791 °	38.697791 °
				-121.674036 °	-121.674036 °
DWR ID	DWR_ST0011_03_f_2021_5				
Comment Code					
V1 : Control annual grass and weeds on the levee slopes and easements.					
Inspector Comment					
The LMA maintains the vegetation at a high level.

View of maintained waterside slope. Fall 2021.

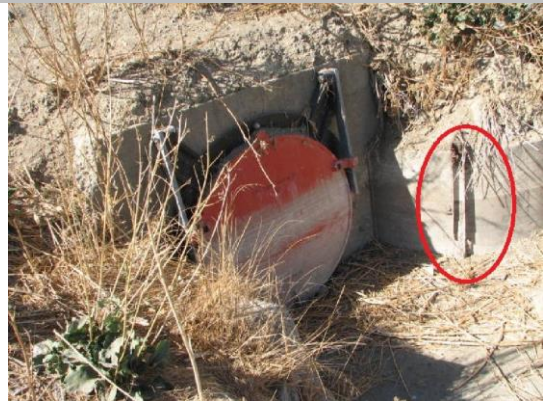
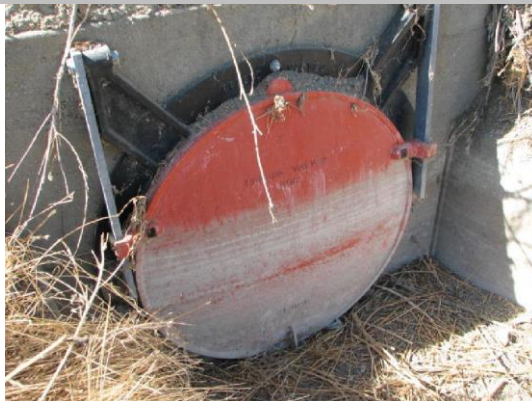
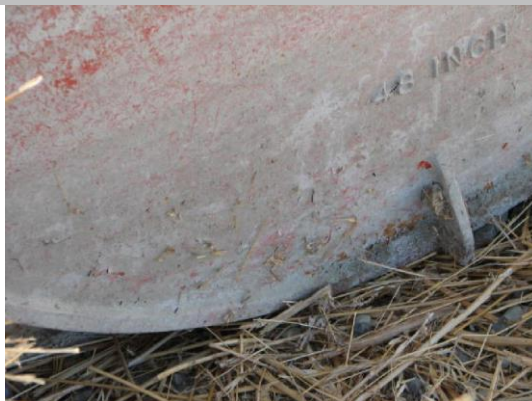
Comment Code					
Inspector Comment					
DS_ID:17754 FS_ID:60671 EP_NO: 10295 Repair Type: Urgent EVAL Issue: Pipe Integrity Crossing Status: Found UCIP Comments: 08/20/2020 Need to obtain a copy of USACE Drawing As-Built listed under additional references. Drawing information was listed by previous inspector. (O. Magana - DWR UCIP) 04/09/2019 Internal inspection was completed and the inspection shows separation of pipe at 22 degree turn. Sink hole visible on LS slope. Coordinating with DMP - Vince Rodriguez. Recommend repair or replace. (T. Skidgel - DWR Sacramento Yard)10/17/2012 Found 48-inch CMP (not concrete culvert) and slide gate not found on LS end. (P. Amatya - DWR UCIP) FIELD_STRUCT_DESC: 48-inch corrugated metal pipe (CMP) sewer culvert through the levee, 18 feet below the crown. Slide gate on the landside (LS) end. (48-inch concrete culvert authorized under Automatic Board Order (ABO) issued as Permit No. 10295, 1974 - City of Woodland). [Additional Reference(s): DWR Levee Log, 2004 (HLM 1.45, listed as 48-inch concrete culvert). USACE As-Built Drawing No. 50-04-3227, Sheet 14, just south of STA 882+00, March 11, 1960, listed as 48-inch CMP]. FS Date: 4/9/2019 8:58:00 AM

Waterside view: flap gate and concrete headwall. Abandoned slide gate on right.

Waterside view: flap gate and concrete headwall.

Waterside view: 48-inch flap gate.

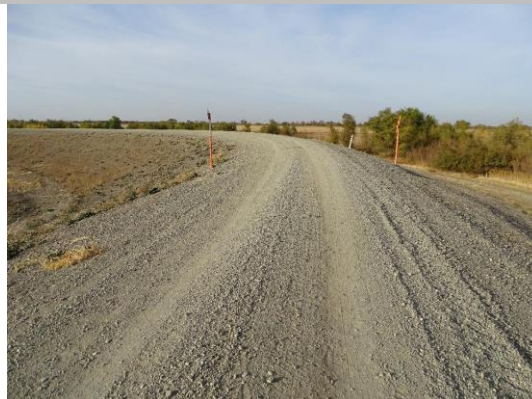
Comment Code						
Inspector Comment						
DS_ID:17695 FS_ID:60245 EP_NO: 16309 Repair Type: Non-Urgent EVAL Issue: Safety Issue Crossing Status: Indicator Found UCIP Comments: 11/07/2019 Record updated from No Action Needed to Non-Urgent. No inspection records were available to determine status of line through the levee. (O.Yakimov - DWR UCIP)09/20/2012 Indicators found on both sides of the levee. This crossing was found during field survey of ST 12 Unit 2. (P. Amatya - DWR UCIP) FIELD_STRUCT_DESC: 20-inch coated steel natural gas pipeline under both levees and within the Yolo Bypass, at an unknown depth. Indicators found on both sides of the levee. (20-inch pipeline authorized under Permit No. 16309, 1995 - Sacramento Municipal Utility District [SMUD] and Ford, Bacon, and Davis, Inc.). FS Date: 11/7/2019 1:10:00 PM

View of levee crown at the crossing

Waterside view: a gasline marker on WS slope of the levee

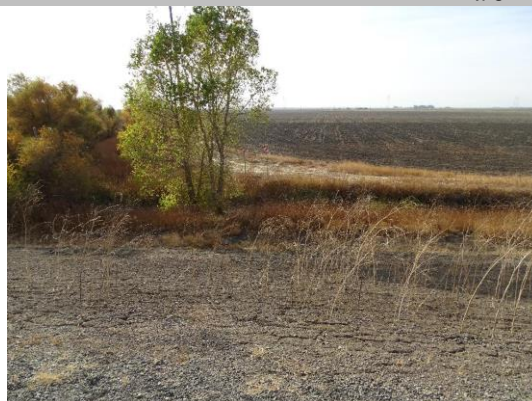
Photo 2 of 2 : UCIP_FA_2021_60277_83280.jpg

Landside view: gasline marker in LS field

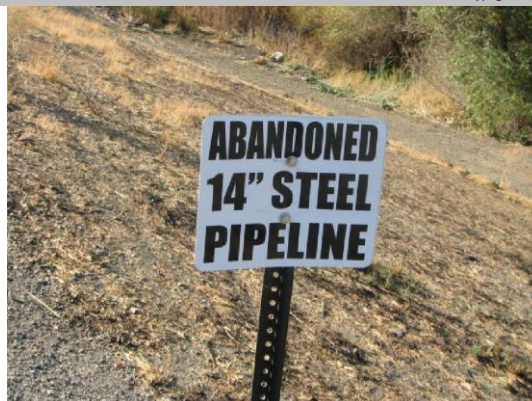
Photo 1 of 1 : UCIP_FA_2021_60248_50974.jpg

DS_ID:19991
FS_ID:60248
EP_NO: N/A
Repair Type: Non-Urgent
EVAL Issue: Safety Issue
Crossing Status: Not Found
UCIP Comments: 11/07/2019 Record updated from No Action Needed to Non-Urgent, unable to locate a sign found during prior inspection on LS shoulder that mentions abandoned pipe. Updated to Not Found. No maintenance records were available to determine current status of line through the levee. (O.Yakimov - DWR UCIP)10/18/2012 Only a sign found on landside of the levee. (P. Amatya - DWR UCIP)
FIELD_STRUCT_DESC: 14-inch steel natural gas pipeline through the levee, at an unknown depth. Sign on the landside (LS) shoulder.
FS Date: 11/7/2019 3:13:00 PM

Landside view: a sign mentioning about the pipe.

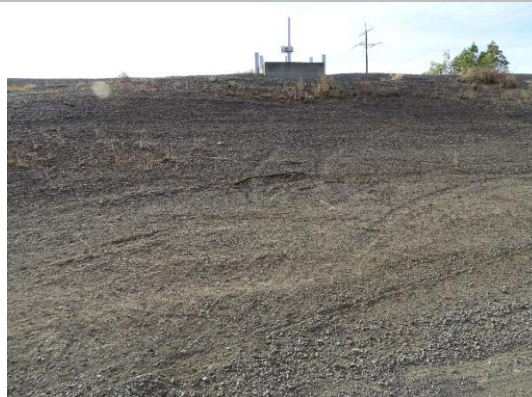
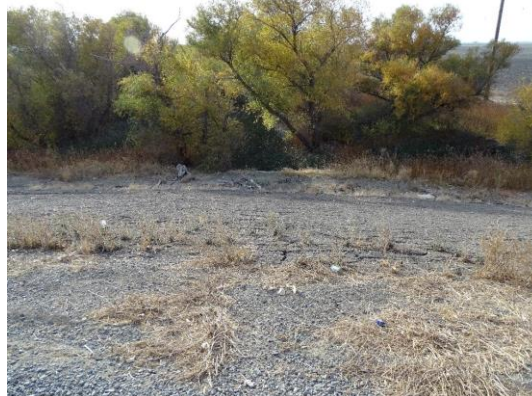
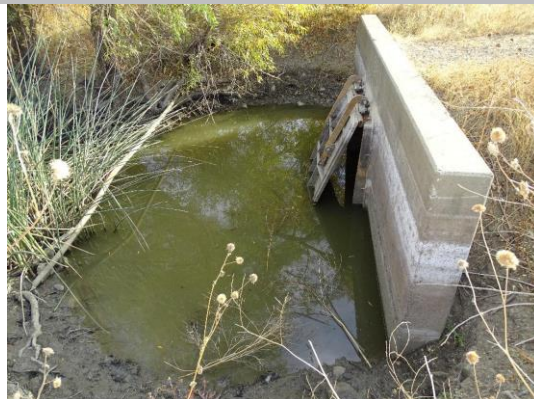
Comment Code					
Inspector Comment					
DS_ID:569 FS_ID:60250 EP_NO: 16096 Repair Type: Urgent EVAL Issue: Flood Risk Crossing Status: Found UCIP Comments: 11/07/2019 Flap gate at WS headwall not closing completely. A wooden stick on the top prevents flap gate closing leaving space for backflow. Provide maintenance on flap gate. About 20-foot long surface cracking observed on levee crown closer to LS shoulder. Not sure if cracking is related to this crossing (potential levee damage concern). (O.Yakimov - DWR UCIP)10/18/2012 The culvert was constructed in 1993. (P. Amatya - DWR UCIP) FIELD_STRUCT_DESC: 60-inch by 60-inch reinforced concrete box gravity drainage culvert through the right bank (west) levee of the Yolo Bypass, 20 feet below the crown. 60-inch by 60-inch culvert replaced an existing 30-inch gravity drain pipeline. (60-inch by 60-inch culvert authorized under Permit No. 16096, 1993 - Yolo County Flood Control and Water Conservation District, square culvert installed about 28 feet south of existing 30-inch pipe). FS Date: 11/7/2019 3:23:00 PM

View of WS slope looking towards levee

View of LS looking from levee crown

Malfunctioning flap gate at WS levee toe

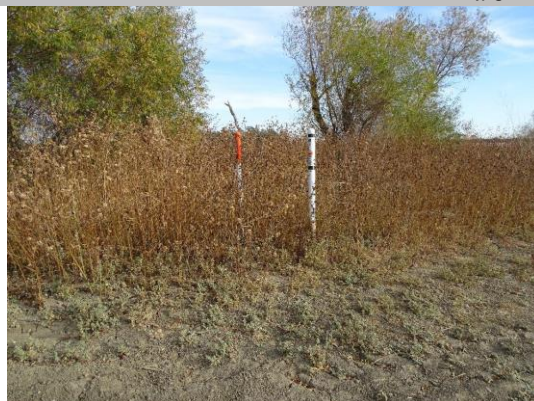
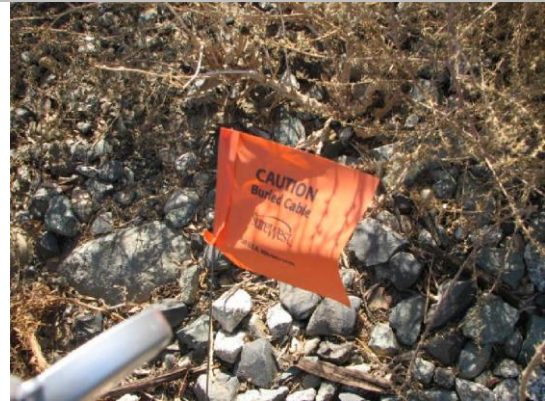
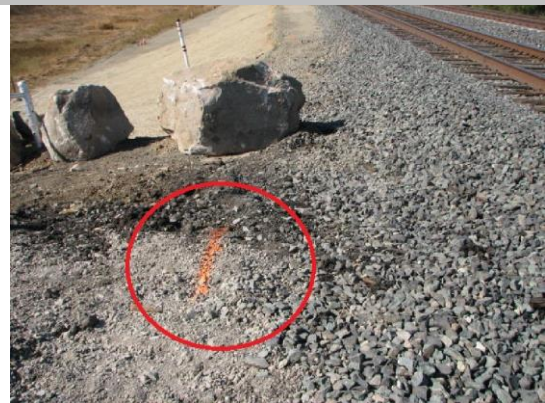
DS_ID:19987
 FS_ID:60252
 EP_NO: N/A
 Repair Type: Non-Urgent
 EVAL Issue: Unauthorized Encroachment
 Crossing Status: Indicator Found
 UCIP Comments: 11/07/2019 Record updated from No Action Needed to Non-Urgent. Permit is not available for this crossing. (O.Yakimov - DWR UCIP)
 10/18/2012 Cable marker/flags found on both sides of the levee. (P. Amatya - DWR UCIP)
 FIELD_STRUCT_DESC: Communications conduit of an unknown size or material through the levee, at an unknown depth. (Sure West Communications).
 FS Date: 11/7/2019 7:44:00 AM

Line marker in the field on WS

Waterside view: mini flag/marker

Landside view: ground marking

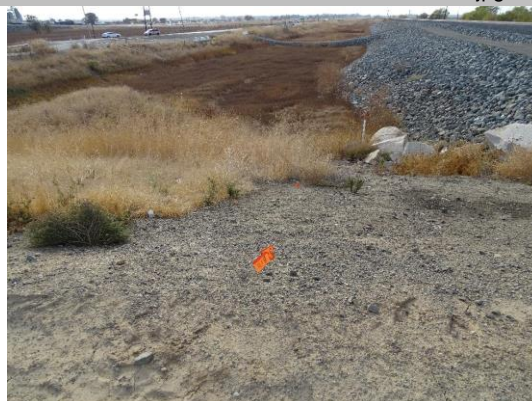
DS_ID:526
FS_ID:60278
EP_NO: 10302
Repair Type: Non-Urgent
EVAL Issue: Unauthorized Encroachment, installed decades prior
Crossing Status: Indicator Found
UCIP Comments: 11/07/2019 Record updated from No Action Needed to Non-Urgent. Need to have CVFPB review ABO and determine current owner. (O.Yakimov - DWR UCIP)10/18/2012 ATT communication marker on both sides of the levee. (P. Amatya - DWR UCIP)
FIELD_STRUCT_DESC: Telephone conduit of an unknown size or material through the levee, at an unknown depth. (Telephone conduit authorized under Automatic Board Order (ABO) issued as Permit No. 10302, 1974 - Pacific Telephone and Telegraph Company [PT&T]). [Additional Reference(s): DWR Levee Log, 2004, (HLM 0.62, listed as buried cable)].
FS Date: 11/7/2019 8:12:00 AM

Closeup view of a marker flag

Landside view: marker flags on levee road shoulder

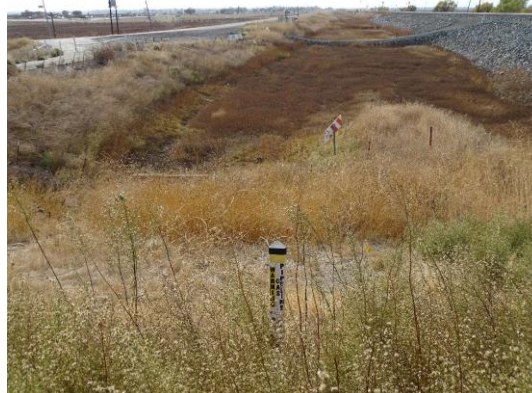
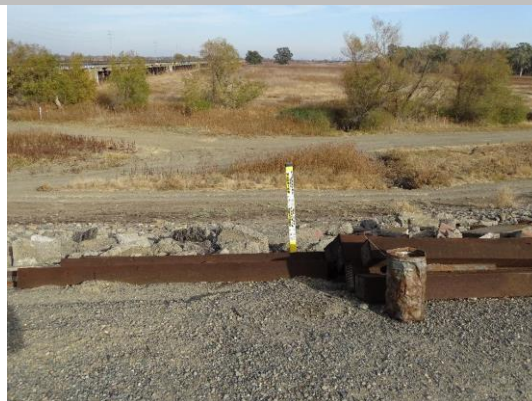
Landside view: gasline markers

Waterside view: gasline marker

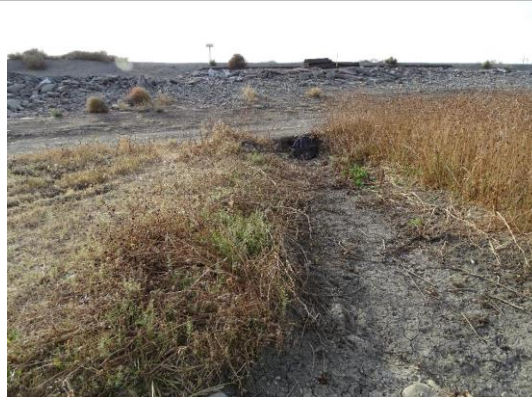
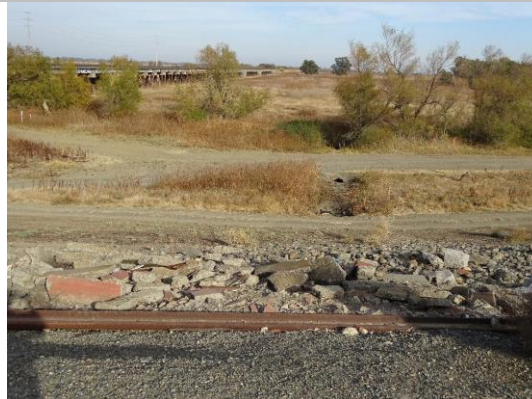
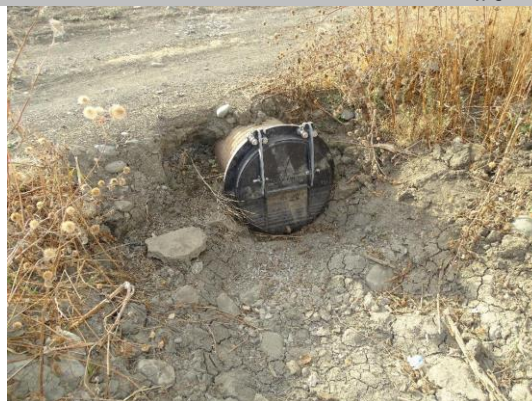
DS_ID:528
FS_ID:60660
EP_NO: 10304
Repair Type: Non-Urgent
EVAL Issue: Unauthorized Encroachment, installed decades prior
Crossing Status: Found
UCIP Comments: 11/07/2019 Record updated from No Action Needed to Non-Urgent. Need to have CVFPB review ABO and determine current owner. (O.Yakimov - DWR UCIP)
FIELD_STRUCT_DESC: 30-inch CIPP-lined corrugated metal gravity drainage pipe through the levee, 22 feet below the crown. Flap gate on the waterside (WS) end. (30-inch pipe [HLM 0.59] authorized under Automatic Board Order (ABO) issued as Permit No. 10304, 1974 - Southern Pacific Transportation Company). [Additional Reference(s): DWR Levee Log, 2004, (HLM 0.63, listed as a 30-inch pipe). USACE Sacramento O&M Manual, Unit 120, June 1952, Revised 29 December 2016, (Station 446+08), listed as 30-inch CMP. USACE As-Built Drawing No. 50-04-2281, Sheet 5, page 5 of 5 pdf file, January 1947].
FS Date: 11/7/2019 8:24:00 AM

View of WS slope looking towards levee

View of WS looking from levee crown

Pipe and flap gate at WS levee toe

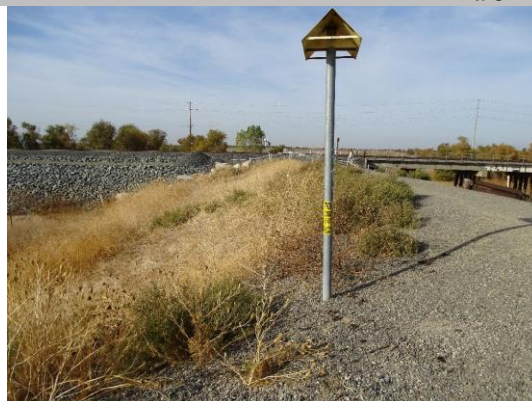
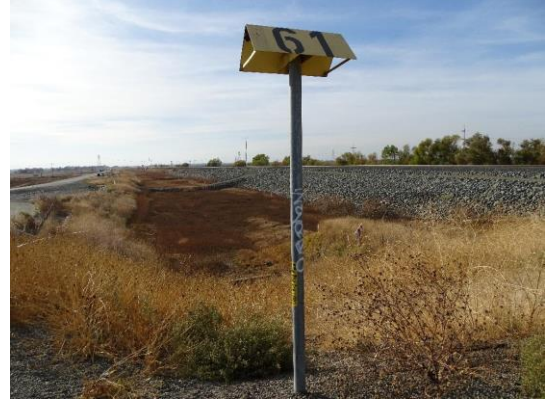
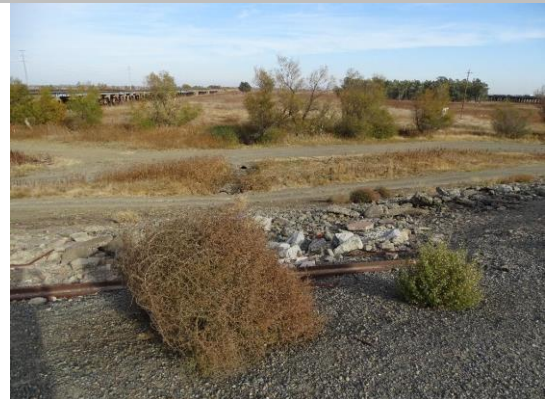
DS_ID:577
 FS_ID:60263
 EP_NO: 5859
 Repair Type: Non-Urgent
 EVAL Issue: Safety Issue
 Crossing Status: Indicator Found
 UCIP Comments: 11/07/2019 Record updated from No Action Needed to Non-Urgent. No inspection records were available to determine status of line through the levee. (O.Yakimov - DWR UCIP)10/18/2012
 Petroleum pipeline markers found on both sides of the levee. CHECK COORDINATES (P. Amatya - DWR UCIP)
 FIELD_STRUCT_DESC: 14-inch coated steel petroleum pipeline through the levees and across the channel of the Yolo Bypass, 3.5 feet below the crown. Petroleum pipeline markers found on both sides of the levee. (Petroleum pipeline authorized under Permit No. 5859, 1967 - Southern Pacific Pipe Lines, Inc.).
 FS Date: 11/7/2019 9:00:00 AM

Landside view: petroleum line marker

View of LS looking from levee crown

View of WS looking from levee crown

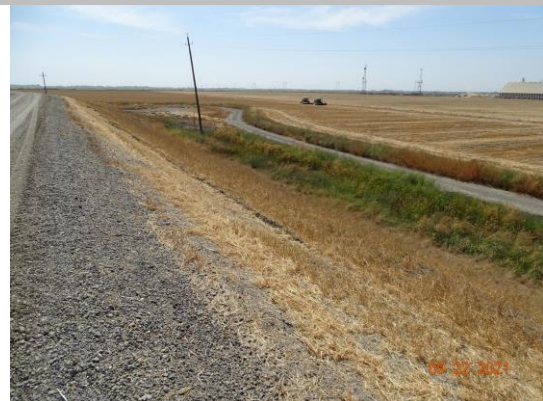
Photo 1 of 1 : FA_2021_ST0011_294_6_20210922_00039.jpg

View of ditch at landside toe. Fall 2021.

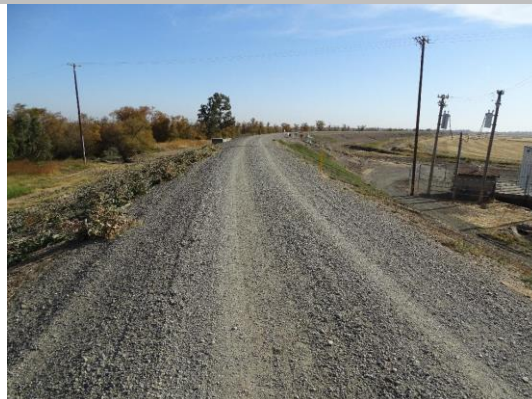
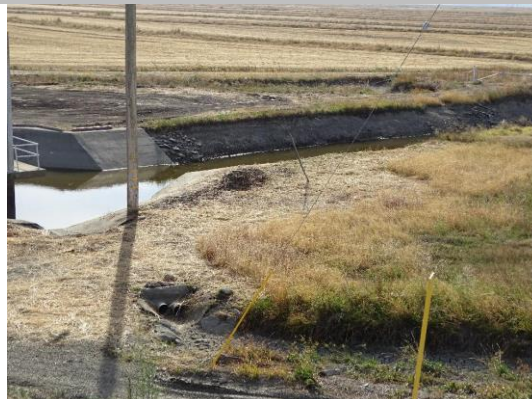
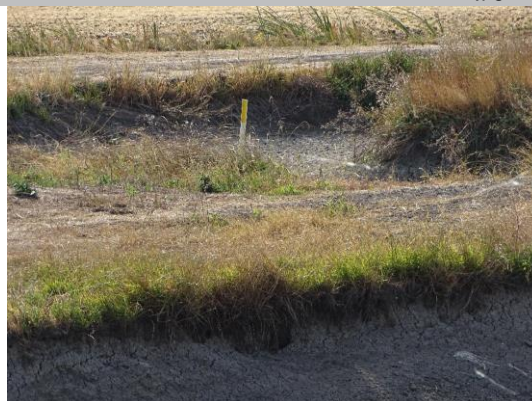
View of levee crown at potential crossing

View of LS looking from levee crown. A yellow marker on LS shoulder

Yellow marker in the field on LS on the other side of irrigation canal

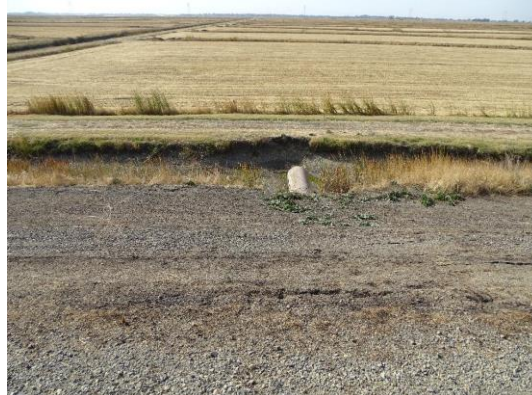
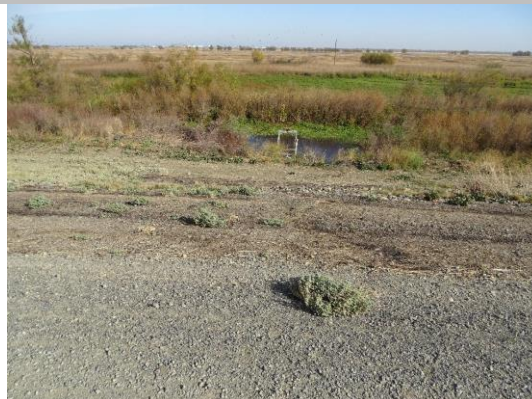
View of LS looking from levee crown

View of WS looking from levee crown

Slide gate and pipe outlet on waterside

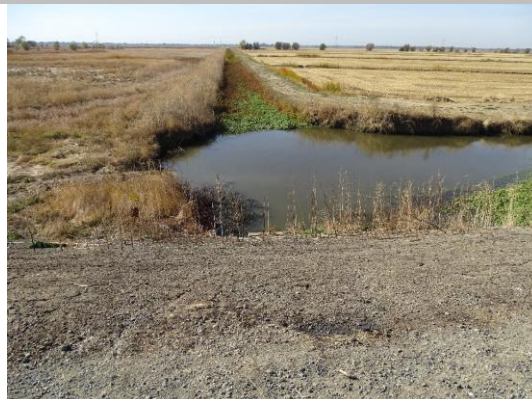
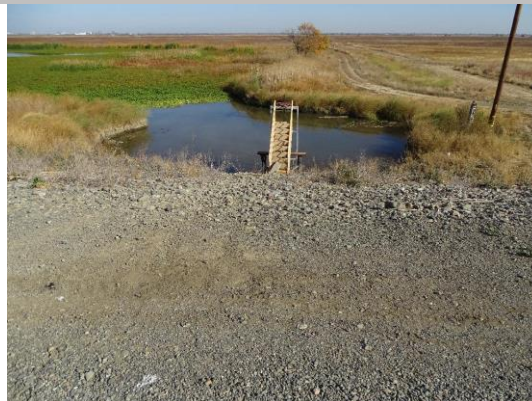
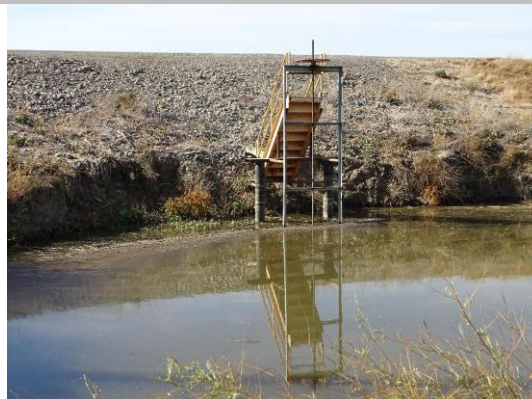
View of LS looking from levee crown

View of WS looking from levee crown

Slide gate under water at WS levee toe
