**Flood Control Project Maintenance
Levee Inspections**

Fall 2022 Levee Maintenance Deficiency Summary Report

Sacramento River Basin

Sacramento Maintenance Yard West Levee Yolo Bypass

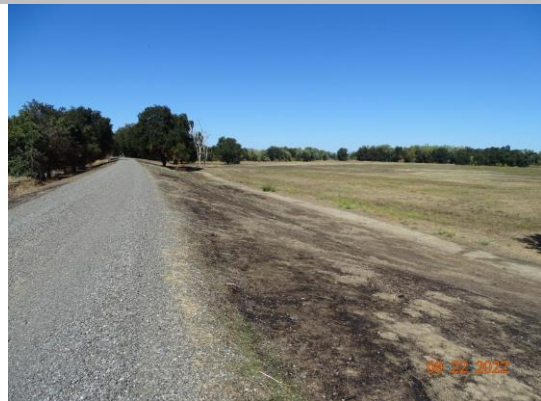
Photo 1 of 1 : FA_2022_ST0011_291_16_20220929_00012.jpg

LM Start	0.23	Rating **	A	Issue No.	16
LM End	0.23	Issue Type +	Ma	Location *	WS
Category	Earthen Levee			GPS Latitude/Longitude	
				Start	End
Item	Vegetation			38.757462 °	38.757462 °
				-121.664454 °	-121.664454 °
DWR ID	DWR_ST0011_01_f_ 2022_16				
Comment Code					
V1 : Control annual grass and weeds on the levee slopes and easements.					
Inspector Comment					
The LMA maintains the vegetation at a high level.

View of maintained waterside slope. Fall 2022.

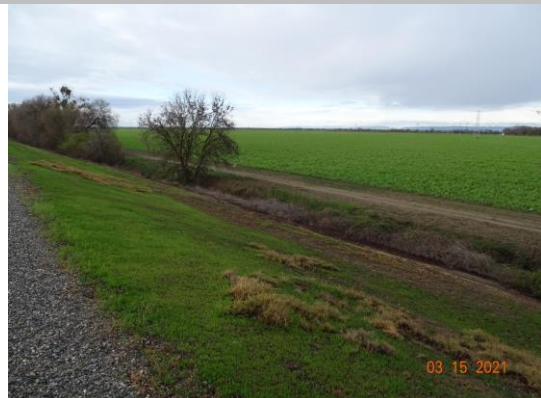
Photo 1 of 1 : FA_2022_ST0011_291_8_20220921_00003.jpg

LM Start	0.94	Rating **	M	Issue No.	8
LM End	1.83	Issue Type +	En	Location *	LS
Category	Earthen Levee			GPS Latitude/Longitude	
				Start	End
Item	Encroachments			38.747888 °	38.734972 °
				-121.660202 °	-121.660265 °
DWR ID	DWR_ST0011_01_s_ 2012_8				
Comment Code					
DT : Ditch					
Inspector Comment					
The ditch is at the toe of the levee.

View of ditch at landside toe. Spring 2021.

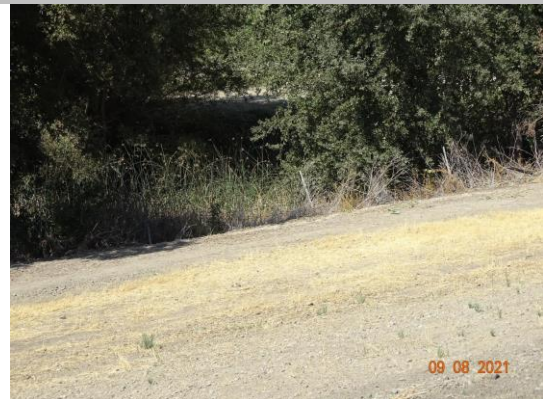
Photo 1 of 1 : FA_2022_ST0011_291_9_20220921_00004.jpg

LM Start	1.70	Rating **	M	Issue No.	9
LM End	1.79	Issue Type +	En	Location *	LS
Category	Earthen Levee			GPS Latitude/Longitude	
				Start	End
Item	Encroachments			38.736842 °	38.735498 °
				-121.660285 °	-121.660287 °
DWR ID	DWR_ST0011_01_f_2016_9				
Comment Code					
FE : Fence					
Inspector Comment

View of fence near landside ditch and toe road. Fall 2021.

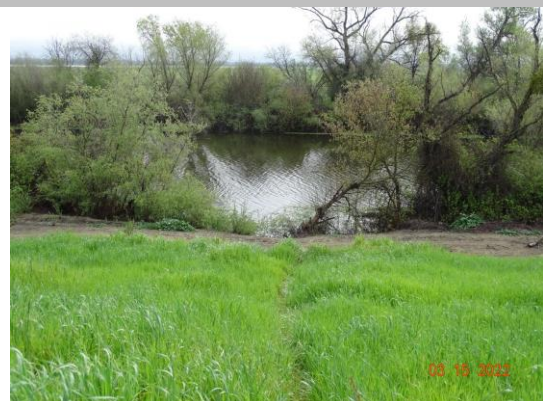
Photo 1 of 1 : FA_2022_ST0011_291_3_20220921_00001.jpg

LM Start	1.85	Rating **	A/W	Issue No.	3
LM End	1.85	Issue Type +	Ma	Location *	WS
Category	Earthen Levee			GPS Latitude/Longitude	
				Start	End
Item	Erosion / Bank Caving			38.734579 °	38.734579 °
				-121.660267 °	-121.660267 °
DWR ID	DWR_ST0011_01_s_2022_3				
Comment Code					
E1 : Note and monitor erosion site.					
Inspector Comment					
Location of narrowing waterside toe road. Recommend monitoring for future erosion.

View of toe road erosion from the crown. Spring 2022.

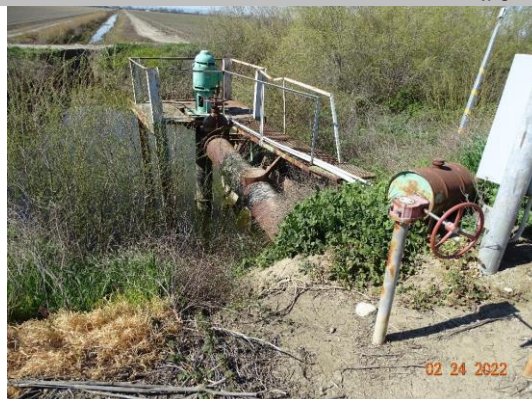
Photo 3 of 3 : UCIP_FA_2022_72852_109327.jpg

Comment Code						
Inspector Comment						
DS_ID:17743 FS_ID:72852 EP_NO: 6306 Repair Type: Non-Urgent EVAL Issue: 4b, Safety Issue Crossing Status: Found UCIP Comments: 02/24/2022 Record updated from No Action Needed to Non-Urgent. Siphon breaker riser needs to have top cover restored. (O.Yakimov - DWR UCIP) 10/17/2012 Walkway on LS to pump is in poor structural condition. Seems pump has been used for dual purpose. There is another pipe (approx. 12-inch) found near the pump crossing the ditch. (T. Skidgel - DWR UCIP)10/17/2012 The pipe is about 18-ft below the crown. Seems pump has been used for dual purpose. There is another pipe (approx. 12-inch) found near the pump crossing the ditch. Two closing valves also found in pumping station. (P. Amatya - DWR UCIP) FIELD_STRUCT_DESC: 20-inch coated steel drainage pipe through the levee, 5.8 feet below the crown. Pump and switch panel at the landside (LS) toe. Siphon breaker on the LS slope. Butterfly valves at pump on the LS toe. (20-inch pipe replaced under Permit No. 6306, 1968 - William P. Wilson). [Additional Reference(s): DWR Levee Log, 2004 (HLM 1.85, listed as 20-inch pipe). USACE Sacramento O&M Manual, Unit 127, June 1953, Revised 16 November 2018, (Station 92+31.5), listed as 20-inch steel]. FS Date: 2/24/2022 3:22:03 PM

Land-Side: Pump on pile structure, pipe with closure device at drainage ditch

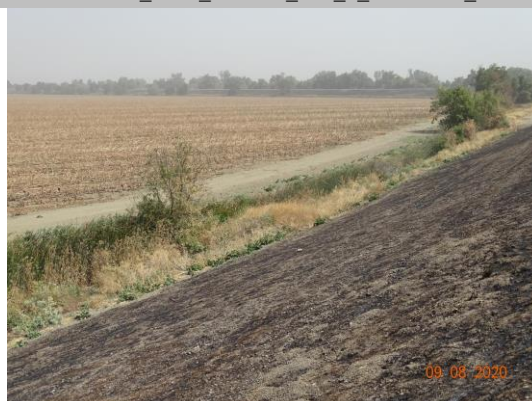
Photo 1 of 1 : FA_2022_ST0011_291_4_20220921_00002.jpg

LM Start	2.63	Rating **	M	Issue No.	4
LM End	2.72	Issue Type +	En	Location *	LS
Category	Earthen Levee			GPS Latitude/Longitude	
				Start	End
Item	Encroachments			38.724853 °	38.724228 °
				-121.663647 °	-121.665137 °
DWR ID	DWR_ST0011_01_s_2012_4				
Comment Code					
DT : Ditch					
Inspector Comment					
Ditch is at the toe of the levee.

View of the ditch at the toe of the levee on the landward side. Fall 2020.

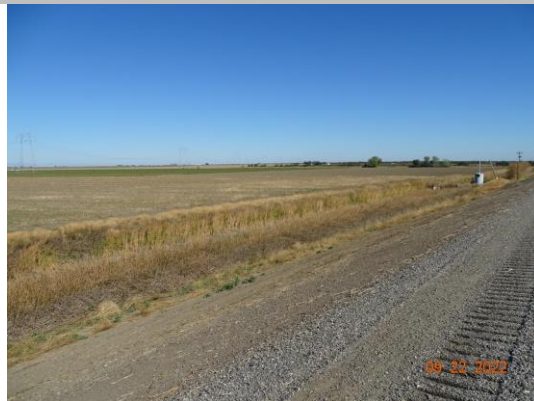
Photo 1 of 1 : FA_2022_ST0011_292_5_20220929_00003.jpg

LM Start	1.01	Rating **	M	Issue No.	5
LM End	1.44	Issue Type +	En	Location *	LS
Category	Earthen Levee			GPS Latitude/Longitude	
				Start	End
Item	Encroachments			38.705475 °	38.699637 °
				-121.671135 °	-121.674112 °
DWR ID	DWR_ST0011_02_s _ 2012_5				
Comment Code					
DT : Ditch					
Inspector Comment					
The ditch is at the toe of the levee.

View of ditch at the landside toe. Fall 2022.

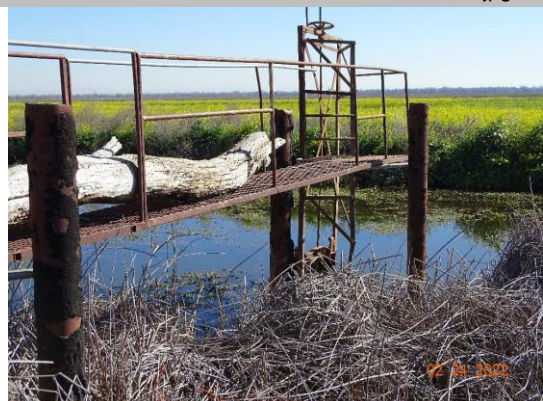
Photo 2 of 3 : UCIP_FA_2022_72996_109374.jpg

Water-Side: View of steel walkway and abandoned slide gate in irrigation ditch

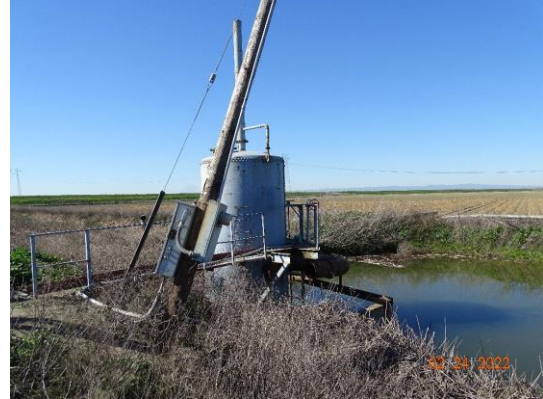
Photo 3 of 3 : UCIP_FA_2022_72996_109376.jpg

Land-Side: Pumping facility at the ditch. Service pole with electrical pannel in failing condition

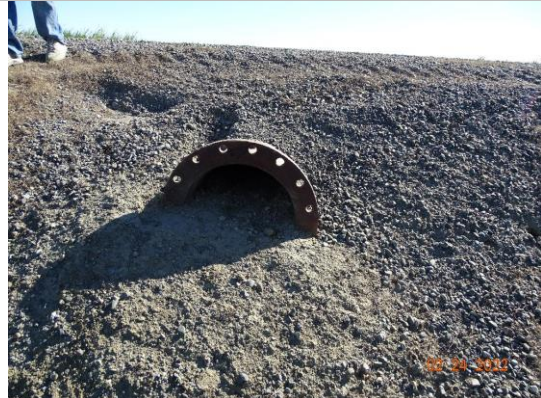
Photo 2 of 3 : UCIP_FA_2022_73243_109711.jpg

Comment Code						
Inspector Comment						
DS_ID:17756 FS_ID:73243 EP_NO: N/A Repair Type: Non-Urgent EVAL Issue: 11, Maintenance Compliance Issue Crossing Status: Found UCIP Comments: 02/24/2022 Record remains Non-Urgent. Pipe is open on waterside. Recommend capping the pipe. Sediment buildup inside the pipe. (O.Yakimov - DWR UCIP) 08/20/2020 Need to obtain a copy of USACE Drawing As-Built listed under additional references. Drawing information was listed by previous inspector. (O. Magana - DWR UCIP) 10/17/2012 Pipe not properly abandoned. (P. Amatya - DWR UCIP) FIELD_STRUCT_DESC: 18-inch steel irrigation or drainage pipe through the levee, 3 feet below the crown. [Additional Reference(s): USACE Drawing referenced as Station 74+00, As-Built Drawing: USACE, Sacramento Districts. Levee Repair- Cache Creek Settling Basin, Wahler Associates, May 1991]. (24-inch steel irrigation pipes at 5 locations authorized under Permit No. 12705, 1979 - Layton Knaggs. Permit was administratively closed). FS Date: 2/24/2022 10:58:56 AM

Water-Side: Pipe end is open on levee slope

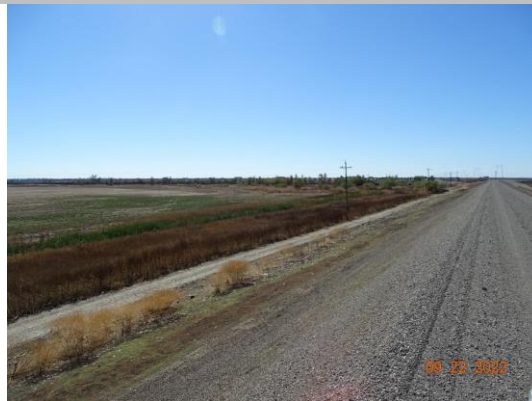
Photo 1 of 1 : FA_2022_ST0011_293_8_20220929_00005.jpg

LM Start	1.24	Rating **	A	Issue No.	8
LM End	1.24	Issue Type +	Ma	Location *	LS
Category	Earthen Levee			GPS Latitude/Longitude	
				Start	End
Item	Vegetation			38.680646 °	38.680646 °
				-121.672906 °	-121.672906 °
DWR ID	DWR_ST0011_03_f_2022_8				
Comment Code					
V1 : Control annual grass and weeds on the levee slopes and easements.					
Inspector Comment					
The LMA maintains the vegetation at a high level.

View of maintained landside slope. Fall 2022.

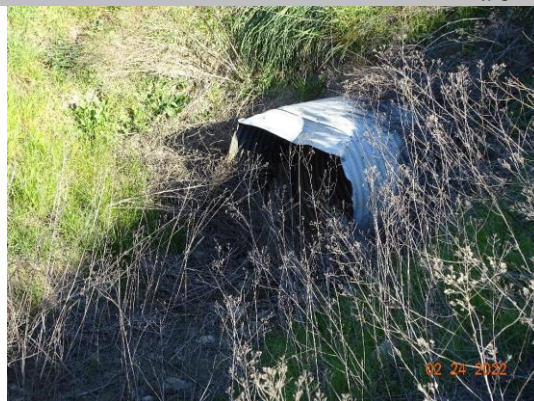
Photo 2 of 3 : UCIP_FA_2022_73263_109751.jpg

Comment Code					
Inspector Comment					
DS_ID:17754 FS_ID:73263 EP_NO: 10295 Repair Type: Urgent EVAL Issue: 1, Pipe Integrity Crossing Status: Found UCIP Comments: 02/24/2022 Record remains Urgent. DMP internal video inspection has found pipe integrity issues. LOF of crossing is between 5 and 6. Crossing will be monitored until funding becomes available to address the issues. Pipe inlet on landside is out of round shape. Sinkhole on landside slope is still present. Pipe is approaching levee at an angle on landside. (O.Yakimov - DWR UCIP) 08/20/2020 Need to obtain a copy of USACE Drawing As-Built listed under additional references. Drawing information was listed by previous inspector. (O. Magana - DWR UCIP) 04/09/2019 Internal inspection was completed and the inspection shows separation of pipe at 22 degree turn. Sink hole visible on LS slope. Coordinating with DMP - Vince Rodriguez. Recommend repair or replace. (T. Skidgel - DWR Sacramento Yard)10/17/2012 Found 48-inch CMP (not concrete culvert) and slide gate not found on LS end. (P. Amatya - DWR UCIP) FIELD_STRUCT_DESC: 48-inch corrugated metal pipe culvert through the levee, 18 feet below the crown. Slide gate on the landside (LS) end. (48-inch concrete culvert authorized under Automatic Board Order (ABO) issued as Permit No. 10295, 1974 - City of Woodland). (Intention to abandon pipe in place by grouting is pending authorization under Permit No. 19624, permit not yet issued). [Additional Reference(s): DWR Levee Log, 2004 (HLM 1.45, listed as 48-inch concrete culvert). USACE As-Built Drawing No. 50-04-3227, Sheet 14, just south of STA 882+00, March 11, 1960, listed as 48-inch CMP]. FS Date: 2/24/2022 4:12:46 PM

Land-Side: Pipe inlet at the ditch out of round shape

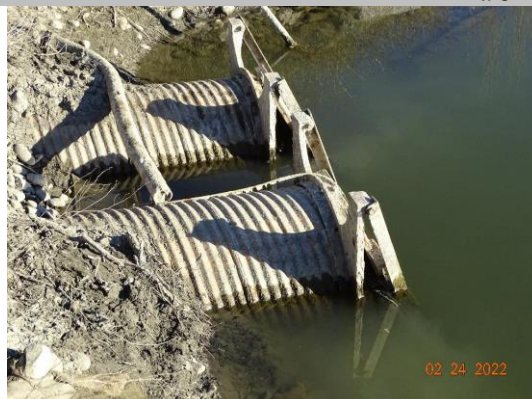
Photo 2 of 3 : UCIP_FA_2022_73266_109758.jpg

Comment Code					
Inspector Comment					
DS_ID:17761 FS_ID:73266 EP_NO: 10296 Repair Type: Urgent EVAL Issue: 3a, Flood Risk Crossing Status: Found UCIP Comments: 02/24/2022 Record updated from No Action Needed to Urgent. Flap gate cannot be properly closed due to debris accumulation. Unauthorized encroachment recorded in Levee Log. Need to have CVFPB review ABO and determine current owner. (O.Yakimov - DWR UCIP) 08/20/2020 Need to obtain a copy of USACE Drawing As-Built listed under additional references. Drawing information was listed by previous inspector. (O. Magana - DWR UCIP) 04/10/2014 summer of 2013 removed debris. (T. Skidgel - DWR Sacramento Yard)10/17/2012 Flap gate was partially open. Intake pipes in LS burried with floating debris/wooden logs. Debris removal or trash rack/screen is required. Two pipes are 5 ft apart from each other. (P. Amatya - DWR UCIP) FIELD_STRUCT_DESC: 2 of 2: 36-inch corrugated metal gravity drainage pipe through the levee, 20 feet below the crown. Slide gate on the landside (LS) end. (36-inch pipe authorized under Automatic Board Order (ABO) issued as Permit No. 10296, 1974 - Woodland Farms, Ltd.). (Intention to remove and replace pipe is pending authorization under Permit No. 19624, permit not yet issued). [Additional Reference(s): DWR Levee Log, 2004 (HLM 1.48, listed as two 36-inch pipes). USACE Drawing referenced as E-2 at Station 1+75, As-Built Drawing: USACE, Sacramento Districts. Levee Repair- Cache Creek Settling Basin, Wahler Associates, May 1991] FS Date: 2/24/2022 4:41:41 PM

Water-Side: Pipe with flap gate on waterside end. Flap gate remains open

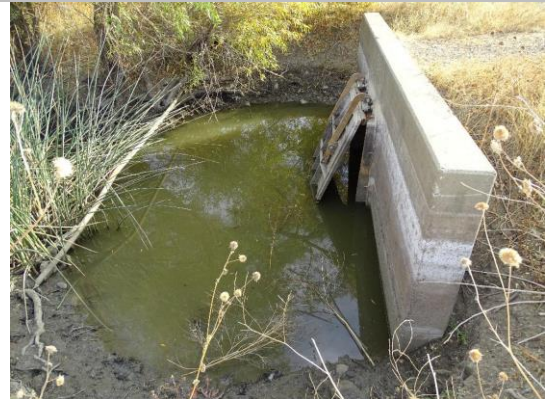
Photo 3 of 3 : UCIP_FA_2022_60250_83283.jpg

Comment Code						
Inspector Comment						
DS_ID:569 FS_ID:60250 EP_NO: 16096 Repair Type: Urgent EVAL Issue: 3a, Flood Risk Crossing Status: Found UCIP Comments: 11/07/2019 Flap gate at WS headwall not closing completely. A wooden stick on the top prevents flap gate closing leaving space for backflow. Provide maintenance on flap gate. About 20-foot long surface cracking observed on levee crown closer to LS shoulder. Not sure if cracking is related to this crossing (potential levee damage concern). (O.Yakimov - DWR UCIP)10/18/2012 The culvert was constructed in 1993. (P. Amatya - DWR UCIP) FIELD_STRUCT_DESC: 60-inch by 60-inch reinforced concrete box gravity drainage culvert through the right bank (west) levee of the Yolo Bypass, 20 feet below the crown. 60-inch by 60-inch culvert replaced an existing 30-inch gravity drain pipeline. (60-inch by 60-inch culvert authorized under Permit No. 16096, 1993 - Yolo County Flood Control and Water Conservation District, square culvert installed about 28 feet south of existing 30-inch pipe). FS Date: 11/7/2019 3:23:00 PM

Malfunctioning flap gate at WS levee toe

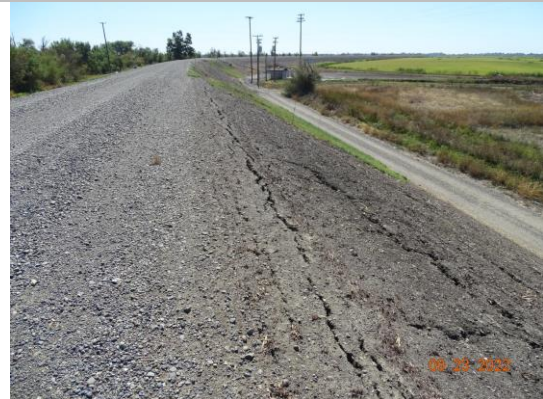
Photo 1 of 1 : FA_2022_ST0011_294_27_20220929_00039.jpg

LM Start	1.55	Rating **	A/W	Issue No.	27
LM End	1.56	Issue Type +	Ma	Location *	WS
Category	Earthen Levee			GPS Latitude/Longitude	
				Start	End
Item	Cracking			38.553316 °	38.553215 °
				-121.632420 °	-121.632325 °
DWR ID	DWR_ST0011_04_f_2022_27				
Comment Code					
CR1 : Monitor and have inspected by geotechnical engineer.					
Inspector Comment					
There appears to be desiccation cracking on the waterside slope. Recommend monitoring.

View of cracking on the waterside shoulder. Fall 2022.
