Flood Control Project Maintenance Levee Inspections

Fall 2023 Levee Maintenance Deficiency Summary Report

Sacramento River Basin

Sacramento Maintenance Yard West Levee Yolo Bypass

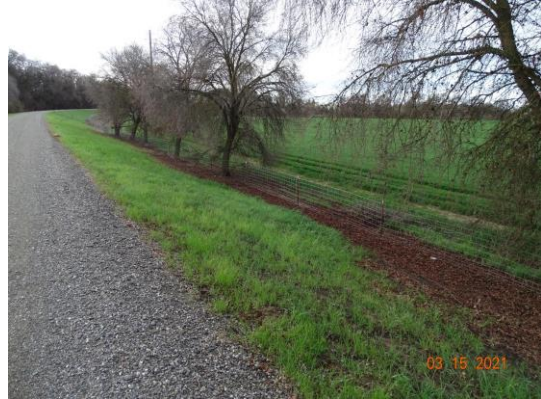
Photo 1 of 1 : FA_2023_ST0011_291_10_20231009_00005.jpg

View of fence at landside toe. Spring 2021.

LM Start	0.42	Rating **	M	Issue No.	18
LM End	0.70	Issue Type +	Ma	Location *	LS
Category	Earthen Levee			GPS Latitude/Longitude	
				Start	End
Item	Vegetation			38.754688°	38.751052°
				-121.663890°	-121.661860°
DWR ID	DWR_ST0011_01_f_2023_18				
Comment Code					
V1 : Control annual grass and weeds on the levee slopes and easements.					
Inspector Comment					
Remove vegetation off the toe of the levee.

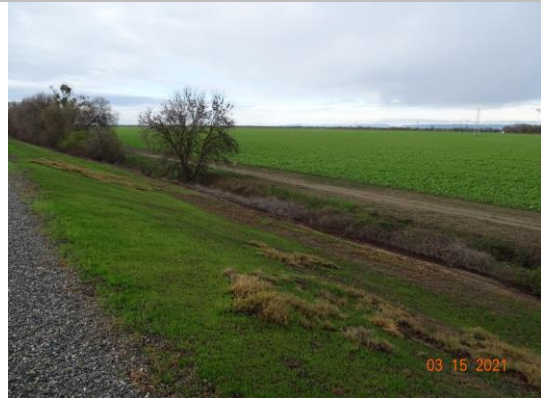
Photo 1 of 1 : FA_2023_ST0011_291_8_20231009_00003.jpg

View of ditch at landside toe. Spring 2021.

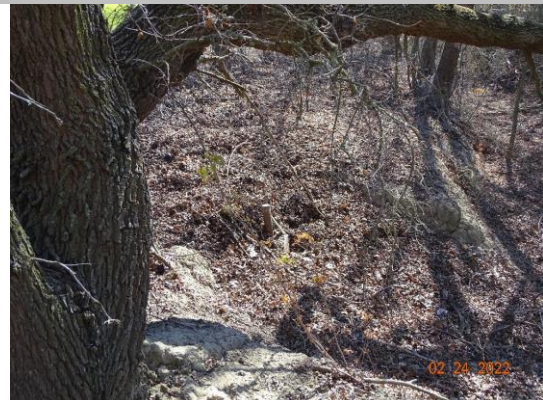
Photo 2 of 3 : UCIP_FA_2023_72806_109296.jpg

Comment Code					
Inspector Comment					
DS_ID:17745 FS_ID:72806 EP_NO: 10284 Repair Type: Non-Urgent EVAL Issue: Crossing Status: Found UCIP Comments: 02/24/2022 Record is Non-Urgent. Steel plate welded landside pipe end found in drainage ditch. Grout filler tube on the top of pipe, crossing appears abandoned by grouting. Unable to find a permit authorizing abandonment. Another pipe end is visible at riverbank. Geophysical results did not confirm presence of pipe through levee. Record will remain in UCIP's inspection records until future Levee Improvement Project can confirm no crossing was found through the levee. (O.Yakimov - DWR UCIP) FIELD_STRUCT_DESC: 24-inch corrugated metal gravity drainage pipe through the levee, 18 feet below the crown. Slide gate on the waterside (WS) slope. (24-inch pipe [HLM 0.94] authorized under Automatic Board Order (ABO) issued as Permit No. 10284, 1974 - La Borde and Hoover). [Additional Reference(s): DWR Levee Log, 2004 (HLM 0.94). USACE Sacramento O&M Manual, Unit 127, June 1953, Revised 23 November 2021, (STA 43+95), listed as 24-inch CMP. USACE As-Built Drawing No. 50-04-1548, July 1936, Sheet 1, STA 43+00]. FS Date: 2/24/2022 10:15:34 AM

Land-Side: Pipe found in drainage ditch off levee toe

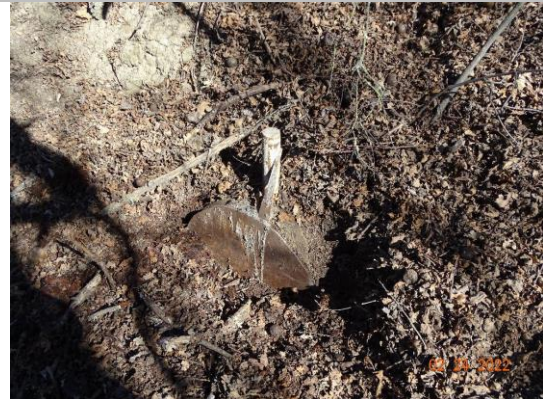
Photo 3 of 3 : UCIP_FA_2023_72806_109292.jpg

Land-Side: View of pipe end in drainage ditch

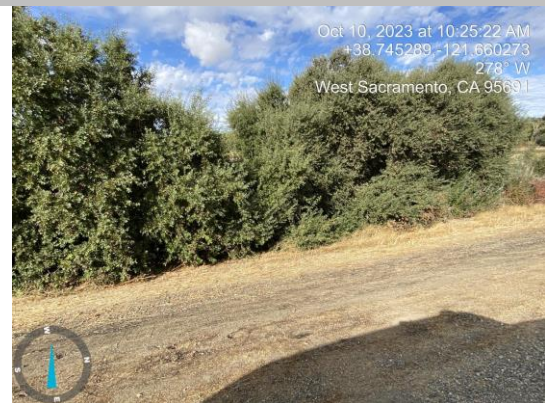
Photo 1 of 1 : FA_2023_ST0011_291_15_20231016_00021.jpg

View of low hanging limbs on the landside levee slope (Fall 2023).

LM Start	1.26	Rating **	M	Issue No.	14
LM End	1.26	Issue Type +	Ma	Location *	LS
Category	Earthen Levee			GPS Latitude/Longitude	
				Start	End
Item	Trim / Thin Trees			38.743229°	38.743229°
				-121.660252°	-121.660252°
DWR ID	DWR_ST0011_01_f_2023_14				
Comment Code					
T2 : Tree or limb.					
Inspector Comment					
Remove fallen and cut tree limbs from levee slope.

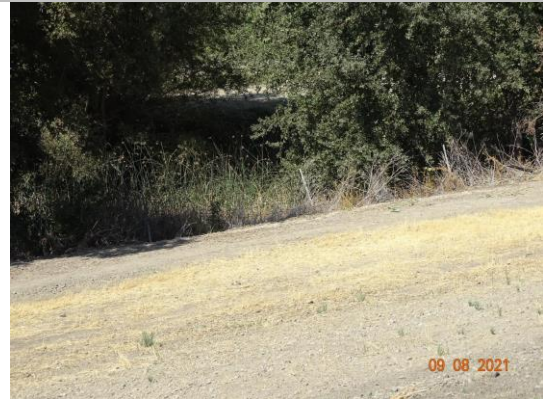
Photo 1 of 1 : FA_2023_ST0011_291_9_20231009_00004.jpg

View of fence near landside ditch and toe road. Fall 2021.

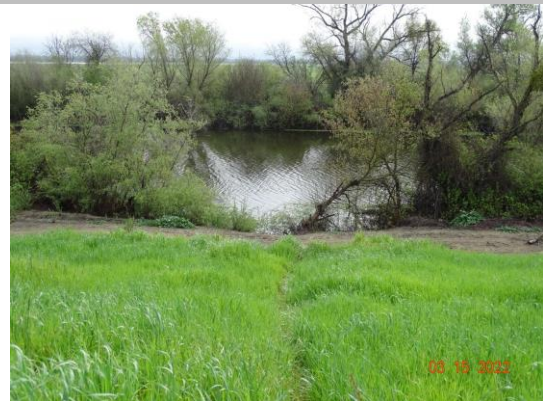
Photo 1 of 1 : FA_2023_ST0011_291_3_20231009_00001.jpg

LM Start	1.85	Rating **	A/W	Issue No.	3
LM End	1.85	Issue Type +	Ma	Location *	WS
Category	Earthen Levee			GPS Latitude/Longitude	
				Start	End
Item	Erosion / Bank Caving			38.734579°	38.734579°
				-121.660267°	-121.660267°
DWR ID	DWR_ST0011_01_s_2022_3				
Comment Code					
E1 : Note and monitor erosion site.					
Inspector Comment					
Location of narrowing waterside toe road. Recommend monitoring for future erosion.

View of toe road erosion from the crown. Spring 2022.

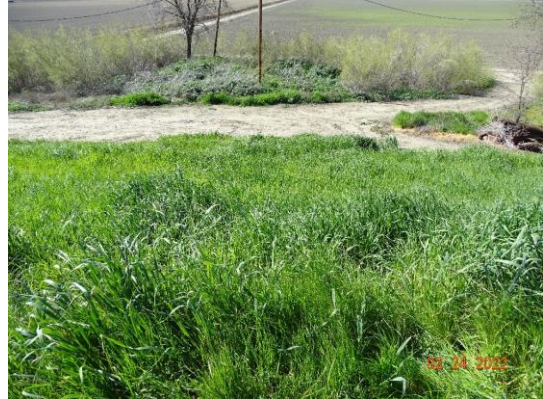
Photo 2 of 3 : UCIP_FA_2023_72846_109325.jpg

Comment Code					
Inspector Comment					
DS_ID:17744					
FS_ID:72846					
EP_NO: 10284					
Repair Type: Non-Urgent					
EVAL Issue:					
Crossing Status: Indicator Found					
UCIP Comments: 02/24/2022 Record updated from No Action Needed to Non-Urgent. Crossing not found. CMP and steel pipe debris at landside toe. Geophysical results did not confirm presence of pipe through levee. Record will remain in UCIP's inspection records until future Levee Improvement Project can confirm no crossing was found through the levee. Previous inspection comment indicate that pipe was abandoned. No permit has been identified authorizing pipe. Need to have CVFPB review ABO and determine current owner. (O.Yakimov - DWR UCIP)					
04/10/2014 This was abandoned by farmer, how Unknown. need to have verified if removed or concreted. (T. Skidgel - DWR Sacramento Yard) 10/17/2012 Found abandoned 42-inch CM pipe on LS berm of the levee. (P. Amatya - DWR UCIP)

Land-Side: View of levee slope looking from crown. Pipe debris at levee toe

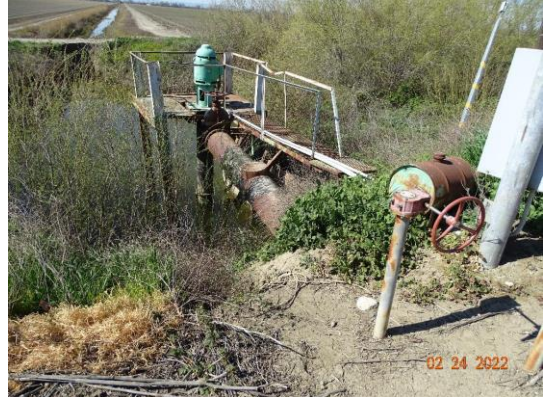
Photo 3 of 3 : UCIP_FA_2023_72852_109327.jpg

Comment Code						
Inspector Comment						
DS_ID:17743 FS_ID:72852 EP_NO: 6306 Repair Type: Non-Urgent EVAL Issue: 4b, Safety Issue Crossing Status: Found UCIP Comments: 02/24/2022 Record updated from No Action Needed to Non-Urgent. Siphon breaker riser needs to have top cover restored. (O.Yakimov - DWR UCIP) 10/17/2012 Walkway on LS to pump is in poor structural condition. Seems pump has been used for dual purpose. There is another pipe (approx. 12-inch) found near the pump crossing the ditch. (T. Skidgel - DWR UCIP)10/17/2012 The pipe is about 18-ft below the crown. Seems pump has been used for dual purpose. There is another pipe (approx. 12-inch) found near the pump crossing the ditch. Two closing valves also found in pumping station. (P. Amatya - DWR UCIP) FIELD_STRUCT_DESC: 20-inch coated steel drainage pipe through the levee, 5.8 feet below the crown. Pump and switch panel at the landside (LS) toe. Siphon breaker on the LS slope. Butterfly valves at pump on the LS toe. This crossing replaces 20-inch pipe (see DSID 25371). (20-inch pipe replacement authorized under Permit No. 6306, 1968 - William P. Wilson). [Additional Reference(s): DWR Levee Log, 2004 (HLM 1.85). USACE Sacramento O&M Manual, Unit 127, June 1953, Revised 23 November 2021, (STA 92+31.5), listed as 20-inch steel pipe]. FS Date: 2/24/2022 3:22:03 PM

Land-Side: Pump on pile structure, pipe with closure device at drainage ditch

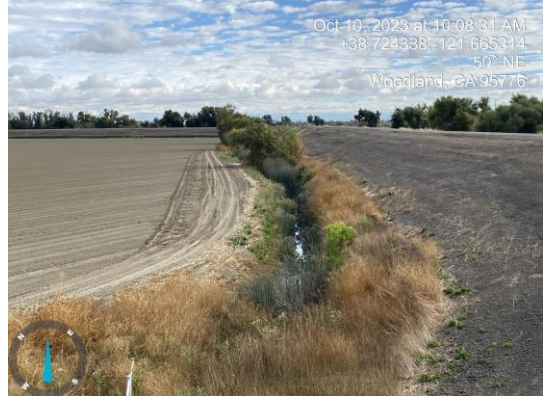
Photo 1 of 1 : FA_2023_ST0011_291_4_20231016_00022.jpg

LM Start	2.63	Rating **	M	Issue No.	4
LM End	2.72	Issue Type +	En	Location *	LS
Category	Earthen Levee			GPS Latitude/Longitude	
				Start	End
Item	Encroachments			38.724853°	38.724228°
				-121.663647°	-121.665137°
DWR ID	DWR_ST0011_01_s_2012_4				
Comment Code					
DT : Ditch					
Inspector Comment					
A ditch is at the toe of the levee.

View of the ditch at the toe of the levee on the landward side (Fall 2023).

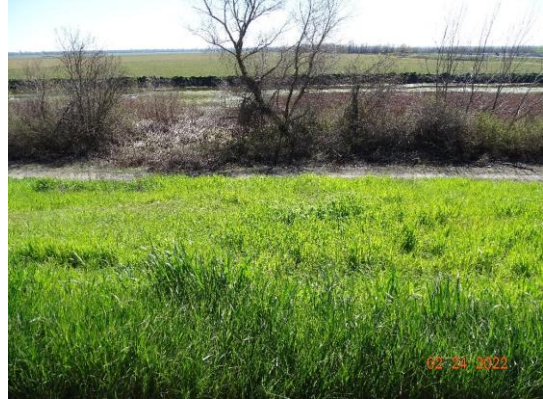
Photo 2 of 3 : UCIP_FA_2023_72854_109332.jpg

Comment Code						
Inspector Comment						
DS_ID:17742 FS_ID:72854 EP_NO: 10284 Repair Type: Non-Urgent EVAL Issue: Crossing Status: Found UCIP Comments: 02/24/2022 Record updated from No Action Needed to Non-Urgent. Crossing appears grouted. Grout filler tube on the top of pipe at concrete distribution box on landside. Marks of concrete around pipe. Unable to find a permit and confirm that pipe was properly abandoned. No signs of pipe on waterside. (O.Yakimov - DWR UCIP) 11/16/2018 Pipe is Grouted. (T. Skidgel - DWR Sacramento Yard)04/10/2014 Screw gates where removed and pipe was abanded by farmer, How pipe was abanded is unknown. (T. Skidgel - DWR Sacramento Yard)10/17/2012 Slide gate not found. (P. Amatya - DWR UCIP) FIELD_STRUCT_DESC: 1 of 2: 42-inch corrugated metal gravity drainage pipe through the levee, 23.6 feet below the crown. Slide gate on the waterside (WS) slope. Concrete distribution box at the landside (LS) toe. (42-inch pipe [HLM 2.63] authorized under Automatic Board Order (ABO) issued as Permit No. 10284, 1974 - La Borde and Hoover). [Additional Reference(s): DWR Levee Log, 2004 (HLM 2.63). USACE Sacramento O&M Manual, Unit 127, June 1953, Revised 23 November 2021, (STA 133+82), listed as two 42-inch CMP. USACE As-Built Drawing No. 50-04-1548, July 1936, Sheet 1, STA 18+90, listed as two 42-inch pipes]. FS Date: 2/24/2022 3:30:41 PM

Water-Side: View of levee slope looking from crown. Pipe not found on waterside

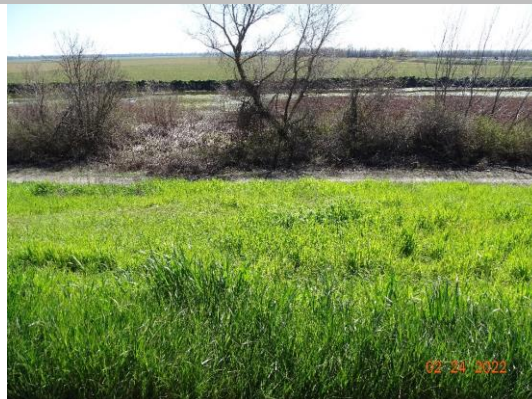
Photo 2 of 3 : UCIP_FA_2023_72858_109339.jpg

Comment Code					
Inspector Comment					
DS_ID:17747 FS_ID:72858 EP_NO: 10284 Repair Type: Non-Urgent EVAL Issue: Crossing Status: Found UCIP Comments: 02/24/2022 Record updated from No Action Needed to Non-Urgent. Crossing appears grouted. Grout filler tube on the top of pipe at concrete distribution box on landside. Marks of concrete around pipe. Unable to find a permit and confirm that pipe was properly abandoned. No signs of pipe on waterside. Geophysical results did not confirm presence of pipe through levee. Record will remain in UCIP's inspection records until future Levee Improvement Project can confirm no crossing was found through the levee. (O.Yakimov - DWR UCIP) 10/14/2014 Screw gate removed and pipe abandon by farmer, How pipe was abandoned is unknown. (T. Skidgel - DWR Sacramento Yard)10/17/2012 No slide gate found. (P. Amatya - DWR UCIP) FIELD_STRUCT_DESC: 2 of 2: 42-inch corrugated metal gravity drainage pipe through the levee, 23.6 feet below the crown. Slide gate on the waterside (WS) slope. Concrete distribution box at the landside (LS) toe. (42-inch pipe [HLM 2.63] authorized under Automatic Board Order (ABO) issued as Permit No. 10284, 1974 - La Borde and Hoover). [Additional Reference(s): DWR Levee Log, 2004 (HLM 2.63). USACE Sacramento O&M Manual, Unit 127, June 1953, Revised 23 November 2021, (STA 133+82), listed as two 42-inch CMP. USACE As-Built Drawing No. 50-04-1548, July 1936, Sheet 1, STA 18+90, listed as two 42-inch pipes]. FS Date: 2/24/2022 3:41:05 PM

Water-Side: View of levee slope looking from crown. Pipe not found on waterside

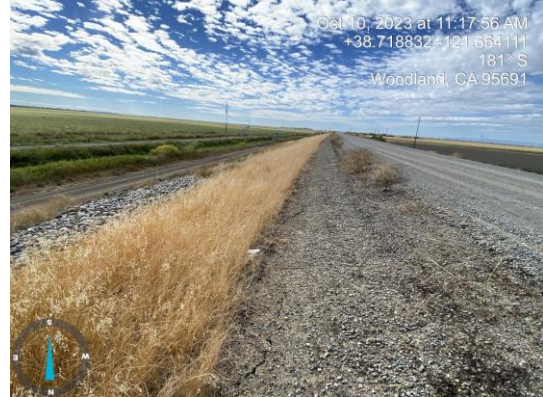
Photo 1 of 1 : FA_2023_ST0011_292_4_20231016_00009.jpg

View of vegetation on the waterside slope (Fall 2023).

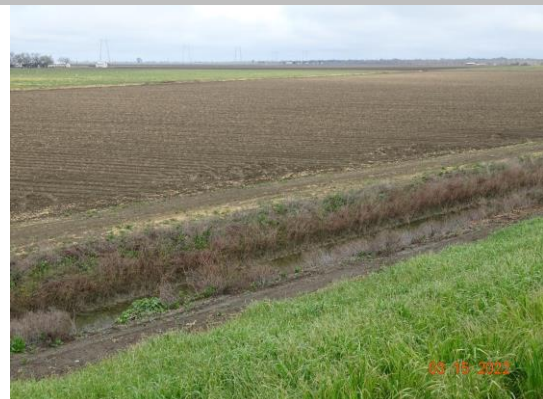
Photo 1 of 1 : FA_2023_ST0011_292_3_20231009_00001.jpg

LM Start	0.47	Rating **	M	Issue No.	3
LM End	0.97	Issue Type +	En	Location *	LS
Category	Earthen Levee			GPS Latitude/Longitude	
				Start	End
Item	Encroachments			38.712813°	38.706018°
				-121.667349°	-121.670831°
DWR ID	DWR_ST0011_02_s_2012_3				
Comment Code					
DT : Ditch					
Inspector Comment					
The ditch is approximately 10 ft deep.

View of ditch at the landside toe. Spring 2022.

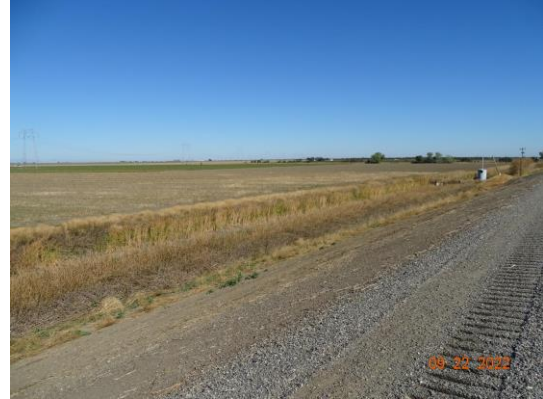
Photo 1 of 1 : FA_2023_ST0011_292_5_20231009_00002.jpg

View of ditch at the landside toe. Fall 2022.

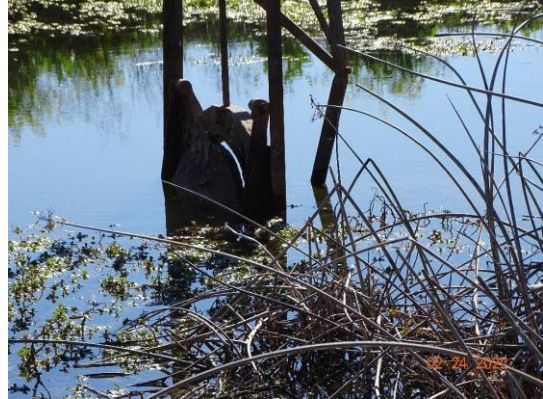
Photo 1 of 3 : UCIP_FA_2023_72996_109373.jpg

Comment Code						
Inspector Comment						
DS_ID:17748 FS_ID:72996 EP_NO: 16507 Repair Type: Non-Urgent EVAL Issue: 10, Unauthorized Modification or Non-Compliant Permit Crossing Status: Indicator Found UCIP Comments: 02/24/2022 Record updated from No Action Needed to Urgent. Crossing not found. Pump and slide gate in landside ditch have been removed. Pipe under steel walkway and in irrigation ditch on waterside have been removed, only slide gate in the ditch is visible. Unable to find a permit for original 36-inch pipe installation and for modifications. Steel walkway on waterside is in failing condition. (O.Yakimov - DWR UCIP) 10/17/2012 Slide gate on landside and waterside of the levee. Dual purpose pumping station. (P. Amatya - DWR UCIP) FIELD_STRUCT_DESC: 34-inch steel pipe sleeved through 36-inch coated steel storm drainage discharge pipeline under the right bank (west) levee of the Yolo Bypass, 18.2 feet below the crown. The annular space between the pipes filled with grout. Slide gate on the waterside (WS) slope. Pump mounted on concrete block sump at the landside (LS) toe. (Placement of 34-inch pipe inside existing 36-inch pipeline authorized under Permit No. 16507, 1995 - Joe Heidrick Enterprises, Inc). (Platform and screened-in sump authorized under Permit No. 3212, 1959 - B&J Farms). [Additional Reference(s): DWR Levee Log, 2004 (HLM 1.30). USACE As-Built Drawing No. 50-04-2185, October 1943, Sheet 1, approximate STA 248+00, listed as 36-inch CMP]. FS Date: 2/24/2022 10:02:20 AM

Water-Side: View of abandoned slide gate in irrigation ditch

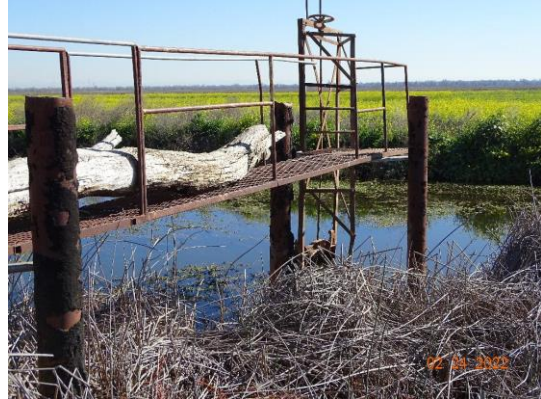
Photo 2 of 3 : UCIP_FA_2023_72996_109374.jpg

Water-Side: View of steel walkway and abandoned slide gate in irrigation ditch

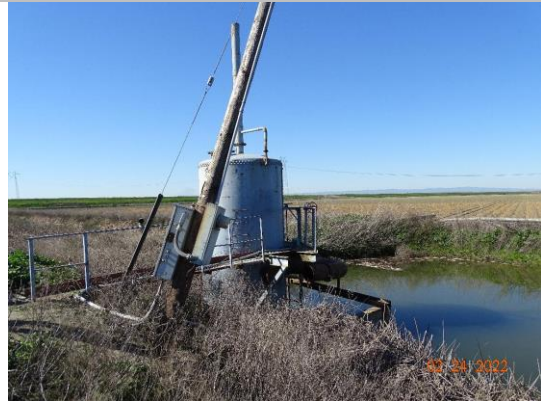
Photo 3 of 3 : UCIP_FA_2023_72996_109376.jpg

Land-Side: Pumping facility at the ditch. Service pole with electrical pannel in failing condition

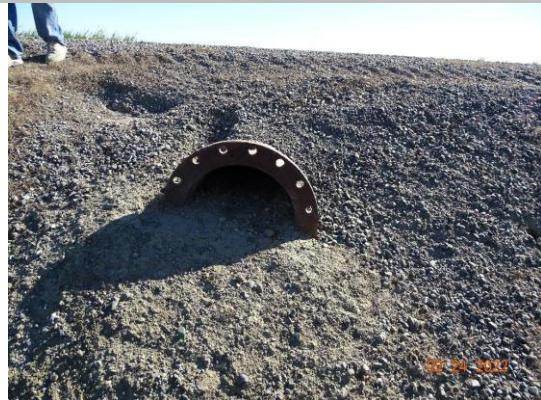
Photo 2 of 3 : UCIP_FA_2023_73243_109711.jpg

Comment Code					
Inspector Comment					
DS_ID:17756 FS_ID:73243 EP_NO: N/A Repair Type: Non-Urgent EVAL Issue: 11, Maintenance Compliance Issue Crossing Status: Found UCIP Comments: 02/24/2022 Record remains Non-Urgent. Pipe is open on waterside. Recommend capping the pipe. Sediment buildup inside the pipe. Permit associated with this pipe was administratively closed, no other permits authorizing pipe installation were identified. (O.Yakimov - DWR UCIP) 08/20/2020 Need to obtain a copy of USACE Drawing As-Built listed under additional references. Drawing information was listed by previous inspector. (O. Magana - DWR UCIP) 10/17/2012 Pipe not properly abandoned. (P. Amatya - DWR UCIP) FIELD_STRUCT_DESC: 18-inch steel irrigation or drainage pipe through the levee, 1.5 feet below the crown. (24-inch steel irrigation pipes at 5 locations authorized under Permit No. 12705, 1979 - Layton Knaggs. Permit was administratively closed). [Additional Reference(s): USACE As-Built Drawing No. CC5-04-0070, Revised 27 January 1994, Sheet 15, STA 74+00]. FS Date: 2/24/2022 10:58:56 AM

Water-Side: Pipe end is open on levee slope

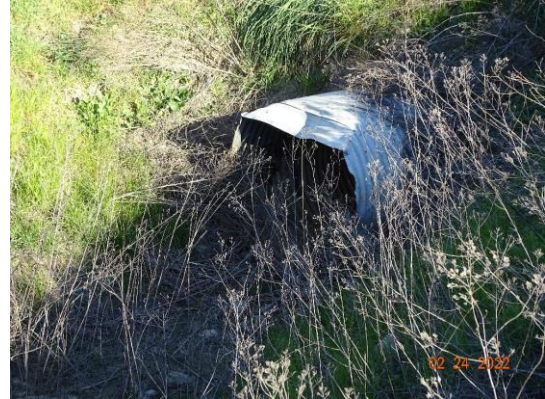
Photo 2 of 3 : UCIP_FA_2023_73263_109751.jpg

Comment Code					
Inspector Comment					
DS_ID:17754 FS_ID:73263 EP_NO: 10295 Repair Type: Urgent EVAL Issue: 1, Pipe Integrity Crossing Status: Found UCIP Comments: 02/24/2022 Record remains Urgent. DMP internal video inspection has found pipe integrity issues. LOF of crossing is between 5 and 6. Crossing will be monitored until funding becomes available to address the issues. Pipe inlet on landside is out of round shape. Sinkhole on landside slope is still present. Pipe is approaching levee at an angle on landside. No permit other then ABO has been identified authorizing pipe. (O.Yakimov - DWR UCIP) 08/20/2020 Need to obtain a copy of USACE Drawing As-Built listed under additional references. Drawing information was listed by previous inspector. (O. Magana - DWR UCIP) 04/09/2019 Internal inspection was completed and the inspection shows separation of pipe at 22 degree turn. Sink hole visible on LS slope. Coordinating with DMP - Vince Rodriguez. Recommend repair or replace. (T. Skidgel - DWR Sacramento Yard)10/17/2012 Found 48-inch CMP (not concrete culvert) and slide gate not found on LS end. (P. Amatya - DWR UCIP) FIELD_STRUCT_DESC: 48-inch corrugated metal pipe culvert through the levee, 18 feet below the crown. Slide gate on the landside (LS) end. (48-inch concrete culvert [HLM 1.45] authorized under Automatic Board Order (ABO) issued as Permit No. 10295, 1974 - City of Woodland). (Intention to abandon pipe in place by grouting is pending authorization under Permit No. 19624, City of Woodland, permit not yet issued). [Additional Reference(s): DWR Levee Log, 2004 (HLM 1.45, listed as 48-inch concrete culvert). USACE As-Built Drawing No. 50-04-3227, Sheet 14, just south of STA 882+00, March 11, 1960, listed as 48-inch CMP]. FS Date: 2/24/2022 4:12:46 PM

Land-Side: Pipe inlet at the ditch out of round shape

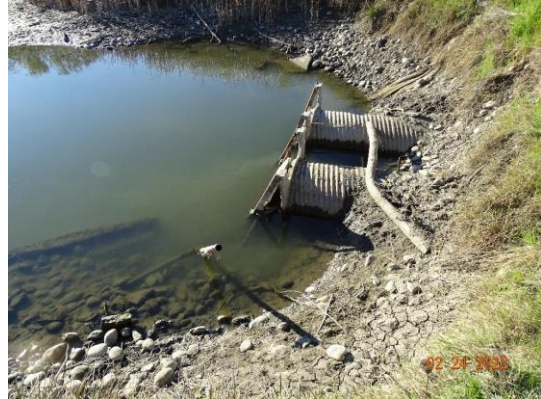
Photo 2 of 3 : UCIP_FA_2023_73265_109753.jpg

Comment Code					
Inspector Comment					
DS_ID:17753 FS_ID:73265 EP_NO: 10296 Repair Type: Urgent EVAL Issue: 3a, Flood Risk Crossing Status: Found UCIP Comments: 02/24/2022 Record updated from No Action Needed to Urgent. Flap gate cannot be properly closed due to debris accumulation. Unauthorized encroachment recorded in Levee Log. Need to have CVFPB review ABO and determine current owner. (O.Yakimov - DWR UCIP) 08/20/2020 Need to obtain a copy of USACE Drawing As-Built listed under additional references. Drawing information was listed by previous inspector. (O. Magana - DWR UCIP) 04/10/2014 summer of 2013 removed debris and mud. (T. Skidgel - DWR Sacramento Yard)10/17/2012 Flap gate was partially opened during field survey period. Intake pipe on LS was buried with floated debris/logs. Debris removal or trash rack/screen is required. Two pipes are 5 ft apart from each other. Slide gate on landward end not found. (P. Amatya - DWR UCIP) FIELD_STRUCT_DESC: 1 of 2: 36-inch corrugated metal gravity drainage pipe through the levee, 20 feet below the crown. Slide gate on the landside (LS) end. (Two 36-inch pipes [HLM 1.48] authorized under Automatic Board Order (ABO) issued as Permit No. 10296, 1974 - Woodland Farms, Ltd.). (Intention to remove and replace pipe is pending authorization under Permit No. 19624, permit not yet issued). [Additional Reference(s): DWR Levee Log, 2004 (HLM 1.48). USACE Drawing referenced as E-2 at Station 1+75, As-Built Drawing: USACE, Sacramento Districts. Levee Repair- Cache Creek Settling Basin, Wahler Associates, May 1991] FS Date: 2/24/2022 4:37:29 PM

Water-Side: Pipe with flap gate on waterside end. Flap gate remains open

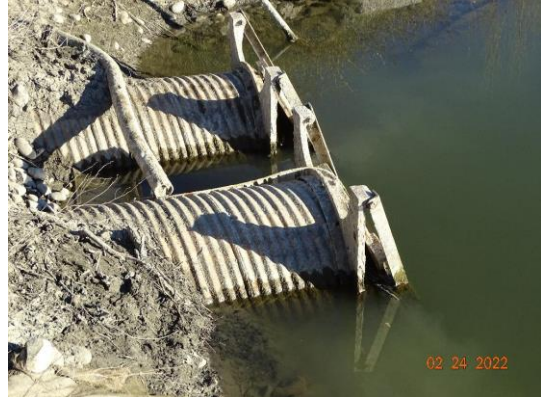
Photo 2 of 3 : UCIP_FA_2023_73266_109758.jpg

Comment Code					
Inspector Comment					
DS_ID:17761 FS_ID:73266 EP_NO: 10296 Repair Type: Urgent EVAL Issue: 3a, Flood Risk Crossing Status: Found UCIP Comments: 02/24/2022 Record updated from No Action Needed to Urgent. Flap gate cannot be properly closed due to debris accumulation. Unauthorized encroachment recorded in Levee Log. Need to have CVFPB review ABO and determine current owner. (O.Yakimov - DWR UCIP) 08/20/2020 Need to obtain a copy of USACE Drawing As-Built listed under additional references. Drawing information was listed by previous inspector. (O. Magana - DWR UCIP) 04/10/2014 summer of 2013 removed debris. (T. Skidgel - DWR Sacramento Yard)10/17/2012 Flap gate was partially open. Intake pipes in LS burried with floating debris/wooden logs. Debris removal or trash rack/screen is required. Two pipes are 5 ft apart from each other. (P. Amatya - DWR UCIP) FIELD_STRUCT_DESC: 2 of 2: 36-inch corrugated metal gravity drainage pipe through the levee, 20 feet below the crown. Slide gate on the landside (LS) end. (Two 36-inch pipes [HLM 1.48] authorized under Automatic Board Order (ABO) issued as Permit No. 10296, 1974 - Woodland Farms, Ltd.). (Intention to remove and replace pipe is pending authorization under Permit No. 19624, permit not yet issued). [Additional Reference(s): DWR Levee Log, 2004 (HLM 1.48). USACE Drawing referenced as E-2 at Station 1+75, As-Built Drawing: USACE, Sacramento Districts. Levee Repair- Cache Creek Settling Basin, Wahler Associates, May 1991] FS Date: 2/24/2022 4:41:41 PM

Water-Side: Pipe with flap gate on waterside end. Flap gate remains open

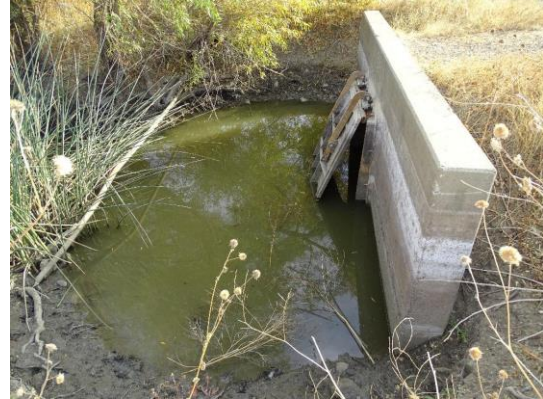
Photo 3 of 3 : UCIP_FA_2023_60250_83283.jpg

Malfunctioning flap gate at WS levee toe

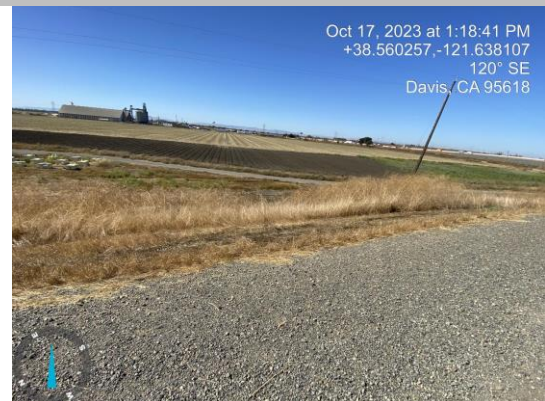
Photo 1 of 1 : FA_2023_ST0011_294_8_20231023_00015.jpg

View of vegetation on the landside slope (Fall 2023).

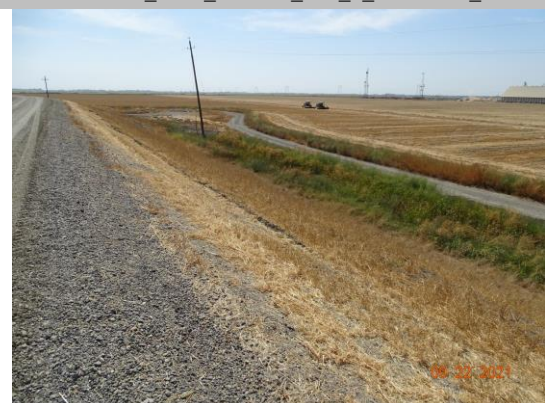
Photo 1 of 1 : FA_2023_ST0011_294_6_20231009_00003.jpg

View of ditch at landside toe. Fall 2021.

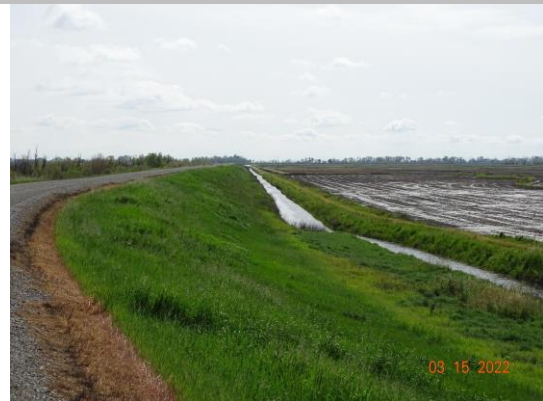
Photo 1 of 1 : FA_2023_ST0011_294_3_20231009_00001.jpg

View of the irrigation ditch at the landside toe. Spring 2022.

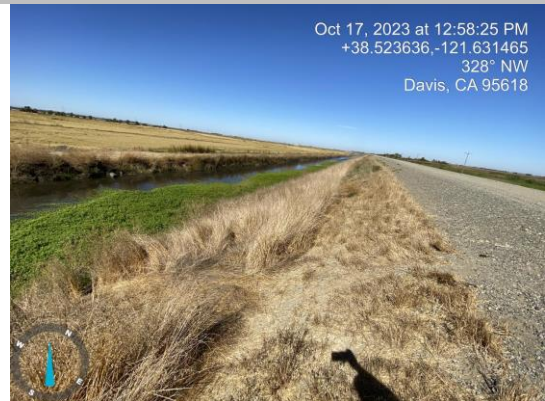
Photo 1 of 1 : FA_2023_ST0011_294_7_20231023_00016.jpg

View of vegetation on the landside slope (Fall 2023).

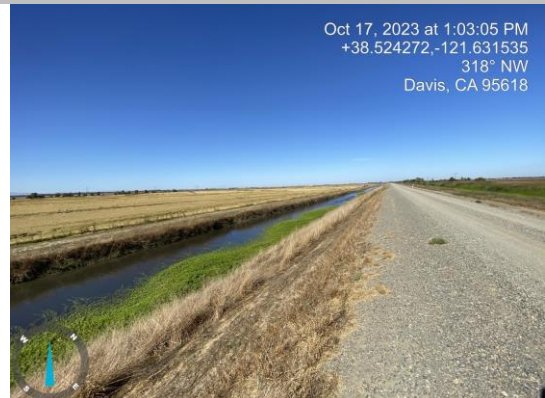
Photo 1 of 1 : FA_2023_ST0011_294_4_20231023_00017.jpg

The ditch is at the levee toe on the landward side of the levee looking downstream (Fall 2023).
