## Flood Control Project Maintenance Levee Inspections

### Fall 2024 Levee Maintenance Deficiency Summary Report

#### Sacramento River Basin

**Sacramento Maintenance Yard West Levee Yolo Bypass**

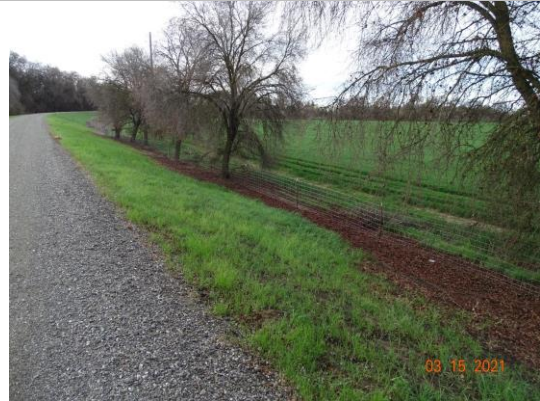
Photo 1 of 1 : FA\_2024\_ST0011\_291\_10\_20240916\_00005.jpg

View of fence at landside toe. Spring 2021.

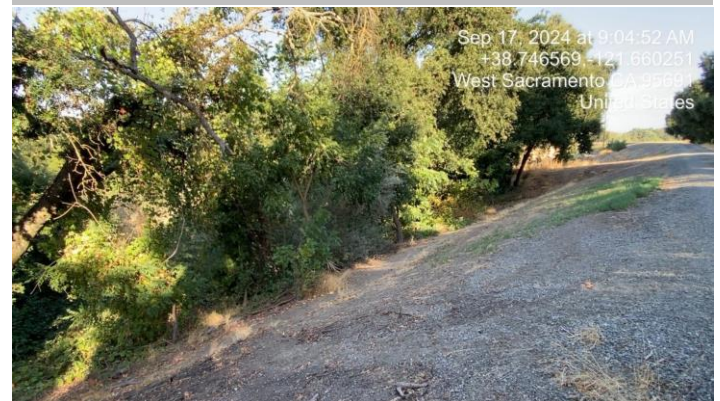
Photo 1 of 1 : FA\_2024\_ST0011\_291\_18\_20240917\_00022.jpg

LM Start	0.31	Rating **	M	Issue No.	18
LM End	0.35	Issue Type +	Ma	Location *	LS
Category	Earthen Levee			GPS Latitude/Longitude	
				Start	End
Item	Vegetation			38.756246°	38.755715°
				-121.664105°	-121.664031°
DWR ID	DWR_ST0011_01_f_2024_18				
Comment Code					
V2 : Remove the wild growth and woody vegetation other than native grasses from the levee slopes.					
Inspector Comment					
Vegetation on the toe partially blocks visibility and access.

View of vegetation on the landside toe (Fall 2024).

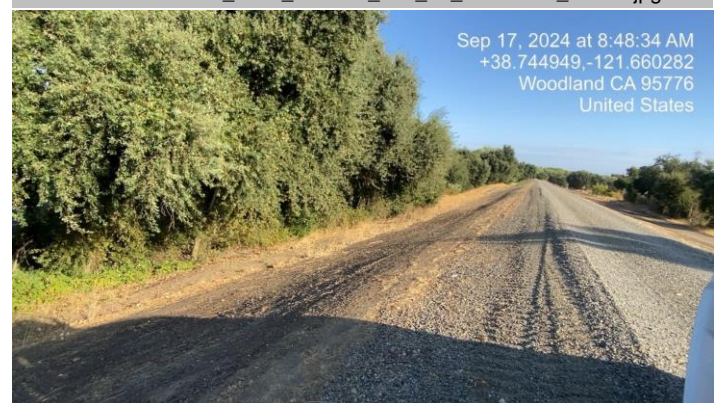
Photo 1 of 1 : FA\_2024\_ST0011\_291\_19\_20240917\_00023.jpg

LM Start	0.93	Rating **	M	Issue No.	19
LM End	1.82	Issue Type +	Ma	Location *	LS
Category	Earthen Levee			GPS Latitude/Longitude	
				Start	End
Item	Vegetation			38.748029°	38.735074°
				-121.660243°	-121.660298°
DWR ID	DWR_ST0011_01_f_2023_19				
Comment Code					
V2 : Remove the wild growth and woody vegetation other than native grasses from the levee slopes.					
Inspector Comment					
Wild growth, brush, bushes, and other woody vegetation partially block visibility and access along the theoretical toe within the ditch.

View of vegetation along the theoretical, landside, toe within the ditch (Fall 2024).

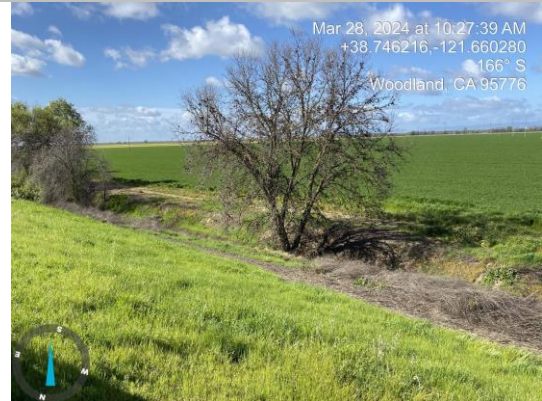
Photo 1 of 1 : FA\_2024\_ST0011\_291\_8\_20240916\_00003.jpg

View of ditch at the landside levee toe (Spring 2024).

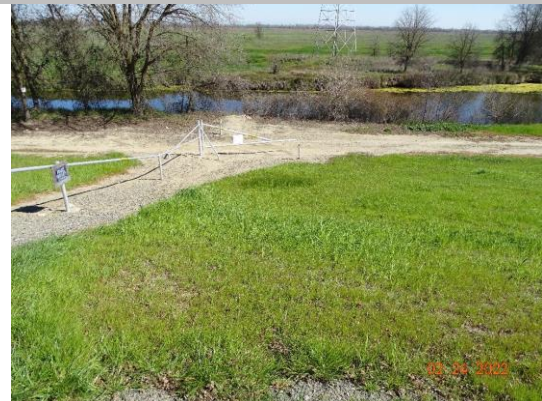
Photo 1 of 3 : UCIP\_FA\_2024\_72806\_109294.jpg

Comment Code					
Inspector Comment					
DS_ID:17745 FS_ID:72806 EP_NO: 10284 Repair Type: Non-Urgent EVAL Issue: Crossing Status: Found UCIP Comments: 02/24/2022 Record is Non-Urgent. Steel plate welded landside pipe end found in drainage ditch. Grout filler tube on the top of pipe, crossing appears abandoned by grouting. Unable to find a permit authorizing abandonment. Another pipe end is visible at riverbank. Geophysical results did not confirm presence of pipe through levee. Record will remain in UCIP's inspection records until future Levee Improvement Project can confirm no crossing was found through the levee. (O.Yakimov - DWR UCIP) FIELD_STRUCT_DESC: 24-inch corrugated metal gravity drainage pipe through the levee, 18 feet below the crown. Slide gate on the waterside (WS) slope. (24-inch pipe [HLM 0.94] authorized under Automatic Board Order (ABO) issued as Permit No. 10284, 1974 - La Borde and Hoover). [Additional Reference(s): DWR Levee Log, 2004 (HLM 0.94). USACE Sacramento O&M Manual, Unit 127, June 1953, Revised 23 November 2021, (STA 43+95), listed as 24-inch CMP. USACE As-Built Drawing No. 50-04-1548, July 1936, Sheet 1, STA 43+00]. FS Date: 2/24/2022 10:15:34 AM

Water-Side: View of levee slope looking from crown

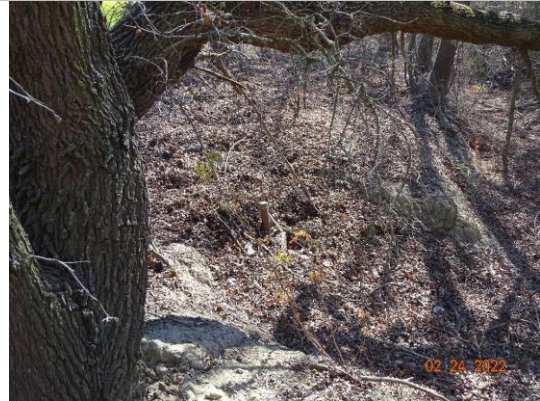
Photo 2 of 3 : UCIP\_FA\_2024\_72806\_109296.jpg

Land-Side: Pipe found in drainage ditch off levee toe

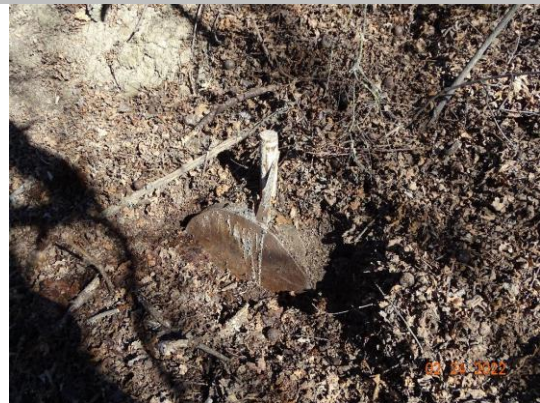
Photo 3 of 3 : UCIP\_FA\_2024\_72806\_109292.jpg

Land-Side: View of pipe end in drainage ditch

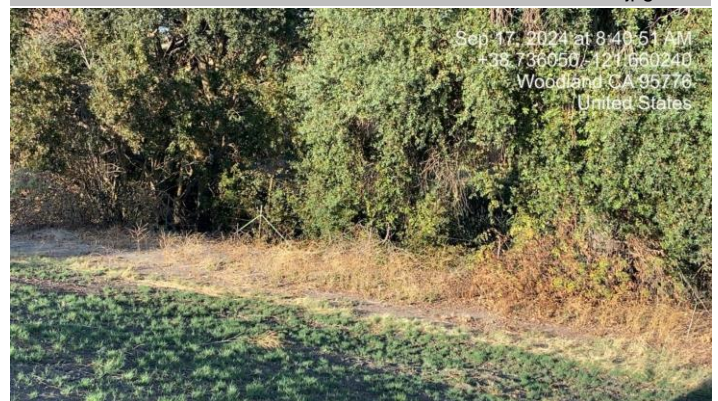
Photo 1 of 1 : FA\_2024\_ST0011\_291\_9\_20240917\_00024.jpg

View of fence near the landside toe (Fall 2024).

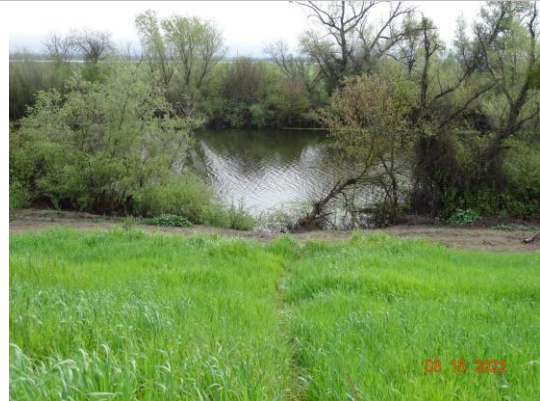
Photo 1 of 1 : FA\_2024\_ST0011\_291\_3\_20240916\_00001.jpg

LM Start	1.85	Rating **	A/W	Issue No.	3
LM End	1.85	Issue Type +	Ma	Location *	WS
Category	Earthen Levee			GPS Latitude/Longitude	
				Start	End
Item	Erosion / Bank Caving			38.734579°	38.734579°
				-121.660267°	-121.660267°
DWR ID	DWR_ST0011_01_s_2022_3				
Comment Code					
E1 : Note and monitor erosion site.					
Inspector Comment					
Location of narrowing waterside toe road. Recommend monitoring for future erosion.

View of toe road erosion from the crown. Spring 2022.

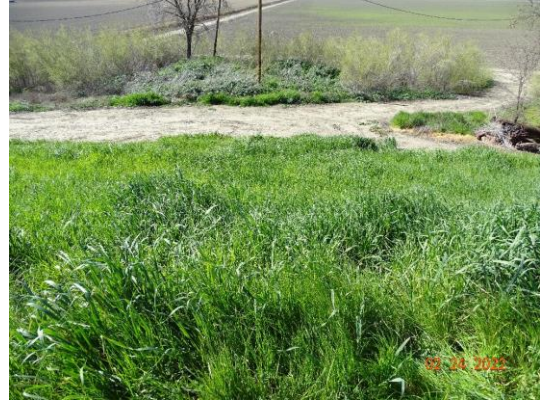
Photo 2 of 3 : UCIP\_FA\_2024\_72846\_109325.jpg

Comment Code						
Inspector Comment						
DS_ID:17744 FS_ID:72846 EP_NO: 10284 Repair Type: Non-Urgent EVAL Issue: Crossing Status: Indicator Found UCIP Comments: 02/24/2022 Record updated from No Action Needed to Non-Urgent. Crossing not found. CMP and steel pipe debris at landside toe. Geophysical results did not confirm presence of pipe through levee. Record will remain in UCIP's inspection records until future Levee Improvement Project can confirm no crossing was found through the levee. Previous inspection comment indicate that pipe was abandoned. No permit has been identified authorizing pipe. Need to have CVFPB review ABO and determine current owner. (O.Yakimov - DWR UCIP) 04/10/2014 This was abandoned by farmer, how Unknown. need to have verified if removed or concreted. (T. Skidgel - DWR Sacramento Yard) 10/17/2012 Found abandoned 42-inch CM pipe on LS berm of the levee. (P. Amatya - DWR UCIP) FIELD_STRUCT_DESC: 42-inch corrugated metal gravity drainage pipe through the levee, 25 feet below the crown. Slide gate on the waterside (WS) end. (42-inch pipe [HLM 1.85] authorized under Automatic Board Order (ABO) issued as Permit No. 10284, 1974 - La Borde and Hoover). [Additional Reference(s): DWR Levee Log, 2004 (HLM 1.85). USACE Sacramento O&M Manual, Unit 127, June 1953, Revised 23 November 2021, (STA 92+35), listed as 42-inch CMP. USACE As-Built Drawing No. 50-04-1548, July 1936, Sheet 1, STA number is unclear]. FS Date: 2/24/2022

Land-Side: View of levee slope looking from crown. Pipe debris at levee toe

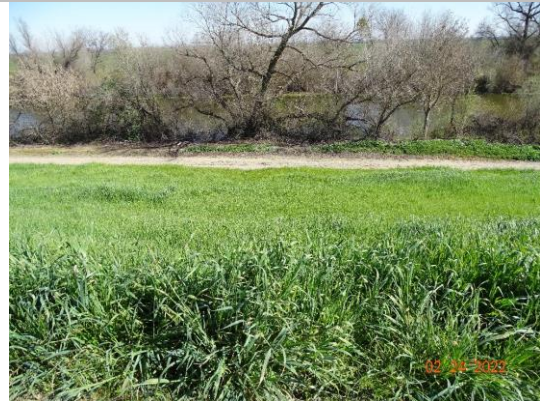
Photo 3 of 3 : UCIP\_FA\_2024\_72846\_109324.jpg

Water-Side: View of levee crown looking from crown. No evidence of pipe

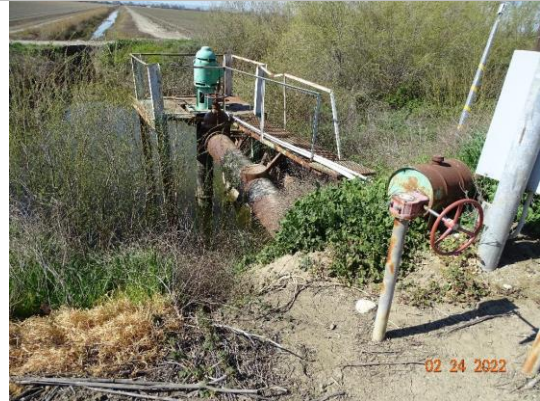
Photo 3 of 3 : UCIP\_FA\_2024\_72852\_109327.jpg

Comment Code						
Inspector Comment						
DS_ID:17743 FS_ID:72852 EP_NO: 6306 Repair Type: Non-Urgent EVAL Issue: 4b, Safety Issue Crossing Status: Found UCIP Comments: 02/24/2022 Record updated from No Action Needed to Non-Urgent. Siphon breaker riser needs to have top cover restored. (O.Yakimov - DWR UCIP) 10/17/2012 Walkway on LS to pump is in poor structural condition. Seems pump has been used for dual purpose. There is another pipe (approx. 12-inch) found near the pump crossing the ditch. (T. Skidgel - DWR UCIP)10/17/2012 The pipe is about 18-ft below the crown. Seems pump has been used for dual purpose. There is another pipe (approx. 12-inch) found near the pump crossing the ditch. Two closing valves also found in pumping station. (P. Amatya - DWR UCIP) FIELD_STRUCT_DESC: 20-inch coated steel drainage pipe through the levee, 5.8 feet below the crown. Pump and switch panel at the landside (LS) toe. Siphon breaker on the LS slope. Butterfly valves at pump on the LS toe. This crossing replaces 20-inch pipe (see DSID 25371). (20-inch pipe replacement authorized under Permit No. 6306, 1968 - William P. Wilson). [Additional Reference(s): DWR Levee Log, 2004 (HLM 1.85). USACE Sacramento O&M Manual, Unit 127, June 1953, Revised 23 November 2021, (STA 92+31.5), listed as 20-inch steel pipe]. FS Date: 2/24/2022 3:22:03 PM

Land-Side: Pump on pile structure, pipe with closure device at drainage ditch

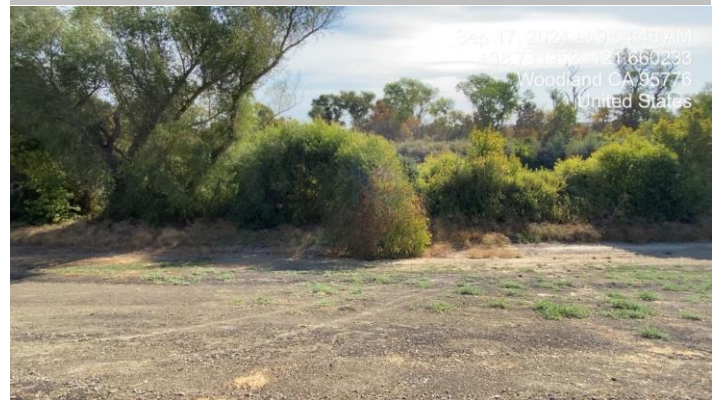
Photo 1 of 1 : FA\_2024\_ST0011\_291\_21\_20240917\_00025.jpg

LM Start	2.04	Rating **	M	Issue No.	21
LM End	2.04	Issue Type +	Ma	Location *	WS
Category	Earthen Levee			GPS Latitude/Longitude	
				Start	End
Item	Trim / Thin Trees			38.731937°	38.731937°
				-121.660293°	-121.660293°
DWR ID	DWR_ST0011_01_f_2024_21				
Comment Code					
T4 : Trim trees over roadway to at least 12 feet above ground level.					
Inspector Comment					
Hanging tree on the waterside toe road needs to be trimmed.

View of hanging tree limbs over the waterside toe road (Fall 2024).

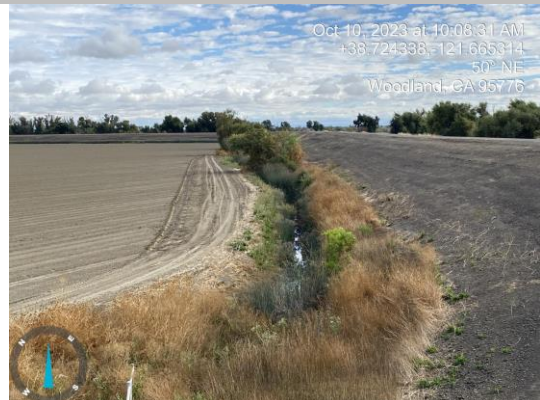
Photo 1 of 1 : FA\_2024\_ST0011\_291\_4\_20240916\_00002.jpg

LM Start	2.63	Rating **	M	Issue No.	4
LM End	2.72	Issue Type +	En	Location *	LS
Category	Earthen Levee			GPS Latitude/Longitude	
				Start	End
Item	Encroachments			38.724853°	38.724228°
				-121.663647°	-121.665137°
DWR ID	DWR_ST0011_01_s_2012_4				
Comment Code					
DT : Ditch					
Inspector Comment					
A ditch is at the toe of the levee.

View of the ditch at the toe of the levee on the landward side (Fall 2023).

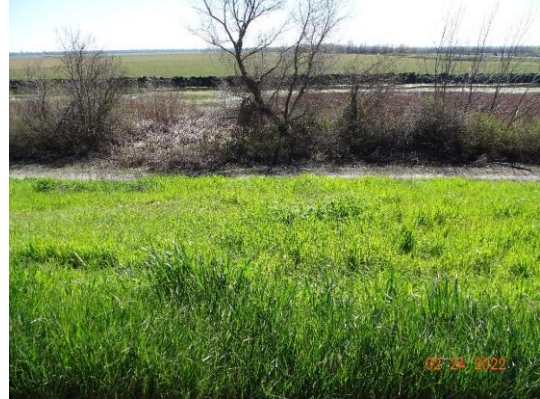
Photo 2 of 3 : UCIP\_FA\_2024\_72854\_109332.jpg

Comment Code						
Inspector Comment						
DS_ID:17742 FS_ID:72854 EP_NO: 10284 Repair Type: Non-Urgent EVAL Issue: Crossing Status: Found UCIP Comments: 02/24/2022 Record updated from No Action Needed to Non-Urgent. Crossing appears grouted. Grout filler tube on the top of pipe at concrete distribution box on landside. Marks of concrete around pipe. Unable to find a permit and confirm that pipe was properly abandoned. No signs of pipe on waterside. (O.Yakimov - DWR UCIP) 11/16/2018 Pipe is Grouted. (T. Skidgel - DWR Sacramento Yard)04/10/2014 Screw gates where removed and pipe was abanded by farmer, How pipe was abanded is unknown. (T. Skidgel - DWR Sacramento Yard)10/17/2012 Slide gate not found. (P. Amatya - DWR UCIP) FIELD_STRUCT_DESC: 1 of 2: 42-inch corrugated metal gravity drainage pipe through the levee, 23.6 feet below the crown. Slide gate on the waterside (WS) slope. Concrete distribution box at the landside (LS) toe. (42-inch pipe [HLM 2.63] authorized under Automatic Board Order (ABO) issued as Permit No. 10284, 1974 - La Borde and Hoover). [Additional Reference(s): DWR Levee Log, 2004 (HLM 2.63). USACE Sacramento O&M Manual, Unit 127, June 1953, Revised 23 November 2021, (STA 133+82), listed as two 42-inch CMP. USACE As-Built Drawing No. 50-04-1548, July 1936, Sheet 1, STA 18+90, listed as two 42-inch pipes]. FS Date: 2/24/2022 3:30:41 PM

Water-Side: View of levee slope looking from crown. Pipe not found on waterside

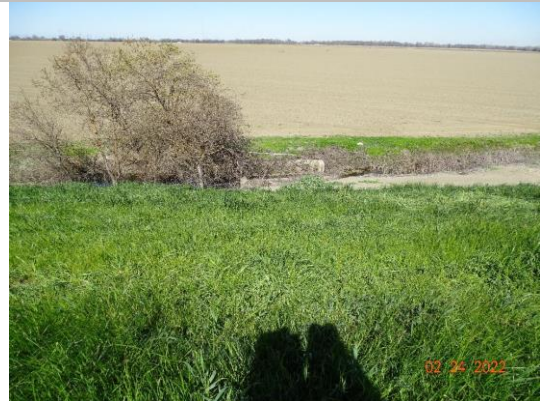
Photo 3 of 3 : UCIP\_FA\_2024\_72854\_109331.jpg

Land-Side: View of levee slope looking from crown, concrete distribution box at levee toe

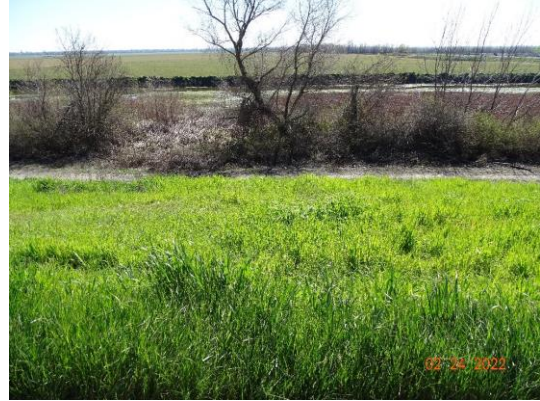
Photo 2 of 3 : UCIP\_FA\_2024\_72858\_109339.jpg

Comment Code						
Inspector Comment						
DS_ID:17747 FS_ID:72858 EP_NO: 10284 Repair Type: Non-Urgent EVAL Issue: Crossing Status: Found UCIP Comments: 02/24/2022 Record updated from No Action Needed to Non-Urgent. Crossing appears grouted. Grout filler tube on the top of pipe at concrete distribution box on landside. Marks of concrete around pipe. Unable to find a permit and confirm that pipe was properly abandoned. No signs of pipe on waterside. Geophysical results did not confirm presence of pipe through levee. Record will remain in UCIP's inspection records until future Levee Improvement Project can confirm no crossing was found through the levee. (O.Yakimov - DWR UCIP) 10/14/2014 Screw gate removed and pipe abandon by farmer, How pipe was abandoned is unknown. (T. Skidgel - DWR Sacramento Yard)10/17/2012 No slide gate found. (P. Amatya - DWR UCIP) FIELD_STRUCT_DESC: 2 of 2: 42-inch corrugated metal gravity drainage pipe through the levee, 23.6 feet below the crown. Slide gate on the waterside (WS) slope. Concrete distribution box at the landside (LS) toe. (42-inch pipe [HLM 2.63] authorized under Automatic Board Order (ABO) issued as Permit No. 10284, 1974 - La Borde and Hoover). [Additional Reference(s): DWR Levee Log, 2004 (HLM 2.63). USACE Sacramento O&M Manual, Unit 127, June 1953, Revised 23 November 2021, (STA 133+82), listed as two 42-inch CMP. USACE As-Built Drawing No. 50-04-1548, July 1936, Sheet 1, STA 18+90, listed as two 42-inch pipes]. FS Date: 2/24/2022 3:41:05 PM

Water-Side: View of levee slope looking from crown. Pipe not found on waterside

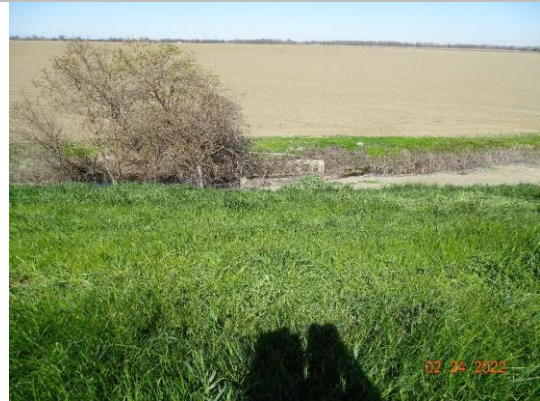
Photo 3 of 3 : UCIP\_FA\_2024\_72858\_109338.jpg

Land-Side: View of levee slope looking from crown, concrete distribution box at levee toe

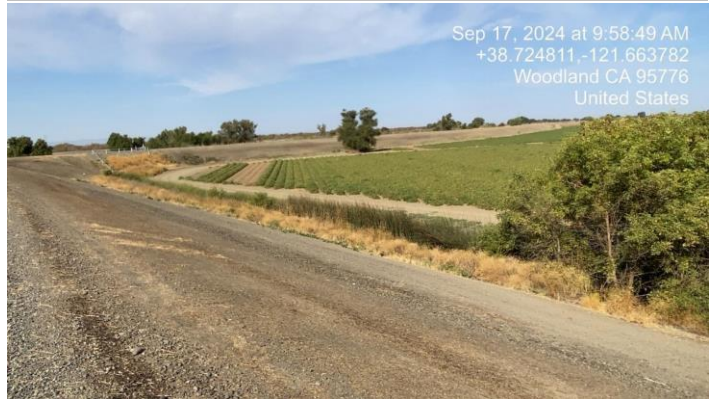
Photo 1 of 1 : FA\_2024\_ST0011\_291\_14\_20240917\_00026.jpg

View of vegetation from nearby ditch encroaching onto the slope and limiting visibility of theoretical toe (Fall 2024).

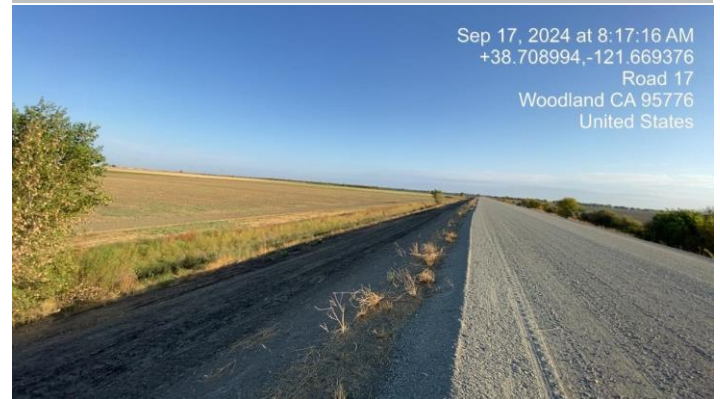
Photo 1 of 1 : FA\_2024\_ST0011\_292\_3\_20240918\_00009.jpg

View of ditch on the landside toe (Fall 2024).

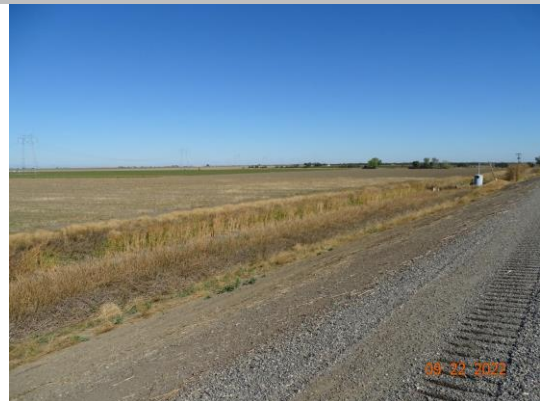
Photo 1 of 1 : FA\_2024\_ST0011\_292\_5\_20240916\_00002.jpg

View of ditch at the landside toe. Fall 2022.

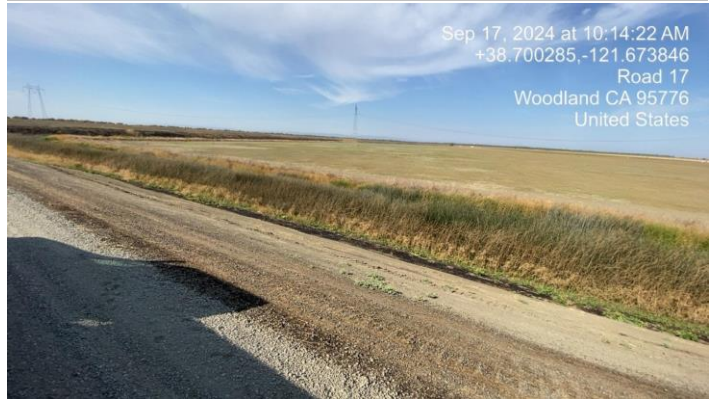
Photo 1 of 1 : FA\_2024\_ST0011\_292\_4\_20240918\_00010.jpg

View of vegetation within the ditch that is encroaching onto the slope and inhibiting visibility of the theoretical toe (Fall 2024).

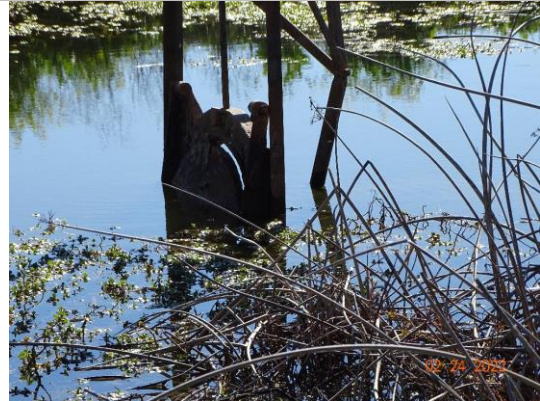
Photo 1 of 3 : UCIP\_FA\_2024\_72996\_109373.jpg

Comment Code						
Inspector Comment						
DS_ID:17748 FS_ID:72996 EP_NO: 16507 Repair Type: Non-Urgent EVAL Issue: 10, Unauthorized Modification or Non-Compliant Permit Crossing Status: Indicator Found UCIP Comments: 02/24/2022 Record updated from No Action Needed to Urgent. Crossing not found. Pump and slide gate in landside ditch have been removed. Pipe under steel walkway and in irrigation ditch on waterside have been removed, only slide gate in the ditch is visible. Unable to find a permit for original 36-inch pipe installation and for modifications. Steel walkway on waterside is in failing condition. (O.Yakimov - DWR UCIP) 10/17/2012 Slide gate on landside and waterside of the levee. Dual purpose pumping station. (P. Amatya - DWR UCIP) FIELD_STRUCT_DESC: 34-inch steel pipe sleeved through 36-inch coated steel storm drainage discharge pipeline under the right bank (west) levee of the Yolo Bypass, 18.2 feet below the crown. The annular space between the pipes filled with grout. Slide gate on the waterside (WS) slope. Pump mounted on concrete block sump at the landside (LS) toe. (Placement of 34-inch pipe inside existing 36-inch pipeline authorized under Permit No. 16507, 1995 - Joe Heidrick Enterprises, Inc). (Platform and screened-in sump authorized under Permit No. 3212, 1959 - B&J Farms). [Additional Reference(s): DWR Levee Log, 2004 (HLM 1.30). USACE As-Built Drawing No. 50-04-2185, October 1943, Sheet 1, approximate STA 248+00, listed as 36-inch CMP]. FS Date: 2/24/2022 10:02:20 AM

Water-Side: View of abandoned slide gate in irrigation ditch

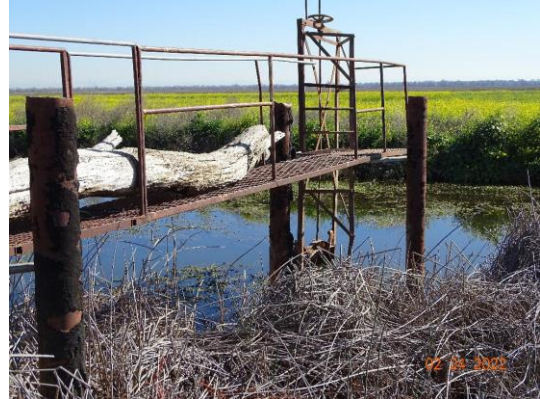
Photo 2 of 3 : UCIP\_FA\_2024\_72996\_109374.jpg

Water-Side: View of steel walkway and abandoned slide gate in irrigation ditch

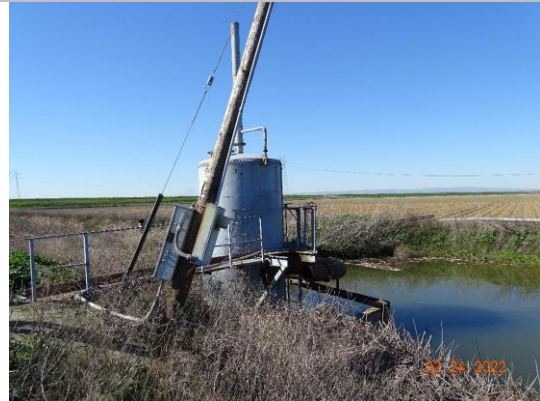
Photo 3 of 3 : UCIP\_FA\_2024\_72996\_109376.jpg

Land-Side: Pumping facility at the ditch. Service pole with electrical pannel in failing condition

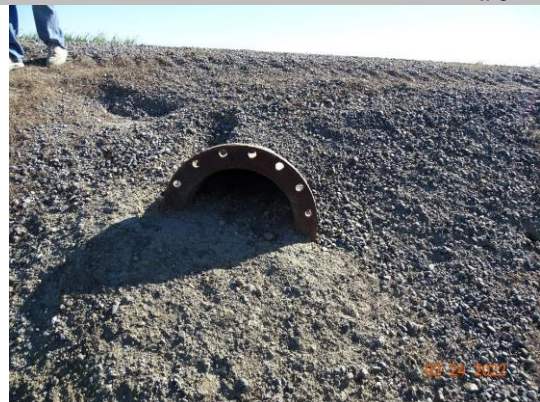
Photo 2 of 3 : UCIP\_FA\_2024\_73243\_109711.jpg

Comment Code						
Inspector Comment						
DS_ID:17756 FS_ID:73243 EP_NO: N/A Repair Type: Non-Urgent EVAL Issue: 11, Maintenance Compliance Issue Crossing Status: Found UCIP Comments: 02/24/2022 Record remains Non-Urgent. Pipe is open on waterside. Recommend capping the pipe. Sediment buildup inside the pipe. Permit associated with this pipe was administratively closed, no other permits authorizing pipe installation were identified. (O.Yakimov - DWR UCIP) 08/20/2020 Need to obtain a copy of USACE Drawing As-Built listed under additional references. Drawing information was listed by previous inspector. (O. Magana - DWR UCIP) 10/17/2012 Pipe not properly abandoned. (P. Amatya - DWR UCIP) FIELD_STRUCT_DESC: 18-inch steel irrigation or drainage pipe through the levee, 1.5 feet below the crown. (24-inch steel irrigation pipes at 5 locations authorized under Permit No. 12705, 1979 - Layton Knaggs. Permit was administratively closed). [Additional Reference(s): USACE As-Built Drawing No. CC5-04-0070, Revised 27 January 1994, Sheet 15, STA 74+00]. FS Date: 2/24/2022 10:58:56 AM

Water-Side: Pipe end is open on levee slope

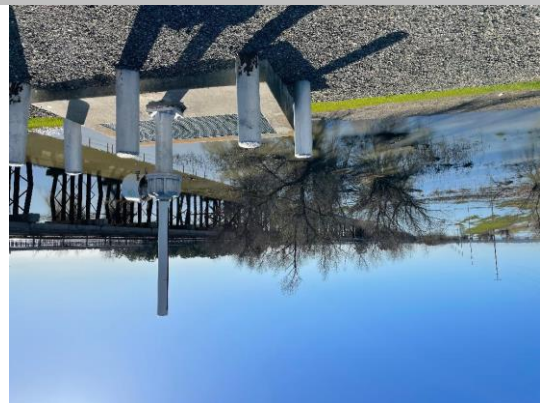
Photo 2 of 3 : UCIP\_FA\_2024\_82492\_119539.jpg

Comment Code					
Inspector Comment					
DS_ID:569 FS_ID:82492 EP_NO: 16096 Repair Type: Urgent EVAL Issue: 3a, Flood Risk Crossing Status: Found UCIP Comments: 02/28/2024 WS headwall was submerged in water and not visible during inspection. Could not verify if flap gate repairs completed since previous inspections. (J. Singh - DWR UCIP)11/07/2019 Flap gate at WS headwall not closing completely. A wooden stick on the top prevents flap gate closing leaving space for backflow. Provide maintenance on flap gate. About 20-foot long surface cracking observed on levee crown closer to LS shoulder. Not sure if cracking is related to this crossing (potential levee damage concern). (O.Yakimov - DWR UCIP)10/18/2012 The culvert was constructed in 1993. (P. Amatya - DWR UCIP) FIELD_STRUCT_DESC: 60-inch by 60-inch reinforced concrete box gravity drainage culvert through the right bank (west) levee of the Yolo Bypass, 20 feet below the crown. Concrete headwall with flap gate on waterside (WS). Concrete control box with slide gate located on WS shoulder. Concrete headwall on landside(LS). 60-inch by 60-inch culvert replaced an existing 30-inch gravity drain pipeline. (60-inch by 60-inch culvert authorized under Permit No. 16096, 1993 - Yolo County Flood Control and Water Conservation District, square culvert installed about 28 feet south of existing 30-inch pipe). FS Date: 2/28/2024

View of waterside slope with concrete control box with slide gate operator

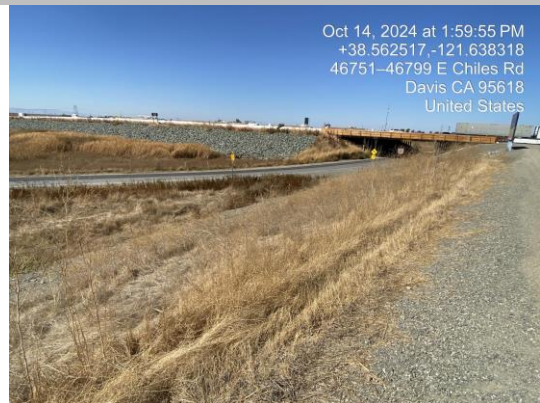
Photo 1 of 1 : FA\_2024\_ST0011\_294\_11\_20241017\_00014.jpg

View of vegetation on the landside slope (Fall 2024).

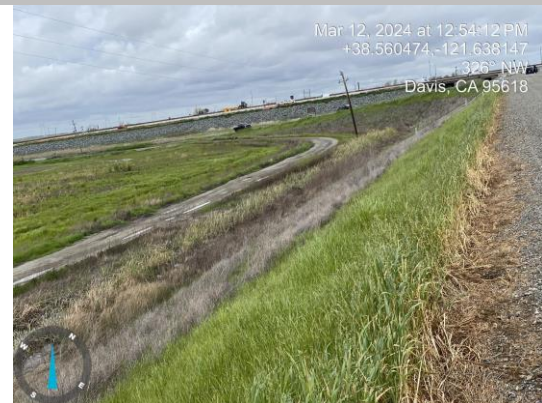
Photo 1 of 1 : FA\_2024\_ST0011\_294\_6\_20240916\_00003.jpg

View of ditch at landside toe (Spring 2024).

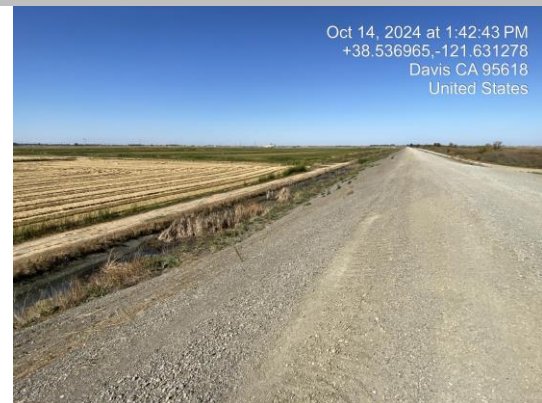
Photo 1 of 1 : FA\_2024\_ST0011\_294\_3\_20241017\_00015.jpg

View of ditch along the landside toe (Fall 2024).

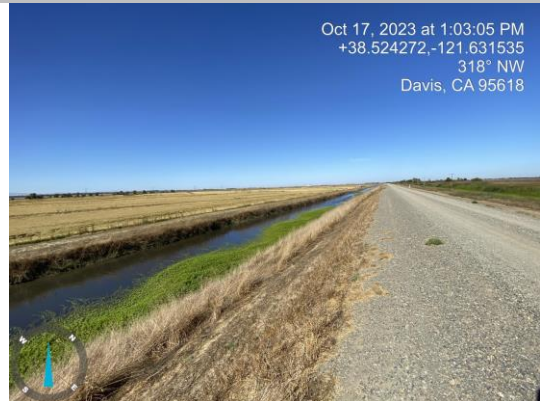
Photo 1 of 1 : FA\_2024\_ST0011\_294\_4\_20240916\_00002.jpg

The ditch is at the levee toe on the landward side of the levee looking downstream (Fall 2023).
