**Flood Control Project Maintenance  
Levee Inspections**  
**LMA District Cover Sheet**  
**Spring 2013 Levee Inspection Results**

**Sacramento Maintenance Yard West Levee Yolo Bypass**

**Levee Inspection Report By Mile - Spring 2013**

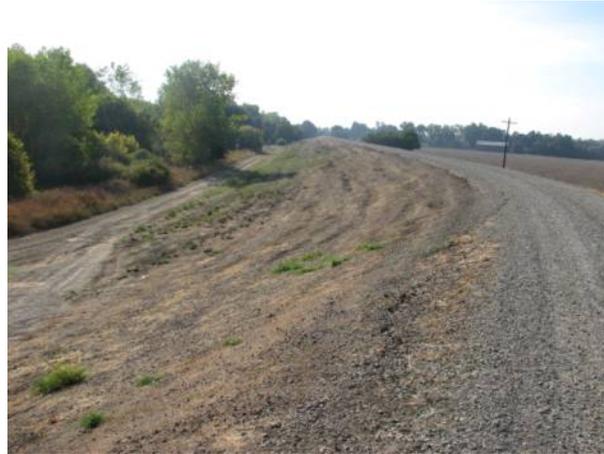
Levee Mile Report Line	1
Start Levee Mile	
End Levee Mile	
Location	Land Side
Category	
Item	Operations & Maintenance Manuals
The levee slope is mostly grasses. Photo fall 2012.	
johngw_s_20130221_754.jpg

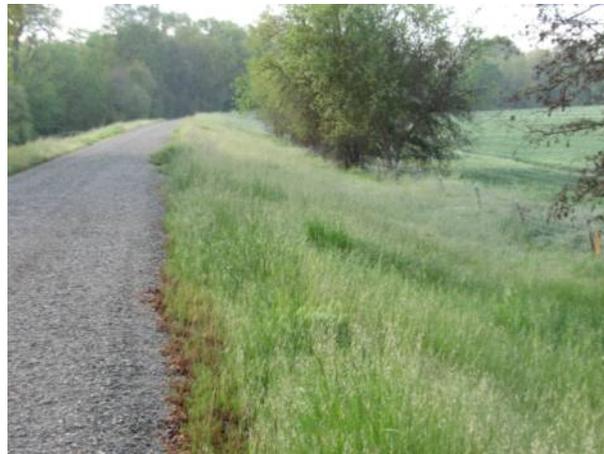
Levee Mile Report Line	4
Start Levee Mile	0.02
End Levee Mile	2.72
Location	Land Side
Category	
Item	Vegetation
The vegetation is taller than 12". Spring 2013	
johngw_s_20130408_899.JPG

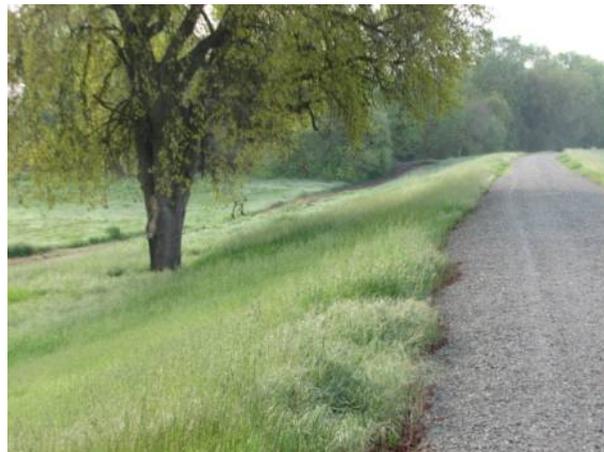
Levee Mile Report Line	5
Start Levee Mile	0.02
End Levee Mile	2.72
Location	Water Side
Category	
Item	Vegetation
The vegetation is taller than 12". Spring 2013	
johngw_s_20130408_900.JPG

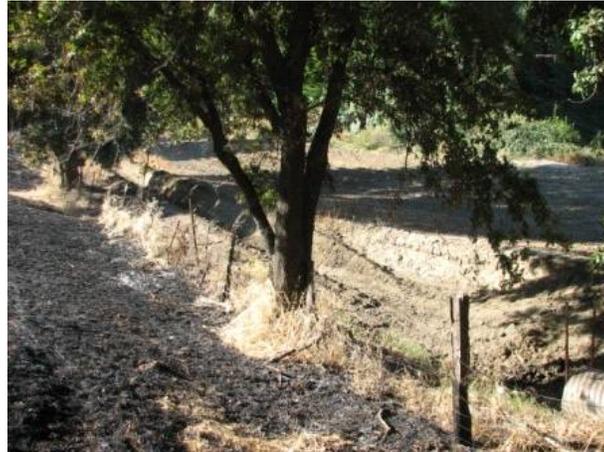
Levee Mile Report Line	6
Start Levee Mile	0.36
End Levee Mile	0.43
Location	Land Side
Category	
Item	Encroachments
<p>The end of the agricultural ditch along the toe of the levee. Photo taken Fall 2011.</p> <p>johngw_s_20130221_749.jpg</p>

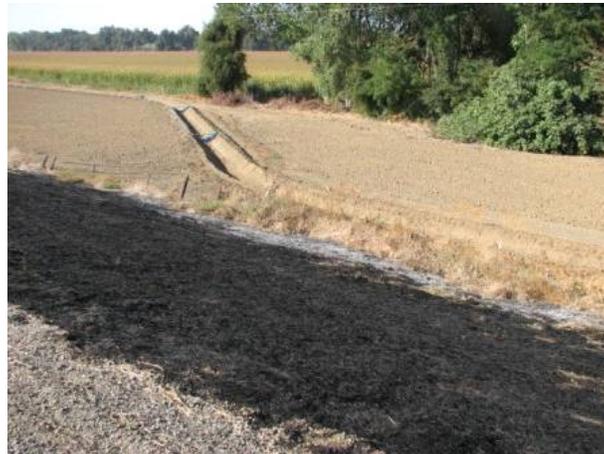
Levee Mile Report Line	6
Start Levee Mile	0.36
End Levee Mile	0.43
Location	Land Side
Category	
Item	Encroachments
<p>This photo shows the agricultural ditch as it turns towards the levee toe. Photo taken Fall 2011.</p> <p>johngw_s_20130221_750.jpg</p>

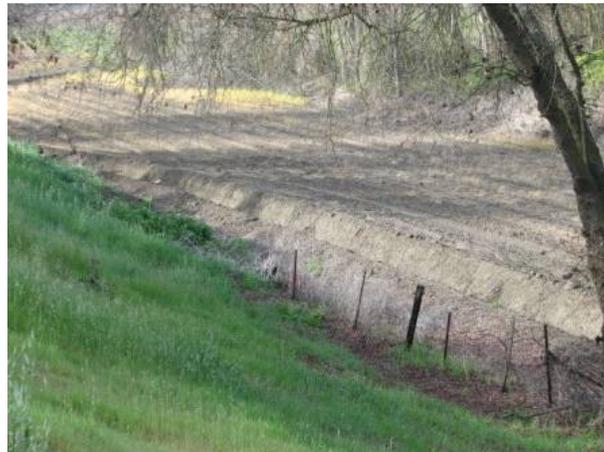
Levee Mile Report Line	6
Start Levee Mile	0.36
End Levee Mile	0.43
Location	Land Side
Category	
Item	Encroachments
<p>Photo taken spring 2012, agricultural ditch runs along toe of levee.</p> <p>johngw_s_20130221_751.jpg</p>

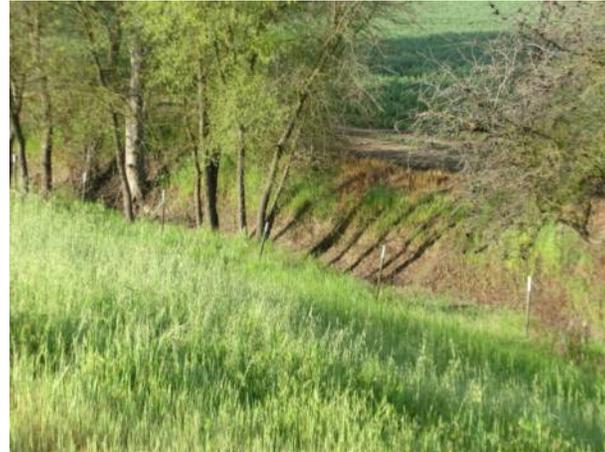
Levee Mile Report Line	7
Start Levee Mile	0.93
End Levee Mile	1.63
Location	Land Side
Category	
Item	Encroachments
<p>The agricultural ditch runs along the toe of the levee. Spring 2013</p> <p>johngw_s_20130408_901.JPG</p>

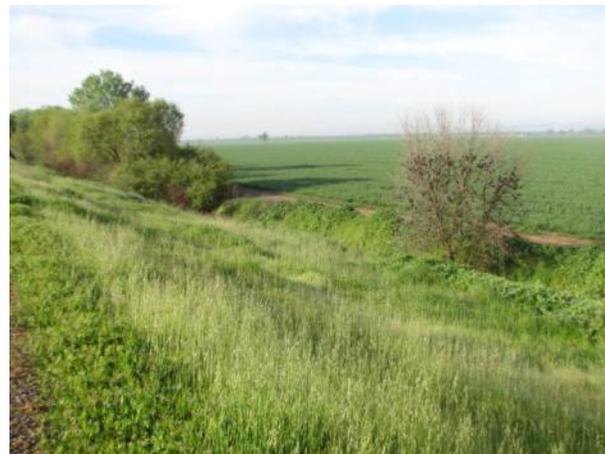
Levee Mile Report Line	7
Start Levee Mile	0.93
End Levee Mile	1.63
Location	Land Side
Category	
Item	Encroachments
<p>Another view of the agricultural ditch along the toe. Spring 2013</p> <p>johngw_s_20130408_902.JPG</p>

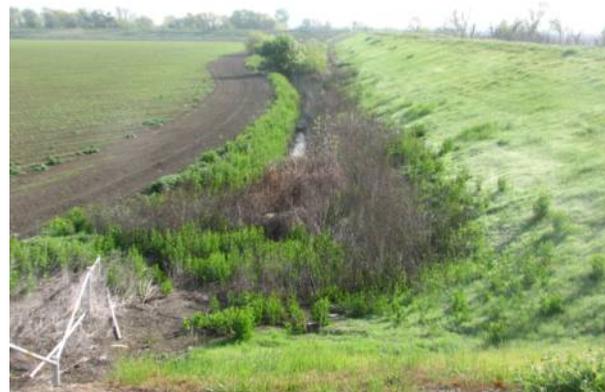
Levee Mile Report Line	9
Start Levee Mile	2.63
End Levee Mile	2.70
Location	Land Side
Category	
Item	Encroachments
<p>The agricultural ditch runs along the toe of the levee. Spring 2013</p> <p>johngw_s_20130408_903.JPG</p>

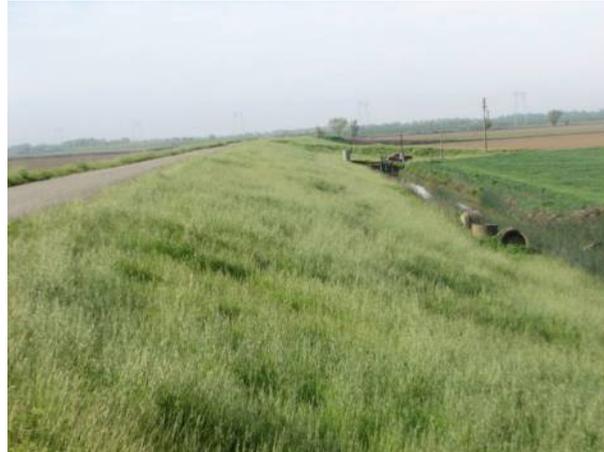
Levee Mile Report Line	1
Start Levee Mile	0.00
End Levee Mile	1.52
Location	Land Side
Category	
Item	Vegetation
The vegetation is taller than 12". Spring 2013	
johngw_s_20130408_904.JPG

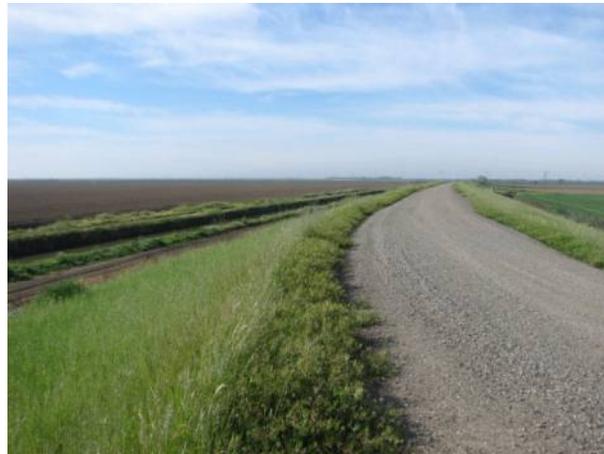
Levee Mile Report Line	2
Start Levee Mile	0.00
End Levee Mile	1.52
Location	Water Side
Category	
Item	Vegetation
The vegetation is taller than 12". Spring 2013	
johngw_s_20130408_905.JPG

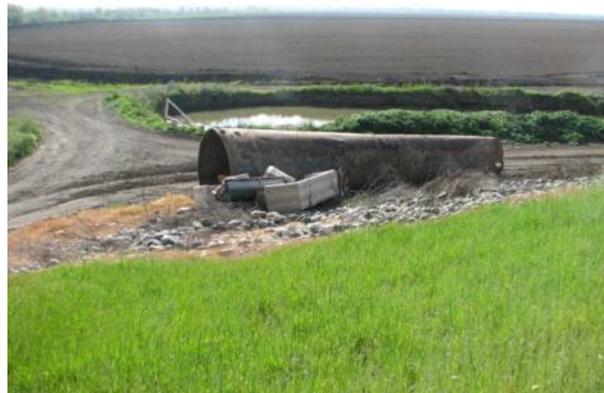
Levee Mile Report Line	3
Start Levee Mile	0.01
End Levee Mile	0.01
Location	Water Side
Category	
Item	Encroachments
Pipe and debris at the toe of the waterside of the levee. Spring 2013	
johngw_s_20130408_906.JPG

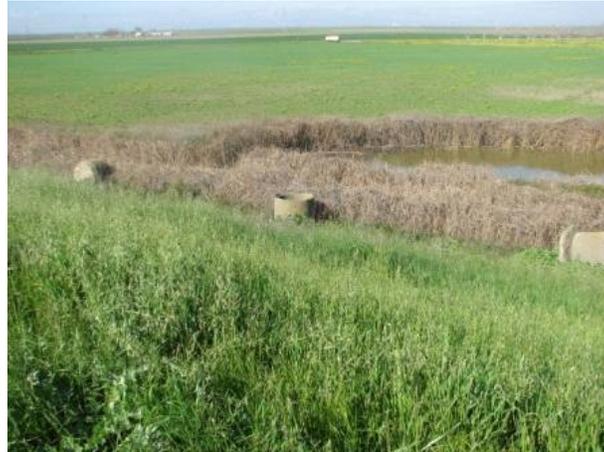
Levee Mile Report Line	4
Start Levee Mile	0.07
End Levee Mile	0.07
Location	Land Side
Category	
Item	Encroachments
Photo taken spring 2012, concrete stand pipe laying at toe of levee.	
johngw_s_20130221_761.jpg

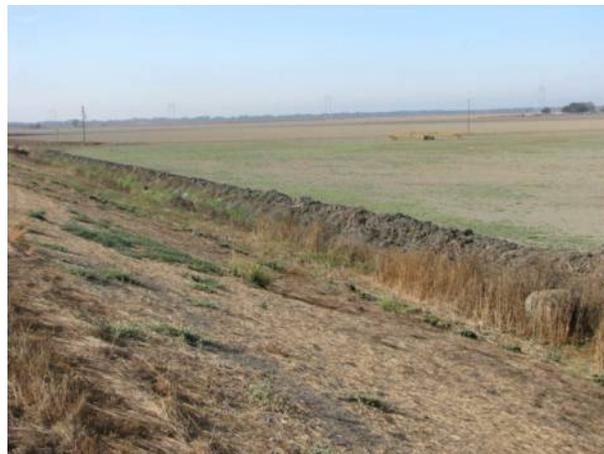
Levee Mile Report Line	5
Start Levee Mile	0.08
End Levee Mile	0.21
Location	Land Side
Category	
Item	Encroachments
The agricultural ditch is at the toe of the levee. Photo fall 2012.	
johngw_s_20130221_758.jpg

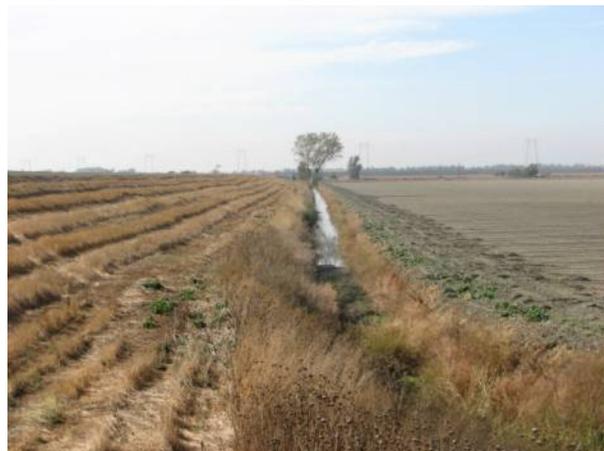
Levee Mile Report Line	6
Start Levee Mile	0.47
End Levee Mile	0.97
Location	Land Side
Category	
Item	Encroachments
The agricultural ditch is at the toe of the levee. Photo 2012.	
johngw_s_20130221_757.jpg

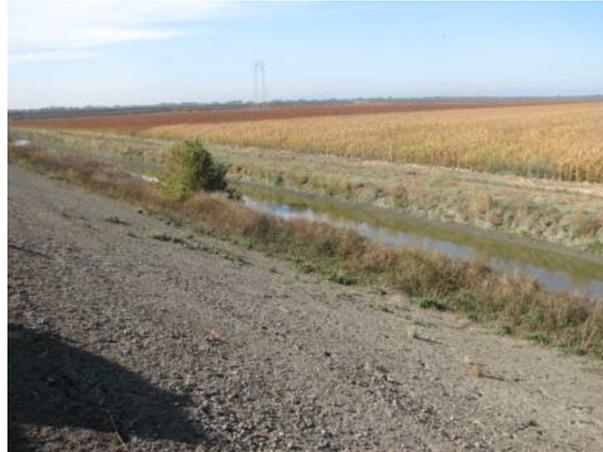
Levee Mile Report Line	7
Start Levee Mile	1.15
End Levee Mile	1.44
Location	Land Side
Category	
Item	Encroachments
<p>The agricultural ditch is at the toe of the levee. Photo fall 2012.</p>	
<p>johngw_s_20130221_759.jpg</p>

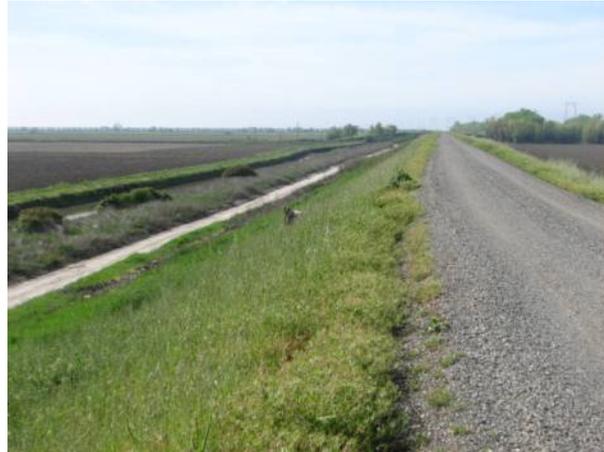
Levee Mile Report Line	1
Start Levee Mile	0.00
End Levee Mile	1.46
Location	Water Side
Category	
Item	Vegetation
The vegetation is taller than 12". Spring 2013	
dpesaven_s_20130412_914.JPG

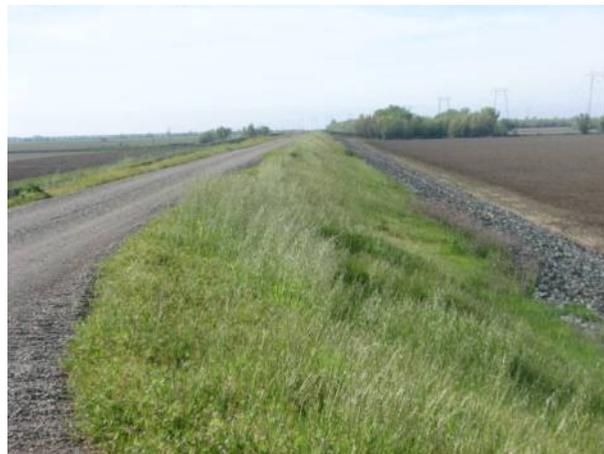
Levee Mile Report Line	2
Start Levee Mile	0.00
End Levee Mile	1.46
Location	Land Side
Category	
Item	Vegetation
The vegetation is taller than 12". Spring 2013	
johngw_s_20130408_913.JPG

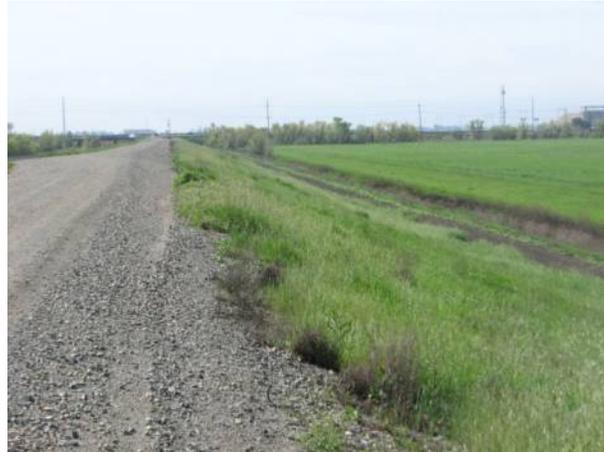
Levee Mile Report Line	1
Start Levee Mile	0.02
End Levee Mile	3.60
Location	Land Side
Category	
Item	Vegetation
The vegetation is taller than 12". Spring 2013	
johngw_s_20130408_911.JPG

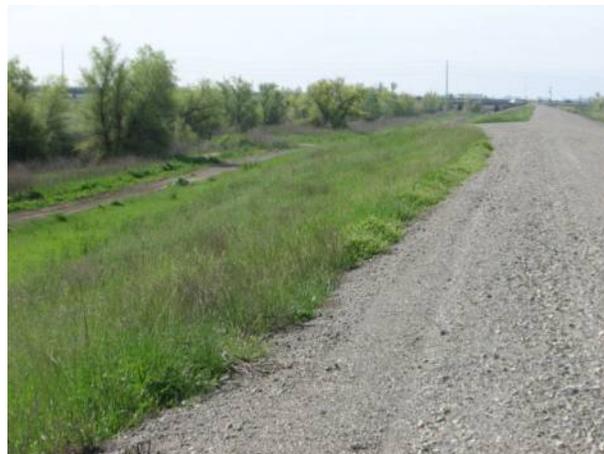
Levee Mile Report Line	2
Start Levee Mile	0.02
End Levee Mile	3.60
Location	Water Side
Category	
Item	Vegetation
The vegetation is taller than 12". Spring 2013	
johngw_s_20130408_910.JPG

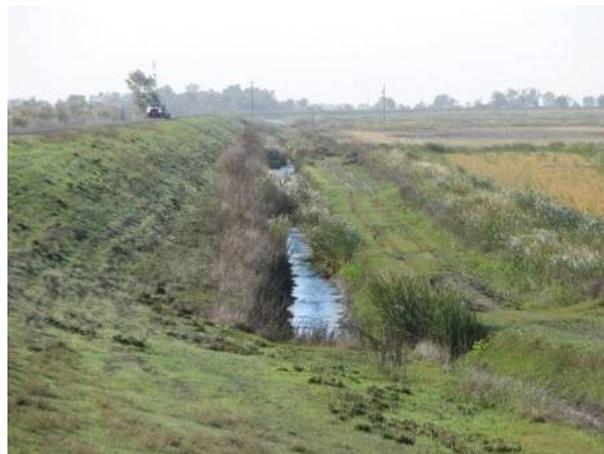
Levee Mile Report Line	3
Start Levee Mile	1.78
End Levee Mile	2.70
Location	Land Side
Category	
Item	Encroachments
The argricultural ditch runs along the landside toe. Fall 2011	
johngw_s_20130221_765.jpg

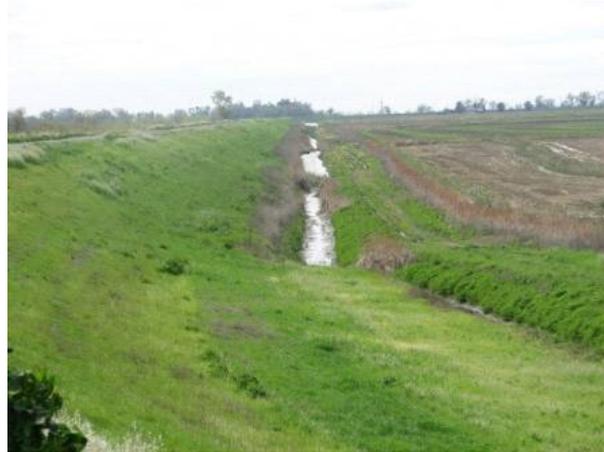
Levee Mile Report Line	3
Start Levee Mile	1.78
End Levee Mile	2.70
Location	Land Side
Category	
Item	Encroachments
Photo taken spring 2012, agricultural ditch runs along toe of levee.	
johngw_s_20130221_766.jpg

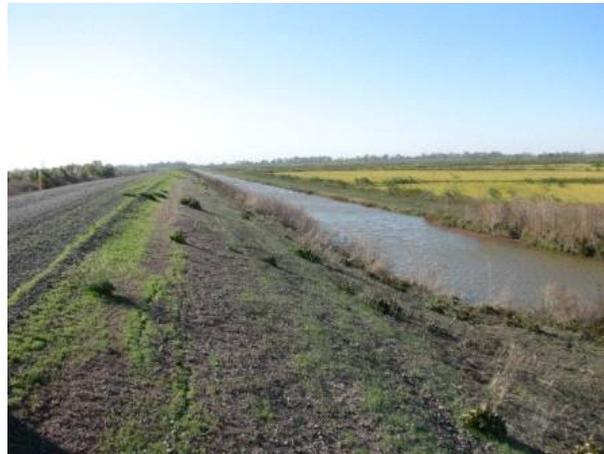
Levee Mile Report Line	4
Start Levee Mile	2.76
End Levee Mile	3.60
Location	Land Side
Category	
Item	Encroachments
The argricultural ditch runs along the toe of the landside. Fall 2011	
johngw_s_20130221_767.jpg

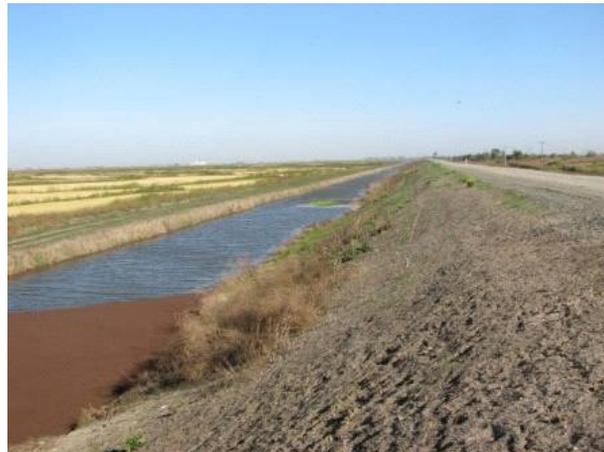
Levee Mile Report Line	4
Start Levee Mile	2.76
End Levee Mile	3.60
Location	Land Side
Category	
Item	Encroachments
This view is looking to the north. Fall 2011	
johngw_s_20130221_768.jpg

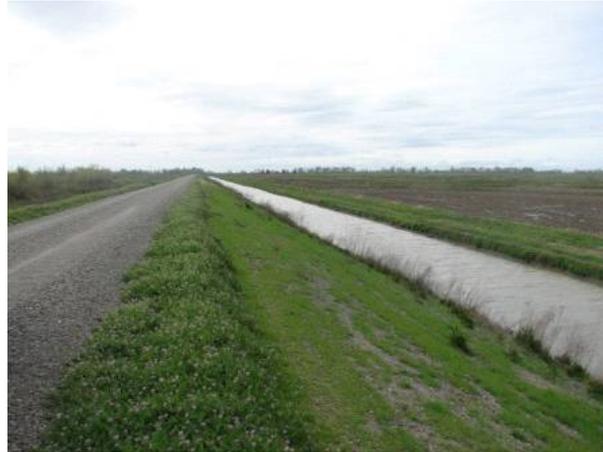
Levee Mile Report Line	4
Start Levee Mile	2.76
End Levee Mile	3.60
Location	Land Side
Category	
Item	Encroachments
Photo taken spring 2012, agricultural ditch runs along toe of levee.	
johngw_s_20130221_769.jpg
