**Flood Control Project Maintenance
Levee Inspections
LMA District Cover Sheet
Spring 2014 Levee Inspection Results**

Sacramento Maintenance Yard West Levee Yolo Bypass

Spring 2014 Levee Inspection Results

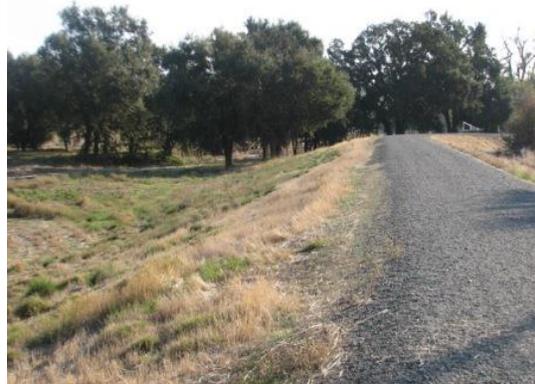
Photo 1 of 2 : johngw_s_20140306_597.jpg

LM Start	0.01	Rating **	A	Issue No.	172
LM End	2.72	Issue Type +	Ma	Location *	WS
Category	Earthen Levee		GPS Latitude/Longitude		
			Start	End	
Item	Vegetation		38.758955 °	38.724230 °	
			-121.667352 °	-121.665188 °	
DWR ID	DWR_ST0011_01_f_2013_172				
Action/Comments					
Control annual grass and weeds on the levee slopes and easements.

The levee slope is covered with grasses or sod. Fall 2013

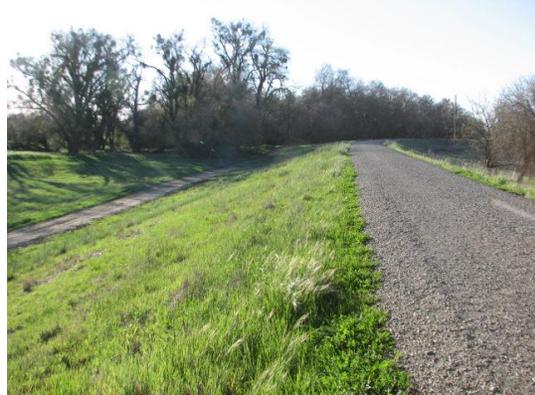
Photo 2 of 2 : johngw_s_20140317_621.jpg

The levee slope complies with standards. Spring 2014

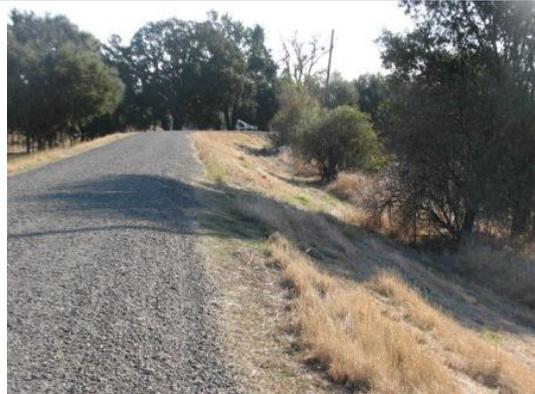
Photo 1 of 2 : johngw_s_20140306_592.jpg

LM Start	0.01	Rating **	A	Issue No.	3
LM End	2.72	Issue Type +	Ma	Location *	LS
Category	Earthen Levee		GPS Latitude/Longitude		
			Start	End	
Item	Vegetation		38.758932 °	38.724242 °	
			-121.667330 °	-121.665162 °	
DWR ID	DWR_ST0011_01_s_2014_3				
Action/Comments					
Control annual grass and weeds on the levee slopes and easements.

Better than 50% of the levee slope are grasses. Fall 2013

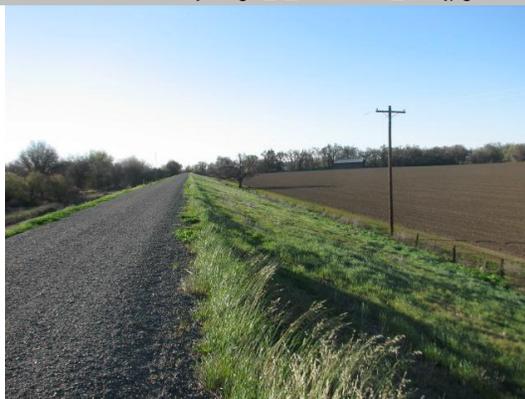
Photo 2 of 2 : johngw_s_20140317_622.jpg

The levee slope complies with standards. Spring 2014

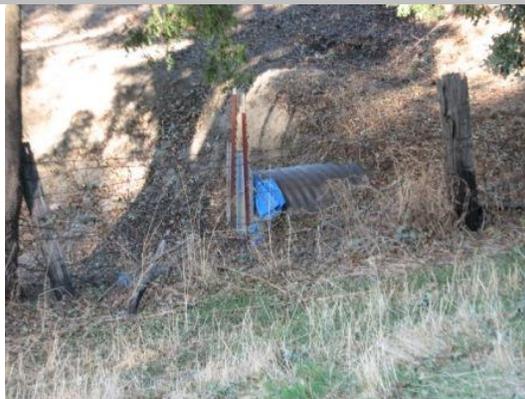
Photo 1 of 3 : johngw_s_20140306_590.jpg

LM Start	0.36	Rating **	M	Issue No.	1
LM End	0.43	Issue Type +	En	Location *	LS
Category	Earthen Levee		GPS Latitude/Longitude		
			Start	End	
Item	Encroachments		38.755535 °	38.754512 °	
			-121.664127 °	-121.663907 °	
DWR ID	DWR_ST0011_01_s_2012_1				
Action/Comments					
Ditch

The culvert at the end of the agricultural ditch. Fall 2013

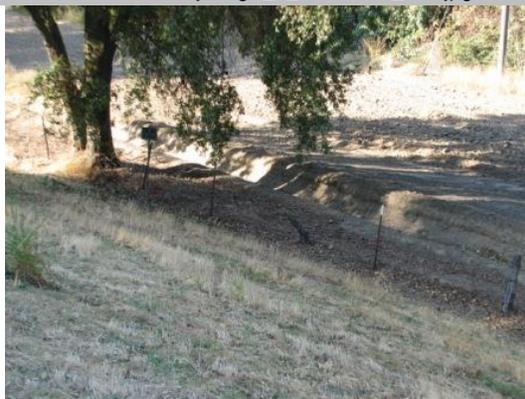
Photo 2 of 3 : johngw_s_20140306_591.jpg

The agricultural ditch along the levee toe. Fall 2013

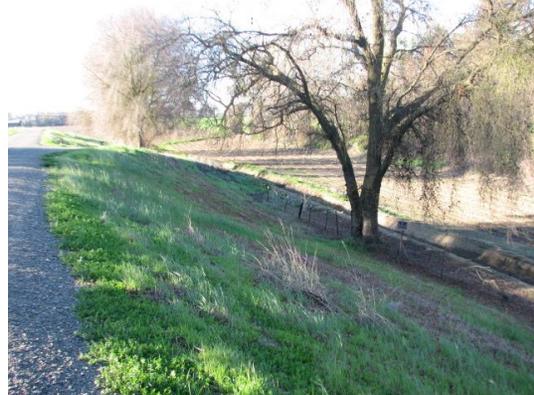
Photo 3 of 3 : johngw_s_20140317_623.jpg

The drain ditch runs along the toe of the levee. Spring 2014

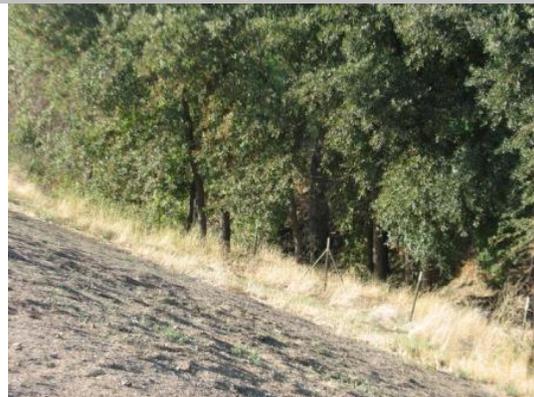
Photo 1 of 2 : johngw_s_20140306_595.jpg

LM Start	0.93	Rating **	M	Issue No.	8
LM End	1.63	Issue Type +	En	Location *	LS
Category	Earthen Levee		GPS Latitude/Longitude		
			Start	End	
Item	Encroachments		38.747888 °	38.737688 °	
			-121.660202 °	-121.660235 °	
DWR ID	DWR_ST0011_01_s_2012_8				
Action/Comments					
Ditch

The agricultural ditch runs along the toe of the levee. Fall 2013

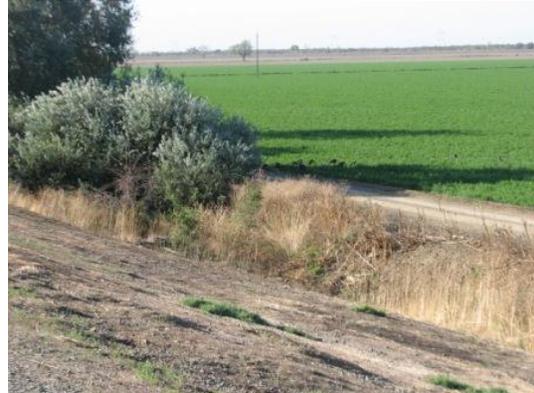
Photo 2 of 2 : johngw_s_20140306_596.jpg

Another view of the agricultural ditch at the toe. Fall 2013

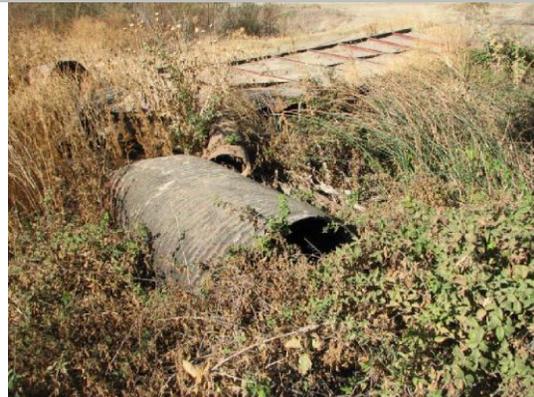
Photo 1 of 1 : UCIP_5412.jpg

LM Start	1.85	Rating **	M	Issue No.	9
LM End	1.85	Issue Type +	En	Location *	LS
Category	Supplemental			GPS Latitude/Longitude	
				Start	End
Item	DWR UCIP Field Study			38.734568 °	38.734568 °
				-121.660264 °	-121.660264 °
DWR ID	DWR_ST0011_01_s_2014_9				
Action/Comments					
Inspector Comments: FS_ID:27448 EP_NO: 10284 Repair Type: Crossing Status: UCIP Comments: Found abandoned 42-inch CM pipe on LS berm of the levee. This was abandoned by farmer, how Unknown. need to have verified if removed or concreted FIELD_STRUCT_DESC: 42-inch CM drainpipe through levee 25.0 feet below crown. Slide gate on waterward end. (ABO No. 10284 - Hershey). O&M manual 127, Revision Year 2011 FS Date: 1/21/2014 2:35:55 PM

Landside view: an abandoned CM pipe on LS berm of the levee.

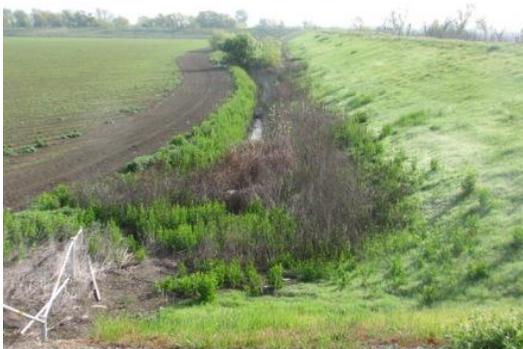
Photo 1 of 2 : johngw_s_20140306_593.jpg

LM Start	2.63	Rating **	M	Issue No.	4
LM End	2.70	Issue Type +	En	Location *	LS
Category	Earthen Levee		GPS Latitude/Longitude		
			Start	End	
Item	Encroachments		38.724800 °	38.724230 °	
			-121.663710 °	-121.664873 °	
DWR ID	DWR_ST0011_01_s_2012_4				
Action/Comments					
Ditch

The agricultural ditch runs along the toe of the levee. Spring 2013

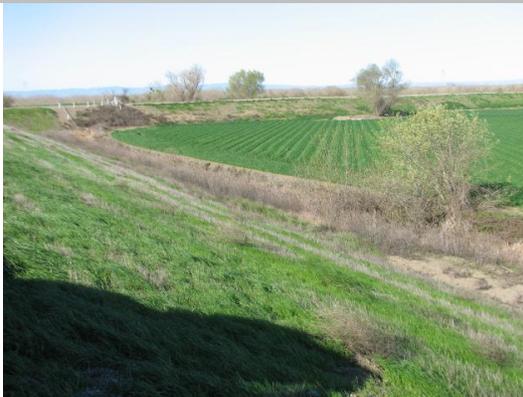
Photo 2 of 2 : johngw_s_20140317_625.jpg

The agricultural ditch runs along the toe of the levee. Spring 2014

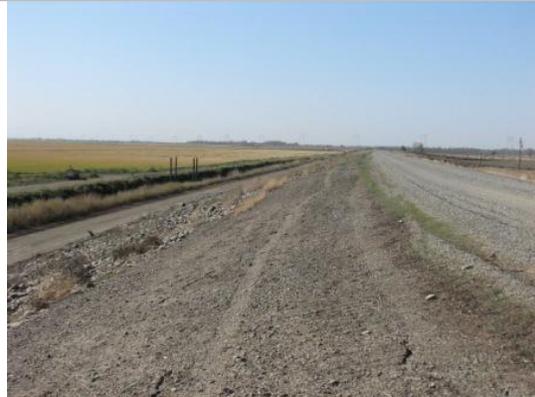
Photo 1 of 2 : johngw_s_20140306_604.jpg

LM Start	0.00	Rating **	A	Issue No.	9
LM End	1.51	Issue Type +	Ma	Location *	WS
Category	Earthen Levee		GPS Latitude/Longitude		
			Start	End	
Item	Vegetation		38.719040 °	38.698727 °	
			-121.664095 °	-121.674105 °	
DWR ID	DWR_ST0011_02_s_2012_9				
Action/Comments					
Control annual grass and weeds on the levee slopes and easements.

The levee has grasses or sod on the levee slope. Fall 2013

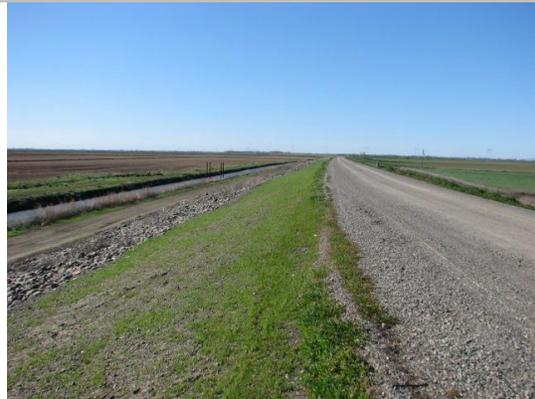
Photo 2 of 2 : johngw_s_20140317_626.jpg

The vegetation complies with standards. Spring 2014

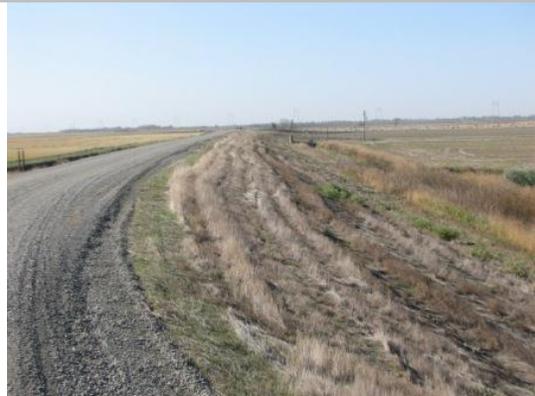
Photo 1 of 2 : johngw_s_20140306_603.jpg

LM Start	0.00	Rating **	A	Issue No.	7
LM End	1.51	Issue Type +	Ma	Location *	LS
Category	Earthen Levee		GPS Latitude/Longitude		
			Start	End	
Item	Vegetation		38.719040 °	38.698727 °	
			-121.664095 °	-121.674105 °	
DWR ID	DWR_ST0011_02_s_2012_7				
Action/Comments					
Control annual grass and weeds on the levee slopes and easements.

The levee slope has grasses or sod. Fall 2013

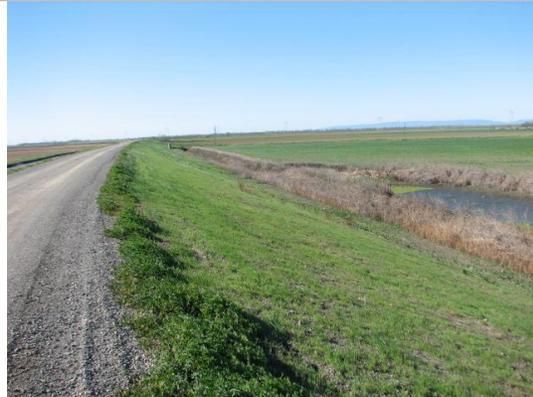
Photo 2 of 2 : johngw_s_20140317_627.jpg

The vegetation complies with standards. Spring 2014

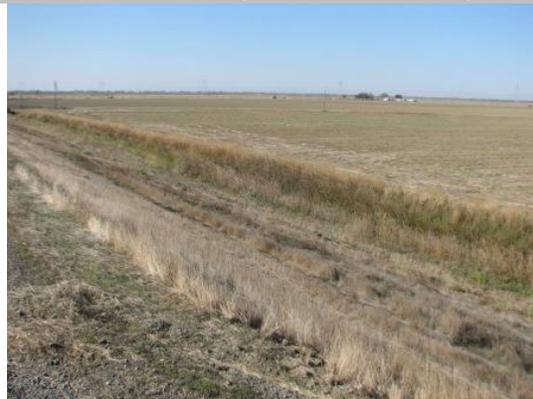
Photo 1 of 1 : johngw_s_20140306_601.jpg

LM Start	0.08	Rating **	M	Issue No.	4
LM End	0.21	Issue Type +	En	Location *	LS
Category	Earthen Levee		GPS Latitude/Longitude		
			Start	End	
Item	Encroachments		38.718005 °	38.716140 °	
			-121.664496 °	-121.665460 °	
DWR ID	DWR_ST0011_02_s_2012_4				
Action/Comments					
Ditch

The agricultural ditch is at the toe of the levee. Fall 2013

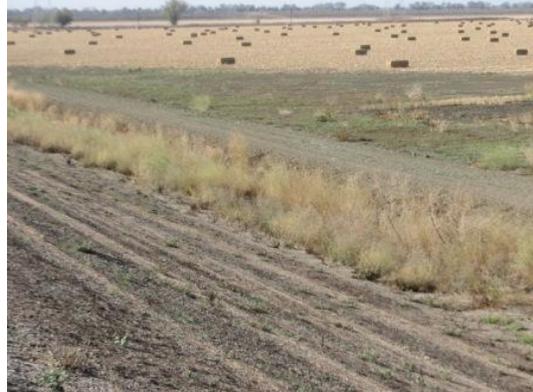
Photo 1 of 1 : johngw_s_20140306_600.jpg

LM Start	0.47	Rating **	M	Issue No.	3
LM End	0.97	Issue Type +	En	Location *	LS
Category	Earthen Levee		GPS Latitude/Longitude		
			Start	End	
Item	Encroachments		38.712813 °	38.706018 °	
			-121.667349 °	-121.670831 °	
DWR ID	DWR_ST0011_02_s_2012_3				
Action/Comments					
Ditch

The agricultural ditch is within the easement of the levee. Fall 2013

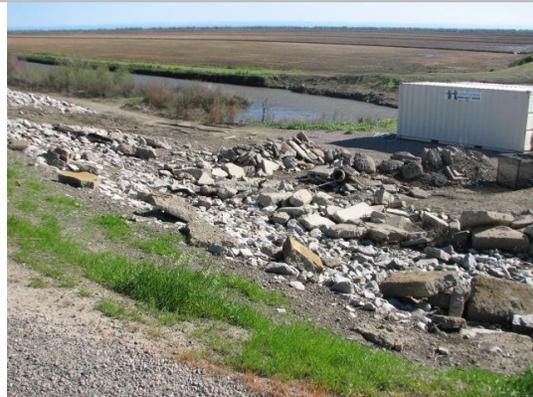
Photo 1 of 1 : johngw_s_20140317_628.jpg

LM Start	0.98	Rating **	M	Issue No.	2
LM End	0.98	Issue Type +	En	Location *	WS
Category	Earthen Levee		GPS Latitude/Longitude		
			Start	End	
Item	Encroachments		38.705783 °	38.705783 °	
			-121.670951 °	-121.670951 °	
DWR ID	DWR_ST0011_02_s_2014_2				
Action/Comments					
Debris Inspector Comments: concrete debris on levee toe and slope.

Concrete debris is on the slope and at the toe of the levee. Spring 2014

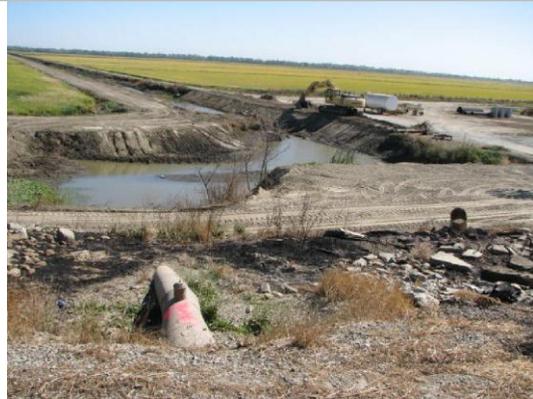
Photo 1 of 1 : UCIP_5416.jpg

LM Start	0.98	Rating **	M	Issue No.	1
LM End	0.98	Issue Type +	En	Location *	WS
Category	Supplemental			GPS Latitude/Longitude	
				Start	End
Item	DWR UCIP Field Study			38.705952 °	38.705952 °
				-121.670875 °	-121.670875 °
DWR ID	DWR_ST0011_02_s_2014_1				
Action/Comments					
Inspector Comments: FS_ID:27449 EP_NO: 10288 Repair Type: Crossing Status: UCIP Comments: Sloughing at pipe day light on WS slope. A 8-inch pipe was not visible during field survey. Air vent leaking water when pump activated causing erosion around pipe on slope. FIELD_STRUCT_DESC: 24 inch pipe through levee 5.2 feet below crown; a 8-inch pipe sleeved through the 24-inch pipe with the annular space grouted, a pump in a pumphouse at the toe of the landward slope, and a siphon breaker on the waterside slope. (ABO No. 10288 - Cache Creek Ranch). FS Date: 1/21/2014 2:36:24 PM

Waterside view: overview of pipe and water channel

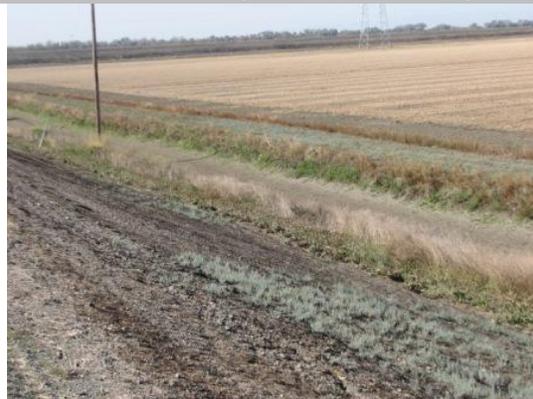
Photo 1 of 1 : johngw_s_20140306_602.jpg

LM Start	1.15	Rating **	M	Issue No.	5
LM End	1.44	Issue Type +	En	Location *	LS
Category	Earthen Levee			GPS Latitude/Longitude	
				Start	End
Item	Encroachments			38.703681 °	38.699637 °
				-121.672090 °	-121.674112 °
DWR ID	DWR_ST0011_02_s_2012_5				
Action/Comments					
Ditch

The agricultural ditch is within the easement of the levee. Fall 2013

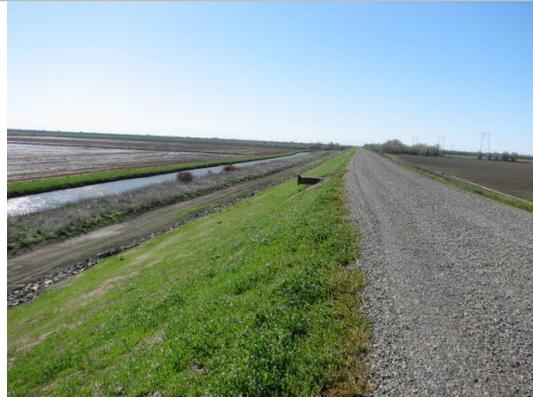
Photo 1 of 1 : johngw_s_20140317_630.jpg

The vegetation on the slope complies with standards. Spring 2014

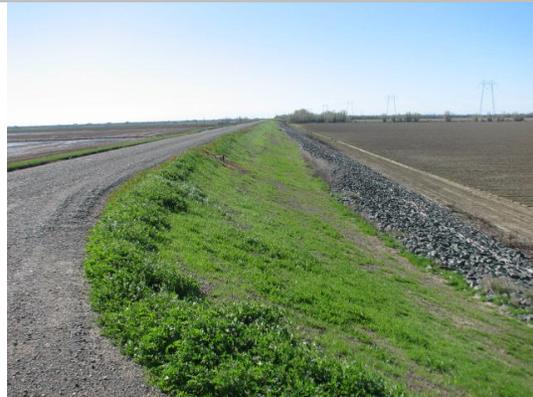
Photo 1 of 1 : johngw_s_20140317_629.jpg

LM Start	0.00	Rating **	A	Issue No.	10
LM End	0.66	Issue Type +	Ma	Location *	LS
Category	Earthen Levee		GPS Latitude/Longitude		
			Start	End	
Item	Vegetation		38.698595 °	38.687363 °	
			-121.674129 °	-121.673727 °	
DWR ID	DWR_ST0011_03_f_2013_10				
Action/Comments					
Control annual grass and weeds on the levee slopes and easements.

The vegetation on the slope complies with standards. The Cache Weir breaks up the levee slope. Spring 2014

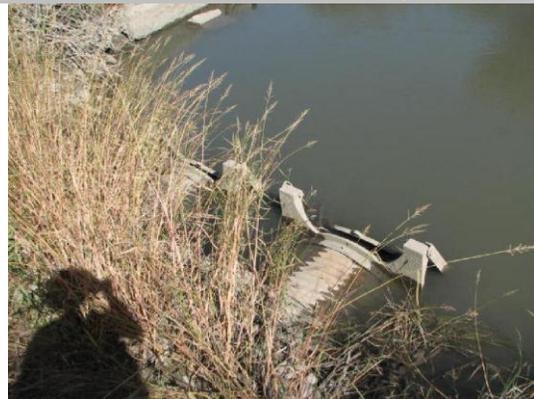
Photo 1 of 1 : UCIP_5405.jpg

LM Start	1.45	Rating **	M	Issue No.	1
LM End	1.45	Issue Type +	En	Location *	LS
Category	Supplemental		GPS Latitude/Longitude		
			Start	End	
Item	DWR UCIP Field Study		38.677539 °	38.677539 °	
			-121.672841 °	-121.672841 °	
DWR ID	DWR_ST0011_03_s_2014_1				
Action/Comments					
Inspector Comments: FS_ID:27444 EP_NO: 10296 Repair Type: Crossing Status: UCIP Comments: Flap gate was partially opened during field survey period. Intake pipe on LS was buried wth floated debrid/logs. Debris removal or trash rack/screen is required. Two pipes are 5 ft apart from each other. Slide gate on landward end not found. FIELD_STRUCT_DESC: One of two CMP. Two 36-inch C.M. pipes through levee 20.0 feet below crown. (ABO No. 10296 Woodland Farms). FS Date: 1/21/2014 2:33:35 PM

Waterside view: CM pipes and flap gates.

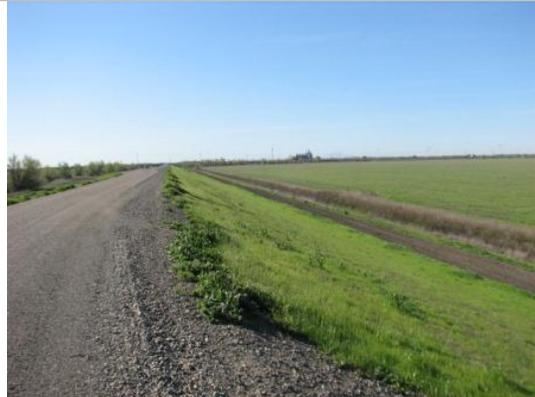
Photo 1 of 1 : johngw_s_20140324_670.jpg

The vegetation complies with standards. Spring 2014

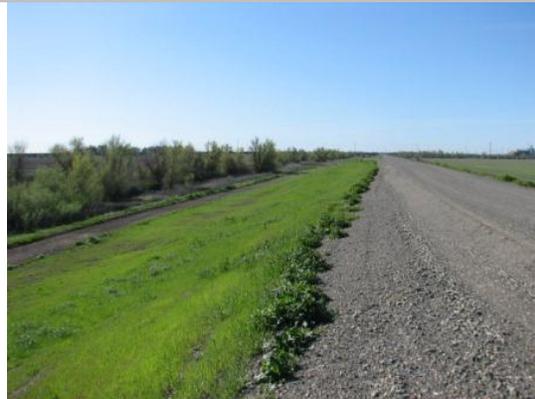
Photo 1 of 1 : johngw_s_20140324_671.jpg

LM Start	0.02	Rating **	A	Issue No.	5
LM End	3.61	Issue Type +	Ma	Location *	WS
Category	Earthen Levee		GPS Latitude/Longitude		
			Start	End	
Item	Vegetation		38.574401 °	38.523809 °	
			-121.638766 °	-121.631446 °	
DWR ID	DWR_ST0011_04_s_2014_5				
Action/Comments					
Control annual grass and weeds on the levee slopes and easements.

The vegetation complies with standards. Spring 2014

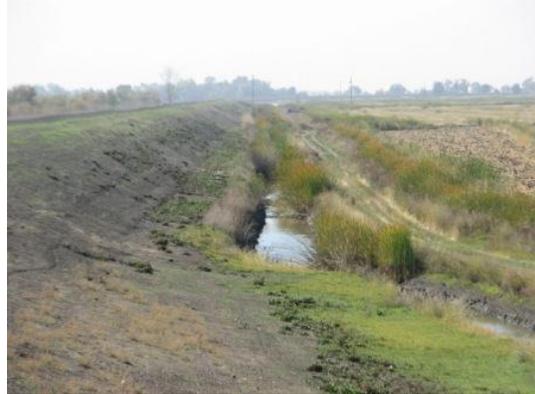
Photo 1 of 2 : johngw_s_20140306_609.jpg

The agricultural ditch is within the easement of the levee. Fall 2013

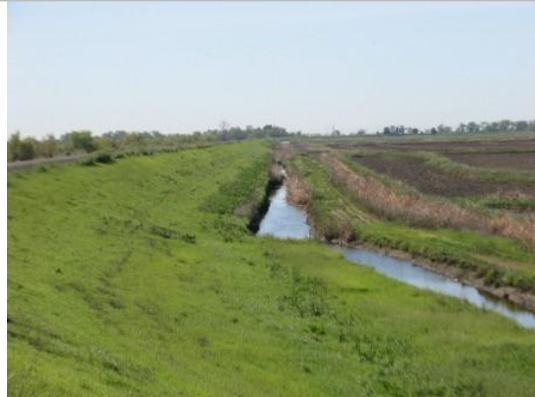
Photo 2 of 2 : johngw_s_20140324_672.jpg

The ditch runs along the toe of the landside levee slope. Spring 2014

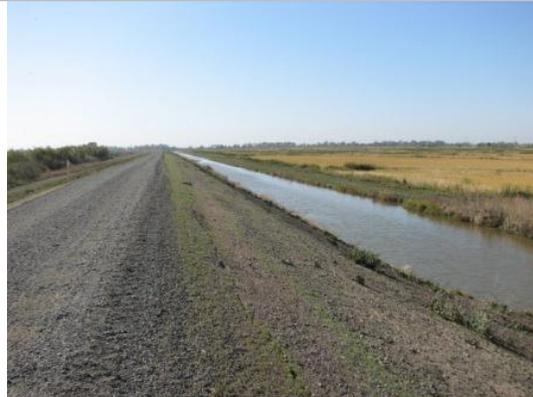
Photo 1 of 4 : johngw_s_20140306_610.jpg

The agricultural ditch is within the easement of the levee. Fall 2013

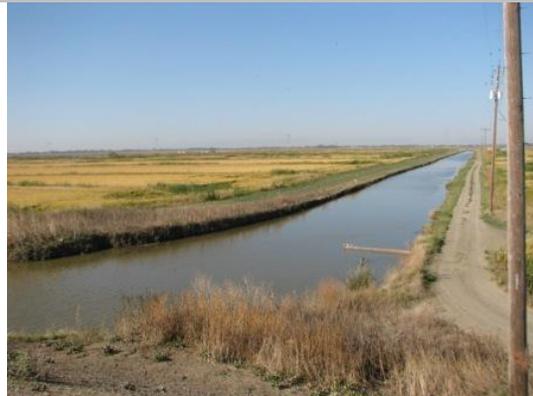
Photo 2 of 4 : johngw_s_20140306_611.jpg

Looking west at the agricultural ditch. Fall 2013

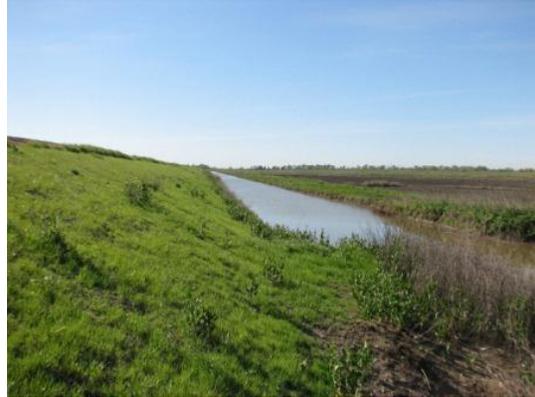
Photo 3 of 4 : johngw_s_20140324_673.jpg

The ditch is in the profile of the levee slope. Spring 2014

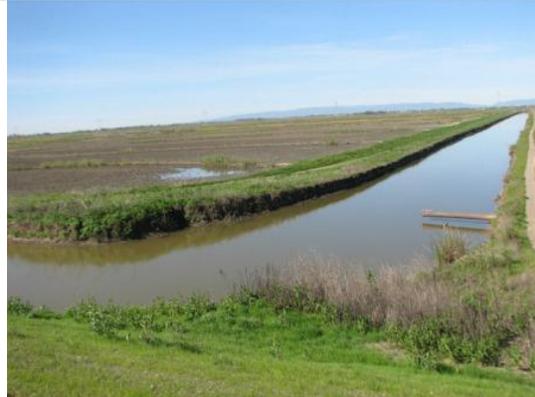
Photo 4 of 4 : johngw_s_20140324_674.jpg

The ditch runs west for about a quarter of a mile. Spring 2014
