**Flood Control Project Maintenance  
Levee Inspections**  
**LMA District Cover Sheet**  
**Spring 2015 Levee Inspection Results**

**Sacramento Maintenance Yard West Levee Yolo Bypass**

**Spring 2015 Levee Inspection Results**

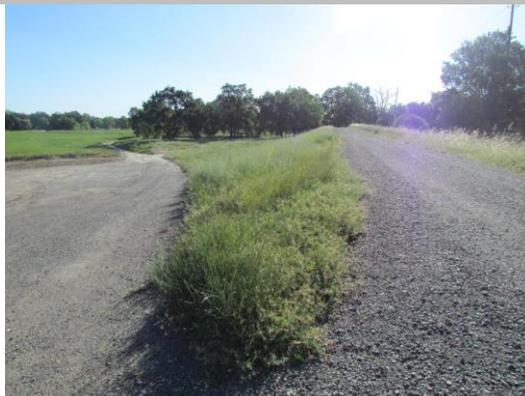
Photo 1 of 1 : SP\_2015\_ST0011\_291\_3\_20150415\_00008.jpg

LM Start	<b>0.01</b>	Rating **	M	Issue No.	<b>3</b>
LM End	<b>2.72</b>	Issue Type +	Ma	Location *	WS
Category	Earthen Levee		GPS Latitude/Longitude		
			Start	End	
Item	Vegetation		38.759035 °	38.724252 °	
			-121.667447 °	-121.665222 °	
DWR ID	DWR_ST0011_01_s_2015_3				
Action/Comments					
Control annual grass and weeds on the levee slopes and easements.

View of the vegetation on the waterward side of the levee looking downstream. Spring 2015.

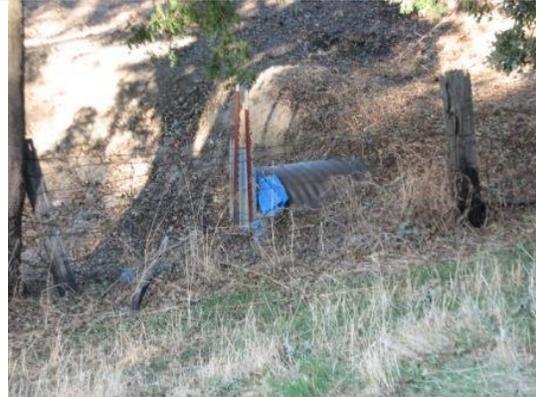
Photo 1 of 3 : SP\_2015\_ST0011\_291\_1\_20150401\_00001.jpg

LM Start	<b>0.36</b>	Rating **	M	Issue No.	<b>1</b>
LM End	<b>0.43</b>	Issue Type +	En	Location *	LS
Category	Earthen Levee		GPS Latitude/Longitude		
			Start	End	
Item	Encroachments		38.755535 °	38.754512 °	
			-121.664127 °	-121.663907 °	
DWR ID	DWR_ST0011_01_s_2012_1				
Action/Comments					
Ditch

The culvert at the end of the agricultural ditch. Fall 2013

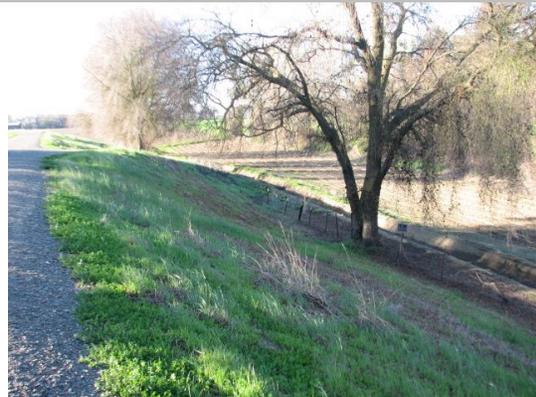
Photo 2 of 3 : SP\_2015\_ST0011\_291\_1\_20150401\_00002.jpg

The drain ditch runs along the toe of the levee. Spring 2014

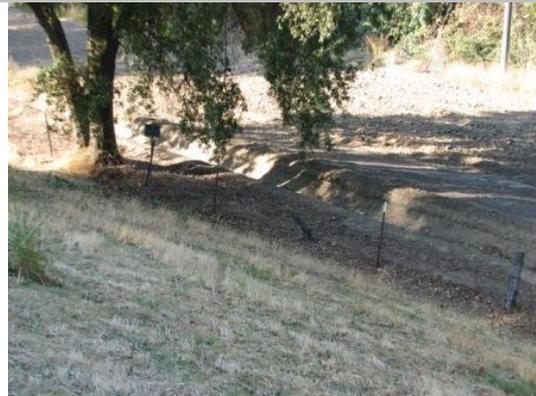
Photo 3 of 3 : SP\_2015\_ST0011\_291\_1\_20150401\_00003.jpg

The agricultural ditch along the levee toe. Fall 2013

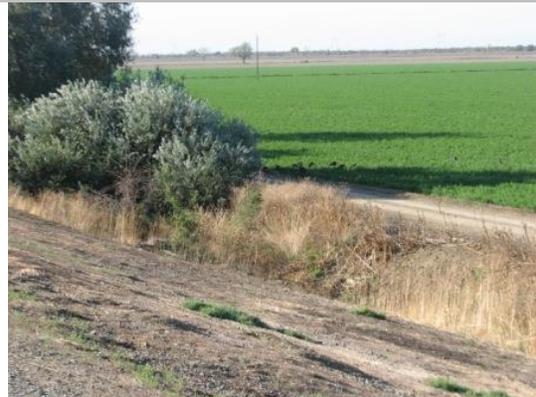
Photo 1 of 2 : SP\_2015\_ST0011\_291\_8\_20150401\_00006.jpg

LM Start	<b>0.94</b>	Rating **	M	Issue No.	<b>8</b>
LM End	<b>1.83</b>	Issue Type +	En	Location *	LS
Category	Earthen Levee		GPS Latitude/Longitude		
			Start	End	
Item	Encroachments		38.747888 °	38.734972 °	
			-121.660202 °	-121.660265 °	
DWR ID	DWR_ST0011_01_s_2012_8				
Action/Comments					
Ditch

Another view of the agricultural ditch at the toe. Fall 2013

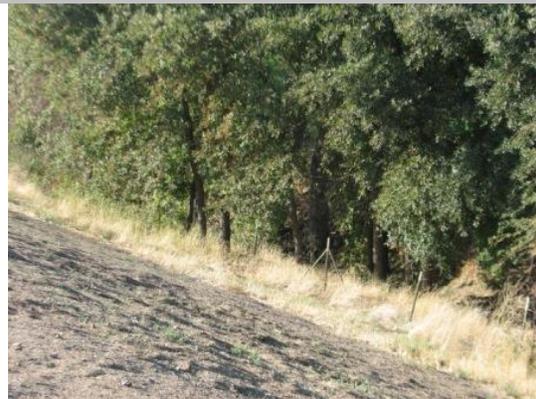
Photo 2 of 2 : SP\_2015\_ST0011\_291\_8\_20150401\_00007.jpg

The agricultural ditch runs along the toe of the levee. Fall 2013

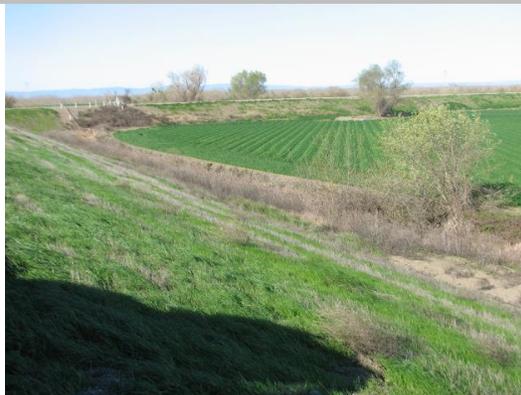
Photo 1 of 2 : SP\_2015\_ST0011\_291\_4\_20150401\_00004.jpg

LM Start	<b>2.63</b>	Rating **	M	Issue No.	<b>4</b>
LM End	<b>2.71</b>	Issue Type +	En	Location *	LS
Category	Earthen Levee		GPS Latitude/Longitude		
			Start	End	
Item	Encroachments		38.724800 °	38.724230 °	
			-121.663710 °	-121.664873 °	
DWR ID	DWR_ST0011_01_s_2012_4				
Action/Comments					
Ditch

The agricultural ditch runs along the toe of the levee. Spring 2014

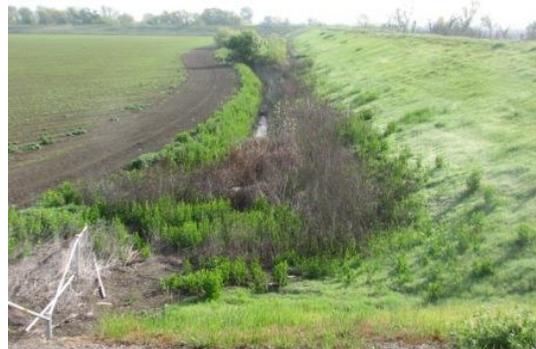
Photo 2 of 2 : SP\_2015\_ST0011\_291\_4\_20150401\_00005.jpg

LM Start	<b>2.63</b>	Rating **	M	Issue No.	<b>4 (cont)</b>
LM End	<b>2.71</b>	Issue Type +	En	Location *	LS
Category	Earthen Levee			GPS Latitude/Longitude	
				Start	End
Item	Encroachments			38.724800 °	38.724230 °
				-121.663710 °	-121.664873 °
DWR ID	DWR_ST0011_01_s_2012_4				
Action/Comments					
Ditch

The agricultural ditch runs along the toe of the levee. Spring 2013

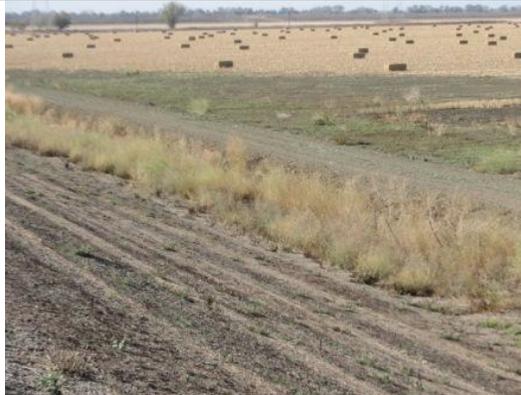
Photo 1 of 1 : SP\_2015\_ST0011\_292\_3\_20150401\_00001.jpg

LM Start	<b>0.47</b>	Rating **	M	Issue No.	<b>3</b>
LM End	<b>0.97</b>	Issue Type +	En	Location *	LS
Category	Earthen Levee			GPS Latitude/Longitude	
				Start	End
Item	Encroachments			38.712813 °	38.706018 °
				-121.667349 °	-121.670831 °
DWR ID	DWR_ST0011_02_s_2012_3				
Action/Comments					
Ditch

The agricultural ditch is within the easement of the levee. Fall 2013

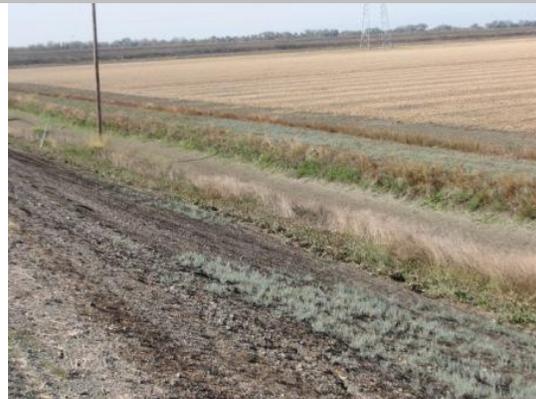
Photo 1 of 1 : SP\_2015\_ST0011\_292\_5\_20150401\_00002.jpg

LM Start	<b>1.15</b>	Rating **	M	Issue No.	<b>5</b>
LM End	<b>1.44</b>	Issue Type +	En	Location *	LS
Category	Earthen Levee			GPS Latitude/Longitude	
				Start	End
Item	Encroachments			38.703681 °	38.699637 °
				-121.672090 °	-121.674112 °
DWR ID	DWR_ST0011_02_s_2012_5				
Action/Comments					
Ditch

The agricultural ditch is within the easement of the levee. Fall 2013

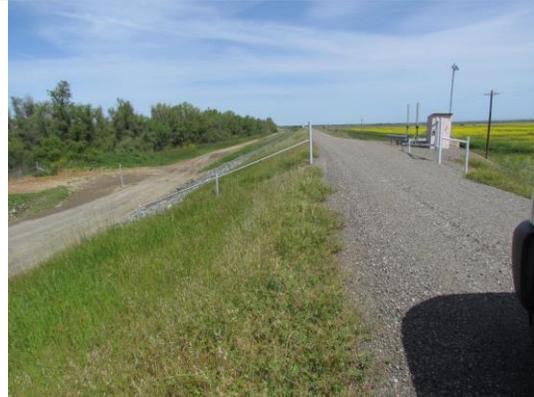
Photo 1 of 1 : SP\_2015\_ST0011\_293\_3\_20150413\_00001.jpg

LM Start	<b>0.00</b>	Rating **	M	Issue No.	<b>3</b>
LM End	<b>1.41</b>	Issue Type +	Ma	Location *	LS
Category	Earthen Levee		GPS Latitude/Longitude		
			Start	End	
Item	Vegetation		38.698643 °	38.678248 °	
			-121.674152 °	-121.672982 °	
DWR ID	DWR_ST0011_03_s_2015_3				
Action/Comments					
Control annual grass and weeds on the levee slopes and easements.

View of vegetation on the landward side of the levee looking upstream. Spring 2015.

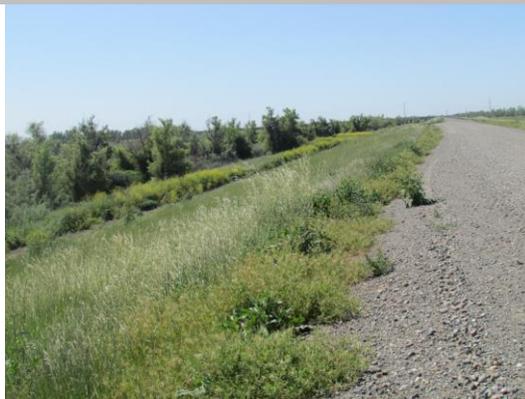
Photo 1 of 1 : SP\_2015\_ST0011\_294\_1\_20150421\_00007.jpg

LM Start	<b>0.00</b>	Rating **	M	Issue No.	<b>1</b>
LM End	<b>3.63</b>	Issue Type +	Ma	Location *	WS
Category	Earthen Levee			GPS Latitude/Longitude	
				Start	End
Item	Vegetation			38.574345 °	38.523421 °
				-121.638753 °	-121.631464 °
DWR ID	DWR_ST0011_04_s_2015_1				
Action/Comments					
Control annual grass and weeds on the levee slopes and easements.

View of the vegetation on the water ward side of the levee looking downstream. Spring 2015.

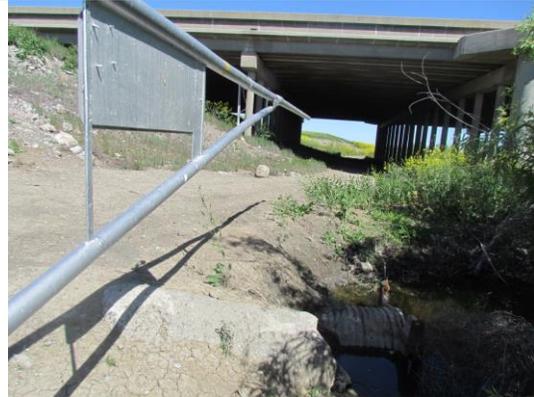
Photo 2 of 2 : SP\_2015\_ST0011\_294\_2\_20150421\_00009.jpg

LM Start	<b>0.78</b>	Rating **	M	Issue No.	<b>2 (cont)</b>
LM End	<b>0.78</b>	Issue Type +	Ma	Location *	WS
Category	Structures & Concrete Lined Channels			GPS Latitude/Longitude	
				Start	End
Item	Flap Gates			38.563163 °	38.563163 °
				-121.637994 °	-121.637994 °
DWR ID	DWR_ST0011_04_s_2015_2				
Action/Comments

View of a perspective on the pipe looking upstream. Spring 2015.

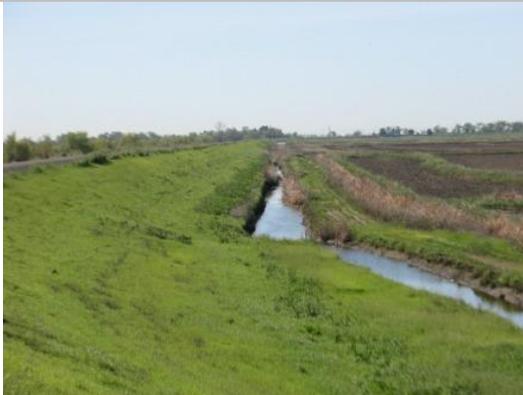
Photo 1 of 2 : SP\_2015\_ST0011\_294\_3\_20150401\_00001.jpg

LM Start	<b>1.77</b>	Rating **	M	Issue No.	<b>3</b>
LM End	<b>2.69</b>	Issue Type +	En	Location *	LS
Category	Earthen Levee			GPS Latitude/Longitude	
				Start	End
Item	Encroachments			38.550387 °	38.536958 °
				-121.631257 °	-121.631450 °
DWR ID	DWR_ST0011_04_s_2012_3				
Action/Comments					
Ditch

The ditch runs along the toe of the landside levee slope. Spring 2014

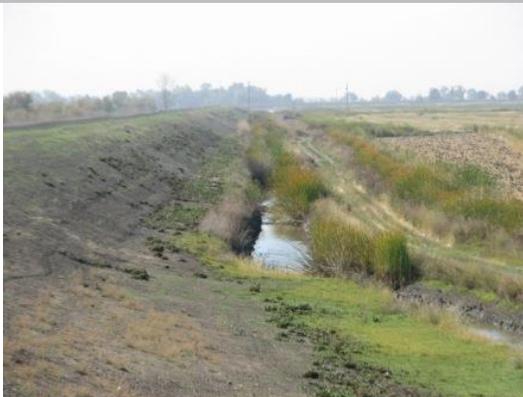
Photo 2 of 2 : SP\_2015\_ST0011\_294\_3\_20150401\_00002.jpg

The agricultural ditch is within the easement of the levee. Fall 2013

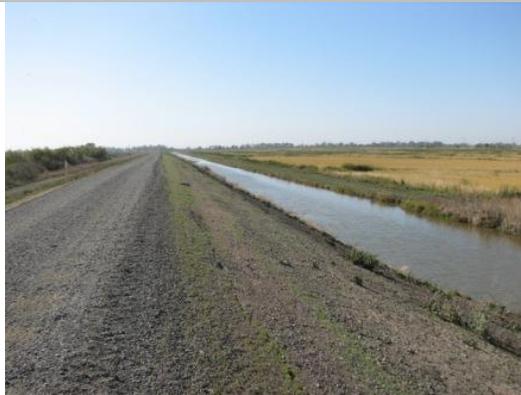
Photo 1 of 4 : SP\_2015\_ST0011\_294\_4\_20150401\_00003.jpg

LM Start	<b>2.75</b>	Rating **	M	Issue No.	<b>4</b>
LM End	<b>3.60</b>	Issue Type +	En	Location *	LS
Category	Earthen Levee			GPS Latitude/Longitude	
				Start	End
Item	Encroachments			38.536100 °	38.523807 °
				-121.631425 °	-121.631535 °
DWR ID	DWR_ST0011_04_s_2012_4				
Action/Comments					
Ditch

The agricultural ditch is within the easement of the levee. Fall 2013

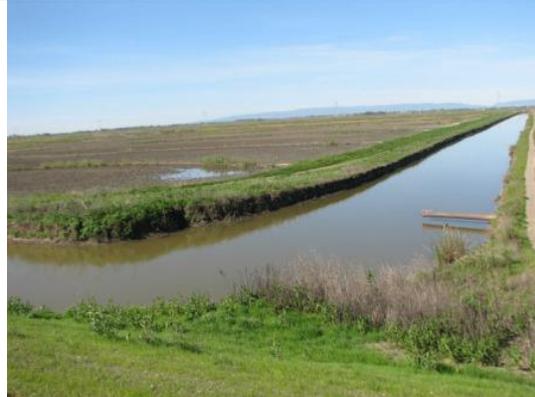
Photo 2 of 4 : SP\_2015\_ST0011\_294\_4\_20150401\_00004.jpg

LM Start	<b>2.75</b>	Rating **	M	Issue No.	<b>4 (cont)</b>
LM End	<b>3.60</b>	Issue Type +	En	Location *	LS
Category	Earthen Levee			GPS Latitude/Longitude	
				Start	End
Item	Encroachments			38.536100 °	38.523807 °
				-121.631425 °	-121.631535 °
DWR ID	DWR_ST0011_04_s_2012_4				
Action/Comments					
Ditch

The ditch runs west for about a quarter of a mile. Spring 2014

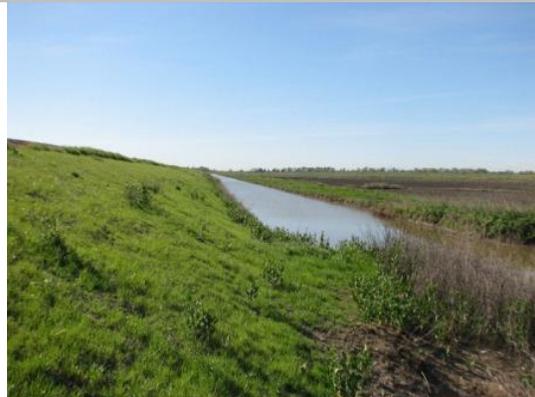
Photo 3 of 4 : SP\_2015\_ST0011\_294\_4\_20150401\_00005.jpg

The ditch is in the profile of the levee slope. Spring 2014

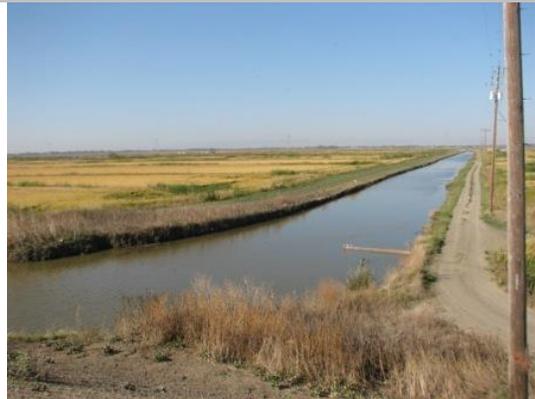
Photo 4 of 4 : SP\_2015\_ST0011\_294\_4\_20150401\_00006.jpg

Looking west at the agricultural ditch. Fall 2013
