**Flood Control Project Maintenance
Levee Inspections**
LMA District Cover Sheet
Spring 2009 Levee Inspection Results

West Levee Yolo Bypass

Levee Inspection Report By Mile - Spring 2009

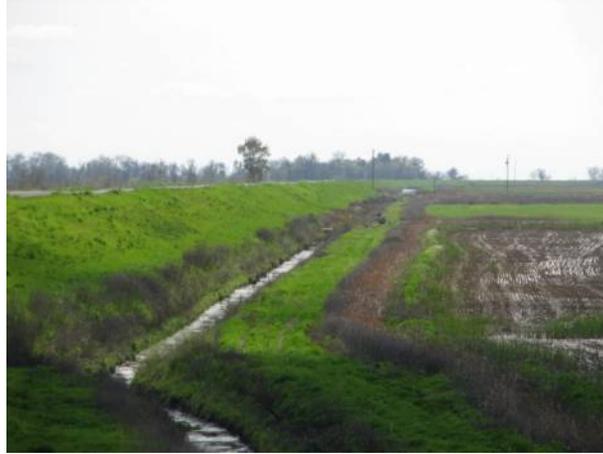
LMR Line	Levee Mile		Category	Item	Location *	Rating **	Action/Comment	GPS Latitude/Longitude		Photo	Issue
	Start	End						Start	End		
1	1.78	2.70	Earthen Levee	Encroachments	LS	PO	Agricultural Ditch	38.550387 ° -121.631257 °	38.536958 ° -121.631450 °	Y	3
2	2.76	3.60	Earthen Levee	Encroachments	LS	PO	Agricultural Ditch	38.536100 ° -121.631425 °	38.523807 ° -121.631535 °	Y	4

Levee Mile Report Line	1
Start Levee Mile	1.78
End Levee Mile	2.70
Location	Land Side
Category	Earthen Levee
Item	Encroachments
ag drain LM 1.78-2.70

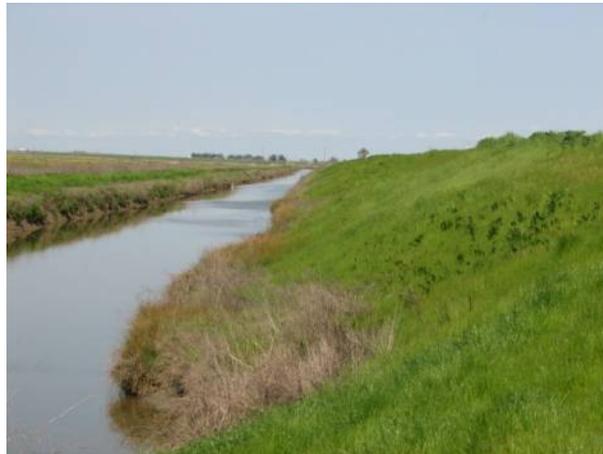
Levee Mile Report Line	2
Start Levee Mile	2.76
End Levee Mile	3.60
Location	Land Side
Category	Earthen Levee
Item	Encroachments
ag drain LM 2.76-3.60
