**Flood Control Project Maintenance
Levee Inspections
LMA District Cover Sheet
Spring 2012 Levee Inspection Results**

Sacramento Maintenance Yard West Levee Yolo Bypass

Levee Inspection Report By Mile - Spring 2012

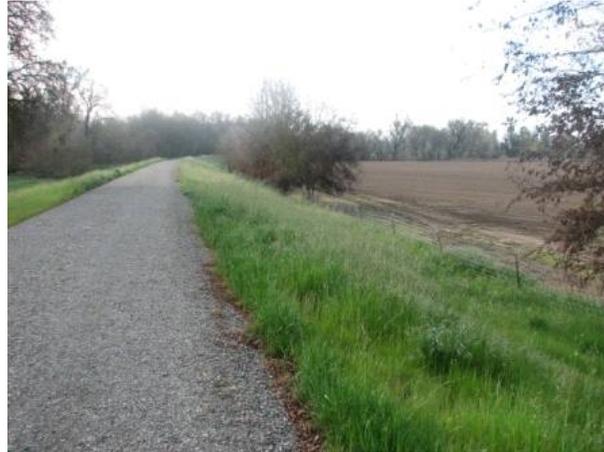
Levee Mile Report Line	4
Start Levee Mile	0.01
End Levee Mile	2.72
Location	Land Side
Category	Earthen Levee
Item	Vegetation
Photo taken spring 2012, grasses taller than 12".	
johngw_s_20120326_578.jpg

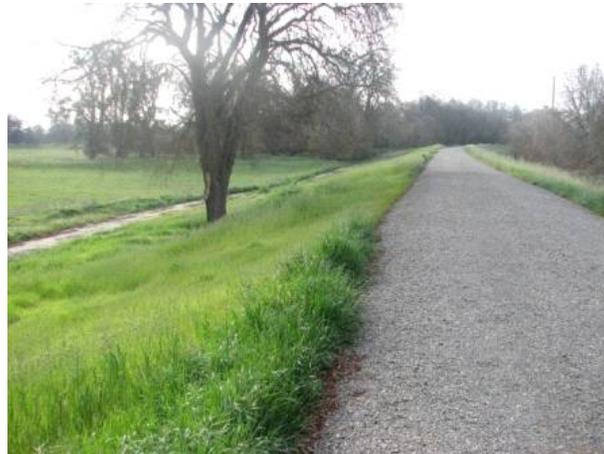
Levee Mile Report Line	5
Start Levee Mile	0.01
End Levee Mile	2.72
Location	Water Side
Category	Earthen Levee
Item	Vegetation
Photo taken spring 2012, grasses taller than 12".	
johngw_s_20120326_579.jpg

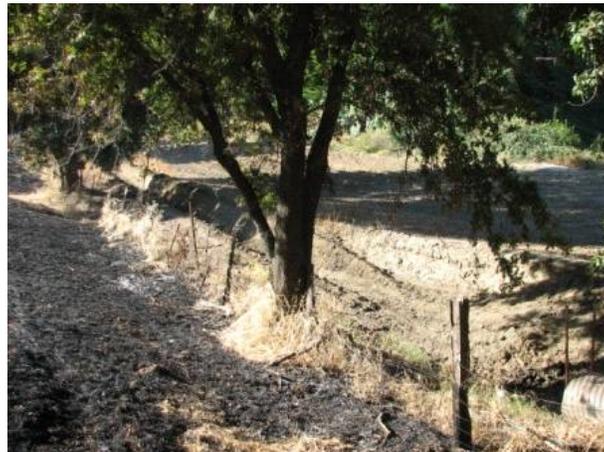
Levee Mile Report Line	6
Start Levee Mile	0.36
End Levee Mile	0.43
Location	Land Side
Category	Earthen Levee
Item	Encroachments
The end of the agricultural ditch along the toe of the levee. Photo taken fall 2011.	
johngw_s_20120313_551.jpg

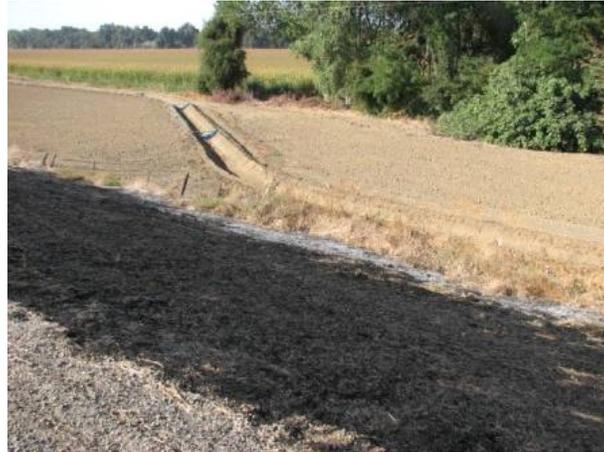
Levee Mile Report Line	6
Start Levee Mile	0.36
End Levee Mile	0.43
Location	Land Side
Category	Earthen Levee
Item	Encroachments

This photo shows the agricultural ditch as it turns towards the levee toe. Photo taken fall 2011.

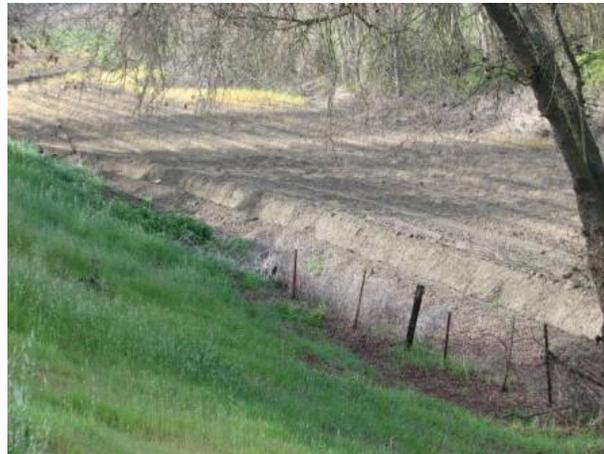
Levee Mile Report Line	6
Start Levee Mile	0.36
End Levee Mile	0.43
Location	Land Side
Category	Earthen Levee
Item	Encroachments

Photo taken spring 2012, agricultural ditch runs along toe of levee.

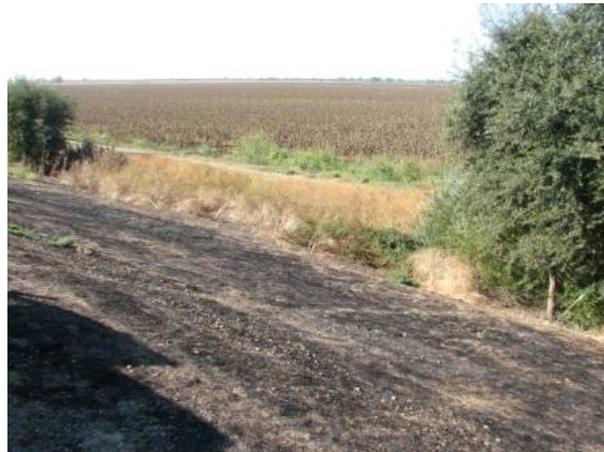
Levee Mile Report Line	7
Start Levee Mile	0.93
End Levee Mile	1.63
Location	Land Side
Category	Earthen Levee
Item	Encroachments

A photo of the agricultural ditch along the toe. Photo taken fall 2011.

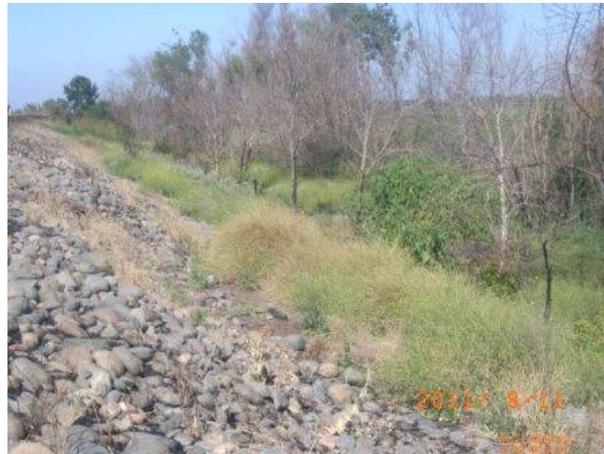
USACE 2011 Photo #1

Levee Mile Report Line	8
Start Levee Mile	2.53
End Levee Mile	2.68
Location	Water Side
Category	Supplemental
Item	USACE Erosion Survey

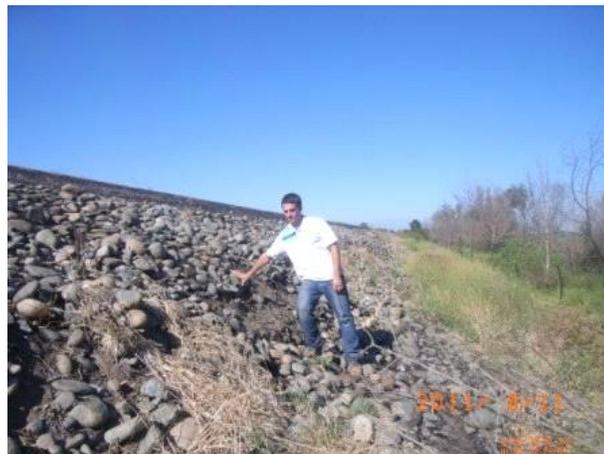
USACE 2011 Photo #2

Levee Mile Report Line	8
Start Levee Mile	2.53
End Levee Mile	2.68
Location	Water Side
Category	Supplemental
Item	USACE Erosion Survey

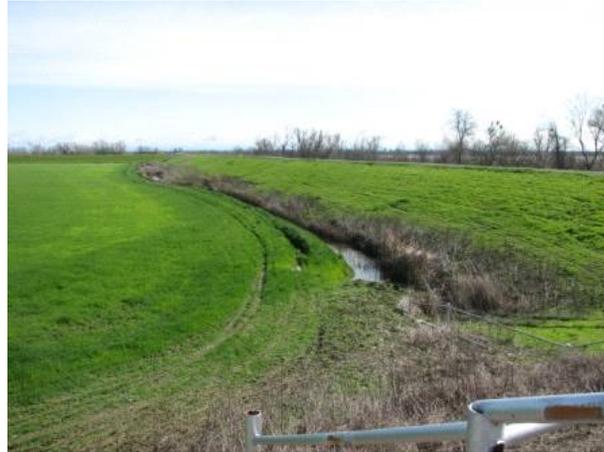
Levee Mile Report Line	9
Start Levee Mile	2.63
End Levee Mile	2.70
Location	Land Side
Category	Earthen Levee
Item	Encroachments
Agricultural ditch running along toe landside. 3-7-11	
johngw_s_20120313_555.jpg

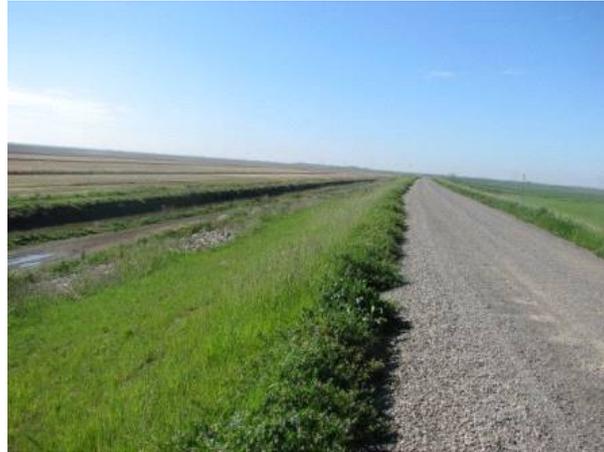
Levee Mile Report Line	4
Start Levee Mile	0.00
End Levee Mile	1.51
Location	Water Side
Category	Earthen Levee
Item	Vegetation
Photo taken spring 2012, grasses taller than 12".	
johngw_s_20120326_583.jpg

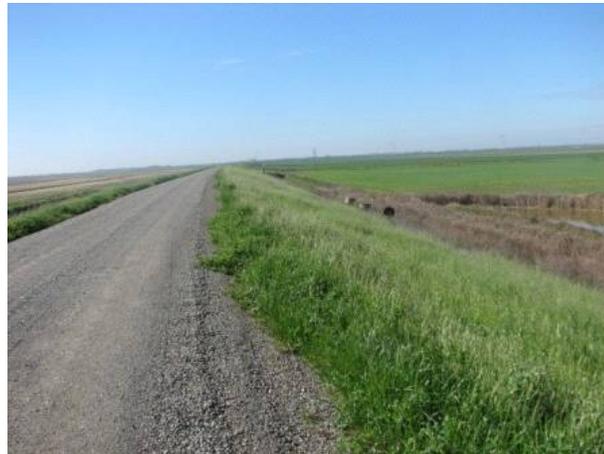
Levee Mile Report Line	5
Start Levee Mile	0.00
End Levee Mile	1.51
Location	Land Side
Category	Earthen Levee
Item	Vegetation
Photo taken spring 2012, grasses taller than 12".	
johngw_s_20120326_582.jpg

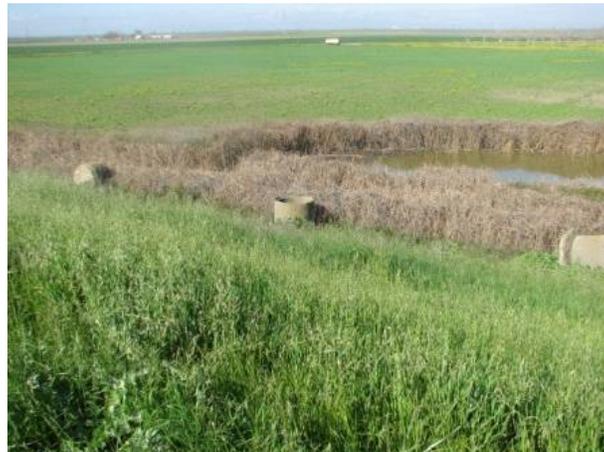
Levee Mile Report Line	6
Start Levee Mile	0.07
End Levee Mile	0.07
Location	Land Side
Category	Earthen Levee
Item	Encroachments
Photo taken spring 2012, concrete stand pipe laying at toe of levee.	
johngw_s_20120326_585.jpg

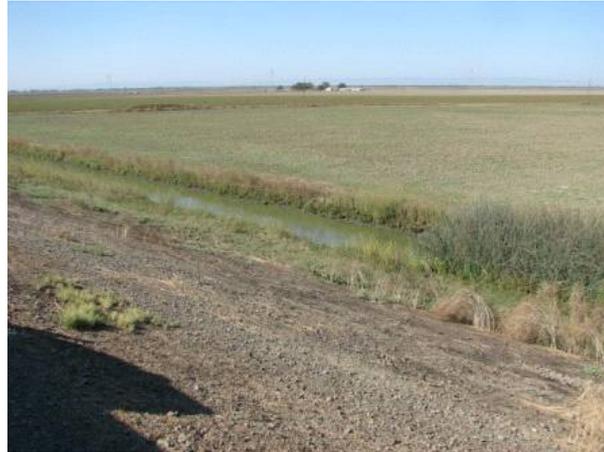
Levee Mile Report Line	7
Start Levee Mile	0.08
End Levee Mile	0.21
Location	Land Side
Category	Earthen Levee
Item	Encroachments
Agricultural ditch full of water runs along the toe of the levee. Photo taken fall 2011.	
johngw_s_20120313_560.jpg

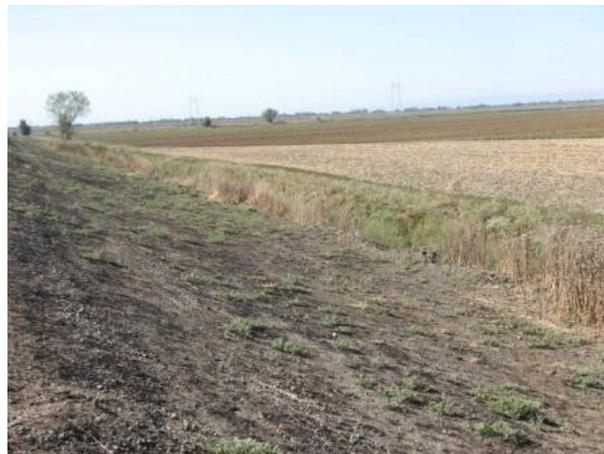
Levee Mile Report Line	8
Start Levee Mile	0.47
End Levee Mile	0.97
Location	Land Side
Category	Earthen Levee
Item	Encroachments
Agricultural ditch runs along the toe of the levee. Photo taken fall 2011.	
johngw_s_20120313_559.jpg

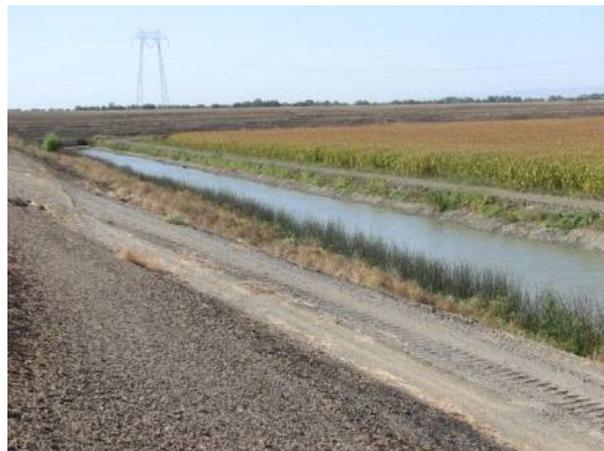
Levee Mile Report Line	9
Start Levee Mile	1.15
End Levee Mile	1.44
Location	Land Side
Category	Earthen Levee
Item	Encroachments
Agricultural ditch runs along the toe of the levee. It varies in distance from toe from 1-10 feet away. Photo taken fall 2011.	
johngw_s_20120313_561.jpg

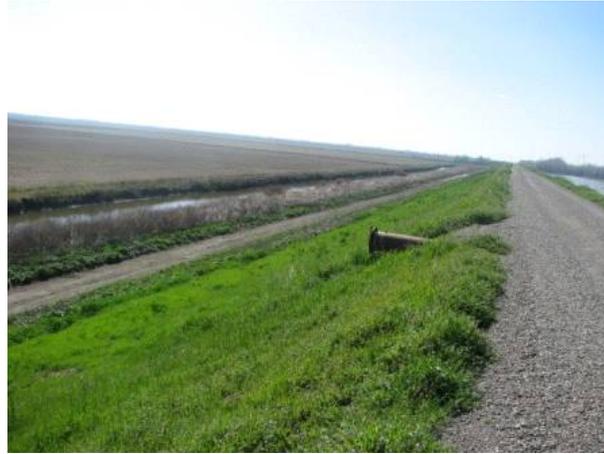
LMR No.	Levee Mile		Category	Item	* Location	** Rating	Action/Comment	GPS Latitude/Longitude		Issue No. Photo
	Start	End						Start	End	
1	0.02	1.41	Earthen Levee	Vegetation	WS	M Ma	V1 : Control annual grass and weeds on the levee slopes and easements. Inspector Comments: Cache weir is from LM .72-1.11 Total distance for grasses is 1.03	38.698380 ° -121.674078 °	38.678132 ° -121.672957 °	4 Y
DWR ID: DWR_ST0011_03_s_2012_4										
2	0.02	1.41	Earthen Levee	Vegetation	LS	M Ma	V1 : Control annual grass and weeds on the levee slopes and easements. Inspector Comments: Cache weir is from LM .72-1.11 Total distance for grasses is 1.03 miles.	38.698373 ° -121.674078 °	38.678147 ° -121.672965 °	3 Y
DWR ID: DWR_ST0011_03_s_2012_3

Levee Mile Report Line	1
Start Levee Mile	0.02
End Levee Mile	1.41
Location	Water Side
Category	Earthen Levee
Item	Vegetation
Photo taken spring 2012, grasses taller than 12".	
johngw_s_20120326_588.jpg

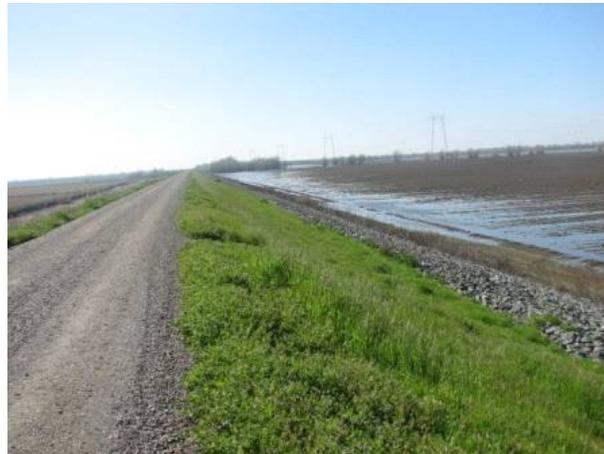
Levee Mile Report Line	2
Start Levee Mile	0.02
End Levee Mile	1.41
Location	Land Side
Category	Earthen Levee
Item	Vegetation
Photo taken spring 2012, grasses taller than 12".	
johngw_s_20120326_587.jpg

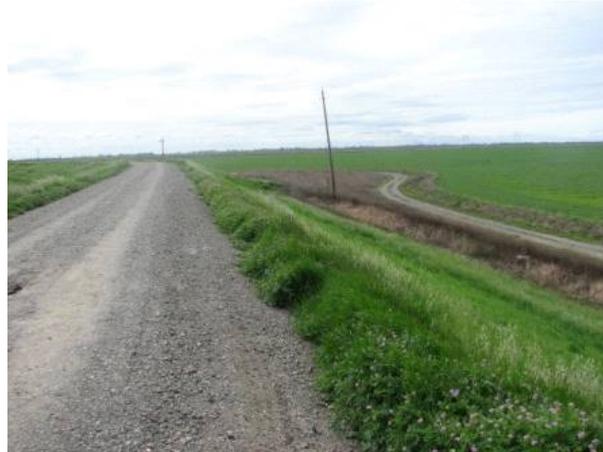
Levee Mile Report Line	4
Start Levee Mile	0.93
End Levee Mile	2.83
Location	Land Side
Category	Earthen Levee
Item	Vegetation
Photo taken spring 2012, grasses are taller than 12".	
johngw_s_20120326_606.jpg

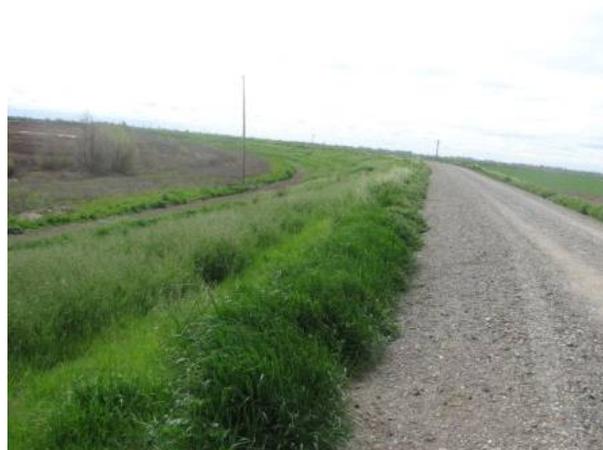
Levee Mile Report Line	5
Start Levee Mile	0.93
End Levee Mile	2.83
Location	Water Side
Category	Earthen Levee
Item	Vegetation
Photo taken spring 2012, grasses are taller than 12".	
johngw_s_20120326_607.jpg

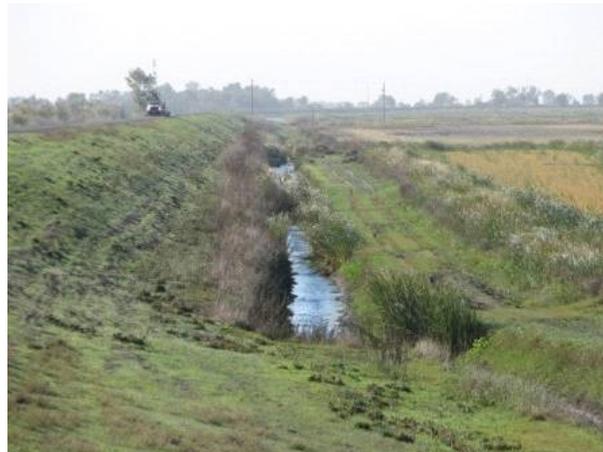
Levee Mile Report Line	6
Start Levee Mile	1.78
End Levee Mile	2.70
Location	Land Side
Category	Earthen Levee
Item	Encroachments
The argricultural ditch runs along the landside toe. Fall 2011	
johngw_s_20120313_564.jpg

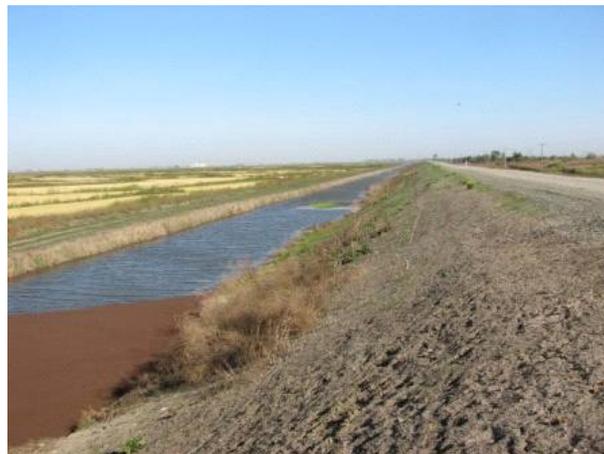
Levee Mile Report Line	7
Start Levee Mile	2.76
End Levee Mile	3.60
Location	Land Side
Category	Earthen Levee
Item	Encroachments
This view is looking to the north. Fall 2011	
johngw_s_20120313_566.jpg
