**Flood Control Project Maintenance  
Levee Inspections**

**Fall 2011 Levee Maintenance Deficiency Summary Report**

**Sacramento Maintenance Yard Willow Slough Bypass**

**Levee Inspection Report By Mile - Fall 2011**

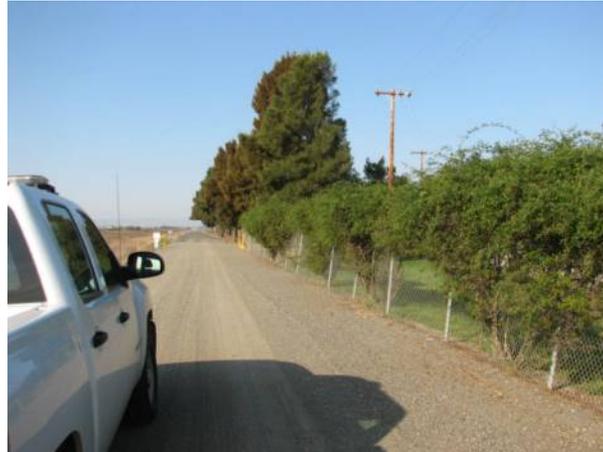
Levee Mile Report Line	1
Start Levee Mile	0.02
End Levee Mile	0.15
Location	Crown
Category	Earthen Levee
Item	Encroachments

The treatment plant's landscape and fence. This runs along the crown and toe of the levee.

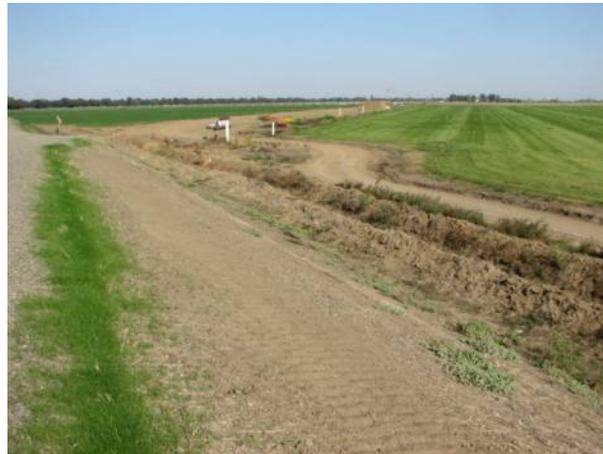
Levee Mile Report Line	2
Start Levee Mile	4.16
End Levee Mile	4.63
Location	Land Side
Category	Earthen Levee
Item	Encroachments

The agricultural ditch runs along the toe of the levee. Fall 2011

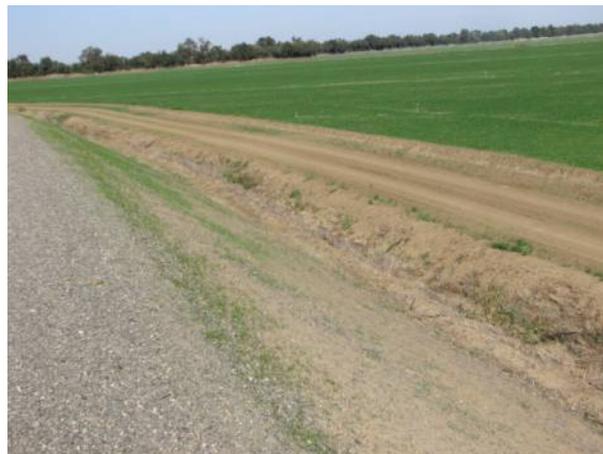
Levee Mile Report Line	2
Start Levee Mile	4.16
End Levee Mile	4.63
Location	Land Side
Category	Earthen Levee
Item	Encroachments

Another view of the agricultural running along the toe of the levee. Fall 2011

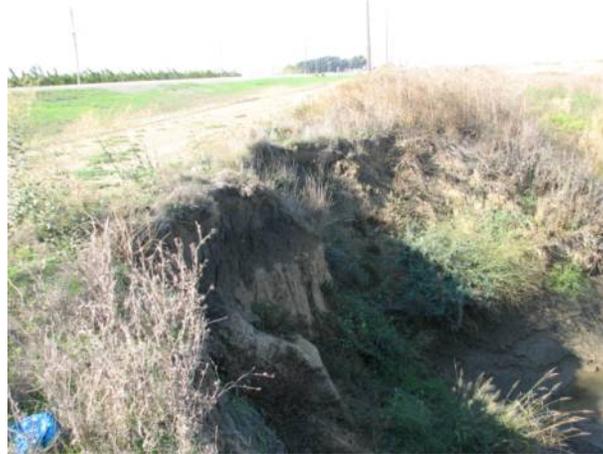
Levee Mile Report Line	1
Start Levee Mile	1.71
End Levee Mile	1.71
Location	Water Side
Category	Earthen Levee
Item	Erosion / Bank Caving

The erosion on the levee channel is encroaching into the toe road. Fall 2011

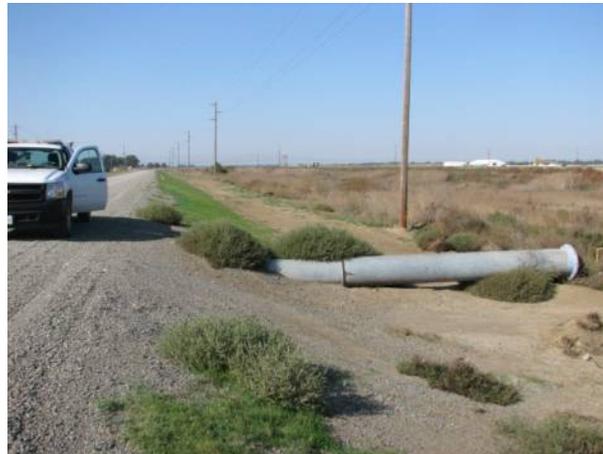
Levee Mile Report Line	2
Start Levee Mile	1.86
End Levee Mile	1.86
Location	Water Side
Category	Earthen Levee
Item	Encroachments

A pipe crossing thru the levee and blocking toe road. Fall 2011

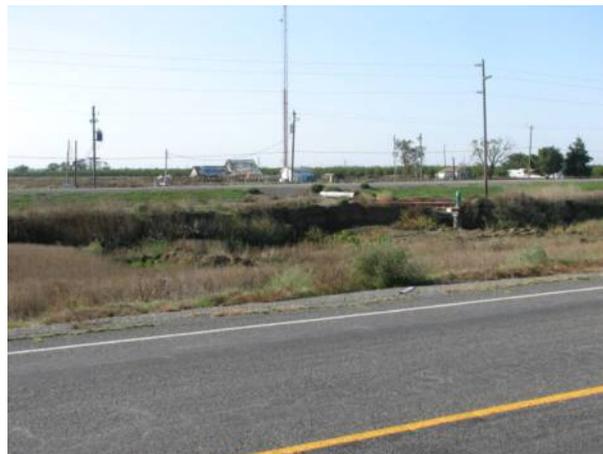
Levee Mile Report Line	3
Start Levee Mile	1.86
End Levee Mile	1.86
Location	Water Side
Category	Earthen Levee
Item	Erosion / Bank Caving

There is erosion occurring at the pump. This may be because the owner has made a pond area in the channel. Fall 2011

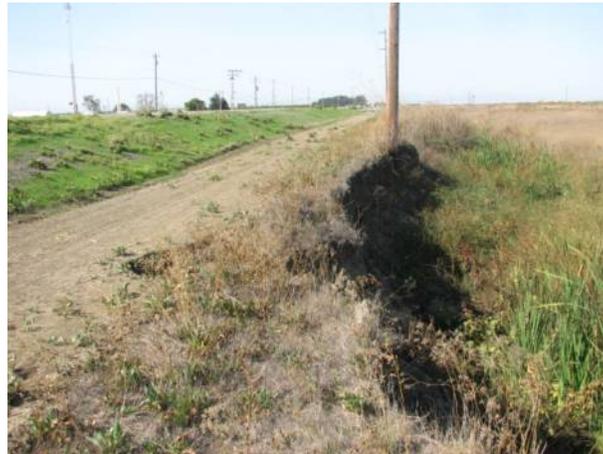
Levee Mile Report Line	4
Start Levee Mile	1.97
End Levee Mile	1.97
Location	Water Side
Category	Earthen Levee
Item	Erosion / Bank Caving
<p>The erosion on the bank of the channel is encroaching into the power pole and toe road. Fall 2011</p>	
<p>johngw_f_20111026_426.jpg</p>

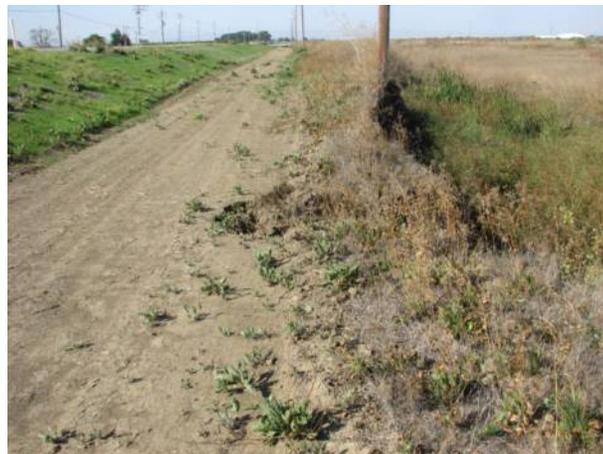
Levee Mile Report Line	4
Start Levee Mile	1.97
End Levee Mile	1.97
Location	Water Side
Category	Earthen Levee
Item	Erosion / Bank Caving
<p>The erosion is starting to encroach into the toe road. Fall 2011</p>	
<p>johngw_f_20111026_427.jpg</p>

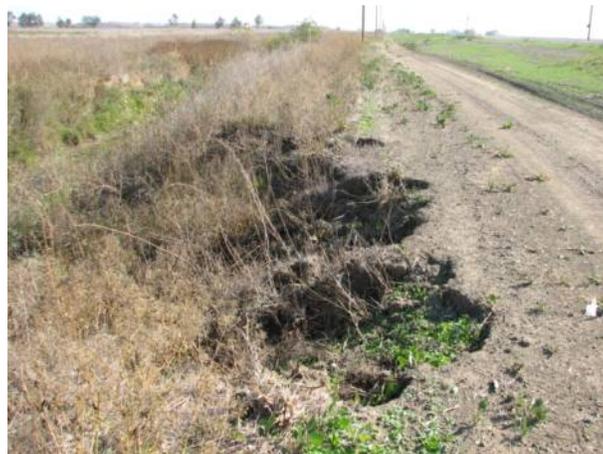
Levee Mile Report Line	5
Start Levee Mile	2.66
End Levee Mile	2.66
Location	Water Side
Category	Earthen Levee
Item	Erosion / Bank Caving
<p>The erosion in the channel is starting to encroach into the toe road. Fall 2011</p>	
<p>johngw_f_20111026_428.jpg</p>

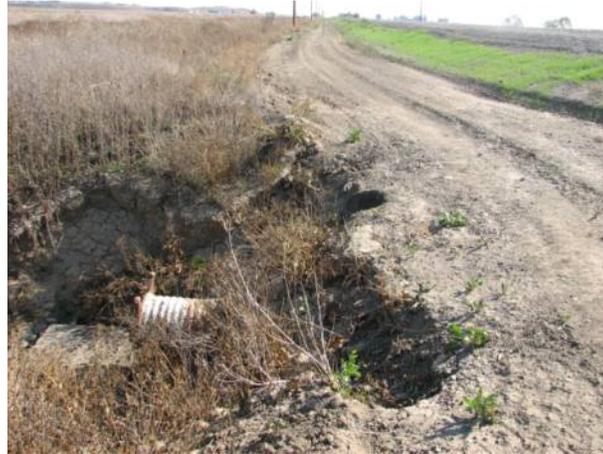
Levee Mile Report Line	6
Start Levee Mile	2.90
End Levee Mile	2.90
Location	Water Side
Category	Earthen Levee
Item	Erosion / Bank Caving

6	2.90	2.90	Earthen Levee	Erosion / Bank Caving	WS	M	Note and monitor erosion site. Inspector Comments: The site has a discharge pipe and has begun eroding around the pipe. It is also eroding into the toe road.	38.589707 ° -121.705044 °	38.589707 ° -121.705044 °	10 Y
7	3.56	3.56	Earthen Levee	Encroachments	LS	PO	Buildings Inspector Comments: Control structure for Davis Drain block building	38.589657 ° -121.692850 °	38.589657 ° -121.692850 °	2 Y

The slope around the discharge pipe is eroding the toe road. Rip rap could be placed around the pipe and re-sloped. Fall 2011

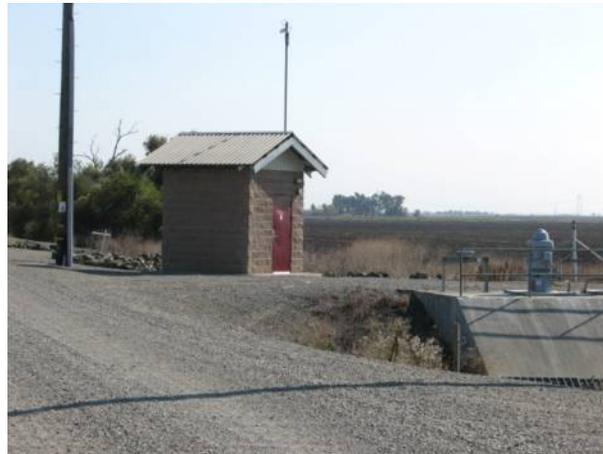
Levee Mile Report Line	7
Start Levee Mile	3.56
End Levee Mile	3.56
Location	Land Side
Category	Earthen Levee
Item	Encroachments

A control structure is placed on top of the levee. Fall 2011
