**Flood Control Project Maintenance
Levee Inspections**

Fall 2014 Levee Maintenance Deficiency Summary Report

Sacramento River Basin

Sacramento Maintenance Yard Willow Slough Bypass

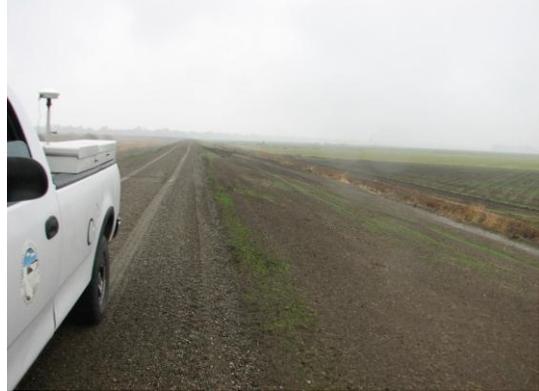
Photo 1 of 1 : FA_2014_ST0012_295_271_20141114_00401.jpg

LM Start	0.00	Rating **	A	Issue No.	271
LM End	5.09	Issue Type +	Ma	Location *	LS
Category	Earthen Levee		GPS Latitude/Longitude		
			Start	End	
Item	Vegetation			°	°
DWR ID	DWR_ST0012_01_f_2014_271				
Action/Comments					
Control annual grass and weeds on the levee slopes and easements.

Levee mile 4.06, vegetation on land side slope. Fall 2014.

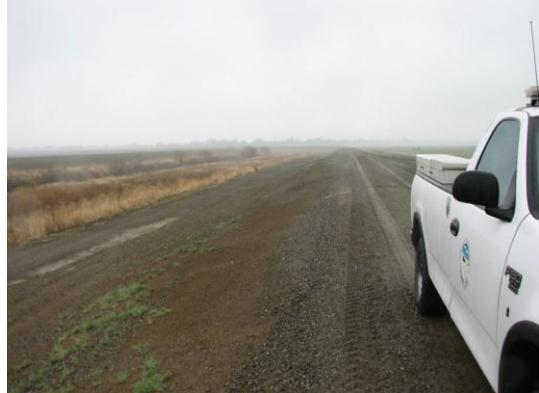
Photo 1 of 1 : FA_2014_ST0012_295_272_20141114_00402.jpg

LM Start	0.00	Rating **	A	Issue No.	272
LM End	5.09	Issue Type +	Ma	Location *	WS
Category	Earthen Levee		GPS Latitude/Longitude		
			Start	End	
Item	Vegetation			°	°
DWR ID	DWR_ST0012_01_f_2014_272				
Action/Comments					
Control annual grass and weeds on the levee slopes and easements.

Levee mile 4.06, vegetation on the water side slope. Fall 2014.

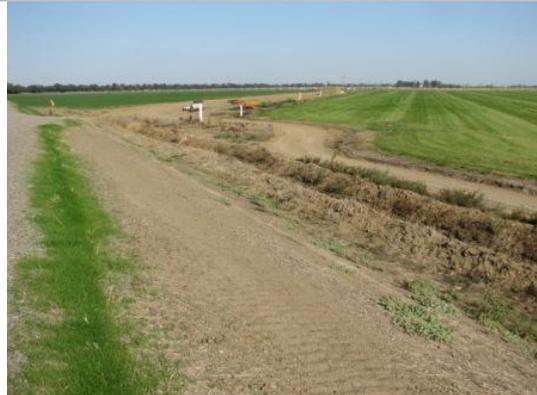
Photo 1 of 1 : FA_2014_ST0012_295_4_20141014_00003.jpg

LM Start	4.32	Rating **	M	Issue No.	4
LM End	4.63	Issue Type +	En	Location *	LS
Category	Earthen Levee		GPS Latitude/Longitude		
			Start	End	
Item	Encroachments		38.598876 °	38.599845 °	
			-121.739640 °	-121.745007 °	
DWR ID	DWR_ST0012_01_s_2012_4				
Action/Comments					
Ditch

The agricultural ditch runs along the toe of the levee. Fall 2011

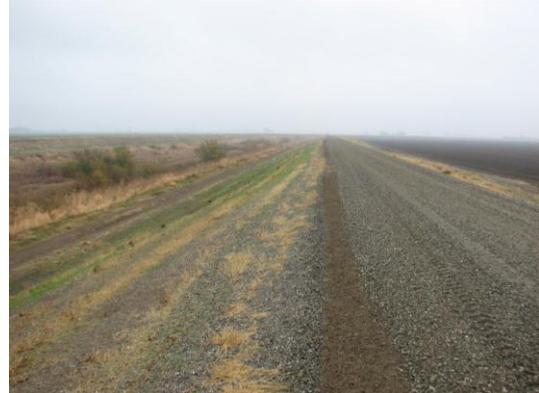
Photo 1 of 1 : FA_2014_ST0012_296_6_20141114_00006.jpg

LM Start	0.03	Rating **	A	Issue No.	6
LM End	7.31	Issue Type +	Ma	Location *	WS
Category	Earthen Levee		GPS Latitude/Longitude		
			Start	End	
Item	Vegetation		38.599117 °	38.574815 °	
			-121.752668 °	-121.640034 °	
DWR ID	DWR_ST0012_02_f_2014_6				
Action/Comments					
Control annual grass and weeds on the levee slopes and easements.

Levee mile 0.19, vegetation on the water side slope. Fall 2014.

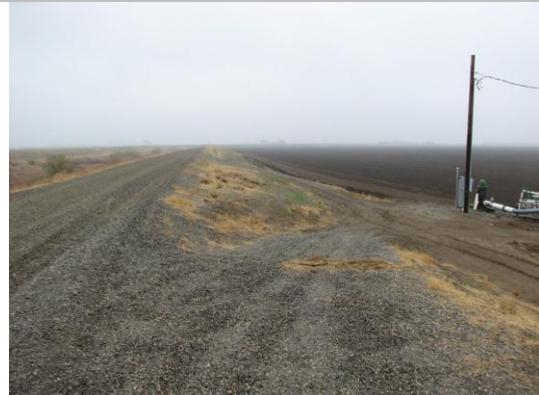
Photo 1 of 1 : FA_2014_ST0012_296_4_20141114_00007.jpg

LM Start	0.03	Rating **	A	Issue No.	4
LM End	7.31	Issue Type +	Ma	Location *	LS
Category	Earthen Levee		GPS Latitude/Longitude		
			Start	End	
Item	Vegetation		38.599118 °	38.574815 °	
			-121.752738 °	-121.640034 °	
DWR ID	DWR_ST0012_02_f_2014_4				
Action/Comments					
Control annual grass and weeds on the levee slopes and easements.

Levee mile 0.19, vegetation on the land side slope. Fall 2014.

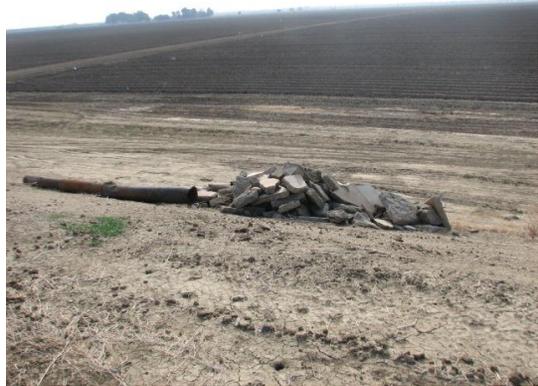
Photo 1 of 1 : FA_2014_ST0012_296_160_20141014_00004.jpg

LM Start	0.17	Rating **	M	Issue No.	160
LM End	0.17	Issue Type +	En	Location *	LS
Category	Earthen Levee		GPS Latitude/Longitude		
			Start	End	
Item	Encroachments		38.599062 °	38.599062 °	
			-121.750156 °	-121.750156 °	
DWR ID	DWR_ST0012_02_f_2013_160				
Action/Comments					
Debris

There is some pipe and concrete debris on the levee slope. Fall 2013

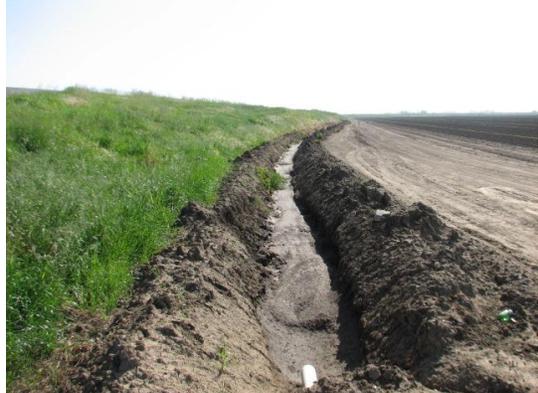
Photo 1 of 1 : FA_2014_ST0012_296_7_20141014_00002.jpg

LM Start	0.22	Rating **	M	Issue No.	7
LM End	0.48	Issue Type +	En	Location *	LS
Category	Earthen Levee		GPS Latitude/Longitude		
			Start	End	
Item	Encroachments		38.598993 °	38.599047 °	
			-121.749130 °	-121.744366 °	
DWR ID	DWR_ST0012_02_s_2014_7				
Action/Comments					
Ditch

Agricultural ditch run along landside toe. Spring 2014

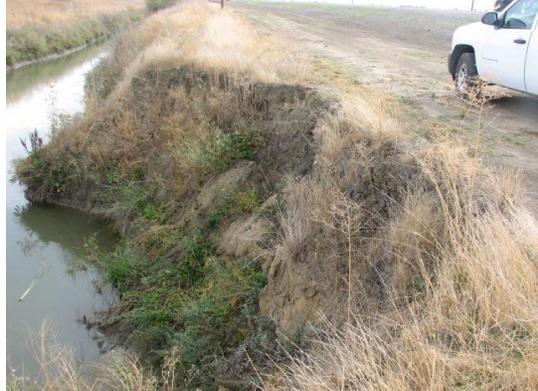
Photo 1 of 1 : FA_2014_ST0012_296_8_20141014_00003.jpg

LM Start	1.71	Rating **	M	Issue No.	8
LM End	1.71	Issue Type +	Ma	Location *	WS
Category	Earthen Levee		GPS Latitude/Longitude		
			Start	End	
Item	Erosion / Bank Caving		38.589966 °	38.589966 °	
			-121.727072 °	-121.727072 °	
DWR ID	DWR_ST0012_02_s_2012_8				
Action/Comments					
Note and monitor erosion site.

Erosion on the edge of the channel. Fall 2012

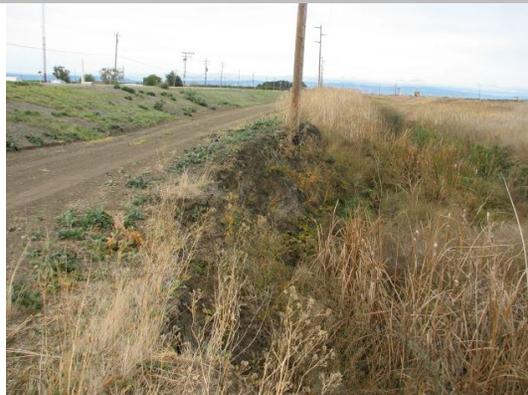
Photo 1 of 1 : FA_2014_ST0012_296_5_20141014_00001.jpg

LM Start	1.97	Rating **	M	Issue No.	5
LM End	1.97	Issue Type +	Ma	Location *	WS
Category	Earthen Levee		GPS Latitude/Longitude		
			Start	End	
Item	Erosion / Bank Caving		38.589906 °	38.589906 °	
			-121.722218 °	-121.722218 °	
DWR ID	DWR_ST0012_02_s_ 2012_5				
Action/Comments					
Note and monitor erosion site.

Erosion on the edge of the channel. Fall 2012.

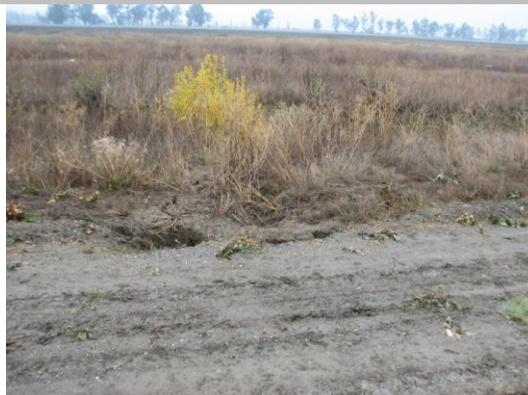
Photo 1 of 1 : FA_2014_ST0012_296_10_20141114_00008.jpg

LM Start	2.75	Rating **	M	Issue No.	10
LM End	2.75	Issue Type +	Ma	Location *	WS
Category	Earthen Levee		GPS Latitude/Longitude		
			Start	End	
Item	Erosion / Bank Caving		38.589691 °	38.589691 °	
			-121.707740 °	-121.707740 °	
DWR ID	DWR_ST0012_02_f_ 2014_10				
Action/Comments					
Note and monitor erosion site.

Levee mile 2.75, erosion on toe road. Fall 2014.

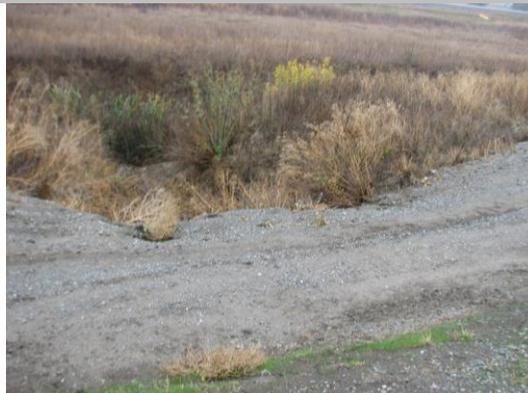
Photo 1 of 1 : FA_2014_ST0012_296_9_20141114_00009.jpg

LM Start	2.90	Rating **	M	Issue No.	9
LM End	2.90	Issue Type +	Ma	Location *	WS
Category	Earthen Levee		GPS Latitude/Longitude		
			Start	End	
Item	Erosion / Bank Caving		38.589686 °	38.589686 °	
			-121.705041 °	-121.705041 °	
DWR ID	DWR_ST0012_02_f_ 2014_9				
Action/Comments					
Note and monitor erosion site.

Levee mile 2.90, erosion on toe road. Fall 2014.
