**Flood Control Project Maintenance
Levee Inspections**

Fall 2015 Levee Maintenance Deficiency Summary Report

Sacramento River Basin

Sacramento Maintenance Yard Willow Slough Bypass

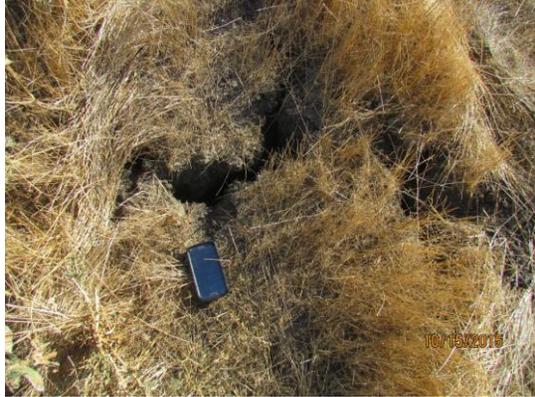
Photo 1 of 2 : FA_2015_ST0012_295_16_20151019_00026.jpg

View of the dessication cracking on the landward side of the levee. Fall 2015.

| Monitor and have inspected by geotechnical engineer. | | | | | |

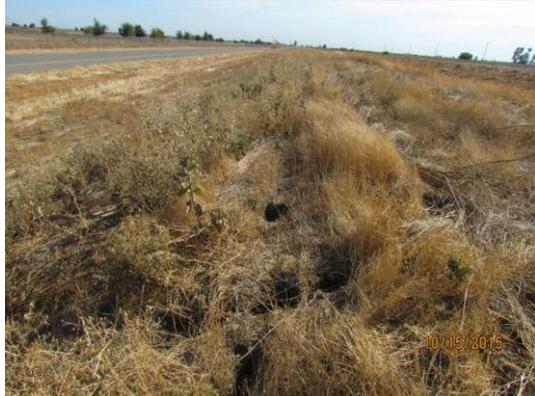
Photo 2 of 2 : FA_2015_ST0012_295_16_20151019_00028.jpg

Perspective view of the crack looking downstream. Fall 2015.

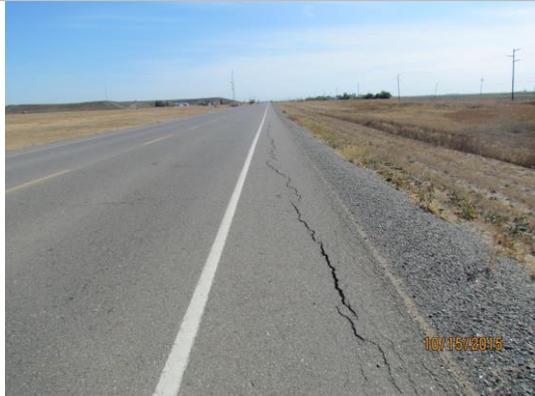
Photo 1 of 3 : FA_2015_ST0012_295_15_20151019_00014.jpg

| Monitor and have inspected by geotechnical engineer. Inspector Comments: Cracks starting to form on the waterward slope. | | | | | |

Perspective view of the crack on the crown of the levee looking downstream. Fall 2015.

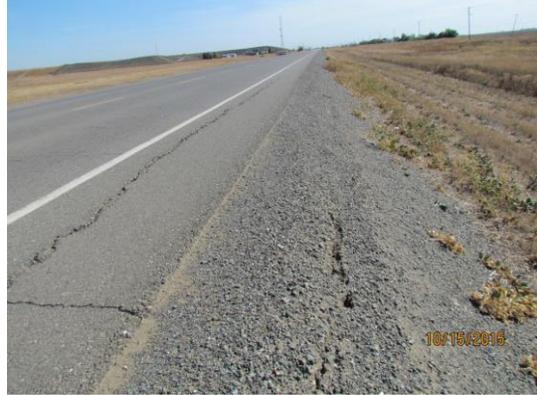
Photo 2 of 3 : FA_2015_ST0012_295_15_20151019_00018.jpg

| Monitor and have inspected by geotechnical engineer. Inspector Comments: Cracks starting to form on the waterward slope. | | | | | |

Cracks are starting to form on the waterward slope of the levee looking downstream. Fall 2015.

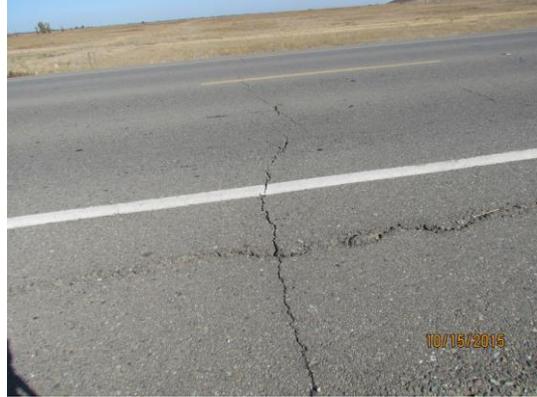
Photo 3 of 3 : FA_2015_ST0012_295_15_20151019_00019.jpg

There is another crack perpendicular to the crack on the levee crown. Fall 2015.

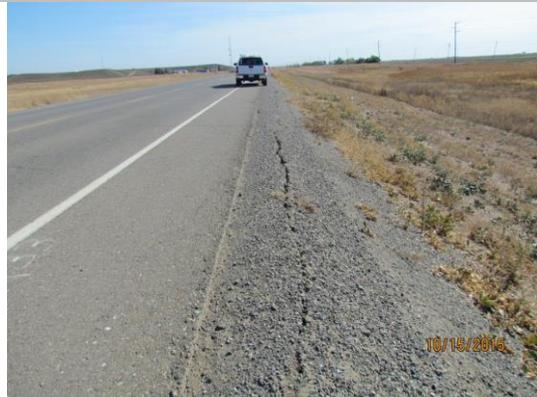
Photo 1 of 1 : FA_2015_ST0012_295_14_20151019_00022.jpg

View of the crack on the waterward side of the levee looking downstream. Fall 2015.

| Monitor and have inspected by geotechnical engineer. | | | | | |

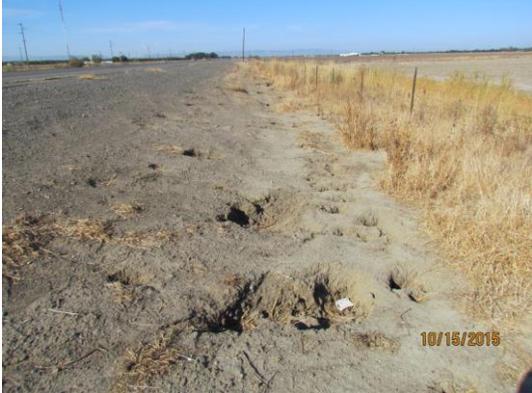
Photo 1 of 1 : FA_2015_ST0012_295_10_20151019_00013.jpg

View of the erosion on the landward side of the levee looking upstream. Fall 2015.

| Schedule repair of erosion site prior to the next inspection. | | | | | |

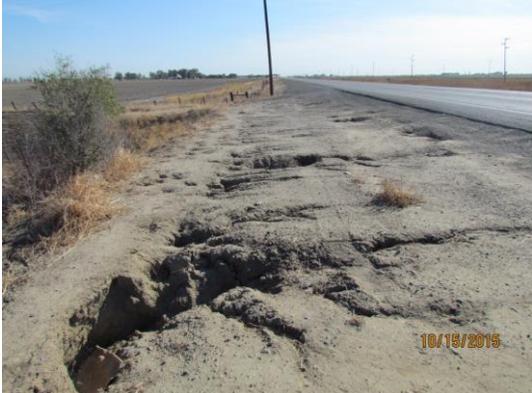
Photo 1 of 3 : FA_2015_ST0012_295_13_20151019_00009.jpg

Perspective view of the erosion on the landward side of the levee looking upstream. Fall 2015.

| Schedule repair of erosion site prior to the next inspection. | | | | | |

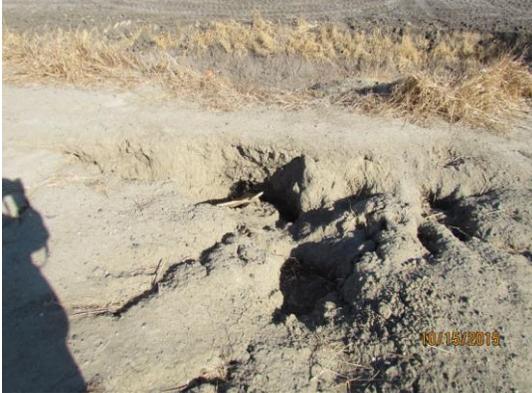
Photo 2 of 3 : FA_2015_ST0012_295_13_20151019_00011.jpg

Close up view of the erosion on the landward side of the levee. Fall 2015.

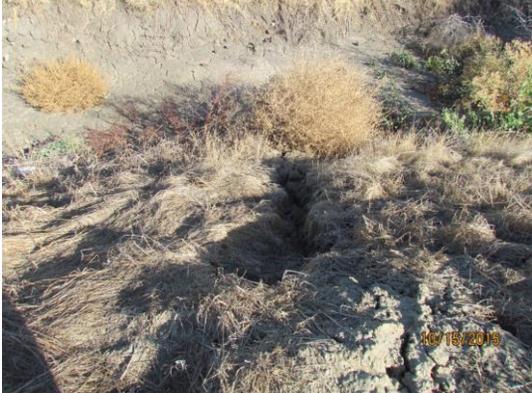
Photo 3 of 3 : FA_2015_ST0012_295_13_20151019_00012.jpg

The erosion continues onto the slope of the channel. Fall 2015.

| Schedule repair of erosion site prior to the next inspection. | | | | | |

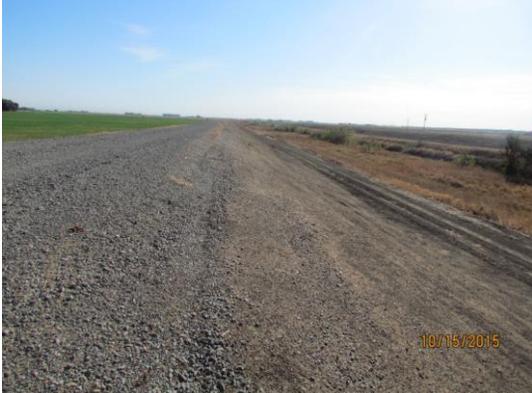
Photo 1 of 1 : FA_2015_ST0012_295_5_20151019_00005.jpg

View of the vegetation on the waterward side of the levee looking downstream. Fall 2015.

| Control annual grass and weeds on the levee slopes and easements. Inspector Comments: Sac Yard has burned and dragged the slope. | | | | | |

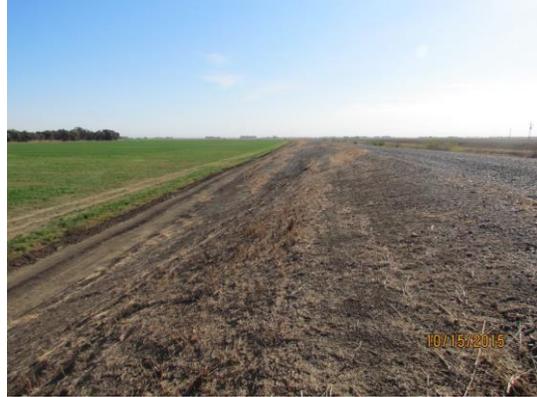
Photo 1 of 1 : FA_2015_ST0012_295_3_20151019_00004.jpg

View of the vegetation on the landward side of the levee looking downstream. Fall 2015.

| Control annual grass and weeds on the levee slopes and easements. Inspector Comments: Sac Yard has mowed the slopes. | | | | | |

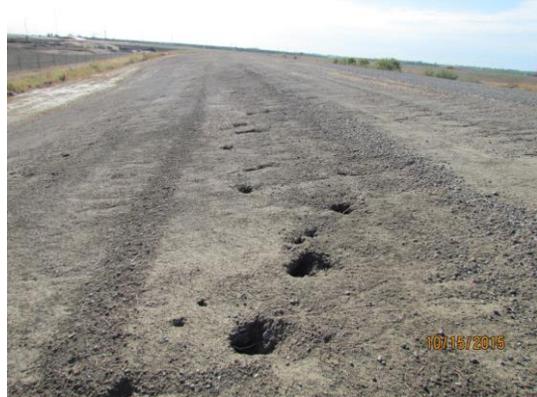
Photo 1 of 1 : FA_2015_ST0012_295_12_20151019_00008.jpg

View of the rodent hole on the landward side of the levee looking downstream. Fall 2015.

| No rodents visible, but rodent burrows visible; need to backfill and compact or grout burrows. | | | | | |

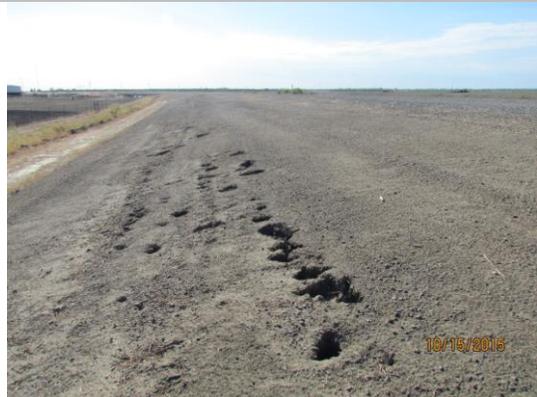
Photo 1 of 1 : FA_2015_ST0012_295_11_20151019_00007.jpg

View of the rodent holes on the landward side of the levee looking downstream. Fall 2015.

| No rodents visible, but rodent burrows visible; need to backfill and compact or grout burrows. Inspector Comments: Connected rodent holes seem to have caved in. | | | | | |

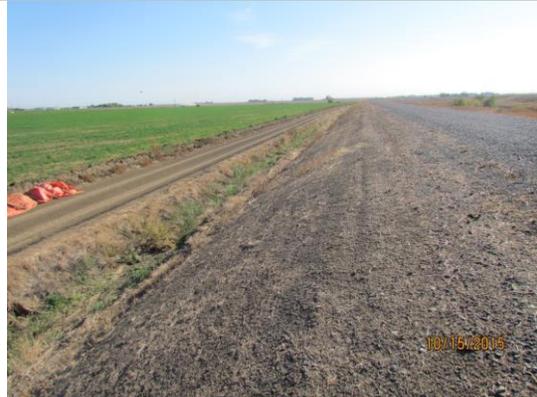
Photo 1 of 1 : FA_2015_ST0012_295_4_20151019_00006.jpg

| Ditch Inspector Comments: Ditch is at the levee toe. | | | | | |

View of the ditch on the landward side of the levee looking downstream. Fall 2015.

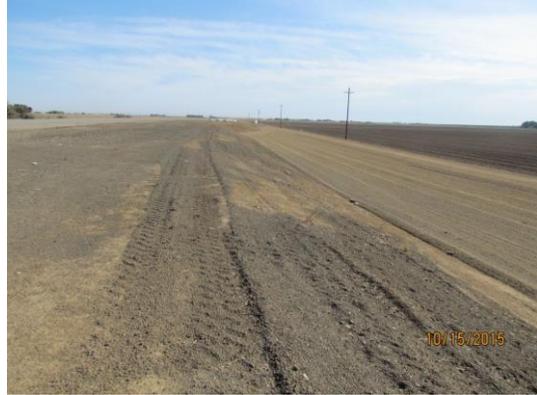
Photo 1 of 1 : FA_2015_ST0012_296_4_20151019_00015.jpg

View of the vegetation on the landward side of the levee looking downstream. Fall 2015.

| Control annual grass and weeds on the levee slopes and easements. Inspector Comments: LMA has maintained levee slope and in compliance. | | | | | |

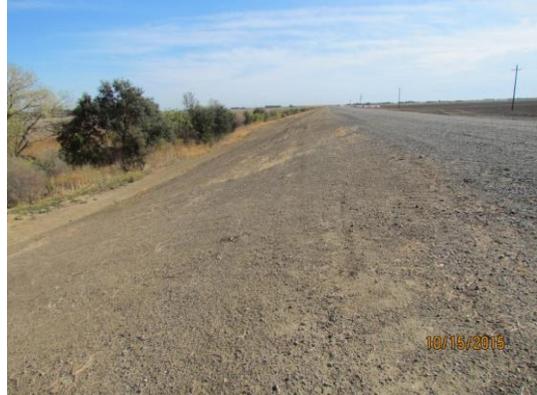
Photo 1 of 1 : FA_2015_ST0012_296_6_20151019_00014.jpg

View of the vegetation on the waterward side of the levee looking downstream. Fall 2015.

| Control annual grass and weeds on the levee slopes and easements. Inspector Comments: LMA has maintained levee slope and in compliance. | | | | | |

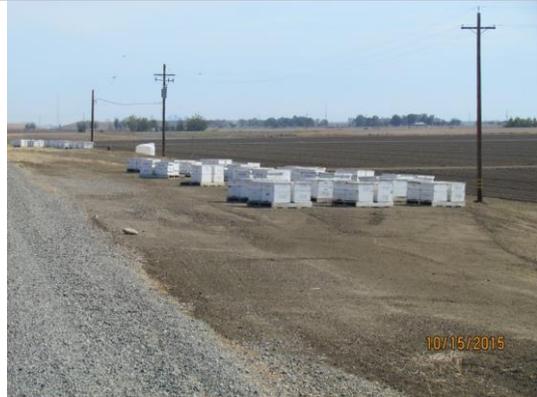
Photo 1 of 1 : FA_2015_ST0012_296_17_20151019_00016.jpg

View of the beehives on the landward side of the levee looking downstream. Fall 2015.

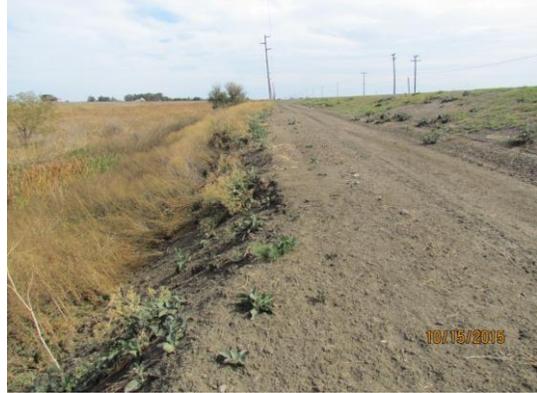
Photo 2 of 2 : FA_2015_ST0012_296_5_20151019_00019.jpg

View of the erosion on the edge of the channel on the waterward side of the levee looking downstream. Fall 2015.

| Note and monitor erosion site. | | | | | |

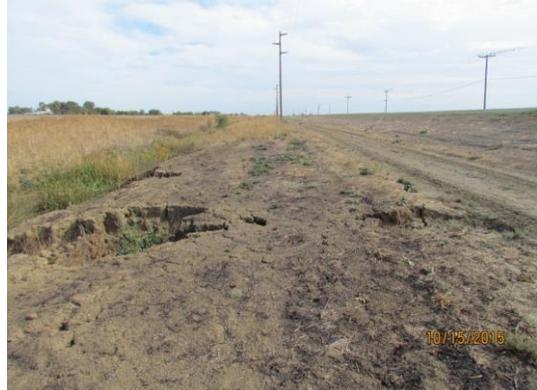
Photo 1 of 1 : FA_2015_ST0012_296_19_20151019_00020.jpg

View of the erosion at the edge of the channel on the waterward side of the levee looking downstream. Fall 2015.

| Note and monitor erosion site. Inspector Comments: Erosion creeping onto toe road. | | | | | |

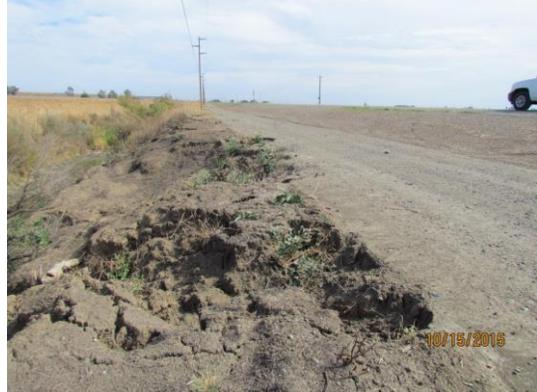
Photo 1 of 1 : FA_2015_ST0012_296_20_20151019_00021.jpg

View of the erosion at the edge of the channel looking downstream. Fall 2015.

| Note and monitor erosion site. Inspector Comments: Erosion starting to creep onto the toe road. | | | | | |

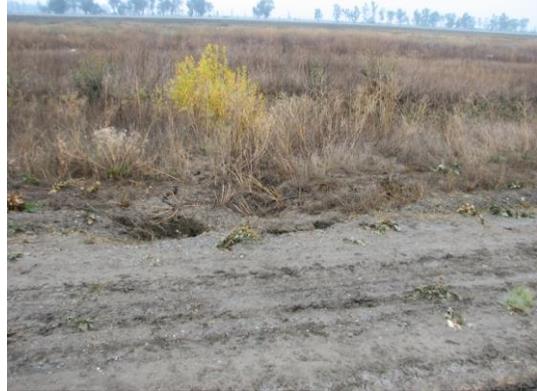
Photo 1 of 1 : FA_2015_ST0012_296_10_20150914_00006.jpg

Erosion on toe road. Fall 2014.

| Note and monitor erosion site. | | | | | |

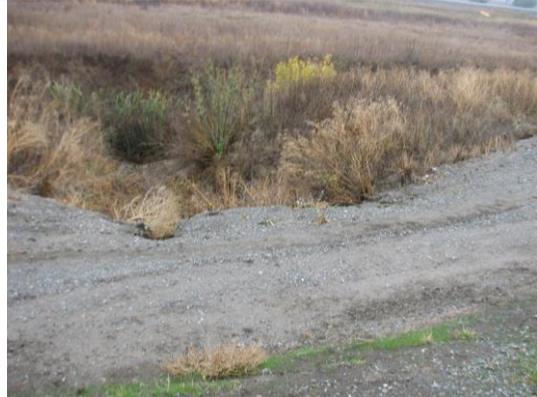
Photo 1 of 2 : FA_2015_ST0012_296_9_20150914_00005.jpg

Erosion on toe road. Fall 2014.

| Note and monitor erosion site. | | | | | |

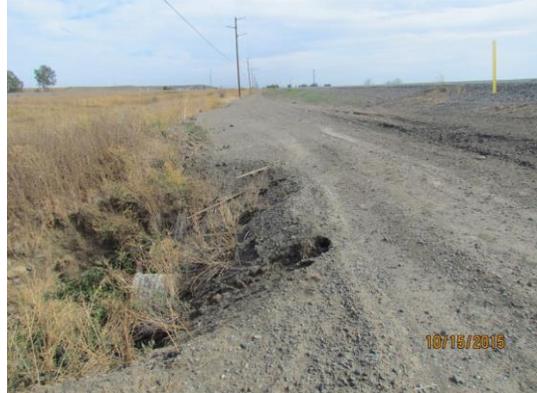
Photo 2 of 2 : FA_2015_ST0012_296_9_20151019_00022.jpg

View of the erosion on the waterward side of the levee looking downstream. Fall 2015.

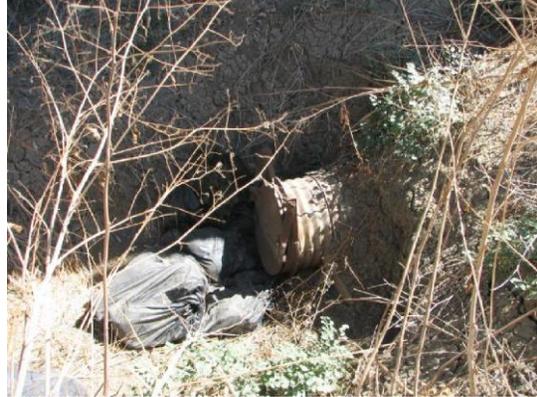
Photo 1 of 1 : UCIP_FA_2015_0782.jpg

| Inspector Comments: FS_ID:45285 DS_ID:546 EP_NO: 10319 FS_HLM: 4.529 Repair Type: Non-Urgent Crossing Status: Found UCIP Comments: Material removed from inlet last fall. Outlet cleared FIELD_STRUCT_DESC: 24-inch CM drainpipe through the levee, 15.0 feet below the crown. Flap gate on the waterward end. (A.B.O. No. 10319 - Bell). O&M manual 120, revision Dec 2010. FS Date: 05/14/2015 | | | | | |

Waterside view- pipe and flap gate.

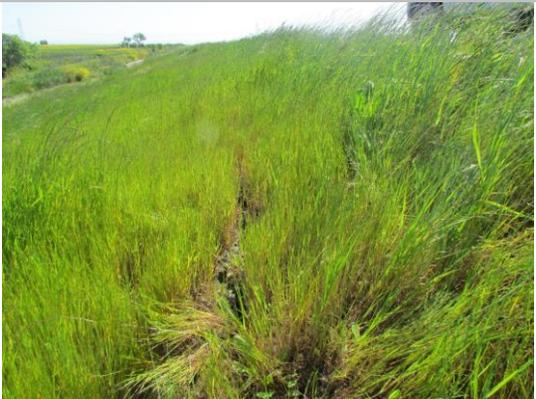
Photo 1 of 3 : FA_2015_ST0012_296_13_20150914_00008.jpg

View of the perspective of the cracking on the water ward side of the levee looking downstream. Spring 2015.

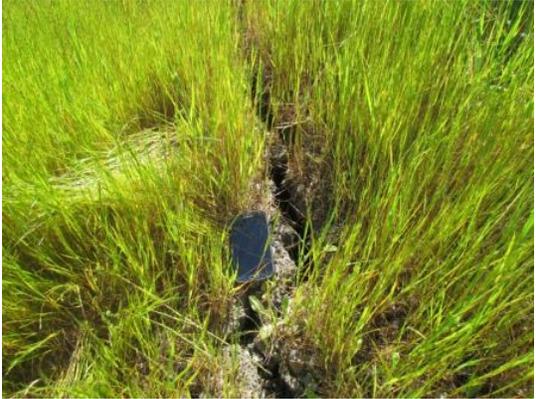
Photo 2 of 3 : FA_2015_ST0012_296_13_20150914_00009.jpg

View of the crack on the water ward side of the levee. Spring 2015.

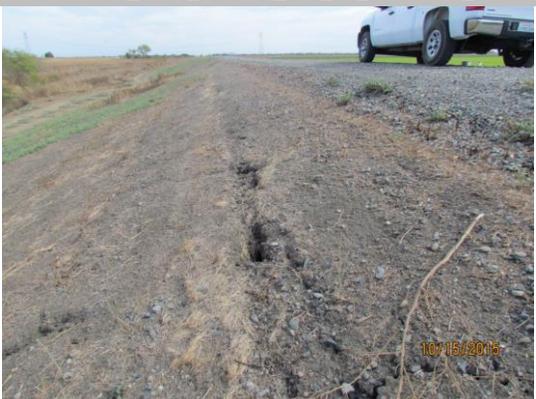
Photo 3 of 3 : FA_2015_ST0012_296_13_20151019_00024.jpg

View of the dessication cracks on the waterward side of the levee looking downstream. Fall 2015.

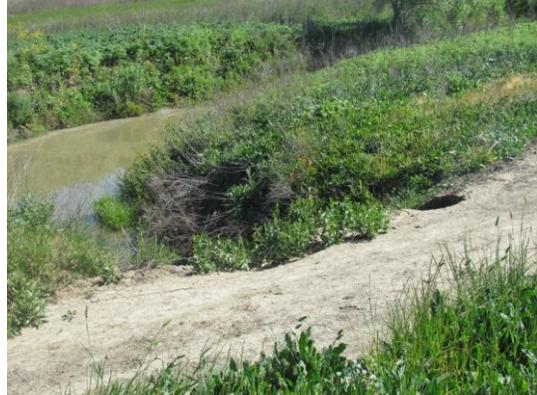
Photo 1 of 2 : FA_2015_ST0012_296_15_20150914_00011.jpg

View of the erosion on the edge of the channel on the waterward side of the levee. Spring 2015.

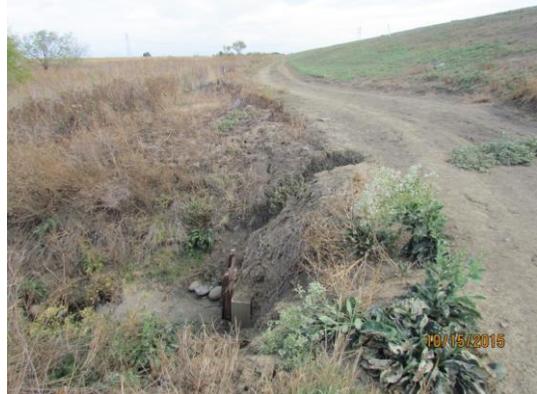
Photo 2 of 2 : FA_2015_ST0012_296_15_20151019_00025.jpg

View of the erosion at the edge of the channel on the waterward side of the levee looking downstream. Fall 2015.

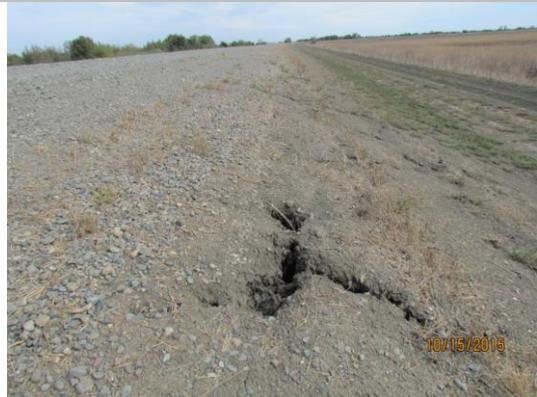
Photo 1 of 1 : FA_2015_ST0012_296_22_20151019_00026.jpg

View of the dessication cracking on the landward side of the levee looking downstream. Fall 2015.

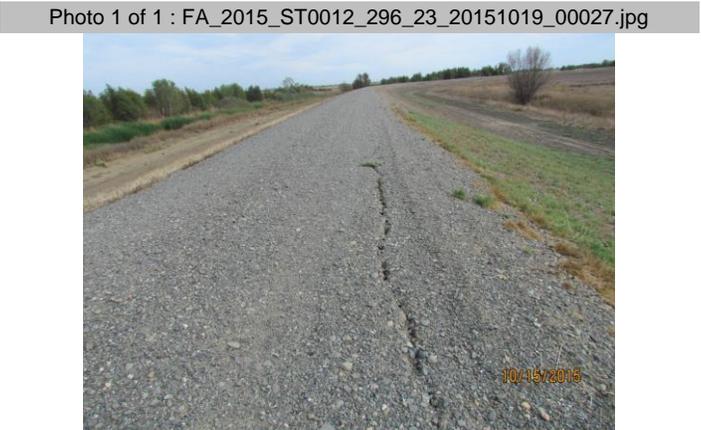
View of the crack on the levee crown looking downstream. Fall 2015.

| Monitor and have inspected by geotechnical engineer. | | | | | |

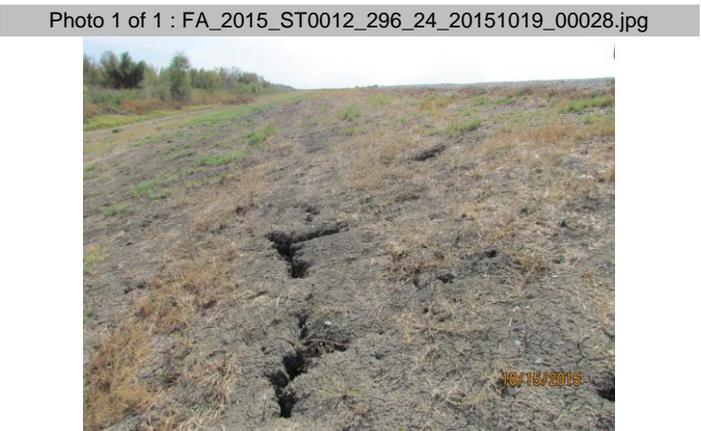
View of the dessication cracking on the waterward side of the levee looking downstream. Fall 2015.

| Monitor and have inspected by geotechnical engineer. | | | | | |
