**Flood Control Project Maintenance  
Levee Inspections**  
**LMA District Cover Sheet**  
**Spring 2014 Levee Inspection Results**

**Sacramento Maintenance Yard Willow Slough Bypass**

**Levee Inspection Report By Mile - Spring 2014**

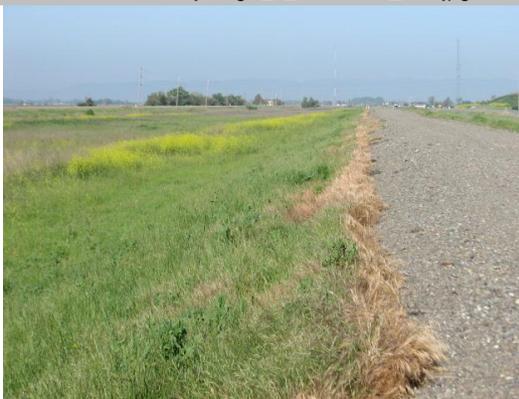
Photo 1 of 1 : johngw\_s\_20140421\_837.jpg

LM Start	<b>0.01</b>	Rating **	M	Issue No.	<b>5</b>
LM End	<b>5.05</b>	Issue Type +	Ma	Location *	WS
Category	Earthen Levee		GPS Latitude/Longitude		
			Start	End	
Item	Vegetation		38.590774 °	38.599988 °	
			-121.665546 °	-121.752813 °	
DWR ID	DWR_ST0012_01_s_2014_5				
Action/Comments					
Control annual grass and weeds on the levee slopes and easements.

Tall grasses partially blocks visibility. Spring 2014

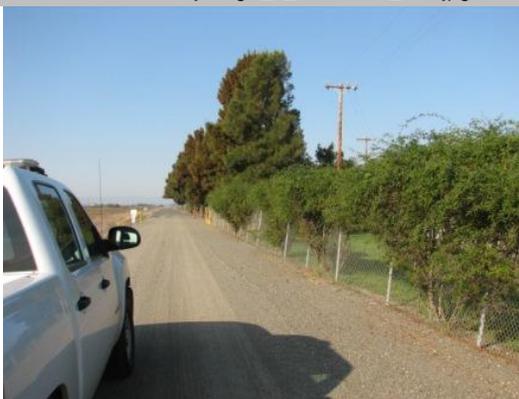
Photo 1 of 2 : johngw\_s\_20140414\_703.jpg

LM Start	<b>0.02</b>	Rating **	M	Issue No.	<b>1</b>
LM End	<b>0.15</b>	Issue Type +	En	Location *	CR
Category	Earthen Levee		GPS Latitude/Longitude		
			Start	End	
Item	Vegetation		38.590742 °	38.590716 °	
			-121.665767 °	-121.668203 °	
DWR ID	DWR_ST0012_01_s_2012_1				
Action/Comments					
Landscaping Inspector Comments: This is the treatment plant's landscaping and chain link fence.

The treatment plant's landscape and fence. This runs along the crown and toe of the levee.

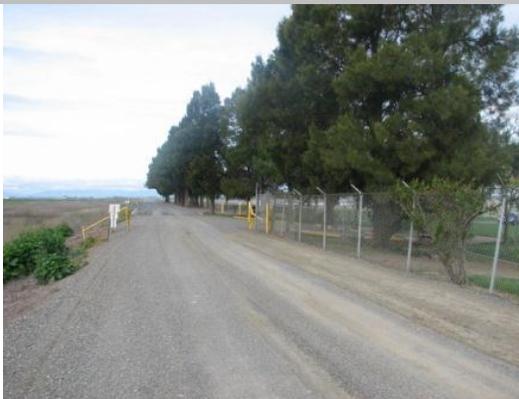
Photo 2 of 2 : johngw\_s\_20140414\_704.jpg

Photo taken spring 2012, the treatment plants landscaping.

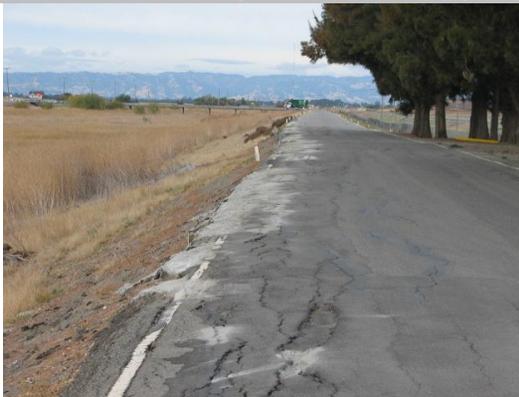
Photo 1 of 2 : johngw\_s\_20140414\_707.jpg

LM Start	<b>0.07</b>	Rating **	M	Issue No.	<b>10</b>
LM End	<b>0.21</b>	Issue Type +	Ob	Location *	WS
Category	Earthen Levee		GPS Latitude/Longitude		
			Start	End	
Item	Cracking		38.590724 °	38.590663 °	
			-121.666749 °	-121.669190 °	
DWR ID	DWR_ST0012_01_f_2012_10				
Action/Comments					
Monitor and have inspected by geotechnical engineer.

There is still cracking and sloughing on the waterside crown. Attempts to fill in the cracks all along the roadway have been done.

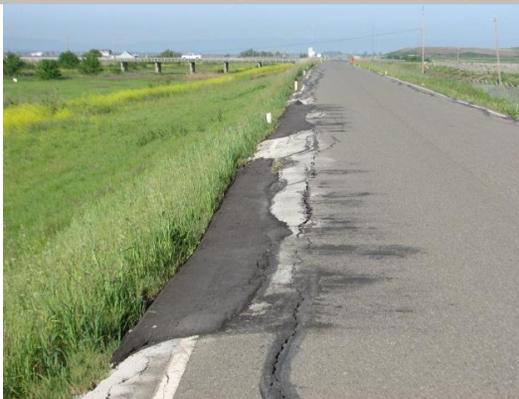
Photo 2 of 2 : johngw\_s\_20140421\_839.jpg

The county road is sloughing off. There is ongoing attempts to repair the shoulders. Spring 2014

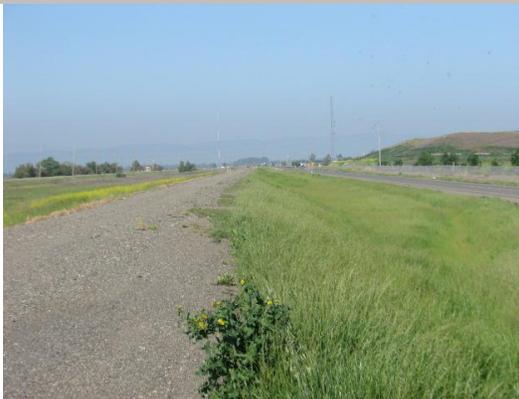
Photo 1 of 1 : johngw\_s\_20140421\_838.jpg

LM Start	<b>0.15</b>	Rating **	M	Issue No.	<b>11</b>
LM End	<b>1.45</b>	Issue Type +	Ma	Location *	LS
Category	Earthen Levee		GPS Latitude/Longitude		
			Start	End	
Item	Vegetation		38.590705 °	38.590331 °	
			-121.668146 °	-121.692046 °	
DWR ID	DWR_ST0012_01_s_2014_11				
Action/Comments					
Control annual grass and weeds on the levee slopes and easements.

Tall grasses partially block visibility. Spring 2014

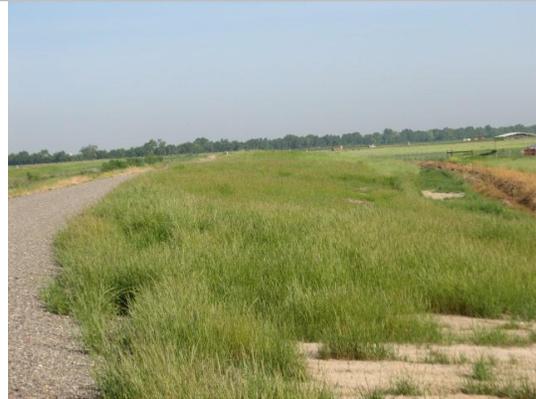
Photo 1 of 1 : johngw\_s\_20140421\_840.jpg

LM Start	<b>3.56</b>	Rating **	M	Issue No.	<b>12</b>
LM End	<b>5.05</b>	Issue Type +	Ma	Location *	LS
Category	Earthen Levee		GPS Latitude/Longitude		
			Start	End	
Item	Vegetation		38.590689 °	38.599988 °	
			-121.730865 °	-121.752813 °	
DWR ID	DWR_ST0012_01_s_2014_12				
Action/Comments					
Control annual grass and weeds on the levee slopes and easements.

Tall grasses partially blocks visibility. Spring 2014

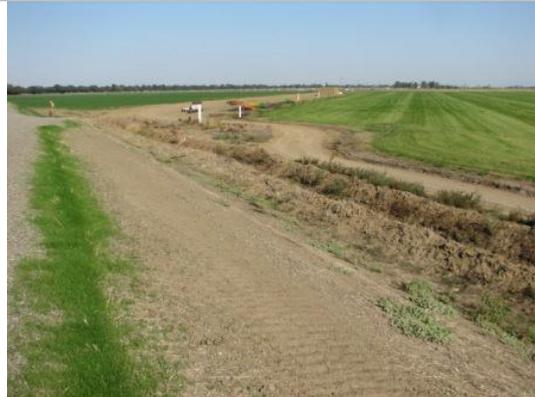
Photo 1 of 1 : johngw\_s\_20140414\_705.jpg

LM Start	<b>4.32</b>	Rating **	M	Issue No.	<b>4</b>
LM End	<b>4.63</b>	Issue Type +	En	Location *	LS
Category	Earthen Levee		GPS Latitude/Longitude		
			Start	End	
Item	Encroachments		38.598876 °	38.599845 °	
			-121.739640 °	-121.745007 °	
DWR ID	DWR_ST0012_01_s_2012_4				
Action/Comments					
Ditch

The agricultural ditch runs along the toe of the levee. Fall 2011

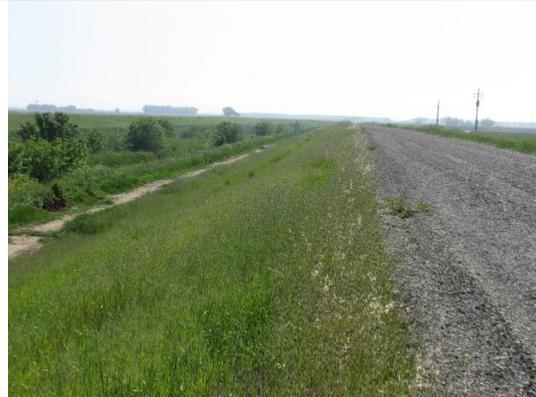
Photo 1 of 1 : johngw\_s\_20140421\_841.jpg

LM Start	<b>0.01</b>	Rating **	M	Issue No.	<b>4</b>
LM End	<b>7.37</b>	Issue Type +	Ma	Location *	WS
Category	Earthen Levee		GPS Latitude/Longitude		
			Start	End	
Item	Vegetation		38.599142 °	38.574613 °	
			-121.752997 °	-121.638946 °	
DWR ID	DWR_ST0012_02_s_2014_4				
Action/Comments					
Control annual grass and weeds on the levee slopes and easements.

Tall grasses partially blocks visibility. Spring 2014

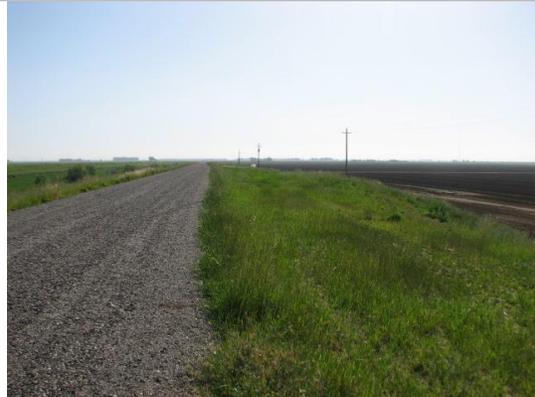
Photo 1 of 1 : johngw\_s\_20140421\_842.jpg

LM Start	<b>0.01</b>	Rating **	M	Issue No.	<b>6</b>
LM End	<b>7.37</b>	Issue Type +	Ma	Location *	LS
Category	Earthen Levee		GPS Latitude/Longitude		
			Start	End	
Item	Vegetation		38.599142 °	38.574613 °	
			-121.752997 °	-121.638946 °	
DWR ID	DWR_ST0012_02_s_2014_6				
Action/Comments					
Control annual grass and weeds on the levee slopes and easements.

Tall grasses partially blocks visibility. Spring 2014

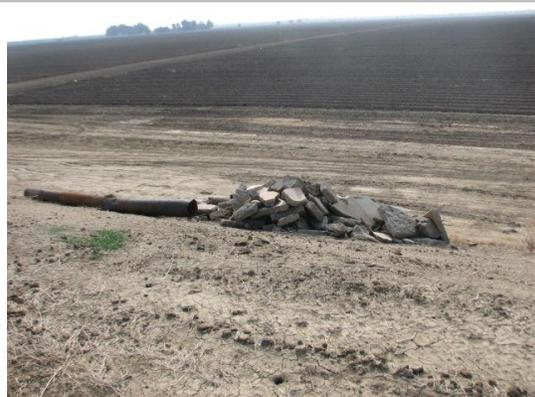
Photo 1 of 1 : johngw\_s\_20140414\_710.jpg

LM Start	<b>0.17</b>	Rating **	M	Issue No.	<b>160</b>
LM End	<b>0.17</b>	Issue Type +	En	Location *	LS
Category	Earthen Levee		GPS Latitude/Longitude		
			Start	End	
Item	Encroachments		38.599062 °	38.599062 °	
			-121.750156 °	-121.750156 °	
DWR ID	DWR_ST0012_02_f_2013_160				
Action/Comments					
Debris

There is some pipe and concrete debris on the levee slope. Fall 2013

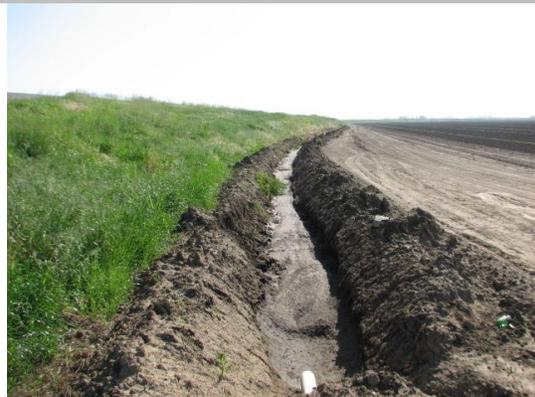
Photo 1 of 1 : johngw\_s\_20140421\_843.jpg

LM Start	<b>0.22</b>	Rating **	M	Issue No.	<b>7</b>
LM End	<b>0.48</b>	Issue Type +	En	Location *	LS
Category	Earthen Levee		GPS Latitude/Longitude		
			Start	End	
Item	Encroachments		38.598993 °	38.599047 °	
			-121.749130 °	-121.744366 °	
DWR ID	DWR_ST0012_02_s_2014_7				
Action/Comments					
Ditch

Agricultural ditch run along landside toe. Spring 2014

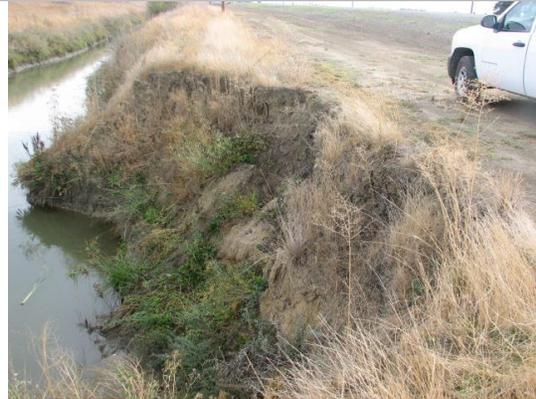
Photo 1 of 1 : johngw\_s\_20140414\_709.jpg

LM Start	<b>1.71</b>	Rating **	M	Issue No.	<b>8</b>
LM End	<b>1.71</b>	Issue Type +	Ma	Location *	WS
Category	Earthen Levee		GPS Latitude/Longitude		
			Start	End	
Item	Erosion / Bank Caving		38.589966 °	38.589966 °	
			-121.727072 °	-121.727072 °	
DWR ID	DWR_ST0012_02_s_2012_8				
Action/Comments					
Note and monitor erosion site.

Erosion on the edge of the channel. Fall 2012

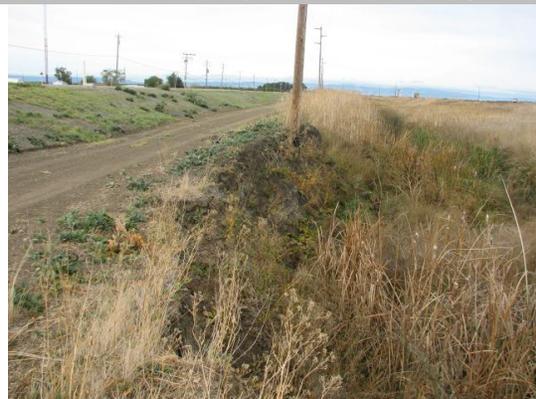
Photo 1 of 1 : johngw\_s\_20140414\_708.jpg

LM Start	<b>1.97</b>	Rating **	M	Issue No.	<b>5</b>
LM End	<b>1.97</b>	Issue Type +	Ma	Location *	WS
Category	Earthen Levee		GPS Latitude/Longitude		
			Start	End	
Item	Erosion / Bank Caving		38.589906 °	38.589906 °	
			-121.722218 °	-121.722218 °	
DWR ID	DWR_ST0012_02_s_2012_5				
Action/Comments					
Note and monitor erosion site.

Erosion on the edge of the channel. Fall 2012.

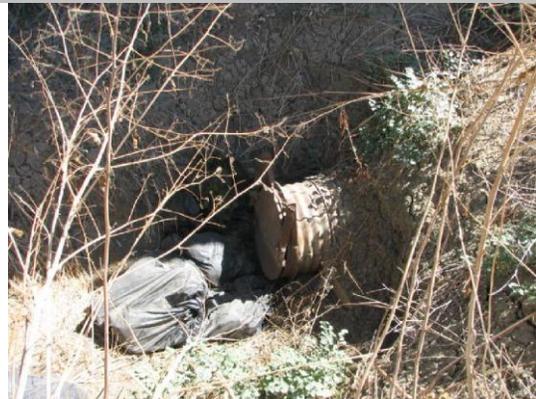
Photo 1 of 1 : UCIP\_931.jpg

LM Start	<b>4.53</b>	Rating **	M	Issue No.	<b>3</b>
LM End	<b>4.53</b>	Issue Type +	En	Location *	WS
Category	Supplemental			GPS Latitude/Longitude	
				Start	End
Item	DWR UCIP Field Study			38.589575 °	38.589575 °
				-121.674950 °	-121.674950 °
DWR ID	DWR_ST0012_02_s_2014_3				
Action/Comments					
Inspector Comments: FS_ID:13877 EP_NO: 10319 Repair Type: Crossing Status: UCIP Comments: Material removed from inlet last fall. Outlet cleared FIELD_STRUCT_DESC: 24-inch CM drainpipe through the levee, 15.0 feet below the crown. Flap gate on the waterward end. (A.B.O. No. 10319 - Bell). O&M manual 120, revision Dec 2010. FS Date: 5/24/2013

Waterside view- pipe and flap gate.
