**Flood Control Project Maintenance  
Levee Inspections**

**Maintenance Issue Types Only, Levee Inspection Report By Mile - Spring 2016**

**Sacramento Maintenance Yard Willow Slough Bypass**

Waterway	Bank	Unit Miles	Inspection Start/End	Inspector
Unit No. 01 Willow Slough Bypass or North Levee	Left	5.05	03/02/2016 03/02/2016	Jai Lor

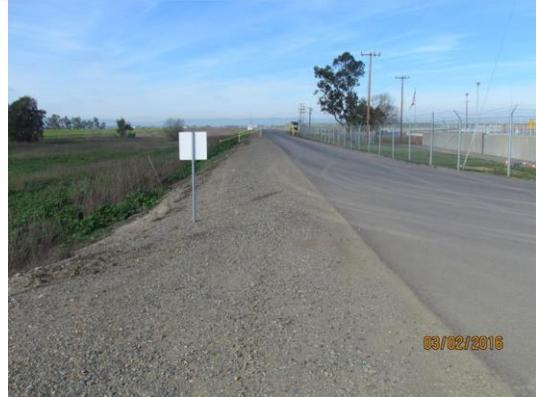
Photo 1 of 1 : SP\_2016\_ST0012\_295\_3\_20160303\_00014.jpg

LM Start	<b>0.00</b>	Rating **	A	Issue No.	<b>3</b>
LM End	<b>0.75</b>	Issue Type +	Ma	Location *	WS
Category	Earthen Levee		GPS Latitude/Longitude		
			Start	End	
Item	Vegetation		38.590785 °	38.590478 °	
			-121.665306 °	-121.679087 °	
DWR ID	DWR_ST0012_01_s_2016_3				
Comment Code					
V1 : Control annual grass and weeds on the levee slopes and easements.					
Inspector Comment					
LMA has maintained vegetation on levee slopes.

View of the vegetation on the waterward side looking upstream. Spring 2016.

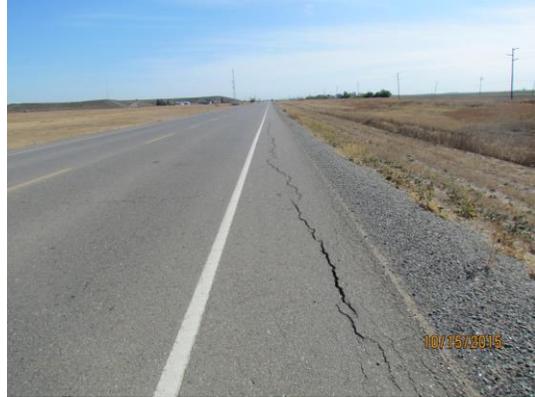
Photo 1 of 3 : SP\_2016\_ST0012\_295\_15\_20160302\_00009.jpg

LM Start	<b>1.86</b>	Rating **	A/W	Issue No.	<b>15</b>
LM End	<b>1.88</b>	Issue Type +	Ma	Location *	CR
Category	Earthen Levee			GPS Latitude/Longitude	
				Start	End
Item	Cracking			38.590378 °	38.590379 °
				-121.699630 °	-121.699920 °
DWR ID	DWR_ST0012_01_f_2015_15				
Comment Code					
CR1 : Monitor and have inspected by geotechnical engineer.					
Inspector Comment					
Cracks starting to form on the waterward slope.

Perspective view of the crack on the crown of the levee looking downstream. Fall 2015.

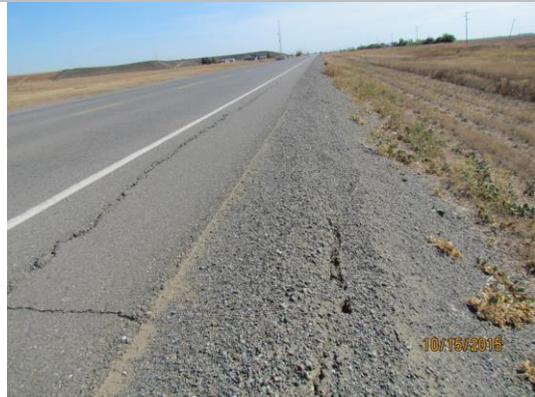
Photo 2 of 3 : SP\_2016\_ST0012\_295\_15\_20160302\_00010.jpg

Cracks are starting to form on the waterward slope of the levee looking downstream. Fall 2015.

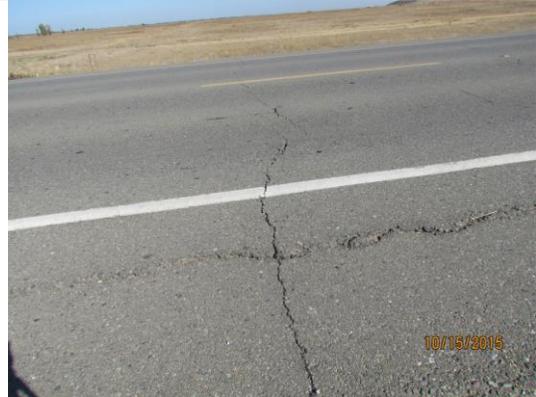
Photo 3 of 3 : SP\_2016\_ST0012\_295\_15\_20160302\_00011.jpg

LM Start	<b>1.86</b>	Rating **	A/W	Issue No.	<b>15 (cont)</b>
LM End	<b>1.88</b>	Issue Type +	Ma	Location *	CR
Category	Earthen Levee			GPS Latitude/Longitude	
				Start	End
Item	Cracking			38.590378 °	38.590379 °
				-121.699630 °	-121.699920 °
DWR ID	DWR_ST0012_01_f_2015_15				
Comment Code					
CR1 : Monitor and have inspected by geotechnical engineer.					
Inspector Comment					
Cracks starting to form on the waterward slope.

There is another crack perpendicular to the crack on the levee crown. Fall 2015.

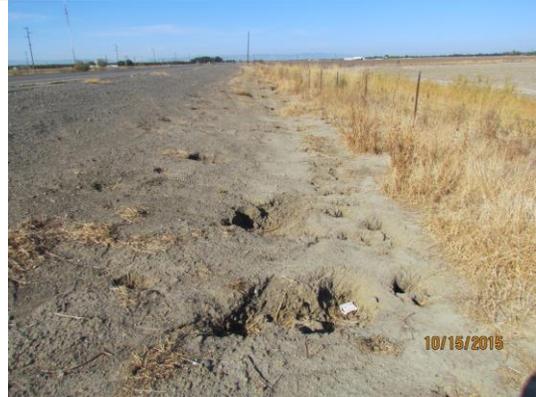
Photo 1 of 1 : SP\_2016\_ST0012\_295\_10\_20160302\_00002.jpg

LM Start	<b>2.93</b>	Rating **	M	Issue No.	<b>10</b>
LM End	<b>3.00</b>	Issue Type +	Ma	Location *	LS
Category	Earthen Levee		GPS Latitude/Longitude		
			Start	End	
Item	Erosion / Bank Caving		38.590572 °	38.590653 °	
			-121.719349 °	-121.720714 °	
DWR ID	DWR_ST0012_01_s_2015_10				
Comment Code					
E2 : Schedule repair of erosion site prior to the next inspection.					
Inspector Comment					
Area is known to erode and may be because of the material of the levee.

View of the erosion on the landward side of the levee looking upstream. Fall 2015.

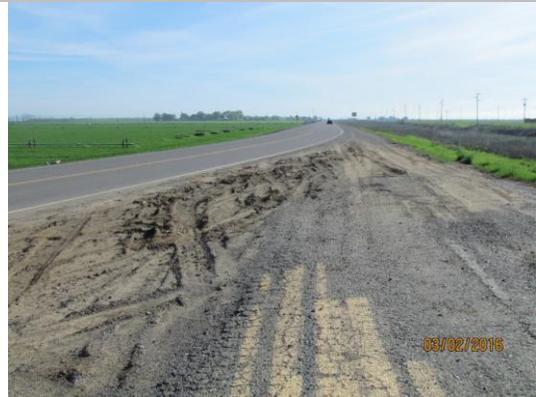
Photo 1 of 1 : SP\_2016\_ST0012\_295\_13\_20160303\_00016.jpg

LM Start	<b>3.36</b>	Rating **	M	Issue No.	<b>13</b>
LM End	<b>3.36</b>	Issue Type +	Ma	Location *	LS
Category	Earthen Levee		GPS Latitude/Longitude		
			Start	End	
Item	Crown Surface / Depressions / Rutting		38.590620 °	38.590620 °	
			-121.727385 °	-121.727385 °	
DWR ID	DWR_ST0012_01_s_2016_13				
Comment Code					
C2 : Repair depressions or ruts in the crown or slope.					
Inspector Comment

View of the ruts created by vehicles on the crown of the levee looking downstream. Spring 2016.

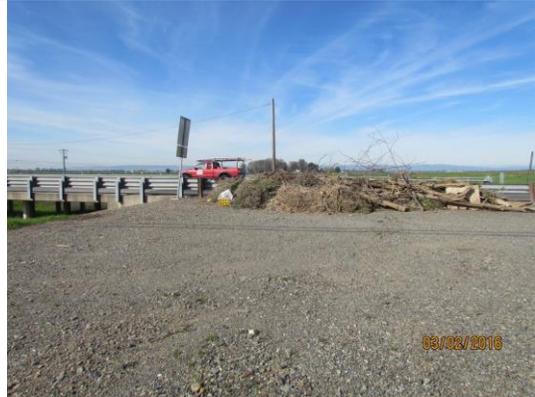
Photo 1 of 1 : SP\_2016\_ST0012\_295\_17\_20160303\_00017.jpg

LM Start	<b>3.51</b>	Rating **	M	Issue No.	<b>17</b>
LM End	<b>3.51</b>	Issue Type +	Ma	Location *	CR
Category	Earthen Levee		GPS Latitude/Longitude		
			Start	End	
Item	Encroachments		38.590751 °	38.590751 °	
			-121.730004 °	-121.730004 °	
DWR ID	DWR_ST0012_01_s_2016_17				
Comment Code					
DE : Debris					
Inspector Comment

View of the debris pile on the crown of the levee looking upstream. Spring 2016.

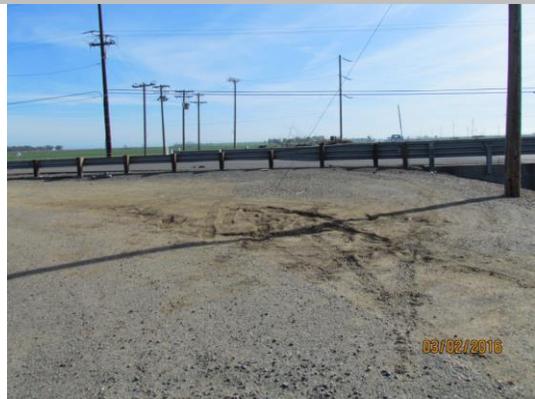
Photo 1 of 1 : SP\_2016\_ST0012\_295\_18\_20160303\_00018.jpg

LM Start	<b>3.54</b>	Rating **	M	Issue No.	<b>18</b>
LM End	<b>3.54</b>	Issue Type +	Ma	Location *	CR
Category	Earthen Levee		GPS Latitude/Longitude		
			Start	End	
Item	Crown Surface / Depressions / Rutting		38.590685 °	38.590685 °	
			-121.730657 °	-121.730657 °	
DWR ID	DWR_ST0012_01_s_2016_18				
Comment Code					
C2 : Repair depressions or ruts in the crown or slope.					
Inspector Comment

View of the ruts caused by vehicles on the crown of the levee looking downstream. Spring 2016.

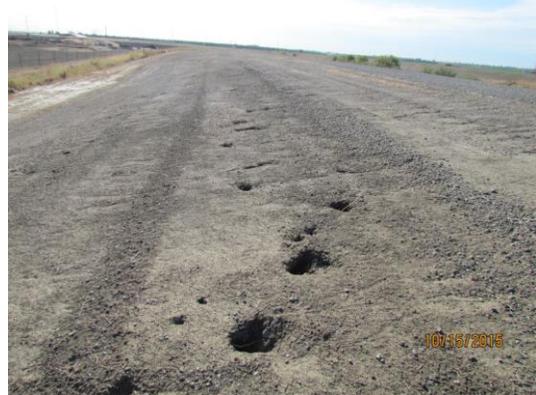
Photo 1 of 2 : SP\_2016\_ST0012\_295\_12\_20160302\_00004.jpg

LM Start	<b>3.90</b>	Rating **	M	Issue No.	<b>12</b>
LM End	<b>3.90</b>	Issue Type +	Ma	Location *	LS
Category	Earthen Levee		GPS Latitude/Longitude		
			Start	End	
Item	Cracking		38.594149 °	38.594149 °	
			-121.735254 °	-121.735254 °	
DWR ID	DWR_ST0012_01_f_2015_12				
Comment Code					
CR1 : Monitor and have inspected by geotechnical engineer.					
Inspector Comment					
The sinkholes are caused by the material of the levee and runoffs. These are not rodent holes.

View of the sinkholes on the landward side of the levee looking downstream. Fall 2015.

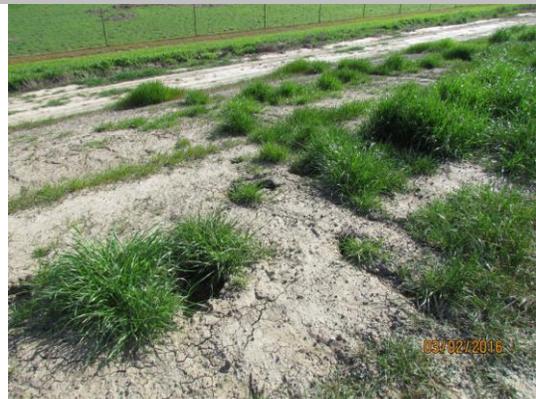
Photo 2 of 2 : SP\_2016\_ST0012\_295\_12\_20160303\_00019.jpg

View of the sinkholes on the landward side of the levee. Sinkholes are caused due to material of the levee and runoffs. Spring 2016.

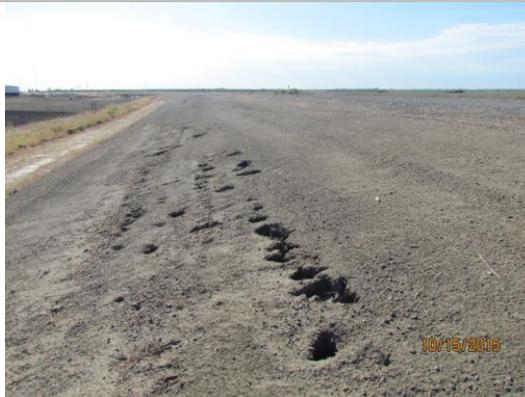
Photo 1 of 1 : SP\_2016\_ST0012\_295\_11\_20160302\_00003.jpg

LM Start	<b>3.94</b>	Rating **	M	Issue No.	<b>11</b>
LM End	<b>3.94</b>	Issue Type +	Ma	Location *	LS
Category	Earthen Levee			GPS Latitude/Longitude	
				Start	End
Item	Cracking			38.594645 °	38.594645 °
				-121.735712 °	-121.735712 °
DWR ID	DWR_ST0012_01_f_2015_11				
Comment Code					
CR1 : Monitor and have inspected by geotechnical engineer.					
Inspector Comment					
The sinkholes are caused by the material of the levee and runoffs. These are not rodent holes.

View of the sinkholes on the landward side of the levee looking downstream. Fall 2015.

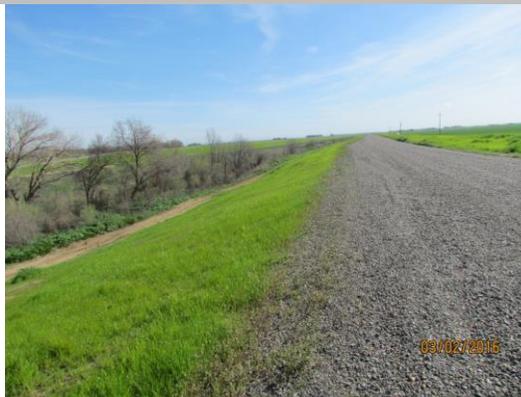
Photo 1 of 1 : SP\_2016\_ST0012\_296\_4\_20160303\_00023.jpg

LM Start	<b>0.01</b>	Rating **	A	Issue No.	<b>4</b>
LM End	<b>2.04</b>	Issue Type +	Ma	Location *	WS
Category	Earthen Levee			GPS Latitude/Longitude	
				Start	End
Item	Vegetation			38.599036 °	38.589890 °
				-121.754342 °	-121.722085 °
DWR ID	DWR_ST0012_02_s_2016_4				
Comment Code					
V1 : Control annual grass and weeds on the levee slopes and easements.					
Inspector Comment					
LMA has maintained levee slope vegetation.

View of the vegetation on the waterward side of the levee looking downstream. Spring 2016.

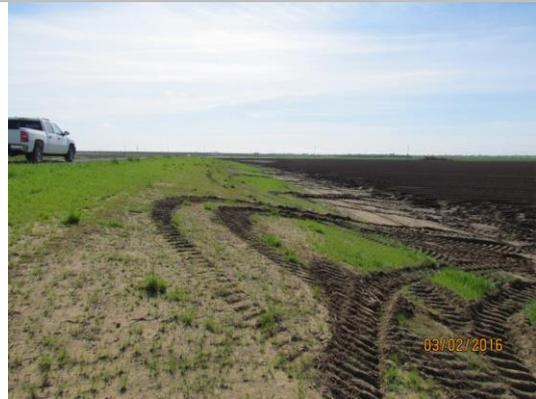
Photo 1 of 1 : SP\_2016\_ST0012\_296\_6\_20160303\_00025.jpg

LM Start	<b>1.28</b>	Rating **	M	Issue No.	<b>6</b>
LM End	<b>1.28</b>	Issue Type +	Ma	Location *	LS
Category	Earthen Levee			GPS Latitude/Longitude	
				Start	End
Item	Slope Stability			38.592503 °	38.592503 °
				-121.734801 °	-121.734801 °
DWR ID	DWR_ST0012_02_s_2016_6				
Comment Code					
S3 : Repair the levee slope damaged by vehicle traffic and prevent access where possible.					
Inspector Comment

View of the slope stability on the landward side of the levee looking downstream. Spring 2016.

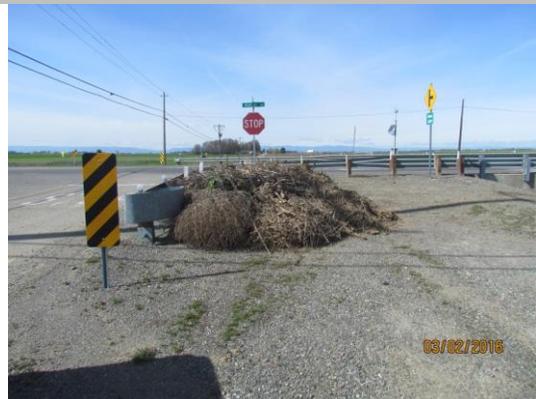
Photo 1 of 1 : SP\_2016\_ST0012\_296\_12\_20160303\_00026.jpg

LM Start	<b>1.61</b>	Rating **	M	Issue No.	<b>12</b>
LM End	<b>1.61</b>	Issue Type +	Ma	Location *	CR
Category	Earthen Levee			GPS Latitude/Longitude	
				Start	End
Item	Encroachments			38.589910 °	38.589910 °
				-121.730042 °	-121.730042 °
DWR ID	DWR_ST0012_02_s_2016_12				
Comment Code					
DE : Debris					
Inspector Comment

View of the debris pile on the crown of the levee looking upstream. Spring 2016.

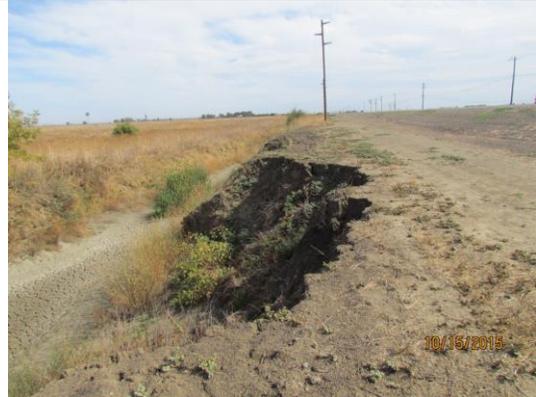
Photo 1 of 1 : SP\_2016\_ST0012\_296\_8\_20160302\_00004.jpg

LM Start	<b>1.77</b>	Rating **	M	Issue No.	<b>8</b>
LM End	<b>1.77</b>	Issue Type +	Ma	Location *	WS
Category	Earthen Levee			GPS Latitude/Longitude	
				Start	End
Item	Erosion / Bank Caving			38.589966 °	38.589966 °
				-121.727072 °	-121.727072 °
DWR ID	DWR_ST0012_02_s_2012_8				
Comment Code					
E1 : Note and monitor erosion site.					
Inspector Comment

View of the erosion on the edge of the channel looking downstream. Fall 2015.

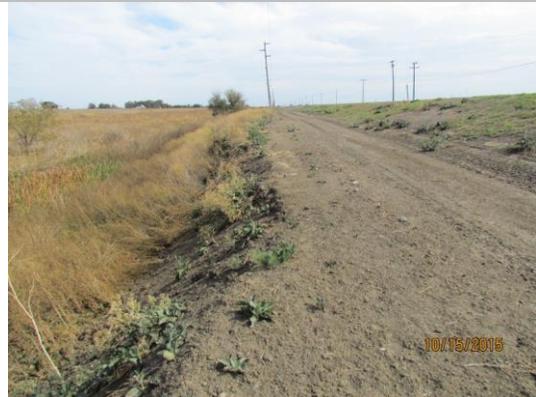
Photo 1 of 2 : SP\_2016\_ST0012\_296\_5\_20160302\_00001.jpg

LM Start	<b>2.04</b>	Rating **	M	Issue No.	<b>5</b>
LM End	<b>2.04</b>	Issue Type +	Ma	Location *	WS
Category	Earthen Levee			GPS Latitude/Longitude	
				Start	End
Item	Erosion / Bank Caving			38.589906 °	38.589906 °
				-121.722218 °	-121.722218 °
DWR ID	DWR_ST0012_02_s_2012_5				
Comment Code					
E1 : Note and monitor erosion site.					
Inspector Comment

View of the erosion on the edge of the channel on the waterward side of the levee looking downstream. Fall 2015.

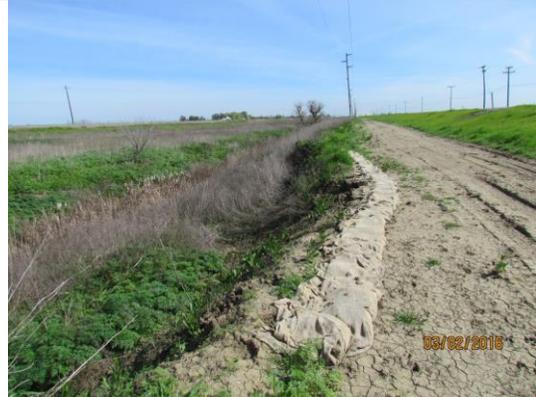
Photo 2 of 2 : SP\_2016\_ST0012\_296\_5\_20160303\_00027.jpg

View of the erosion on the edge of the channel on the waterward side of the levee looking downstream. Spring 2016.

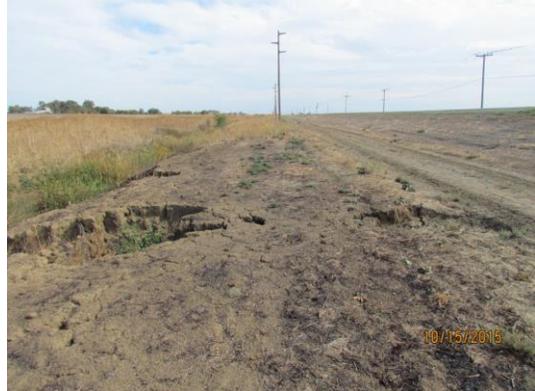
Photo 1 of 2 : SP\_2016\_ST0012\_296\_19\_20160302\_00015.jpg

View of the erosion at the edge of the channel on the waterward side of the levee looking downstream. Fall 2015.

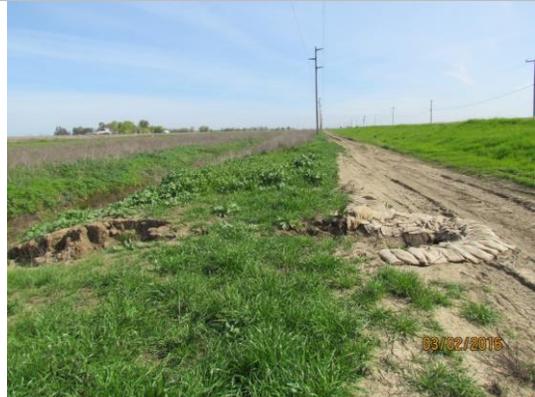
Photo 2 of 2 : SP\_2016\_ST0012\_296\_19\_20160303\_00028.jpg

View of the erosion at the edge of the channel on the waterward side of the levee looking downstream. Spring 2016.

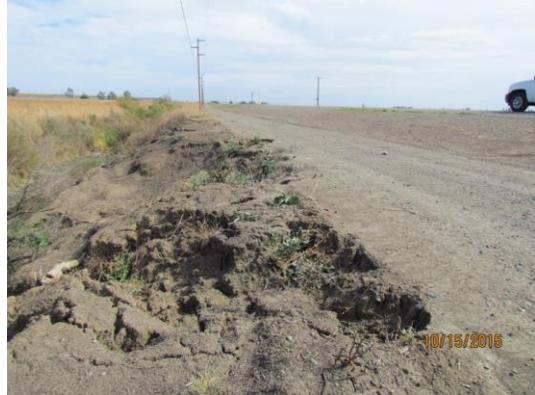
Photo 1 of 1 : SP\_2016\_ST0012\_296\_20\_20160302\_00016.jpg

View of the erosion at the edge of the channel looking downstream. Fall 2015.

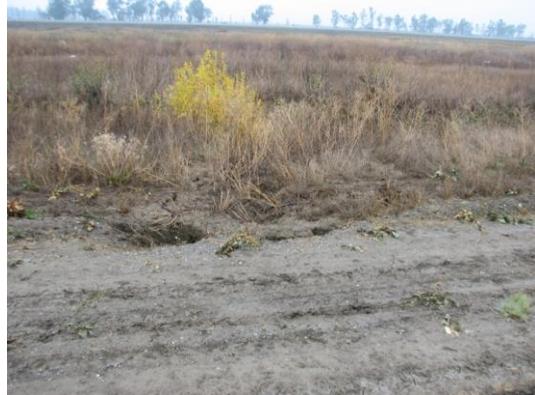
Photo 1 of 2 : SP\_2016\_ST0012\_296\_10\_20160302\_00007.jpg

LM Start	<b>2.82</b>	Rating **	M	Issue No.	<b>10</b>
LM End	<b>2.82</b>	Issue Type +	Ma	Location *	WS
Category	Earthen Levee			GPS Latitude/Longitude	
				Start	End
Item	Erosion / Bank Caving			38.589691 °	38.589691 °
				-121.707740 °	-121.707740 °
DWR ID	DWR_ST0012_02_f_2014_10				
Comment Code					
E1 : Note and monitor erosion site.					
Inspector Comment

Erosion on toe road. Fall 2014.

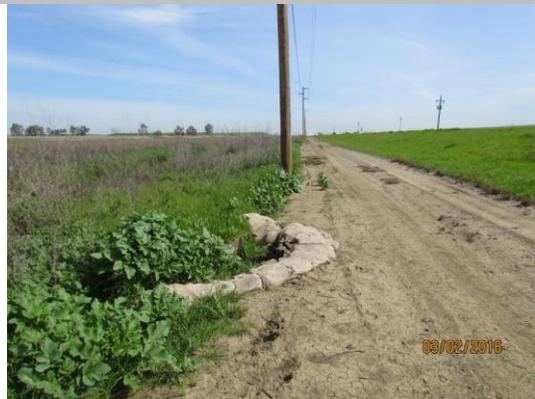
Photo 2 of 2 : SP\_2016\_ST0012\_296\_10\_20160303\_00029.jpg

View of the erosion on the toe road looking downstream. Spring 2016.

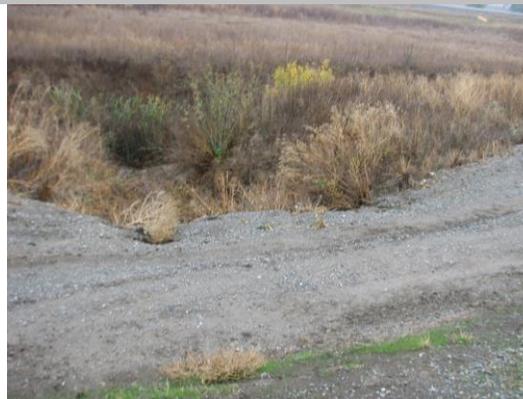
Photo 1 of 2 : SP\_2016\_ST0012\_296\_9\_20160302\_00005.jpg

Erosion on toe road. Fall 2014.

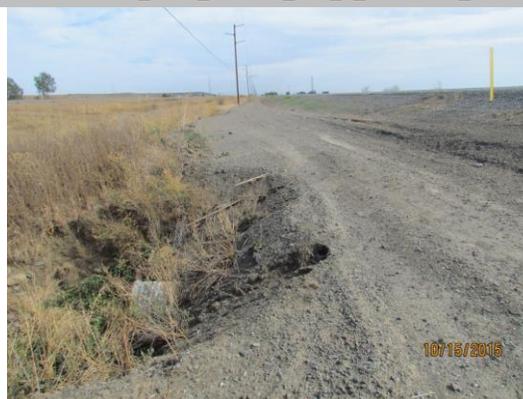
Photo 2 of 2 : SP\_2016\_ST0012\_296\_9\_20160302\_00006.jpg

View of the erosion on the waterward side of the levee looking downstream. Fall 2015.

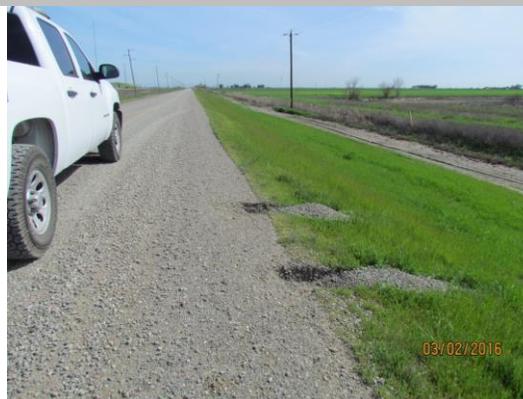
Photo 1 of 1 : SP\_2016\_ST0012\_296\_16\_20160303\_00030.jpg

LM Start	<b>3.05</b>	Rating **	M	Issue No.	<b>16</b>
LM End	<b>3.05</b>	Issue Type +	Ma	Location *	LS
Category	Earthen Levee		GPS Latitude/Longitude		
			Start	End	
Item	Slope Stability		38.589638 °	38.589638 °	
			-121.703452 °	-121.703452 °	
DWR ID	DWR_ST0012_02_s_2016_16				
Comment Code					
S3 : Repair the levee slope damaged by vehicle traffic and prevent access where possible.					
Inspector Comment

View of the slope stability on the shoulder of the levee looking downstream. Spring 2016.

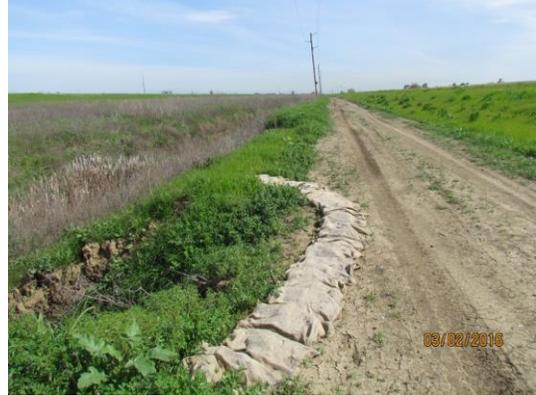
Photo 1 of 1 : SP\_2016\_ST0012\_296\_18\_20160303\_00031.jpg

View of the erosion on the waterward side looking downstream. Spring 2016.

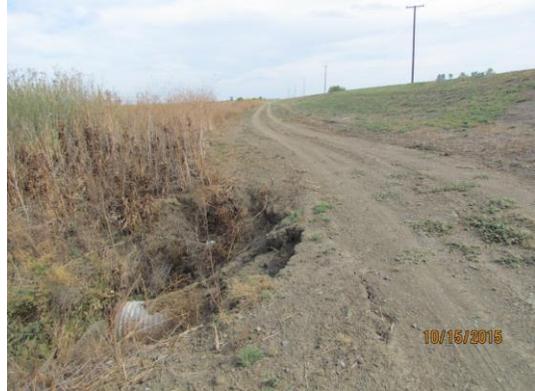
Photo 1 of 1 : SP\_2016\_ST0012\_296\_11\_20160302\_00008.jpg

View of the erosion at the edge of the channel on the waterward side of the levee looking downstream. Fall 2015.

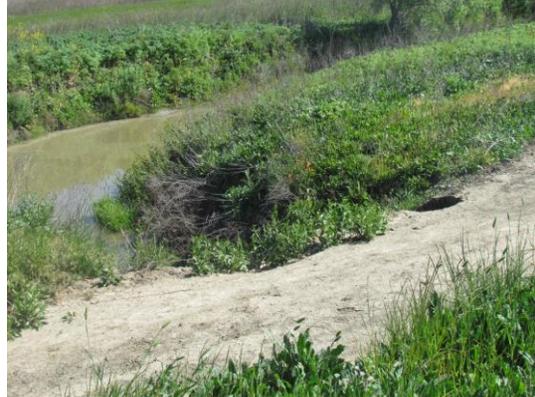
Photo 1 of 2 : SP\_2016\_ST0012\_296\_15\_20160302\_00012.jpg

LM Start	<b>5.05</b>	Rating **	M	Issue No.	<b>15</b>
LM End	<b>5.05</b>	Issue Type +	Ma	Location *	WS
Category	Earthen Levee			GPS Latitude/Longitude	
				Start	End
Item	Erosion / Bank Caving			38.589570 °	38.589570 °
				-121.666588 °	-121.666588 °
DWR ID	DWR_ST0012_02_s_2015_15				
Comment Code					
E1 : Note and monitor erosion site.					
Inspector Comment

View of the erosion on the edge of the channel on the waterward side of the levee. Spring 2015.

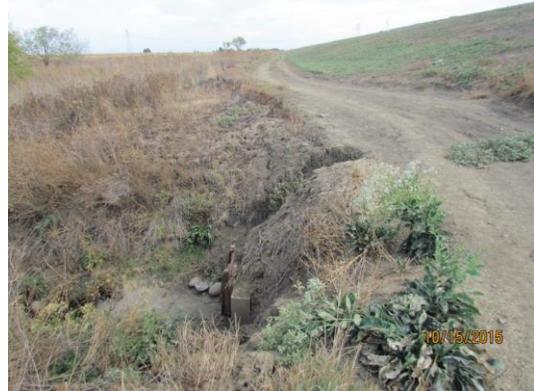
Photo 2 of 2 : SP\_2016\_ST0012\_296\_15\_20160302\_00013.jpg

View of the erosion at the edge of the channel on the waterward side of the levee looking downstream. Fall 2015.

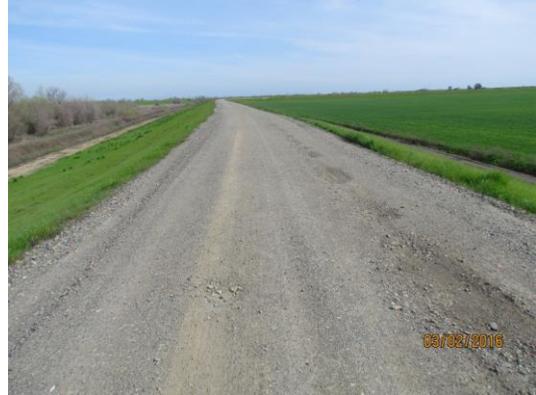
Photo 1 of 1 : SP\_2016\_ST0012\_296\_25\_20160303\_00035.jpg

View of the crown of the levee looking downstream. Road needs to be regraded. Spring 2016.
