**Flood Control Project Maintenance
Levee Inspections**

Fall 2014 Levee Maintenance Deficiency Summary Report

Sutter Maintenance Yard Murphy Slough at M&T Ranch

Waterway			Bank	Unit Miles
Unit No. 01 Murphy Slough at M&T Ranch			Left	0.83
	Spring (March - May)	Summer (June - August)	(September - November) Fall	Winter (December - February)
Unit Maintenance Rating (Fall Only)			U	
Date of Inspection	04/11/2014 - 04/11/2014		11/17/2014 - 11/17/2014	
DWR Inspector	Bob Duffey		Bob Duffey	
Accompanied By	Jason Cooper Sutter Maintenance Yard		Jason Cooper Sutter Maintenance Yard

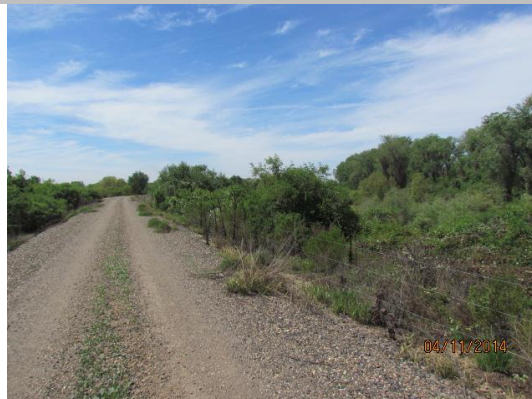
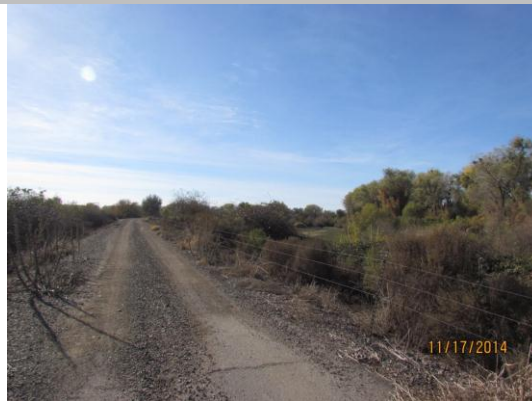
LM Start	0.00	Rating **	M	Issue No.	1
LM End	0.09	Issue Type +	Ma	Location *	WS
Category	Earthen Levee			GPS Latitude/Longitude	
				Start	End
Item	Vegetation			39.667534 °	39.666836 °
				-121.959612 °	-121.960897 °
DWR ID	DWR_NA0014_01_s_2012_1				
Action/Comments					
Elderberries are blocking visibility and flood fight capability.

View of the elderberries along the waterside slope.

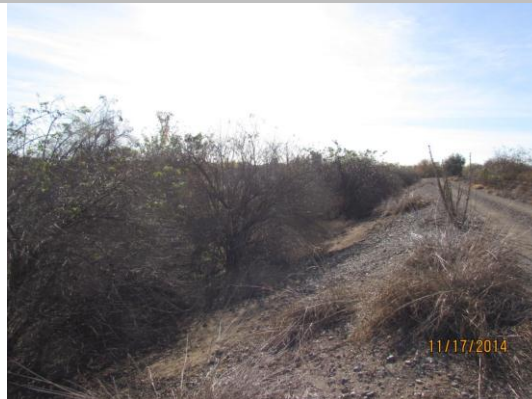
Photo 1 of 1 : FA_2014_ST0014_372_4_20141118_00004.jpg

LM Start	0.00	Rating **	M	Issue No.	4
LM End	0.09	Issue Type +	Ma	Location *	LS
Category	Earthen Levee			GPS Latitude/Longitude	
				Start	End
Item	Vegetation			39.667708 °	39.666983 °
				-121.959817 °	-121.960997 °
DWR ID	DWR_NA0014_01_s_2012_4				
Action/Comments					
Elderberries are blocking visibility and flood fight capability.

View of the elderberries along the landside toe.

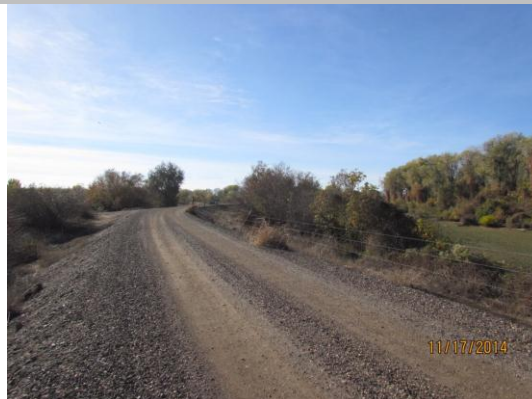
Photo 1 of 1 : FA_2014_ST0014_372_5_20141118_00006.jpg

View of the vegetation along the waterside slope.

LM Start	0.00	Rating **	M	Issue No.	5
LM End	0.20	Issue Type +	Ma	Location *	WS
Category	Earthen Levee			GPS Latitude/Longitude	
				Start	End
Item	Vegetation			39.666988 °	39.666988 °
				-121.960993 °	-121.960993 °
DWR ID	DWR_NA0014_01_s_2012_5				
Action/Comments					
Remove the wild growth other than native grasses from the levee slopes.

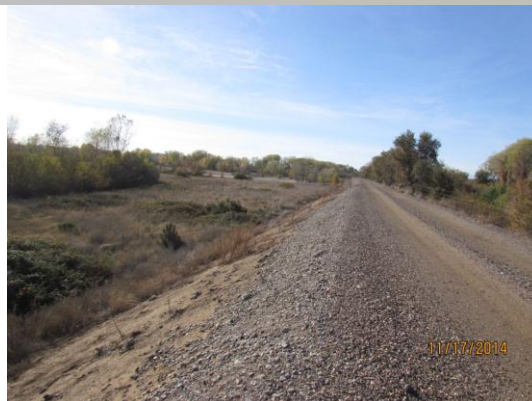
Photo 1 of 1 : FA_2014_ST0014_372_7_20141118_00007.jpg

View of controlled vegetation on the landside slope.

LM Start	0.00	Rating **	A	Issue No.	7
LM End	0.70	Issue Type +	Ma	Location *	LS
Category	Earthen Levee			GPS Latitude/Longitude	
				Start	End
Item	Vegetation			39.666755 °	39.670512 °
				-121.961235 °	-121.970407 °
DWR ID	DWR_ST0014_01_f_2014_7				
Action/Comments					
Control annual grass and weeds on the levee slopes and easements.
