**Flood Control Project Maintenance  
Levee Inspections**

**Fall 2016 Levee Maintenance Deficiency Summary Report**

**Sutter Maintenance Yard Murphy Slough at M&T Ranch**

**Levee Inspection Report By Mile - Fall 2016**

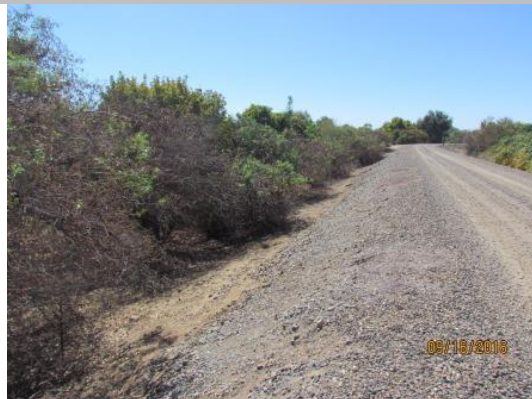
Photo 1 of 1 : FA\_2016\_ST0014\_372\_5\_20160923\_00001.jpg

LM Start	0.00	Rating **	A	Issue No.	5	
LM End	0.00	Issue Type +	Ma	Location *	CR	
Category	Earthen Levee			GPS Latitude/Longitude		
				Start		End
Item	Crown Surface / Depressions / Rutting			39.667534 °		°
				-121.959600 °		°
DWR ID	DWR_ST0014_01_f_2016_5					
Comment Code						
C1 : Add appropriate material and re-grade the levee to bring the crown above the design elevation.						
Inspector Comment						
The crown is adequately maintained.

Crown roadway.
