**Flood Control Project Maintenance  
Levee Inspections**

**Fall 2017 Levee Maintenance Deficiency Summary Report**

**Sutter Maintenance Yard Murphy Slough at M&T Ranch**

**Levee Inspection Report By Mile - Fall 2017**

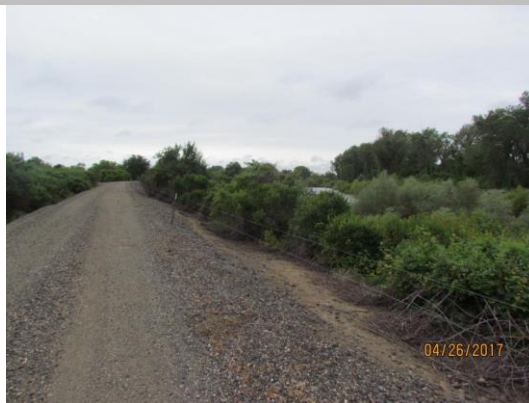
Photo 1 of 1 : FA\_2017\_ST0014\_372\_1\_20170911\_00001.jpg

LM Start	0.00	Rating **	M	Issue No.	1
LM End	0.09	Issue Type +	Ma	Location *	WS
Category	Earthen Levee			GPS Latitude/Longitude	
				Start	End
Item	Vegetation			39.667534 °	39.666836 °
				-121.959612 °	-121.960897 °
DWR ID	DWR_NA0014_01_s_2012_1				
Comment Code					
V4 : Elderberries are blocking visibility and flood fight capability.					
Inspector Comment

View of the elderberries along the waterside toe.

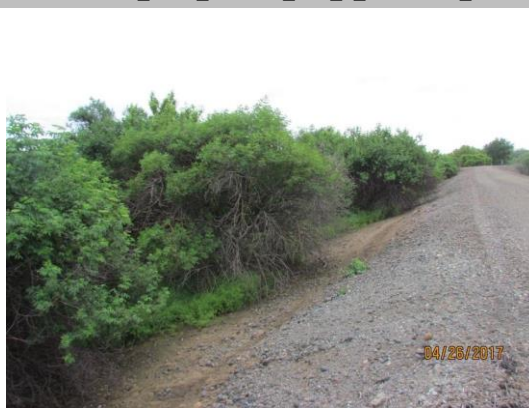
Photo 1 of 1 : FA\_2017\_ST0014\_372\_4\_20170911\_00002.jpg

LM Start	0.00	Rating **	M	Issue No.	4
LM End	0.09	Issue Type +	Ma	Location *	LS
Category	Earthen Levee			GPS Latitude/Longitude	
				Start	End
Item	Vegetation			39.667708 °	39.666983 °
				-121.959817 °	-121.960997 °
DWR ID	DWR_NA0014_01_s_2012_4				
Comment Code					
V4 : Elderberries are blocking visibility and flood fight capability.					
Inspector Comment

View of the elderberries along the landside toe.

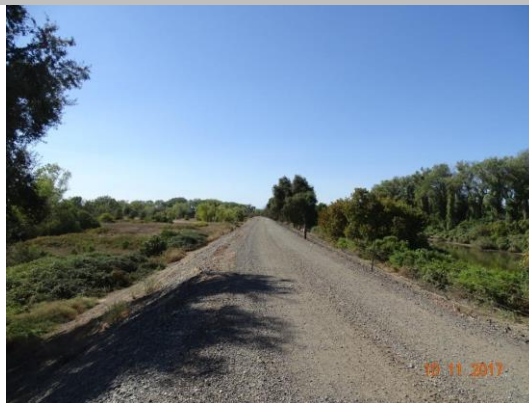
Photo 1 of 1 : FA\_2017\_ST0014\_372\_5\_20171019\_00003.jpg

LM Start	0.11	Rating **	A	Issue No.	5
LM End	0.83	Issue Type +	Ma	Location *	LS
Category	Earthen Levee			GPS Latitude/Longitude	
				Start	End
Item	Vegetation			39.666907 °	39.670728 °
				-121.960853 °	-121.970432 °
DWR ID	DWR_ST0014_01_f_2017_5				
Comment Code					
V1 : Control annual grass and weeds on the levee slopes and easements.					
Inspector Comment					
There is no grass on either slope.

View of no grasses on both slopes.
