**Flood Control Project Maintenance
Levee Inspections**

Fall 2019 Levee Maintenance Deficiency Summary Report

Sacramento River Basin

Sutter Maintenance Yard Murphy Slough at M&T Ranch

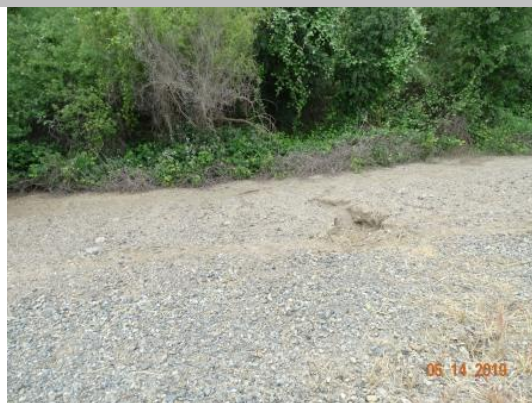
Photo 1 of 1 : FA_2019_ST0014_372_5_20190822_00003.jpg

LM Start	0.56	Rating **	M	Issue No.	5
LM End	0.56	Issue Type +	Ma	Location *	LS
Category	Earthen Levee			GPS Latitude/Longitude	
				Start	End
Item	Erosion / Bank Caving			39.667026 °	39.667026 °
				-121.968890 °	-121.968890 °
DWR ID	DWR_ST0014_01_s_2019_5				
Comment Code					
E2 : Schedule repair of erosion site prior to the next inspection.					
Inspector Comment

View of the erosion on the landside slope. Spring 2019.
