Flood Control Project Maintenance Levee Inspections

Fall 2020 Levee Maintenance Deficiency Summary Report

Sacramento River Basin

Sutter Maintenance Yard Murphy Slough at M&T Ranch

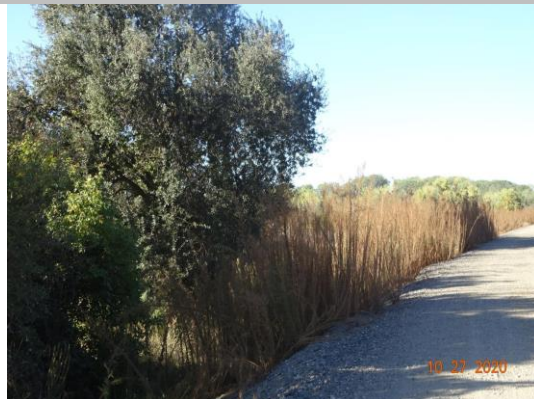
Photo 1 of 1 : FA_2020_ST0014_372_7_20201103_00005.jpg

LM Start	0.12	Rating **	M	Issue No.	7
LM End	0.63	Issue Type +	Ma	Location *	LS
Category	Earthen Levee			GPS Latitude/Longitude	
				Start	End
Item	Vegetation			39.666786 °	39.668049 °
				-121.961007 °	-121.969178 °
DWR ID	DWR_ST0014_01_f_2020_7				
Comment Code					
V1 : Control annual grass and weeds on the levee slopes and easements.					
Inspector Comment

View of the vegetation along the landside slope. Fall 2020.

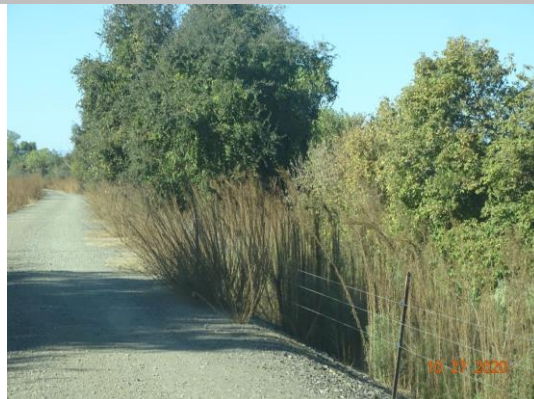
Photo 1 of 1 : FA_2020_ST0014_372_13_20201103_00008.jpg

LM Start	0.13	Rating **	M	Issue No.	13
LM End	0.15	Issue Type +	Ma	Location *	WS
Category	Earthen Levee			GPS Latitude/Longitude	
				Start	End
Item	Vegetation			39.666739 °	39.666688 °
				-121.961250 °	-121.961636 °
DWR ID	DWR_ST0014_01_f_2020_13				
Comment Code					
V1 : Control annual grass and weeds on the levee slopes and easements.					
Inspector Comment

View of the vegetation along the waterside slope. Fall 2020.

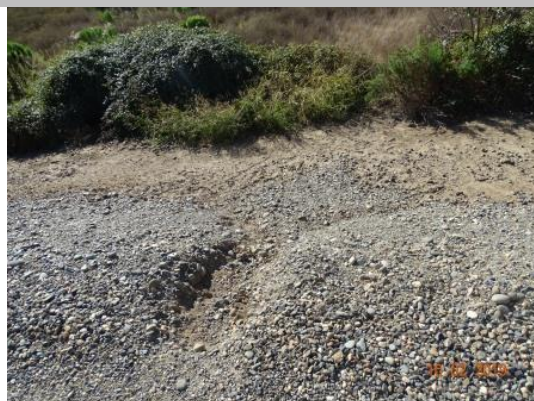
Photo 1 of 1 : FA_2020_ST0014_372_10_20200915_00003.jpg

LM Start	0.24	Rating **	M	Issue No.	10
LM End	0.24	Issue Type +	Ma	Location *	LS
Category	Earthen Levee			GPS Latitude/Longitude	
				Start	End
Item	Erosion / Bank Caving			39.666506 °	39.666506 °
				-121.963237 °	-121.963237 °
DWR ID	DWR_ST0014_01_f_2019_10				
Comment Code					
E2 : Schedule repair of erosion site prior to the next inspection.					
Inspector Comment

View of the erosion at the landside shoulder and slope. Fall 2019.

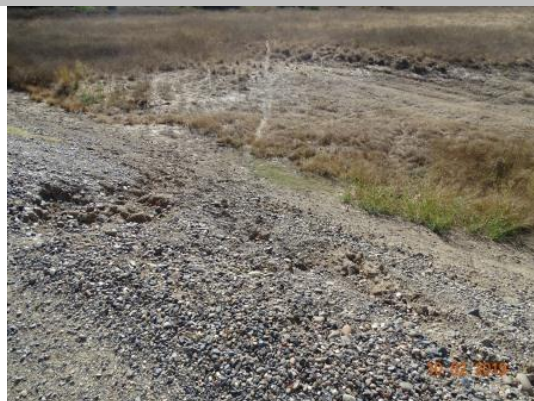
Photo 1 of 1 : FA_2020_ST0014_372_11_20200915_00004.jpg

LM Start	0.28	Rating **	M	Issue No.	11
LM End	0.28	Issue Type +	Ma	Location *	LS
Category	Earthen Levee			GPS Latitude/Longitude	
				Start	End
Item	Erosion / Bank Caving			39.666403 °	39.666403 °
				-121.964004 °	-121.964004 °
DWR ID	DWR_ST0014_01_f_2019_11				
Comment Code					
E2 : Schedule repair of erosion site prior to the next inspection.					
Inspector Comment

View of the erosion at the landside slope. Fall 2019.

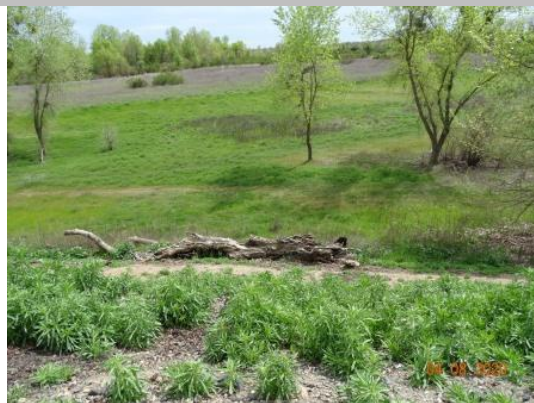
Photo 1 of 1 : FA_2020_ST0014_372_8_20200915_00002.jpg

LM Start	0.31	Rating **	M	Issue No.	8
LM End	0.31	Issue Type +	Ma	Location *	LS
Category	Earthen Levee			GPS Latitude/Longitude	
				Start	End
Item	Encroachments			39.666319 °	39.666319 °
				-121.964544 °	-121.964544 °
DWR ID	DWR_ST0014_01_s_2019_8				
Comment Code					
TR : Tree or limb					
Inspector Comment					
The tree should be removed from the landside toe.

View of the tree at the landside toe. Spring 2020.

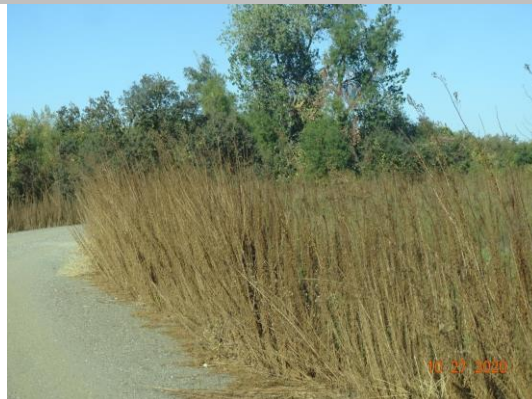
Photo 1 of 1 : FA_2020_ST0014_372_14_20201103_00009.jpg

LM Start	0.50	Rating **	M	Issue No.	14
LM End	0.61	Issue Type +	Ma	Location *	WS
Category	Earthen Levee			GPS Latitude/Longitude	
				Start	End
Item	Vegetation			39.666453 °	39.667646 °
				-121.967970 °	-121.969069 °
DWR ID	DWR_ST0014_01_f_2020_14				
Comment Code					
V1 : Control annual grass and weeds on the levee slopes and easements.					
Inspector Comment

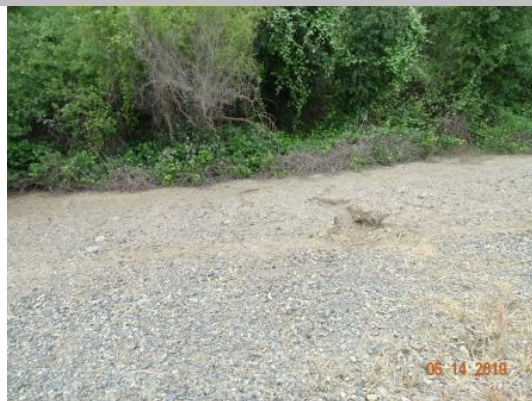
Photo 1 of 1 : FA_2020_ST0014_372_5_20200915_00001.jpg

LM Start	0.56	Rating **	M	Issue No.	5
LM End	0.56	Issue Type +	Ma	Location *	LS
Category	Earthen Levee			GPS Latitude/Longitude	
				Start	End
Item	Erosion / Bank Caving			39.667026 °	39.667026 °
				-121.968890 °	-121.968890 °
DWR ID	DWR_ST0014_01_s _ 2019_5				
Comment Code					
E2 : Schedule repair of erosion site prior to the next inspection.					
Inspector Comment

View of the erosion on the landside slope. Spring 2019.
