**Flood Control Project Maintenance
Levee Inspections**

Fall 2021 Levee Maintenance Deficiency Summary Report

Sutter Maintenance Yard Murphy Slough at M&T Ranch

Waterway			Bank	Unit Miles
Unit No. 01 Murphy Slough at M&T Ranch			Left	0.83
	Spring (March - May)	Summer (June - August)	(September - November) Fall	Winter (December - February)
Unit Maintenance Rating (Fall Only)			U	
Date of Inspection	3/23/2021 - 3/23/2021		10/19/2021 - 10/19/2021	
DWR Inspector	Makar Sokol		Makar Sokol	
Accompanied By

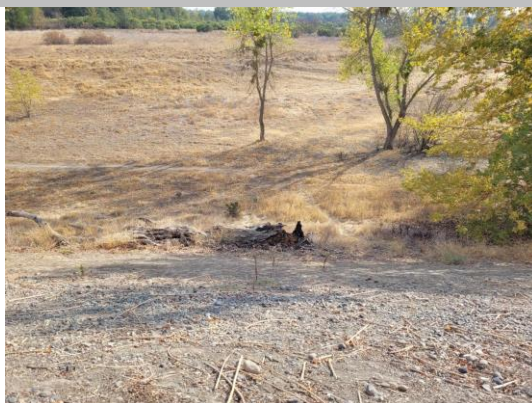
Photo 1 of 1 : FA_2021_ST0014_372_8_20211028_00005.jpg

LM Start	0.31	Rating **	M	Issue No.	8
LM End	0.31	Issue Type +	Ma	Location *	LS
Category	Earthen Levee			GPS Latitude/Longitude	
				Start	End
Item	Encroachments			39.666319 °	39.666319 °
				-121.964544 °	-121.964544 °
DWR ID	DWR_ST0014_01_s_2019_8				
Comment Code					
TR : Tree or limb					
Inspector Comment					
The downed tree should be removed from the landside toe.

View of the downed tree at the landside toe. Fall 2021.
